February 3, 2020

File: 16-1856

**RE: ENGINEER'S ORDER CLOSE-OUT REPORT: GARDOM POND DECOMMISSIONING - CONTRACT 16-1856**

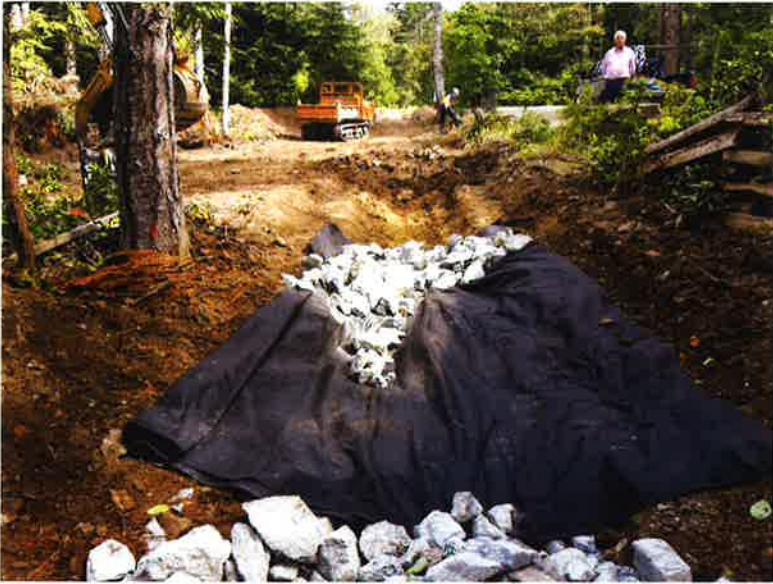
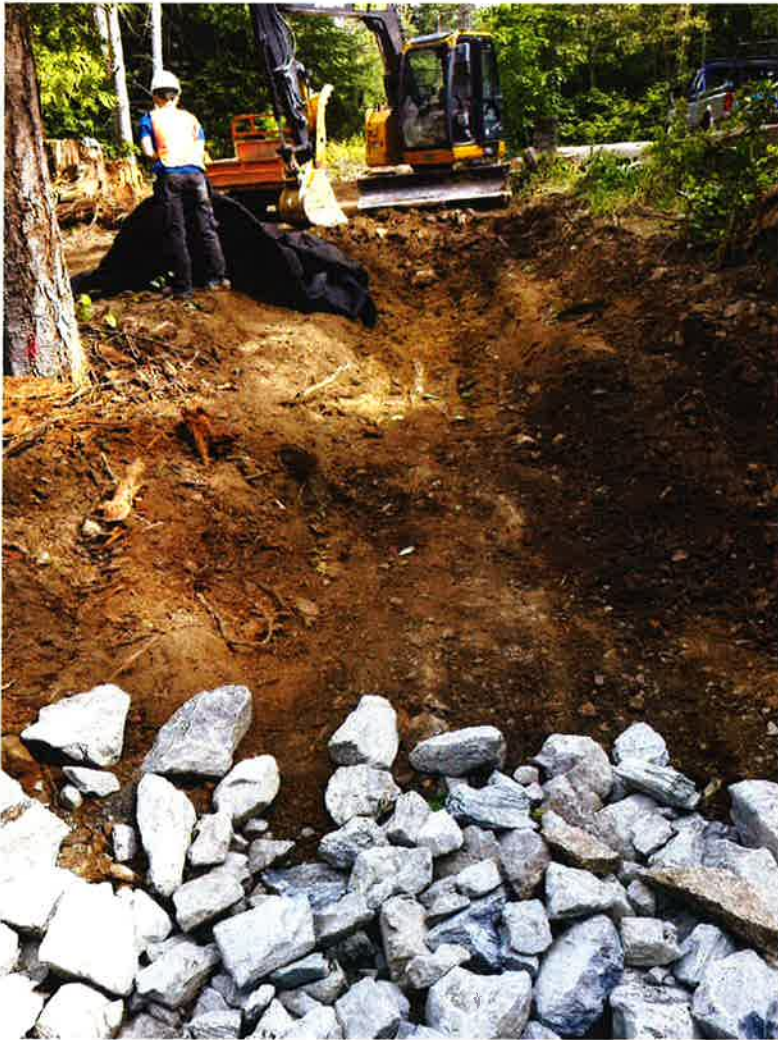
Neighbor had tree fallers on site. Neighbor advised that he had concerns with the tree shown in the picture due to root compromise.

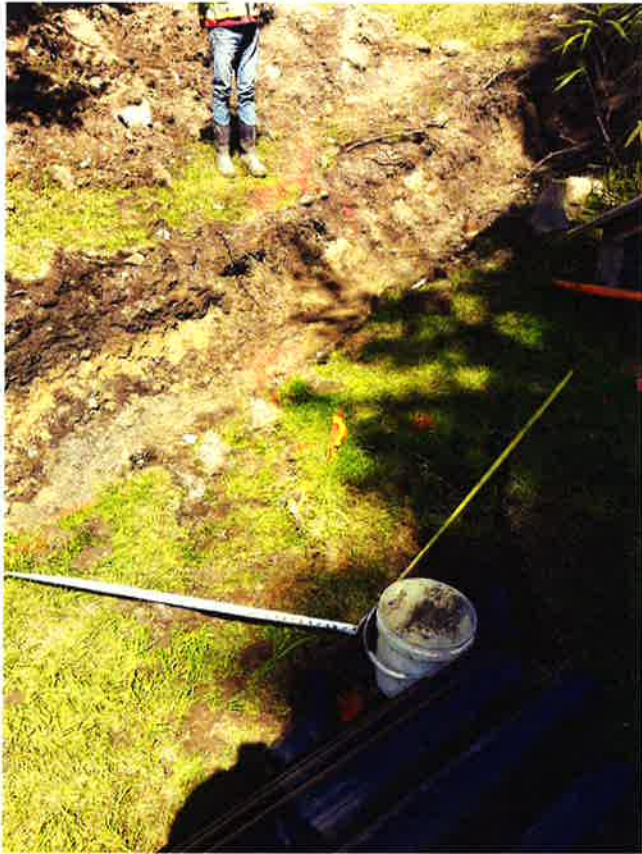
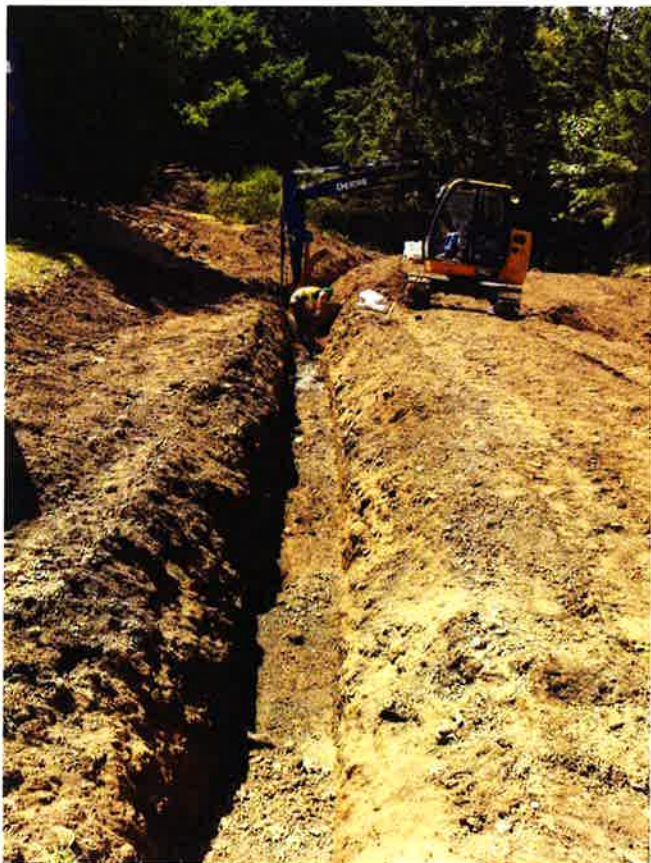
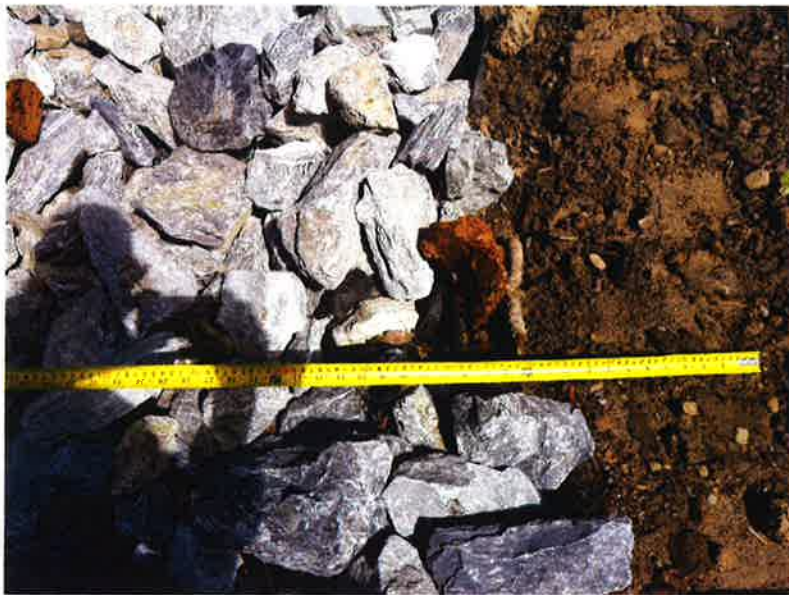
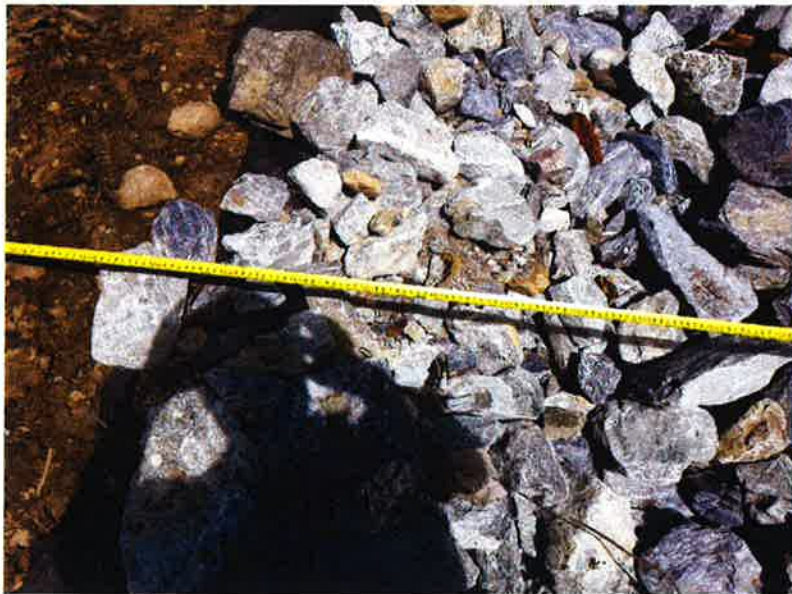
The watermain was more parallel to the proposed ditch and closer to the ditch than the existing right of way would indicate. A 45 degree bend was necessary. Laid this out (where water bucket is in picture) and flange location on the ground. Advised that the portion under the ditch should be left loose for easier tie in later.

Joe / Ben advised that they rushed getting the ditch and riprap up to the road in preparation for rain. We recommend that AESL review the ditch and riprap to ensure that the ditch widths, depths, and riprap depth meet the required section. It is expected that some adjustments will be required.

Checking and adjustments should be made before carrying on up the hill so that methods can be adjusted where required.

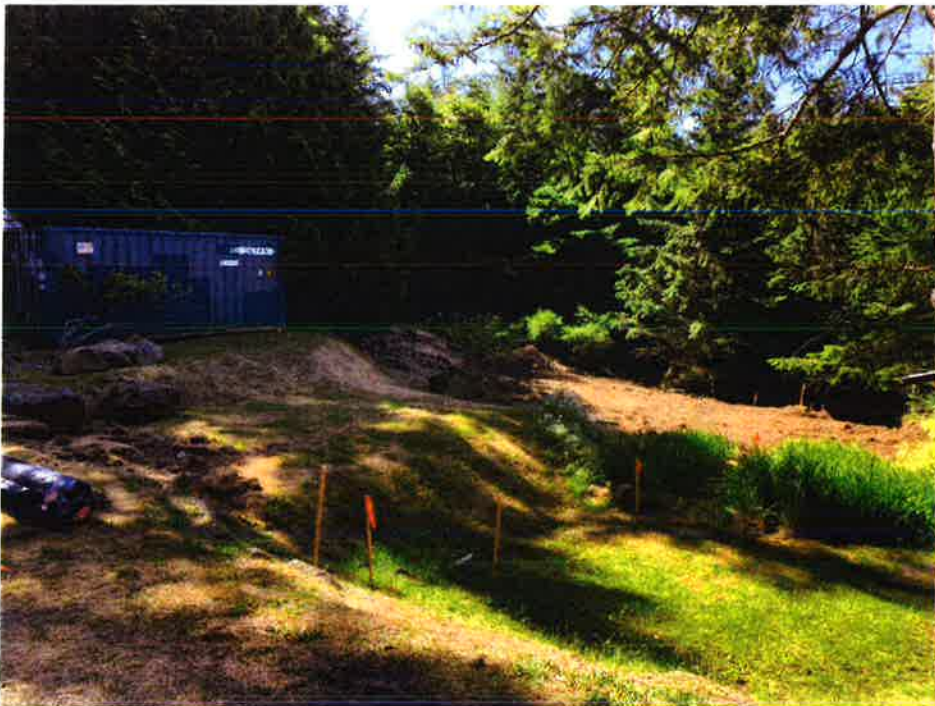
Sewer (above) and RPID 4" water (below) exposed. (pipe to the right was old unused pipe to take surface water through Al's rock garden).

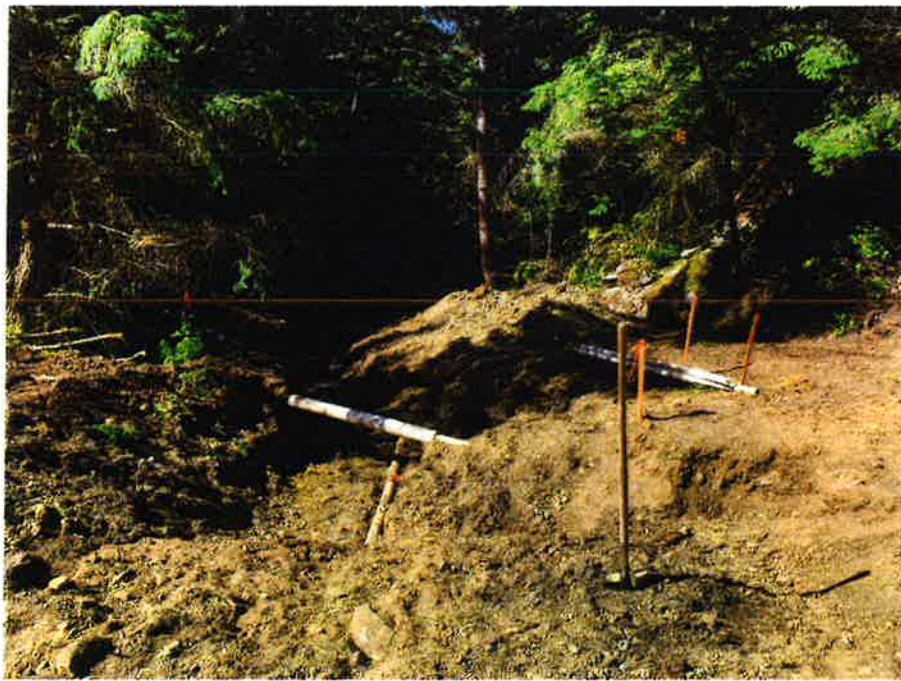
ADVANCED ENERGY SYSTEMS MANAGEMENT CORP.  
Gardom Pond Dam Decommissioning – Weekly Progress Report  
Contract 16-1856C  
Suspected RPID leak. Diverted from work area.

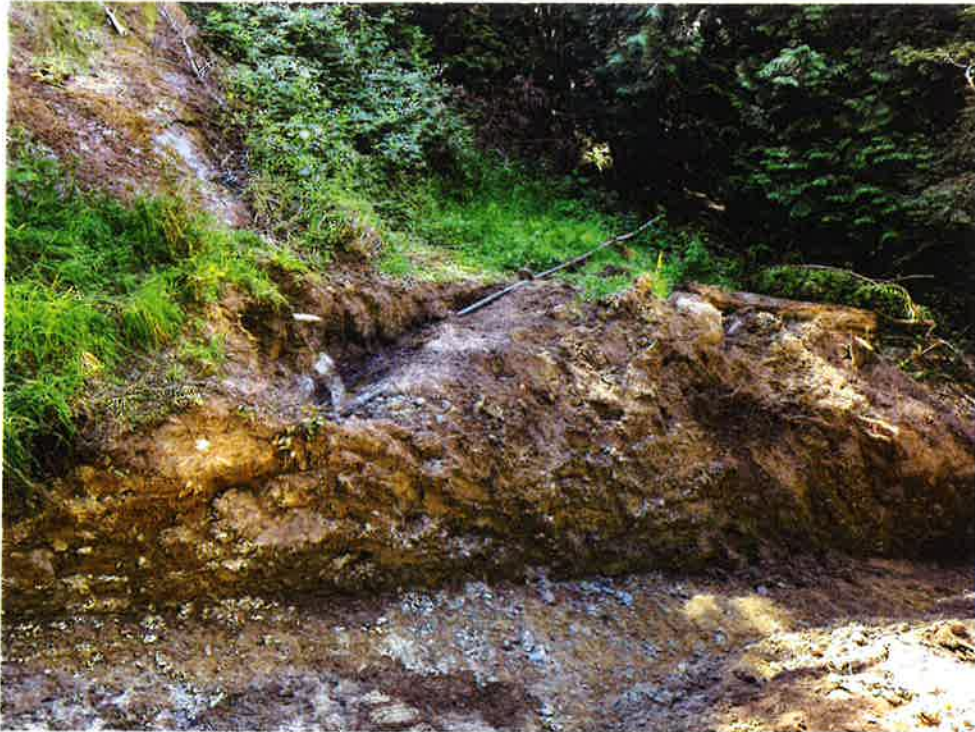
RPID diversion ditch. Mostly completed. 2" line (right) and 4" line (left by shovel) exposed.

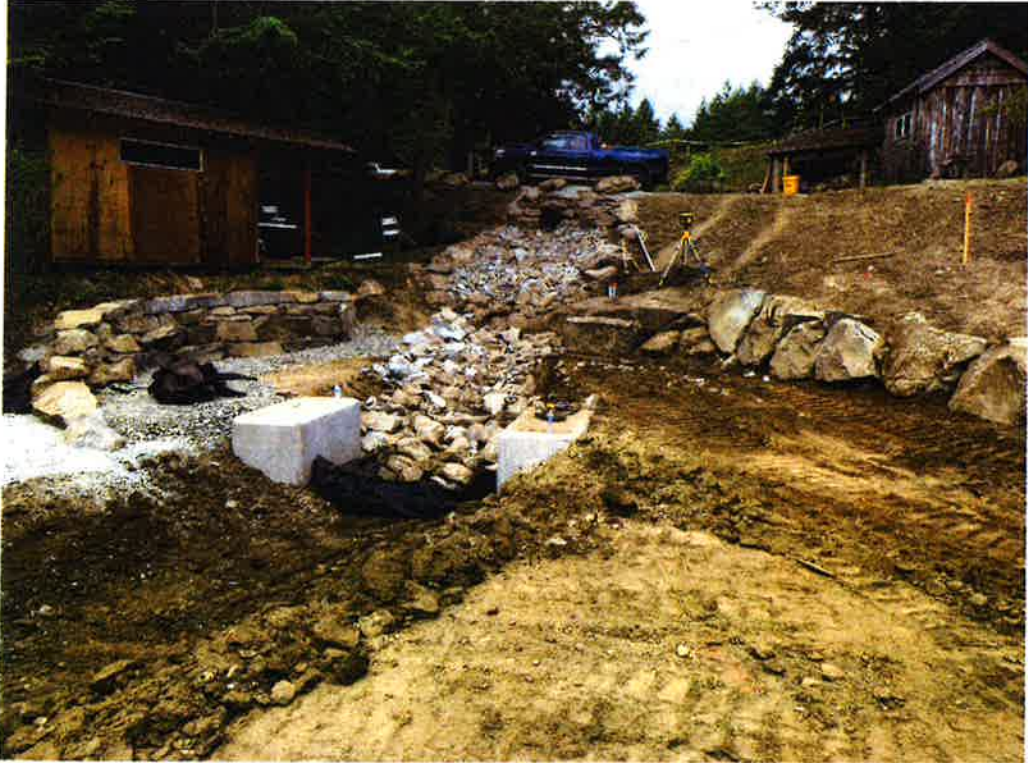
ADVANCED ENERGY SYSTEMS MANAGEMENT CORP.  
Gardom Pond Dam Decommissioning – Progress Report  
Contract 16-1856C  
**Larger Rocks Added to Steep Section of Riprap Channel**
