# Memo

**SUBJECT:** 2017 ANNUAL DAM INSPECTION REPORT – GARDOM POND

## ANNUAL 2017 DAM INSPECTION REPORT GARDOM POND DAM

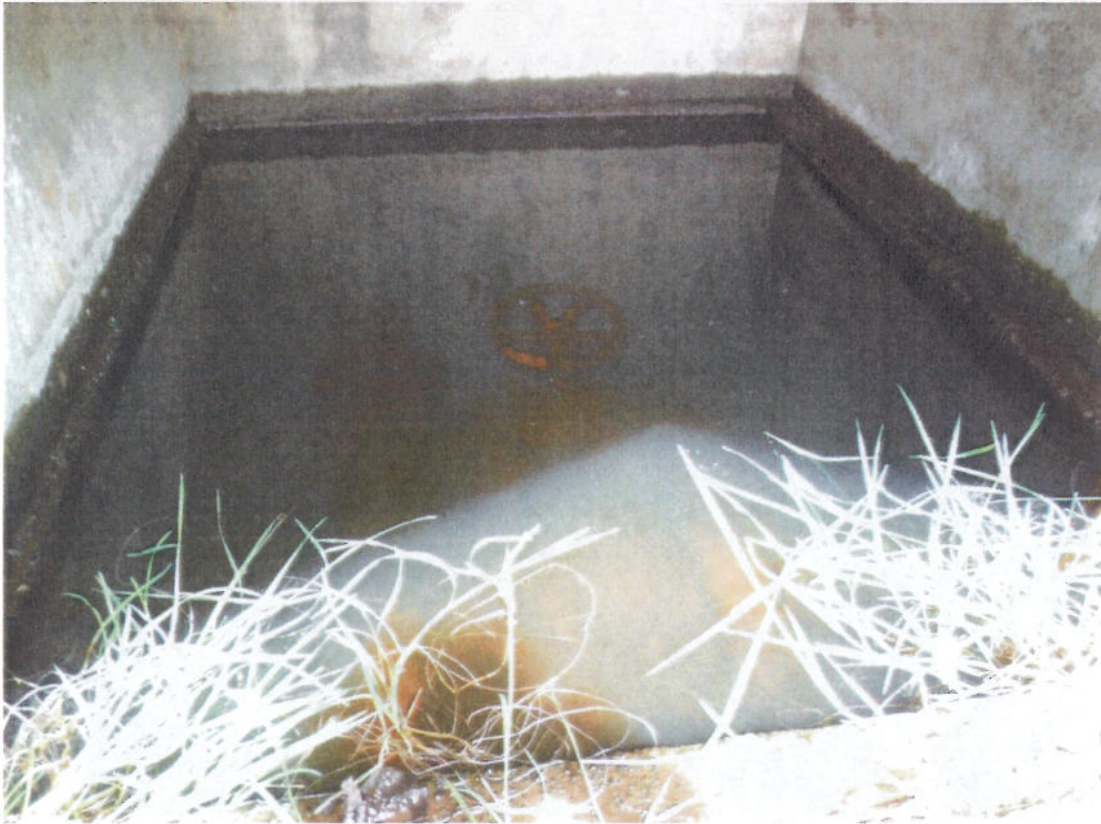
• Valve Chamber		X				Fully submerged valve chamber. No visible seepage, however the ground was quite wet directly below the valve chamber. Recommendation to install a drain from concrete chamber to daylight where seepage flows can be measured. Outlet gate valves were not operated due to concerns regarding the integrity of the valves and pipe-works. An investigation should be completed to either repair or replace the pipe-works.

Gardom Pond Dam valve chamber at downstream toe. Water level staff gauge should be installed. Drain pipe should be installed to keep chamber dry and to monitor seepage into the chamber.

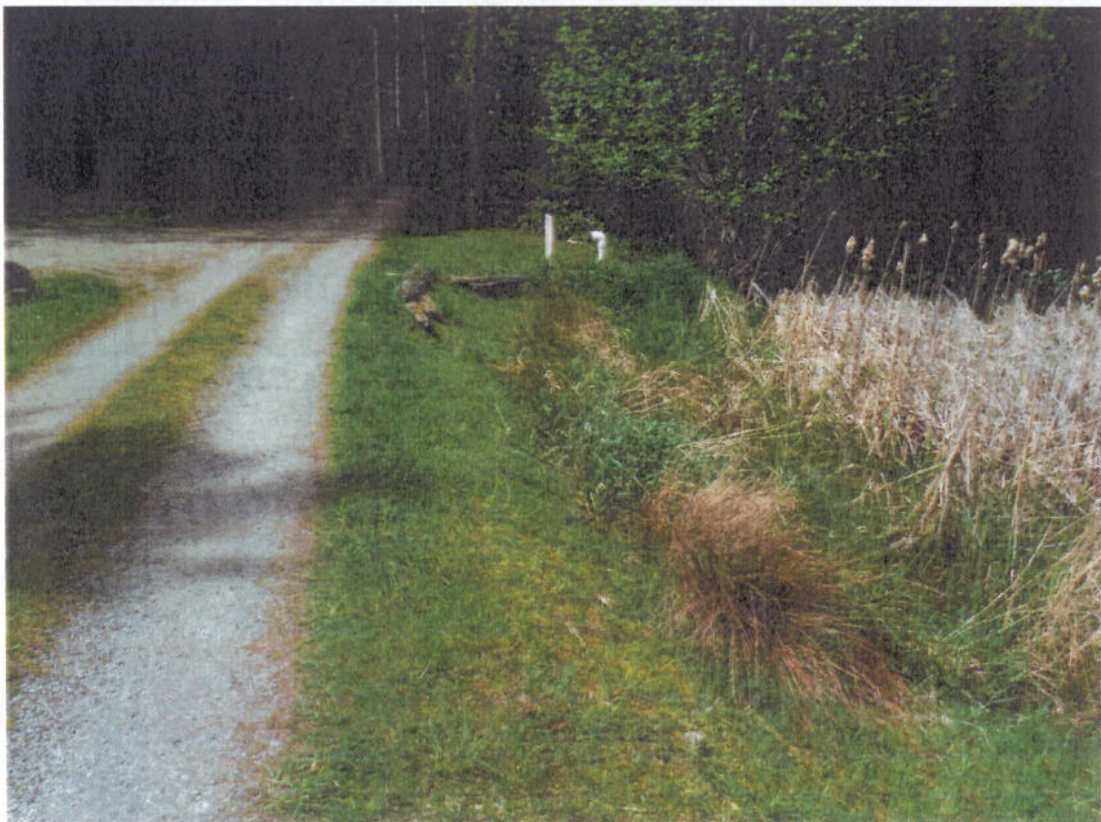
• Excessive vegetation		X				
• Signs of Deterioration	X					
<b>b) Dam Crest - check for:</b>						
• Cracking and Differential Movement	X					Driveway crosses dam with distinct wheel depressions. Depressions should be filled so water can flow freely from dam crest.

Gardom Pond Dam – Ruts in the road on the dam crest should be filled. Upstream face should be brushed to facilitate inspection.

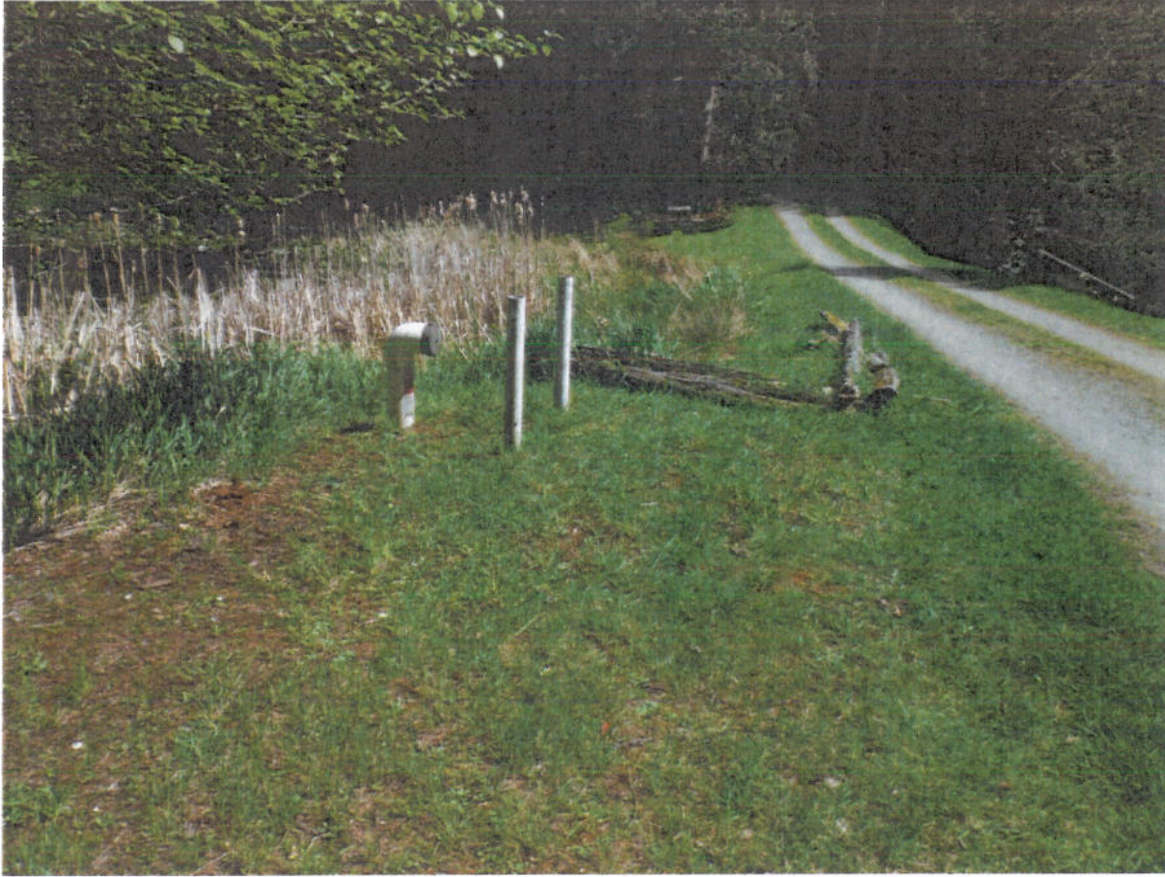
Condition					Remarks/Recommendations
	S	F	P	U	NI	
<b>1. Structure</b>						
<b>a) Upstream Face of Dam - check for:</b>						
• Cracking and Differential Movement	X					Brushing required near waterline. Unable to fully inspect embankment due to vegetation. Large tree to be removed at east end of dam Small trees to be removed at west end of dam

Gardom Pond Dam – Remove vegetation on upstream face of dam.

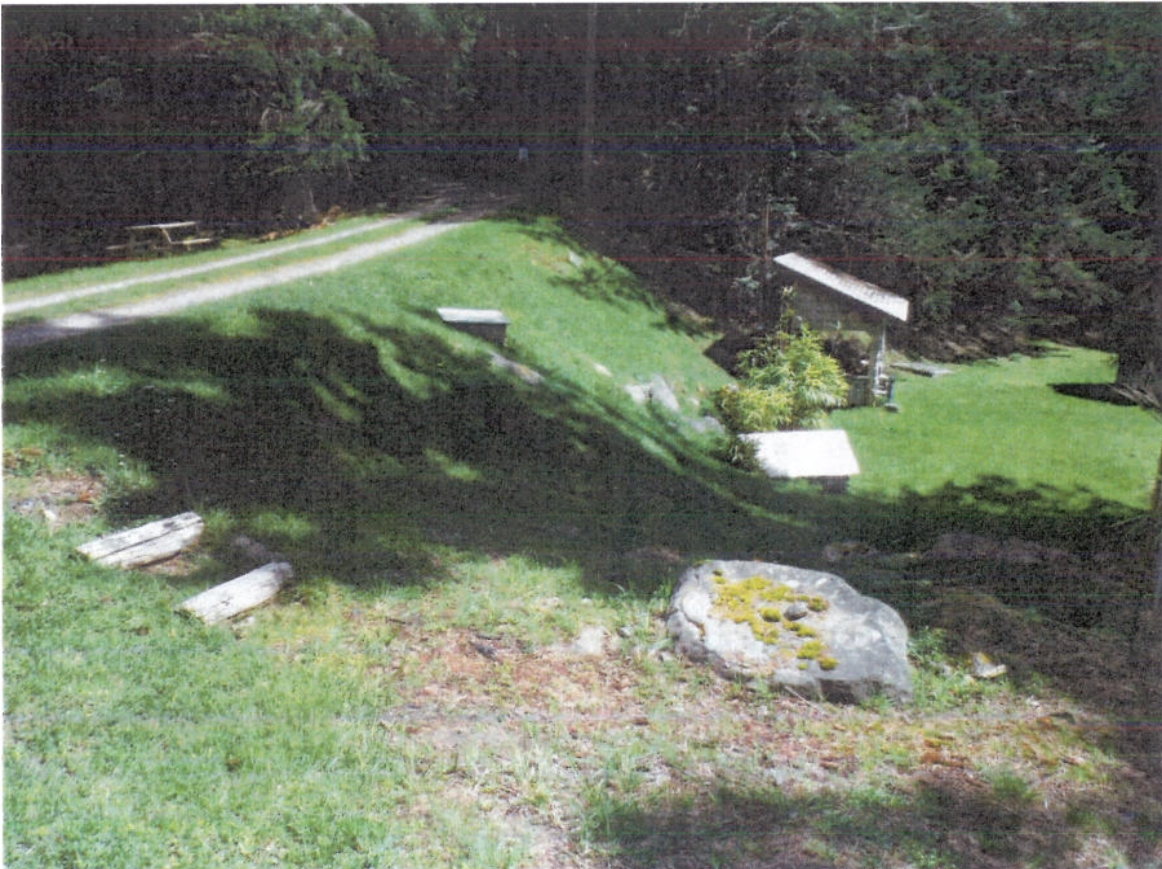
• Signs of wheel depressions			X			
• Signs of deterioration	X					
<b>c) Downstream Face of Dam - check for:</b>						
• Seepage	X					No seepage at time of inspection from RPID box. Irregular steep slope

Gardom Pond Dam – Downstream face of dam.

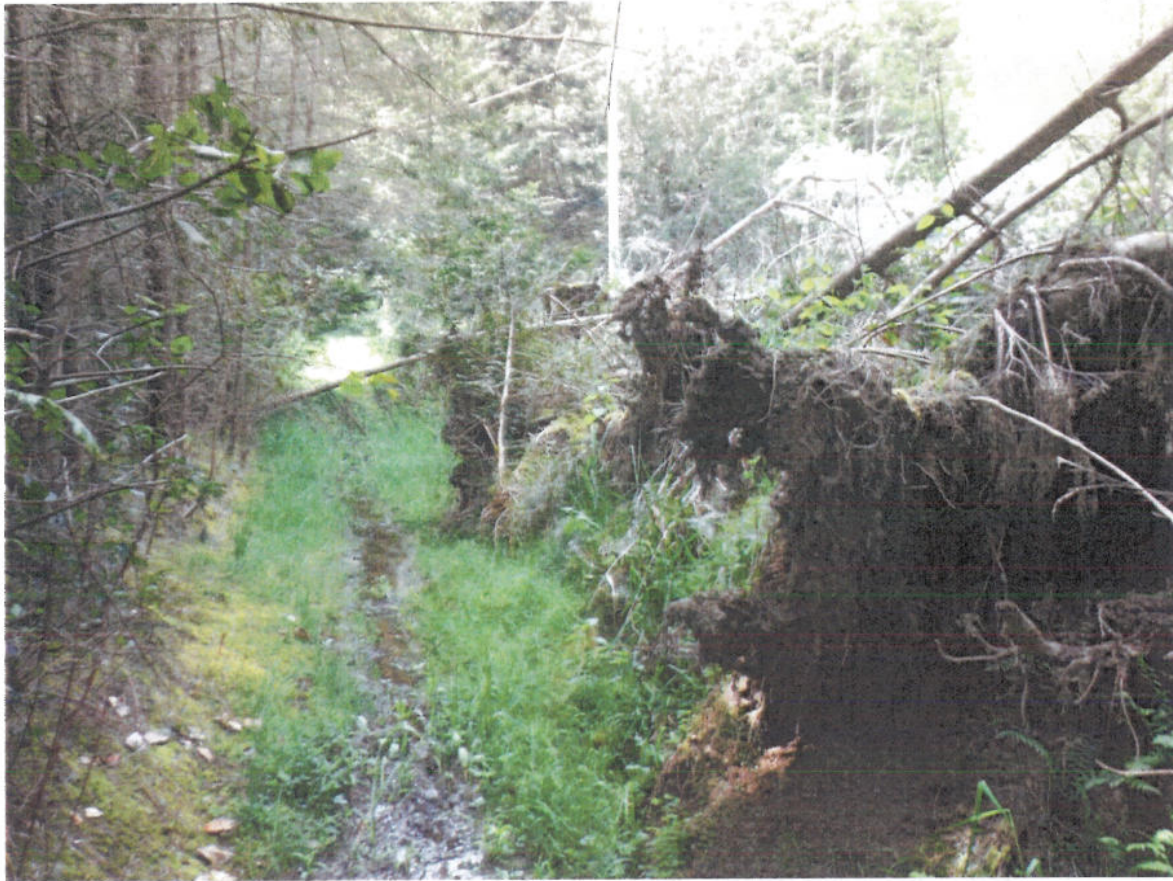
• Outlet Gate Valves and Pipe					X	
<b>3. Spillway - check for:</b>						
• Visible signs of earth deterioration (cracking, subsidence, etc.)		X				Some vegetation to be removed u/s of spillway and along spillway channel. Small trees cover the slopes of the channel and several trees have blown over destabilizing the channel side wall. Brushing and removal of fallen trees and branches along the spillway channel from the Reservoir to Gardom Lane should be carried out. Clearing to 2m from top of spillway bank, both sides.

Gardom Pond Spillway Channel – Damaged channel sidewalls require remediation.

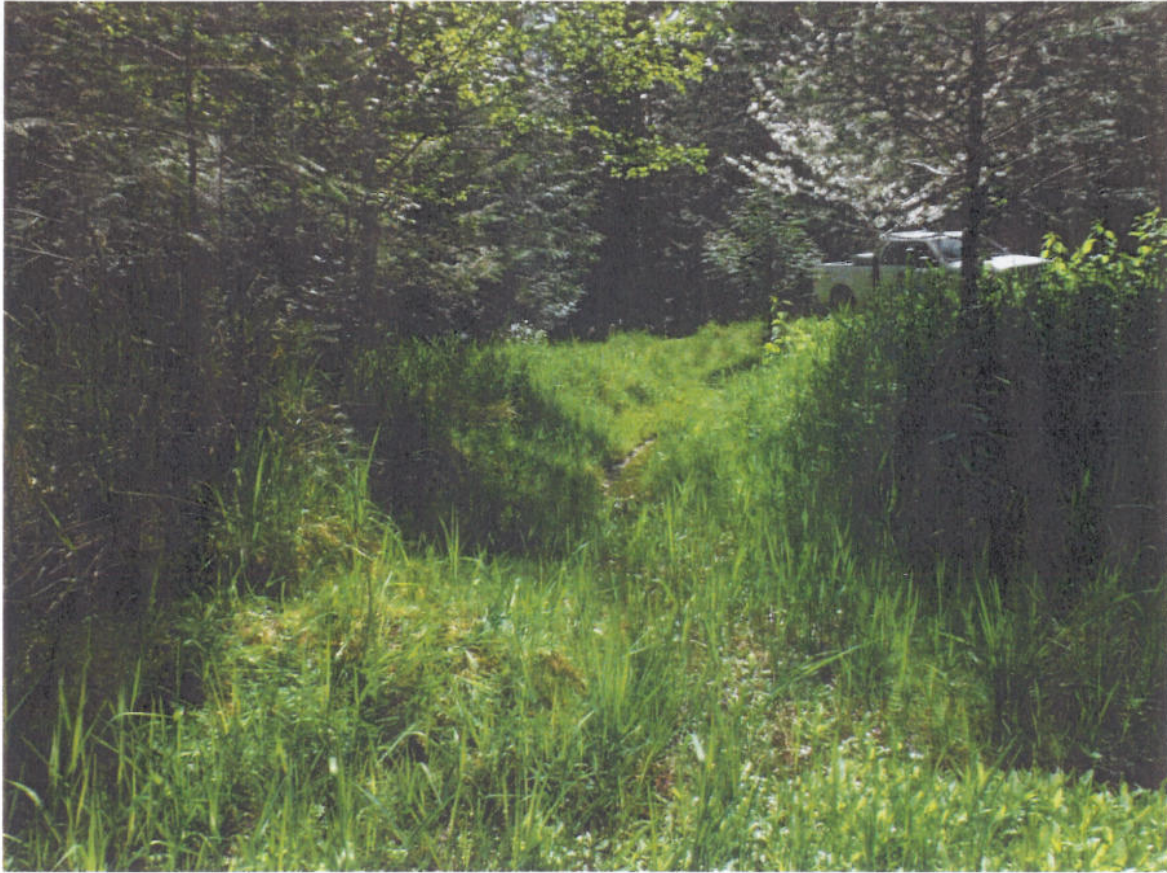
Gardom Pond Spillway Channel – Routine brushing in channel leading up to road culvert required.

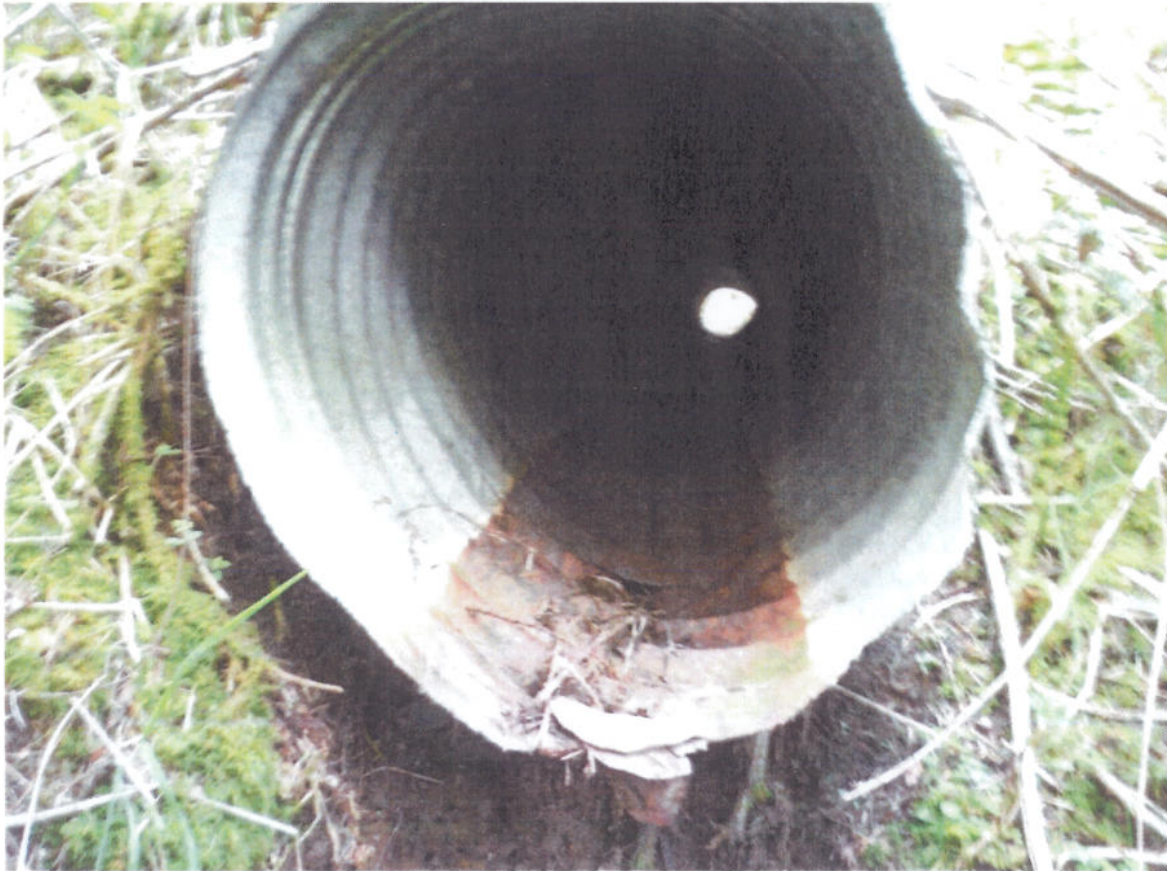
- A water level staff gauge should be installed at a location that will measure seasonal low levels. This will replace the wooden 'yard stick' attached to the dock.
- A staff gauge should be installed in the valve chamber at the downstream toe of the dam to replace the 48" wooden 'yard' stick'.
- The upstream face of the dam has a 'Dry Hydrant' located approximately 10m from the west end of the dam. It is not known how far the submerged end of the connection extends into the reservoir.
- Recommend the installation of a drain pipe from the valve chamber floor elevation to daylight downstream.
- The 510mm CSP culvert under Gardom Lane should be replaced. The culvert has deteriorated to the point that water entering the culvert does not exit the downstream end, but shows up as seepage along the downstream road embankment.

Gardom Lane Spillway Culvert – Road culvert should be replaced.
