Project No: 60285876 Task #3

**Re: Gardom Pond Dam Evaluation – North Pender Island
Low Level Outlet Investigation, October 2017**

**Gardom Pond Dam
Low Level Outlet Chamber Inspection
Photo Album
October 2017**

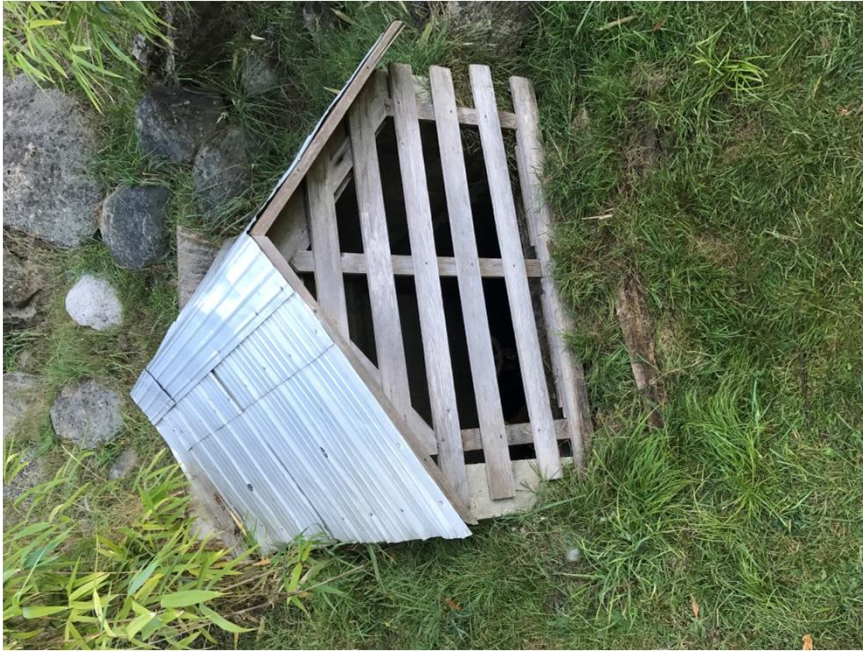
**Photograph #1: Low Level Outlet Chamber and Housing
Located on downstream face of Gardom Pond Dam**

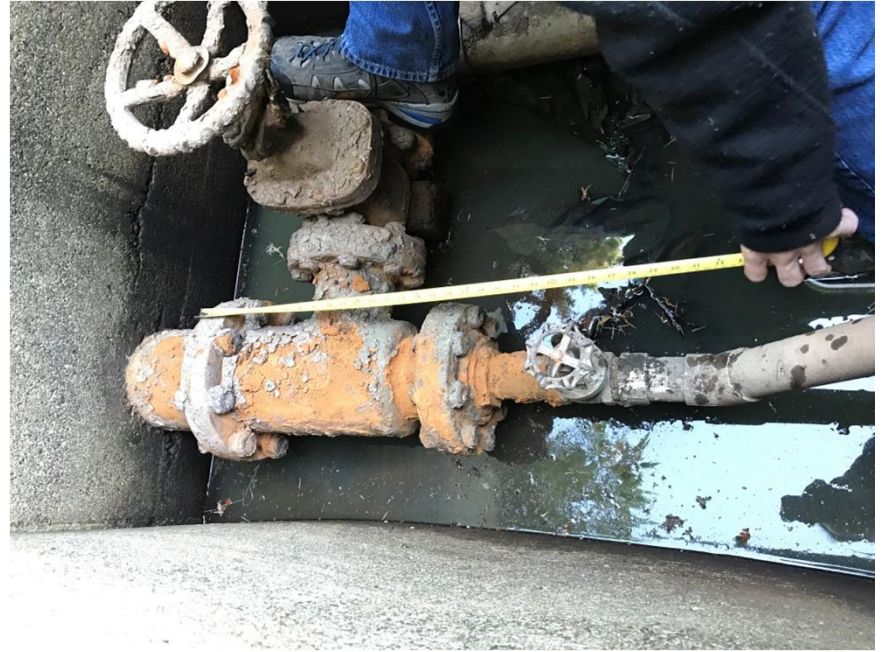
Deposit Buildup: The various piping and fittings within the chamber were covered to an approximate depth of 10 mm in a light brown silt like material with reddish brown mottling (Photo #2 and #3). The material was also noted to be stratified in nature.

**Photograph #2 – Top View: Low Level Outlet Chamber Infrastructure
Deposit build-up partially removed**

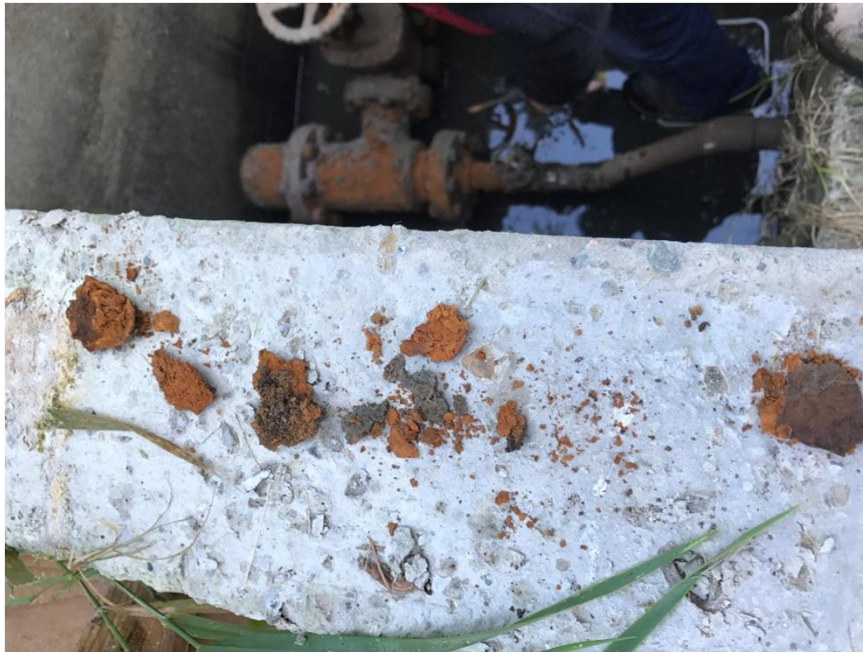
Photograph #3: Deposit Build-Up
Typical samples collected from top of fittings & piping

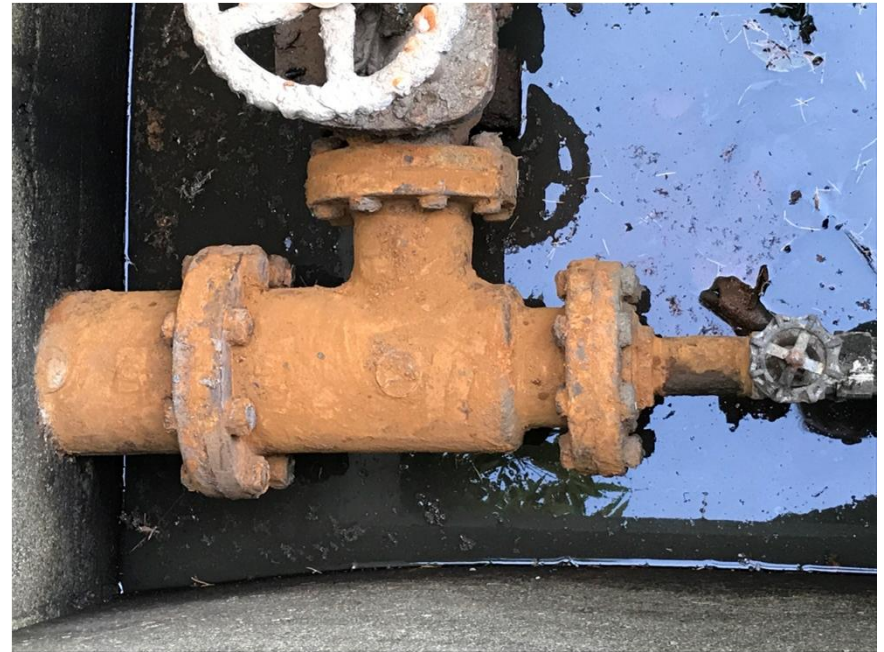
The build-up on the various components within the chamber was carefully removed to identify any underlying corrosion or spalling and to assess the overall conditions of the outlet (Photo #4). Some of the material removed appeared to be larger thin layers that may have been former protective coatings applied during manufacturing, but this was generally indeterminable.

Photograph #4- Top view: Low Level Outlet Fittings
Deposit build-up removed

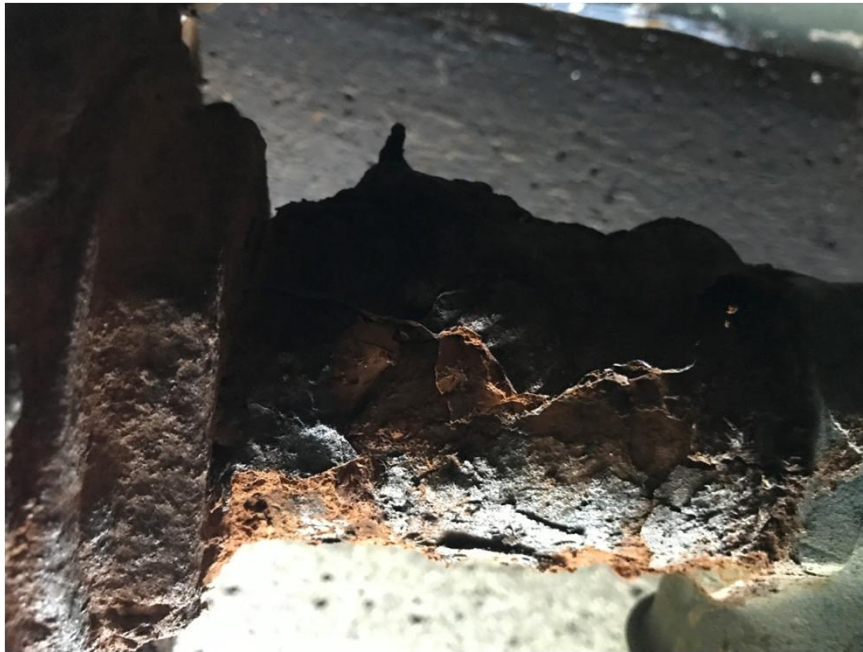
**Photograph #5 – Bottom View: 50 mm dia. Irrigation Feed
Deposit build up and suspect spalling**

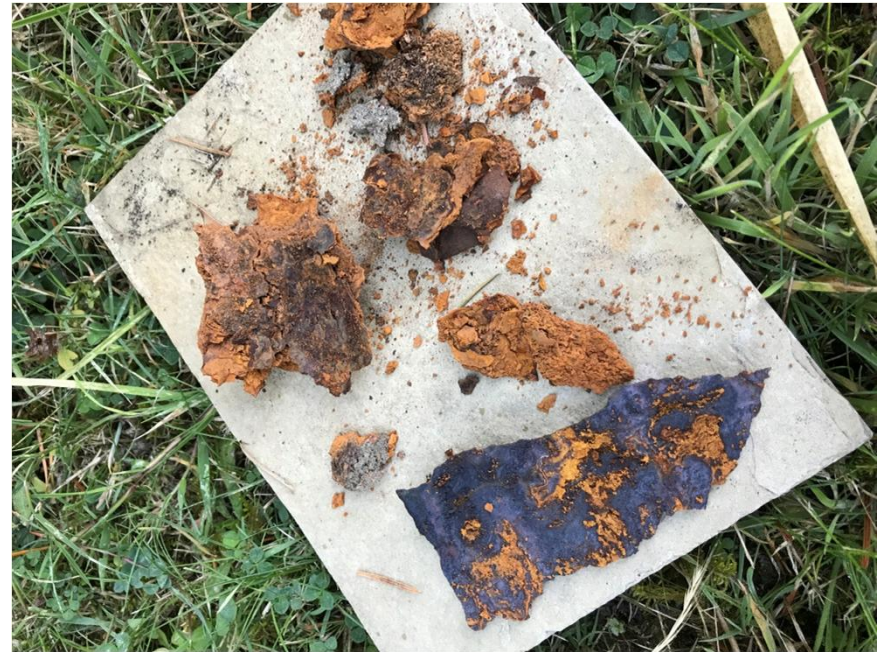
**Photograph #6: 50 mm dia. Irrigation feed
View of samples collected from pipe spool**

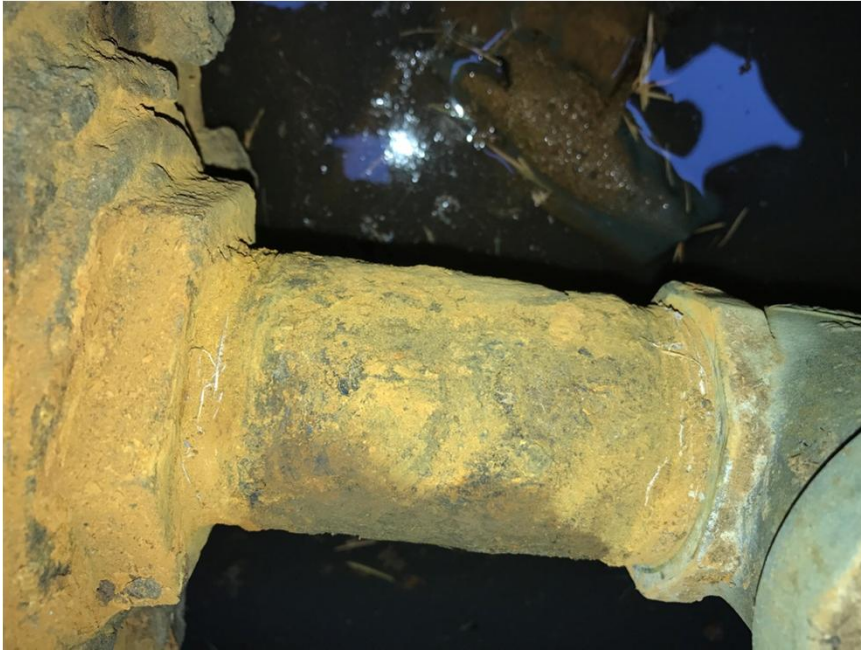
The 50 mm pipe spool showed signs of surface spalling with underlying surface oxidation consisting of visible surface scarring and pitting. Despite this noted surface oxidation, the exposed pipe threads on the end of the pipe spool were still visible and were generally intact (Photo #7).

The surficial qualitative assessment of the Low Level Outlet's piping and fittings identified the short 50 mm irrigation outlet pipe spool, located between the 150 mm reducing tee and the 50 mm gate valve, to have visual signs of metal corrosion; with characteristics of spalling, scarring and pitting of the pipe's surface. The full extent and depth of the identified corrosion within the base metal and the potential risk of failure is not determinable from our qualitative assessment.

**Photograph #7 – Top view: 50 mm dia. Irrigation Feed
Deposits and scaling removed
Note presences of pipe threads and Teflon tape**

To address corrosion concerns attributed to the 50 mm dia. irrigation pipe spool, the pipe segment would ideally be replaced. However, the irrigation pipe is pressurized within the chamber with no means to isolate the pipe segment and the reservoir would need to be drained to conduct the replacement work. This is a significant endeavour and concerns have been raised on the operational integrity of the low level's 100 mm control valve that we understand has not be operated in a number of years.

To provide a measure of protection against possible failure of the 50 mm diameter spool piece was discussed with CRD staff. It would involve capping the irrigation outlet pipe downstream of the 50 mm diameter gate valve and encasing the irrigation outlet and main outlet tee in concrete. Refer to attached Figure #1. It should be recognized that this is a short term solution that should provide a cost effective solution to mitigate the potential risks of the irrigation pipe failing by corrosion until the dam is scheduled to be decommissioned in 2018.

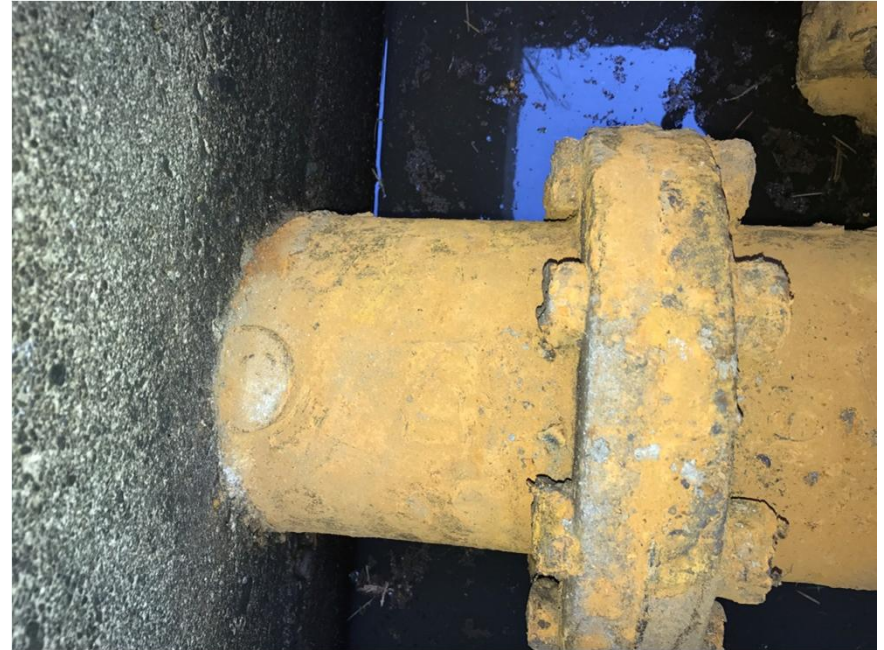
**Photograph #8 – Top view: 150 mm Upstream flanges
and hardware at concrete chamber wall interface**

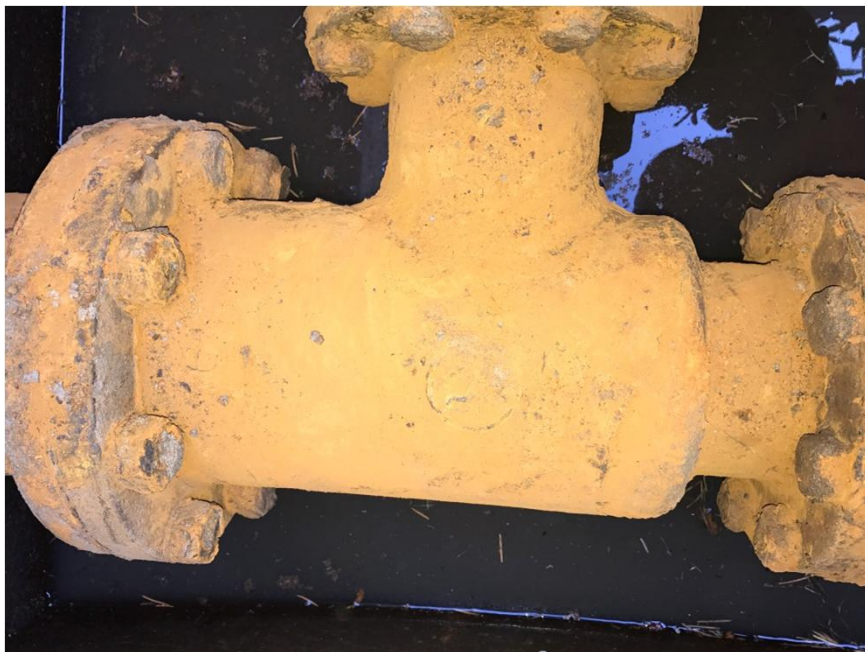
Low Level Outlet: The fittings, valve bodies, pipe flanges and related hardware had a reddish brown discoloration, which may be indicative of corrosion of iron base metals, but no significant pitting, scarring, or spalling of the surface base metals was noted (Photos #9&10). Overall the fittings and valve bodies appear to be in sound condition, despite the surfaces having become somewhat weathered since construction over 35 years ago.

**Photograph #9 – Top View: 150 mm Tee Fitting
Tee Body, flanges, Nuts & Bolts**

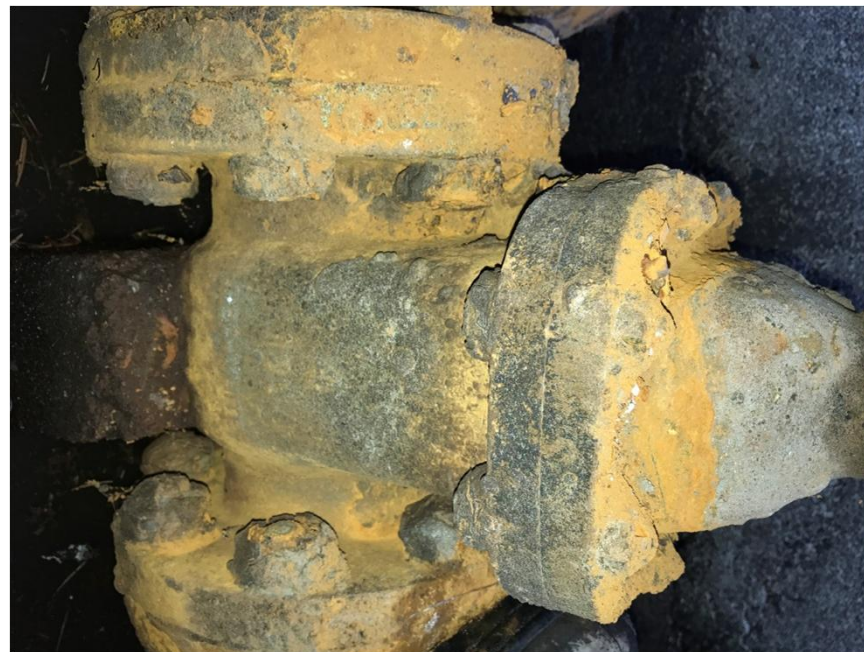
**Photograph #10 – Side View: 150 mm Low Level
Outlet Control Valve, flanges, nuts & bolts**
