## Dallas Road Cliffs, Historic Foreshore Erosion Assessment

Historic Foreshore Erosion  
Assessment

Prepared by:  
Stantec Consulting Ltd.  
500-4730 Kingsway  
Burnaby, BC V6H 0C6

May 30, 2017

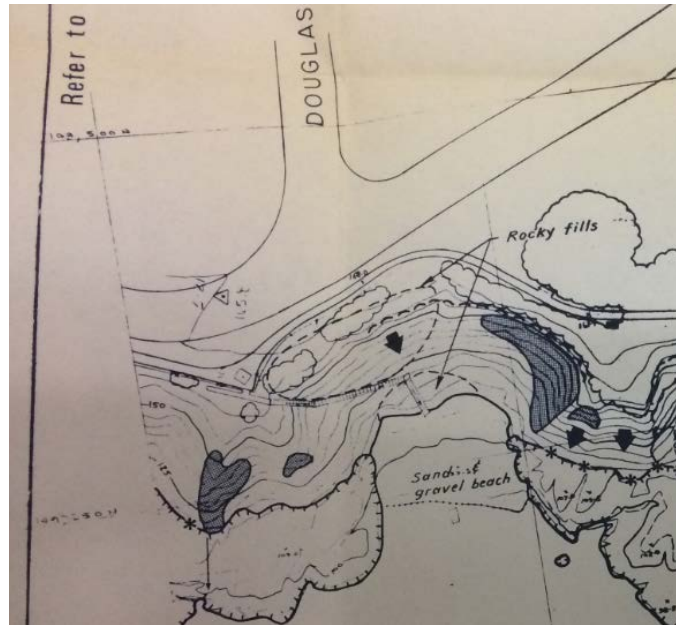
Figure 4 Suspected rocky fill below Douglas Street and Dallas Road intersection (source: Thurber Consultants Ltd. 1977).

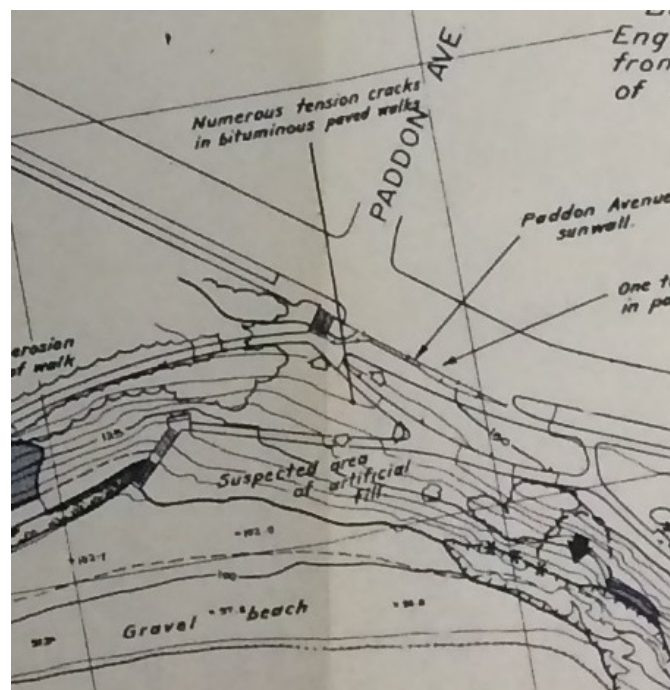
Figure 5 Suspected area of artificial fill below the Paddon Avenue seawall (source: Thurber Consultants Ltd. 1977).

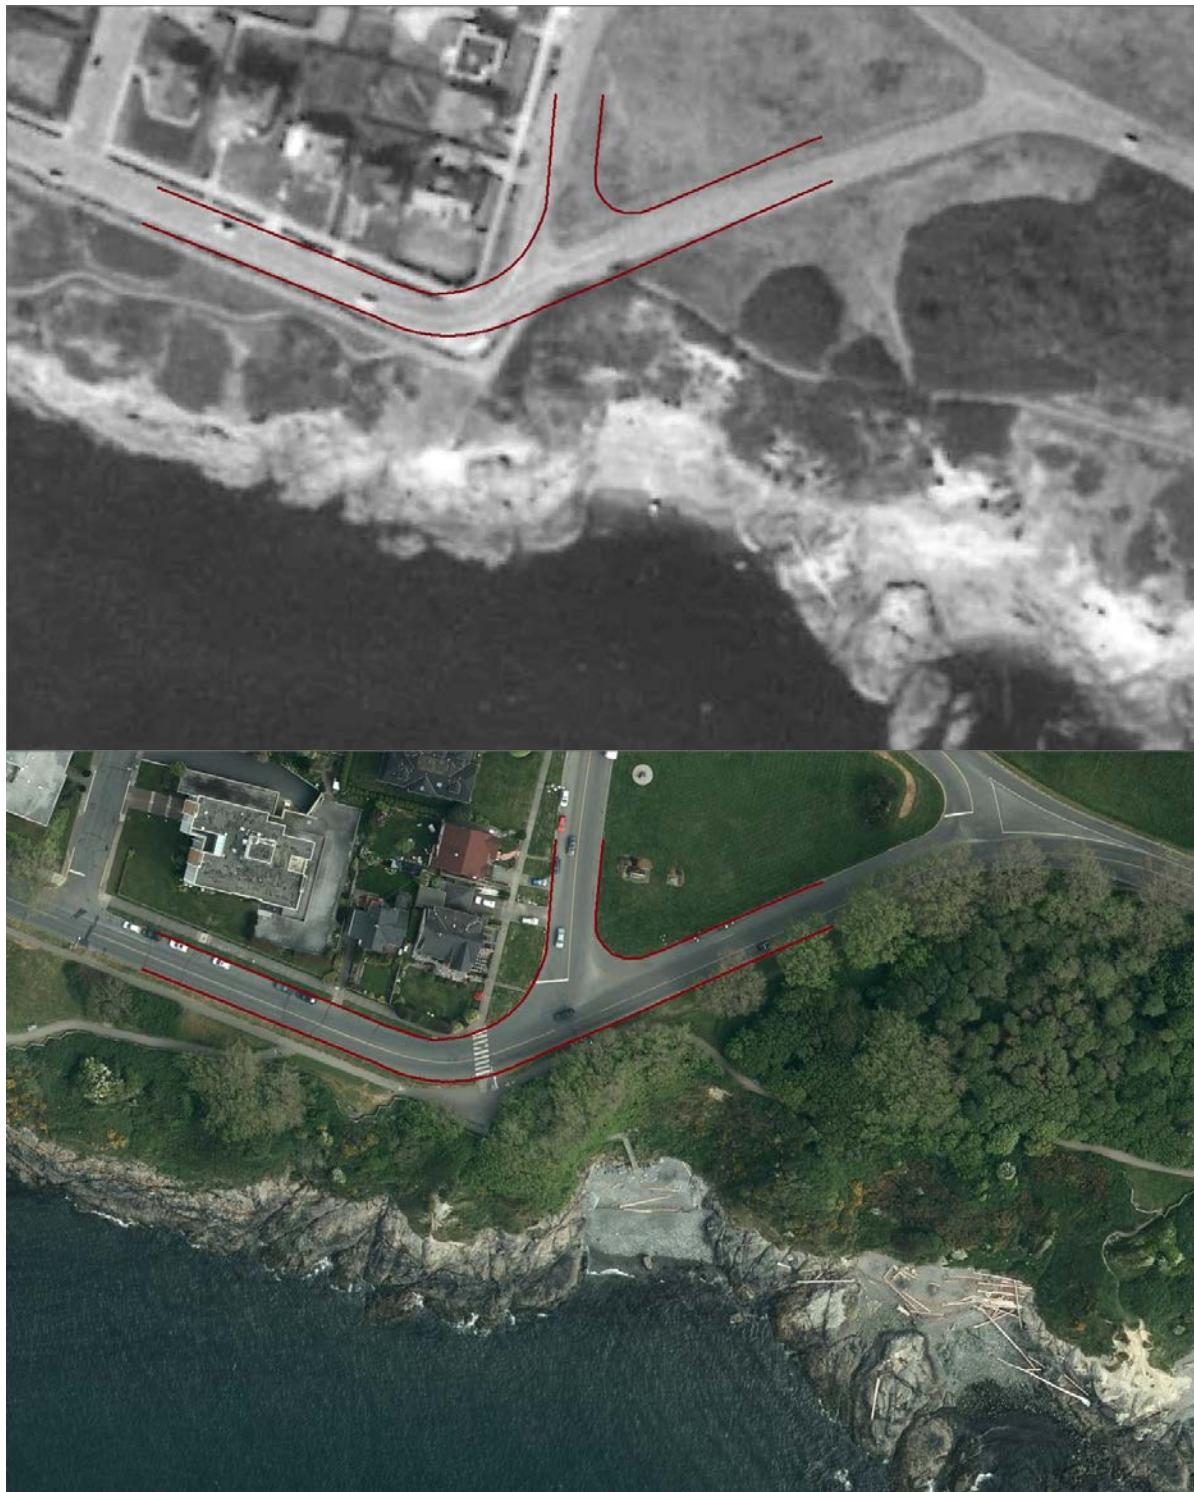
A review and comparison of the historical air photos, archival studies and site observations indicate that in 1956 the top of sea cliff at the Dallas Road and Douglas Street intersection was closer to Dallas Road than the current location (Figures 4 and 6) as previously reported in Thurber 1977. It is suspected that fill was dumped over the cliff during the widening of Dallas Road between 1956 and 1958 based on the 1956 air photos and 1958 ground survey data by the City Engineering Department noted in Gillie 1997. The suspected fill appears to extend down to the beach where wave erosion has exposed the toe of the rocky fill material (Figure 7, Site ST17-013). The slope steepness of the suspect fill ranges from 70 to 85% along the upper 15 metres. The preliminary forcemain route appears to cross the top of the suspect fill slope; therefore, we consider the area around the Dallas Road and Douglas Street intersection to be a likely area for mitigation and recommend that a geotechnical investigation be carried out along this section of Dallas Road to validate the presence, extent, and character of the fill.

Figure 6 Comparison of 1956 air photo and 2015 orthophoto at Douglas Street and Dallas Road intersection. Red lines indicate the curb-to-curb extent of Dallas Road for reference.

Following the recommended geotechnical drilling, modifications to the preliminary forcemain route or ground densification may be required depending on soil conditions (e.g., non-compacted fill) encountered.

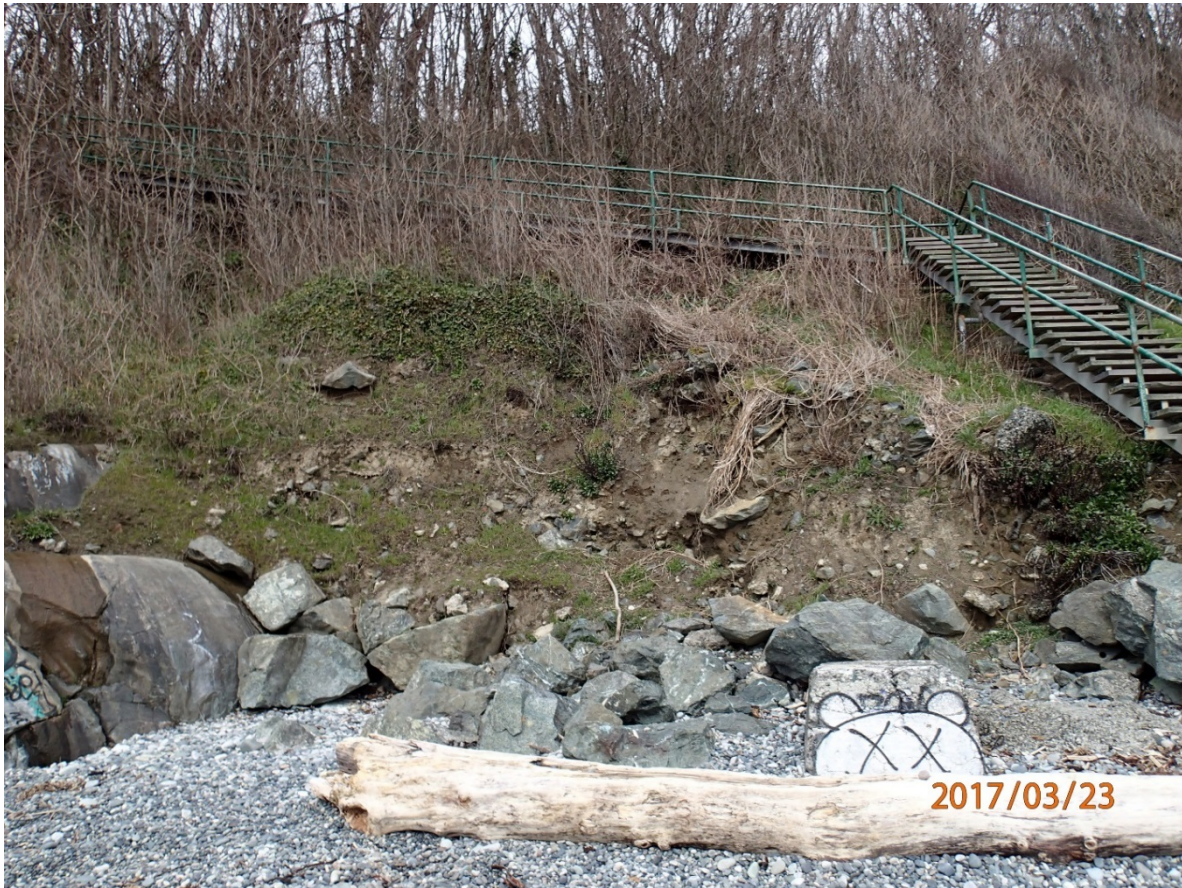
Figure 7 Suspected fill material below Douglas Street stairwell exposed by wave erosion.

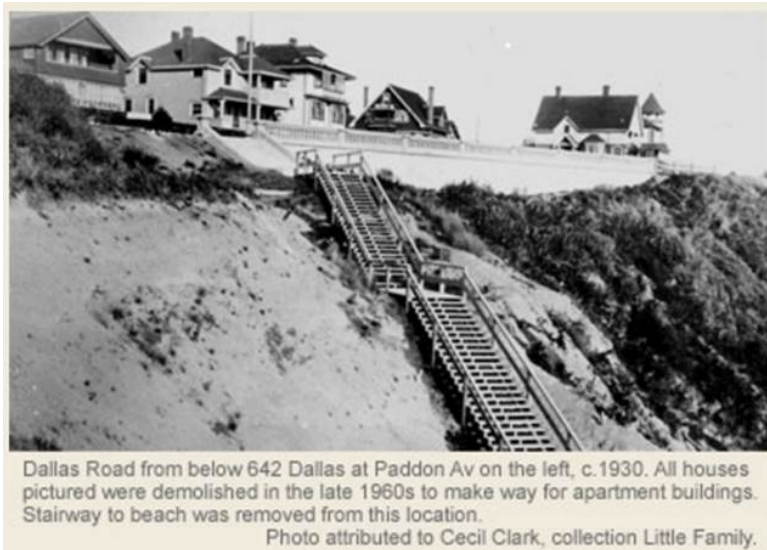
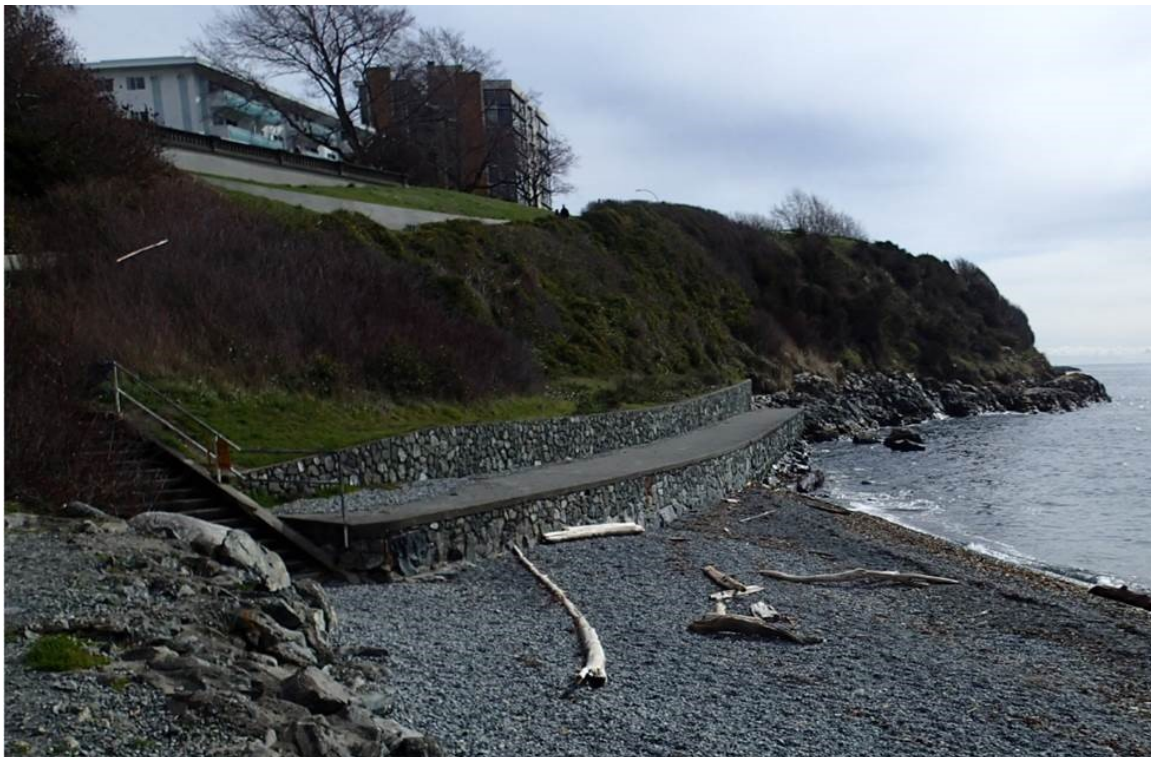
Figure 8 Paddon Avenue seawall circa 1930 and on March 23, 2017. (source: <http://www.victoriaheritagefoundation.ca/Neighbourhoods/jamesbayhistory.html>).

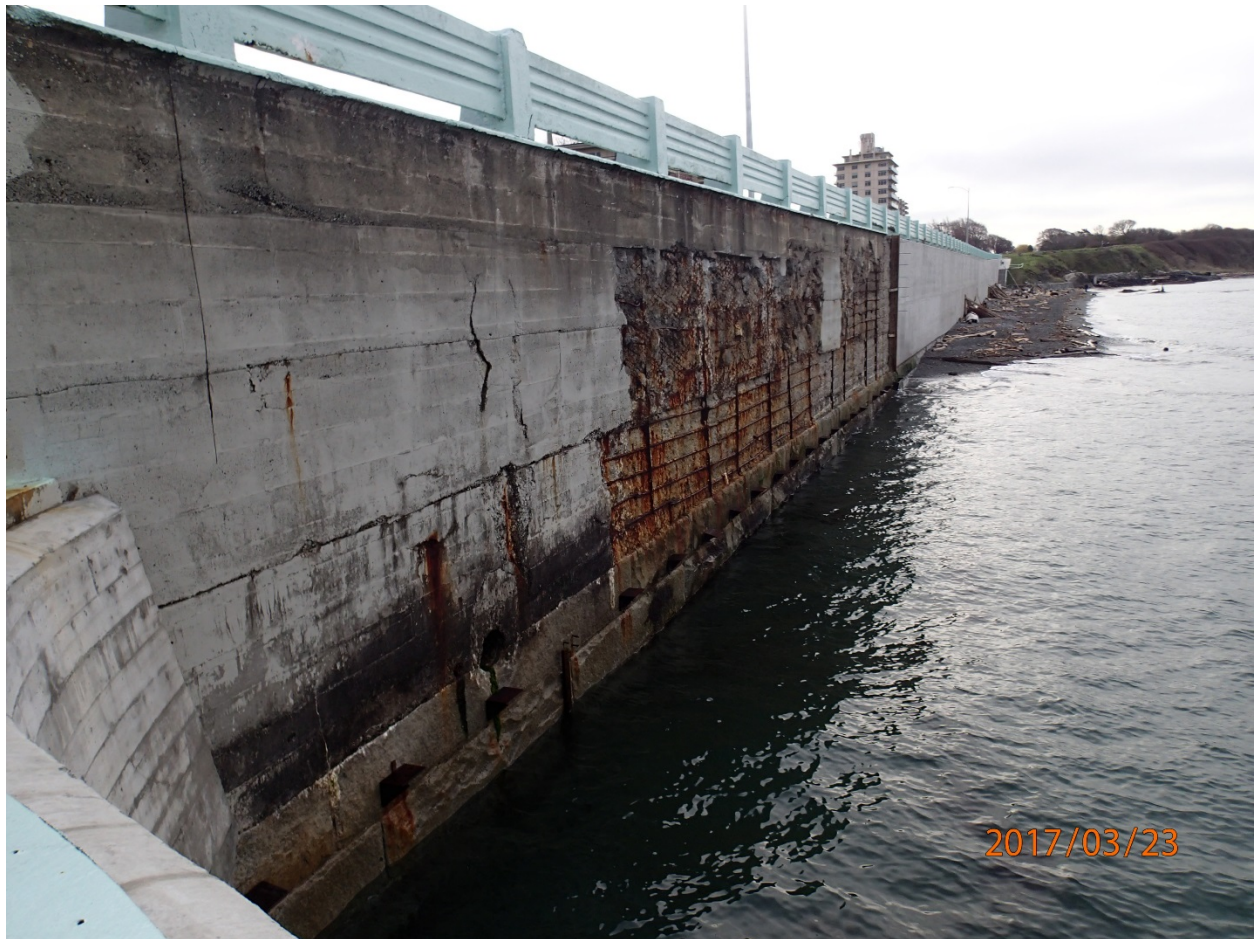
The James Bay seawall was constructed around 1911 to protect Dallas Road and the houses along the north side from foreshore erosion (Gillie 1997). It is unknown at this time whether fill or native soils underlie the seawall. Repairs to the concrete seawall surface were being completed during the site visit (Figure 9).

Figure 9 Resurfacing the James Bay seawall face.

The preliminary forcemain route runs along the top of the seawall. The James Bay seawall is considered a likely area for mitigation along the preliminary forcemain route given the uncertainty of soils behind the sea wall and the historical foreshore erosion prompting the construction of the seawall over a century ago. Also, bedrock does outcrop approximately 15 metres offshore of the seawall; therefore, it is possible that bedrock may exist near the surface under the seawall. It is recommended that geotechnical drilling along the seawall should be carried out to determine whether fill or native soils underlies the preliminary forcemain route and to determine if bedrock will be encountered within the trench.

- a geotechnical borehole drilling program be completed adjacent to the James Bay seawall, identified as a likely area for mitigation to determine whether fill or native soils underlies the preliminary forcemain route and to assess the potential to encounter near-surface bedrock. Geotechnical information should be obtained to determine the potential hazard associated with seawall undercutting due to wave erosion, which in turn could result in subsidence of the forcemain.
