RYZUK GEOTECHNICAL

October 20, 2011
File No: 8-5782-1

Re: Dam Safety Review – **Addendum 1**
Gardom Dam – North Pender Island, BC

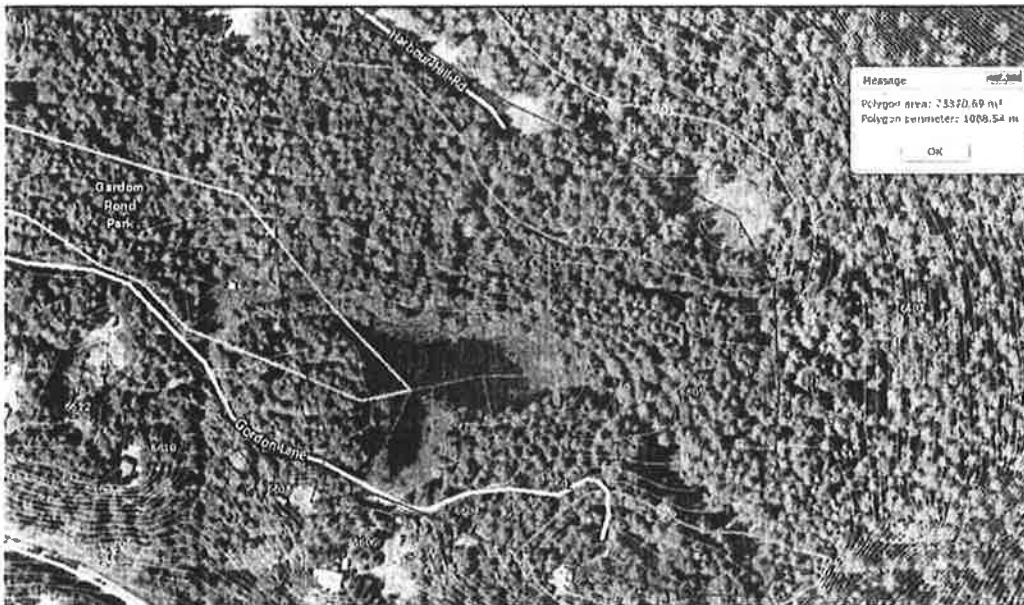
Figure 3- Gardom Pond Catchment Area (Taken from CRD Natural Atlas)

The ability of a dam to safely handle a rainfall flood event is based on two things: how much rainwater is expected to be flowing into the reservoir from its entire catchment area at any one time during a design rainfall event; and how much water the spillway can safely convey out of the reservoir. Making sure the spillway has a greater flow capacity than the IDF is of vital importance when assessing the safety of a dam. When the dam was originally designed the IDF was estimated to be around 4 cubic feet per second (ft^3/s) or 0.11 cubic meters per second (m^3/s) and the capacity of the spillway was calculated to be 14 ft^3/s or 0.4 m^3/s . Using current design standards for a High Consequence Dam combined with historical rainfall data taken from the Rainfall Intensity-Duration-Frequency curves of Victoria International Airport, we found the IDF to be 30.7 ft^3/sec

or $0.87 \text{ m}^3/\text{sec}$, about 8 times larger than the IDF used during the original design in the 1970's. Based on the spillway's physical dimensions and vegetated state, the flow capacity was found to be approximately $22.6 \text{ ft}^3/\text{s}$ or $0.64 \text{ m}^3/\text{s}$. Therefore, using available data, the spillway is only capable of passing 74% of the IDF flow.

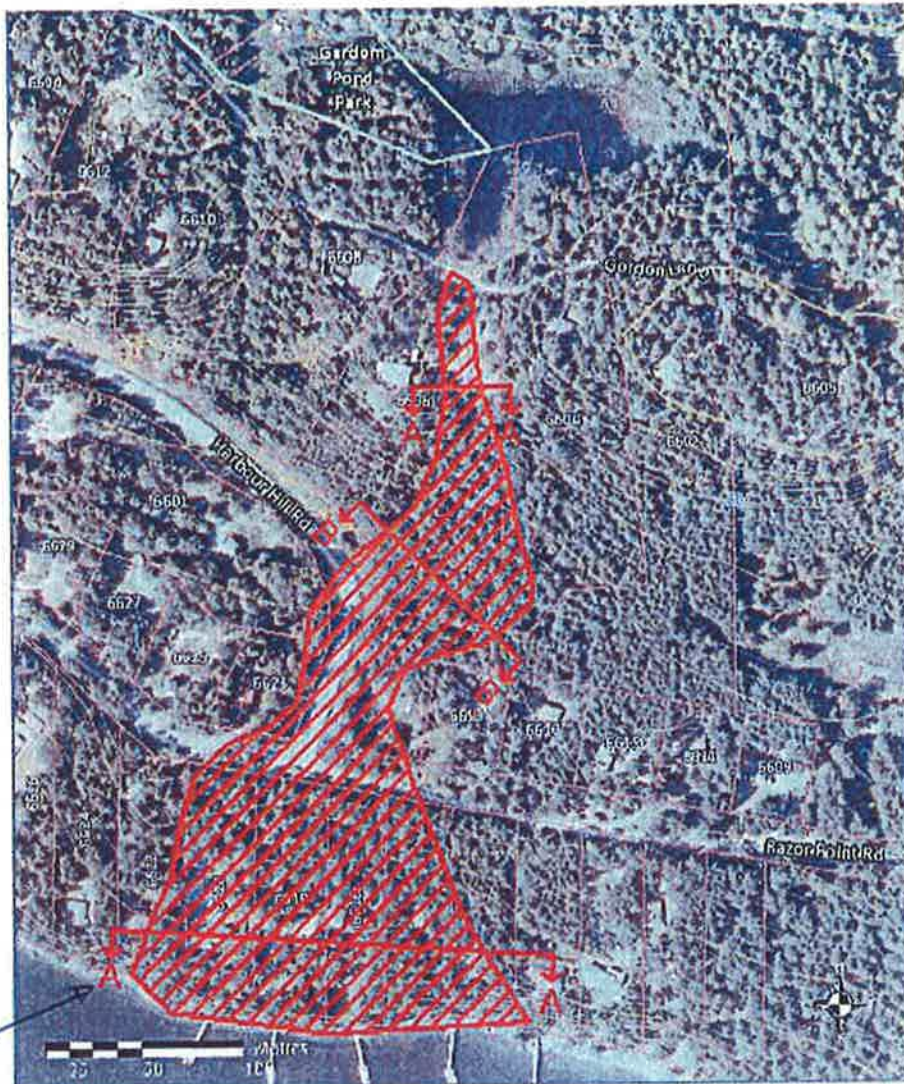
Figure 4 - Potential Flood Routing based on contours taken from CRD Natural Atlas.

We then calculated the probable size of a breach based on the storage volume and height of the dam as well as the material of which the dam was built. With this probable breach size, we calculated the peak breach discharge that would be flowing out of the dam if a failure occurred. This value was calculated to be around $85 \text{ m}^3/\text{s}$.

We routed the potential flood downstream of the dam using the available contour maps and aerial photographs. This routing is shown in Figure 4 and represents the potential inundation zone in the unlikely event of dam failure. Furthermore, the estimated peak flow velocities and peak flood wave heights are shown in Table 1 at various points along the flood route. The inundation zone covers approximately eight properties each with residences, and two public roads.

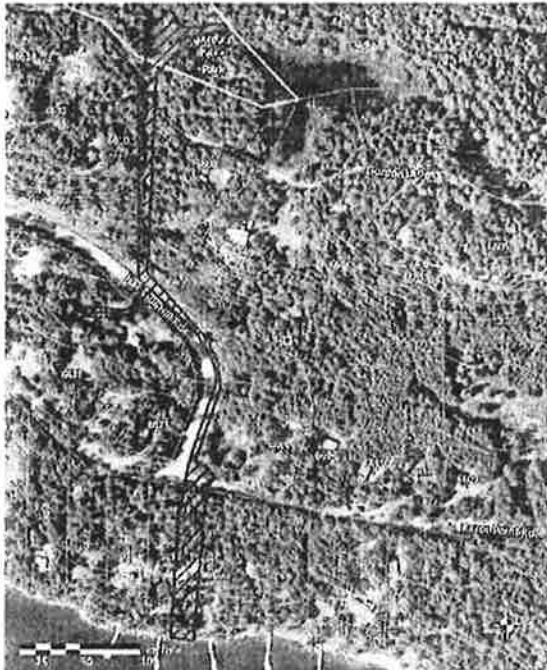
Figure 6 - Spillway Route and Potential Flooded/Washout Areas

We have concern about the possibility of downstream flooding because of the undefined route of the flows after they leave the gully that runs through 6610 and 6608 Gardom Lane and also the inadequate capacity of the 50 cm (20 in) diameter culvert under Gardom Lane. If the flow cannot

be fully passed under Gardom Lane (flow capacity of $0.2 \text{ m}^3/\text{s}$) it will back up and possibly flood or wash out the road. Further downstream, as the flow leaves the gulley it intersects with the ditch on the eastern edge of Harbour Hill Road. The flow then follows Harbour Hill Road down until the intersection with Razor Point Road. Once at the intersection, the flow merges into the ditch to a culvert that runs beneath Harbour Hill Road and outlets into 6601 Harbour Hill Road, and from here the flow path is unknown. Once the remaining water in the ditch reaches the intersection with Razor Point Road, it passes through a culvert beneath the road and follows a small creek down into the ocean. Again, if the capacity of the culvert below Razor Point Road is not equal to or greater than that of the spillway expected peak flow (less the diverted flow into the culvert at 6601 Harbour Hill Road), flooding and or/ washout of Razor Point Road is a possibility. The flow path of the spillway and possible flooded areas due to spillway failure are highlighted in Figure 6 below.
