Capital Regional District Regional Parks

**Gardom Pond Dam Evaluation
North Pender Island**

AECOM

19 June, 2013

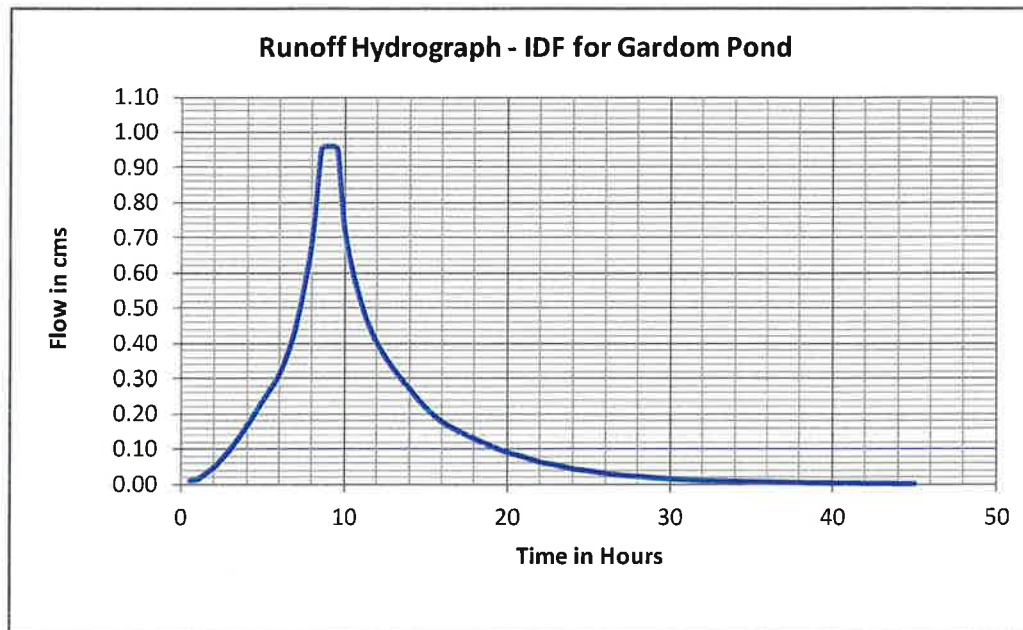
Finally, a spike was applied to the hydrograph to reflect the peak value of the IDF ($0.96 \text{ m}^3/\text{s}$) derived during this study. The spike was applied around the time to peak of the hydrograph, approximate $\frac{1}{2}$ hr. on each side. Graphic capabilities of Excel were used to smooth the curve. The resulting hydrograph is shown below.

Routing of the hydrograph through Gardom Pond resulted in an insignificant (2%) reduction of the IDF but did clearly show that the water level would only rise to 0.29 m above the spillway crest, leaving 0.71 of freeboard to the dam crest. Therefore, a new 4 m wide spillway is recommended.

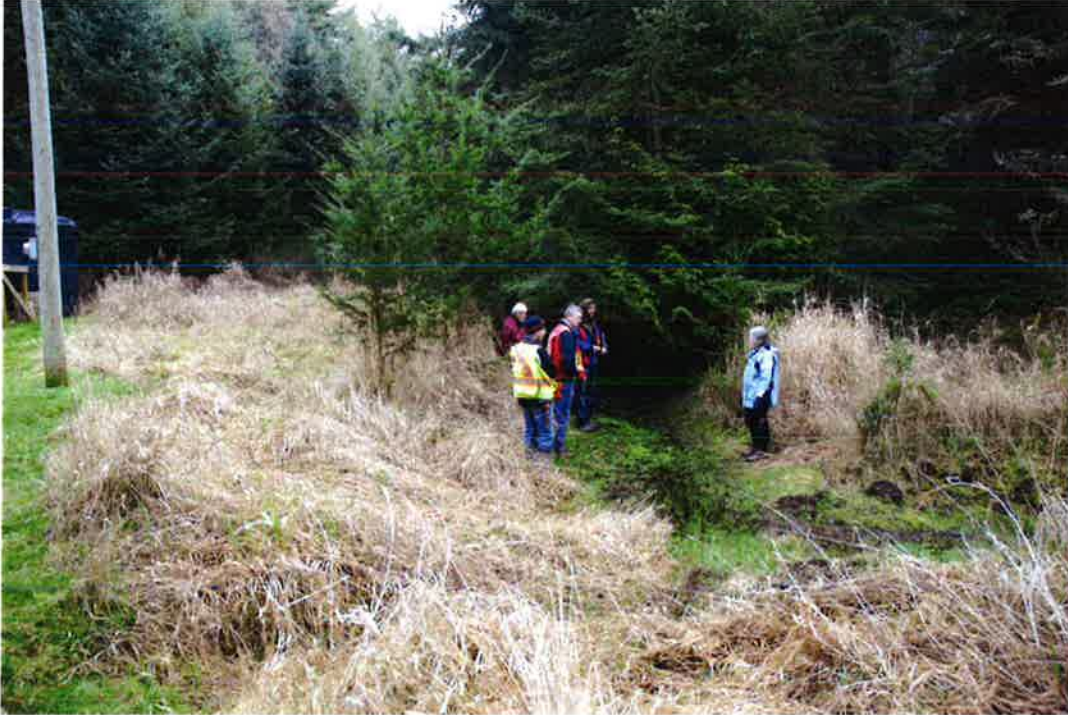
- In 1979 the Inflow Design Flood for Gardom Pond was calculated to be 0.11 m³/s and the spillway was designed to accommodate 0.4 m³/s
- The spillway channel is currently overgrown and is in a general state of disrepair, thereby reducing its design capacity (Photos 5 through 7)
- Due to the reclassification in 1997 of the dam to a High Classification with respect to Downstream Failure Consequences, the spillway must be capable of accommodating an IDF of 0.87 m³/s. Ryzuk calculated the capacity of the present spillway channel in its “vegetated” state to be only 80% of the required IDF.
- The current spillway capacity and associated freeboard (distance from the spillway invert to the dam crest) are incapable of preventing the IDF from overtopping the dam during a 24 hr. rainfall event. Overtopping could lead to a dam failure.

Photograph #5 – Existing Spillway Channel! approximately 70 m Downstream of Pond (looking Upstream)

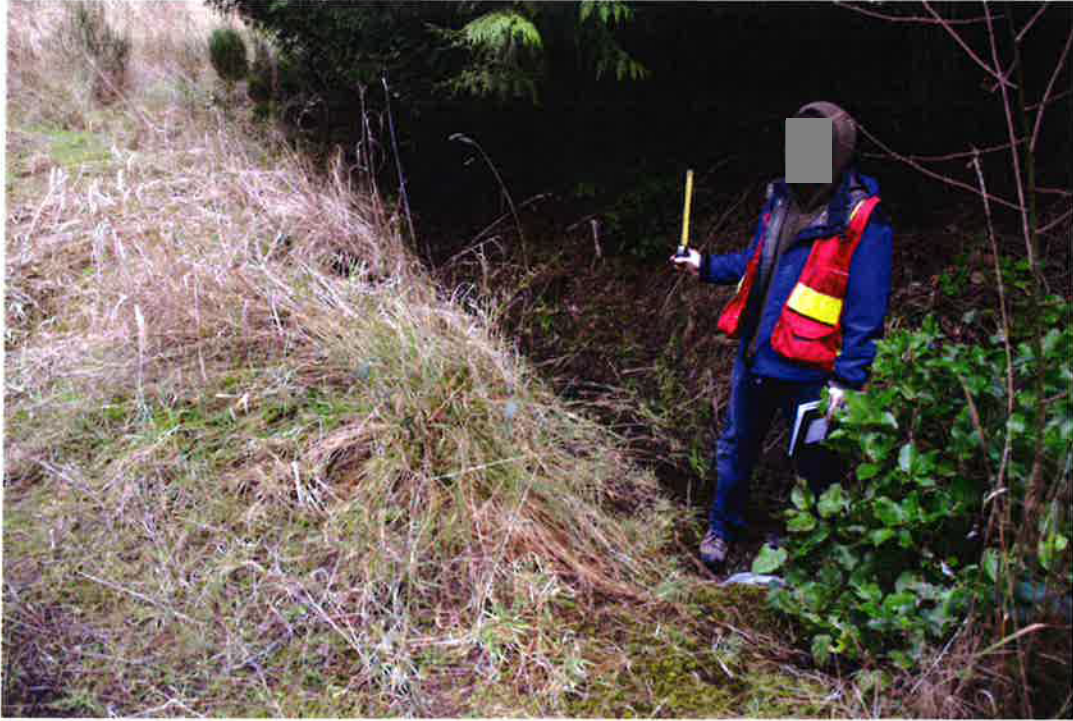
**Photograph #7 – Existing Spillway Cross Section from Pond to
Approx. Location of Photo #5**

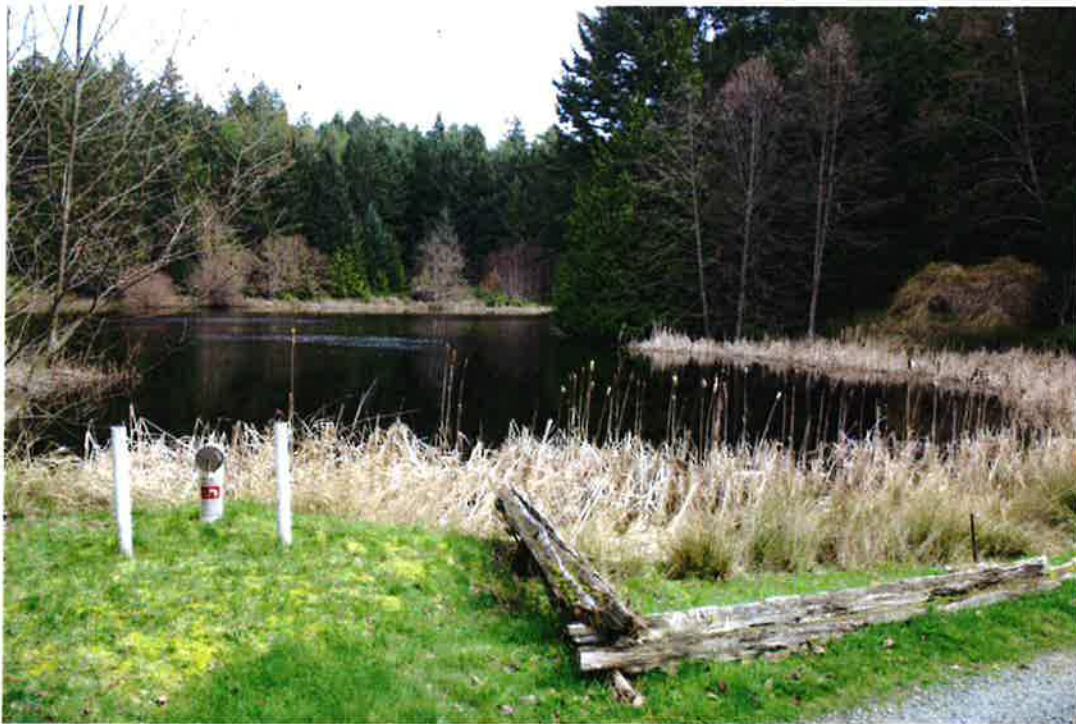
Photograph #8 – Location of RPID Emergency Fire Supply Standpipe

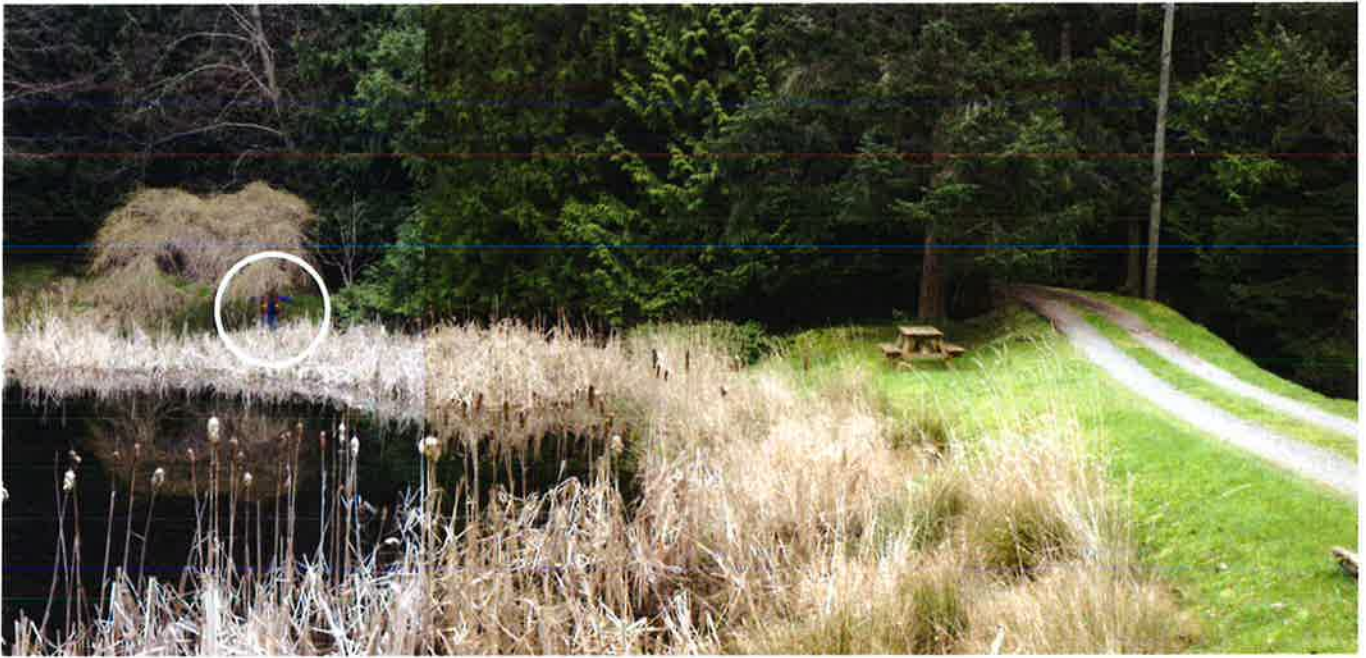
Photograph #9 – Proposed Site of New Spillway (engineer standing at location)

BC Dam Safety Guidelines for the Rehabilitation of Dams state that "A spillway width of less than 4 metres wide is not recommended for high or very high consequence dams." As Gardom Pond Dam is classified as a **high-consequence dam**, a spillway width of 4 m has been selected for this report.

The new spillway would require a dedicated channel to convey peak flows to the ocean. The longer the channel, the greater the cost would be. Leaving the spillway at the present location would require a new channel (the existing channel is inadequate) that is approximately 60% longer than a new proposed channel alignment constructed adjacent to Gardom Dam's east abutment. In addition, two road crossings would be required instead of one, if the original alignment were to be upgraded.

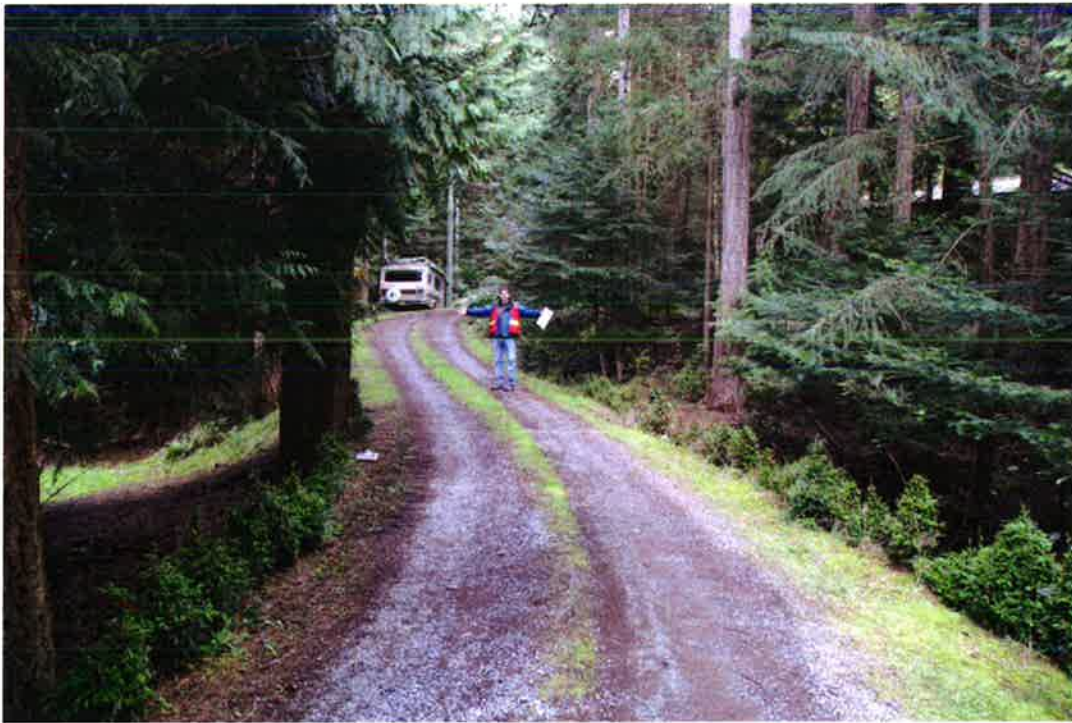
**Photograph #10 – Possible Location of New Spillway beneath Gardom Lane
(from left to right)**

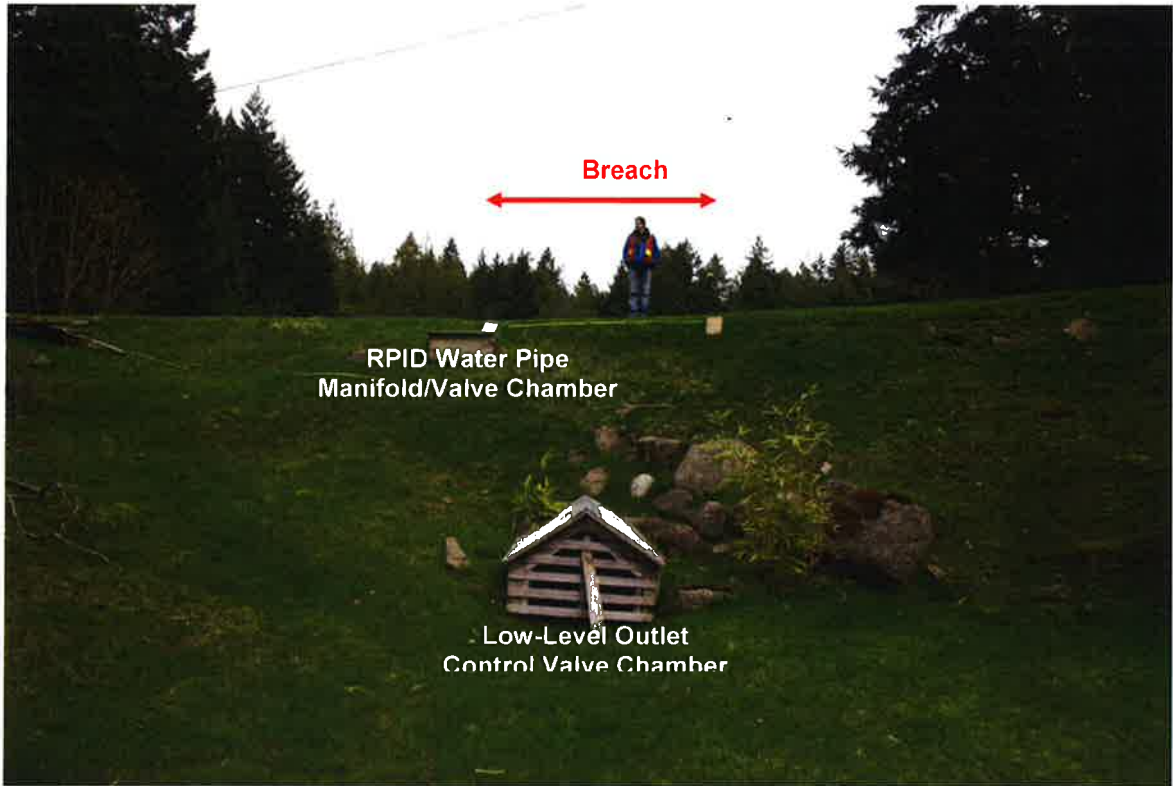
Photograph #11 – Proposed Location of Dam Breach

During construction of the breach it is recommended that the existing low-level outlet be removed in its entirety to avoid future collapse and possibly future remedial works for the breach channel.

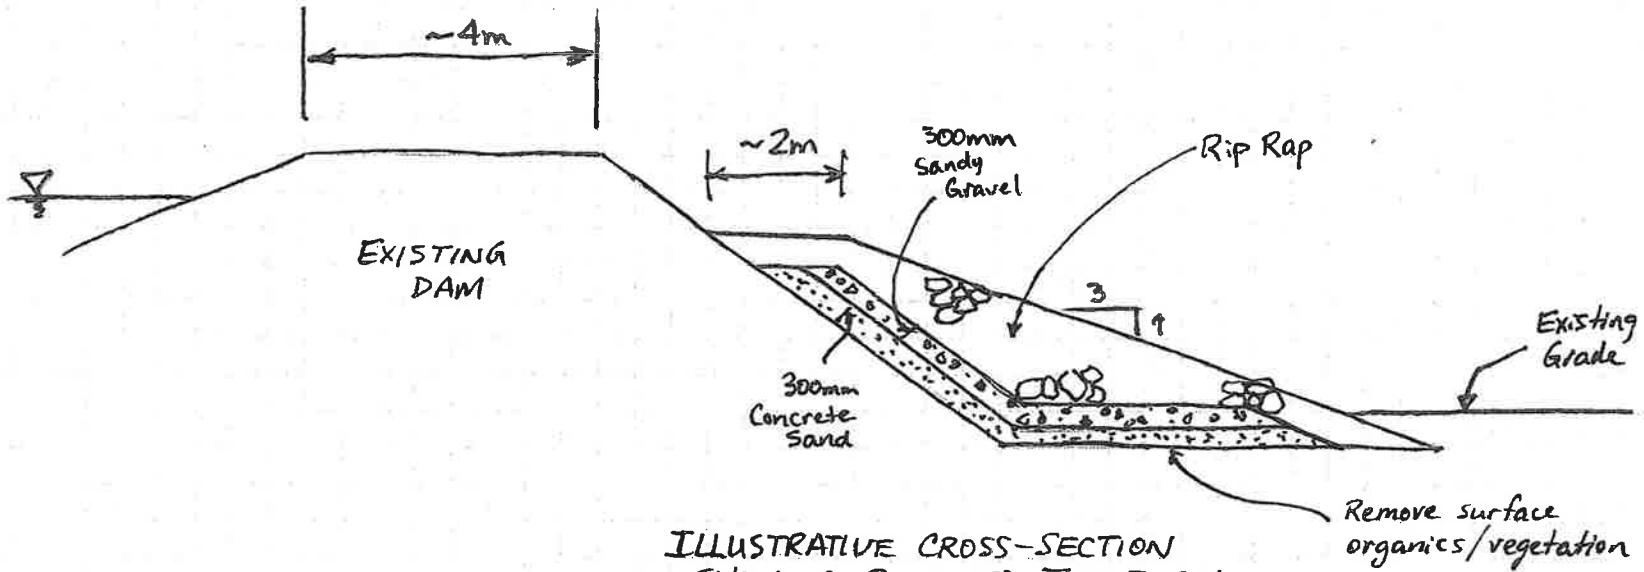
FIGURE 1

ILLUSTRATIVE CROSS-SECTION
SHOWING PROPOSED TOE BERM
(NOT TO SCALE)

The recommended toe berm at Gardom Pond dam would have a height of at least two thirds of the existing dam, meaning the top of the berm would be approximately 1.2 m below the crest of the dam. The toe berm would have a minimum width of 2 m at the top, and slope downward with a gradient no steeper than 3H to 1V (18.4°). This would result in the toe of the dam being shifted approximately 6 m further downstream than the existing configuration. A sketch showing the proposed toe berm concept is attached as Figure 1.

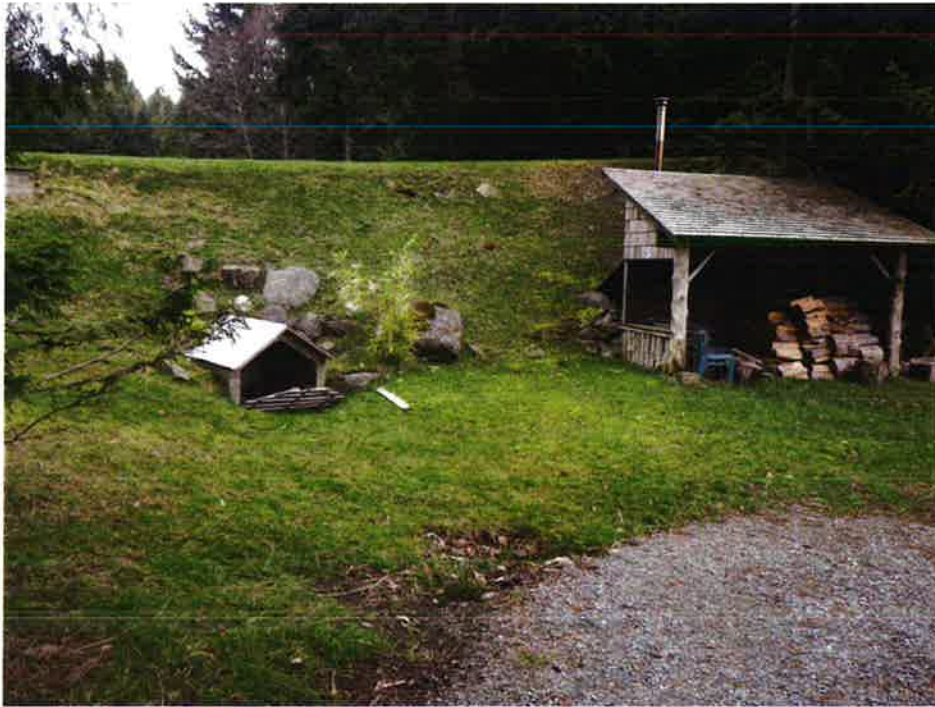
There is a concrete chamber at the downstream end of the pipe, which houses two control valves (100 mm dia. and 50 mm dia.). Having control valves at the downstream end of the pipe instead of the upstream end of the pipe subjects the entire pipe to full reservoir water pressure at all times. This is not a recommended method of design and leakage from the pipe could travel along the pipe eroding material from the dam over time resulting in a potential breaching of the dam through piping.

Photo 3: Area below downstream slope. Note outlet chamber and boulder stack.

As it is a threat to dam integrity, it is recommended that it be taken out of service by being carefully filled with grout. Pond drawdown under careful environmental monitoring would be the preferred scenario for implementing the grouting procedure since there is not an upstream valve/gate on the pipe.

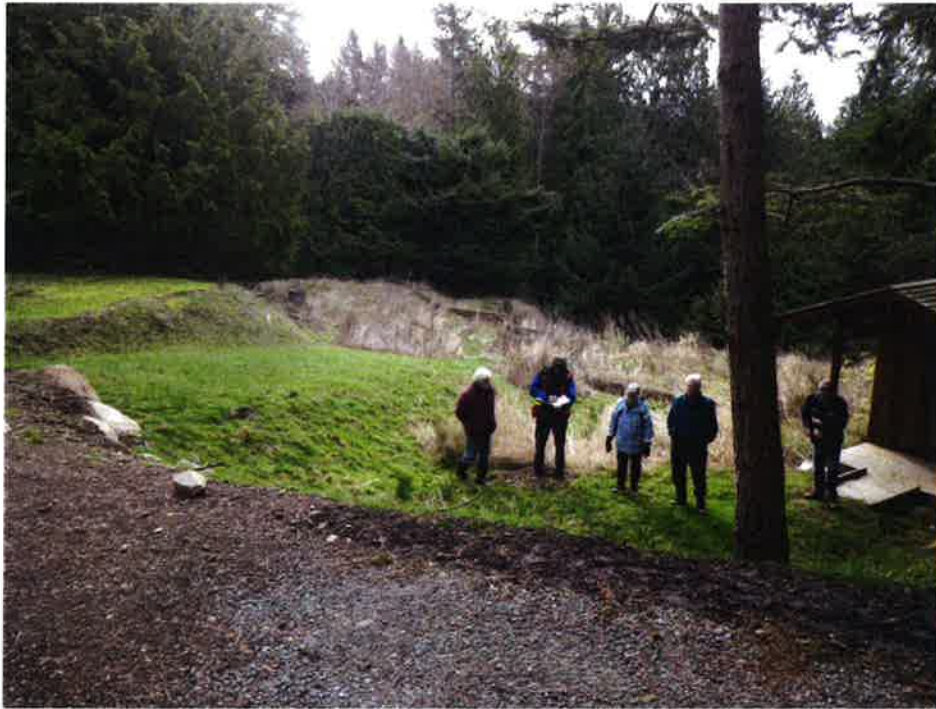
Photo 5: Area downstream of dam – note terracing (Feb. 13, 2013).

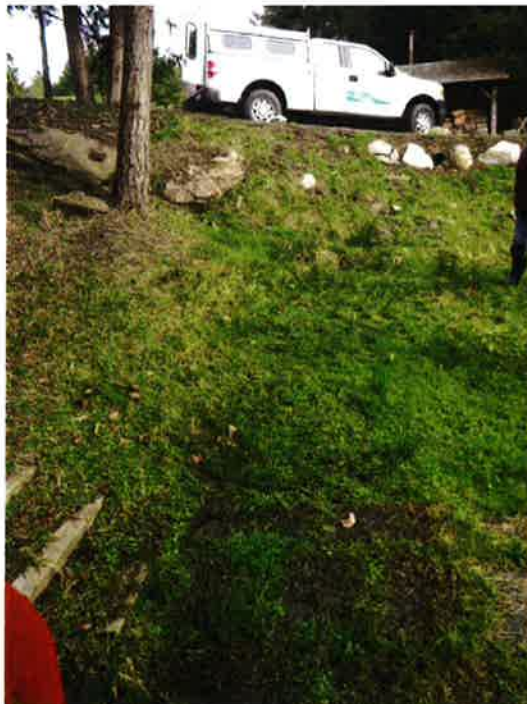
- The area downstream of the dam is characterized by a series of relatively flat, stepped benches or terraces, with a central drainage gully. Immediately below the dam, a relatively flat grassy area extends approximately 5 to 6 m beyond the downstream toe. Beyond this area is a flat gravel-surfaced parking area. Below the central section of the dam, the ground slopes down into a gully where a small seepage zone was observed on the slope. The seepage is exiting the ground closer to the right abutment.

Photo 6: Seepage area downstream of dam (Feb. 13, 2013).

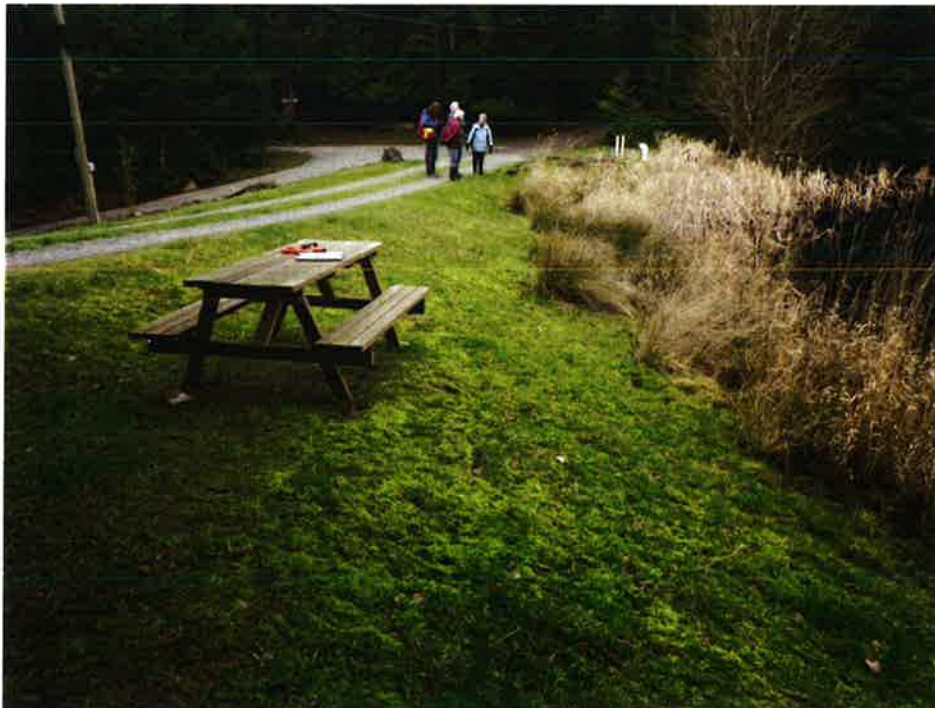
Thurber also noted that there was a lack of slope protection material on the upstream face of the dam.

- It appears there has been some minor re-grading of the upstream slope, and a picnic table has been placed on a flat spot near the left abutment. The overall slope above the waterline was estimated as being graded between 15 to 18°, but this was difficult to measure given the above noted vegetation and overall variable slope conditions.

Photo 8: Upstream slope. Note vegetation along water line (Feb. 13, 2013).

Thurber have also recommended that slope protection be provided for the upstream face of the dam, extending from the dam crest to at least 2 m below full pond elevation.
