3 March, 2015

Project No: 60285876 Task #4

**Re: Gardom Pond Dam – Decommissioning of Low-Level Outlet
Subsequent to Reports: Gardom Pond Dam Evaluation (June 2013) and
Additional Investigations (January 2014) Alternative Spillway Evaluation**

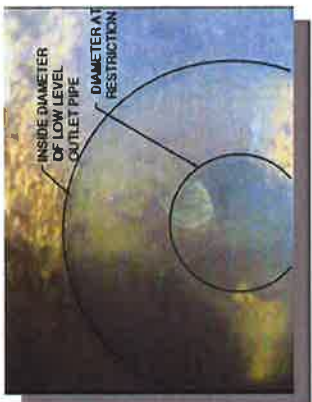
PHOTO 1
 (PIPE RESTRICTION - FROM PIPE VIDEO INSPECTION, JAN 13, 2015)

- Short aquatic growth is present on the inside walls of the low-level inlet in conjunction with sediment buildup on the pipe invert.
 - At approximately 6.1 m into the video investigation, the pipe size is significantly reduced from approximately 150 mm to 75 mm in diameter as shown in Photo #1, on Figure 1. The reduction appears to be made of concrete, with a 75 mm diameter sleeve, and is approximately 0.5 m in length, after which the pipe diameter appears to return to 150 mm in diameter. This pipe reduction is believed to have been integrated into the low-level outlet's concrete collar during construction. It is possible that the reductions may occur every 6 m spacing (for three reductions in total).

- The video equipment on-site was unable to advance through the pipe restriction and it is not certain if additional videos can be obtained through the pipe restrictions.

Upon a thorough evaluation of the concerns noted above and with no assurance that the grouting procedures would mitigate long-term seepage failure, AECOM cannot recommend the grouting of the low-level outlet. Alternatively, the low-level outlet could be replaced, which is discussed further in Section 4.2.

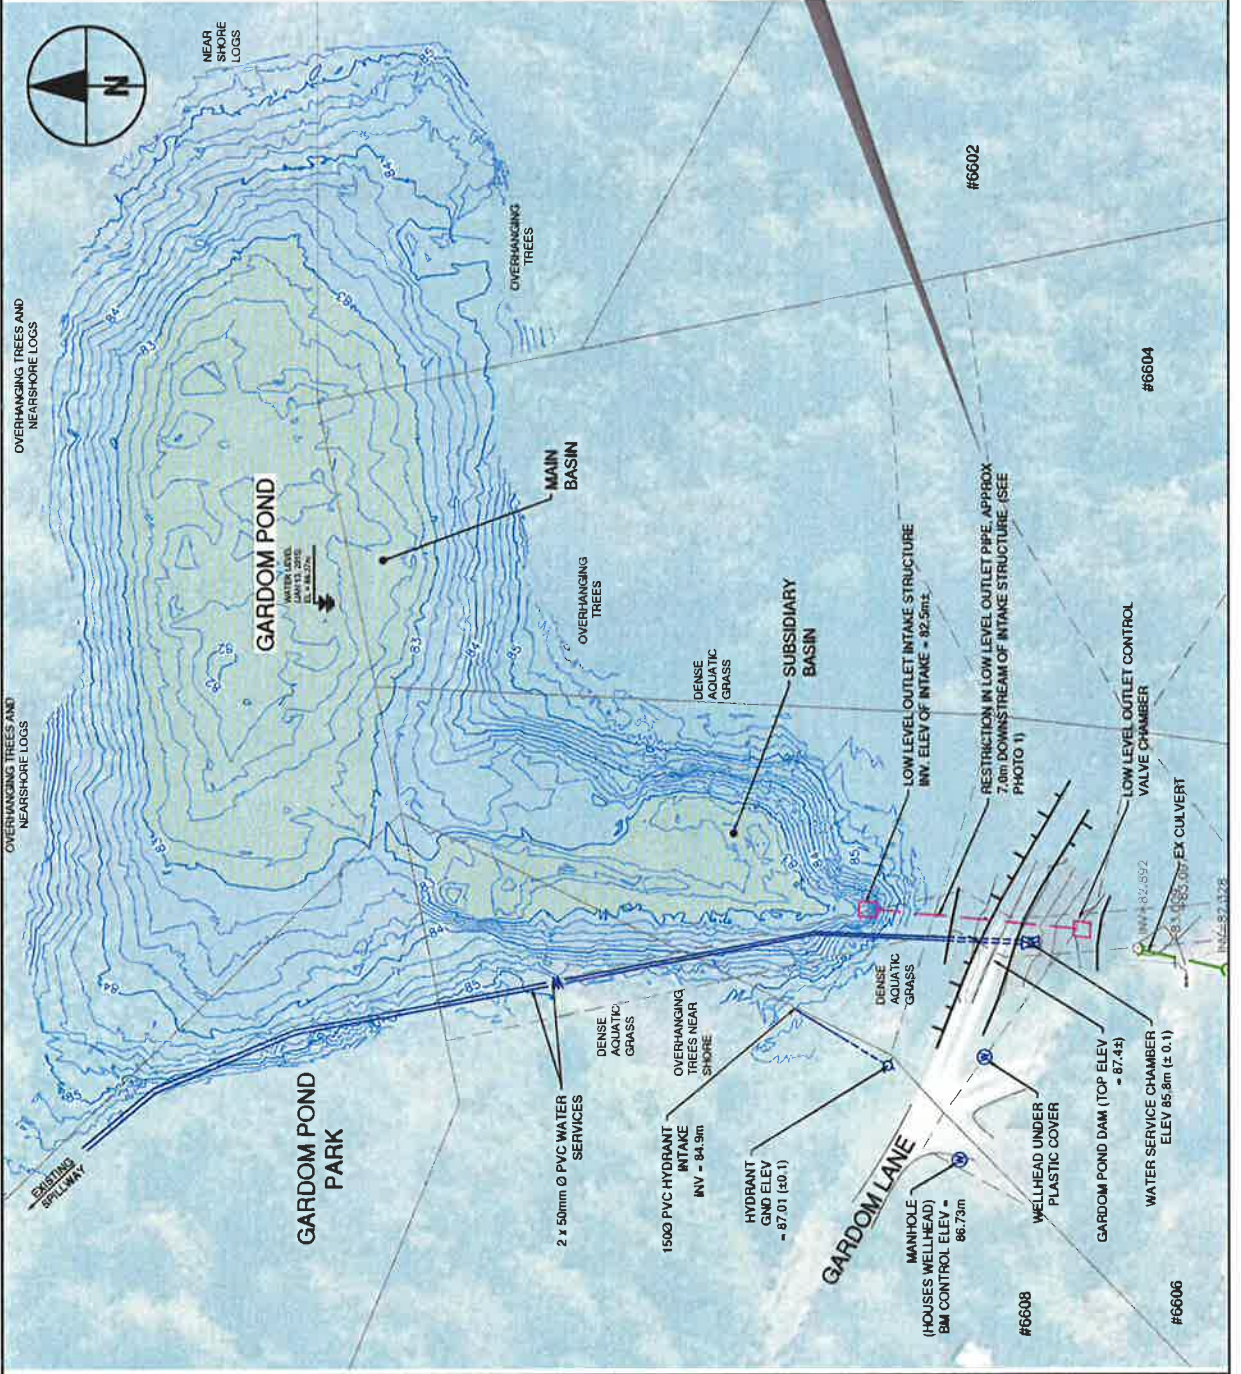
GARDOM POND BATHYMETRY AND EXISTING SITE PLAN

- The bathymetry and topographical survey was tied to Geodetic Elevations. The survey control point was established as the top of the well head casing owned by property 6608 Harbour Hill Road with a geodetic elevation of 86.73 m. In previous reports, the well was given a nominal site elevation of 100.00 m ; a difference of 13.27 m.
- The Bathymetric Survey, Figure 1 attached, identifies two low-lying basins; one to the north-northeast and the second to the south areas of the pond. These low-lying basins would likely

only provide shallow ponds ranging in depths between 0.5 m to 1.0 m in the event the pond were drawn down to the low-level outlet's existing invert of 82.5 m (± 0.2 m).

- The figure also shows key infrastructure identified; the low-level outlet, Razor Point Improvement District's two 50 mm diameter water services and the 150 mm diameter fire intake line designated for emergency use only.
- The pond's surface water elevation was recorded to be 86.27 m on January 13th, 2015, the maximum water depth was approximately 4.3 m (pond floor @ 82.0 m) and the depth to the invert of the low-level outlet was approximately 3.8 m (Inlet elevation @ 82.5 m ± 0.2 m).
- The length of the low-level outlet is approximately 21 m.
