LYALL HARBOUR BOOT COVE WATER LOCAL SERVICE COMMITTEE

Money Lake Dam #1 Engineering Assessment Lyall Harbour/Boot Cove, Saturna Island

OCTOBER 13, 2016
ISSUED FOR USE
FILE: V13103344-02

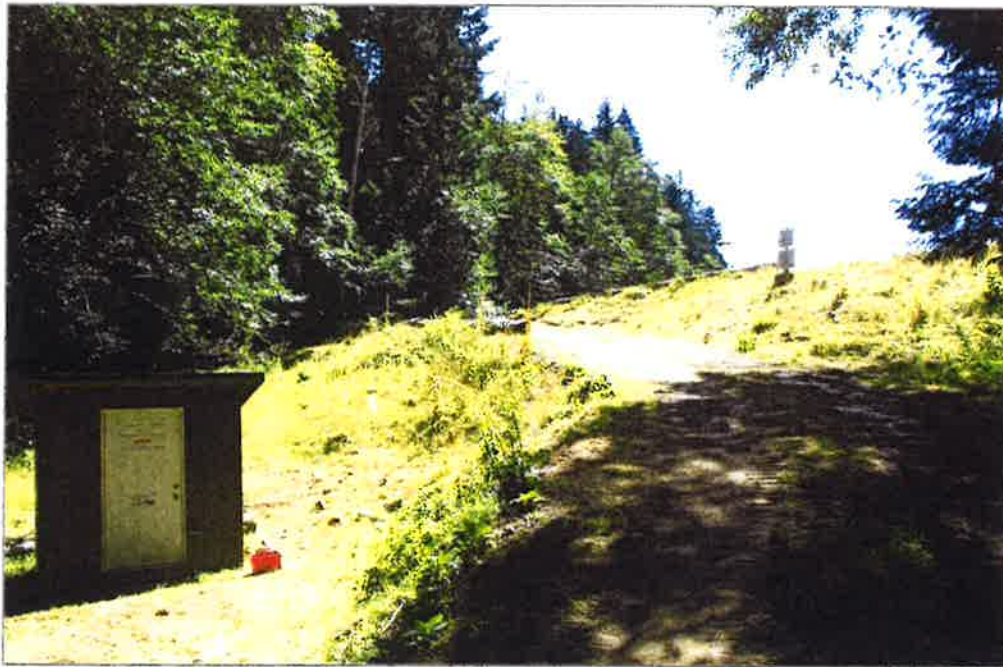
Photo 1: Looking upstream from access road

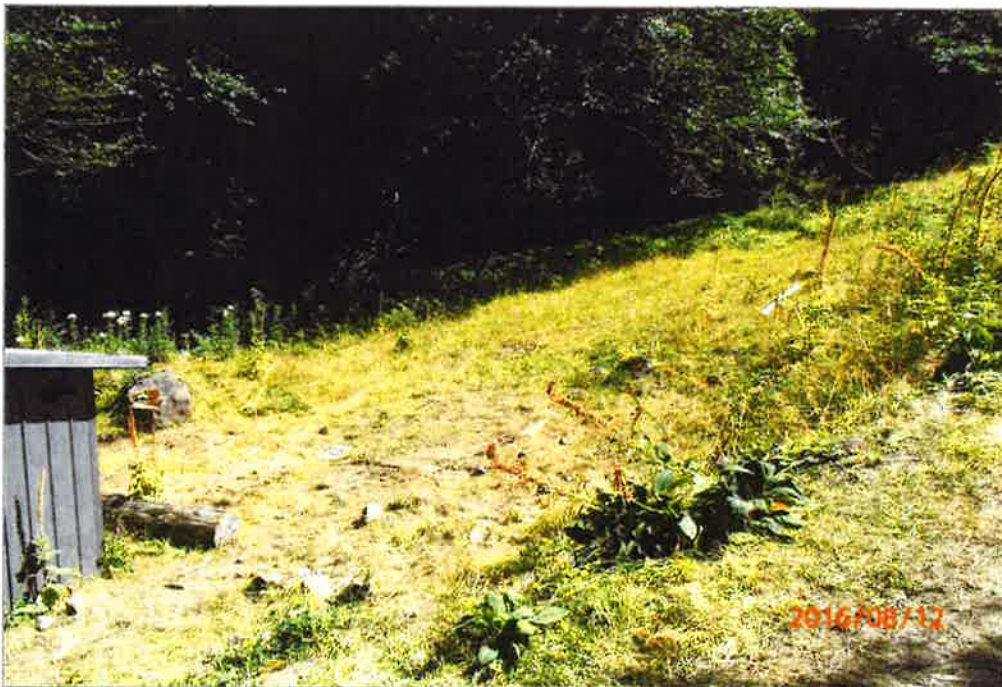
Photo 2: Looking towards right abutment from access road

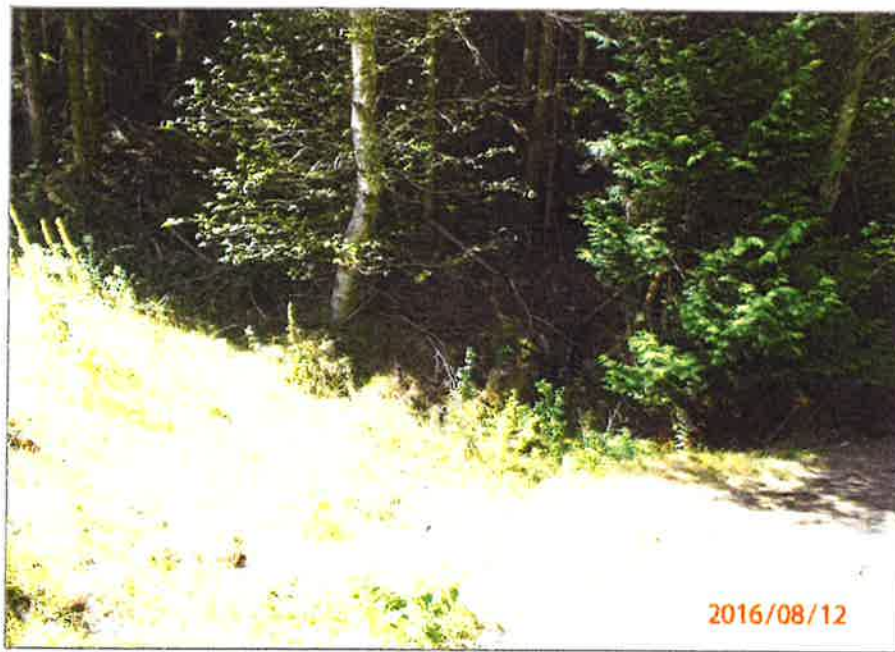
Photo 3: Left abutment contact and downstream slope

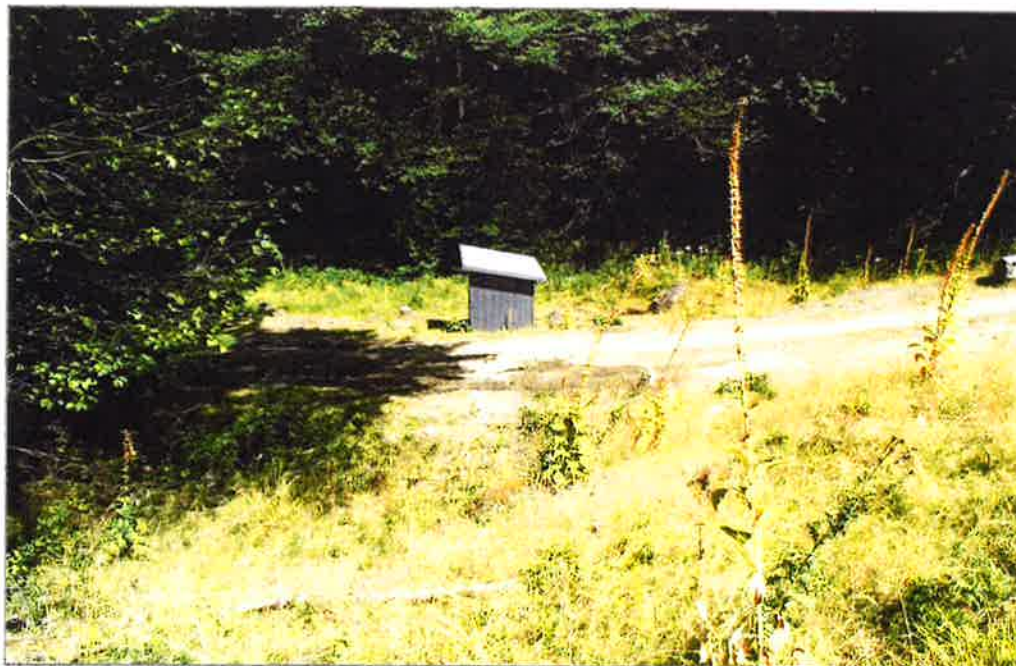
Photo 4: Looking downstream from left abutment at the dam crest

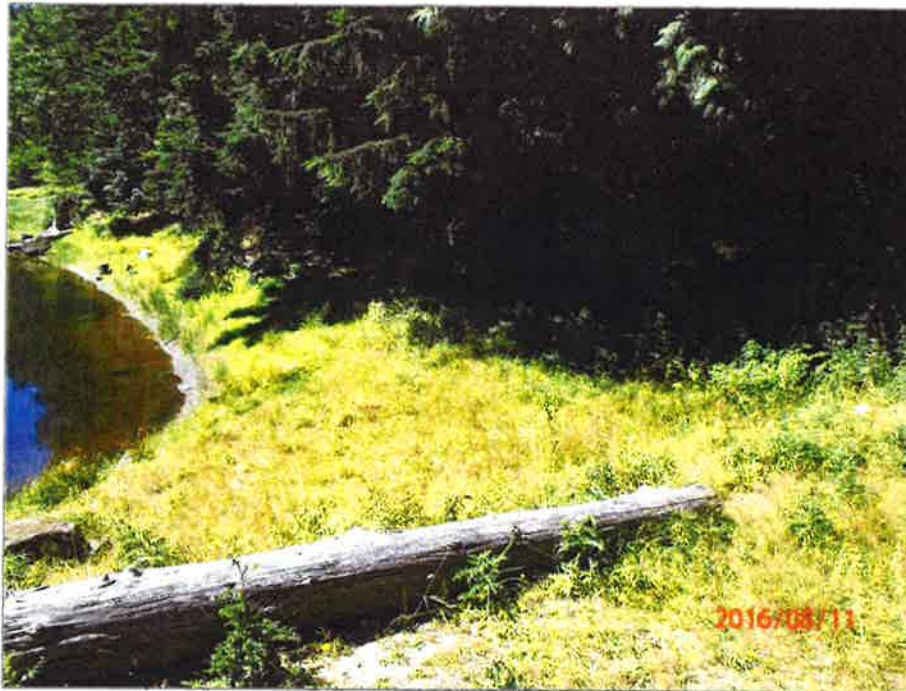
Photo 5: Old road extending upstream of left (west) abutment

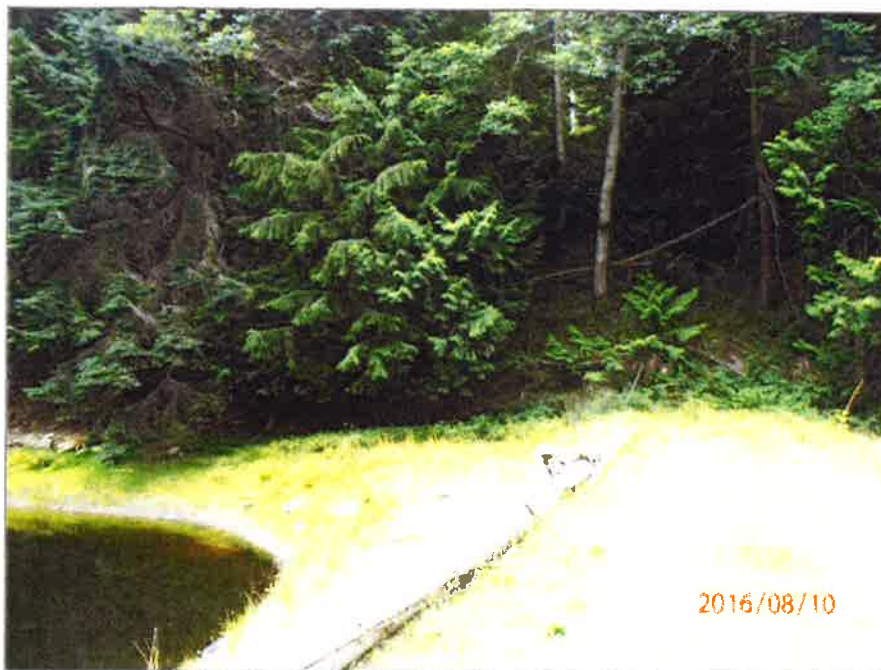
Photo 6: Crest and upstream slope at left abutment

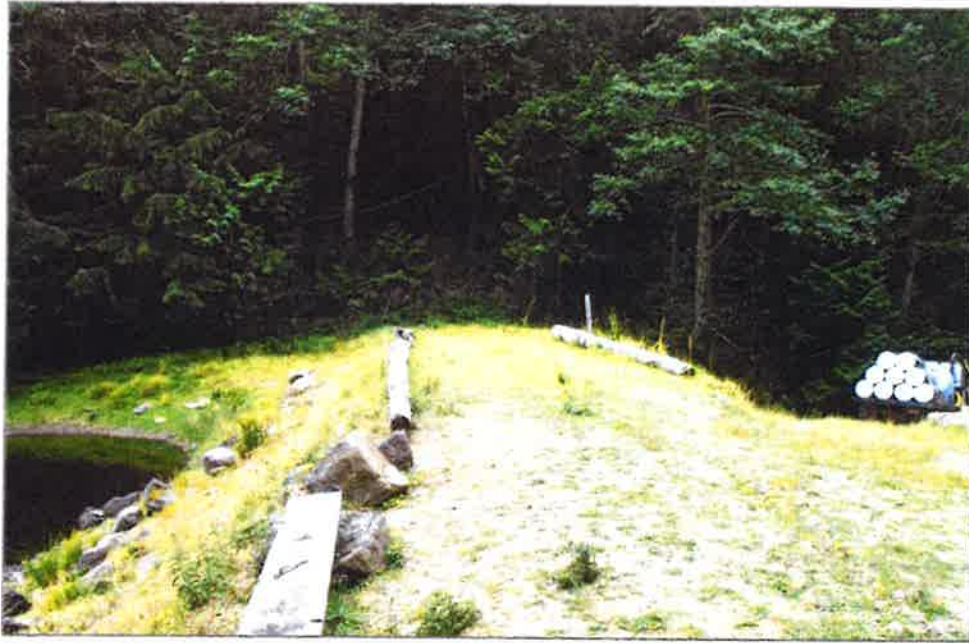
Photo 7: Dam crest looking towards left abutment

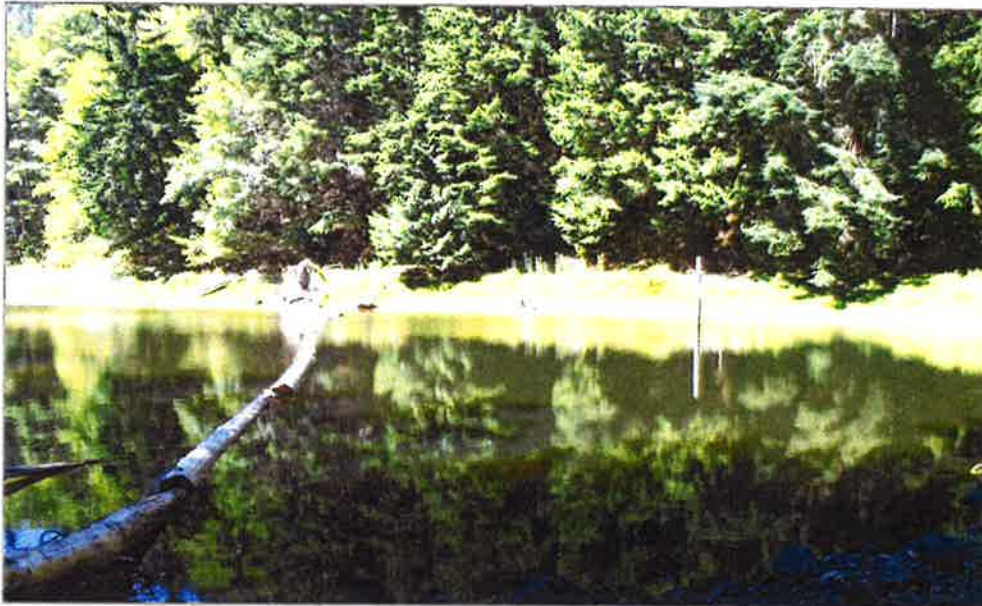
Photo 8: Log boom and staff gauge looking towards left side of the lake from the spillway

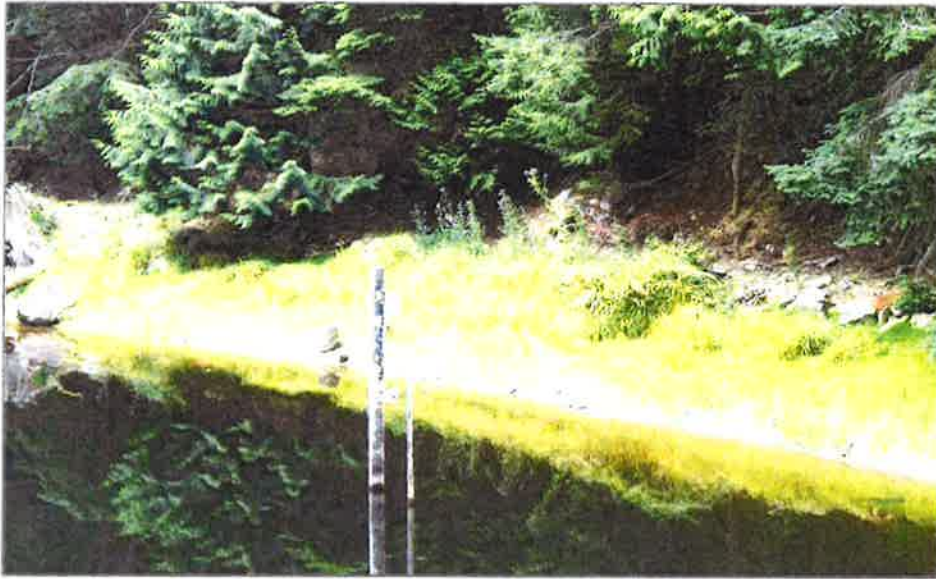
Photo 9: Staff Gauge

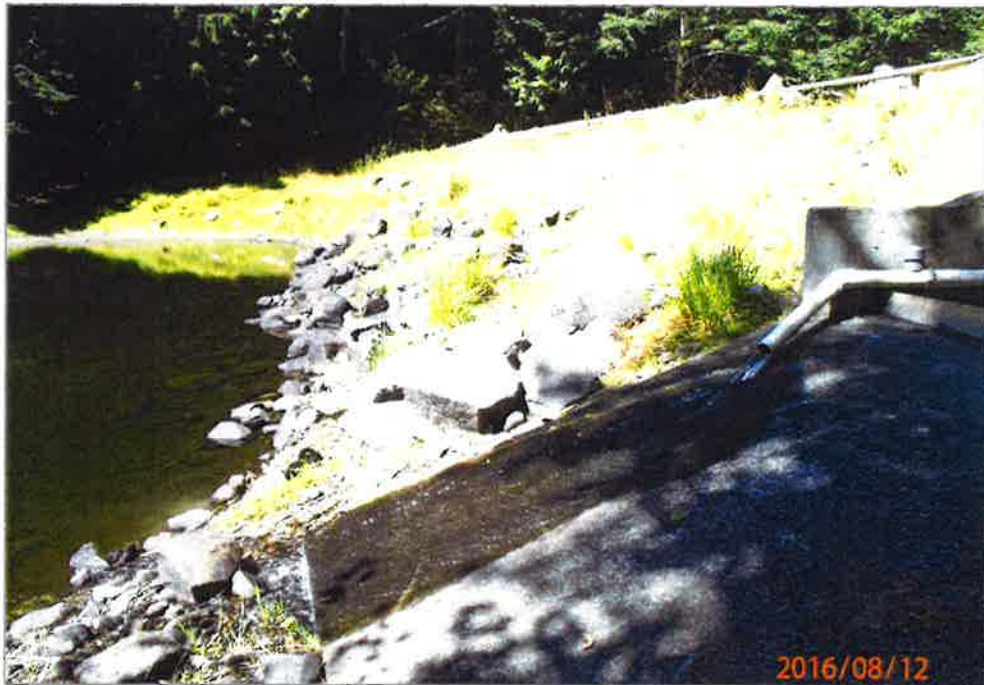
Photo 10: Upstream slope looking towards left abutment from spillway

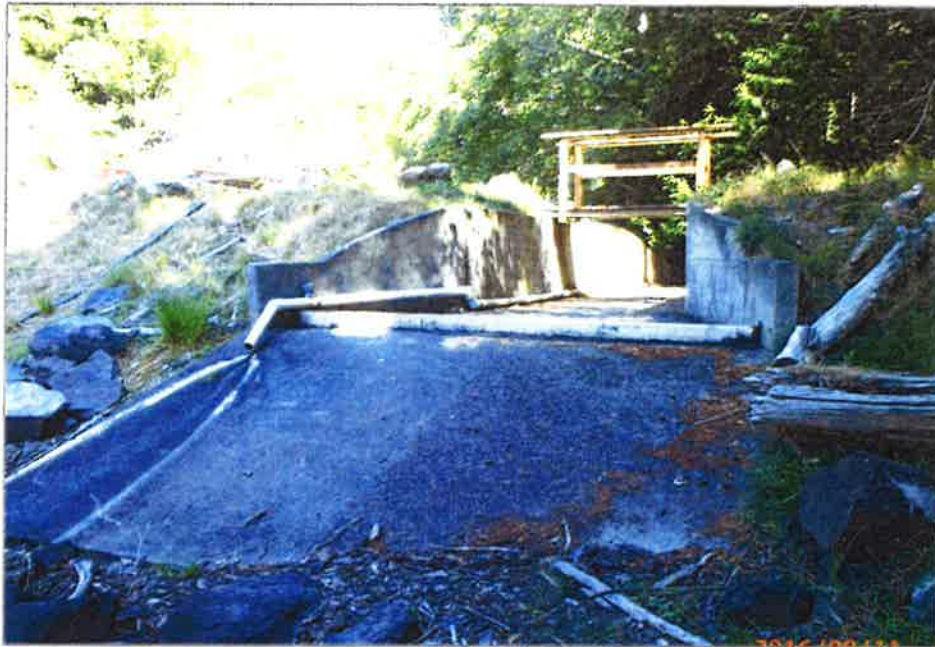
Photo 11: Spillway and bridge

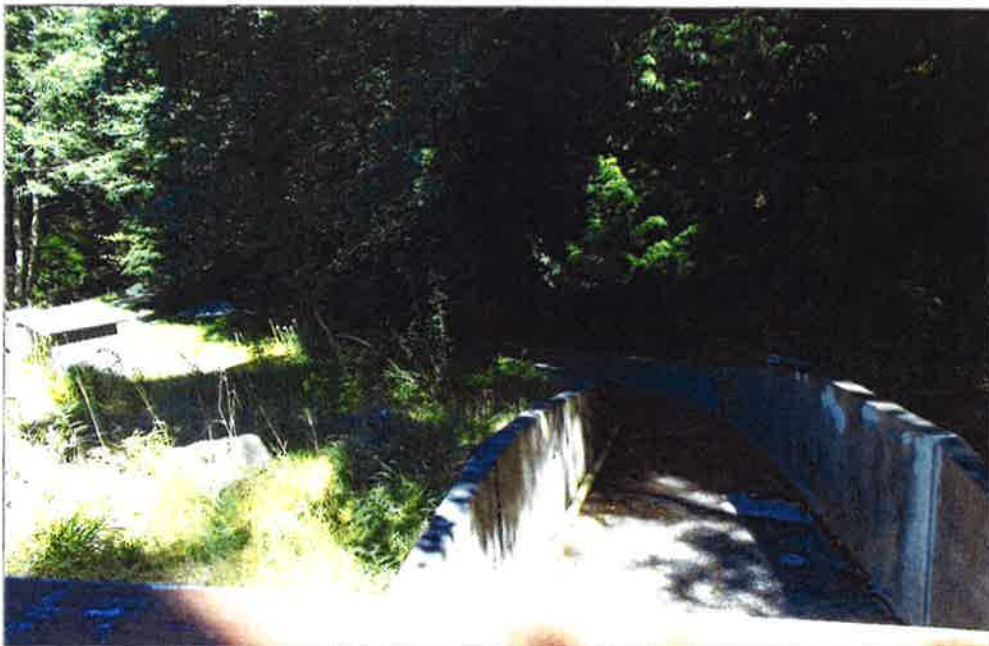
Photo 12: Spillway looking downstream from bridge

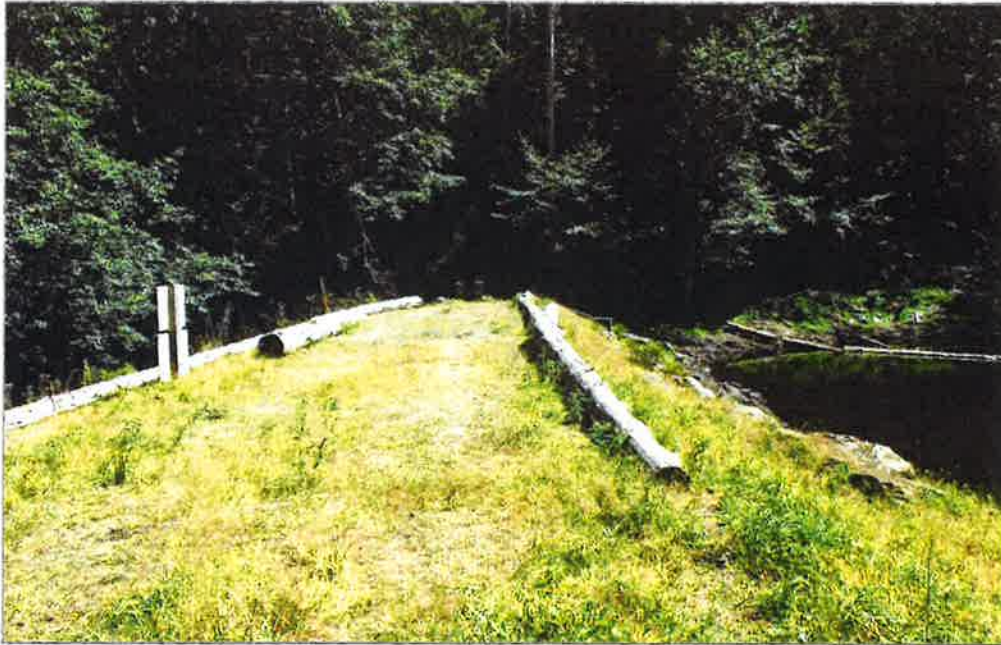
Photo 13: Dam crest looking towards right abutment

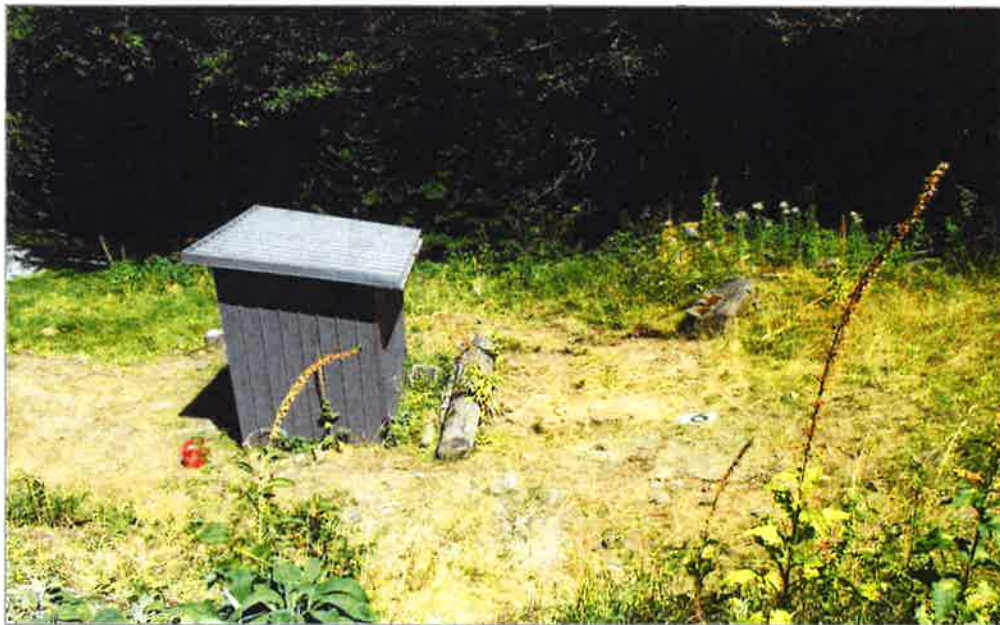
Photo 14: Looking downstream from crest at MW16-01

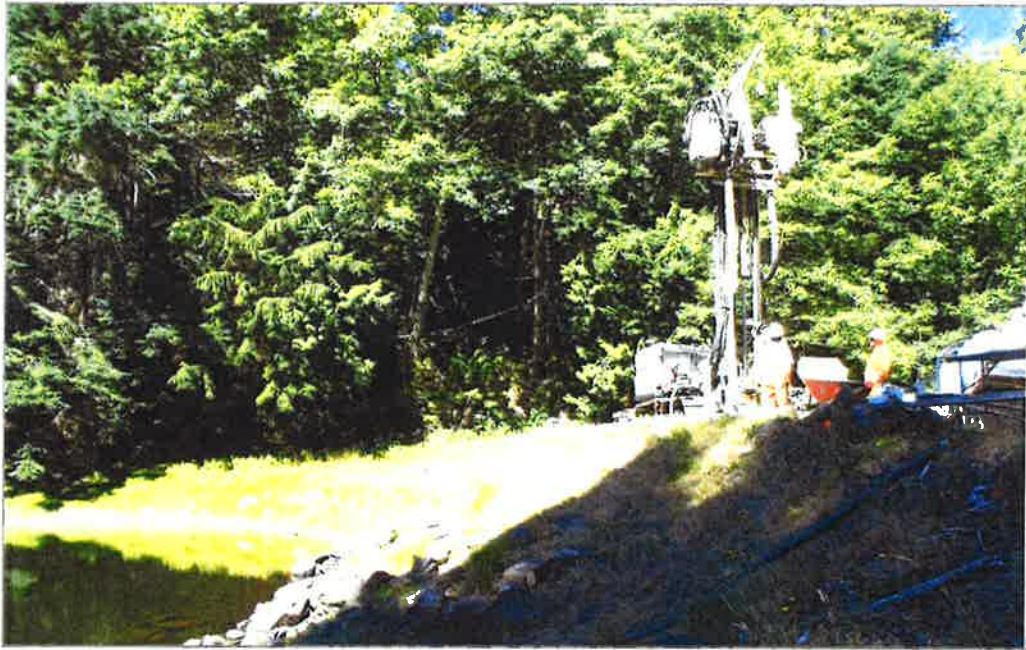
Photo 15: Drilling at the dam crest

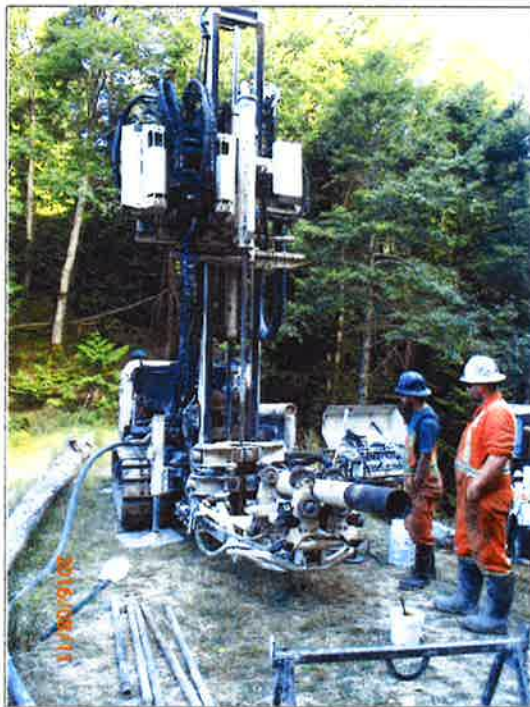
Photo 16: Drilling at the dam crest

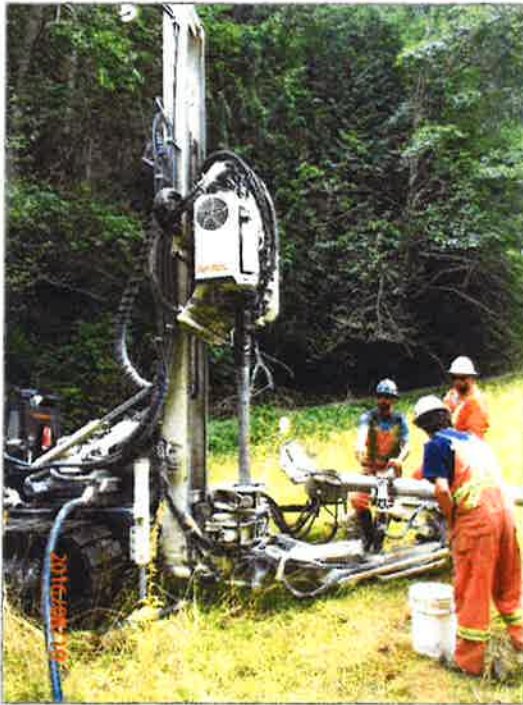
Photo 17: Drilling at the downstream toe

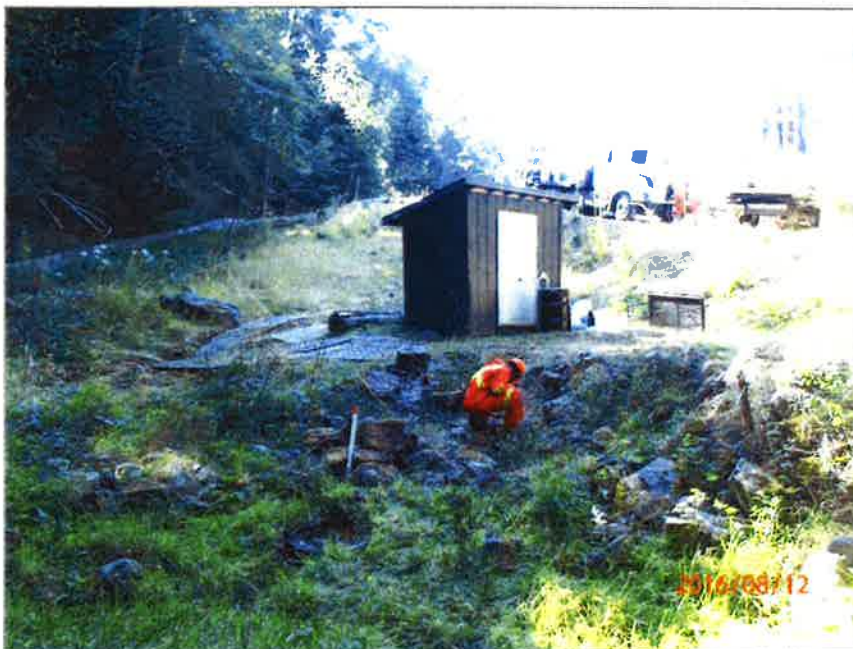
Photo 18: MH 1 and MH2 locations and drilling BH16-05

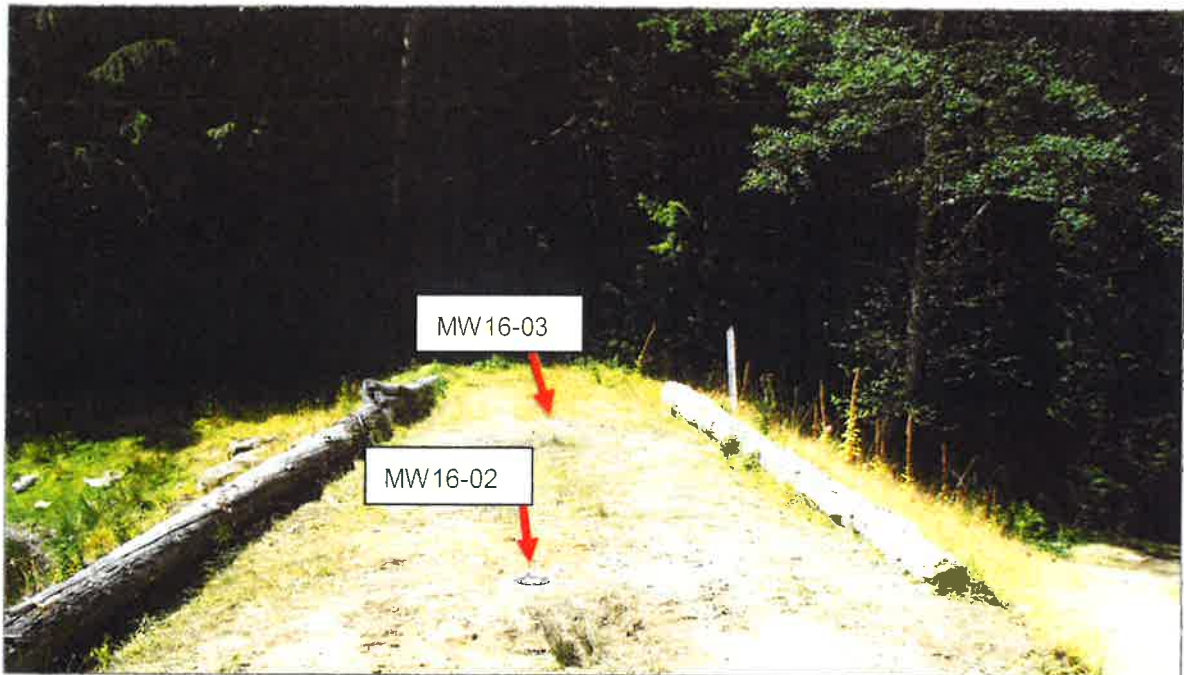
Photo 19: MW16-02 and MW16-03 at dam crest

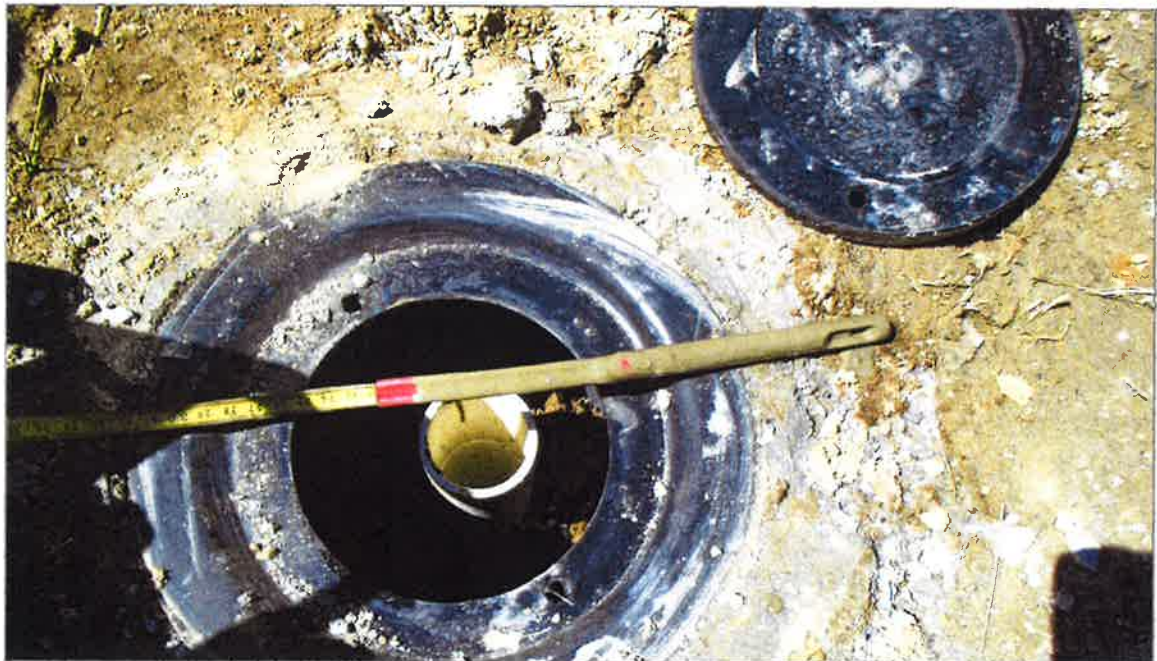
Photo 20: MW16-02 muddy water on end of water reading tape
