MAGIC LAKE ESTATES WATER AND SEWER COMMITTEE

SUBJECT **CONDITION ASSESSMENT OF SCHOONER WASTEWATER TREATMENT AERATION TANK**

**Assessment of Schooner Water
System Tank, Pender Island, BC**

June 23, 2017

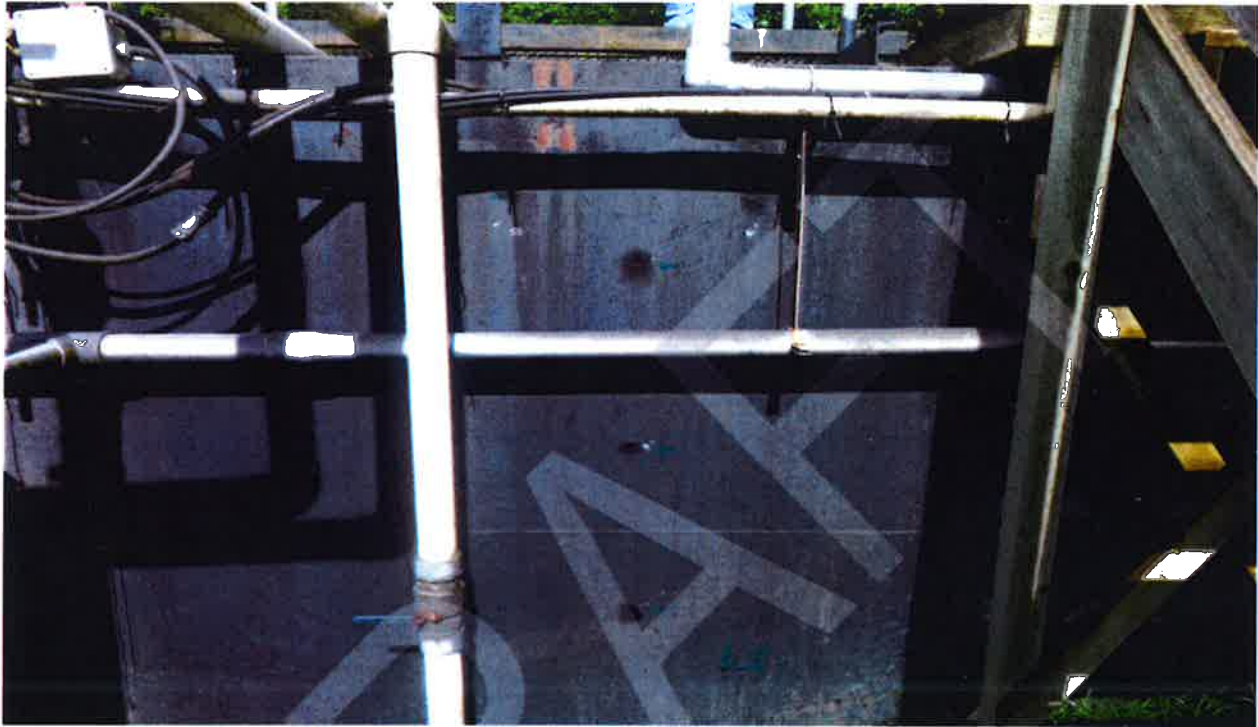
Figure 3: East tank wall thickness survey performed by Stasuk Testing & Inspection

Stantec conducted a review of the tank structure based on the findings from Stasuk Testing & Inspection (included in Appendix B). The tank has an original wall thickness of 6.35mm (0.25") with the lowest thickness noted to be 4.78mm (0.188") with minor pitting and corrosion present on the internal shell surfaces.

A stress check was performed on the steel wall plates, based on the minimum thickness measurements provided by Stasuk Testing & Inspection. The stress on the walls is at the upper yielding limit for steel for the tank and is not acceptable due to corrosion and material loss which is approximately 35% of the original base material.

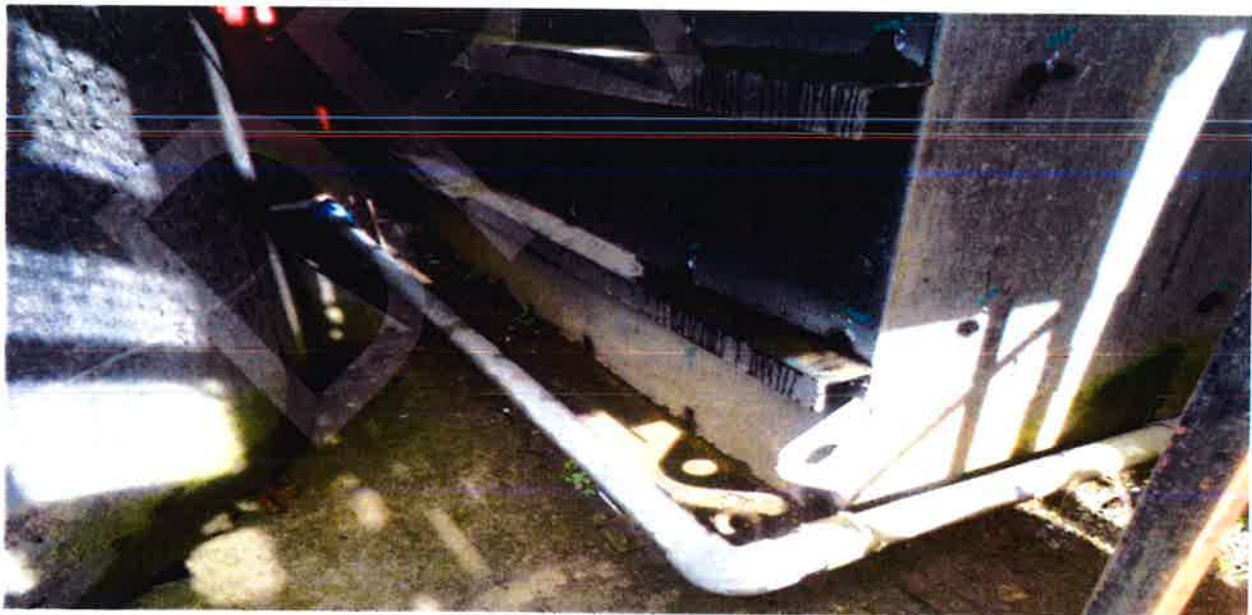
In addition, no seismic restraint (base anchorage) of the tank was noted at grade elevation. During a seismic event, the tank will overturn in the short direction and sliding of the tank structure will occur in both the longitudinal and transverse directions as lateral passive soil pressure at the northern end of the site is not adequate to resist horizontal forces when the tank is at capacity during a seismic event in one direction only.

Figure 4: Tank base with no foundation or anchorage at existing grade

Seismic restraint of the tank at grade elevation should be designed by a structural engineer registered within the Province of British Columbia.

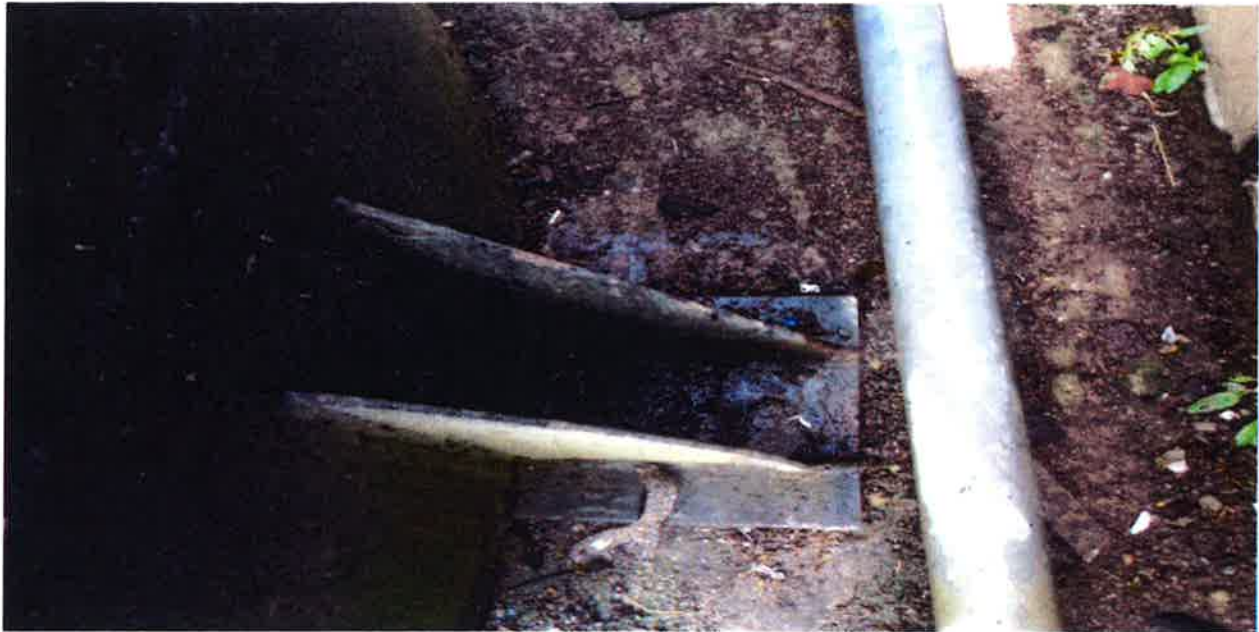
Two adjacent above grade circular tank structures bearing on an existing concrete slab at grade level had four equally spaced steel base gusset plates located at the bottom of each tank, however, expansion bolt connections to the foundation slab were missing.

Figure 5: Adjacent 2 No. circular above grade steel tank structures. Note: Missing bolted connections (4 total/tank) to the existing foundation slab

Without providing anchorage connections for each above grade steel tank structure, each tank has a high probability of failure during an earthquake event.

- Provide field installed soil anchors with associated steel brackets field welded to each corner of the tank at the base elevation. Anchors and brackets to be located on the east and west walls to resist lateral post-disaster demand loads, preventing sliding and overturning of the tank in the short direction
- Both circular aeration tank structures to have epoxy resin field installed anchors to each brackets already provided, preventing sliding and overturning of each tank
- Provide a new internal liner, this will reduce further corrosion of the steel inner walls

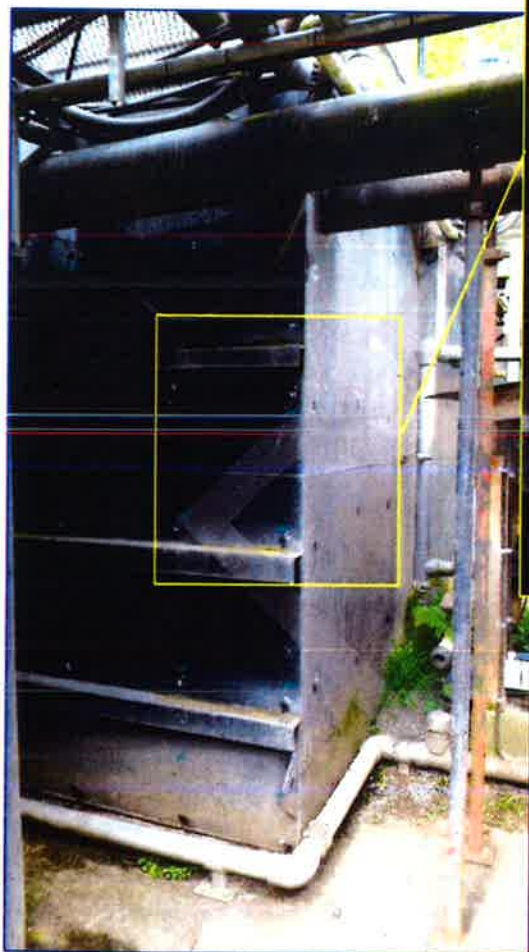
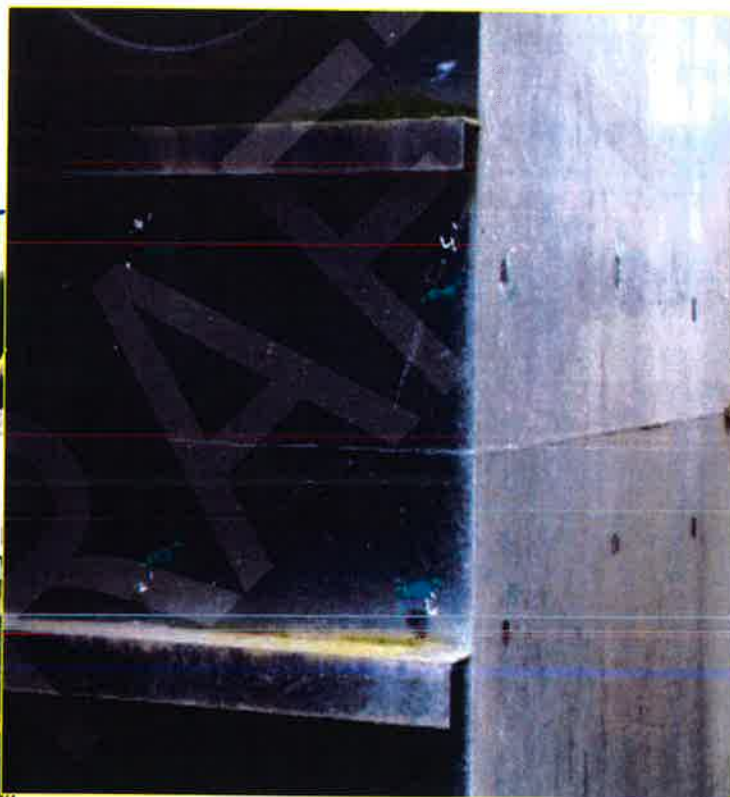
Image-1: South Eastern corner of the wastewater aeration tank; note the stiffeners and the vertical and horizontal seam welds.

Image-2: Overview of the Eastern shell of the wastewater aeration tank and close-up of the pipe hangar welds and the cutting disc mark.

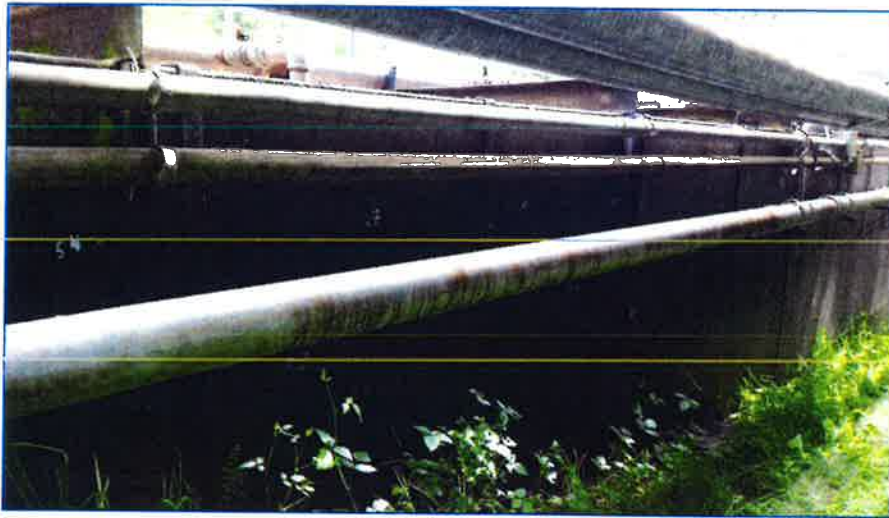
Image-7: Overview of the Western wall of the wastewater aeration tank. Note the hangars are not welded on this side of the tank. They are bolted to the top ledge.

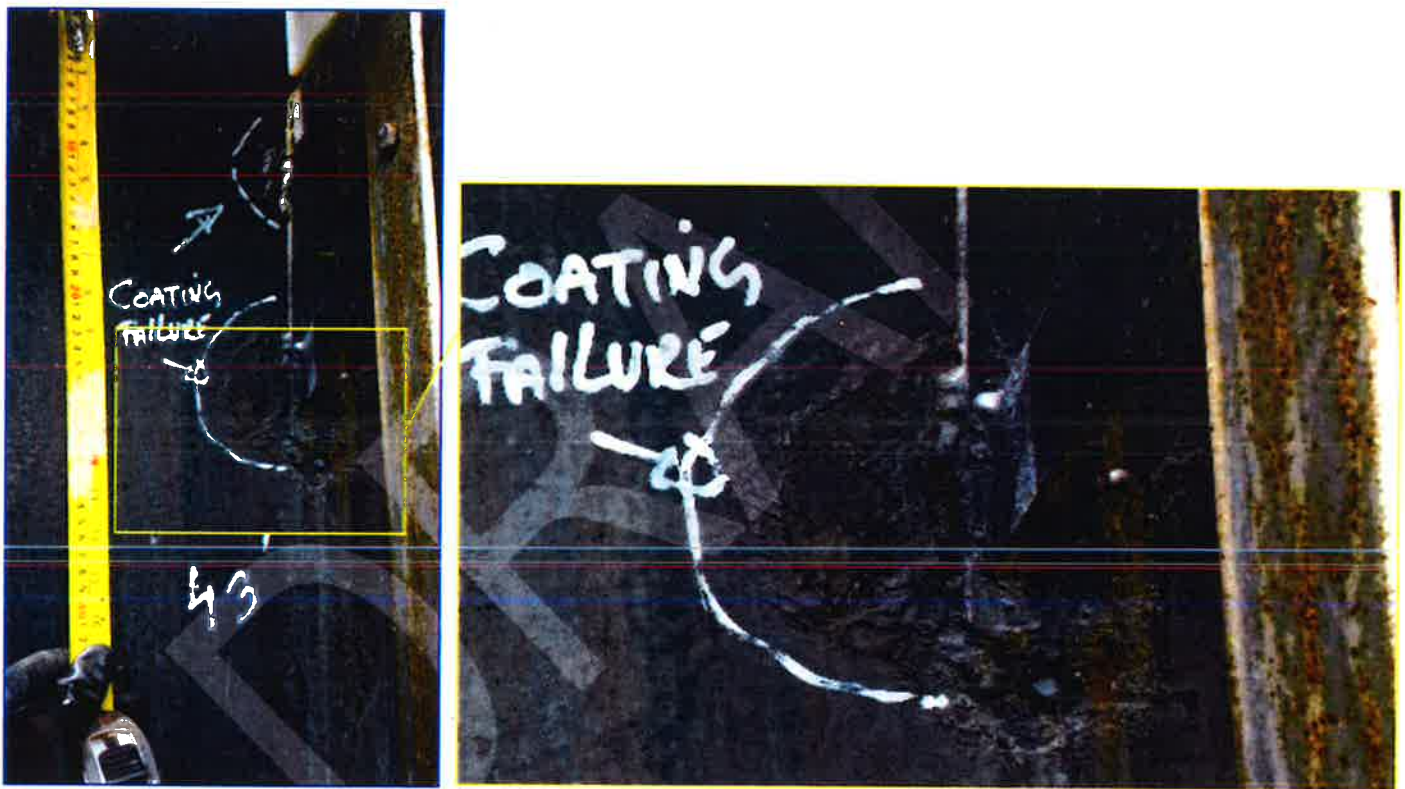
Some concern should be noted on the condition of the external pipe hangers that are welded to the upper east side of the tank shell: The welding quality is low and the integrity of the coating in these locations was found to be compromised. A recommendation is to wire wheel each location, prime with an anti-rust agent and re-coat with an approved coating compatible with the existing shell coating, alleviating the chance of a more detrimental corrosion forming in the future.

Image-13: Area of concern located at 43' from the north end of the tank on the Upper East Side shell. The welding quality and coating has been compromised.

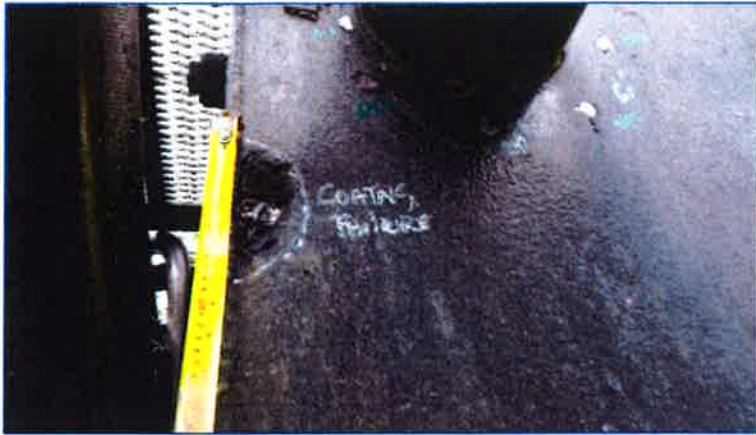
Image-14: Coating failures present the South East corner of the wastewater tank approximately 3' from the top ledge.

- Seismic restraints for piping and miscellaneous equipment
- Provide patch repairs of the exterior coating at locations noted on the NDT
- Monitoring and formalizing a tank inspection and maintenance programme will extend all above ground tanks serviceability requirements

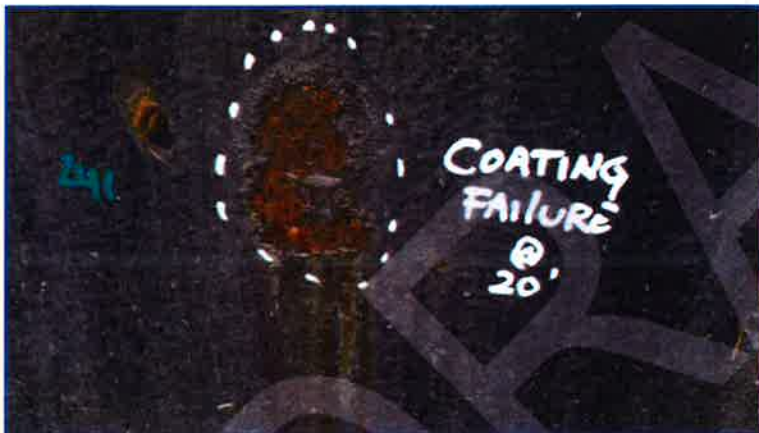
Image-15: Coating failures present the East shell wall of the wastewater tank at 20' from the North end.

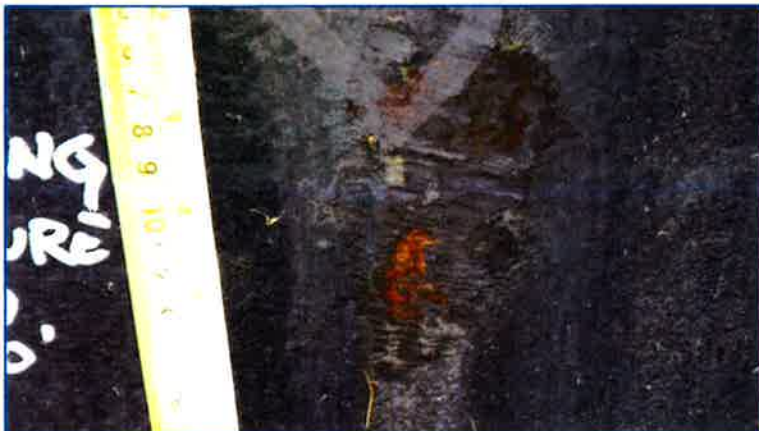
Image-16: Coating failures present the East shell wall of the wastewater tank at 29'6" from the North end.

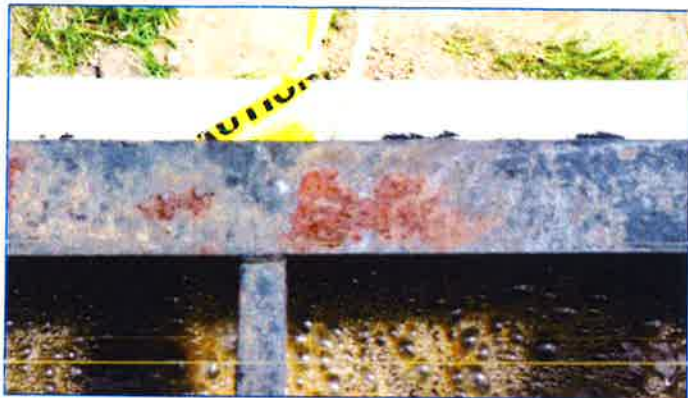
Image-17: A close-up image of the typical coating failure present along the entirety of the top tank ledge. Coating failure may be due to weather exposure as well as chemicals used in the treatment process.

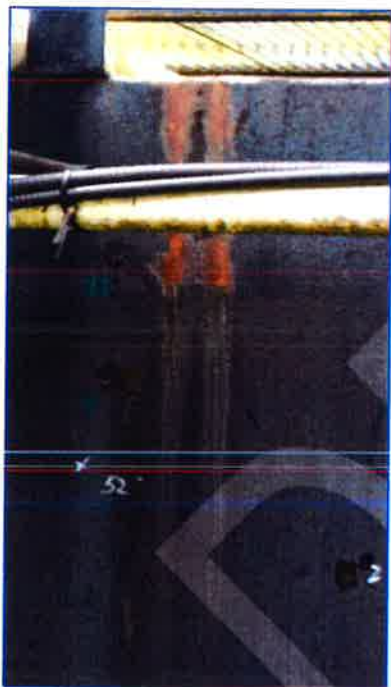
Image-18: Coating failures present on the Upper East shell wall of the wastewater tank at 52' from the North end.
