**SKANA WATER SERVICE COMMITTEE**  
Notice of Meeting on **Tuesday, April 12, 2016 at 9:30am**  
Main Conference Room, 479 Island Highway, Victoria, BC

### **SUBJECT**      **CONDITION ASSESSMENT OF POTABLE WATER STORAGE TANKS**

This document entitled *Structural Assessment of Skana Water System Tanks* was prepared by Stantec Consulting Ltd. for Capital Regional District (CRD), and for the attention of Mr. Gary Plevin, AScT. The material in it reflects Stantec's best judgment in light of the information available to it at the time of preparation. Any use, which a third party makes of this report, or any reliance on or decisions made based on it, are the responsibilities of such third parties. Stantec Consulting Ltd. accepts no responsibility for damages, if any, suffered by any third party as a result of decisions made or actions based on this report.

## **ASSESSMENT OF SKANA WATER SYSTEM TANKS, MAYNE ISLAND, BC**

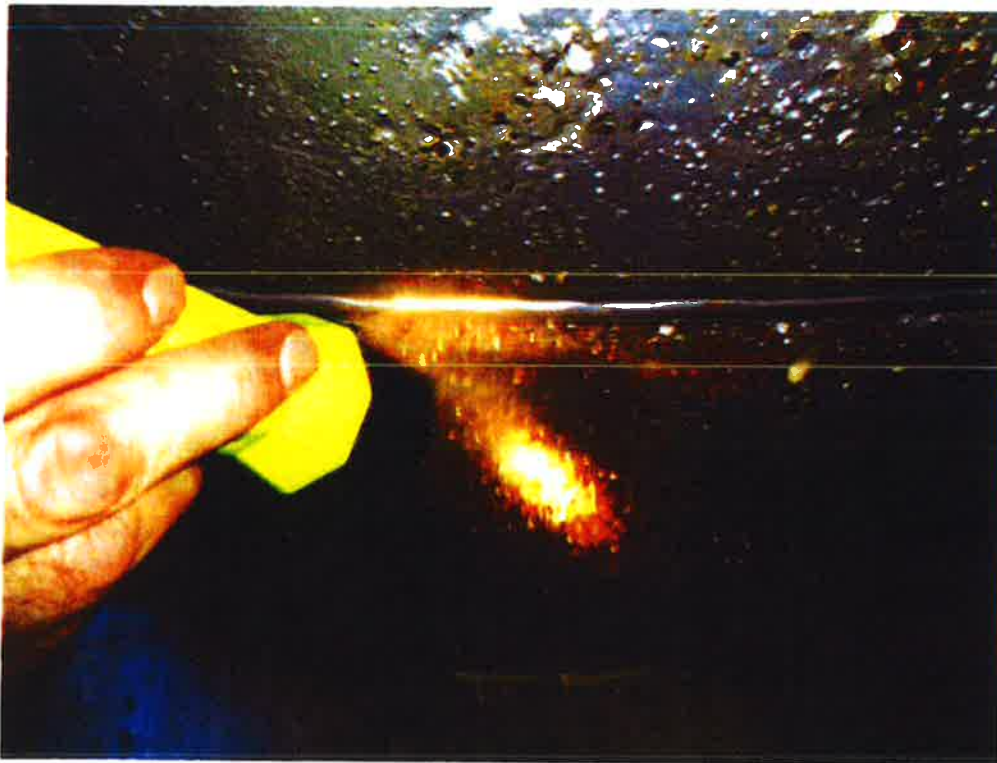
The motivation for our analysis and review is the apparent visual pitting of the lower section of cylindrical steel shell panels adjacent to concrete saddle support locations. The pitting is evident along the bottom of each tank. The following figure details noticeable pitting of the tank wall next to the concrete saddle support.

**Figure 2: Tank #1 Pitting at bottom of exterior shell at support saddle**

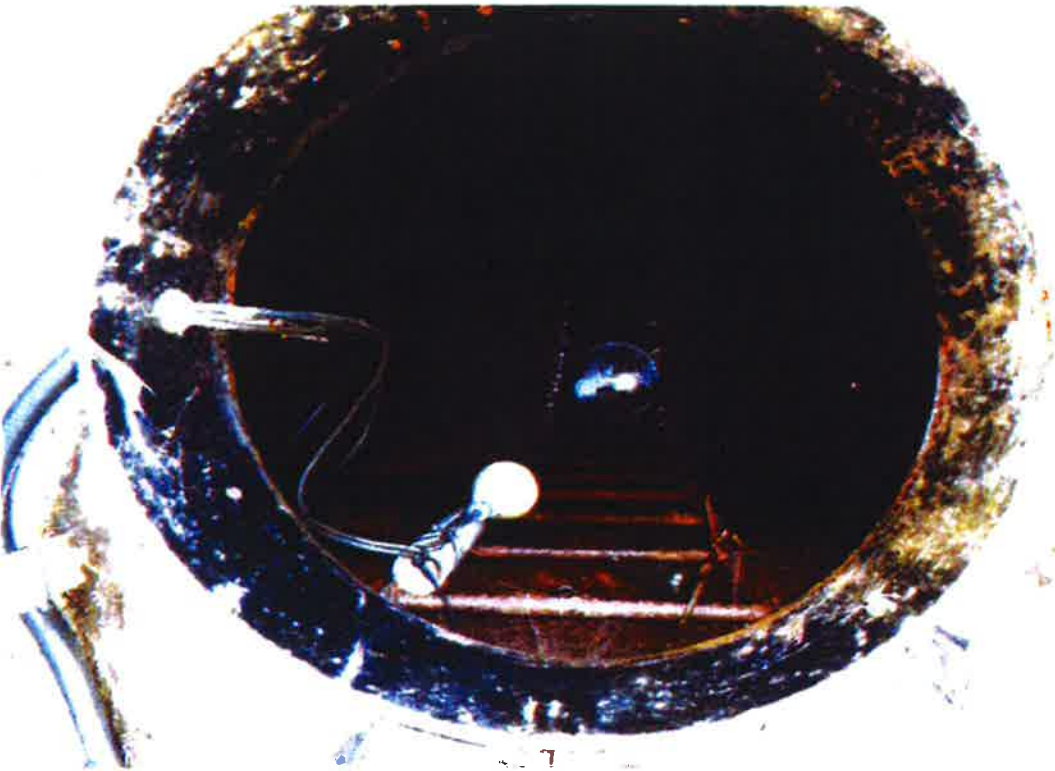
As depicted in the image below, the roof hatch is in good condition, however access ladders down into the tank and visual observations from the roof hatch inside the tank (tank #1 observed) indicates significant corrosion and scaling present.

**Figure 3: Roof Hatch Observation (Tank #1)**

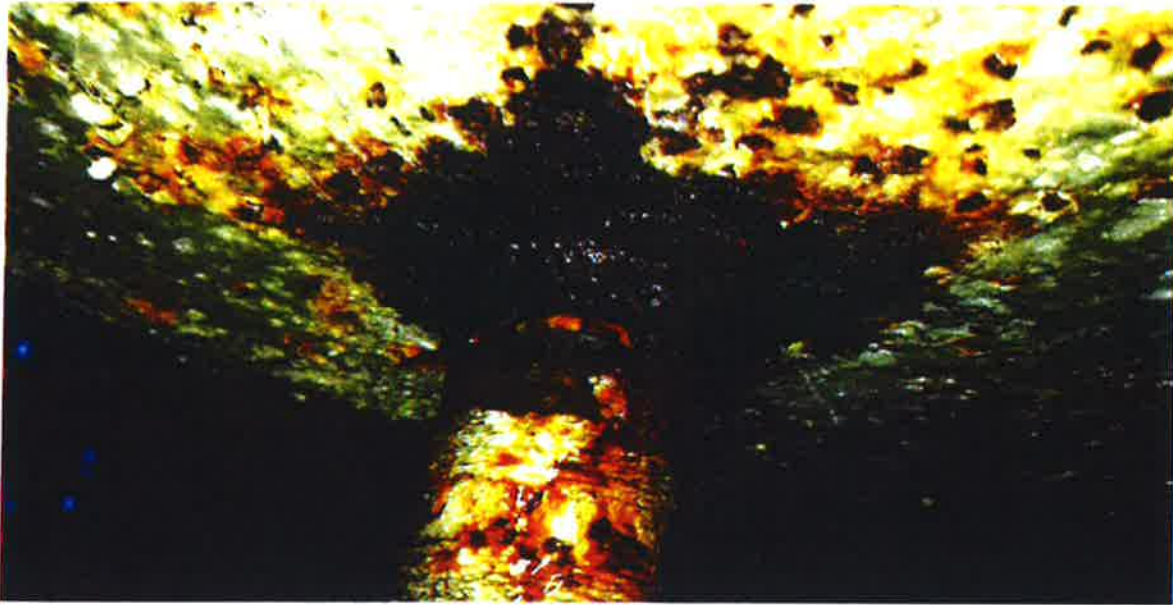
**Figure 4: Tank #2 East drain port nozzle pipe fitting failure**

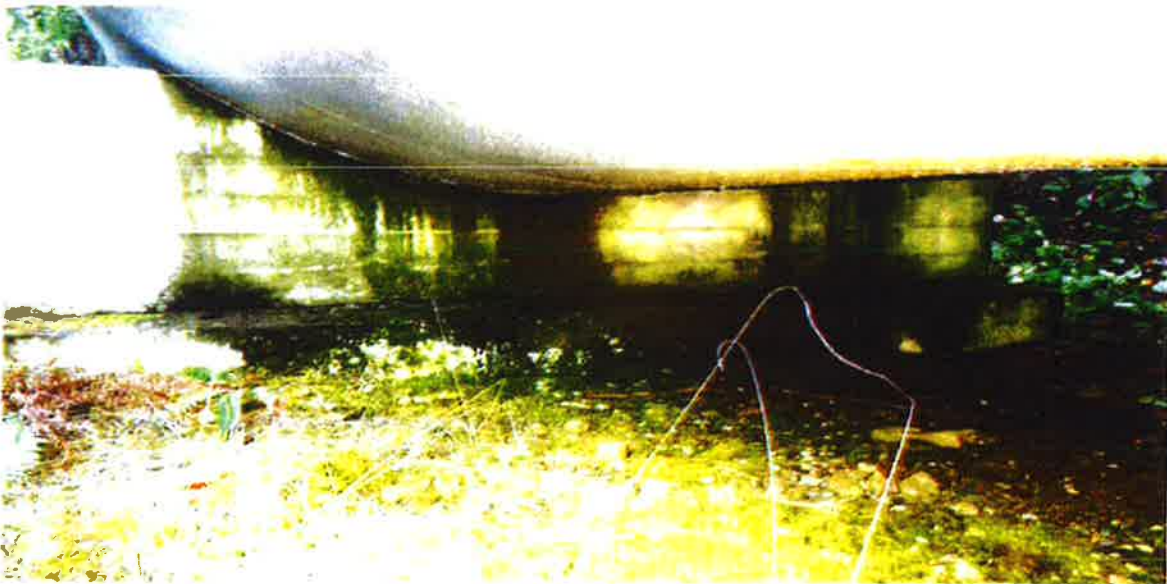
**Photo 2:** Typical concrete support pedestal and stem wall footing. *Note: No permanent bracket connection of tank to pedestal/footing.*

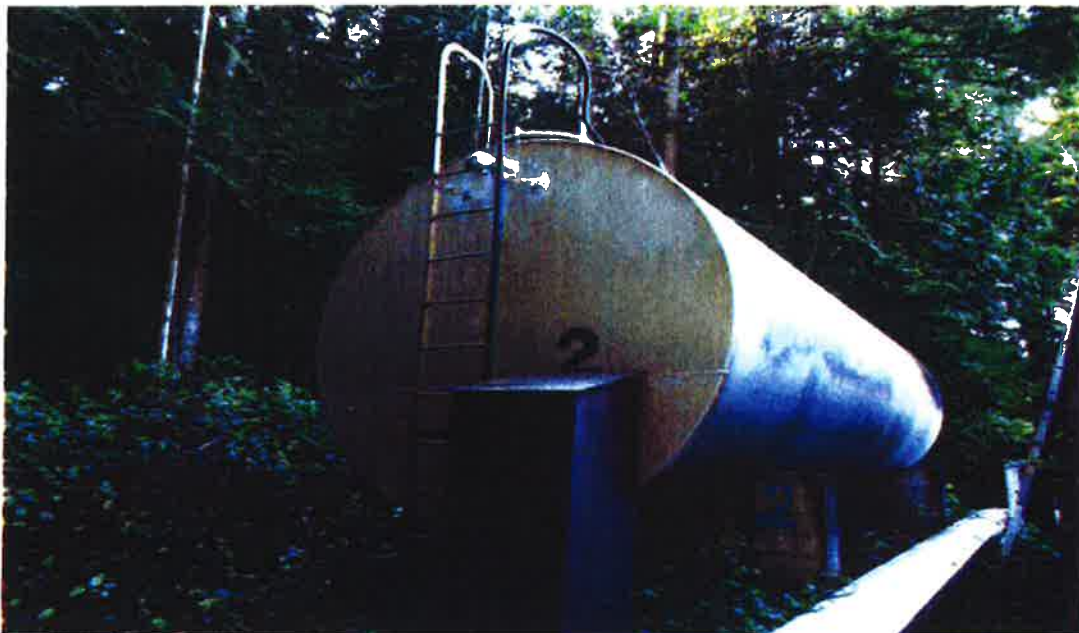
**Photo 3** Exterior access ladder in good condition for both tanks with localized corrosion present.

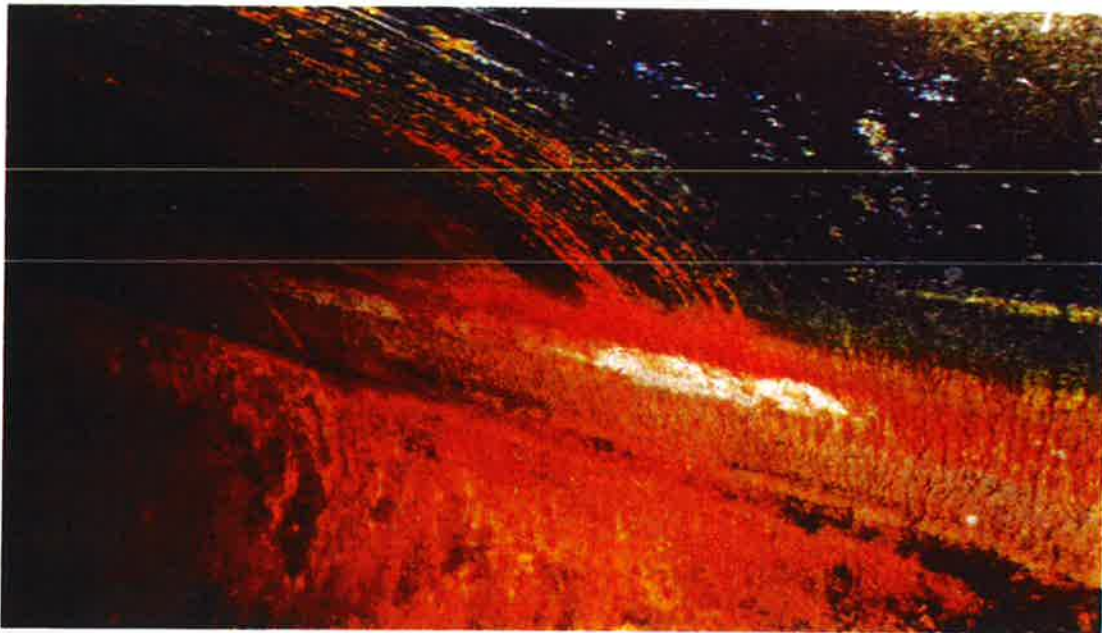
**Photo 6:** View of water scaling on side of Tank #1.

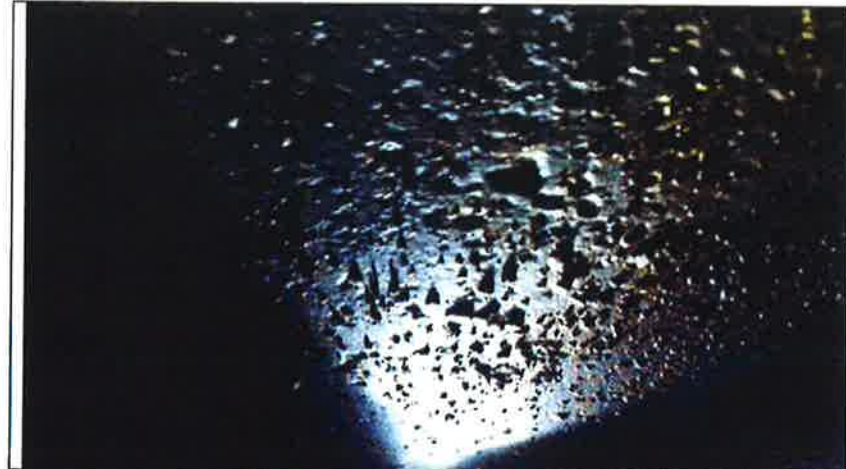
<p>Image -1: Close-up example of the severe corrosion on the bottom of the tank</p>

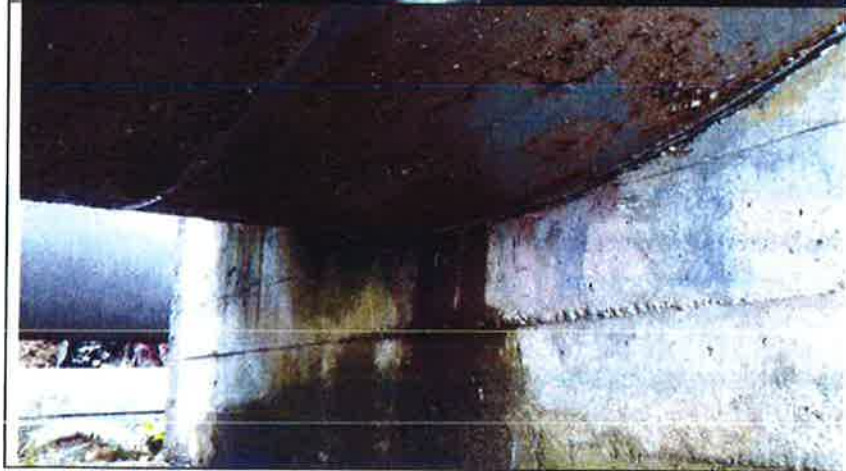
- 1.3 Minor and inconsistent corrosion was also noted around the tank saddles. See Image -2.
- 1.4 Severe coating degradation was noted throughout the areas of corrosion mentioned above; however the rest of the tank was noted only to be covered in mildew caused by weather with no significant recorded coating failure.

<p>Image -2: Another example of the severe corrosion on the bottom of the tank. This is continues along the entire bottom.</p>

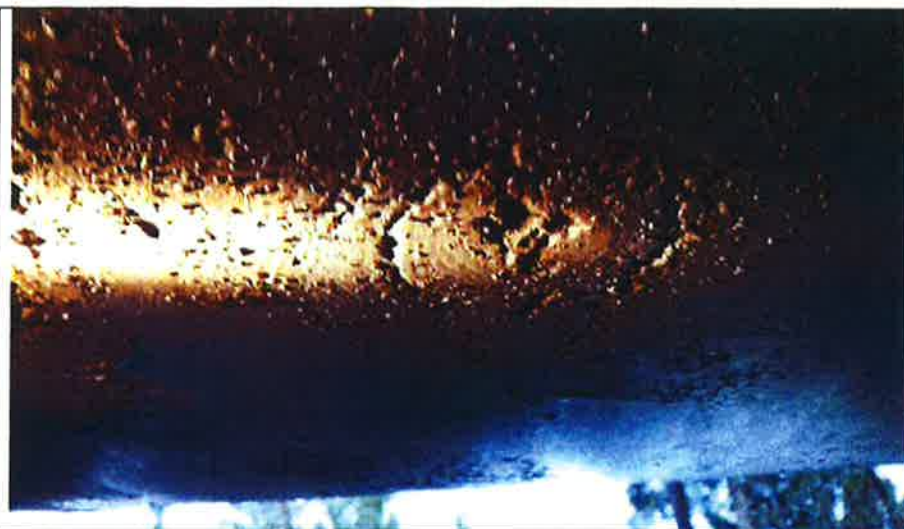
Image -3: Corrosion colony slightly up from bottom dead center.

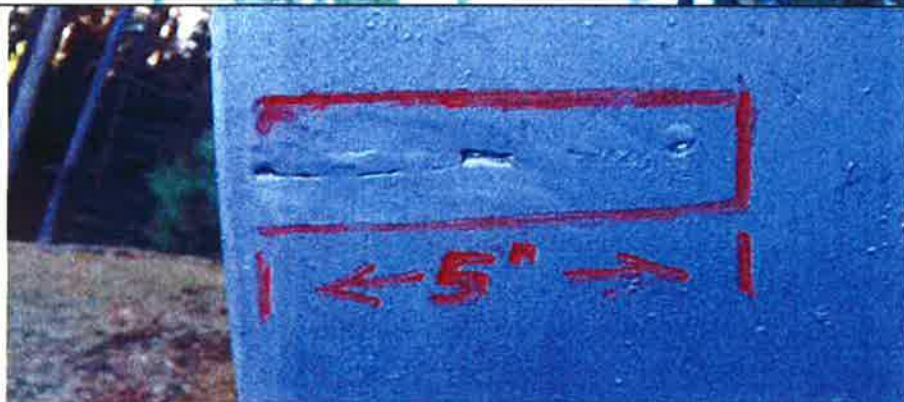
Image -4: Weld defect just below the 9 o'clock position on the west end of the tank as mentioned above.

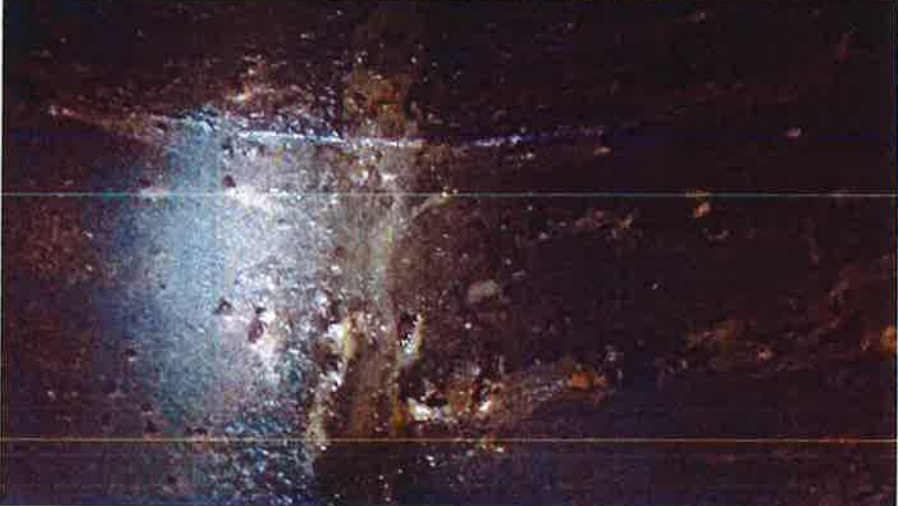
<p>Image -6: Example of the calcium build up found on the internal side of the tank.</p>

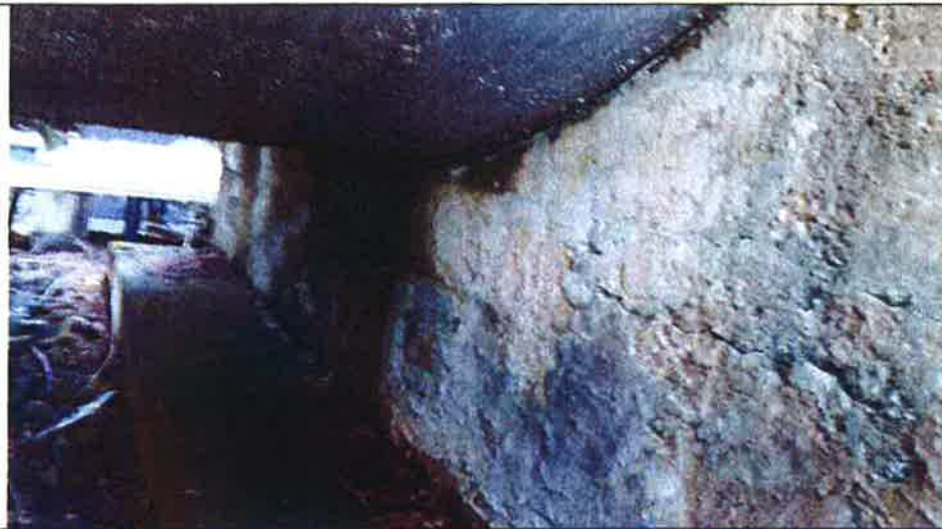
- 5.1 It was noted that the tank saddle liners have become very brittle. It was noted also that concrete repairs have been made to the saddles in the past. Cracking was noted in areas. The determination of the usability of the saddles and whether or not code requirements are met are left to the engineer. See Image 7.

Image -7: example of the condition of the tank saddles. Note the repairs that have been made also the cracking present in the image.

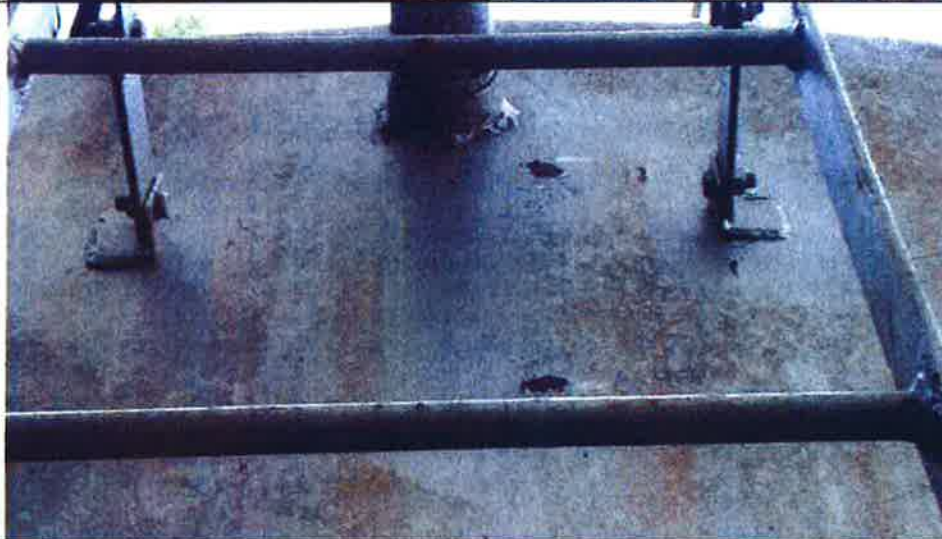
Image -8: Example of the access ladder welds as found to be in acceptable condition. Also not eh breather nozzle found on the upper east end of the tank.

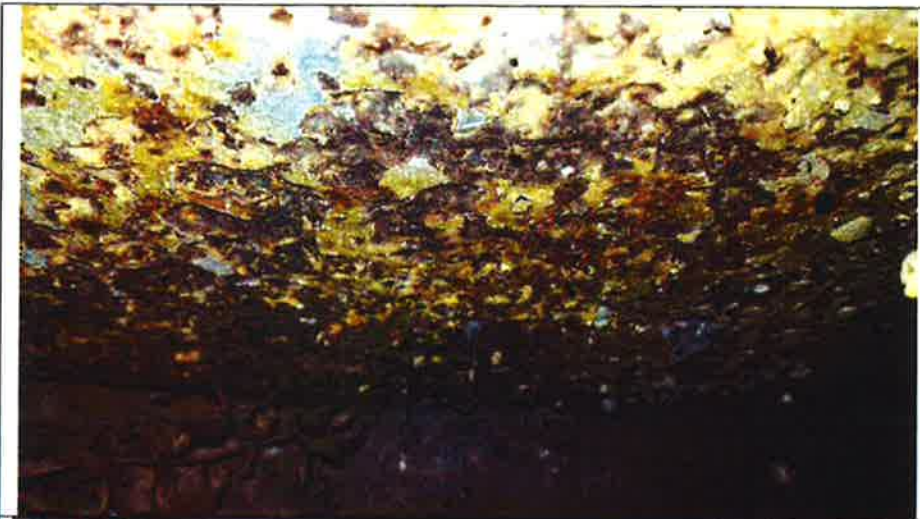
<p>Image -1: Extreme corrosion attack on the bottom of the tank. Up to 5mm deep pitting recorded.</p>

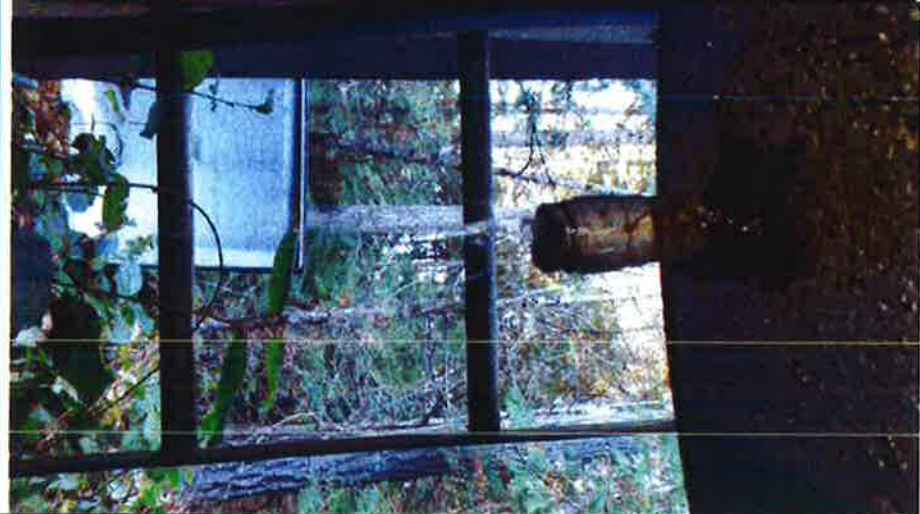
<p>Image-2: East end bottom drain port. Was found to have a minor leak. Rust removal revealed a crack around the circumference of the nozzle to shell weld. With minor pressure the nozzle came away from the shell. See next image.</p>

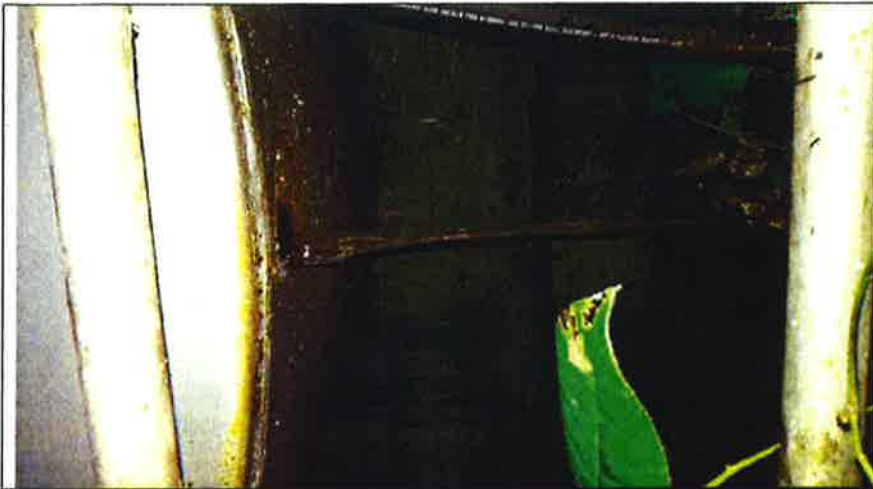
Image-3: East end drain port after nozzle came failed.

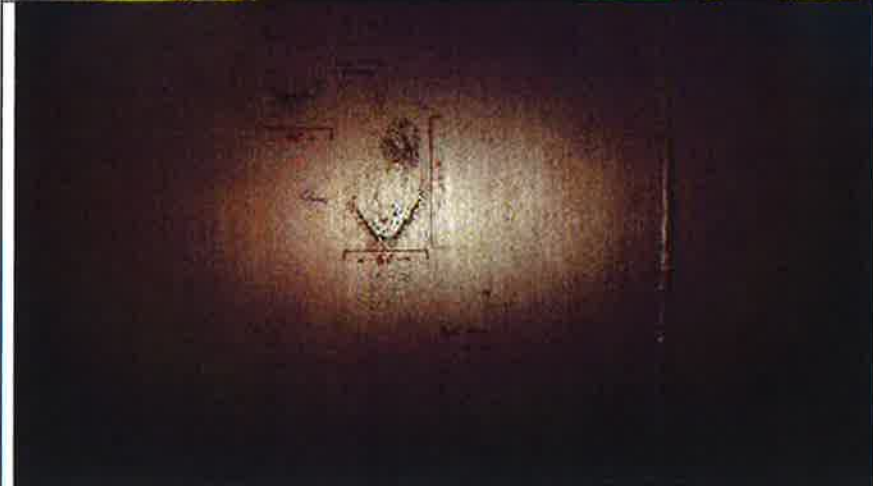
Image -4: Example of the corrosion colonies present on the tank. The location of this image is on the south side. The circ. Weld in the image is the center line of the tank.

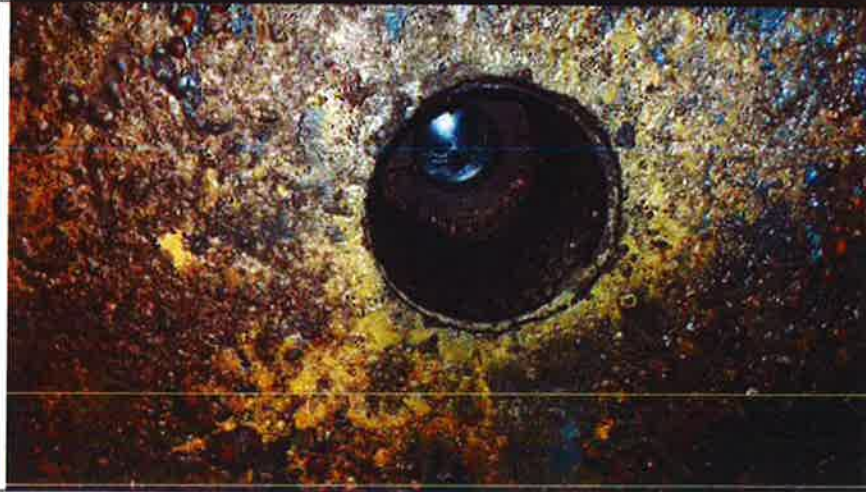
Image-6: Upper nozzle on the west end of the tank. Note the lack of weld material present. Believed to be from manufacturing.

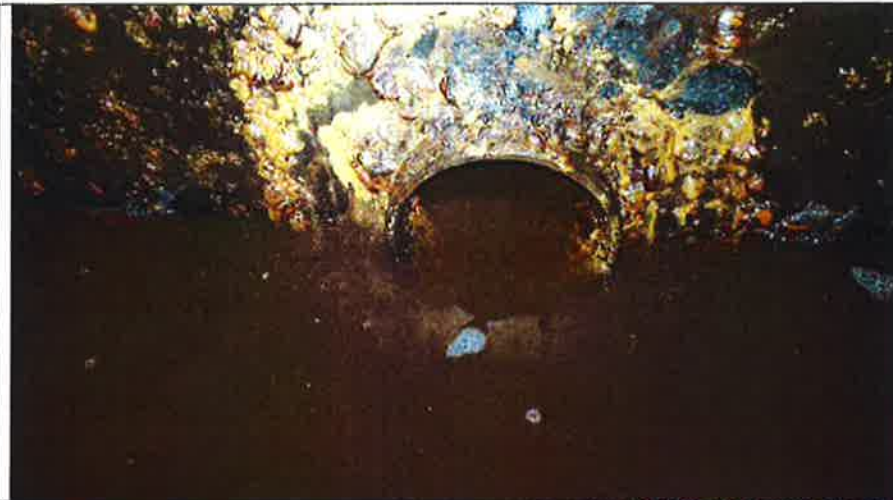
Image-7: Set through lower nozzle on the west end of the tank. Note the calcium buildup.

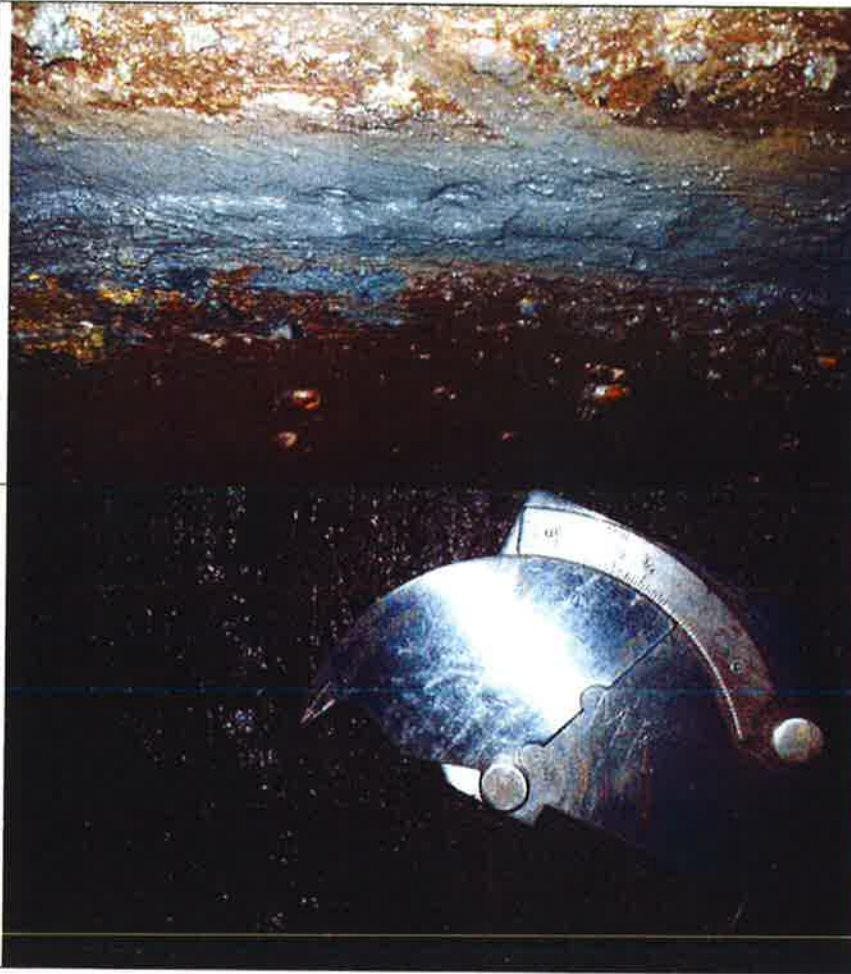
Image-9: Example of the corrosion attack on the circumferential welds on the internal side of the shell.

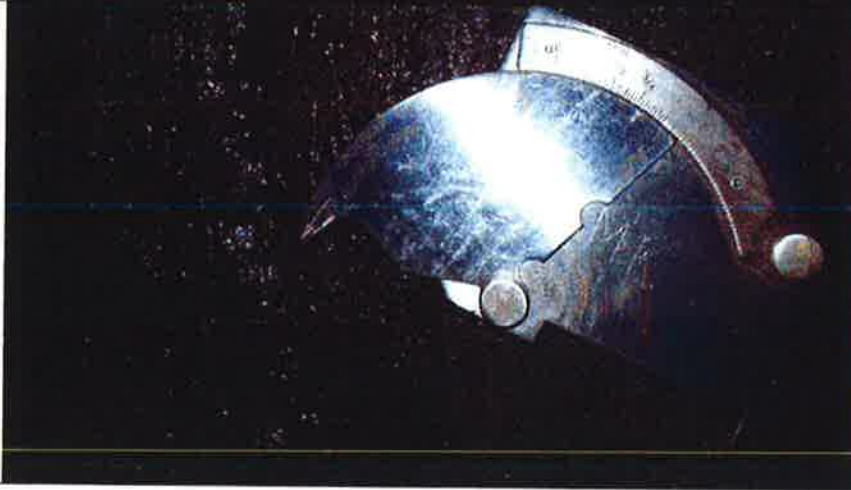
Image -10: Example of the instrument used for measuring the pit depths. The pit in the image was found to have a depth of 7mm.
