**STAFF REPORT TO THE SOOKE &
ELECTORAL AREA PARKS AND RECREATION COMMISSION
SPECIAL MEETING OF FEBRUARY 24, 2014**

SUBJECT: A-20 Desiccant Dehumidifier Installation

ARENA DEHUMIDIFICATION ASSESSMENT REPORT

SEAPARC Leisure Complex

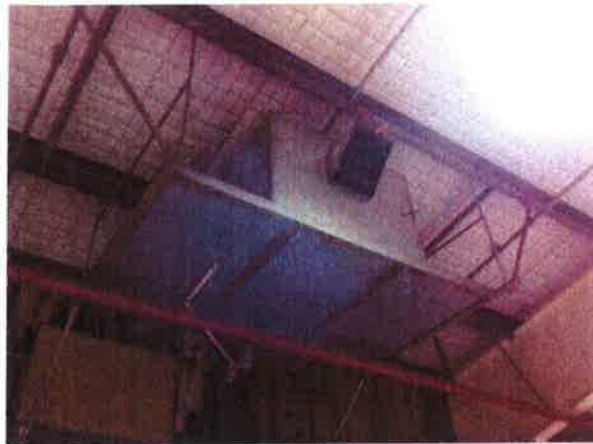
The existing dehumidifier is a gas-fired, Cimco Humicon model #MK VII, rated to remove approximately 11 lbs of moisture per hour from the space. There is no ductwork to or from the unit; it discharges directly to, and pulls directly from, the arena bowl. It is located on a platform above the visitors' bench.

Fig. 1 – Existing Dehumidifer

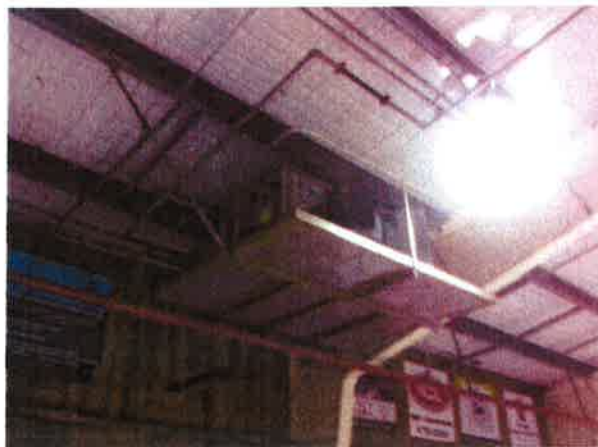
The new dehumidifier is a gas-fired, Munters model #A5, rated to remove 25 lbs per hour of moisture from the space. As with the existing unit, there is no significant ductwork to or from the unit, though an elbow was added after installation, with the intent to direct the discharging air from the unit. It is located on a platform above the home bench.

Fig. 2 – Munters Dehumidifier installed in 2009

AME Recommendation: Due to the loose construction of the building (see section 3.3 below), there is a significant infiltration load being introduced to the arena that was likely not included in the 2006 design calculations, nor in 2009. If we even assume, as a best case, that the building construction tightness is now 'average', the estimated dehumidification load is approximately 90 lbs/hr. If we assume that the building construction tightness is now 'loose', the estimated dehumidification load jumps to approximately 125 lbs/hr. It is to be noted that both of these calculations are based on the summer design temperatures from the BC Building Code, and as such, are expected to occur only 2.5% of the year.

The conclusion that is reached from here is that a single Munters A10 unit, rated at 75 lbs of moisture removal per hour, should be able to meet the dehumidification load for a majority of the time. However, it will not be able to meet the full dehumidification demand when the weather is not favourable. This is expected to occur during the summer, and periodically during the spring and fall. As the former tends to be when playoffs are occurring and the latter tends to be when ice is being put in for the year, it is recommended to install the next largest size of Munters unit, the A20.

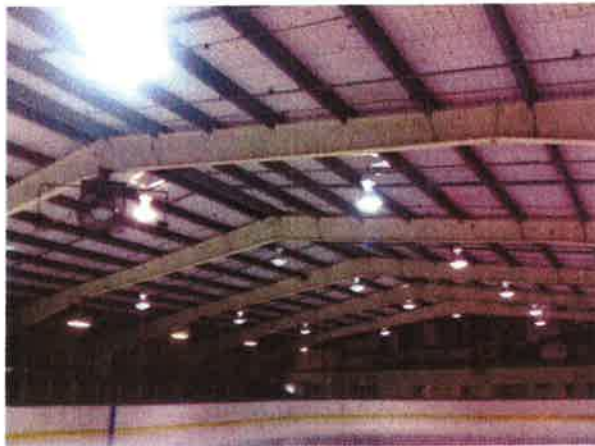
The report prepared by Chatwin also discusses signs of corrosion in the entrance lobby and hypothesizes that there may be a pressurization issue in the facility that is resulting in corrosion pool hall air being transferred into the lobby. Corrosion can be seen on metal elements both in the lobby and the natatorium viewing area, as well as in the hallway adjacent to the administration offices.

This was observed during the site visit at the doors between the arena viewing area and the lobby. It is AME's understanding that these doors used to be kept closed most of the time, but are now held open during operating hours. Opening and closing the doors allows one to demonstrate a pressure differential exists between the two spaces. This transfer of air within the facility allows corrosive air to travel from the pool hall throughout the building, including into the arena. This helps to explain the corrosion in the arena being most prevalent nearest to the lobby, and decreasing as one moves further away.

Fig. 3 – Corrosion on Arena Structure Facing Away from Lobby

AME recommendation: It is recommended that the pressure differentials both with individual spaces, but also between spaces be measured and confirmed as follows:

- The arena is to be held at a positive pressure differential relative to the lobby. This serves to prevent corrosive air from traveling into the arena from the natatorium, but also serves to prevent migration of humidity from lobby to the arena.

It is further recommended that weather-stripping and door sweeps be remediated or re-installed on all doors between the lobby and the arena, and on all doors between the arena bowl and the viewing area.

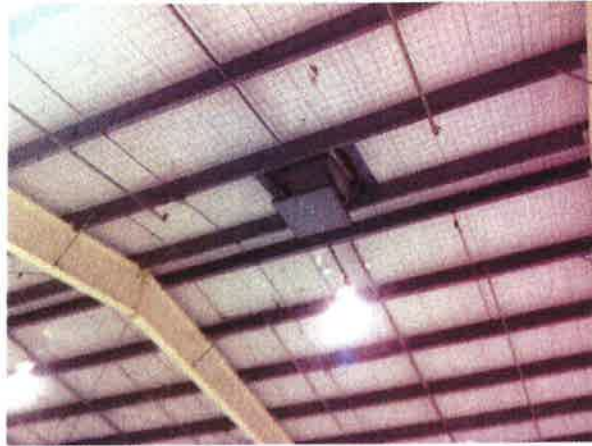
Two existing, roof-mounted exhaust fans serve the arena, exhausting air from the space when sensors detect carbon monoxide. It is not AME's conclusion that the negative pressure that results when these fans turn on is responsible for the corrosion. If it were, then one would expect the corrosion in the arena to be observed more evenly throughout the arena.

Fig. 4 – Existing Arena Exhaust Fan
