SOUTHERN GULF ISLANDS HARBOURS COMMISSION
Notice of Meeting on **Tuesday, July 25, 2023 at 9:30 a.m.**
Saanich Peninsula Wastewater Treatment Plant Meeting Room,
9055 Mainwaring Road, North Saanich, BC

Southern Gulf Islands Harbours DOCK INSPECTION REPORT

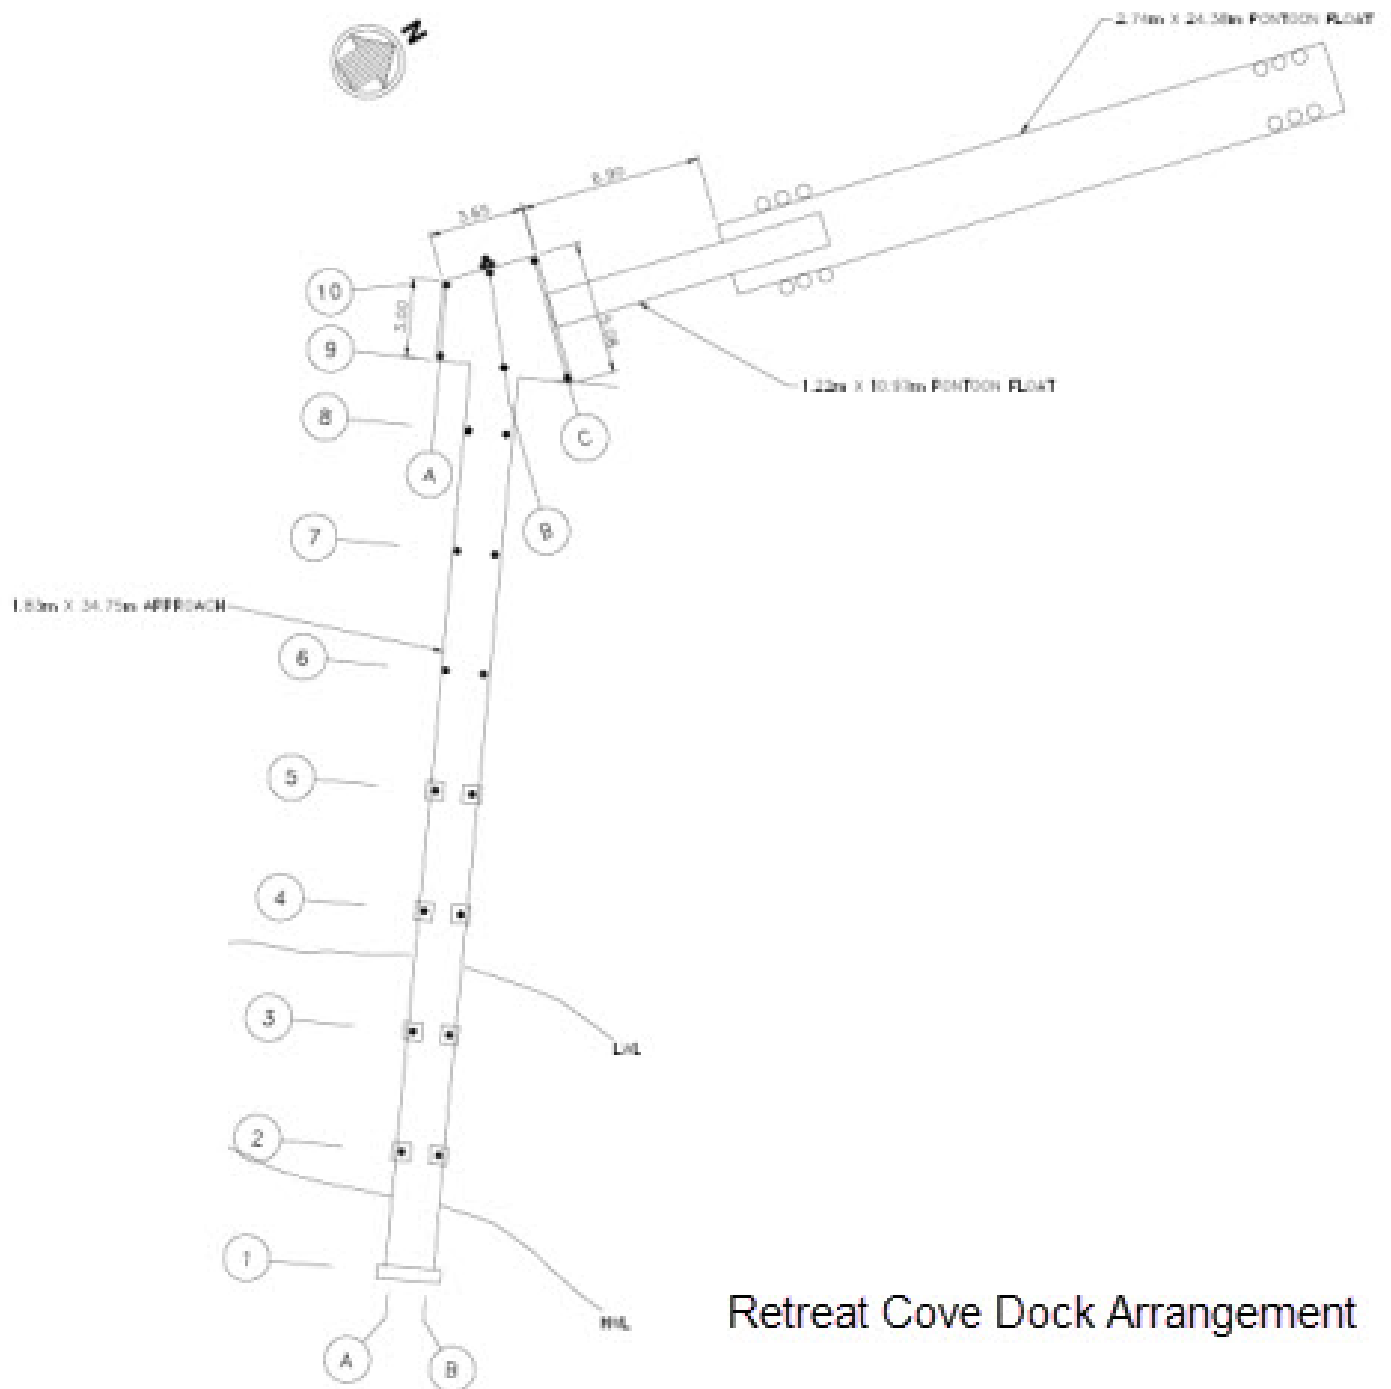
Retreat Cove Dock Arrangement

APPROACH	<input checked="" type="checkbox"/> Signage <input checked="" type="checkbox"/> Envelope Supply <input checked="" type="checkbox"/> Notices Posted <input checked="" type="checkbox"/> Rates Posted
	<p>The railings are painted and the decking is in good condition. The notice board is also painted and the lock box has been repaired.</p> <p>The broken cross bracing has been repaired.</p>

GANGWAY FLOATS	<p>The gangway and railings are painted and along with the decking are all in good condition. The bottom transition plate has a worn skid plate and 1 of the 2 new UHMW skid strips installed (for the skid plate to ride on) was too short and with the low tides, it has peeled this shorter strip off. A longer (to match the other) strip is required. The roller and bearings are in good condition. The guide rail is rusty but still in fair condition.</p> <p>The float is in good condition but the bull rail bolts require tightening and the deck boards require re-nailing (Kiyo will deal with the nailing). The 2 x 3 outside piles (no pile well) are in good to fair condition with one of the 6 piles showing moderate wear. The other 2 x 3 pile wells and pilings are in good condition with minimal wear.</p>
-----------------------	---

COMMENTS/INSTRUCTIONS	<p>> Replace the UHMW skid strip for the gangway bottom transition plate with one of the same length as the other.</p> <p>> The bull rail bolts on the float require tightening.</p> <p>> The deck boards require re-nailing (Kiyo).</p>
------------------------------	---

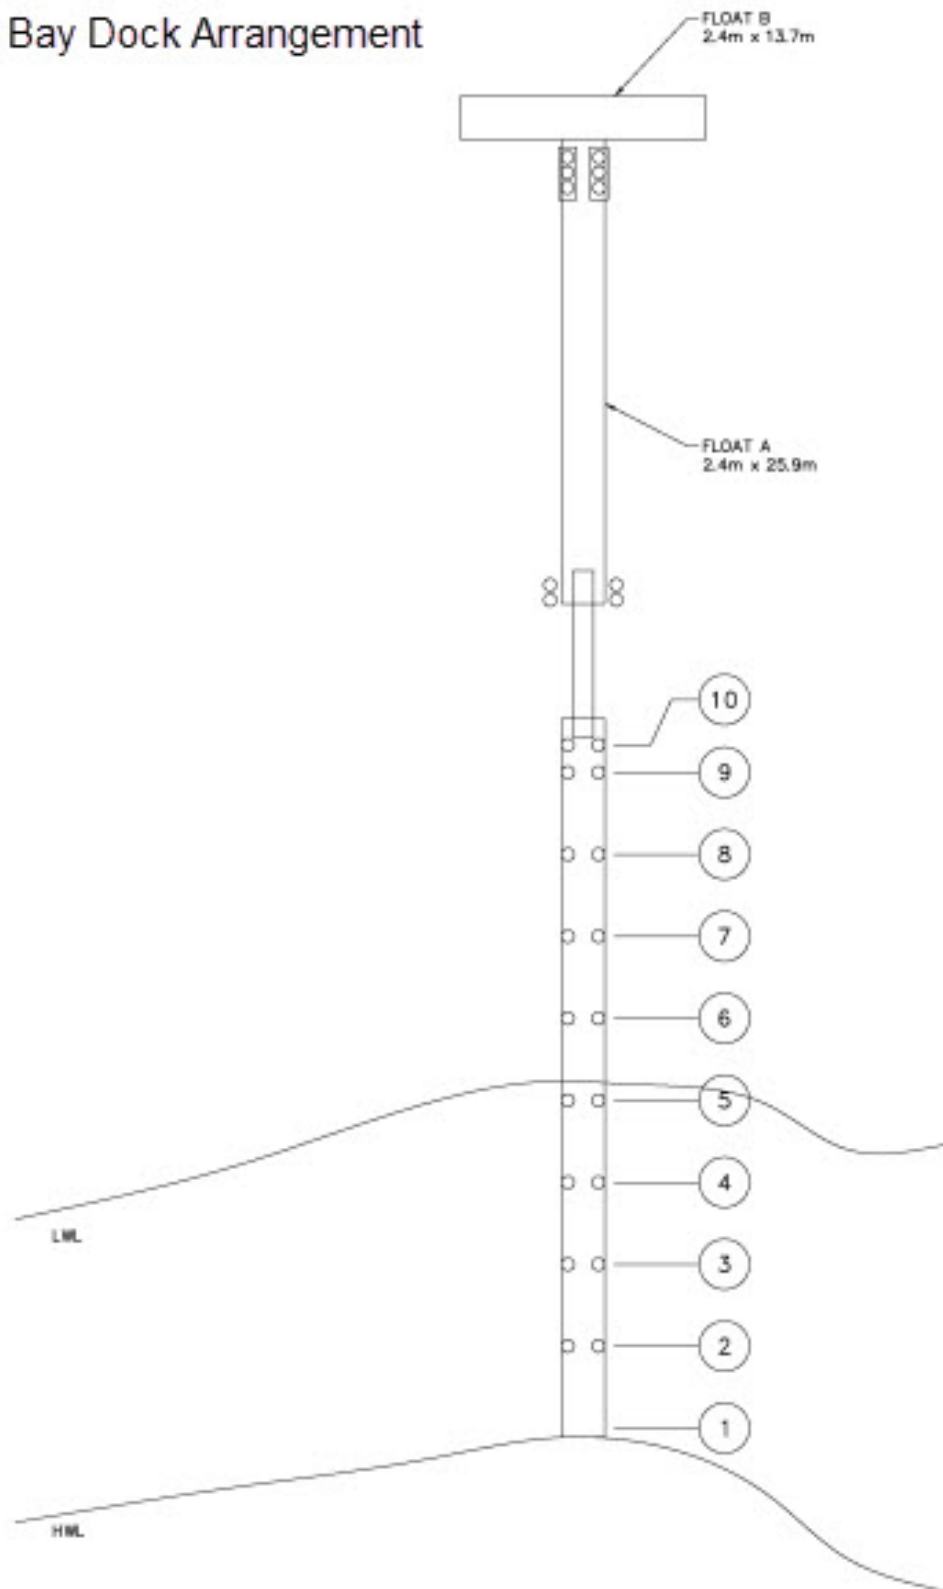
Horton Bay Dock Arrangement

APPROACH	<input checked="" type="checkbox"/> Signage <input checked="" type="checkbox"/> Envelope Supply <input checked="" type="checkbox"/> Notices Posted <input type="checkbox"/> Rates Posted
	<p>There is new decking and the bull rail has been replaced. After this section the old decking is in poor condition. the railings are also in poor condition in some sections. The notice board, the light standard and the railing are all tied together and are very loose and appear to be poorly secured. The decking under the light standard appears to be rotten and the bolts at the base of the structure are loose. Inspection and repair is required.</p> <p>There are no rate sheets posted.</p>

GANGWAY FLOATS	The gangway structure is rusty but in good condition. The decking is in very poor condition.
	The floats are low in the water and the flotation requires inspection. The dinghy float has questionable floating.
	The pilings and pile wells are in fair condition.

COMMENTS/INSTRUCTIONS	> Replace the life ring, gone missing.
	> Provide rate sheets.
	> Inspect and repair the flotation.
	> Replace the rotten decking and sections of railing.
	> Secure the railing, notice board and light standard.

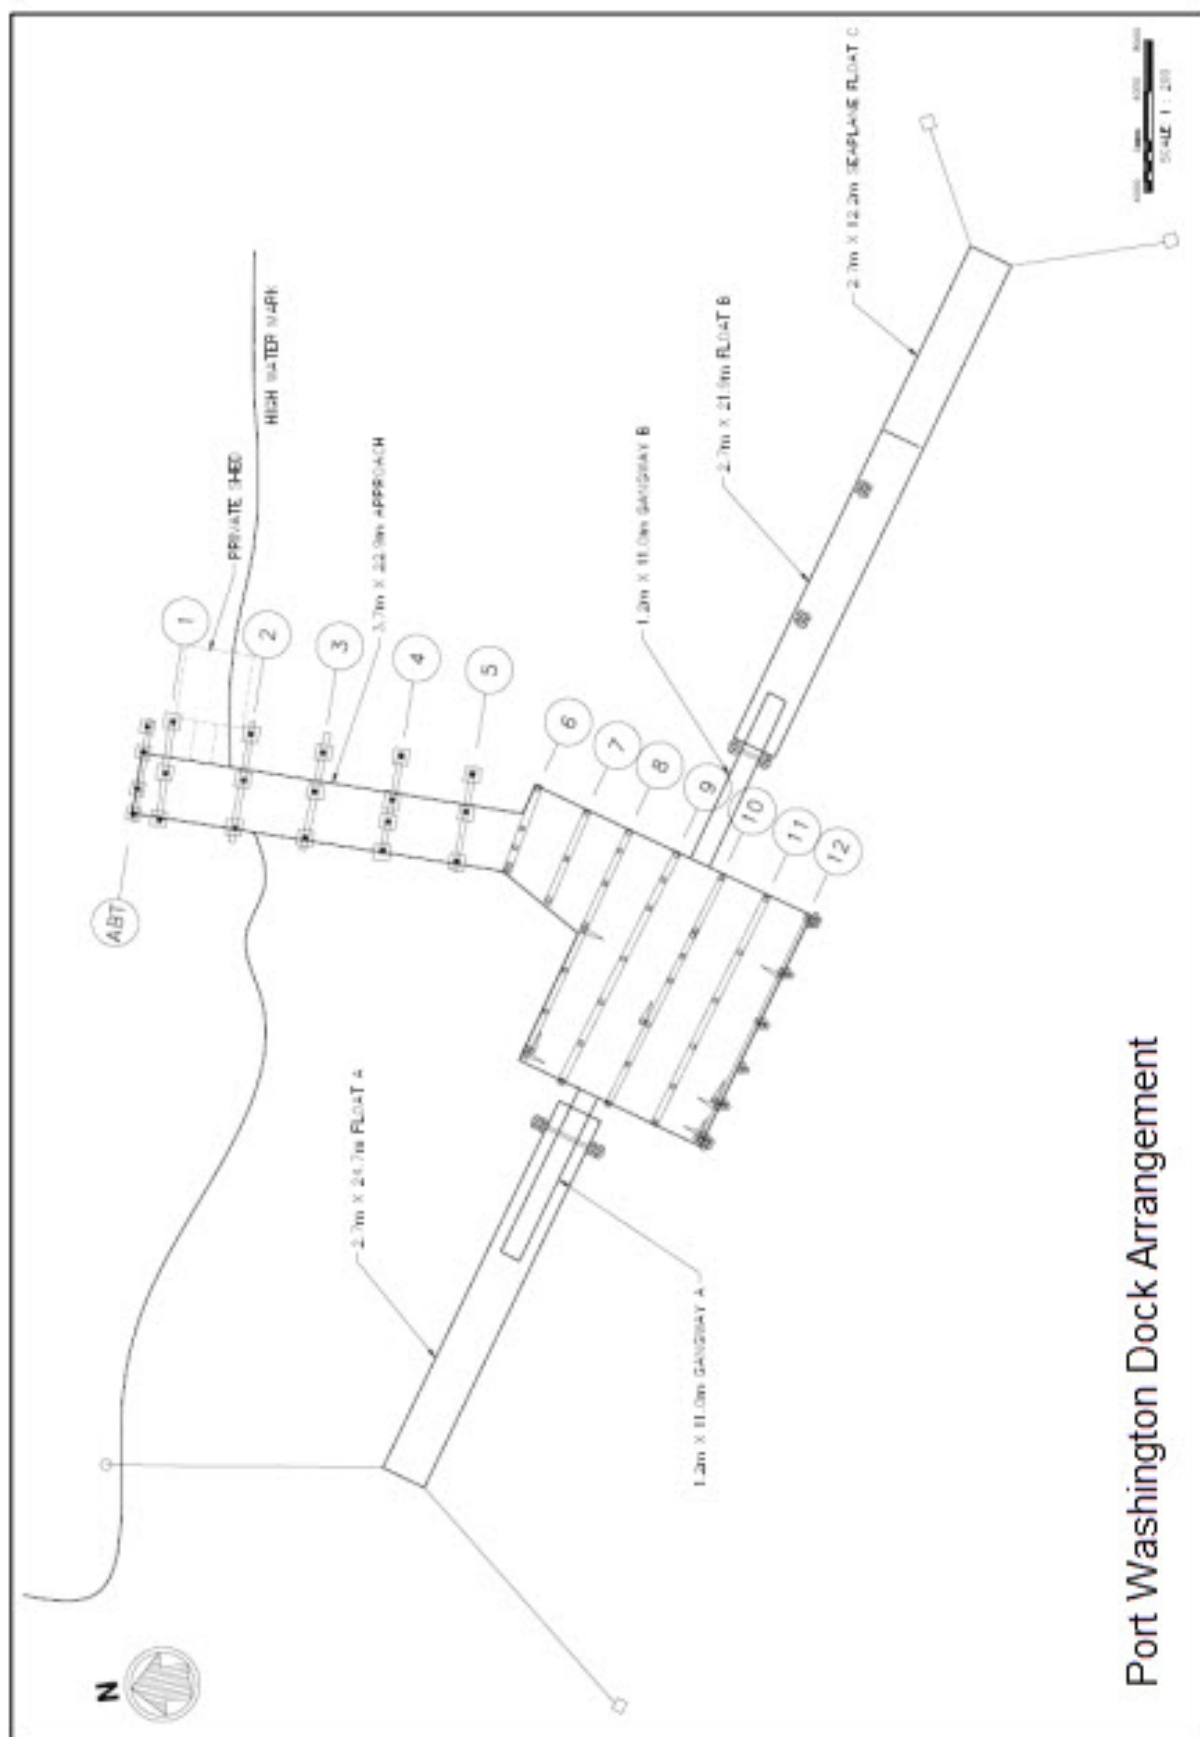
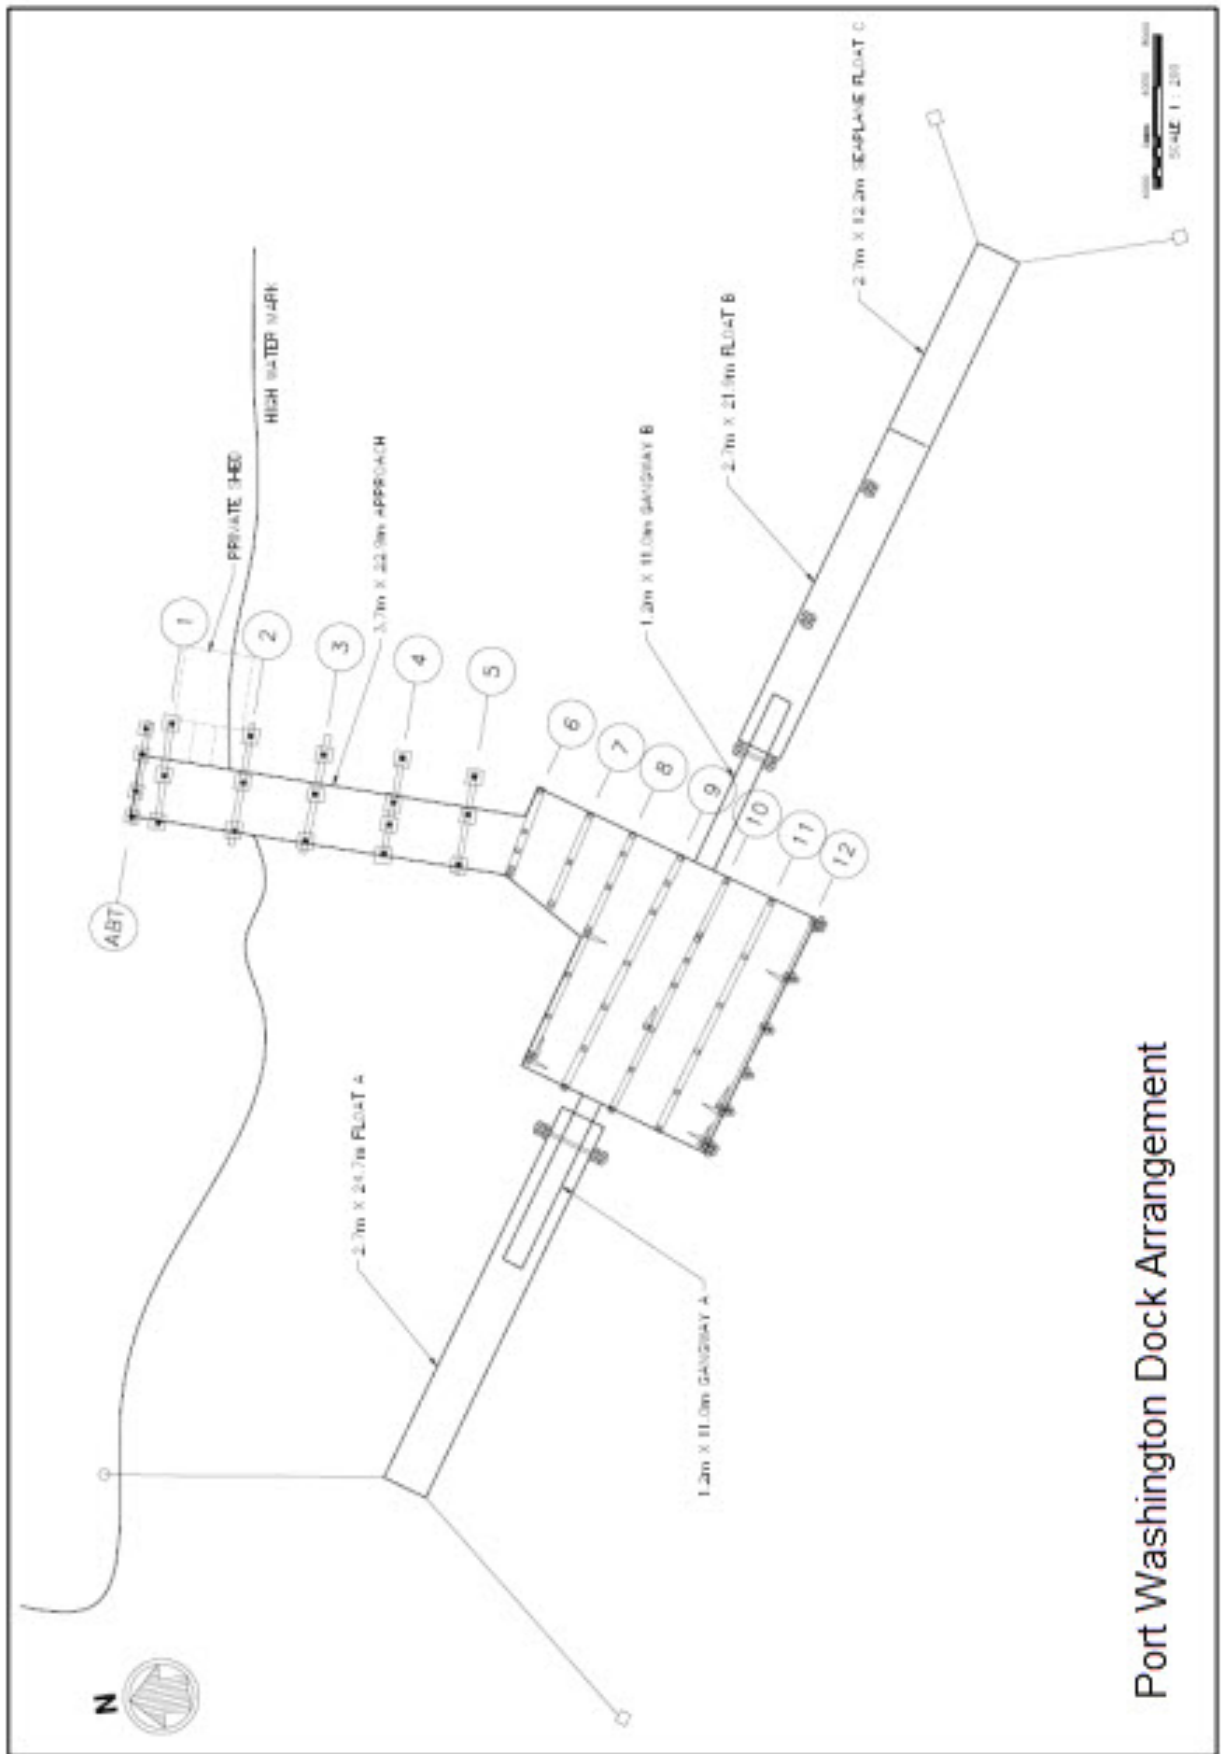
Port Washington Dock Arrangement

APPROACH	<input checked="" type="checkbox"/> Signage <input checked="" type="checkbox"/> Envelope Supply <input checked="" type="checkbox"/> Notices Posted <input checked="" type="checkbox"/> Rates Posted					
	The railings and bull rails are unpainted and in good condition. The decking is also in good condition. The notice board is rotten and requires replacement.					
WHARF HEAD	<input type="checkbox"/> Signage <input type="checkbox"/> Envelope Supply <input type="checkbox"/> Notices Posted <input type="checkbox"/> Rates Posted					
	New decking has been installed replacing roughly 80 to 90% of the area. New railings have been installed all around the bull rails.					
GANGWAY FLOATS	Gangway "A" has had the hinge bracket repaired and is now back in alignment. The gangway and railings are painted but there is considerable rust and deterioration of the metal frame at the bottom end. The wooden decking is in fair condition. The roller is rusty and one new roller bearing was installed, both roller bearings are in good condition. Float "A" is slightly lower in the water at the end under the gangway further. Inspection is recommended. The piles (2 wells x 4 piles) are in good condition along with the open pile wells. There are new rub boards replacing the missing boards in the middle of the float where the bull rail bolts are broken and loose. Repair and tightening of the bolts is required. Gangway "B" and the railings are painted and the decking is in fair condition. There is one badly warped deck board at the bottom end along with a rotten end of the kick board on the same side. The roller is rusty and the guide rails are in fair condition and the roller bearings have been serviced. The guide rails have been re-fastened. Float "B" requires repair to damaged bull rails under the gangway. There are other sections of bull rail that are deteriorating and require replacement along with tightening the loose bull rail bolts. The flotation at the end of the float has been improved but the light requires re-location as there is too much weight effecting the flotation in the current location. There were 2 sections of rub board that have been replaced. The pilings and pile wells are in fair condition with moderate wear. There are 12 piles, 2 open wells x 2 piles / well and 2 wells x 4 piles / well on this float. The chain and shackles that connect float "C" have been replaced. Float "C" is in fair condition, flotation is good, bull rails are tight and the decking and rub boards are good.

Gangway "A" has had the hinge bracket repaired and is now back in alignment. The gangway and railings are painted but there is considerable rust and deterioration of the metal frame at the bottom end. The wooden decking is in fair condition. The roller is rusty and one new roller bearing was installed, both roller bearings are in good condition. Float "A" is slightly lower in the water at the end under the gangway further. Inspection is recommended. The piles (2 wells x 4 piles) are in good condition along with the open pile wells. There are new rub boards replacing the missing boards in the middle of the float where the bull rail bolts are broken and loose. Repair and tightening of the bolts is required. Gangway "B" and the railings are painted and the decking is in fair condition. There is one badly warped deck board at the bottom end along with a rotten end of the kick board on the same side. The roller is rusty and the guide rails are in fair condition and the roller bearings have been serviced. The guide rails have been re-fastened. Float "B" requires repair to damaged bull rails under the gangway. There are other sections of bull rail that are deteriorating and require replacement along with tightening the loose bull rail bolts. The flotation at the end of the float has been improved but the light requires re-location as there is too much weight effecting the flotation in the current location. There were 2 sections of rub board that have been replaced. The pilings and pile wells are in fair condition with moderate wear. There are 12 piles, 2 open wells x 2 piles / well and 2 wells x 4 piles / well on this float. The chain and shackles that connect float "C" have been replaced. Float "C" is in fair condition, flotation is good, bull rails are tight and the decking and rub boards are good.

OTHER INSPECTIONS	<input checked="" type="checkbox"/>	Lighting	good	<input checked="" type="checkbox"/>	Life Rings / Heaving Lines	2 x good
	<input checked="" type="checkbox"/>	Extinguishers (expiry dates)	Nov 2023	<input type="checkbox"/>	Unpaid Moorage	
COMMENTS/INSTRUCTIONS	<ul style="list-style-type: none"> > The rotten notice board requires replacement. > The bull rail bolts require tightening on floats B & C. > The light standard on float B requires re-location, further away from the end of the float. > Bull rails on float B require replacement. > Replace warped deck board and kick board on Gangway B.

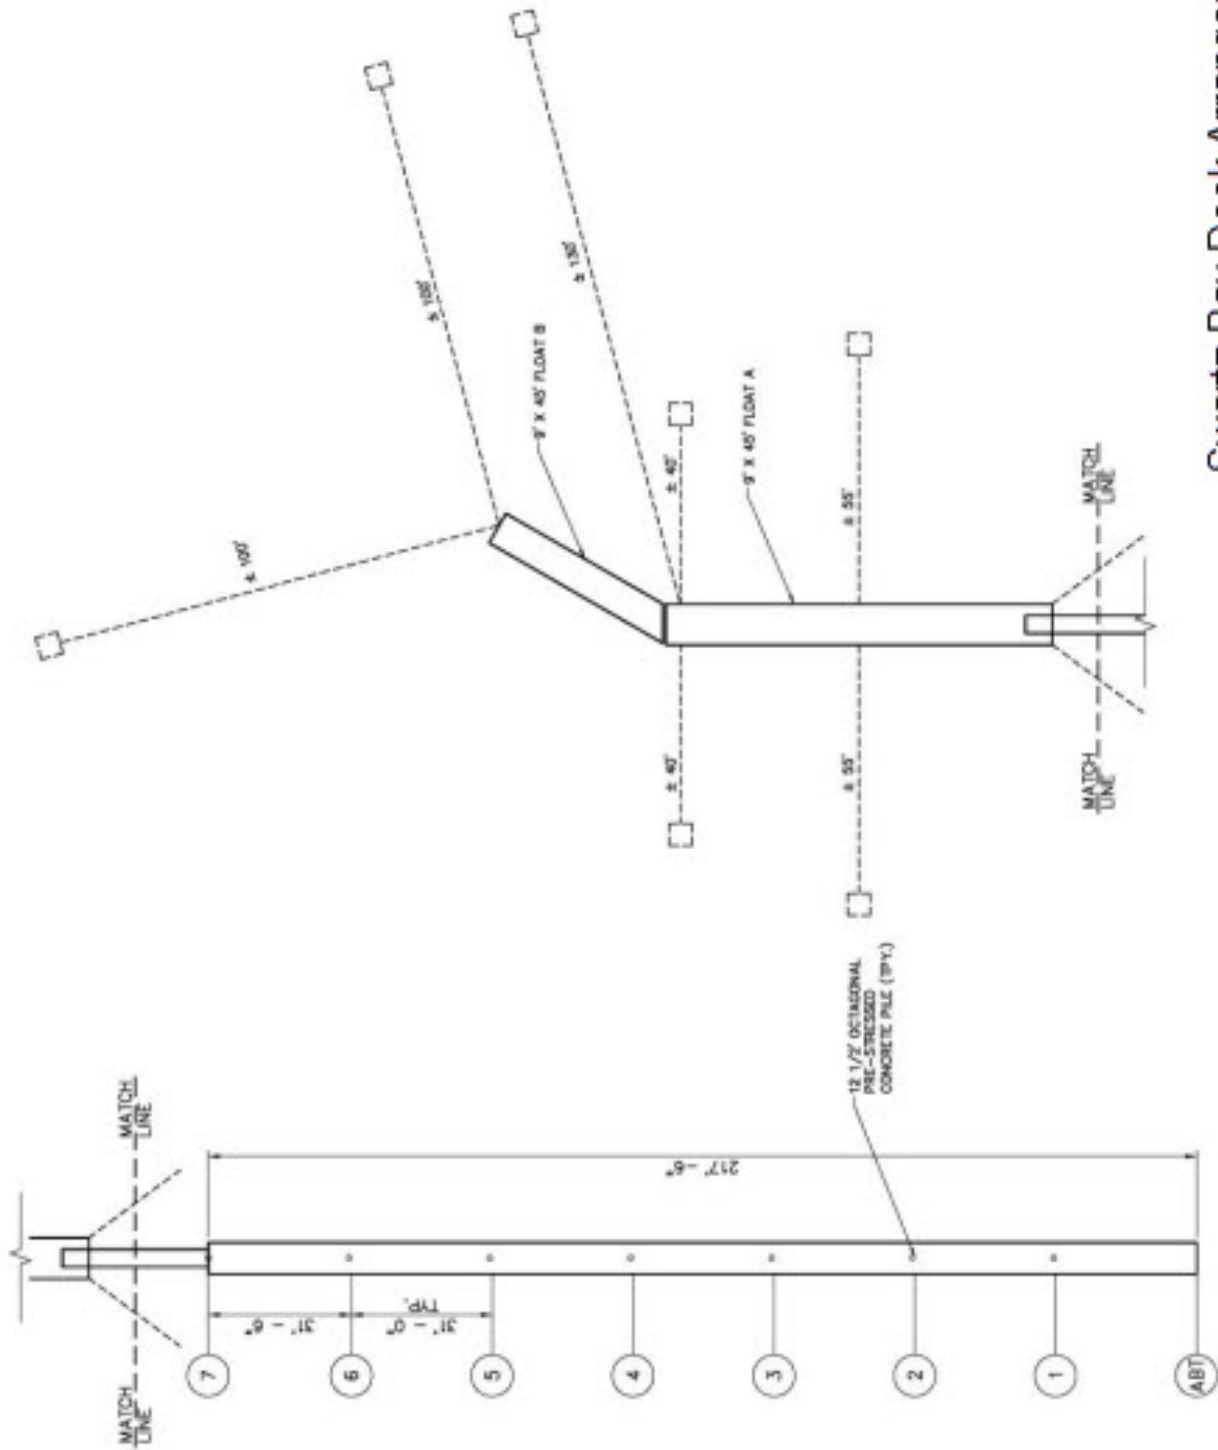
Swartz Bay Dock Arrangement

APPROACH	<input checked="" type="checkbox"/> Signage <input type="checkbox"/> Envelope Supply <input checked="" type="checkbox"/> Notices Posted <input checked="" type="checkbox"/> Rates Posted
	<p>The concrete approach is in good condition. The railings are painted red and painting is recommended. The notice board is missing the lock box as it requires repair.</p>

GANGWAY FLOATS	<p>The gangway is in fair condition and the decking is in fairly worn condition. Replacing the decking and non-skid or replace the whole gangway is recommended. The transition plate at the bottom of the gangway requires repair to a section of expanded aluminum grating and the pillow blocks / roller bearings require replacement. The guide rails are in good condition.</p>
	<p>Float A is in new condition but there is a very loose bull rail bolt in the section on the East side, first section from the end of the gangway, far end. This requires tightening or repair (it may have been hit very hard by a boat?). Float B is in fair condition with possible flotation issues at the end with the connecting anchor chains. The hinged rigid transition plates between the 2 floats can lift up on A float and present a tripping hazard if too many people are on float B. A curved rigid transition plate is recommended. In most cases where we have a transition between the floats (or gangways), a hinged rigid curved plate will provide a less problematic and safer transition.</p> <p>** Can the 2 flat plates be slightly curved? If this is possible, doing this is highly recommended. The curve allows the free edge (on float A) to remain in contact with the decking where as the flat plate edge will lift up several inches as the 2 floats rise and dip in weather or with a number of people transiting the floats.</p>

COMMENTS/INSTRUCTIONS	<p>> Repair and replace items related to the gangway or replace the gangway.</p> <p>> Tighten or repair the very loose bull rail bolt on float A.</p> <p>> Can the pair of hinged flat transition plates be modified with a slight curve to provide a safer transition?</p> <p>> Inspect flotation on float B.</p>
