**Limited Hazardous Materials Investigation  
Village on the Green  
1132 Johnson Street, Victoria, BC**

**Capital Region Housing Corporation**

## Executive Summary

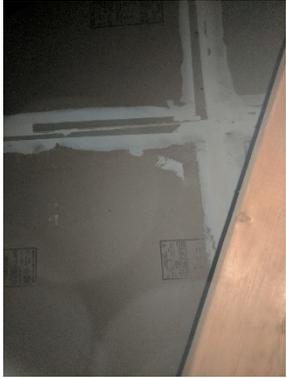
Sample: 12440 - 1  
Unit/Location: Unit 1, Attic  
Description: Drywall filler  
Asbestos: None Detected

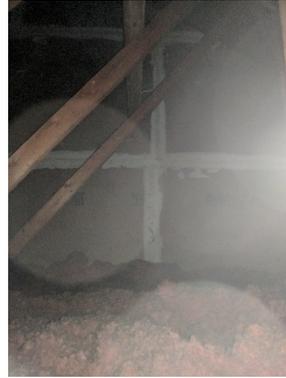
Sample: 12440 - 2  
Unit/Location: Unit 37, Attic  
Description: Drywall filler  
Asbestos: None Detected

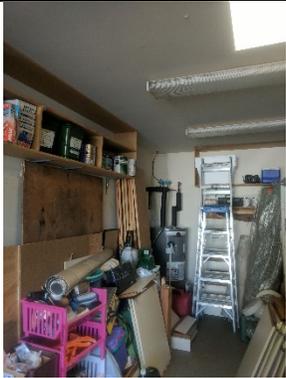
Sample: 12440 - 3  
Unit/Location: Garage / Laundry  
Description: Drywall filler  
Asbestos: None Detected

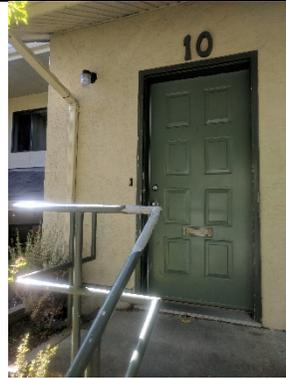
Sample: 12440 - 4  
Unit/Location: Building 1 - 15, Front  
Description: Stucco  
Asbestos: None Detected

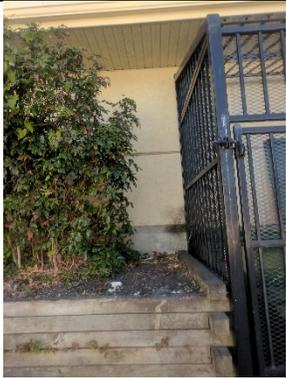
Sample: 12440 - 5  
Unit/Location: Building 1 - 15, Side  
Description: Stucco  
Asbestos: None Detected

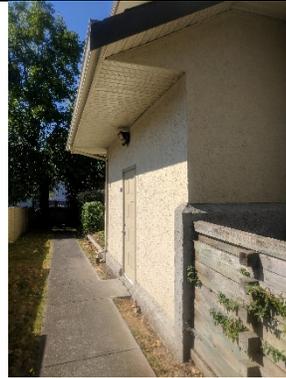
Sample: 12440 - 6  
Unit/Location: Building 1 - 15, Side  
Description: Stucco  
Asbestos: None Detected

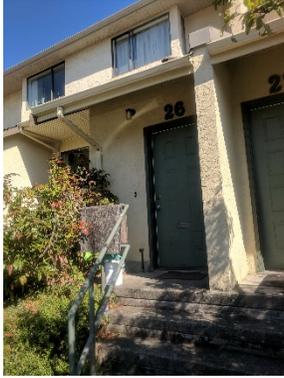
Sample: 12440 - 7  
 Unit/Location: Building 16 – 37, Rear  
 Description: Stucco  
 Asbestos: None Detected

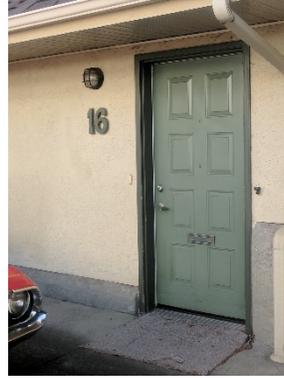
Sample: 12440 – 8  
 Unit/Location: Building 16 – 37, Side  
 Description: Stucco  
 Asbestos: None Detected

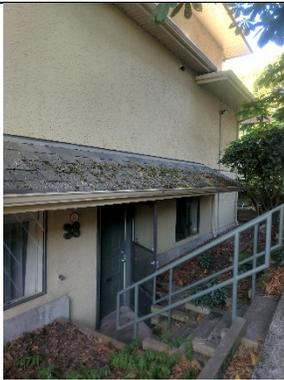
Sample: 12440 - 9  
 Unit/Location: Building 16 – 37, Side  
 Description: Stucco  
 Asbestos: None Detected

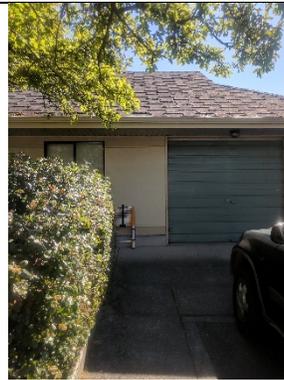
Sample: 12440 – 10  
 Unit/Location: Garage / Laundry  
 Description: Stucco  
 Asbestos: None Detected

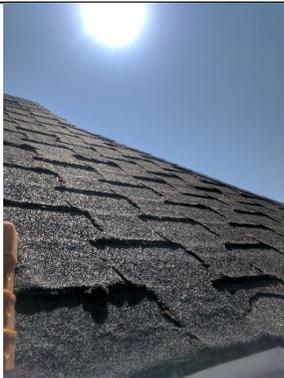
Sample: 12440 - 11  
 Unit/Location: Garage / Laundry  
 Description: Tar Shingle  
 Asbestos: None Detected

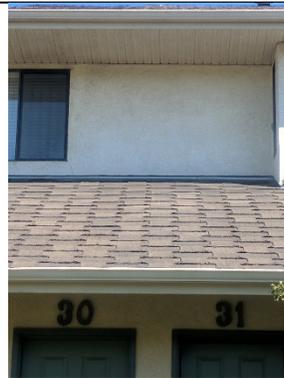
Sample: 12440 – 12  
 Unit/Location: Building 16 – 37  
 Description: Tar Shingle  
 Asbestos: None Detected

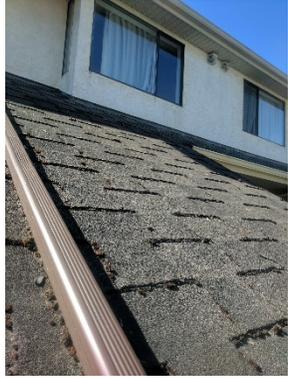
Sample: 12440 - 13  
Unit/Location: Building 1 - 15  
Description: Tar Shingle  
Asbestos: None Detected
