Memo

DATE: December 19, 2016

SUBJECT: 2016 DAM INSPECTION REPORT – GARDOM POND

GARDOM POND DAM INSPECTION CHECKLIST 2016 ANNUAL

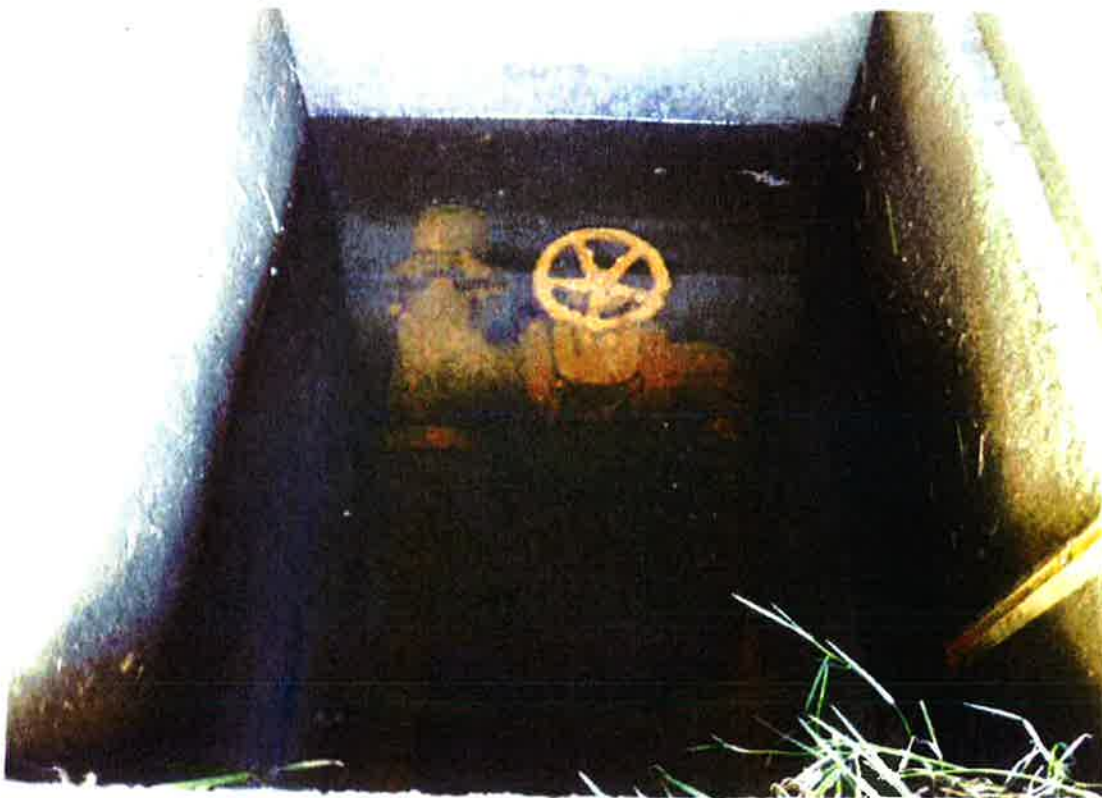
2. Mechanical						
• Valve Chamber		X				Some standing water in valve chamber. No visible seepage. Recommendation to install drain from concrete chamber to daylight where seepage flows can be measured. Outlet gate valves were not operated due to concerns regarding the integrity of the valves and pipeworks. Investigations should be completed to either repair or replace the pipeworks.

Gardom Pond Dam – Valve chamber at downstream. Drain pipe should be installed to keep chamber dry and to monitor seepage into the chamber.

- Recent heavy rain two days prior to inspection.
- A water level staff gauge should be installed at a location that will measure seasonal low levels to replace the wooden yard stick attached to a dock.
- A staff gauge should be installed in the valve chamber at the downstream toe of the dam to replace the 48" wooden 'yard' stick.
- The upstream face of the dam has a 'Dry Hydrant' located approximately 10m from the west end of the dam. It is not known how far the submerged end of the connection extends into the reservoir.
- Investigate the installation of a drain pipe from the valve chamber floor to daylight downstream.

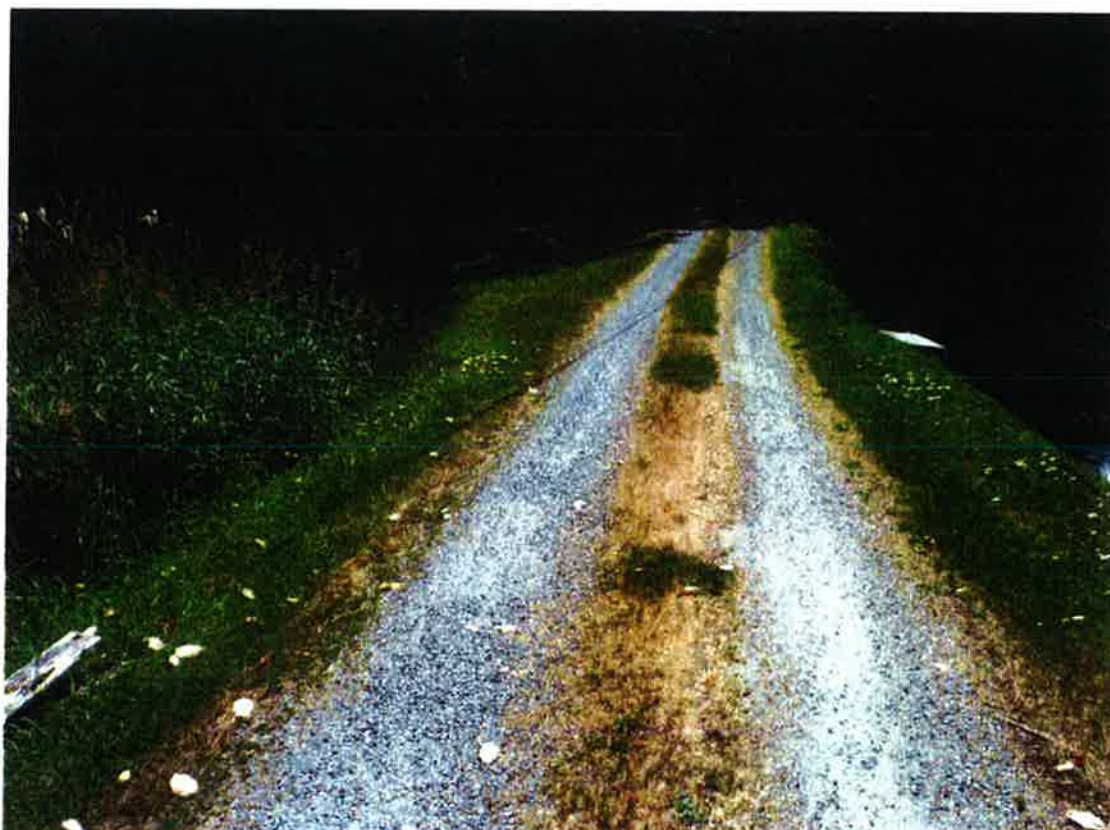
• Excessive vegetation		X				
• Signs of Deterioration	X					
b) Dam Crest - check for:						
• Cracking and Differential Movement	X					Driveway crosses dam with distinct wheel depressions. Depressions should be filled so water can flow freely.

Gardom Pond Dam – Ruts in the road on the dam crest should be filled. Upstream face should be brushed to facilitate inspection.

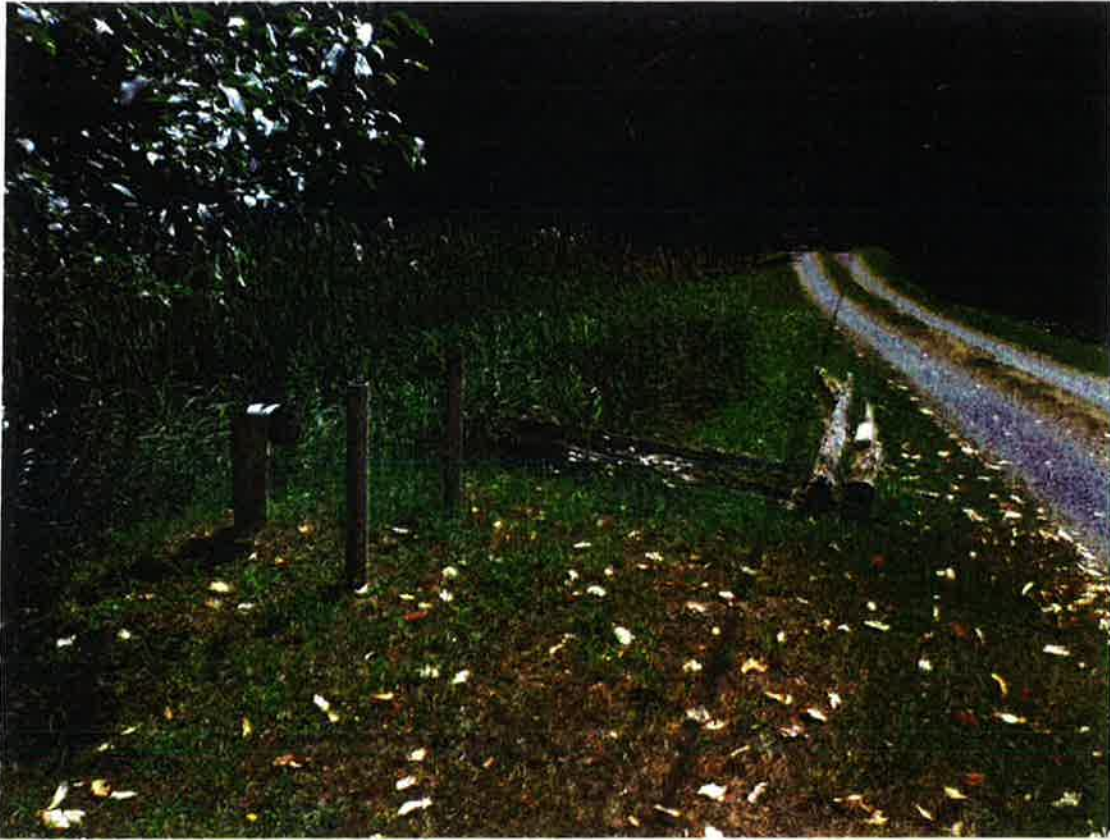
Condition					Remarks/Recommendations
	S	F	P	U	NI	
1. Structure						
a) Upstream Face of Dam - check for:						
• Cracking and Differential Movement	X					Brushing required near waterline. Unable to fully inspect embankment due to heavy vegetation. Large tree to be removed at east end of dam Small trees to be removed at west end of dam

Gardom Pond Dam – Remove vegetation on upstream face.

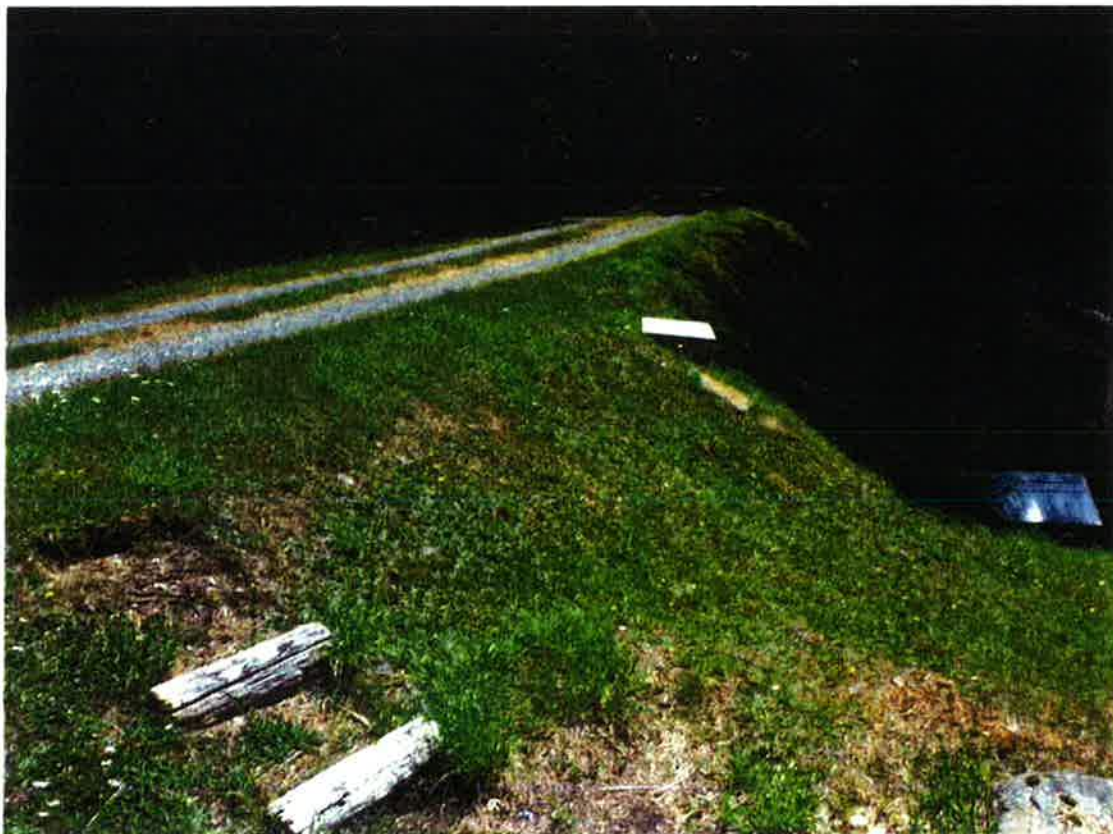
• Signs of wheel depressions			X			
• Signs of deterioration	X					
c) Downstream Face of Dam - check for:						
• Seepage	X					No seepage at time of inspection from RPID box. Irregular steep slope

Gardom Pond Dam – Downstream face

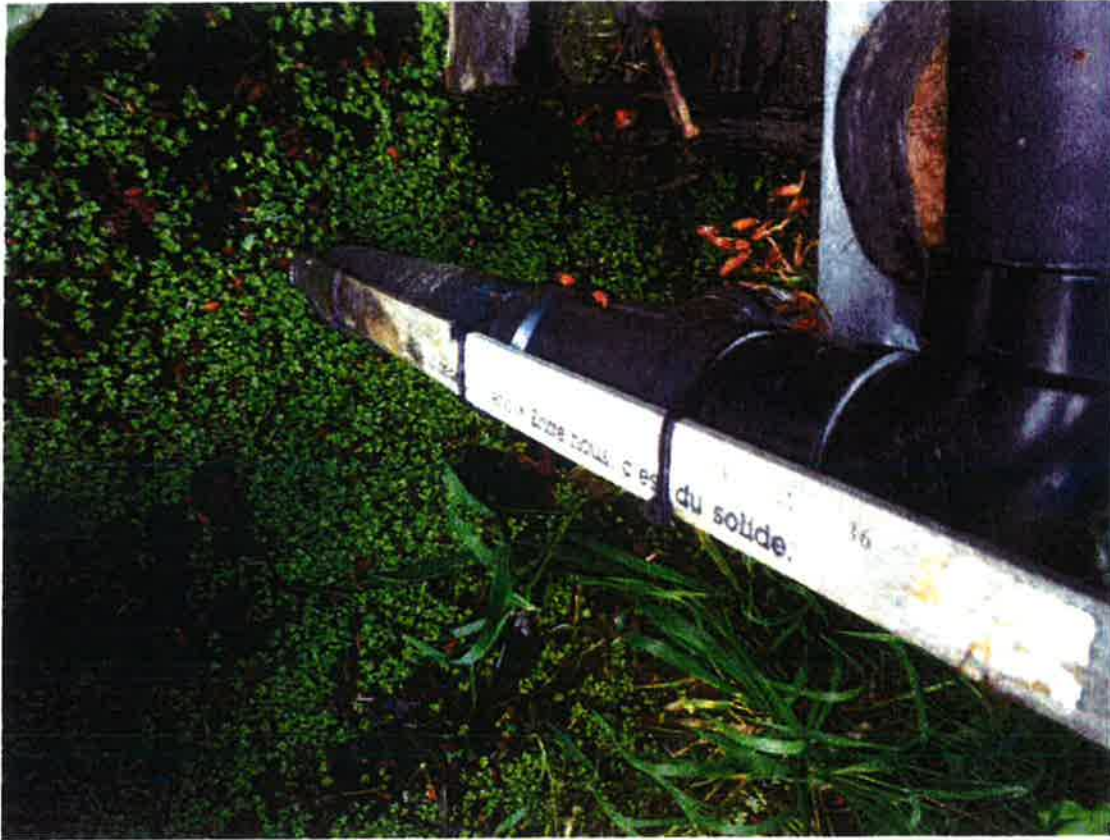
Gardom Pond Reservoir Water Level Gauge – To be replaced at suitable location.

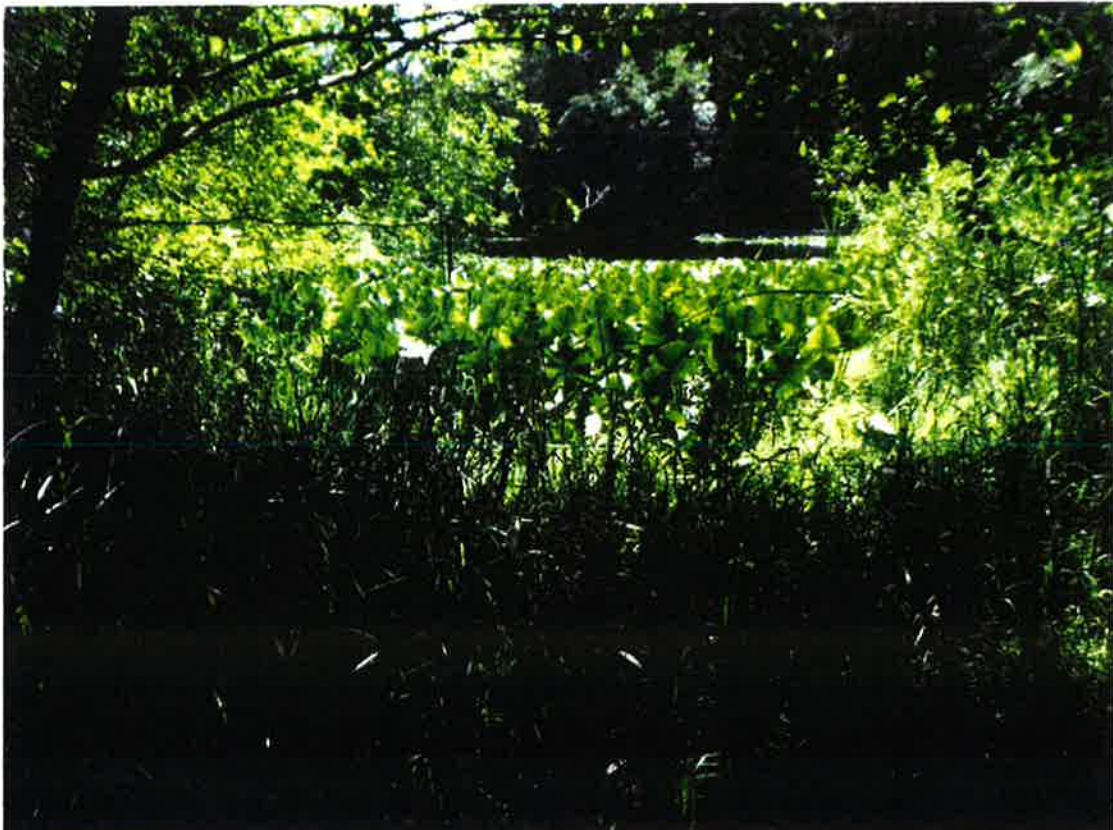
• Outlet Gate Valves and Pipe					X	
3. Spillway - check for:						
• Visible signs of earth deterioration (cracking, subsidence, etc.)		X				Some vegetation to be removed u/s spillway and alongside spillway channel. Small trees cover the slopes of the channel. Brushing and removal of fallen trees and branches along spillway channel from Reservoir to Gardom Lane should be carried out. Clearing to 2m from top of spillway bank, both sides.

Gardom Pond Spillway Outlet – Remove vegetation leading up to channel.

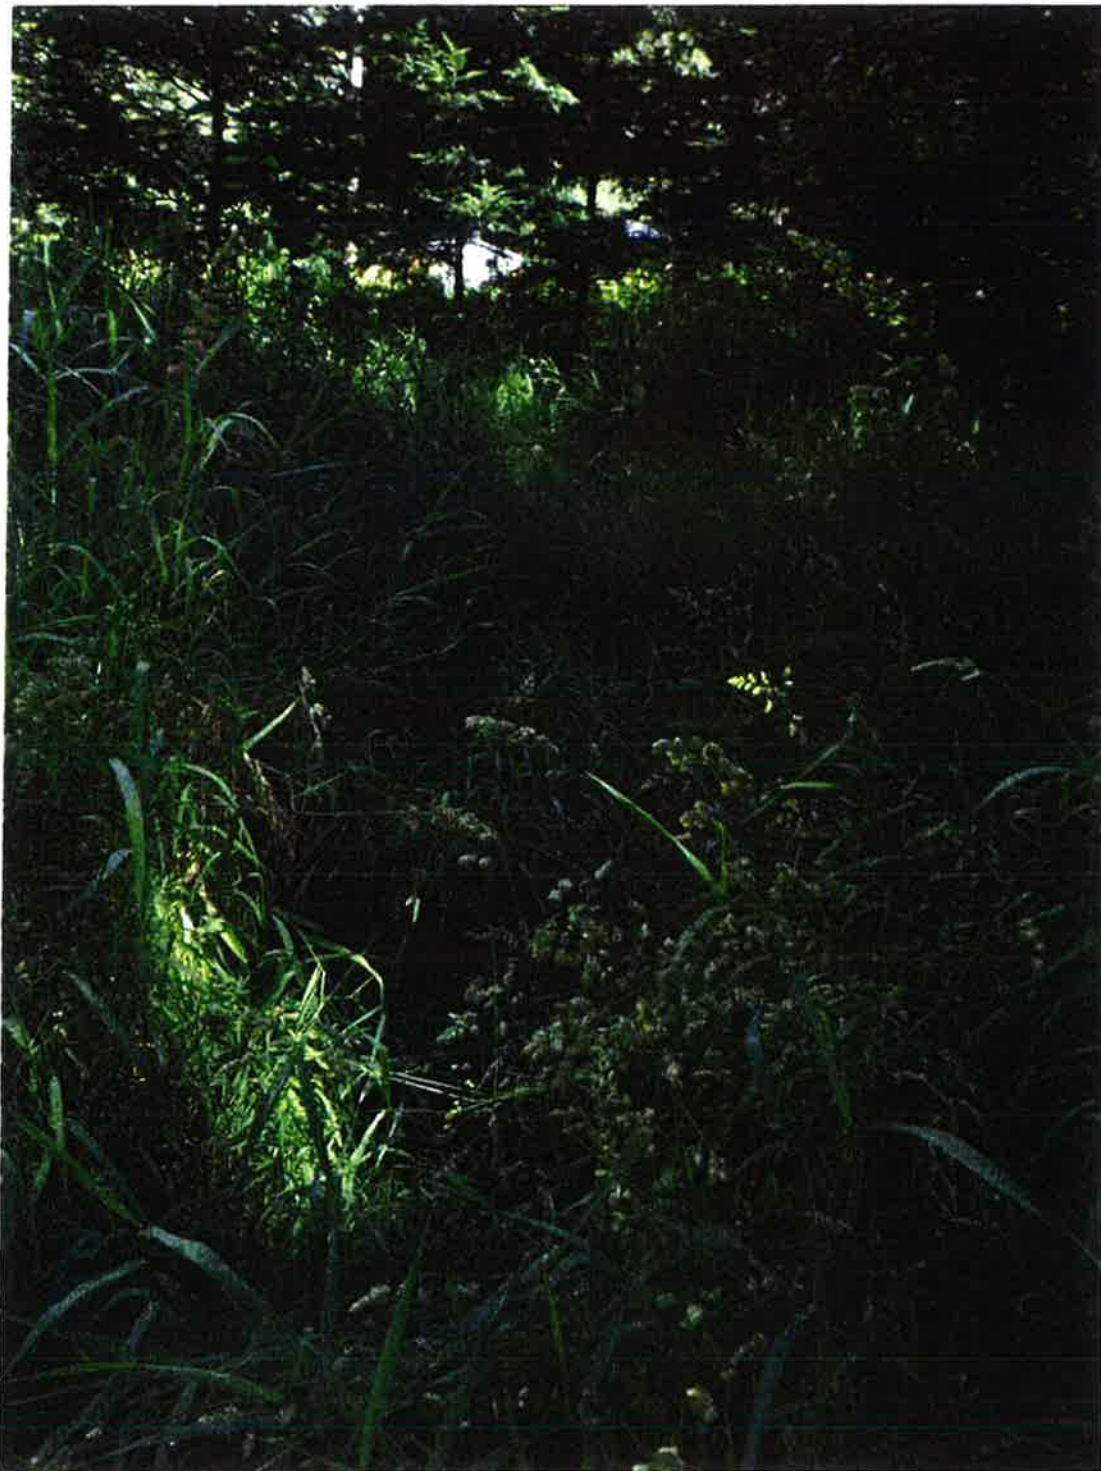
Gardom Pond Spillway Channel – Brush and remove vegetation in channel leading up to road culvert.
