**Project No: 60285876 Task #3**

**Re: Gardom Pond Dam Evaluation – North Pender Island  
Low Level Outlet Investigation, October 2017**

**Gardom Pond Dam  
Low Level Outlet Chamber Inspection  
Photo Album  
October 2017**

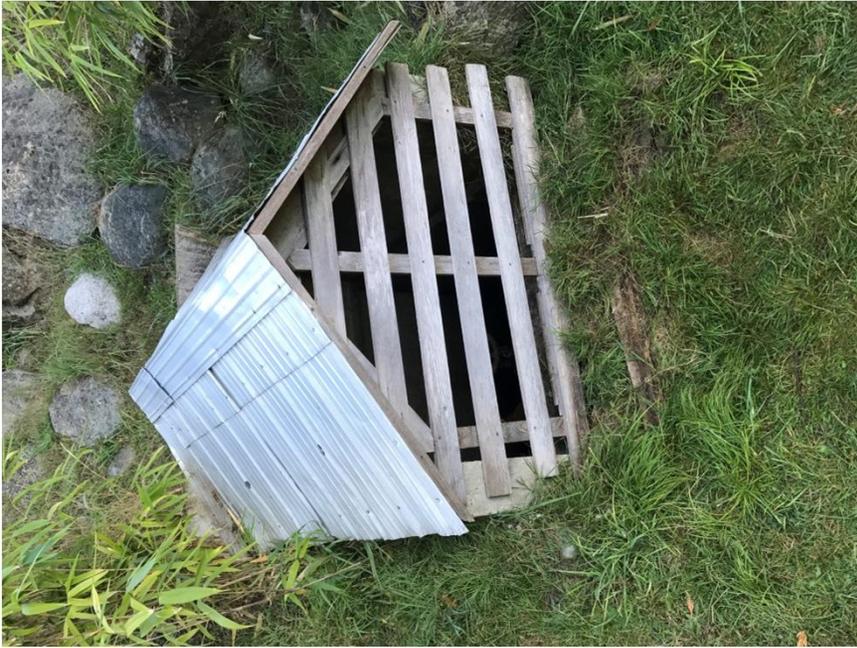
**Photograph #1: Low Level Outlet Chamber and Housing  
Located on downstream face of Gardom Pond Dam**

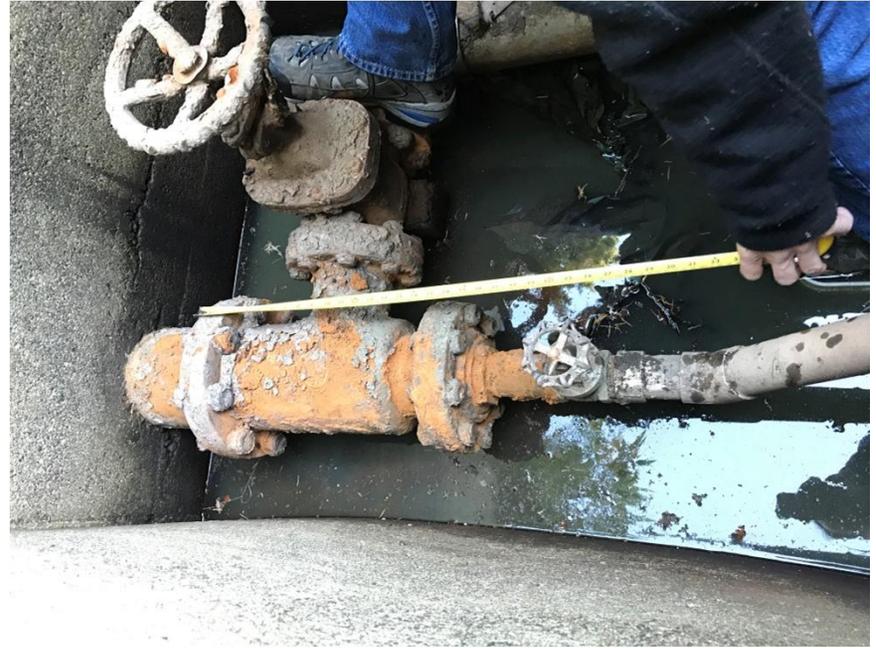
Deposit Buildup: The various piping and fittings within the chamber were covered to an approximate depth of 10 mm in a light brown silt like material with reddish brown mottling (Photo #2 and #3). The material was also noted to be stratified in nature.

**Photograph #2 – Top View: Low Level Outlet Chamber Infrastructure  
Deposit build-up partially removed**

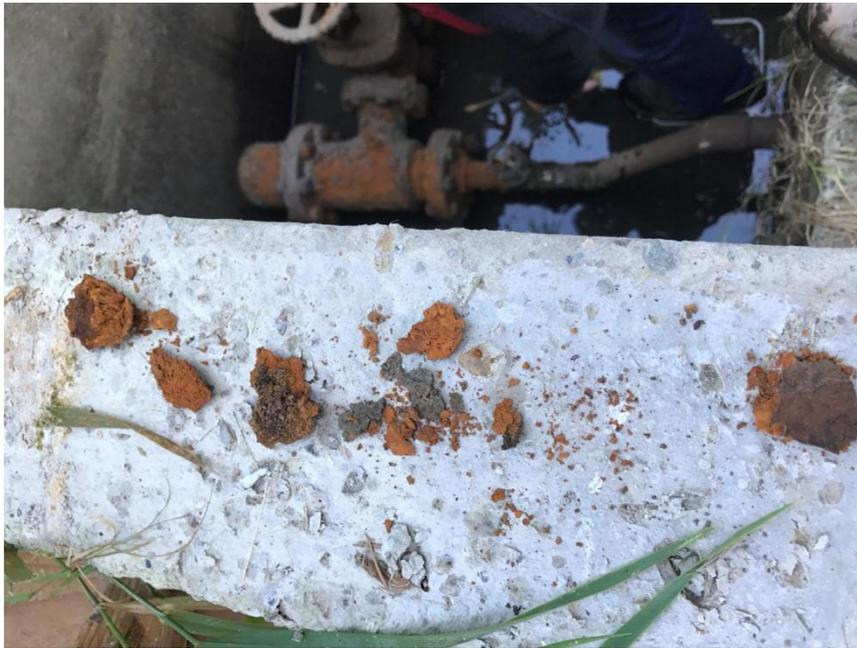
**Photograph #3: Deposit Build-Up**  
Typical samples collected from top of fittings & piping

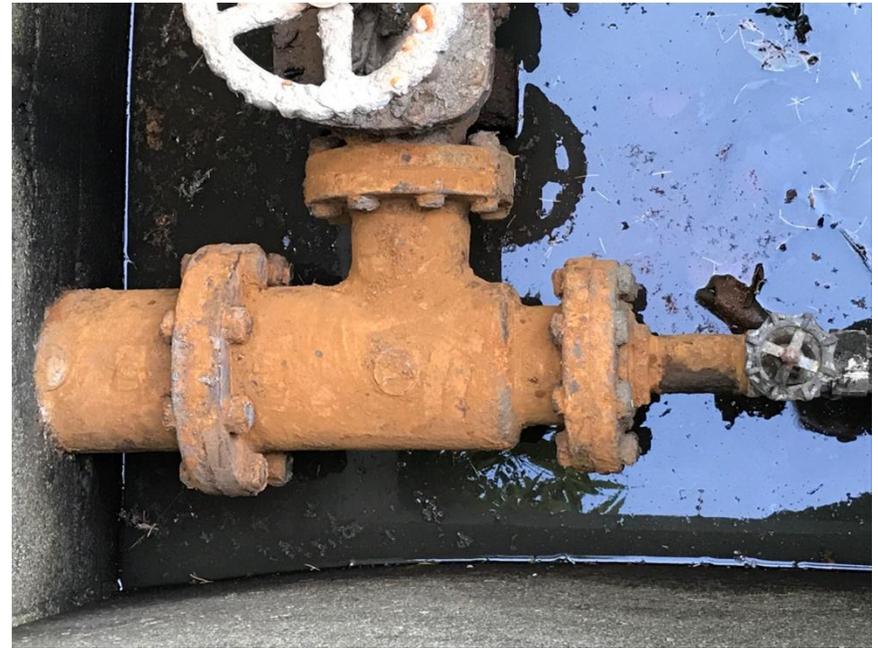
The build-up on the various components within the chamber was carefully removed to identify any underlying corrosion or spalling and to assess the overall conditions of the outlet (Photo #4). Some of the material removed appeared to be larger thin layers that may have been former protective coatings applied during manufacturing, but this was generally indeterminable.

**Photograph #4- Top view: Low Level Outlet Fittings**  
Deposit build-up removed

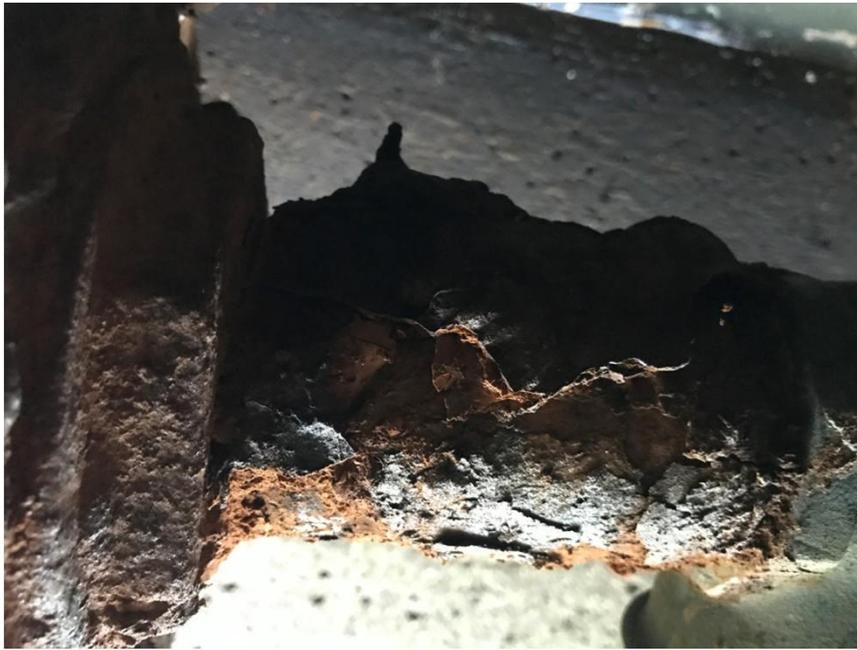
**Photograph #5 – Bottom View: 50 mm dia. Irrigation Feed  
Deposit build up and suspect spalling**

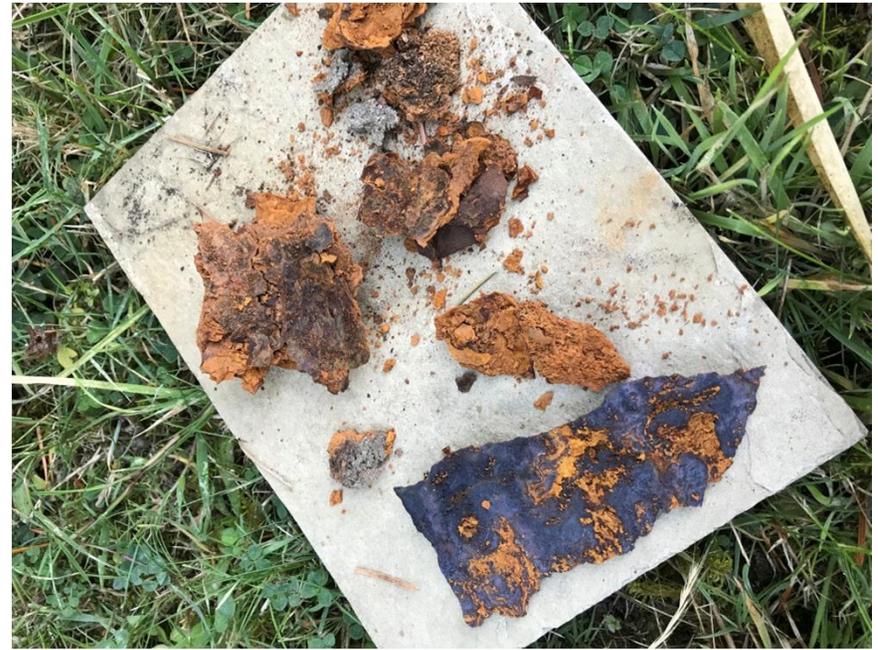
**Photograph #6: 50 mm dia. Irrigation feed  
View of samples collected from pipe spool**

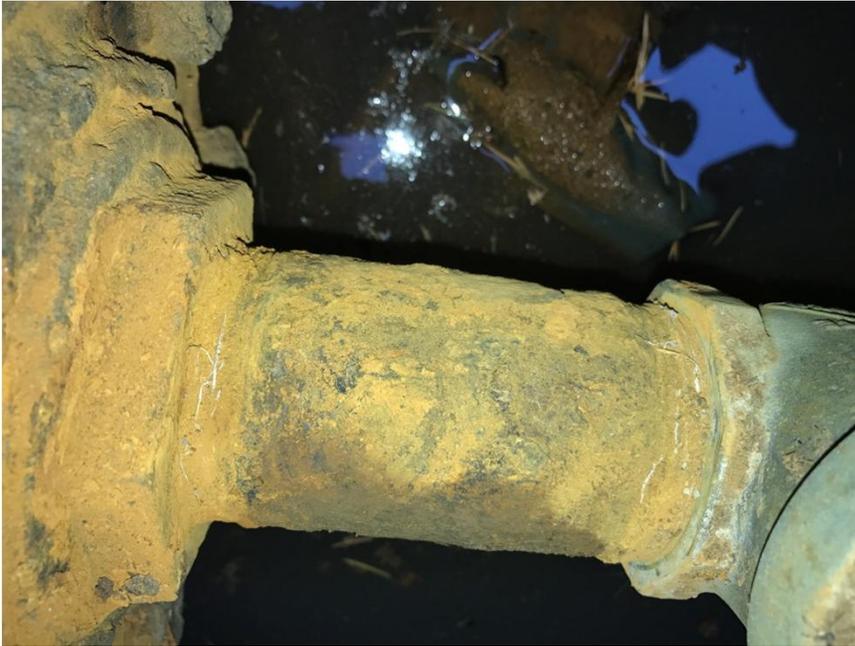
The 50 mm pipe spool showed signs of surface spalling with underlying surface oxidation consisting of visible surface scarring and pitting. Despite this noted surface oxidation, the exposed pipe threads on the end of the pipe spool were still visible and were generally intact (Photo #7).

The surficial qualitative assessment of the Low Level Outlet's piping and fittings identified the short 50 mm irrigation outlet pipe spool, located between the 150 mm reducing tee and the 50 mm gate valve, to have visual signs of metal corrosion; with characteristics of spalling, scarring and pitting of the pipe's surface. The full extent and depth of the identified corrosion within the base metal and the potential risk of failure is not determinable from our qualitative assessment.

We note this 50 mm diameter piping is pressurized upstream of the gate valve as a result of the dam's static water elevation and the extent of internal corrosion is not known, if any. To verify the pipe's integrity quantitatively would require further specialized investigations. This would incur additional consulting costs and may require the reservoir to be drained to conduct any pipe testing.

**Photograph #7 – Top view: 50 mm dia. Irrigation Feed  
Deposits and scaling removed  
Note presences of pipe threads and Teflon tape**

To address corrosion concerns attributed to the 50 mm dia. irrigation pipe spool, the pipe segment would ideally be replaced. However, the irrigation pipe is pressurized within the chamber with no means to isolate the pipe segment and the reservoir would need to be drained to conduct the replacement work. This is a significant endeavour and concerns have been raised on the operational integrity of the low level's 100 mm control valve that we understand has not be operated in a number of years.

To provide a measure of protection against possible failure of the 50 mm diameter spool piece was discussed with CRD staff. It would involve capping the irrigation outlet pipe downstream of the 50 mm diameter gate valve and encasing the irrigation outlet and main outlet tee in concrete. Refer to attached Figure #1. It should be recognized that this is a short term solution that should provide a cost effective solution to mitigate the potential risks of the irrigation pipe failing by corrosion until the dam is scheduled to be decommissioned in 2018.

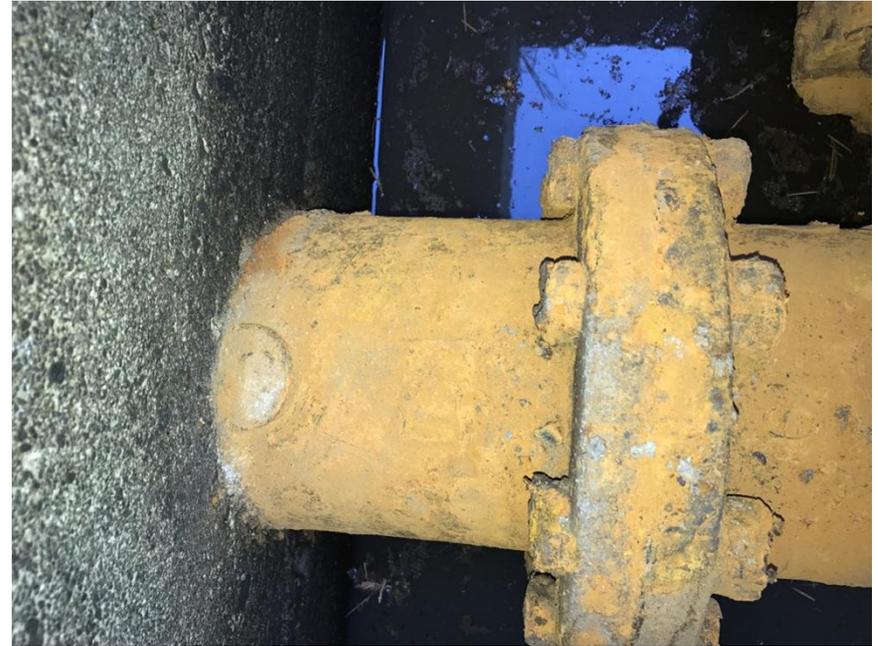
**Photograph #8 – Top view: 150 mm Upstream flanges  
and hardware at concrete chamber wall interface**

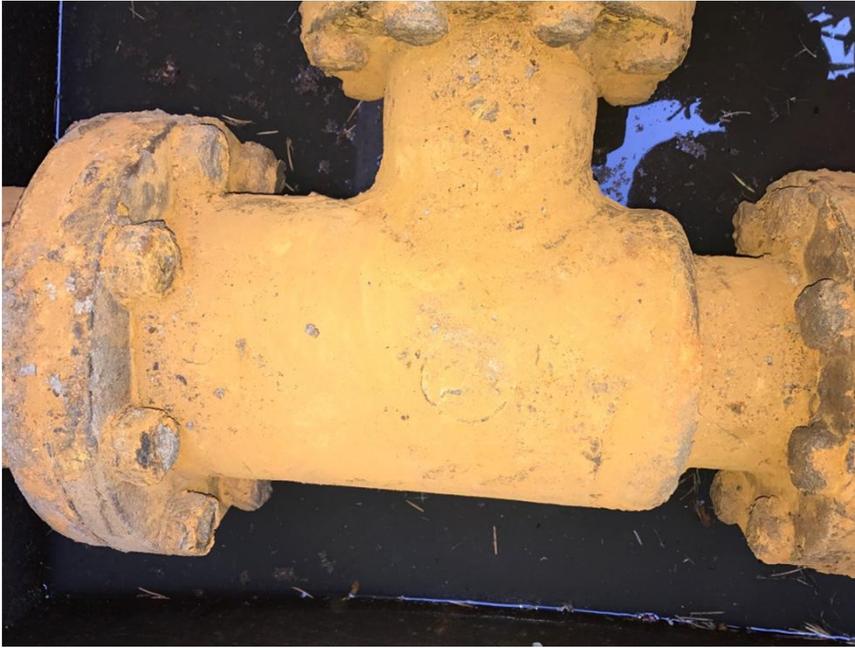
Low Level Outlet: The fittings, valve bodies, pipe flanges and related hardware had a reddish brown discolouration, which may be indicative of corrosion of iron base metals, but no significant pitting, scarring, or spalling of the surface base metals was noted (Photos #9&10). Overall the fittings and valve bodies appear to be in sound condition, despite the surfaces having become somewhat weathered since construction over 35 years ago.

**Photograph #9 – Top View: 150 mm Tee Fitting  
Tee Body, flanges, Nuts & Bolts**

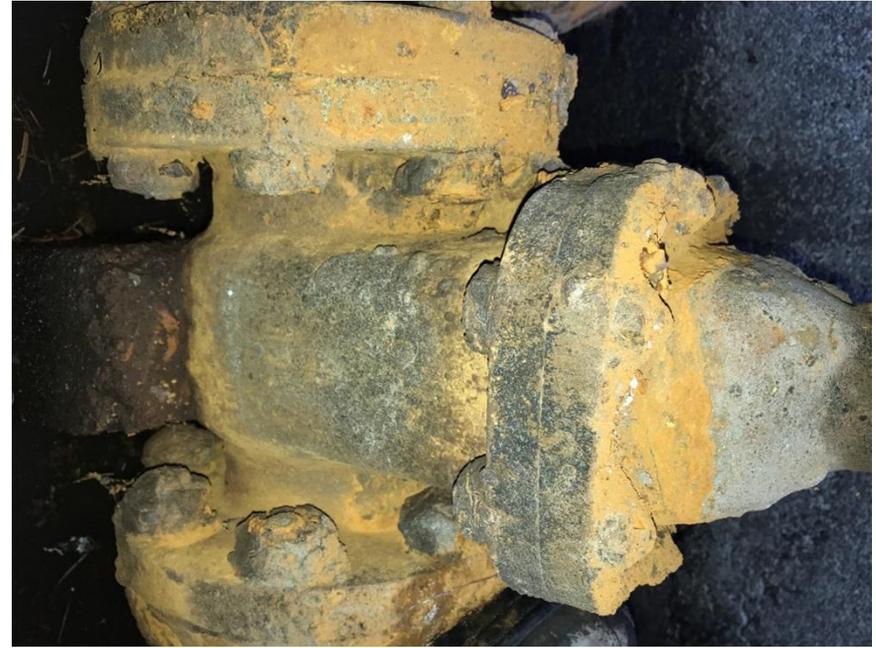
**Photograph #10 – Side View: 150 mm Low Level  
Outlet Control Valve, flanges, nuts & bolts**
