APPENDIX C

APPENDIX C—BOWKER CREEK CHANNEL RESTORATION NEEDS AND PRESCRIPTIONS

By Tanis Gower, RPBio

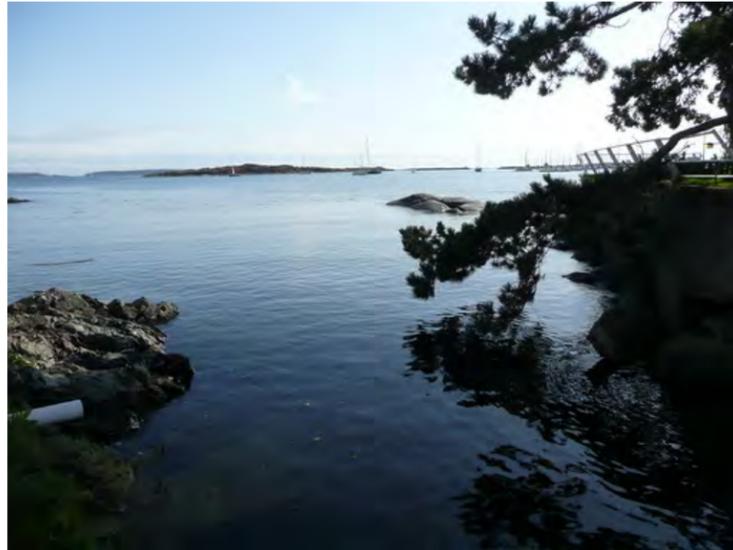
Plate 1: View of the creek mouth where it enters the ocean

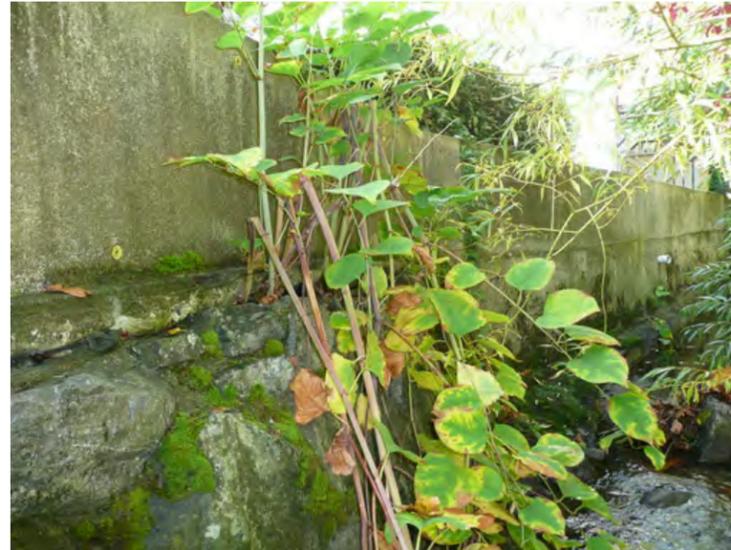
Plate 2: Knotweed growing from south bank retaining wall in Reach 1A

Short term riparian restoration potential and techniques Remove knotweed growing from concrete wall on south bank below Beach Drive— <u>high priority</u> . Remove ivy growing on private property along the south bank above and below Beach Drive. This would be particularly useful above Beach Drive where there is space for native plantings above the retaining wall. Remove blackberry and ivy along the Kachan property particularly where there is no bank hardening (no cement sand bags) and replace with native shrubs. Use native tree and shrub species in landscaping Address erosion just below Beach Ave by installing bioengineering terraces (willow wattles) if the property uses allow. This would require resloping the bank to a gentler angle and the existing land use in this area (front yard of an apartment building) would need to be assessed.
Short term channel restoration potential and techniques Channel bed below Beach Drive is mainly bedrock and cobble with some sandy deposits. Good channel complexity (see Plate 5) as a result.

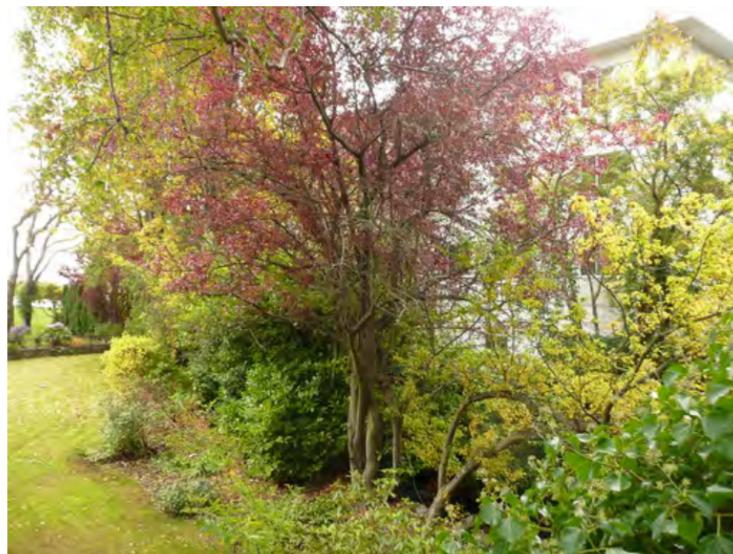
Plate 4: View looking downstream from Beach Drive. Note the narrow riparian 'strip' on north bank, apartment building on south bank

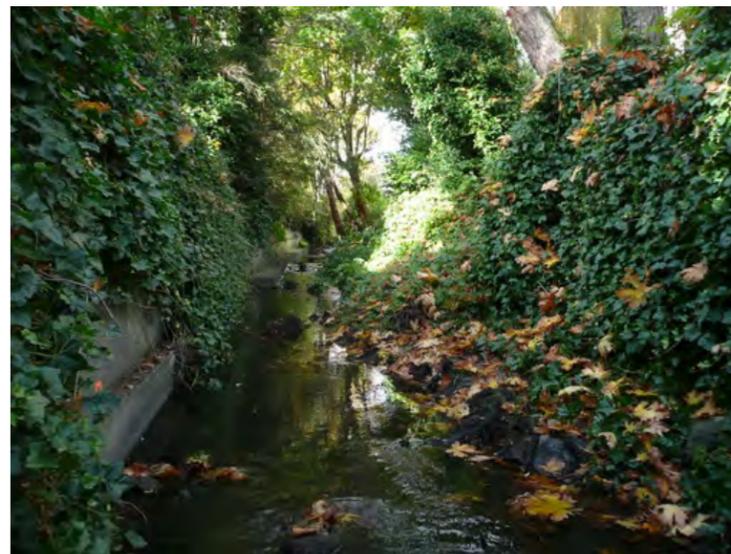
Plate 5: Reach 1A above Beach Drive. The Kachan property at 1776 Beach Drive is on the right hand side. Ivy and adjacent blackberry can be removed and native shrubs planted above the retaining wall on the south bank and in space on the north bank made available by blackberry removal.

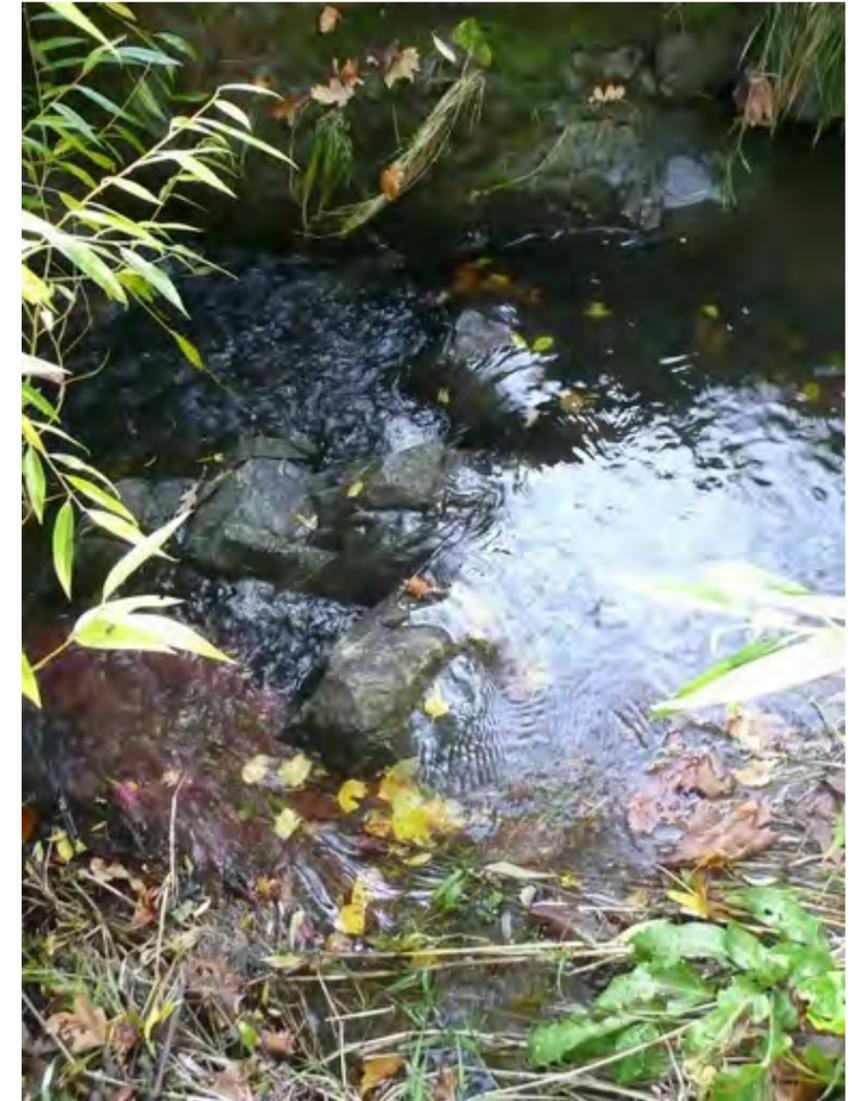
Plate 3: Natural cobble line providing complexity in Reach 1A. Reddish substrate on the left is yellow willow root mats commonly found in Bowker Creek.

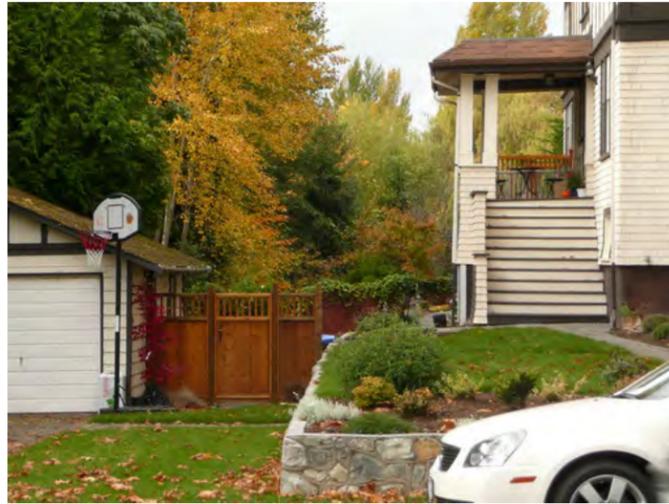
Plate 8: Kachan property at 1776 Beach Drive. The fence in the far distance marks the location where the creek narrows and bends around the fill that was historically used to create/extend the side yard on this property.

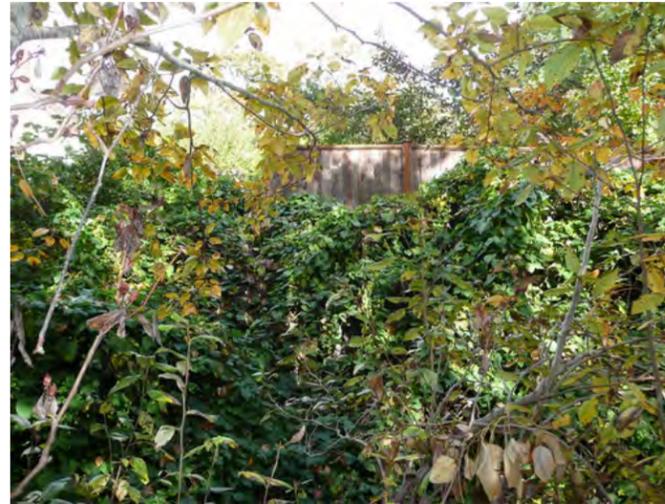
Plate 7: The steep north bank on reach 1B, covered in blackberry and morning glory. Fence shown is from panhandle of property at 1790 Cranmore Road.

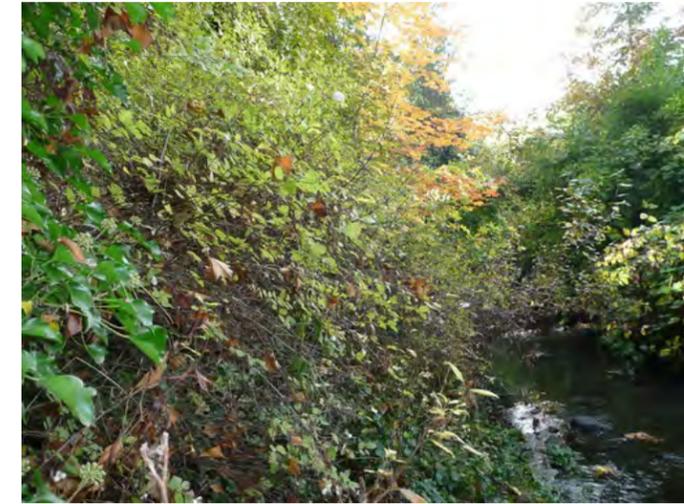
Plate 6: The more natural south bank of reach 1B is shown at left.

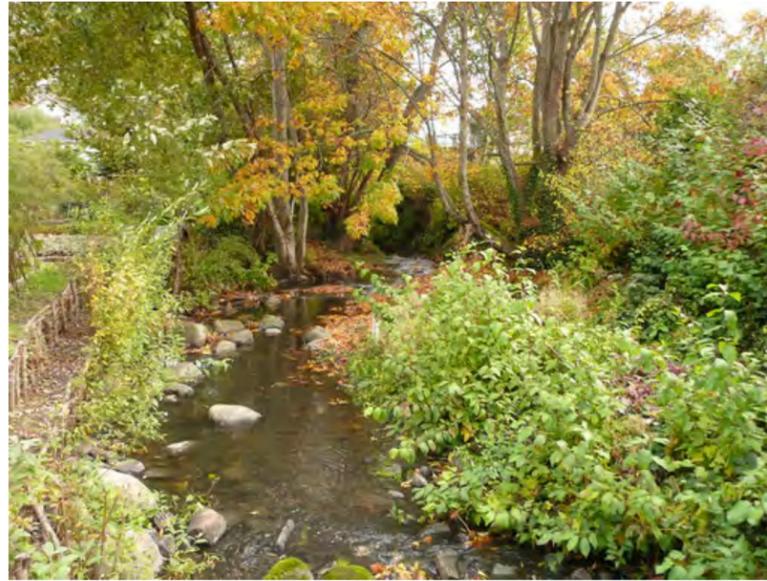
Plate 9: Downstream view of Reach 1C showing bioengineering on the left and a relatively new 'bar' in centre, created by an artificially dug channel.

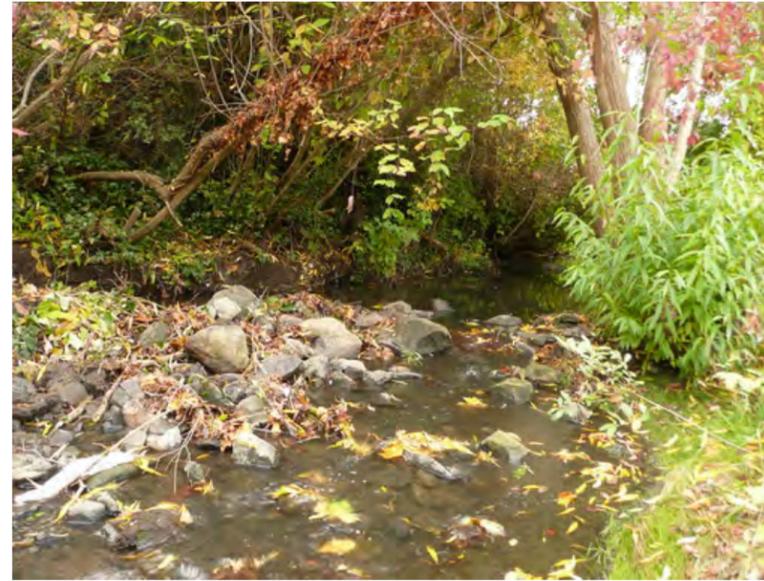
Plate 10: Upstream end of point bar showing top end of excavated channel, and looking towards Fireman's Park culvert exit.

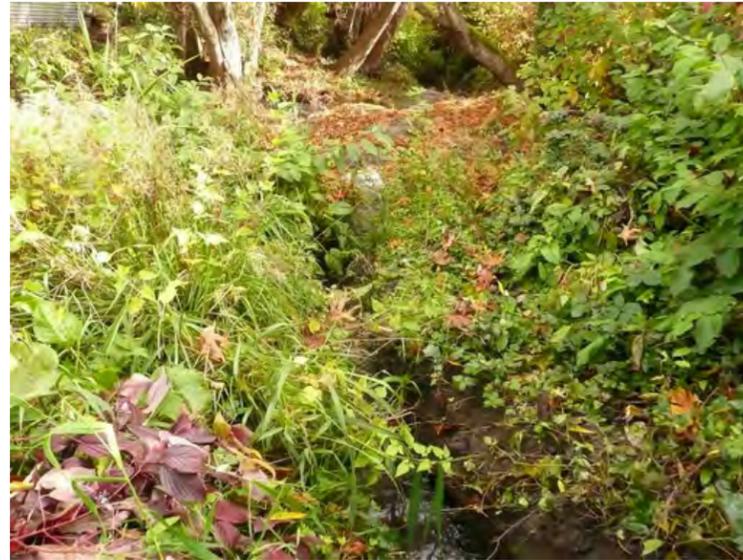
Plate 12: Artificially created 'side channel'. This channel has been stable since its creation sometime in the winter of 2007/2008, presumably by an individual concerned about erosion and flooding at the community gardens. Invasive vegetation on the bar should be addressed.

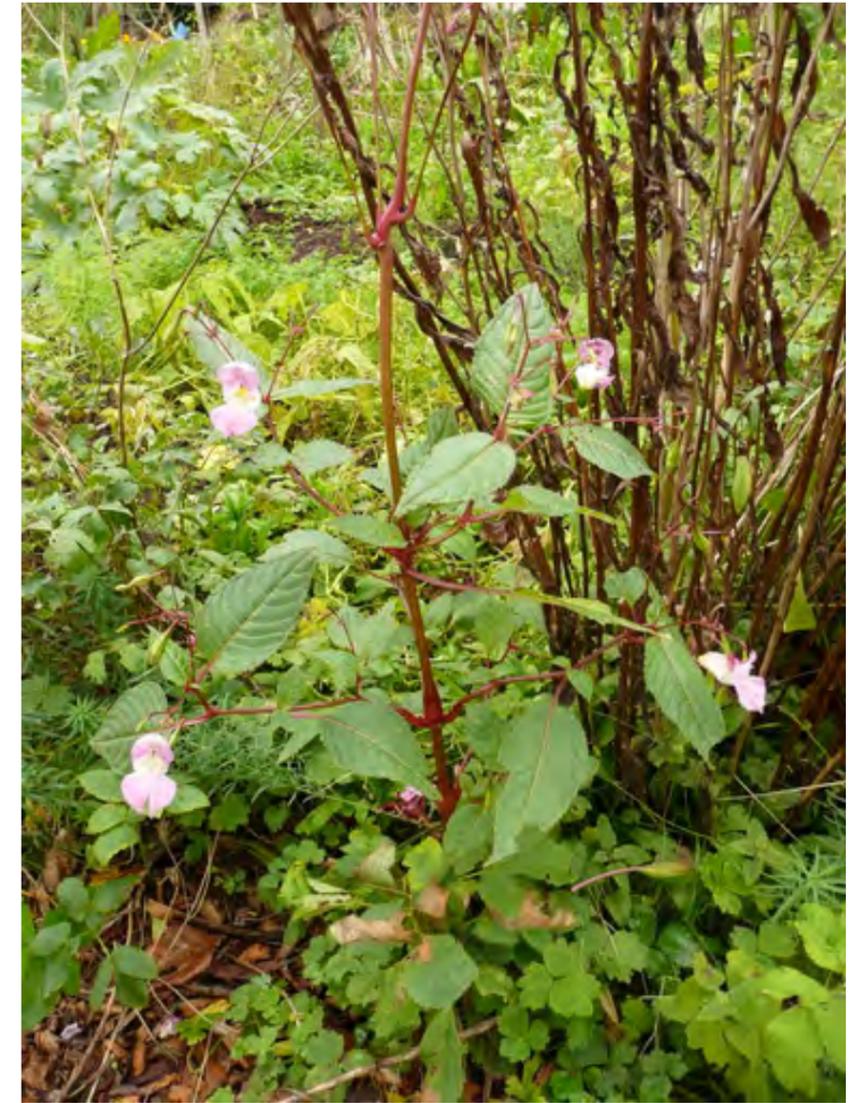
Plate 11: Policeman's helmet (*Impatiens glandulifera*) is an invasive annual plant that needs to be controlled before it establishes in the watershed. A few plants were found along Bowker Creek in the Monteith Street community gardens

Short term riparian restoration potential and techniques Remove occasional occurrences of policeman’s helmet (<i>Impatiens glandulifera</i>) (Plate 12) from the community gardens on an annual basis until eradicated— <u>high priority</u> For the south bank, funding is in place to purchase native plants to improve the riparian buffer (10–15 meter wide strip) and remove invasives. No short term riparian restoration is possible on the north bank unless community garden plots can be removed along the streambank. Note: the bioengineering treatment is not thriving as previously, particularly in the central section. Some areas have been clipped by the gardeners to control shade and in certain locations it is possible this may have affected the viability of the stakes.
Short term channel restoration potential and techniques In-channel conditions have been altered (Fig. 11 and 12). The resultant ‘point bar’ needs to be treated to remove invasive species. Currently, the channel throughout the reach has some diversity with cobble, some boulders, and gravel in pockets.

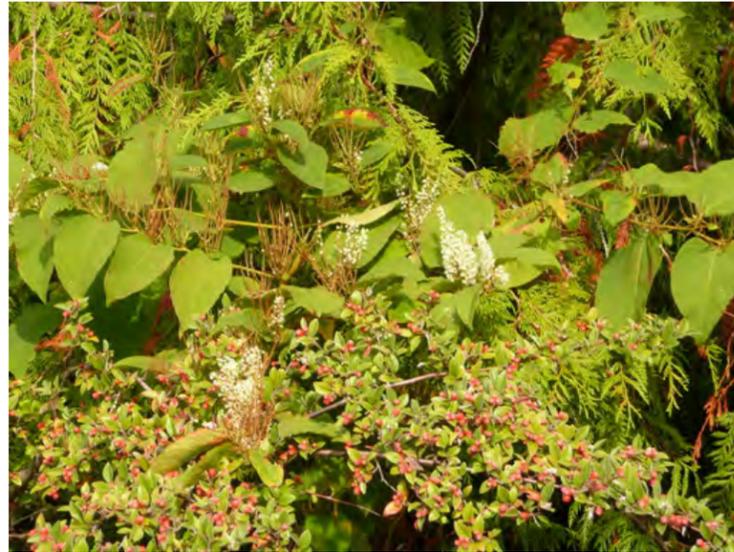
Plate 13: Knotweed intermixed with other vegetation on the west bank south of Hampshire Road.

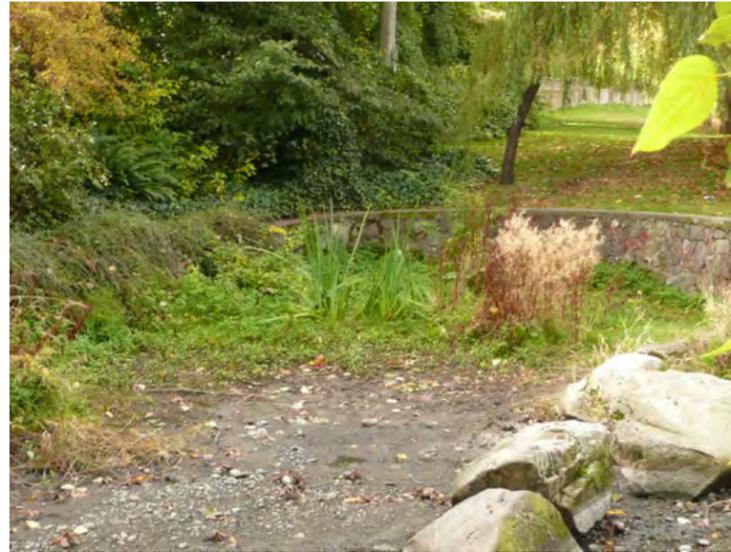
Plate 14: Partially vegetated in-channel area that could be enhanced with plantings of Spirea and/or other water-loving plants.

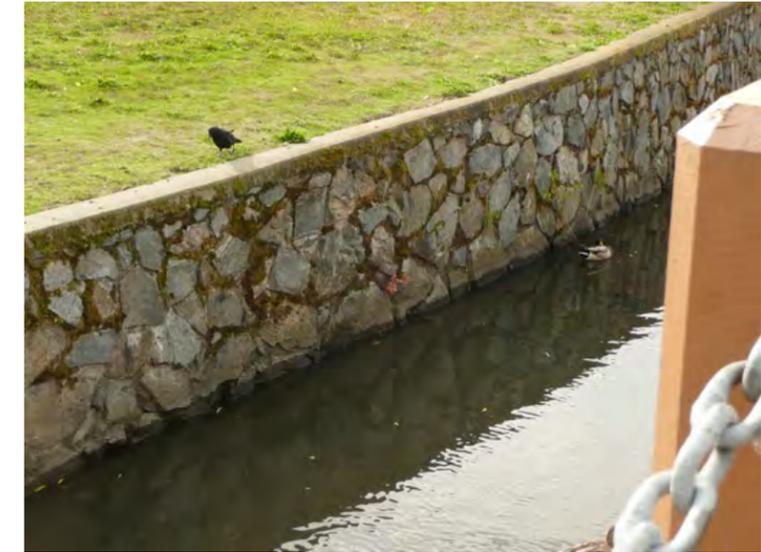
Plate 15: Typical concrete channel wall.

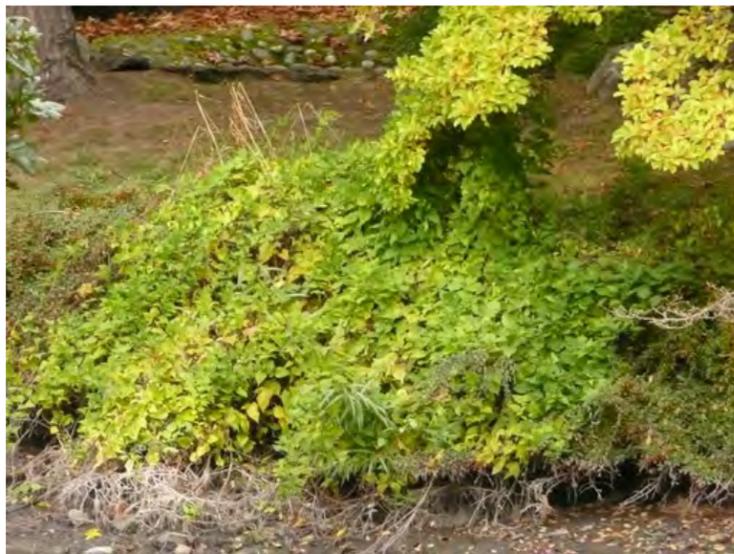
Plate 16: Large knotweed patch found within the channel boundaries, on the west bank north of Hampshire Road. All knotweed should be removed and monitored to ensure it is eradicated.

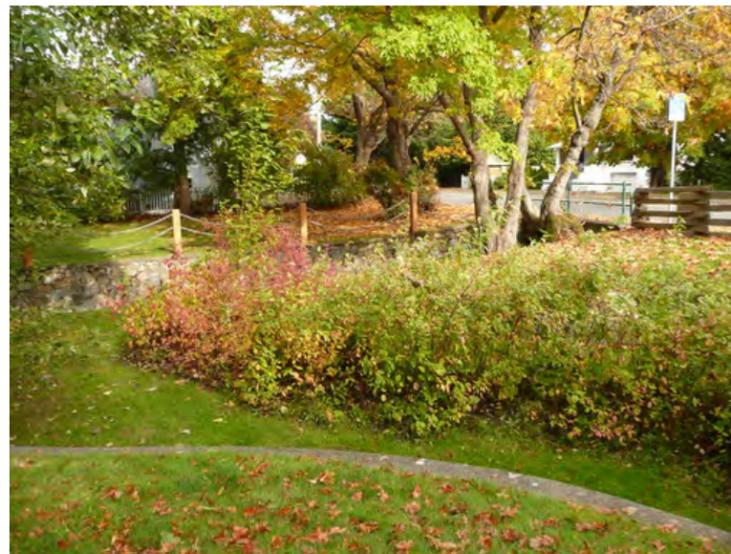
Plate 17: The area on the far bank (west bank north of Hampshire Road) is a potential candidate for a pilot project to create a more natural channel bank and riparian area due its lower public use and available space.

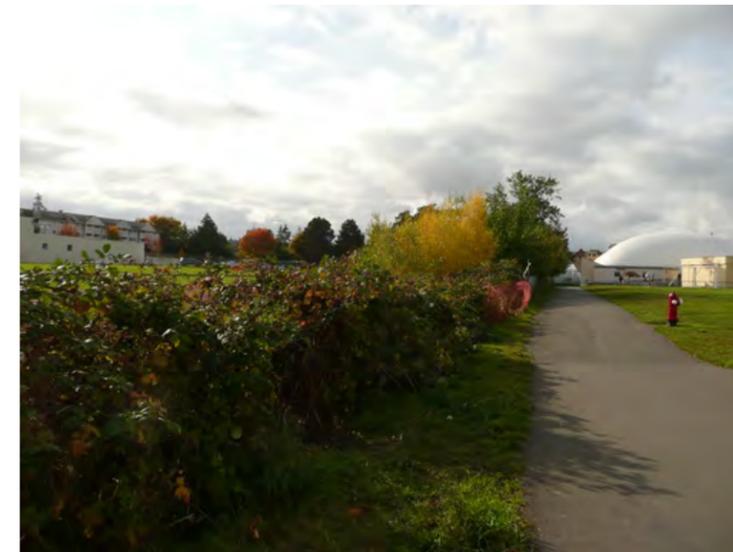
Plate 18: Narrow creek corridor between athletic track (left) and school property (right). Tennis bubble is in the background.

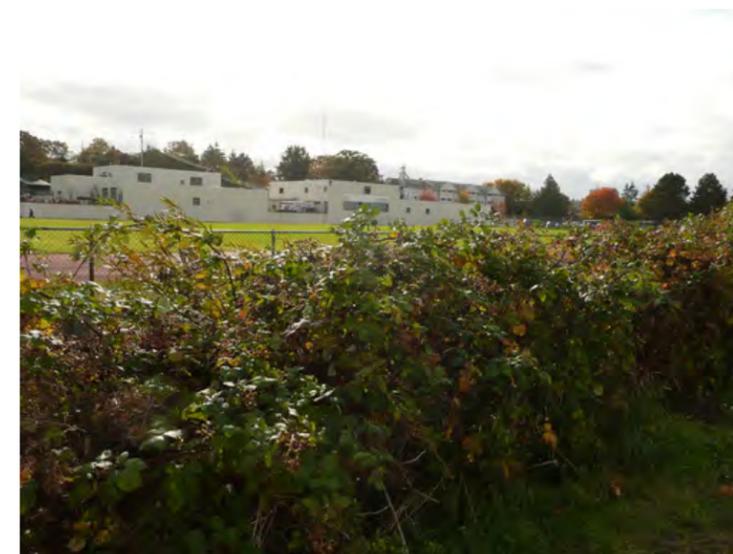
Plate 19: The narrow band of streamside vegetation on the north bank is a mix of blackberry and young cottonwood and yellow willow.

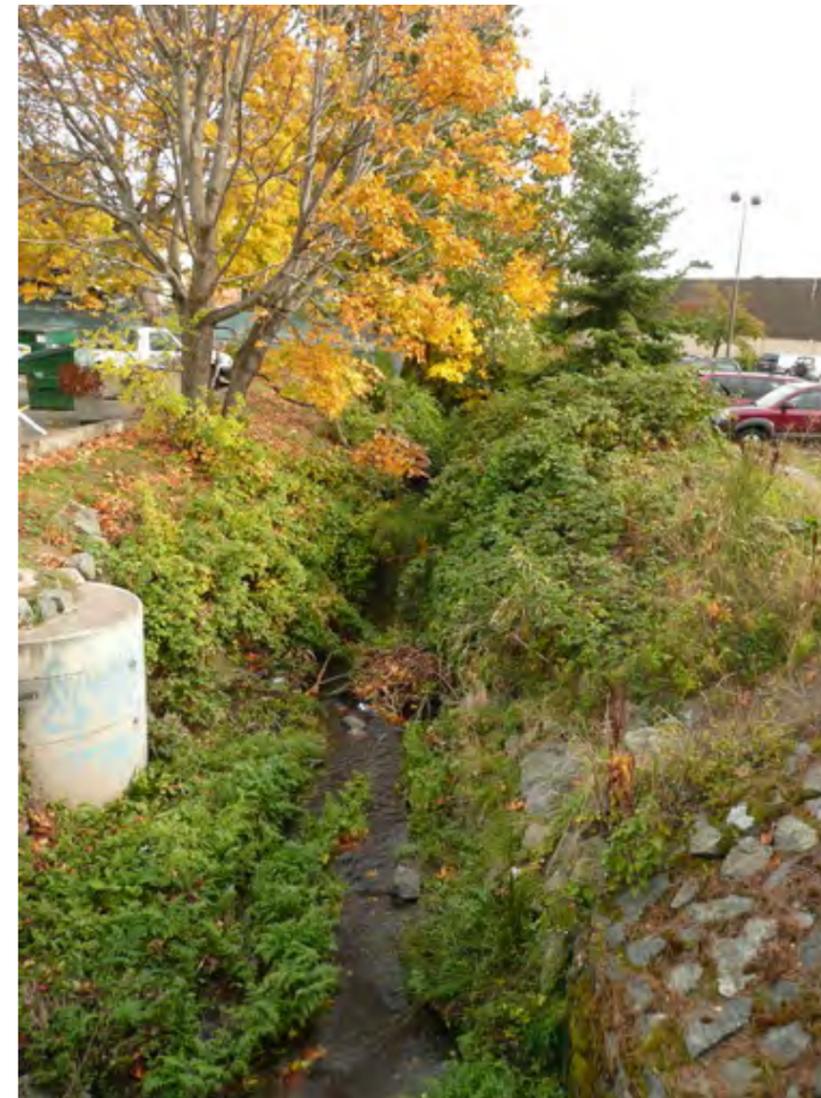
Plate 20: Reach 5A beside the Oak Bay Recreation Centre, looking downstream from Bee Street. Note the steep banks and mix of invasive and native vegetation.

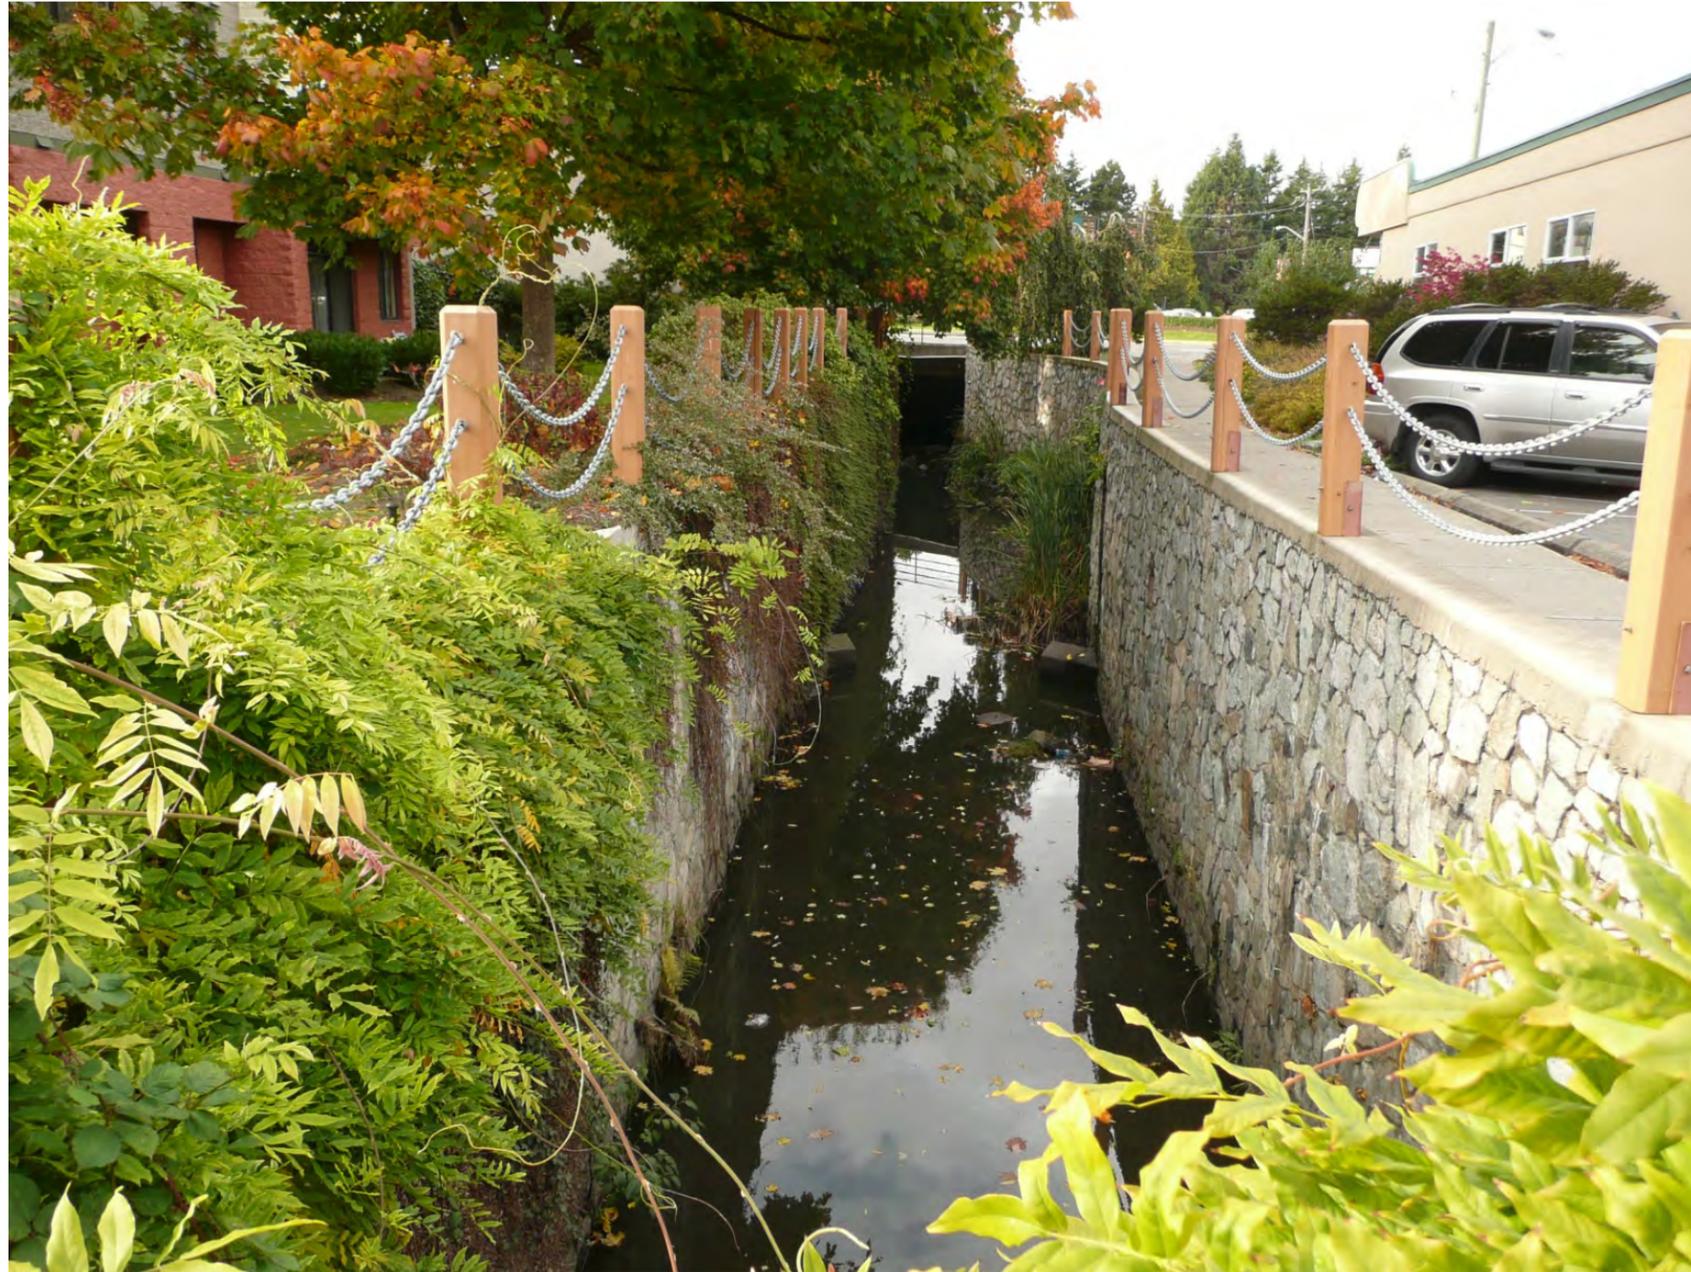
Plate 21: Reach 5B looking upstream from Bee Street. Few options exist to improve this reach. One possibility is installing in-stream baffles for complexity and aeration.

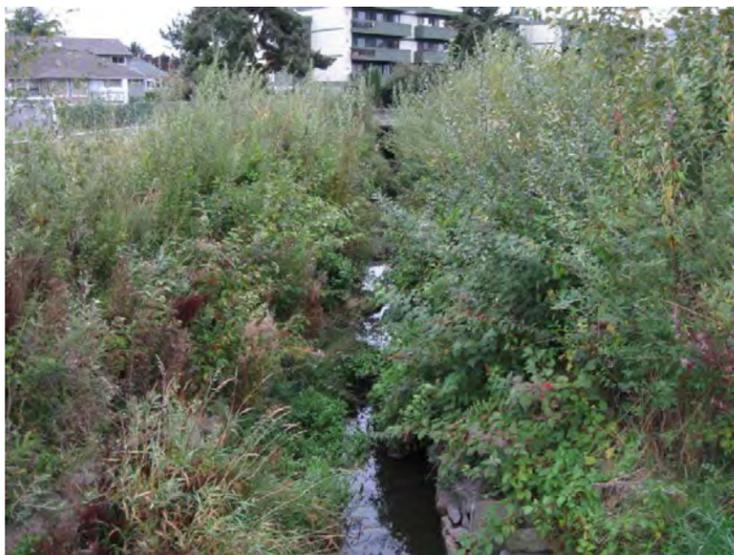
Plate 22: The 45-m long restoration demonstration section completed in 2005 is doing well and the willow/cottonwood wattles are thriving along with a variety of native shrubs (Photo October 2008).

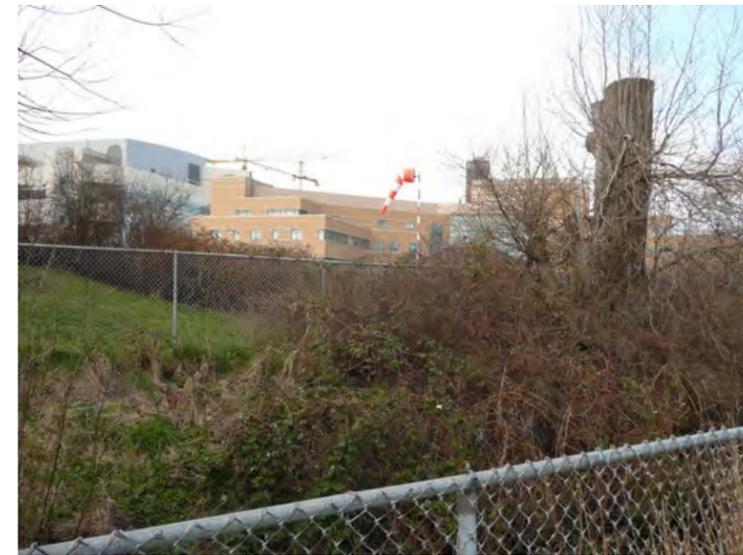
Plate 23: One of two 'topped' cottonwood next to the hospital heliport

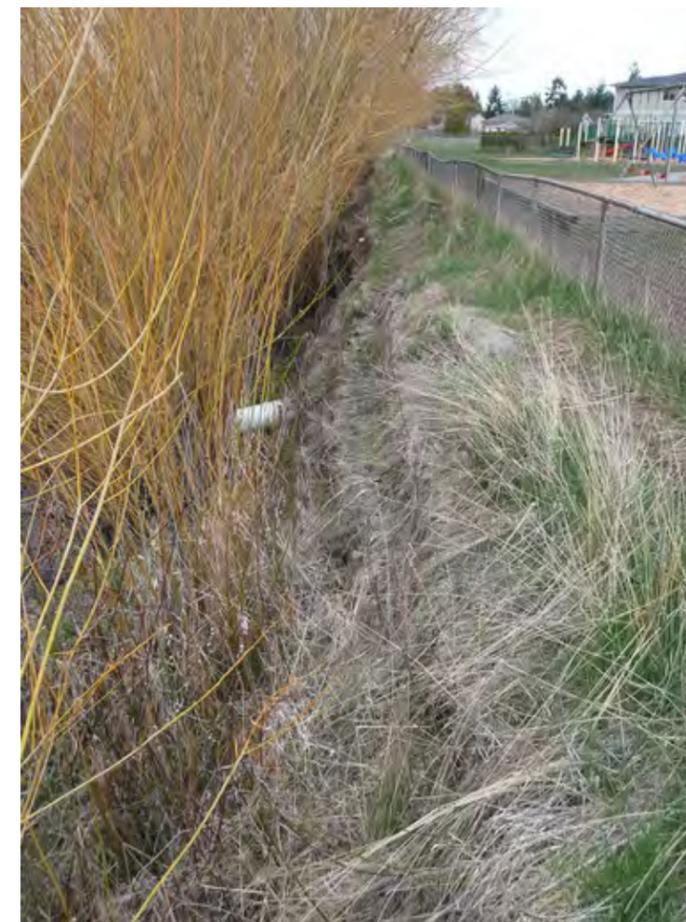
Plate 24: Upstream of the demonstration restoration section showing dead bioengineering along the east bank, behind thriving yellow willow growing on the channel bottom.

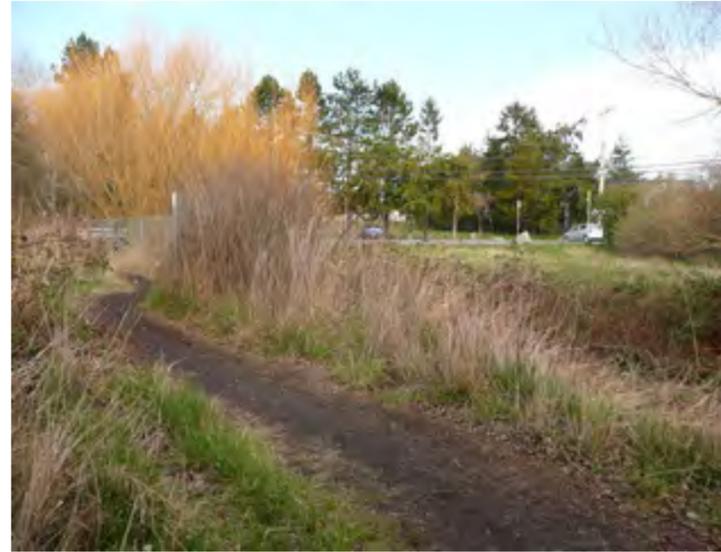
Plate 26: looking from the west bank to the triangle of land south of Haultain on the east bank. This area provides potential for widening the creek corridor.

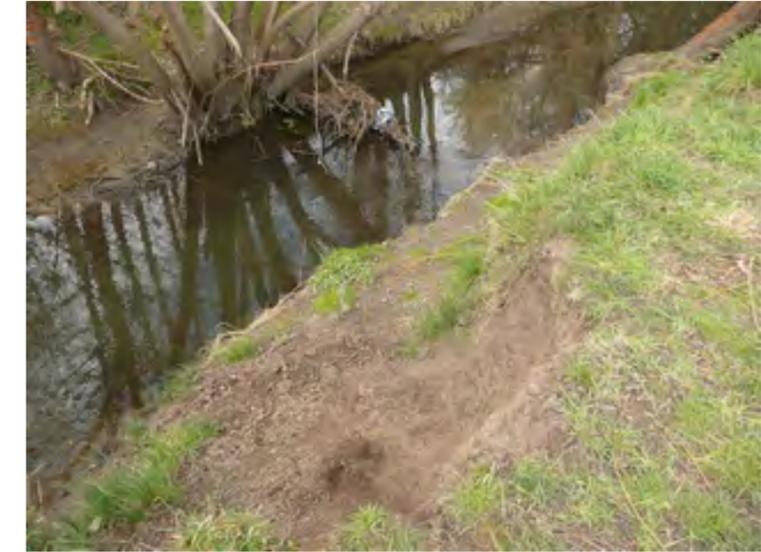
Plate 27: Eroding unvegetated banks on the Bishop of Victoria and Adanac right-of-way property provide an opportunity for short and/or long term restoration actions.

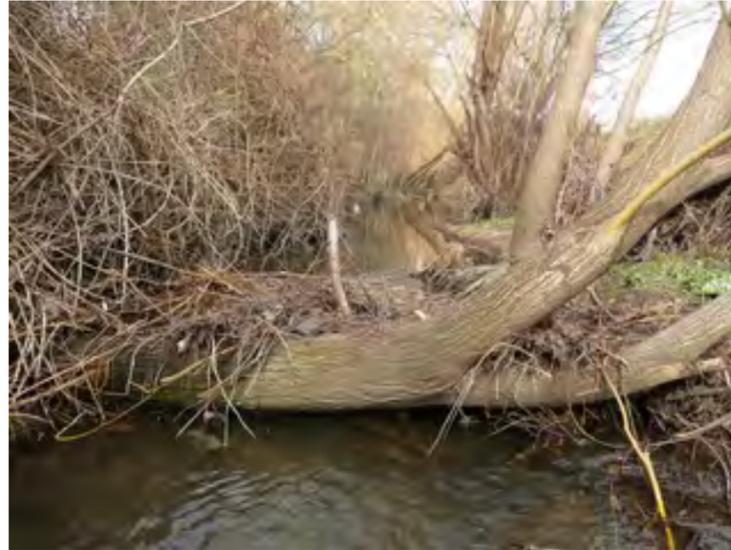
Plate 28: This fallen yellow willow offers rare large woody debris in Bowker Creek.

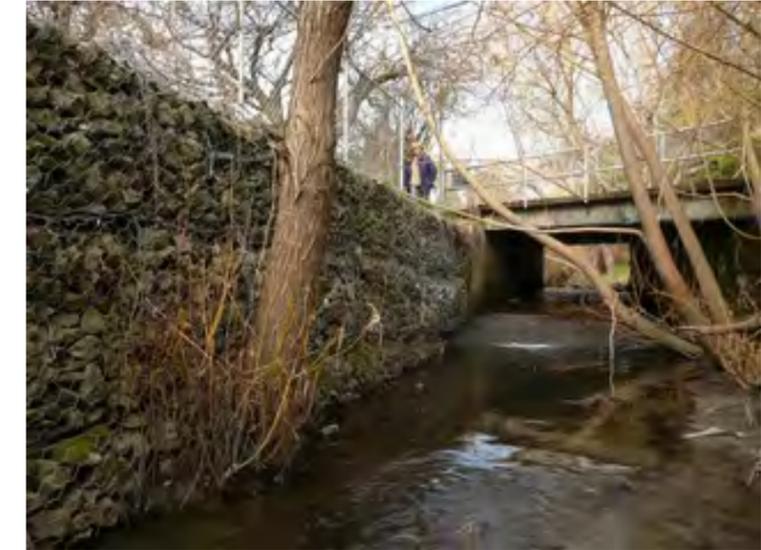
Plate 30: Gabions are controlling erosion at the top end of this reach, allowing for a streamside footpath on the west bank.

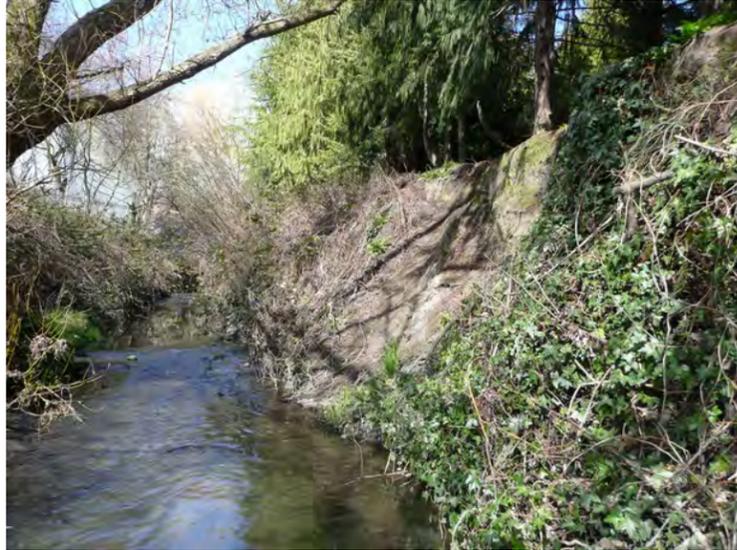
Plate 31: This reach is typified by steep, sparsely vegetated eroding banks and by blackberry on the west bank. It also has more riffle habitat than many sections of Bowker Creek.

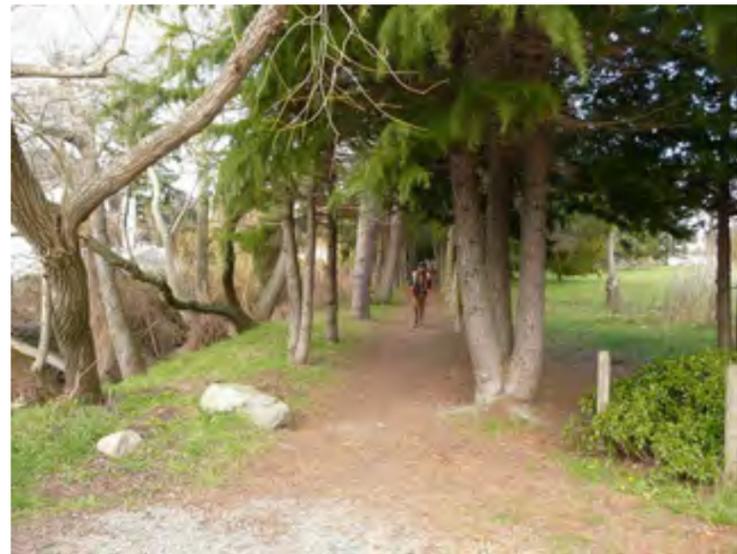
Plate 32: The path along this reach is popular with neighbours and the mature conifer trees that line the path are important to the community.

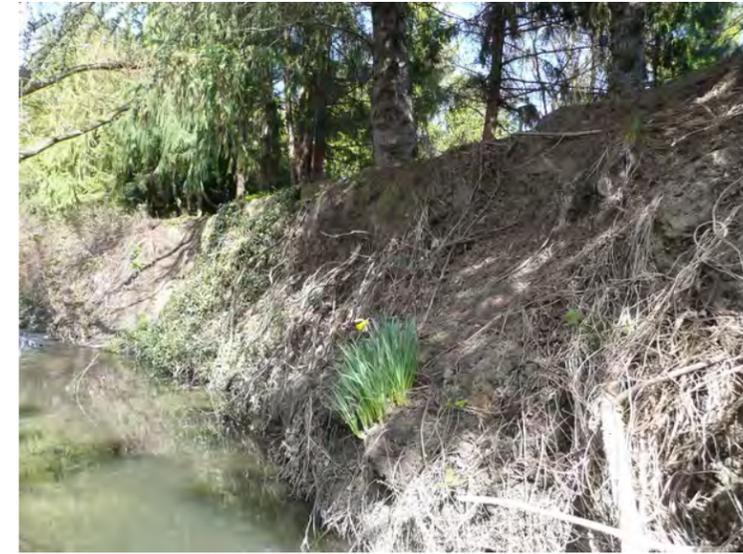
Plate 33: Typical view of the east bank, with the row of conifer trees visible at the top of bank.

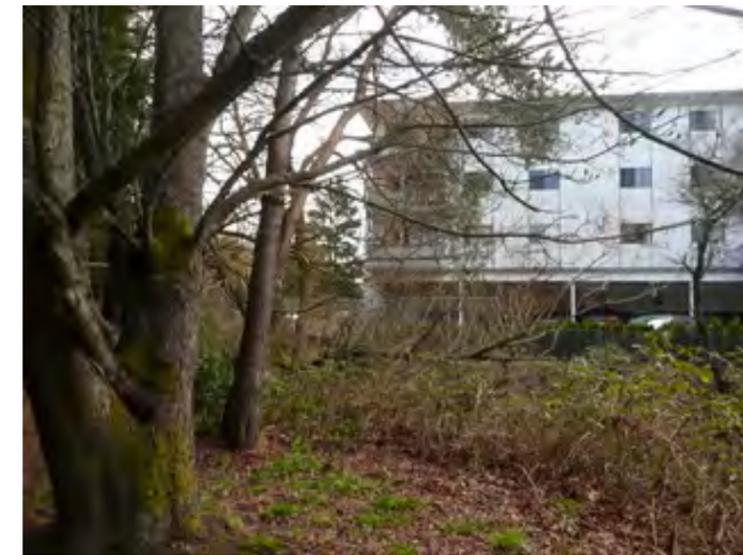
Plate 34: Looking toward the west bank. Bowker Creek is constrained along the west side of the Hydro property and restoration would entail expansion to the east.

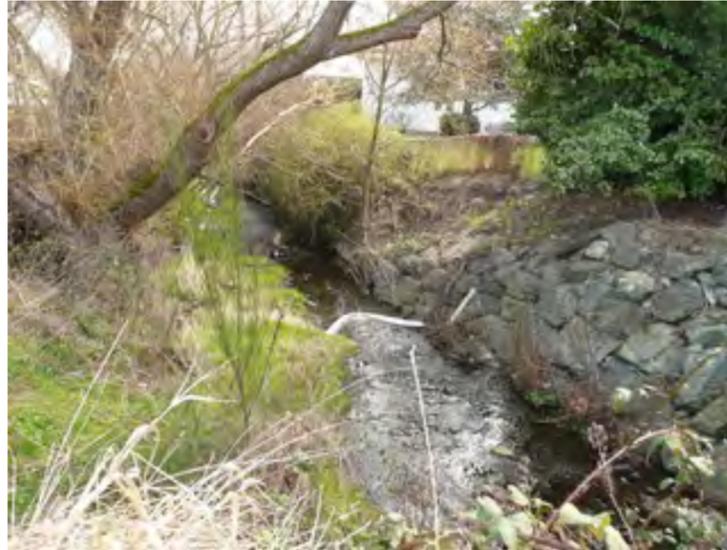
Plate 35: The upper part of the reach below Pearl Avenue is the healthiest in terms of substrate, channel configuration and riparian vegetation. Benthic invertebrate sampling is done here.

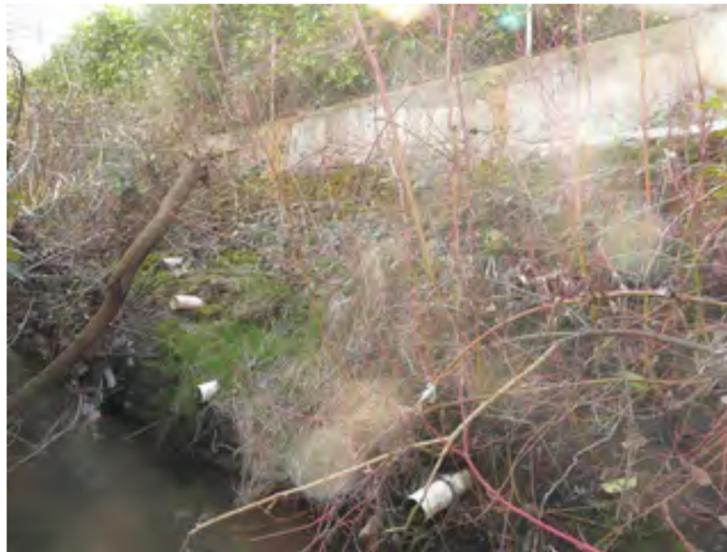
Plate 36: The west bank is constrained in the upper two-thirds of the reach by an extensive apartment complex at 1702 Newton Street.

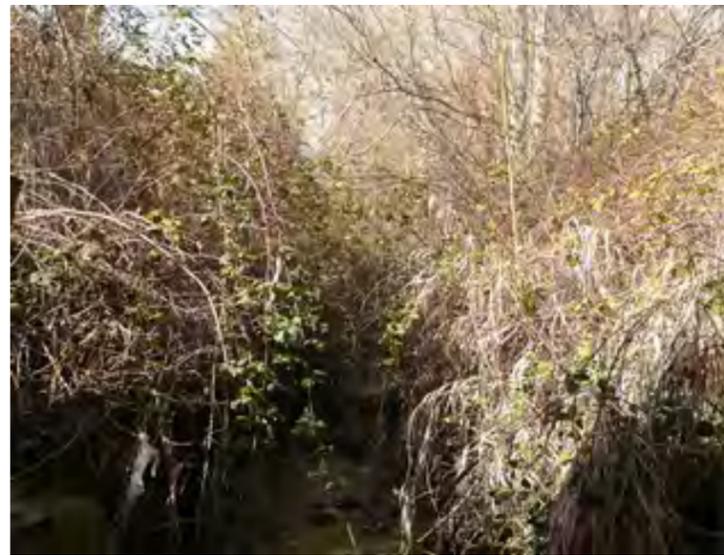
Plate 37: Extensive blackberry is a major feature of this reach.

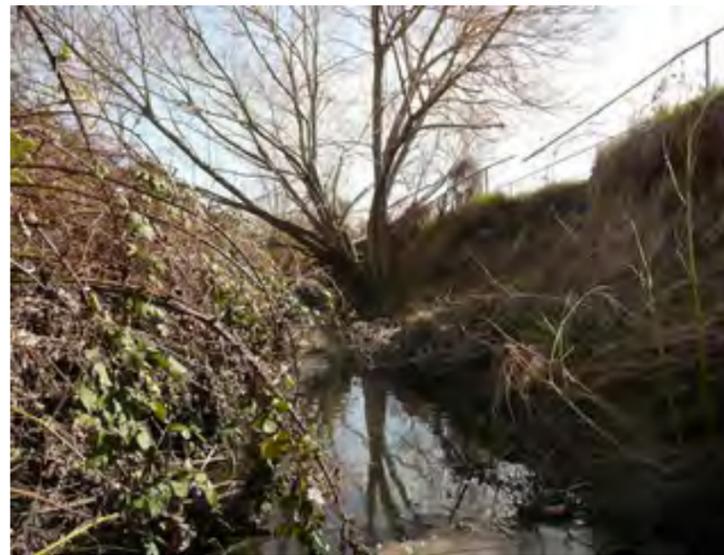
Plate 38: Erosion is an issue through the school grounds. The fence footings have been eroding and public access is worsening the issue.

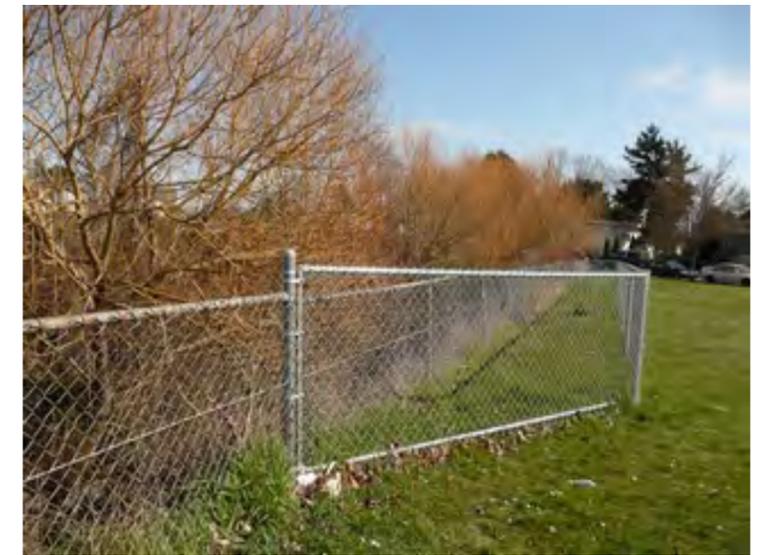
Plate 39: The school district has put extra fencing around eroding sections as a public safety measure.

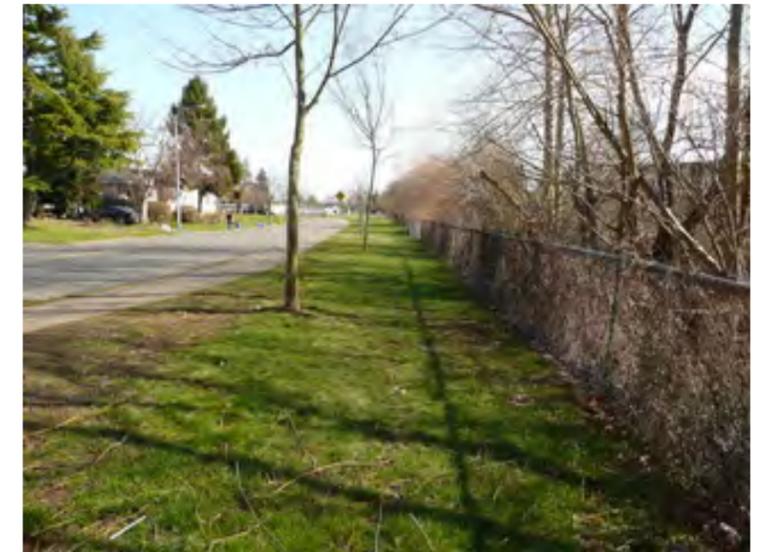
Plate 40: The right-of-way along Townley Street is relatively narrow, but still allows an opportunity to widen the creek corridor.

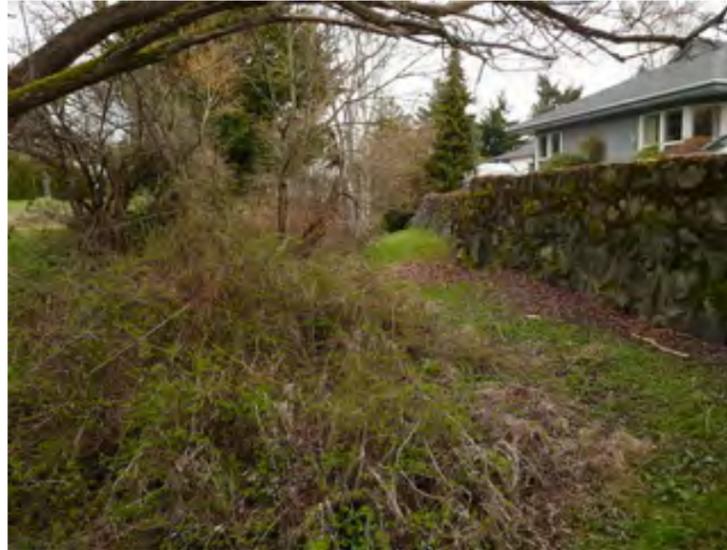
Plate 41: Reach 12A looking north. The patch of grass on the left is the Wordsworth Street right of way accessed from McRae street. The lawn below the rock wall on the right has potential for riparian restoration if the property owner agrees. This could entail some bank resloping.

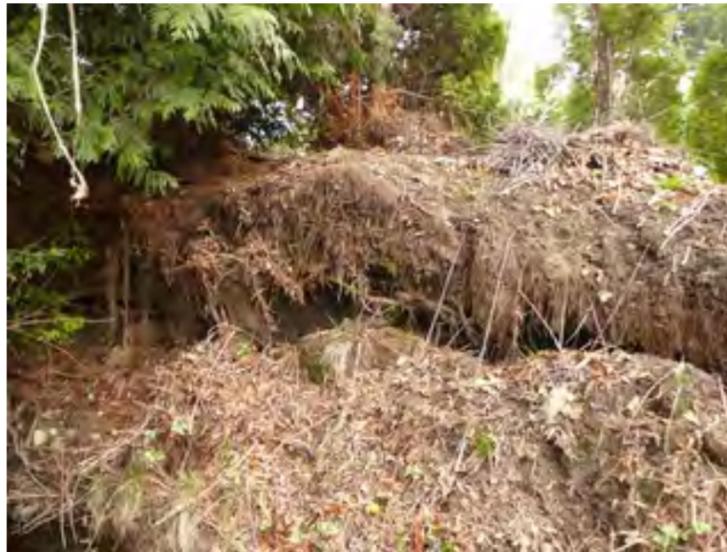
Plate 42: Erosion behind 1599 McRae Avenue. If the property owner agrees, the section along this property is a candidate for bank and riparian restoration.

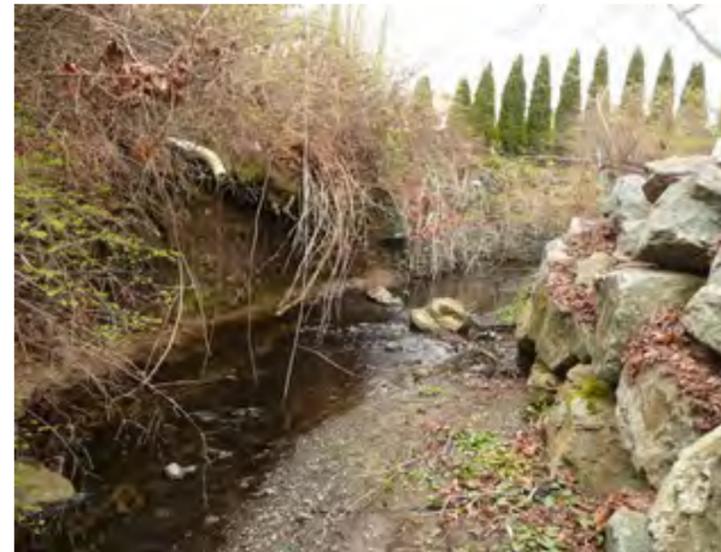
Plate 44: Upstream view. The creek does a sharp turn around this property. This would be a key property to acquire for creek restoration as the house footprint is very close to the creek.

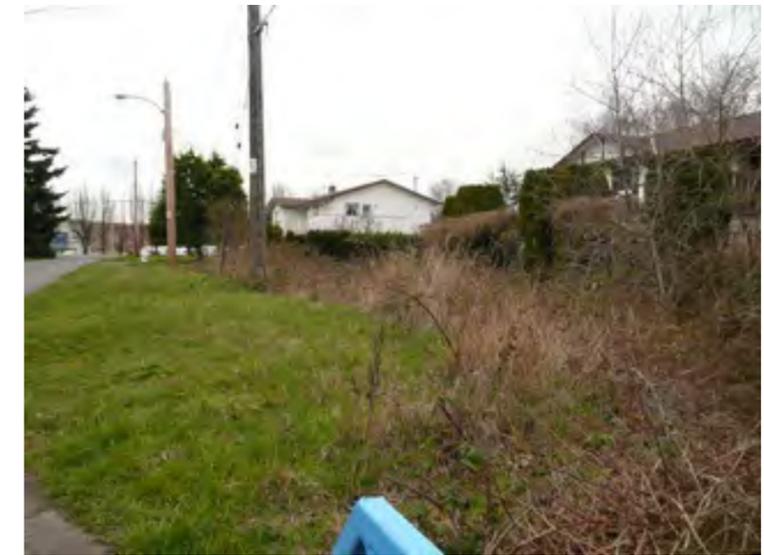
Plate 45: Looking south along the right of way on Keats Street. Depending on whether the power line could be moved, the creek could be extended into the right of way, allowing the gabions on the east bank to be removed and natural riparian vegetation planted.
