APPENDIX C

APPENDIX C—BOWKER CREEK CHANNEL RESTORATION NEEDS AND PRESCRIPTIONS

By Tanis Gower, RPBio

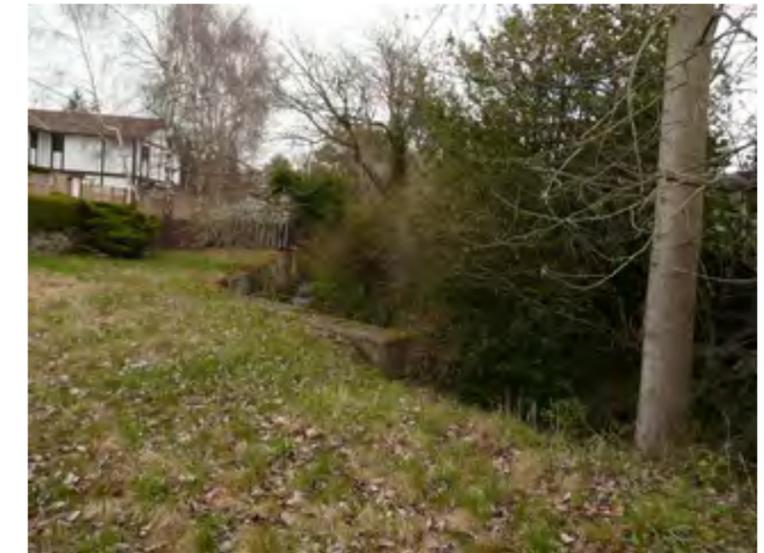
Plate 46: This streamside property appears to be part of the lot at 1564 North Dairy. It could be reconfigured as part of short or long term restoration plans

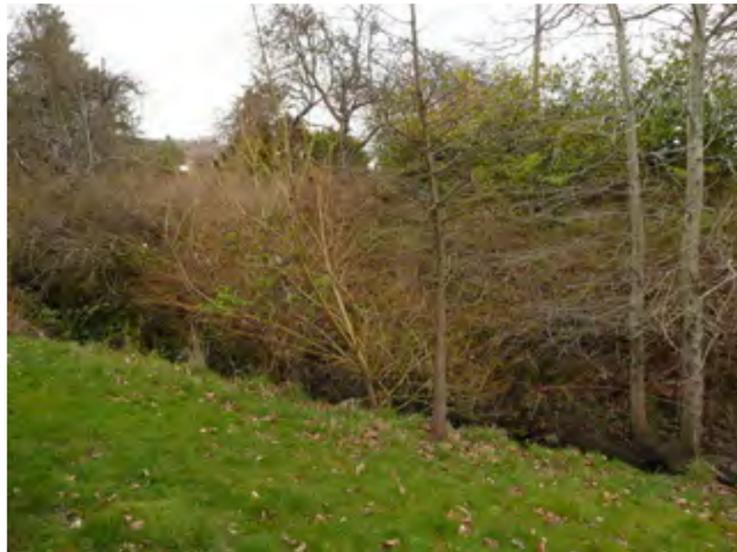
Plate 47: Grassy area along west bank that is a candidate for riparian planting

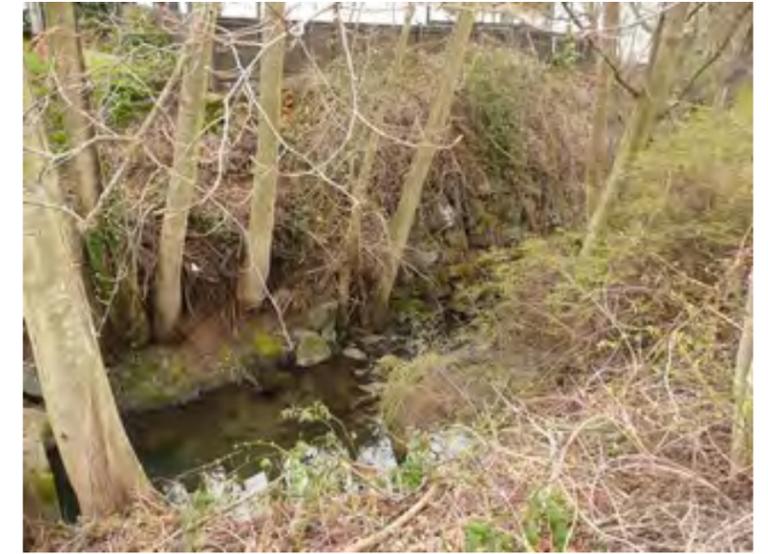
Plate 49: Looking south from the top of the reach. The current path curves towards the creek and with park redevelopment will be moved west to provide space for a riparian buffer, including a resloping of the creek bank.

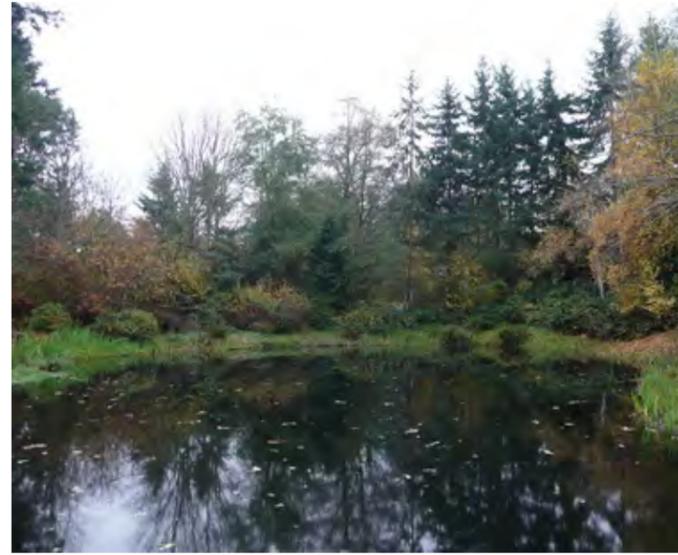
Plate 51: The pond at the Faculty Club, Reach 15A. The pond edge is somewhat landscaped and native plantings could be increased.

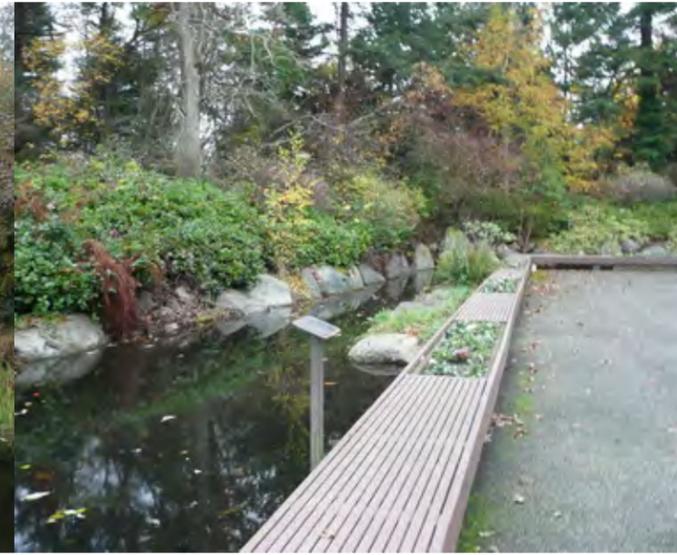
Plate 52: The pond edge is the concrete patio at the Faculty Club. Looking downstream to beginning of outlet channel.

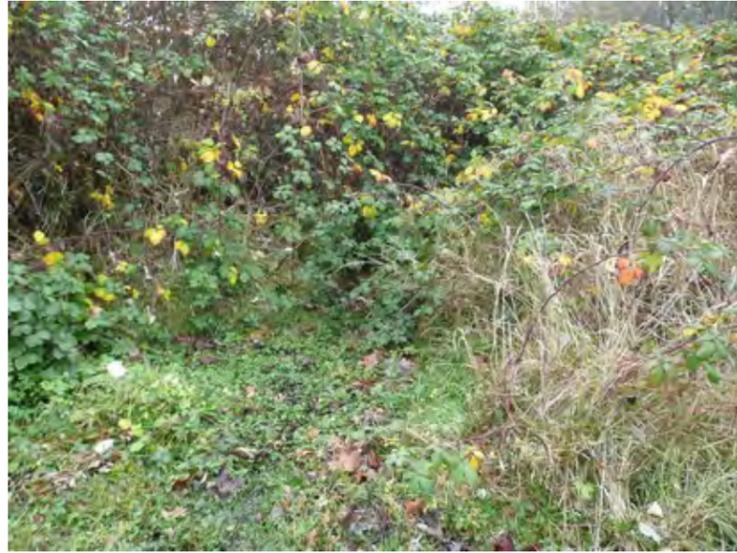
Plate 57: Blackberry lined drainage channel from parking lot 10 (near Visual Arts building) to vicinity of Reach 15B. This presents an opportunity to create a more natural channel with native plants and interpretive signage about runoff and Bowker Creek.

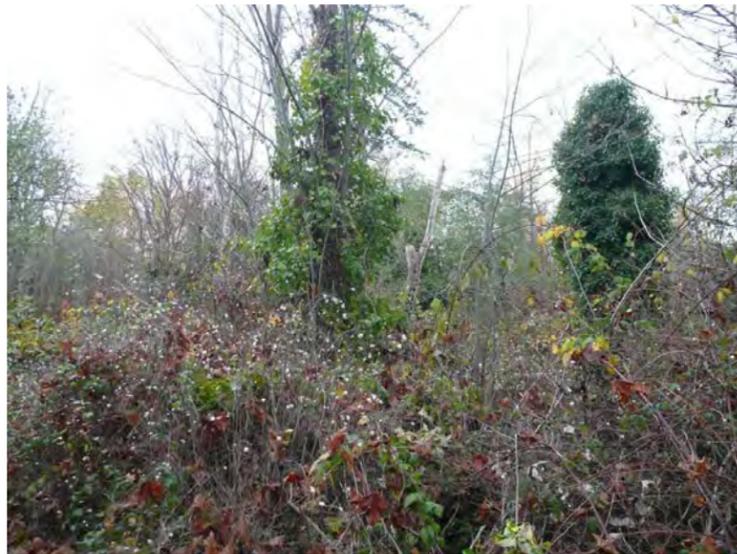
Plate 58: ivy covered trees and blackberry mixed with native vegetation. This is in the area where the forested section of Reach 15C joins with Reach 15B.

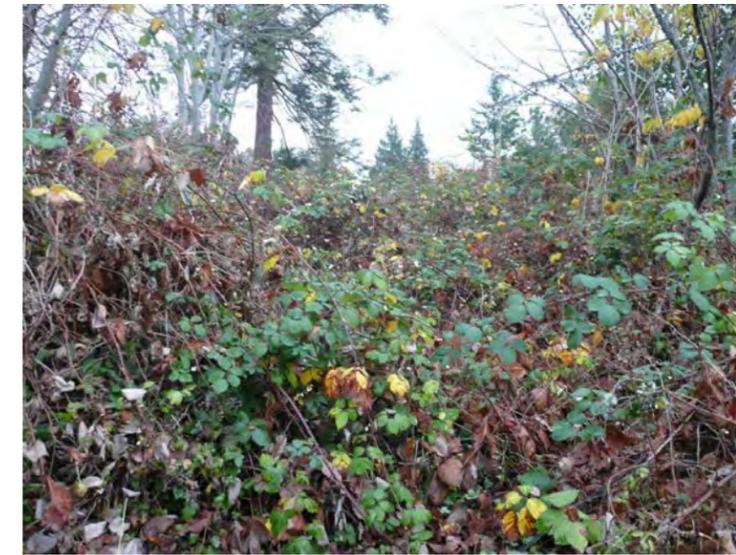
Plate 59: Some pure blackberry patches (in the area of confluence between Reach 15B and 15C, close to the Fraser Building parking lot) are obvious targets for invasive species control

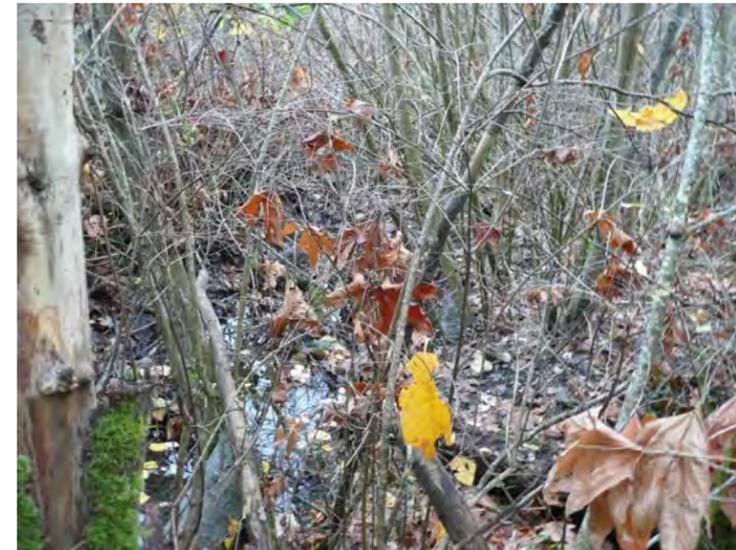
Plate 60: Much of the channel in Reach 15B and the forested area of Reach 15C is impenetrable and inaccessible, and its course has not been accurately mapped.

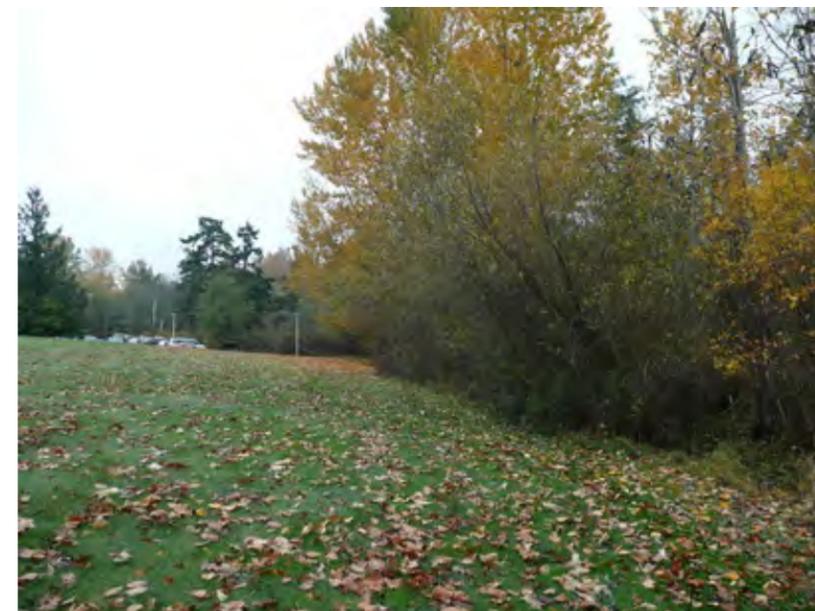
Plate 61: Reach 15C, Section A, has no apparent barriers to restoration. The main restoration action is to increase the width of the riparian buffer.

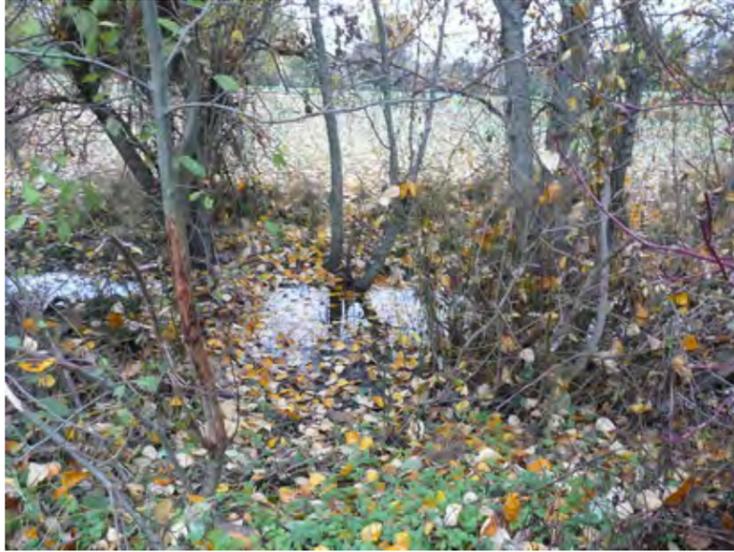
Plate 62: The riparian buffer is quite narrow in some locations, due to mowing near to the creek edge.

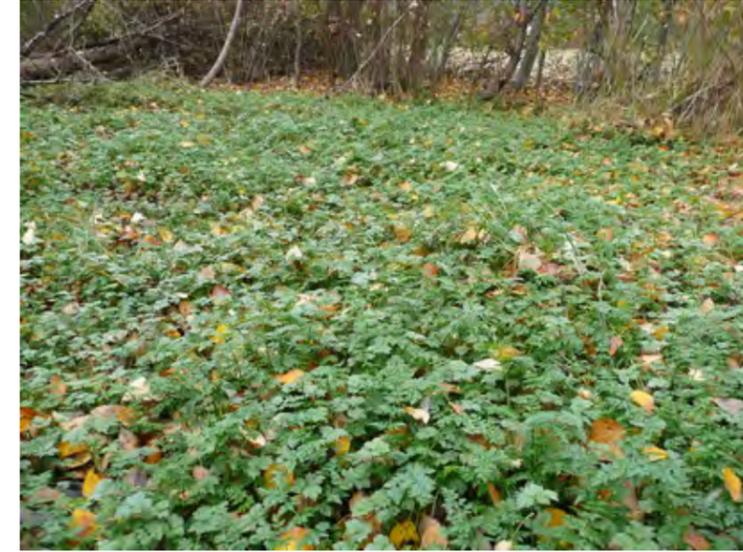
Plate 64: Invasive buttercup occupies a significant area, in some cases mixed with pacific water parsley.

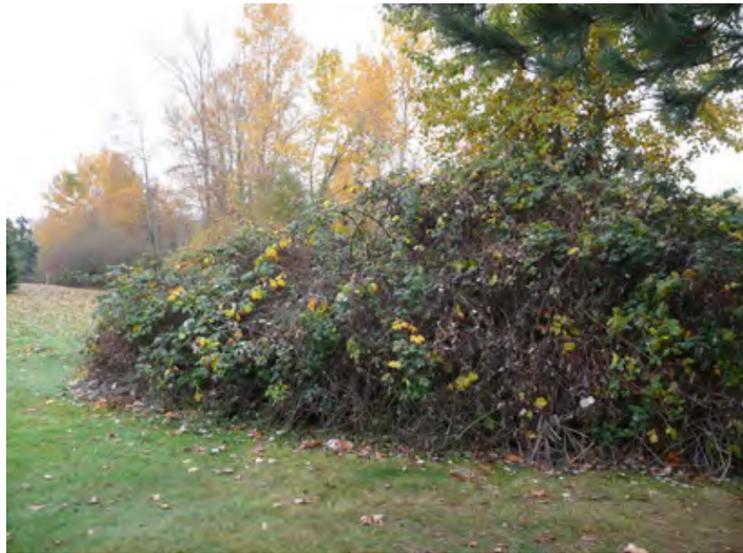
Plate 63: Looking south down Reach 15C (Section A). Stormwater (or groundwater) emerges from inside the blackberry patch to water the reach.

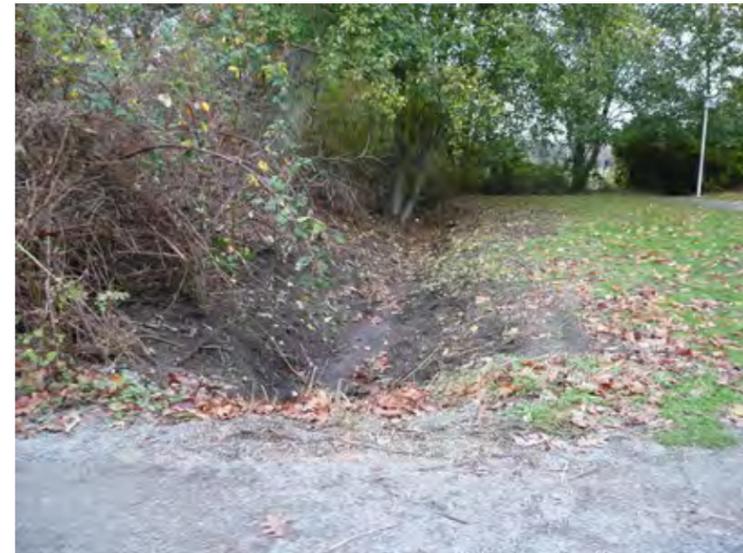
Plate 65: Runoff comes from the Fraser parking lot and is delivered to the channel both overland and through this ditch.

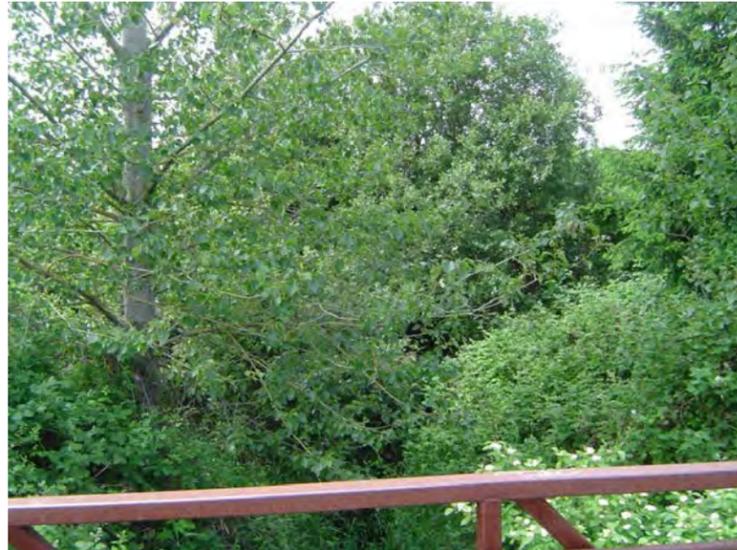
Plate 67: Reach 17A downstream view from footbridge several years after removal of blackberry
