Bowker Creek Watershed

Proper Functioning Condition Assessment

May 2007

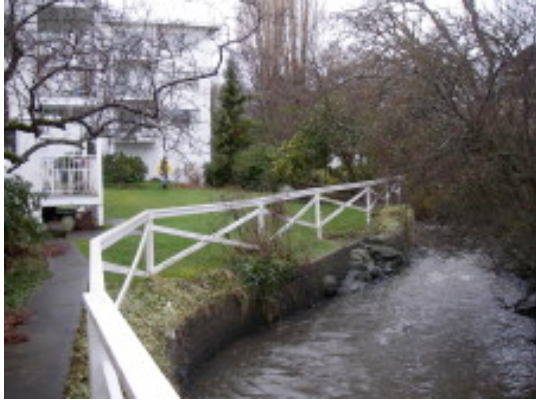
Reach 1, Photo 1, 2007-01-19. Bowker Creek – Residential area next to stream. Reach 1 has concrete lined walls and stream bed throughout.

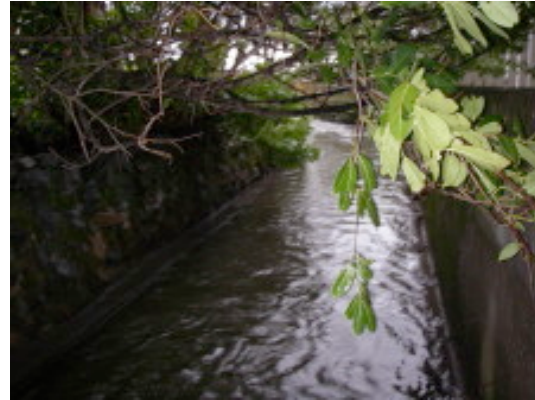
Reach 1, Photo 2, 2007-01-19. Bowker Creek – Concrete lined walls and stream bed downstream of Beach Drive culvert.

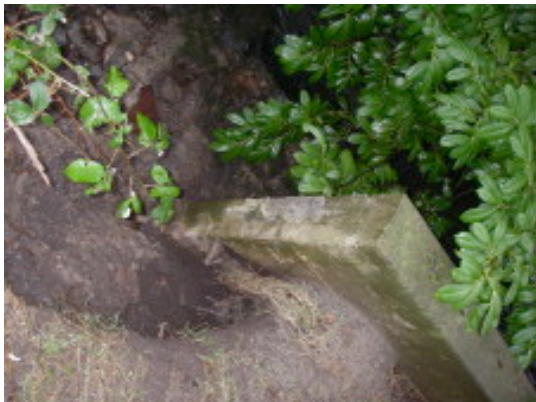
Reach 1, Photo 3, 2007-01-19. Bowker Creek - Water is eroding soil behind concrete wall.

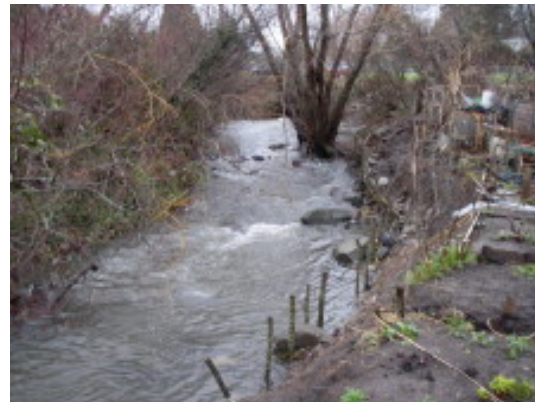
Reach 2, Photo 4, 2007-01-19. Bowker Creek – Allotment Gardens. Stream bank erosion due to trampling and high flows.

In the community gardens, invasive species control should be implemented, the bioengineering project should be repaired, and riparian vegetation re-established.

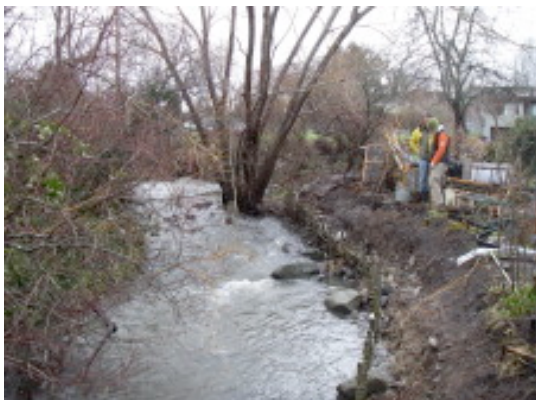
Reach 2, Photo 5, 2007-01-19. Bowker Creek – Allotment Gardens. Stream bank erosion due to trampling and high flows.

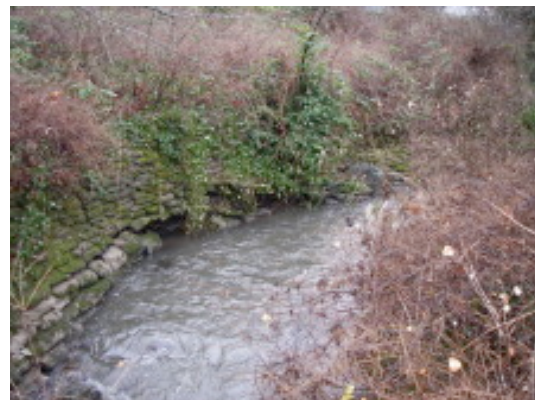
Reach 2, Photo 6, 2007-01-19. Bowker Creek – Allotment Gardens. Erosion of Concrete wall.

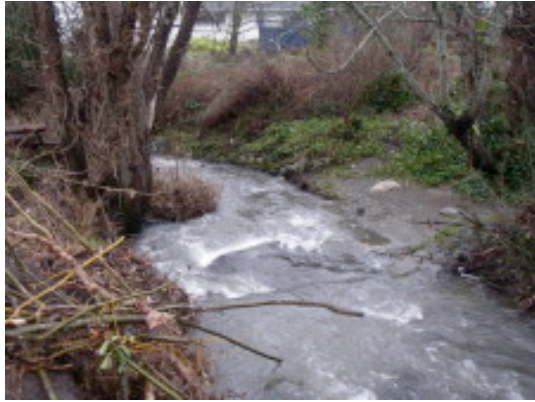
Reach 2, Photo 7, 2007-01-19. Bowker Creek – Allotment Gardens. Side bar formation occurring due to deposition and erosion.

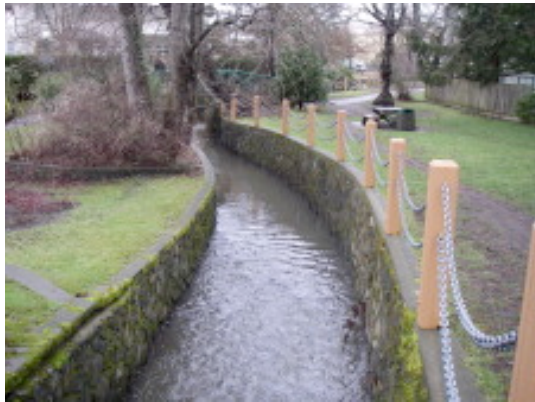
Reach 3, Photo 9, 2007-01-19. Bowker Creek – Urban Park, channelized and hardened in place.

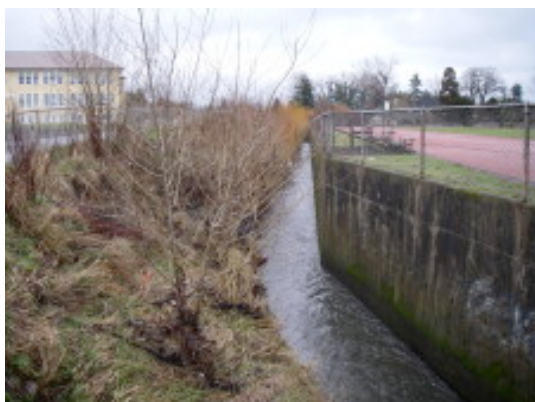
Reach 4, Photo 11, 2007-01-19. Bowker Creek – Oak Bay High School. One armoured side opposite to a steep vegetated side.

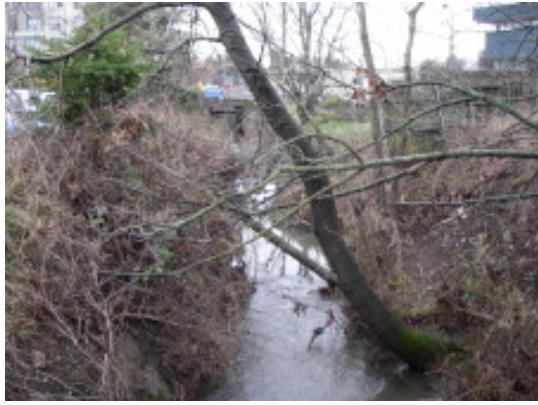
Reach 5, Photo 13, 2007-01-19. Bowker Creek – Oak Bay Recreation Centre. Site is heavily inundated with stormwater run-off due to surrounding impervious surfaces.

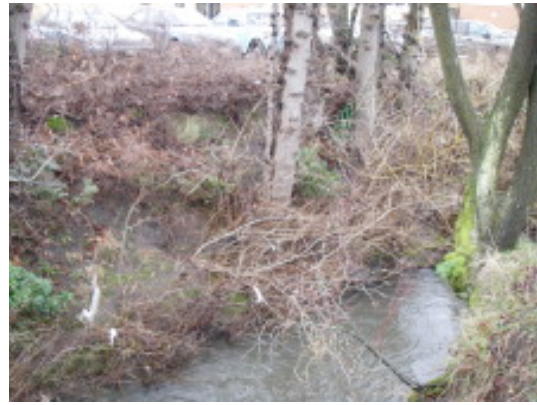
Reach 5, Photo 14, 2007-01-19. Bowker Creek – Oak Bay Recreation Centre. Notable erosion of banks due to high flows and lack of adequate vegetation.

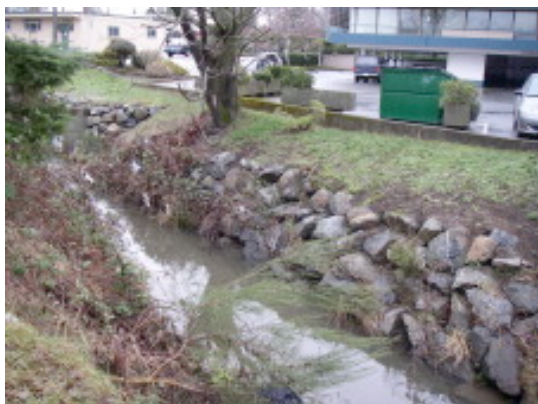
Reach 5, Photo 15, 2007-01-19. Bowker Creek – Oak Bay Recreation Centre. Further down the reach the downstream left-hand side is heavily armored.

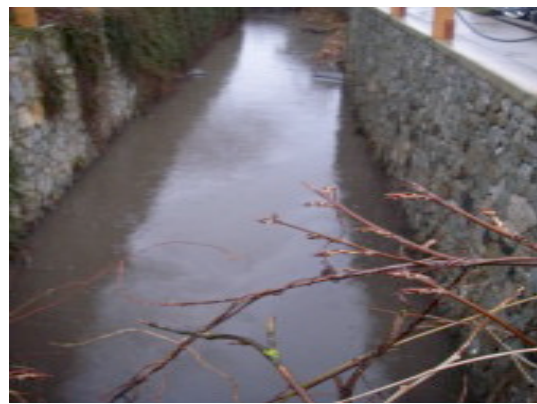
Reach 6, Photo 16, 2007-01-22. Bowker Creek – Bee Street. This reach is entirely armoured throughout.

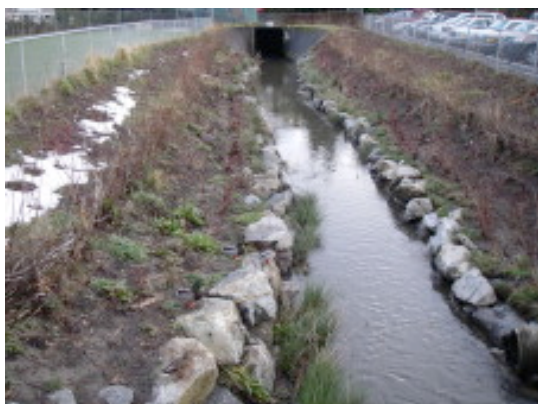
Reach 7, Photo 17, 2007-01-19. Bowker Creek - St. Patrick's Catholic School. Restoration of this part of the reach has occurred with recent terracing of banks and bioengineering.

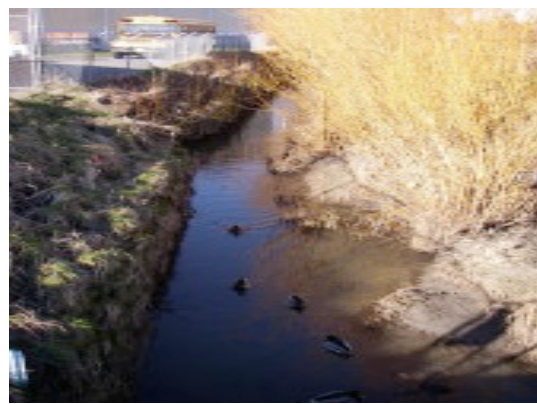
Reach 7, Photo 18, 2007-01-27. Bowker Creek - St. Patrick's Catholic School. Bio-engineering has occurred on the downstream left-hand side. Erosion and deposition occurring throughout reach.

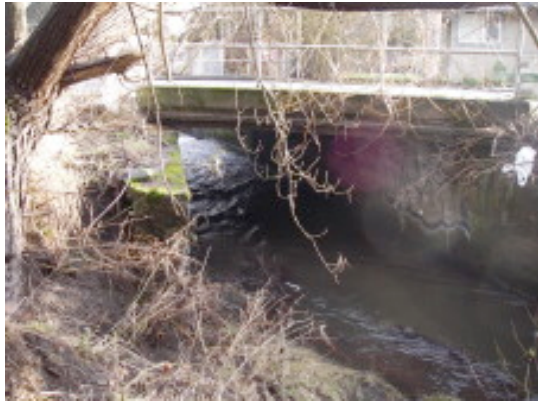
Reach 8, Photo 19, 2007-01-19. Bowker Creek – BC Hydro Lot. Due to high flows, water has eroded soil from behind the culvert wall.

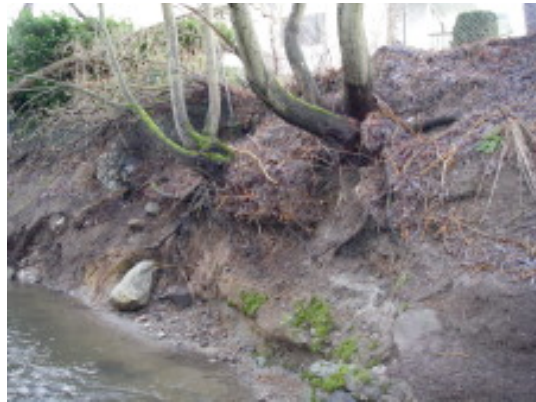
Reach 8, Photo 20, 2007-01-19. Bowker Creek – BC Hydro Lot. Extensive down cutting and bank erosion leaving tree roots exposed and unable to armor the banks.

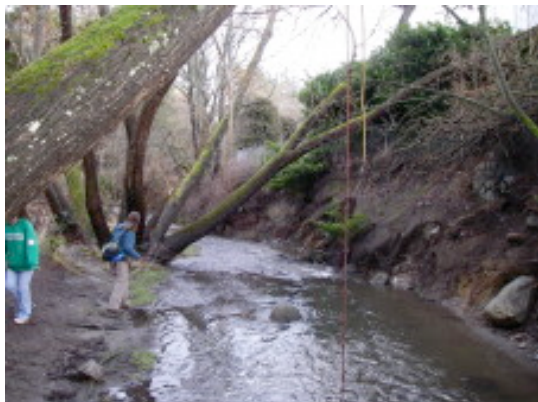
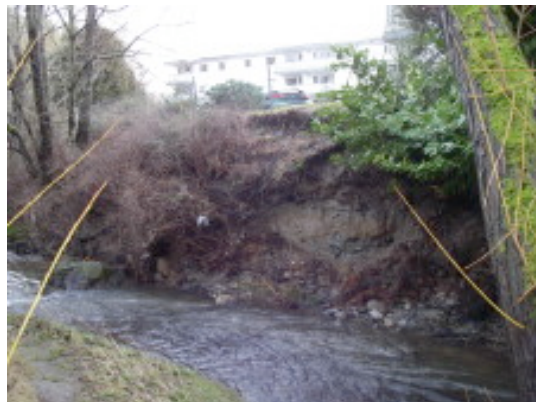
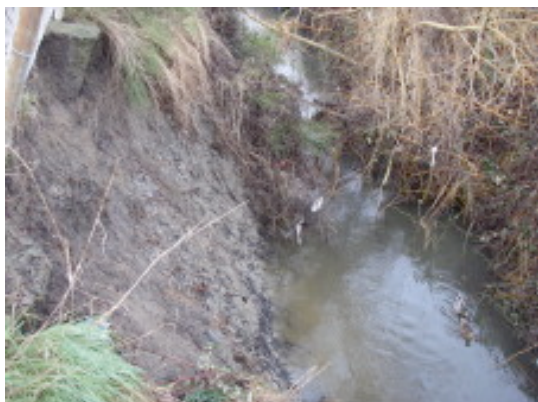
Reach 8, Photo 21, 2007-01-19. Bowker Creek – BC Hydro Lot. Bank erosion and slumping.

Reach 8, Photo 22, 2007-01-19. Bowker Creek – BC Hydro Lot. Bank erosion and slumping.

Reach 8, Photo 23, 2007-01-19. Bowker Creek – BC Hydro Lot. Bank erosion and slumping.

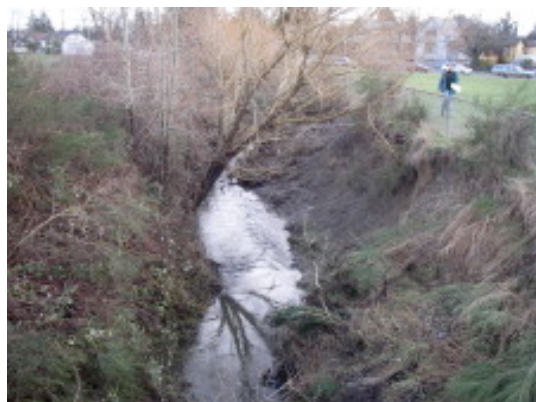
Reach 9, Photo 24, 2007-01-19. Bowker Creek – Richmond Elementary. Vertical erosion occurring within stream banks due to high flows and the lack of available floodplain.

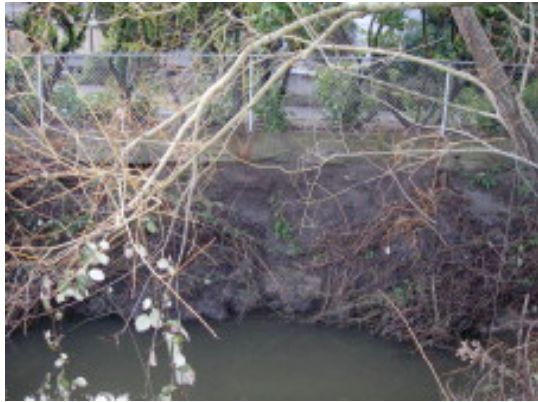
Reach 9, Photo 25, 2007-01-19. Bowker Creek – Richmond Elementary. Erosion occurring within stream banks now undercutting fence.

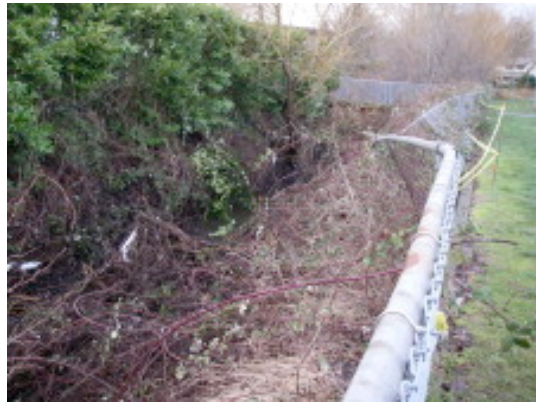
Reach 9, Photo 26, 2007-01-19. Bowker Creek – Richmond Elementary. Due to unstable banks, the fence is losing ground and will soon fall into the creek.

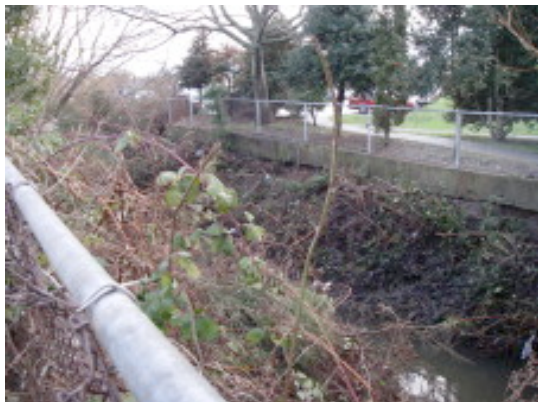
Reach 9, Photo 27, 2007-01-19. Bowker Creek – Richmond Elementary. Unstable banks are weakening the concrete and fence structure above.

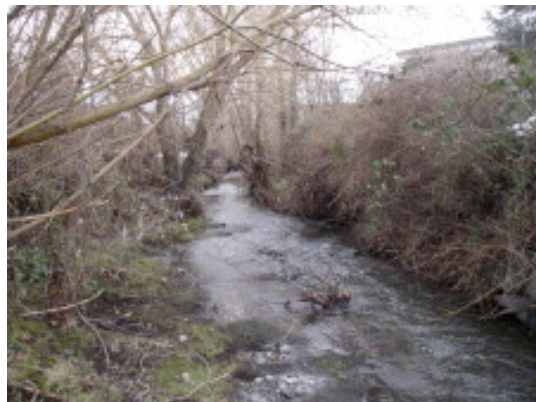
Reach 10, Photo 28, 2007-01-19. Bowker Creek – North Dairy Road. Considerable erosion on the outside bend and gabbions, due to inadequate vegetation and width/depth ratio of channel.

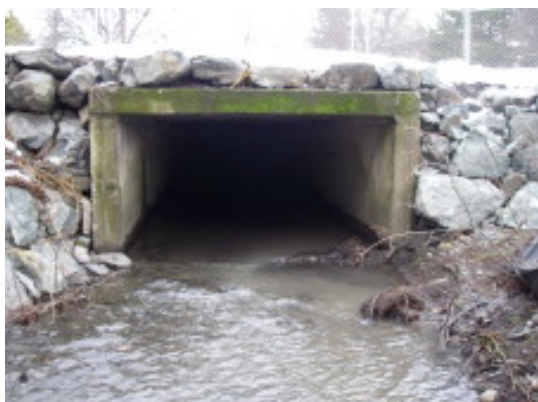
Reach 10, Photo 29, 2007-01-17. Bowker Creek – North Dairy Road. Area was recently repaired. A homeowner's driveway was falling into the creek due to unstable banks within the reach.

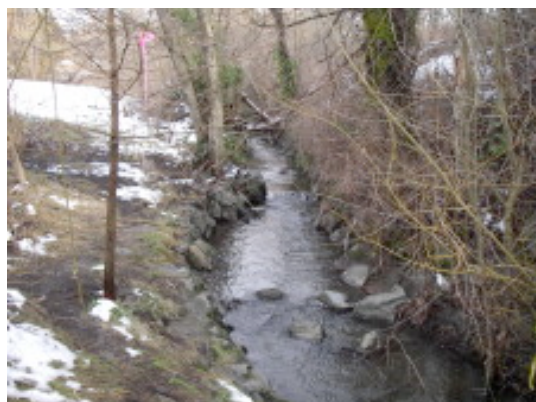
Reach 11, Photo 30, 2007-01-17. Bowker Creek – Browning Park. Reach is armored with concrete and rock. Some flood plain is available, but the system requires more riparian vegetation.

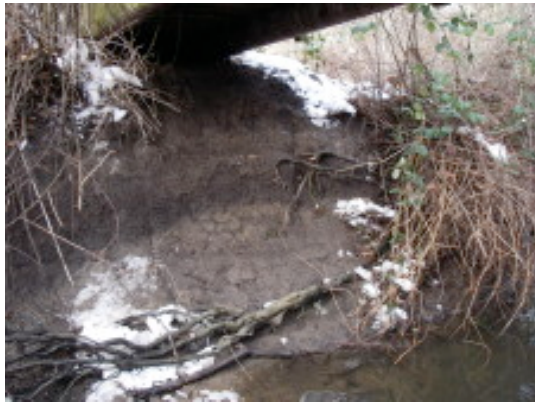
Reach 11, Photo 31, 2007-01-17. Bowker Creek –Browning Park. Notable erosion underneath bridge due to no riparian vegetation.

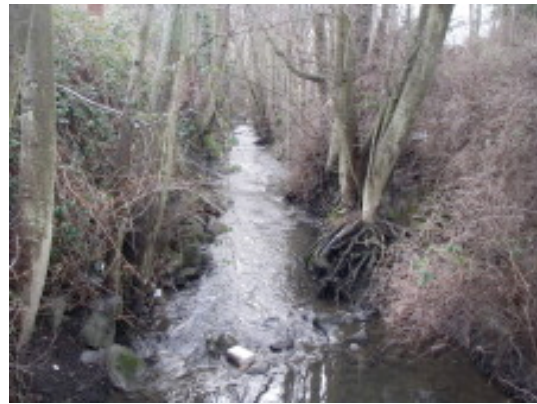
Reach 11, Photo 32, 2007-01-17. Bowker Creek Browning Park. Some erosion of banks have left tree roots unable to armor streambanks.

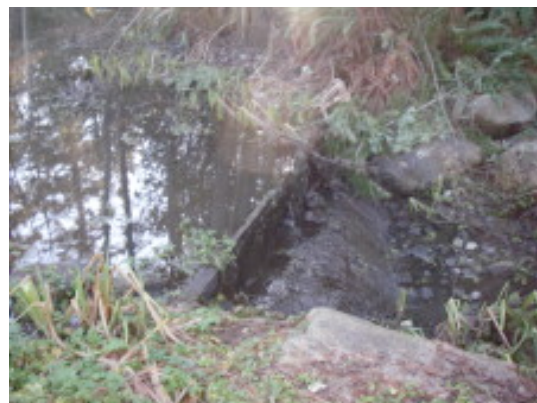
Reach 12, Photo 36, 2007-01-27. Bowker Creek – University of Victoria Pond – Weir below artificial pond is failing due to wood rot.

Riparian vegetation around the perimeter of the pond should be increased and the complexity improved by adding large wood. The stop log on the outlet weir is rotting and should be replaced immediately.

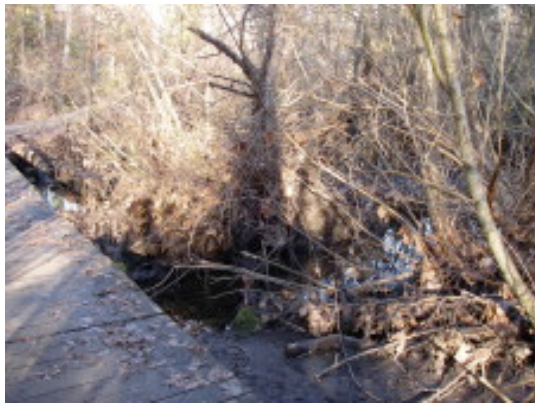
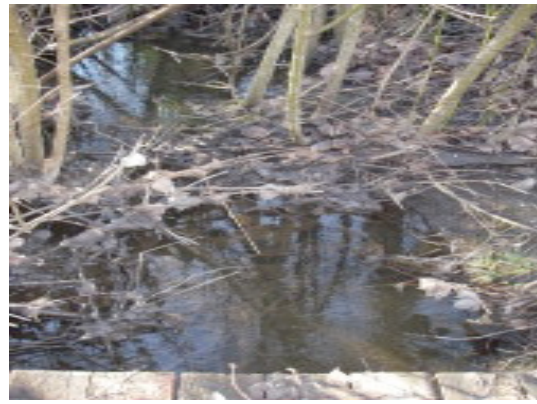
Reach 13, Photo 37, 2007-01-27. Bowker Creek – University of Victoria (University (Faculty) Club to UVic Road). Notable amount of sediment within system.

Reach 13, Photo 38, 2007-01-27. Bowker Creek – University of Victoria (University Club to UVic Road). Notable amount of sediment within system.

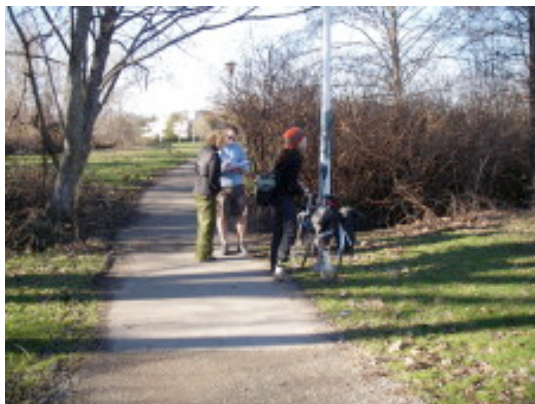
Reach 14, Photo 39, 2007-01-27. Bowker Creek – University of Victoria Tributary (McKenzie Avenue). Bridge and path that should be removed and appropriately sized to the system.

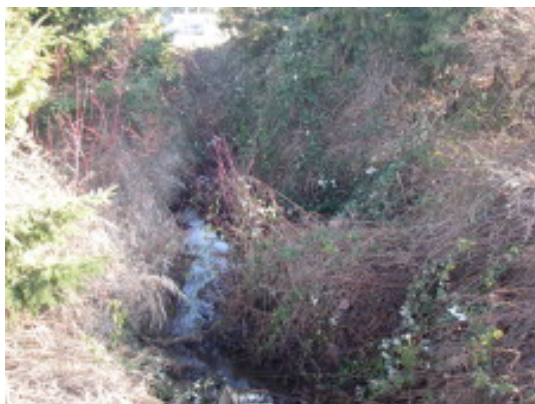
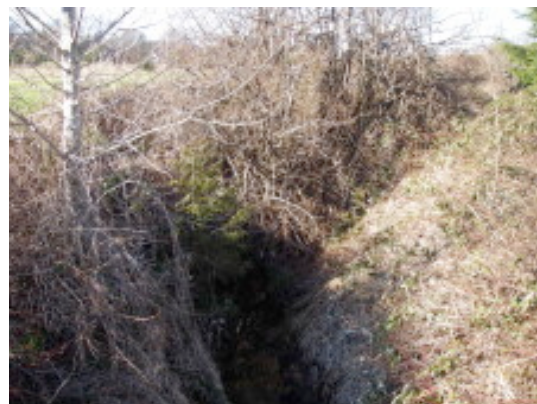
Reach 15, Photo 41, 2007-01-27. Bowker Creek – Tributary (Cedar Hill) - Deep channel with large amounts of reed canary grass – facing downstream of bridge

Reach 15, Photo 42, 2007-01-27. Bowker Creek – Tributary (Cedar Hill) - Deep channel with large amounts of reed canary grass – facing upstream of bridge.

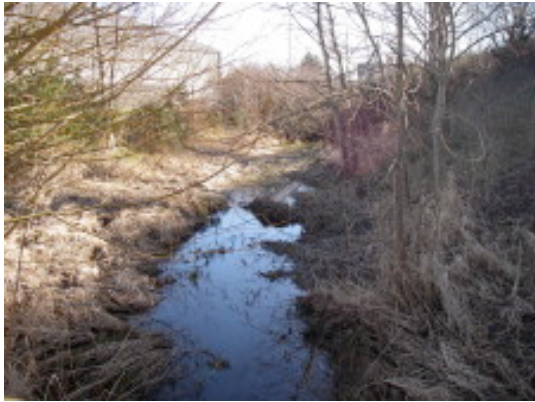
Reach 16, Photo 43, 2007-01-27. Bowker Creek – Tributary (Cedar Hill) – Area is endowed with reed canary grass. Some floodplain is available (seen here).
