BOWKER CREEK WATERSHED ASSESSMENT

October 6, 2000

Project No. 19071-01-3

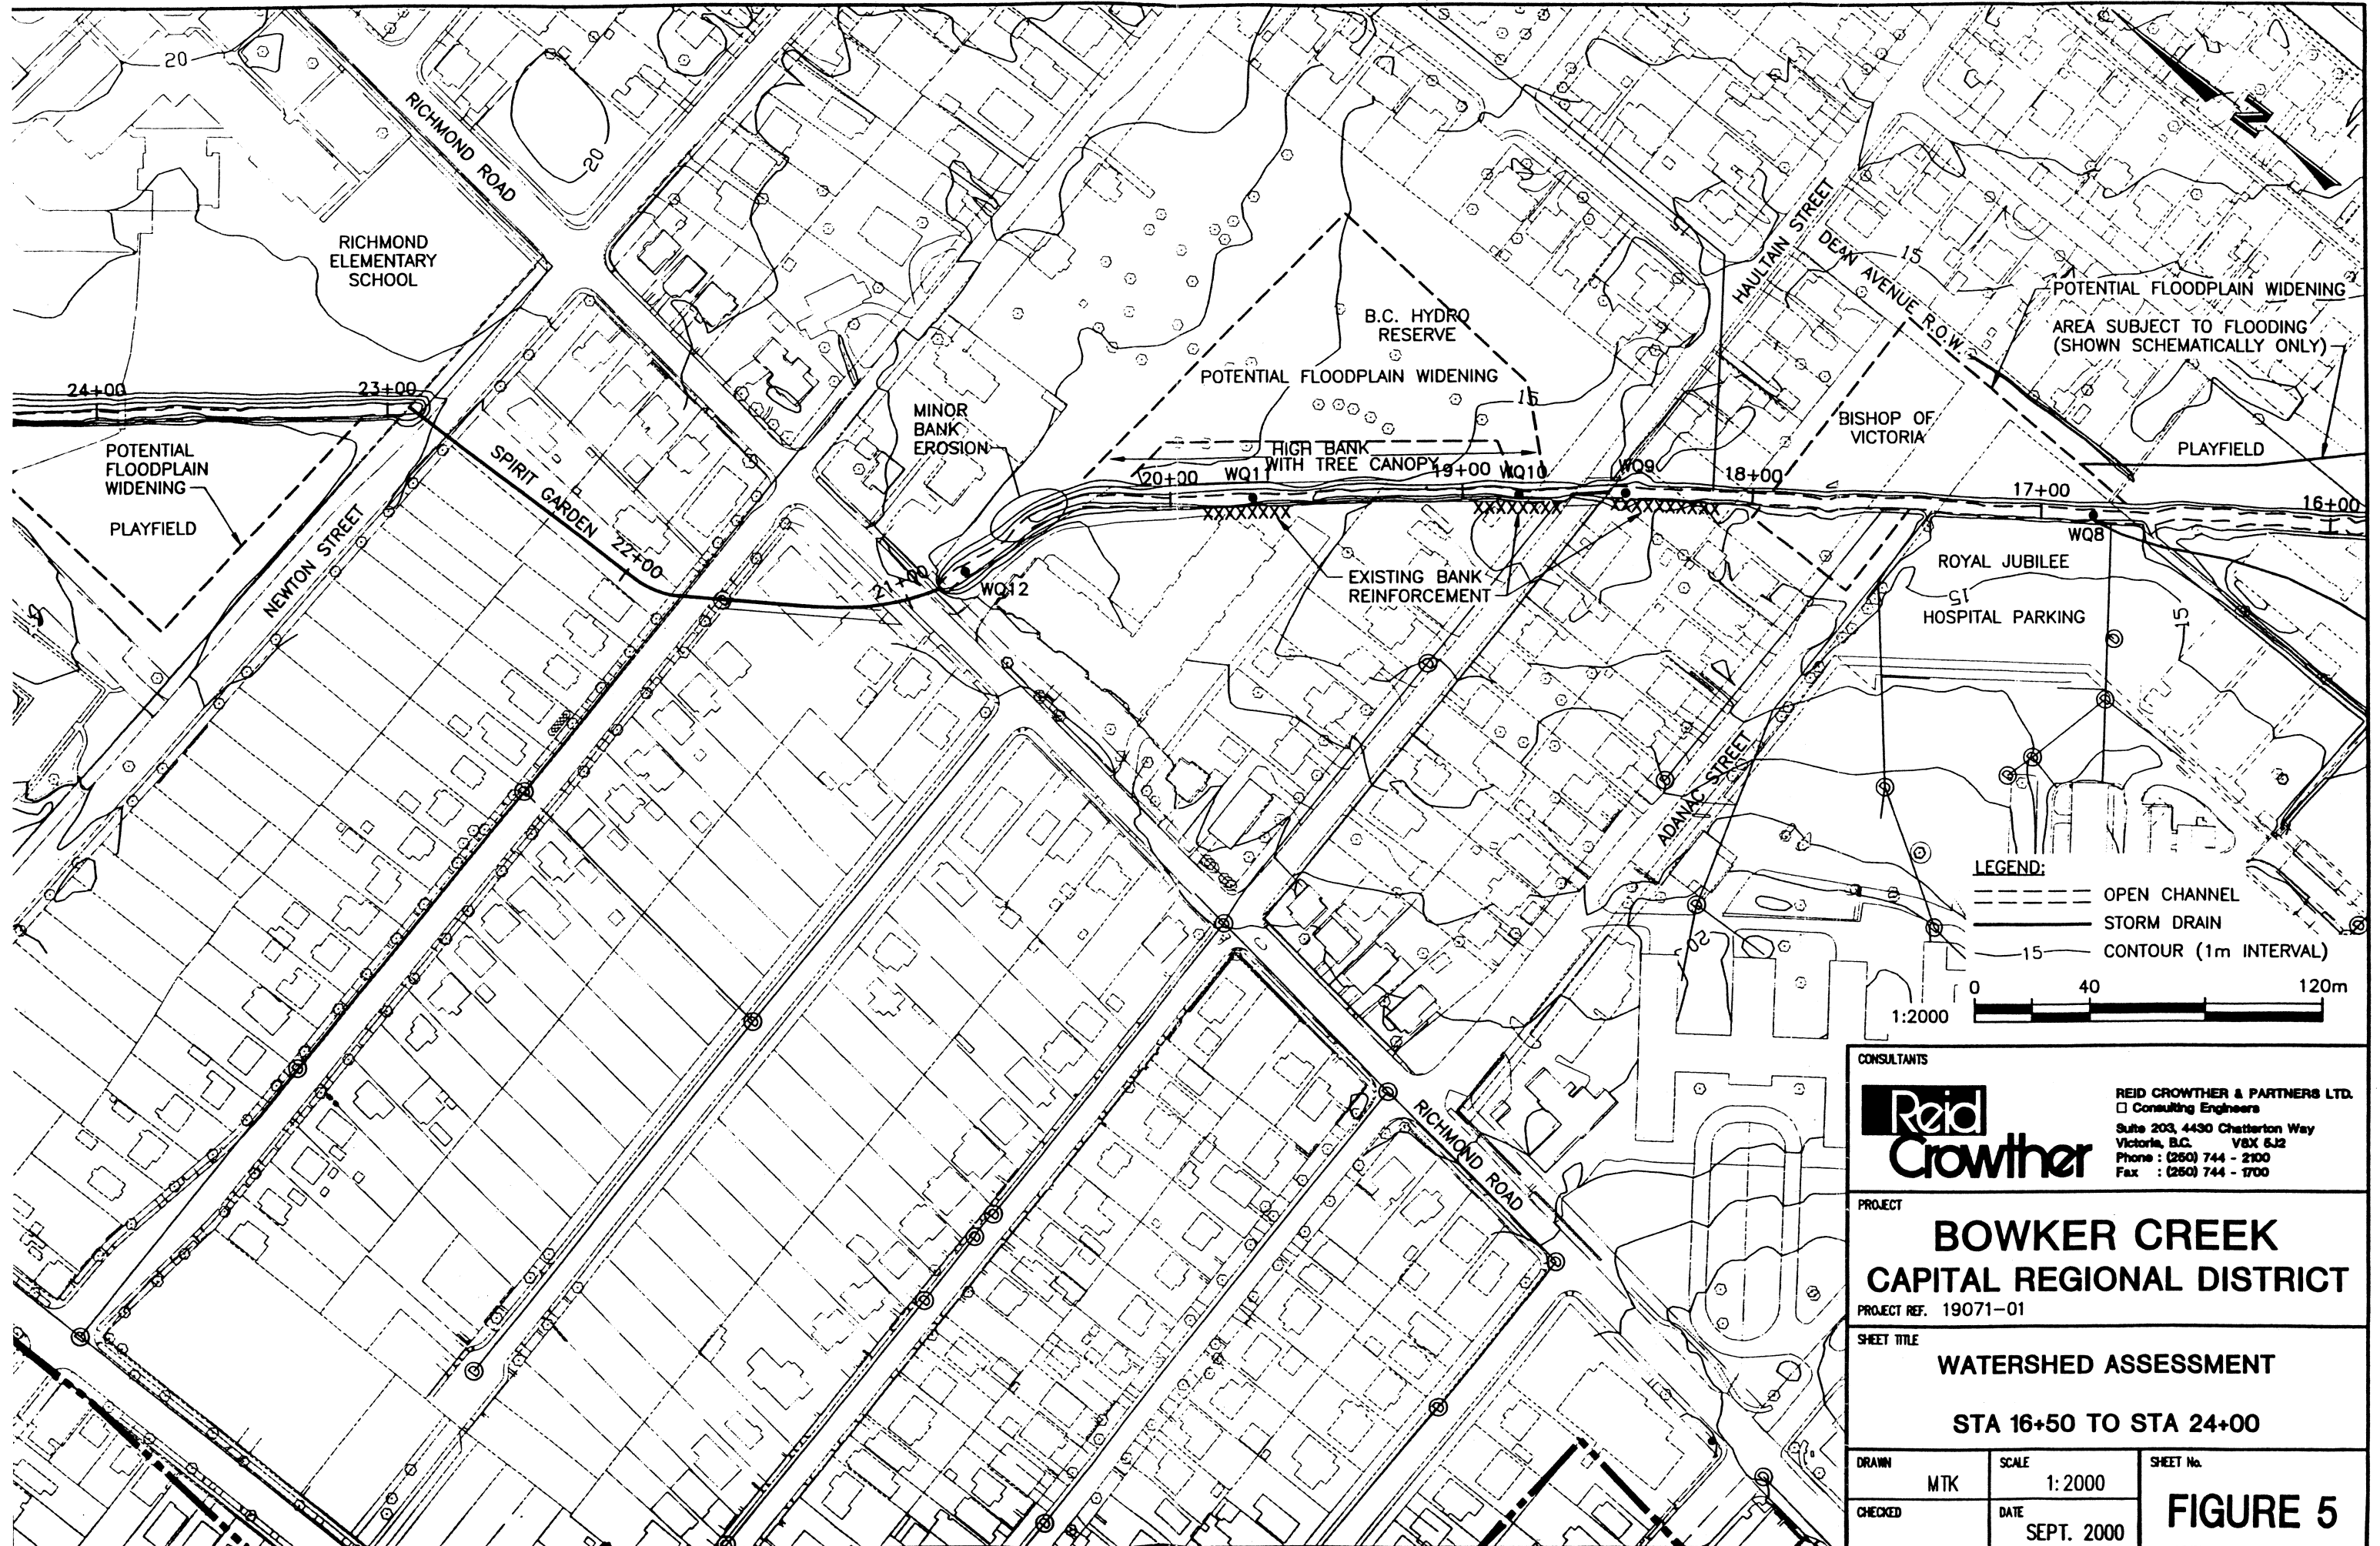
Figure 5 illustrates a location for potential floodplain widening on vacant property at the east end of the Adanac Street right of way. If 1.5 m depth of flood storage could be developed in this area the volume would be approximately 8000 m³, or approximately one-half the potential storage on Uvic property at Gordon Head Road. This is a relatively small volume compared to the storm runoff volume but would nevertheless improve conditions by a small amount. The BC Hydro reserve, north of Haultain Street (**Figure 5**) may also be suitable for floodplain widening but the bank appears to be higher in this reach and excavation volumes would be greater. Also a well established tree canopy exists along the creek in this property, thus making it more difficult to establish floodplain widening. Despite the perceived need to retain the tree canopy, it may still be possible to create 8000 m³ of storage assuming a storage depth of 1.5 m. Other potential floodplain widening sites around Richmond Elementary School and Townley Street (**Figures 5 and 6**) could provide perhaps 2 m of storage for a volume of 11,000 m³; again a relatively small volume, but significant. The costs for such a facility would be mainly excavation and landscaping. Small potential floodplain widening sites exist on the Wordsworth Street right of way and within Browning Park (**Figure 7**). A new detention pond was constructed on the Cedar Hill Golf Course in 1999. It provides 1000 m³ of storage (**Figure 8**). The potential 16,000 m³ detention pond on Uvic property near Gordon Head Road is shown on **Figure 9**.
