Colquitz River Watershed

Proper Functioning Condition Assessment

July 2009

The District of Saanich

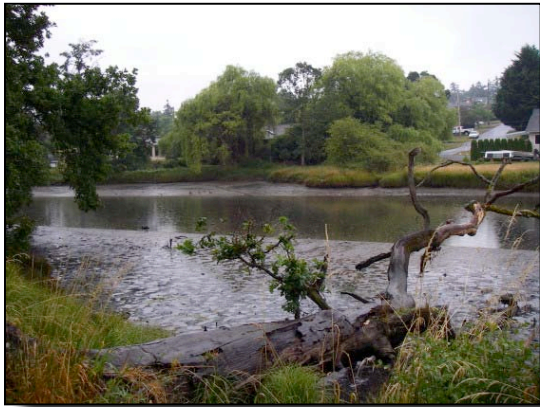
Reach 1 is approximately 1,066m long and consists of a salt marsh with marine influence from Portage Inlet. The right bank of Colquitz River, within Cuthbert Holmes Park, is well-vegetated with primarily native vegetation. A tributary enters the Colquitz River from the north along this bank and is easily visible from the headland just off the main park path. This tributary flows from a wet meadow depression on the north side of the Trans Canada Highway at McKenzie Avenue. The left hand bank, from Admirals Road bridge until the first footbridge in Cuthbert Holmes Park, consists of mostly

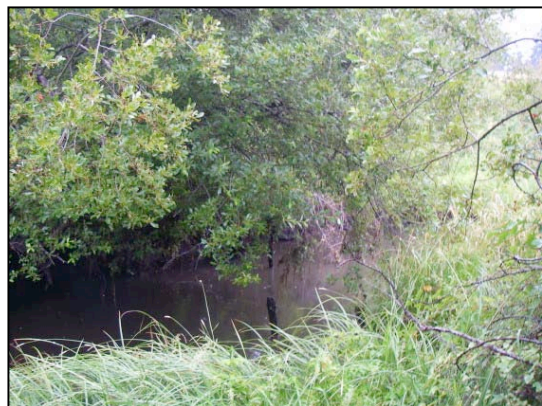
Reach 2 is approximately 814m long and is within a portion of the Colquitz River linear park. This channel extends from where the creek narrows upstream of the second footbridge in Cuthbert Holmes Park, past Tillicum Mall, under Burnside Rd. ending beneath the first span of the Trans Canada Highway bridge. Reach 2 is much narrower than reach 1 and is tidally influenced only for a short section at the downstream end (a transition zone). A gravel path is located on the left bank of Colquitz River, and a portion of it (adjacent to the movie theatre) is known to flood

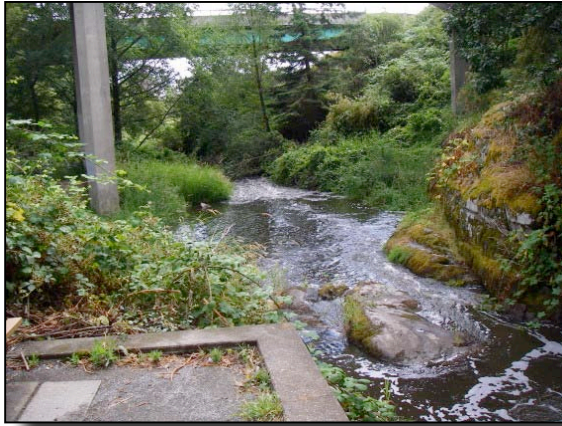
Reach 3 is approximately 155m long and extends from the Trans Canada Highway bridge upstream to the end of the southernmost boardwalk footbridge in the linear park alongside Interurban Road. There is a concrete weir located in the lower portion of the reach directly beneath the Trans Canada highway bridge. Its function is to control water flow and dissipate energy by creating a small pool upstream. An unreadable staff gauge is visible in the middle of the channel further upstream under the second span of the Trans Canada highway bridge (gauge should be replaced).

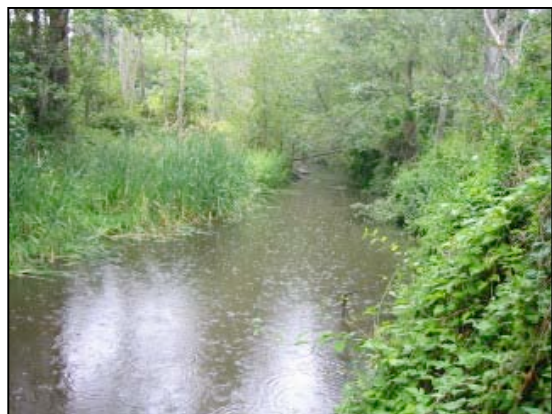
Reach 4 is approximately 145m long. It extends from the end of the southernmost boardwalk footbridge across from the large Douglas fir (*Pseudotsuga menziesii*) to the north end of the northernmost boardwalk bridge at the stand of red alder (*Alnus rubra*) and non-native poplar (*Populus sp.*). On the left bank, this reach is bordered by Interurban Road and on the right, the Pacific Forestry Center and some residential properties. The creek is no longer contained within a steep bedrock channel; instead, the channel is composed of cobble-boulder overlaying clay with interspersed bedrock outcrops. The slope is approximately 2-4% and

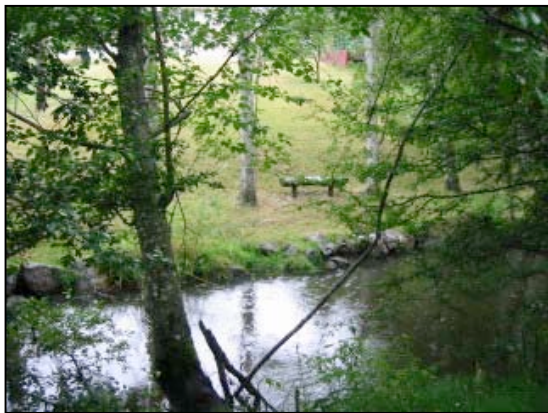
Reach 5 is approximately 297 m long and extends from the end of the second boardwalk footbridge to where the creek narrows again just upstream of the cement platforms and the overhead walkway. A small channel, that may act as an overflow channel is located near the downstream end of the reach. The creek appears to have achieved its potential floodplain extent. Facing downstream, a residential community is located on the steep right bank whereas the left bank is bordered by the park trail and, beyond that, Interurban Rd.

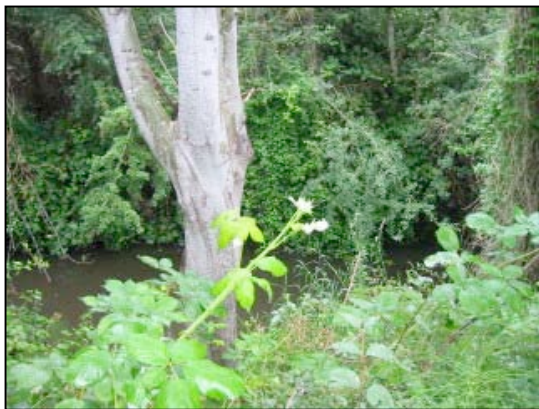
Reach 6 is approximately 343 m long and extends from where the creek narrows into a deep gully upstream of the overhead footbridge, underneath the McKenzie Road overpass to the Interurban Road bridge that crosses Colquitz River. The banks are steep and the creek is located down at the bottom of a gully. The Rosgen channel type is a “G6c” as it is gully-shaped, and has a slope of less than 1%. The stream bank is densely vegetated and is well protected from damaging activities such as trampling. The extent of erosion was difficult to determine due to dense vegetation and difficult

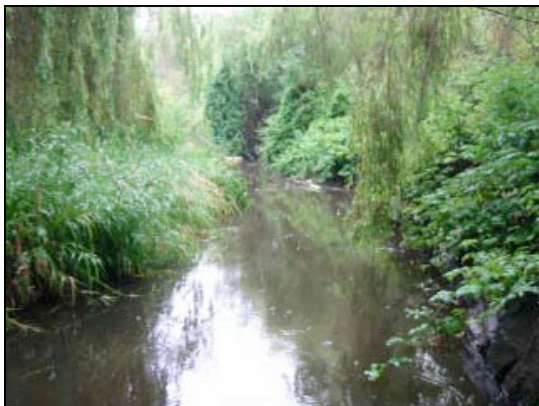
Reach 7 is approximately 450 m long. It runs from the Interurban Rd. bridge crossing, through a picnic area, under Violet Avenue through a culvert with a weir, under Marigold Avenue bridge and ends in Hyacinth Park near the playground.

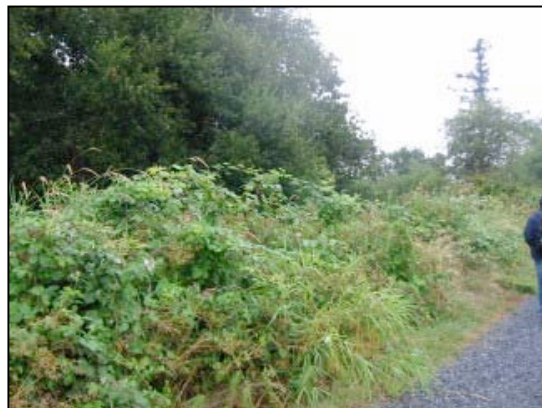
Reach 8 is approximately 1374 m long and extends from the weeping willow across from the playground in Hyacinth Park, through Panama Flats, to the Roy Road bridge. The channel type is a ditch and is located on the west side of Panama Flats. Panama Flats floods annually during the winter months due to overflow from the Colquitz River. The historical wetland was drained for agriculture and thus flood waters tend to cover the entire field for weeks to several months of the winter. The hydrological storage effected by this flooding is important for downstream flood

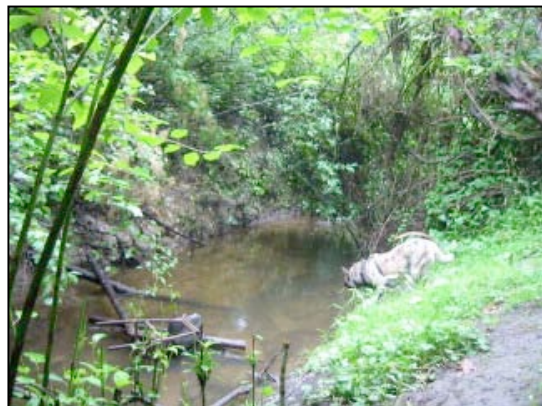
Reach 9 is approximately 1809 m long. The reach begins at the Roy Road Bridge, passes through an open field of vegetation on Saanich Park land, and extends through Copley Park ending downstream of the playground in Rosee Grove (Vanalman Avenue). Single-family detached homes surround the park.

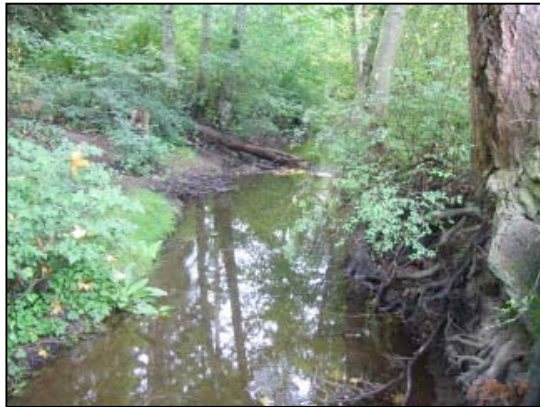
Reach 10a is approximately 944 m long and extends from Rosee Grove, upstream through park and residential areas, to the point where the channel narrows, just off Lindsay Road. Upstream from the playground in Rosee Grove a footbridge crosses the Colquitz River. Trampling in this location has severely reduced the amount of vegetation within this riparian area. There is little variation in species or age class within this reach. A similar age class of species creates a large risk as there is no successional growth to replace populations that die. It is especially concerning in

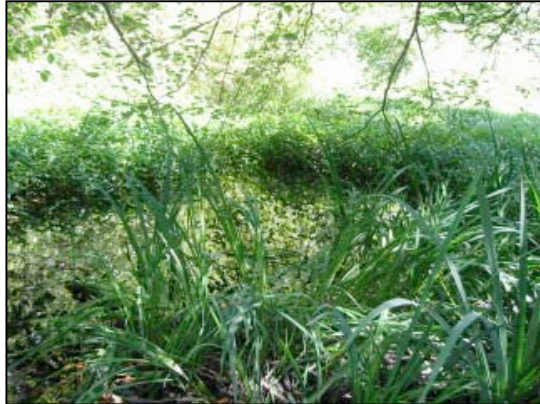
Reach 10b is approximately 0.047 hectares. It is a wetland found near Vanalman Avenue and Northridge Crescent just upstream of the green footbridge in Reach 10. The wetland is surrounded on the edges by English ivy (*Hedera helix*) and Himalayan blackberry (*Rubus armeniacus*). The wetland is protected from wind and is small enough that it does not experience wave events. The riparian-wetland vegetative community is vigorous and consists of species such as Pacific water-parsley (*Oenanthe sarmentosa*), red alder (*Alnus rubra*), smartweed (*Polygonum spp.*), and

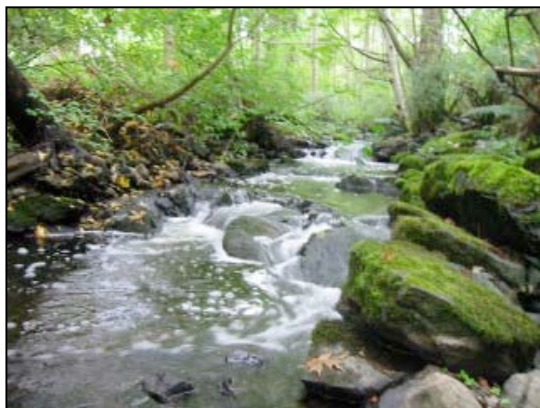
Reach 11 is approximately 191 m long, beginning at the trail that connects to Lindsay Road extending to the bridge at 4444 Wilkinson Road. With the exception of one large residential lawn area, this reach is quite heavily vegetated throughout. This is likely due to surrounding park and paths that are a considerable distance from the creek. Adjacent to the lawn extending to the edge of the right bank, numerous fish were observed in a rocky pool; given their size (>15 cm long), some may have been cutthroat trout. There was very little erosion observed throughout the reach as the

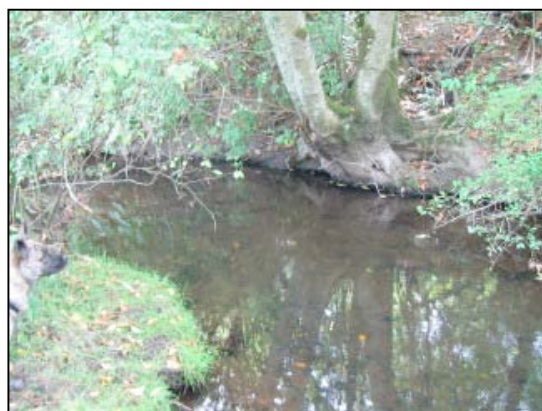
Reach 12 is approximately 229 m long extending from the bridge at 4444 Wilkinson Road through residential property to the footbridge at the entrance to Quick's Bottom. This section of Colquitz River is armoured on the left bank immediately upstream of the bridge by a rock wall up to the bend in the channel. Past this corner, the left bank is no longer armoured and contains a small section of accessible floodplain on 4450 Wilkinson Road property. While the right bank of this reach is initially unarmoured, upstream of the bend a wood piling wall holds this bank in place.

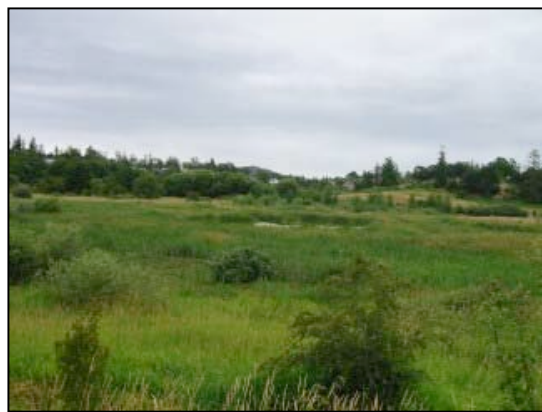
Reach 13: Quick's Bottom

Reach 13 is an approximately 18.8 ha wetland located south of West Saanich Road between Wilkinson and Markham Roads. This area is a designated park space within the Municipality of Saanich and as such is protected and in good condition. Restoration efforts have been conducted in the past to improve fish passage through this area (discussed in Reach 14).

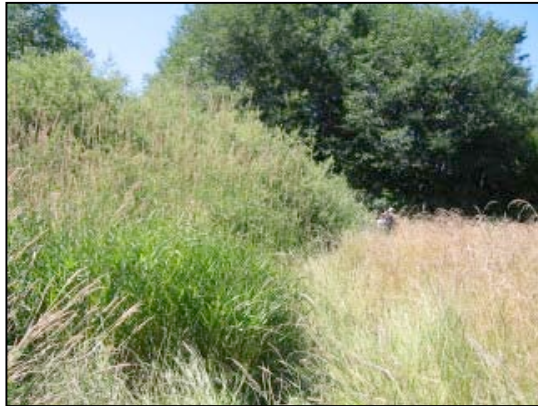
Reach 14 is approximately 810 m long and begins at the pedestrian bridge within Quick's Bottom and extends to the footbridge located on the property of John Oliver (4654 West Saanich Road). Prior work and restoration has been completed on this reach. Between 2000 and 2004, Saanich Parks re-aligned the ditch through the east side of Quick's Bottom wetland, removed the reed canary grass and restored the channel morphology. At the time, the plan was to place additional large woody material into the channel as well as plant various riparian and deciduous/coniferous species.

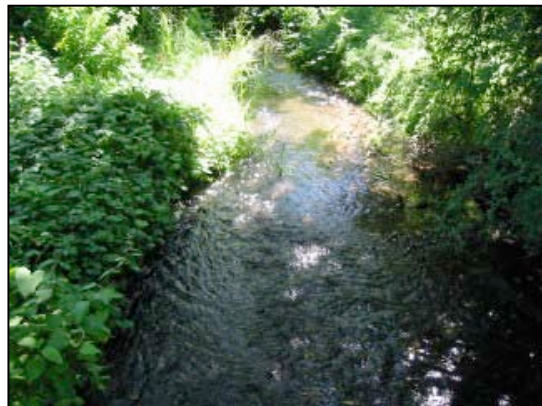
Reach 15 is approximately 300 m long and extends upstream from the footbridge located on the property of John Oliver (4654 West Saanich Road) to the West Saanich Road bridge. The reach is in fair condition with insignificant erosion evident within the reach. This is in part due to the available floodplain, and the two weirs that function to dissipate energy during high velocity flows. One weir is a rock weir downstream of the West Saanich Road Bridge and the other is a wooden weir located underneath the pedestrian bridge at 4654 West Saanich Road. The Rosgen

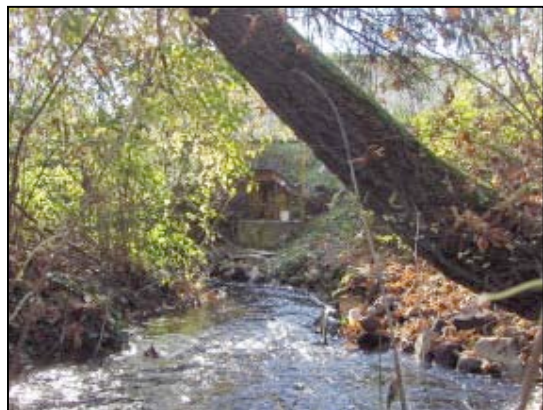
Reach 16 is approximately 156 m long and extends from West Saanich Road, upstream to the middle of the property at 4521 Cheeseman Road (where the slope increases near the dead cedar tree and rock outcrop between two stumps). A sheep paddock borders the creek on the right bank, but is separated from the creek by a fence and a dense thicket of Himalayan blackberry (*Rubus armeniacus*). Alongside the residential properties, there are a number of small trails and trampled areas leading down to the creek. There is a notable amount of garbage (*i.e.* beer cans, concrete slabs, etc.) that has

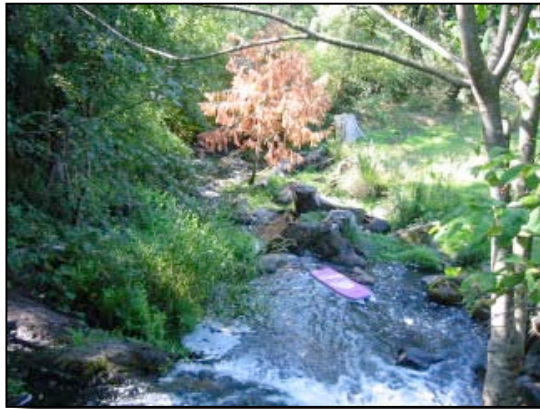
Reach 17 is approximately 93 m long and extends from 4521 Cheeseman Road, through a residential property (4525 Cheeseman Road) to a waterfall located upstream of a shallow pond. In this reach, the right bank, looking downstream, is armoured with a rock wall with 30 m of the upstream portion of the reach having no riparian vegetation. Instead, throughout this un-vegetated portion, lawns are found bordering the edge of the right bank. Evidence of erosion is apparent along these banks. Conversely, the left bank, looking downstream, is densely vegetated and is, therefore, not eroding.

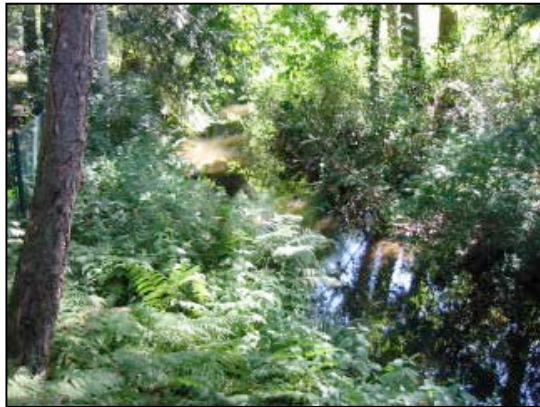
Reach 18 is approximately 100 m long and extends from the waterfall upstream of the pond at 4525 Cheeseman Road, through neighbouring residential properties and Saanich Park land to a cascade adjacent to an old cottage at 4650 Pipeline Road. Throughout this reach, the Colquitz River is entrenched with a vertical, heavily eroding and bare left bank. A mid channel bar is present downstream of the eroding bank, indicating sediment deposition either from the upper watershed or from the eroding bank. The channel material is dominated by clay banks with some

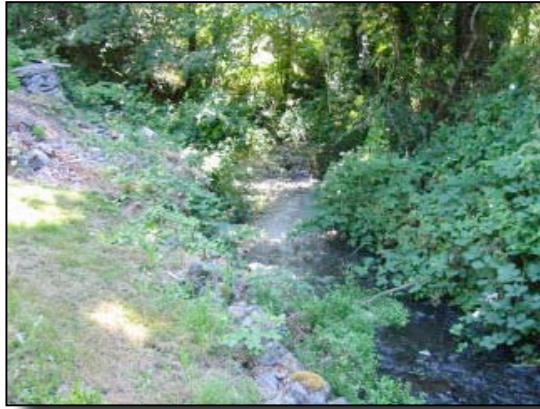
Reach 19 is approximately 25 m long and extends from the riffle or cascade adjacent to the old cottage on 4650 Pipeline Road, to the upstream waterfall parallel with wire fencing at 4656 Pipeline Road. The right bank is densely covered with invasive species, particularly Himalayan blackberry (*Rubus armeniacus*). The left bank is composed of lawn that extends to the water's edge in locations where there are no existing bedrock outcrops. Garden waste was found piled at the wetted perimeter. There are two small waterfalls in this reach, one at the start and one at the end. The

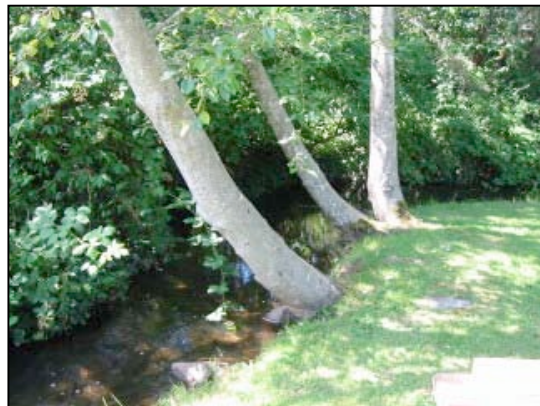
Reach 20 is approximately 168 m long and extends from the waterfall with a wire fence at 4656 Pipeline Road under the Goyette Road bridge through a residential area to the riffle area just upstream of 4674 Pipeline Road. Downstream of the Goyette Road bridge, the left bank consists of manicured lawns to the water's edge, while the right bank (looking downstream) is dominated by Himalayan blackberry (*Rubus armeniacus*). Upstream of the bridge, the right bank (looking downstream) consists of manicured lawns right to the water's edge, while the left bank is bare except

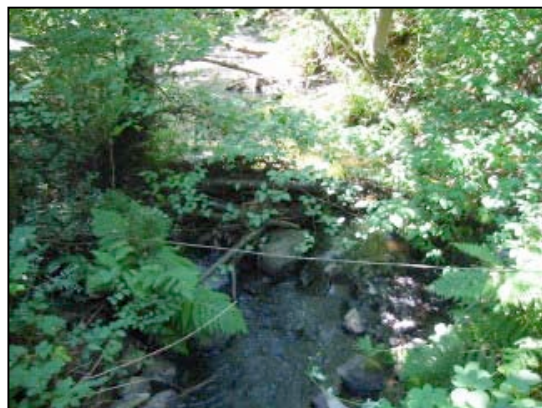
Reach 21 is approximately 136 m long and extends from the riffle just upstream of the property line for 4674 Pipeline Road, upstream along Pipeline trail within Elk/Beaver Lake Park to the second footbridge (which has a concrete weir located directly beneath it). Natural lateral movement of the channel is constrained by the pipeline and adjacent trail on the right hand bank. On the left bank (looking downstream) are sections of bedrock outcrop as well as silt/clay banks. The Rosgen channel type is a “Bc3” with bedrock intrusions. Historically, the Rosgen channel type

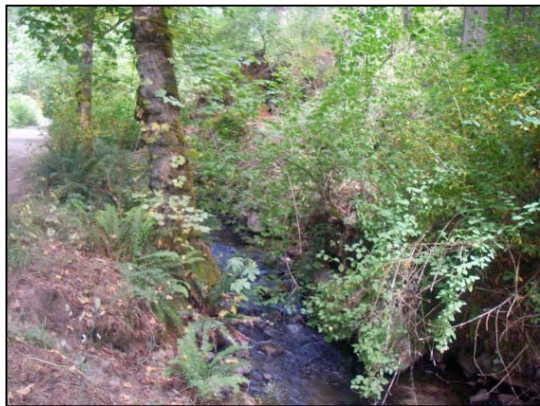
Reach 22 is approximately 403 m long and extends from the second footbridge along Pipeline Trail through a bedrock-lined channel to the outlet dam of Beaver Lake. This dam structure acts as a flow control point. An old steel riveted pipe, which was once used for supplying drinking water, runs the length of the channel with a park trail adjacent to the pipe. Walkers, joggers, equestrians, dogs, cyclists, and park maintenance crews use this popular trail. As in reach 21, the trail is currently widening due to trampling of vegetation. Near the upper end of this reach, horse trails continually

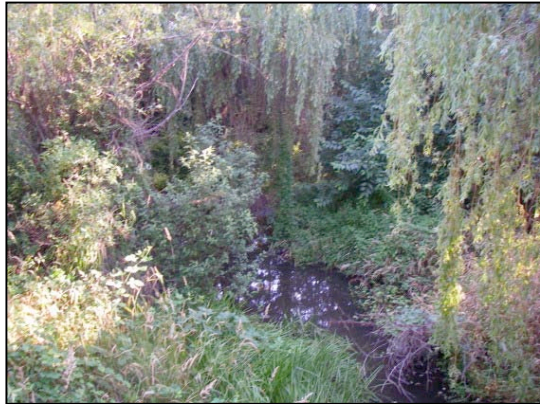
Reach 1 is approximately 61 m long and extends upstream of the Violet Avenue bridge crossing (where Swan Creek enters into Colquitz River), to a pipeline crossing adjacent to 763 Daisy Avenue where the channel becomes more gully-like. A public trail is located along the left bank while residential property is found on the right bank. The stream banks are composed of silt/clay substrate while the bottom of the channel contains a large amount of gravel. The presence of gravel may not be natural to the system, but it does affect the geomorphology of the creek and therefore the

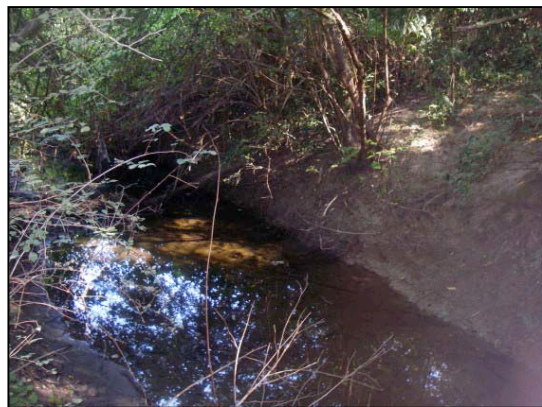
Reach 2 is approximately 490 m long. It extends from 763 Daisy Road where the channel becomes gully-like near 763 Daisy Road, through residential and park lands, to McKenzie Avenue, where the landscape opens up and the channel becomes more ditch-like downstream of the McKenzie Avenue overpass. This reach has steep, undercut, and eroding clay banks, consistent with a gully. In general, the clay banks are undercut and eroding due to scouring from high peak flows. Upstream of Daisy Road, the right bank is armoured with rip-rap while on the opposite bank,

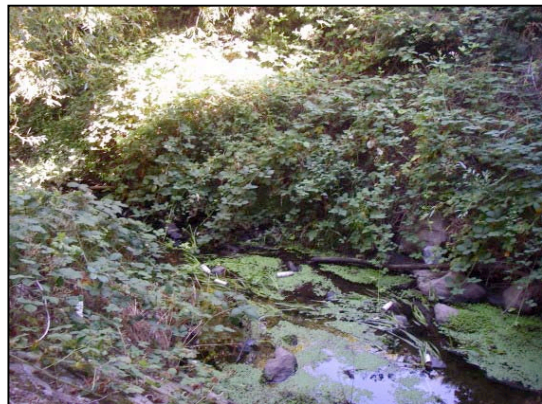
Reach 3 is approximately 54 m long and extends from the upstream end of the mountain biking area in Reach 2 to the willow across from the gravel path that intersects with the trail downstream of the McKenzie Avenue overpass (opposite 4008 Wiseton Street). The channel is composed of silt and clay and utilizes accessible floodplain. The narrow and deep characteristics of the channel are likely related to previous dredging that may have occurred during the overpass construction in the 1980's. As it is now, the Rosgen channel type is an "E6" with a low width/depth ratio. Spray paint

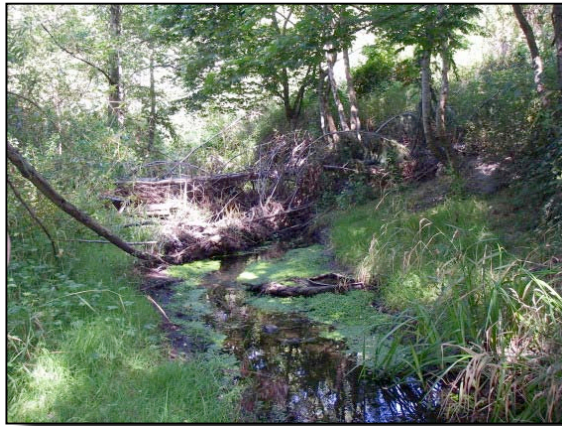
Reach 4 was previously excavated, is approximately 351 m long, and extends from the McKenzie Avenue overpass to downstream of Carey Road where the banks become armoured with rock. Within this reach, Saanich parkland lies on the left bank, and residential properties line the right bank. Underneath the McKenzie Avenue overpass, the banks are lined with rock walls preventing the growth of vegetation. Upstream of the McKenzie Avenue overpass, a small pipe crosses above the channel, whilst a nearby culvert discharges from the left bank. Further upstream, a large culvert with pipes

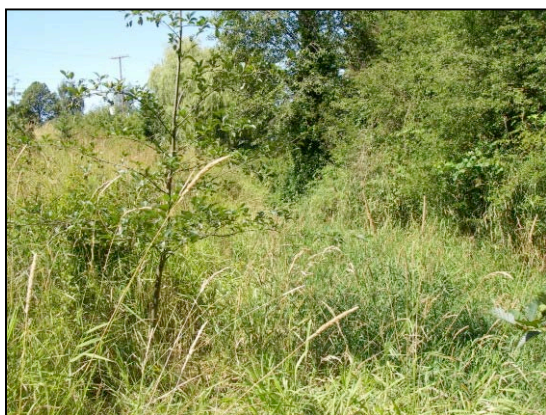
Reach 5 is approximately 361 m long and extends from just downstream of Carey Road alongside McKenzie Avenue, under McKenzie Avenue to the Glanford Road crossing. The channel has steep banks created from the fill for McKenzie Avenue and is constrained between McKenzie Avenue and Glanford Road. Upstream of Carey Road, residential lawns go right to the edge of the bank in some locations and ornamental plants are present. The present Rosgen channel type is a “B6” due to its sinuosity, width/depth ratio, and entrenchment conditions. The stream banks are vegetated but a floodplain is essentially non-existent, due, in part,

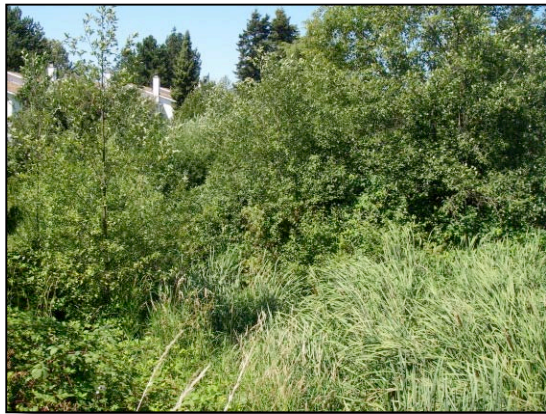
Reach 6 is approximately 292 m long, extending upstream from Glanford Road through a park area into a culvert underneath McKenzie Avenue. The section upstream of the first footbridge in the park was restored between 2000 and 2003. Restoration included development of the adjacent Willowbrook subdivision and stormwater ponds with a connecting outlet channel, as well as realignment of the creek and planting of native vegetation (Malmkvist, 2002). The channel was designed and constructed as a Rosgen “C6” channel type with a low gradient, moderate meanders, and accessible floodplains. The banks

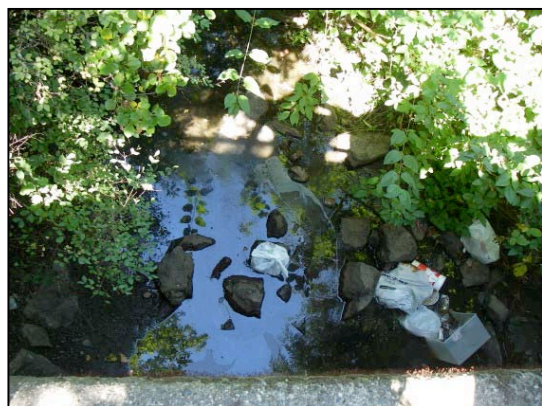
Reach 7 is approximately 367 m long, extending from the McKenzie Avenue culvert (perpendicular to the Willowbrook subdivision), upstream through park and residential areas to the pedestrian bridge crossing at Kent Road. To prevent flooding of neighbouring properties, frequent dredging has occurred throughout this reach, leaving this reach a ditch-like gully. The stream banks are overly steepened, and the reach lacks proper floodplain accessibility. Consequently, the Rosgen channel type is a ditched “Gc6”. The flow in the channel is nearly non-existent due to the low gradient of the

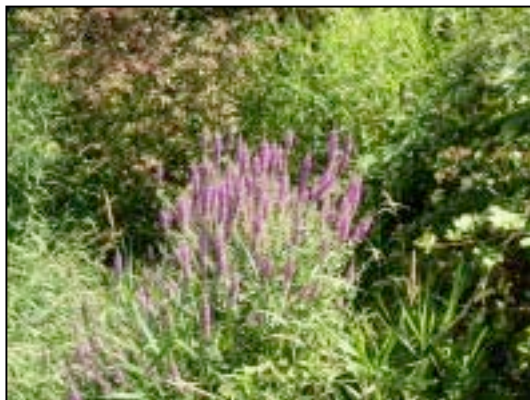
Reach 8 is approximately 353 m long and extends from the pedestrian bridge at Kent Road, through the Saanich Allotment Gardens to a culvert under the Patricia Bay Highway. This section of Swan Lake Creek has also been ditched, similar to Reach 7. At the downstream end between Kent Road and the allotment gardens, the banks are steep, bare in places and the floodplain cannot be accessed. In the upper portion of this reach, however, where it flows through the allotment gardens, flooding occurs every year. (This is perceived as socially undesirable, however, to the gardeners and a few

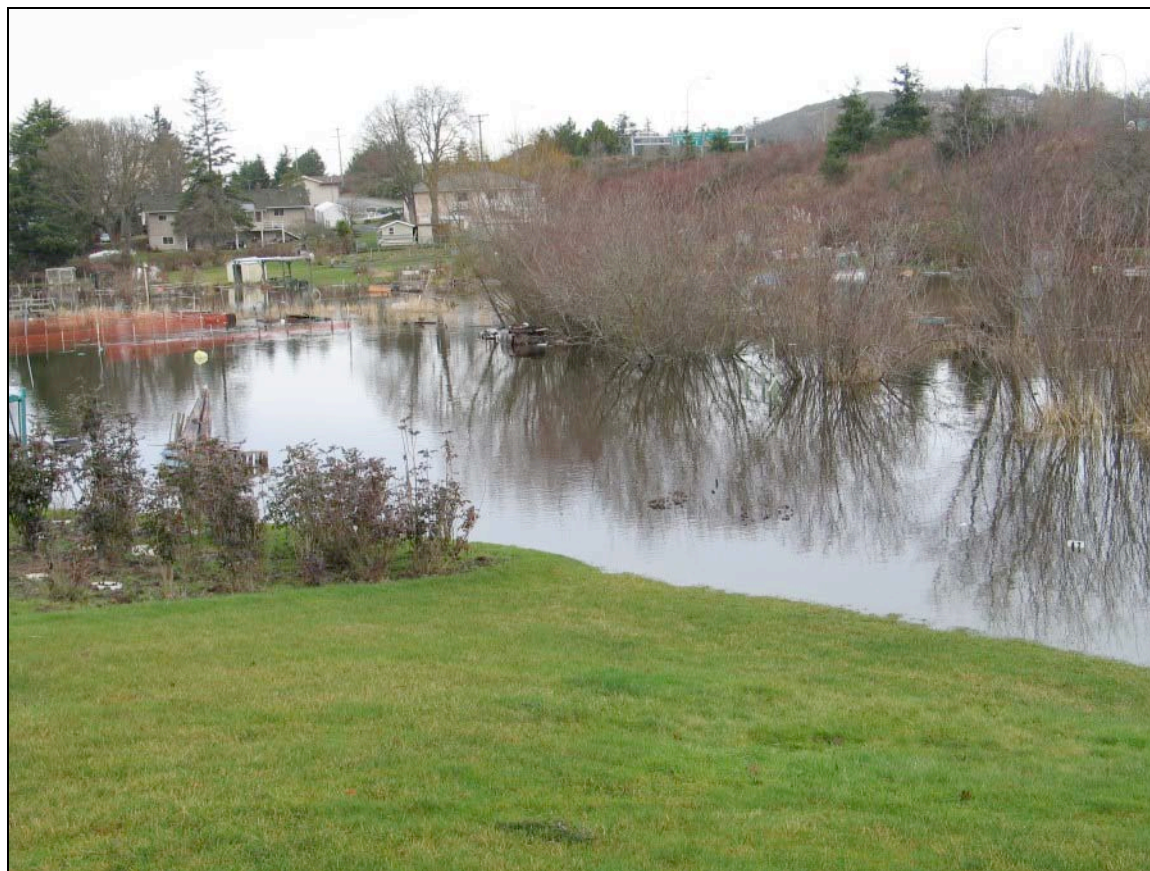
Figure 7. Portion of Reach 8 of Swan Creek when flooded, looking NW from near upstream end, January 6, 2007.

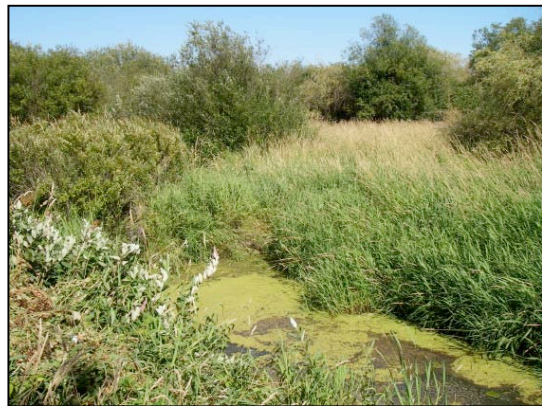
Reach 9 Swan Creek: Swan Lake

Reach 9 includes the outlet channel from Swan Lake to the Patricia Bay Highway as well as the lake itself. Swan Lake is 9.79 hectares in area and is located within the Swan Lake Christmas Hill Nature Sanctuary, which was formed in 1975. Land use around the lake prior to this (since the early 1900s) was primarily agricultural and residential. The wetlands surrounding the lake were cleared of native vegetation, probably in the 1910s, and were cultivated into the 1990s, mostly for hay. The outflow channel appears to have been dredged at least as recently as the late 1970s. The

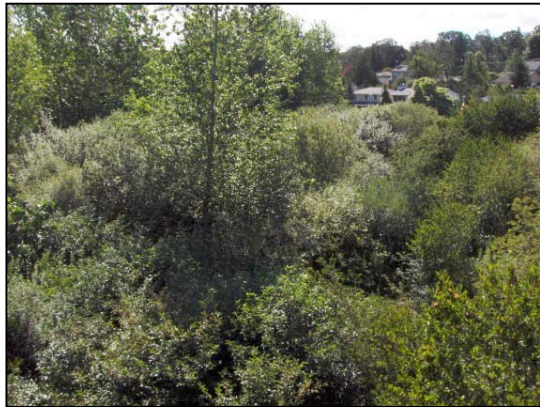
Reach 1 is approximately 296 m long and extends from the willow line at the inlet to Swan Lake, under Saanich Road, to a gully near the north end of the Lochside Trail trestle. The area downstream of the pedestrian bridge to the willow line was not examined in detail due to dense brush but is considered a continuation of the rest of the reach.

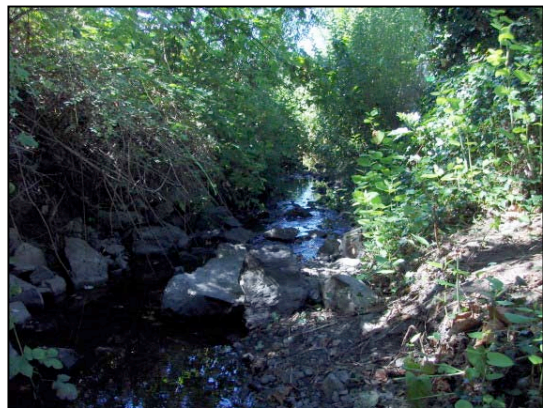
Reach 2 is approximately 249 m long and extends from the upstream end of Lochside Trail trestle alongside the trail to the box culvert downstream of Quadra Street. The channel in this reach consists of a bedrock gully, a width/depth ratio greater than 12% and a slope of roughly 2.5%. The Rosgen channel type is a “B2”. Very little floodplain is accessible as the channel is constrained by the old railway bed; however, what is present is sufficient for the channel type. Just upstream of the north end of the Lochside Trail trestle, both banks are armoured with rock and

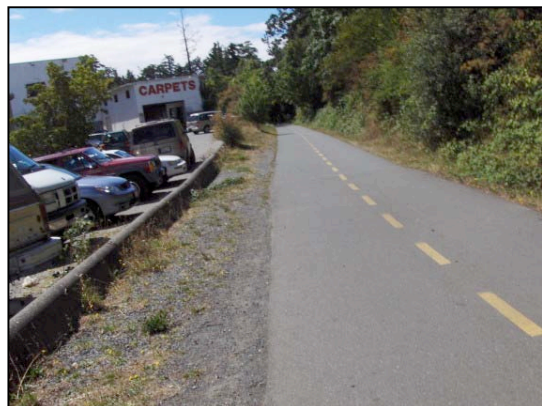
This reach was designated as a separate reach in order to discuss possible restoration opportunities that would arise if it were to be daylighted. The present owner has expressed interest in daylighting and has discussed this with Saanich, Ministry of Environment and the CRD. Reach 3 is culverted for 140 m from the outlet of the box culvert under the parking lot at 3950 Quadra Street to where it opens up briefly, immediately downstream of Quadra Street.

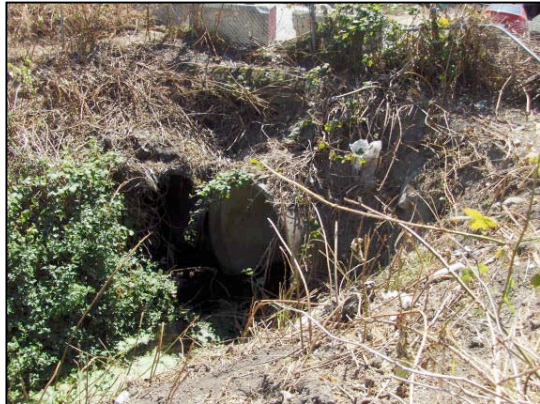
Reach four is approximately 1073 m long and extends from Quadra Street, through a primarily commercial area, followed by agricultural lands to the Cumberland Dam off Lochside Drive. Two sections of the stream in this reach are contained in underground culverts: under Quadra Street, and between McKenzie Avenue and the Lochside BC Hydro substation. Between Quadra Street and McKenzie Avenue, the right bank is constrained by a vertical concrete wall that forms the parkade and part of the London Drugs store in Saanich Centre. The channel here is straight and contained

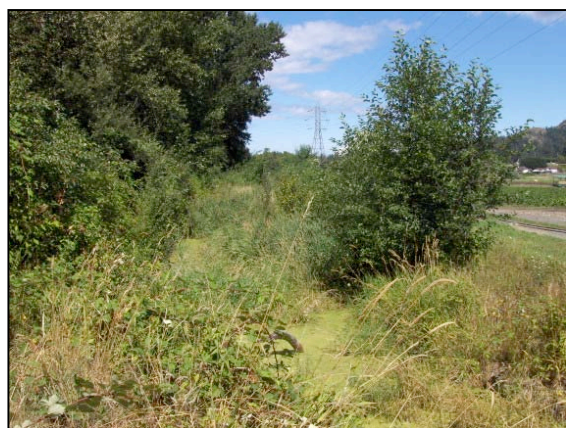
Reach 5 is approximately 517 m long and extends from the Cumberland Dam pedestrian bridge just downstream of Don Mann Excavating Ltd. to the outlet of Blenkinsop Lake. The Don Mann Excavating Ltd. site (4088 Lochside Drive) may be a source of sediment to the creek in this area as a large amount of sediment was observed on their site. However, mitigation techniques may be in place, as a wash area is in use.

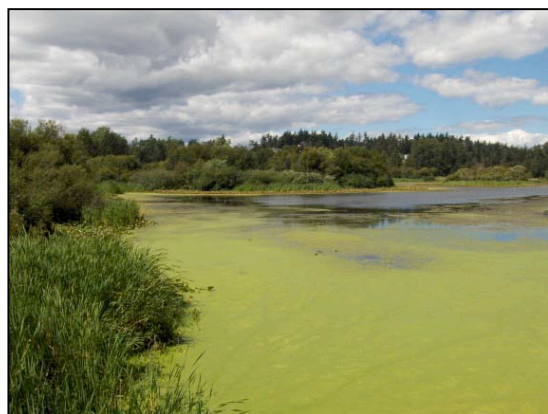
Reach 6 consists of Blenkinsop Lake, which covers approximately 7.24 hectares located within Blenkinsop Lake Park. A weir located at the outlet of the lake controls the amount of flow leaving the lake. The surrounding watershed is urbanized to an extent but also includes working agricultural lands. At the time of the assessment, the lake was covered almost entirely with duckweed (*Lemna* spp.) indicating high nutrient content and eutrophic conditions. Young bullfrogs (invasive species) were noticed in abundance along the edges of the lake.

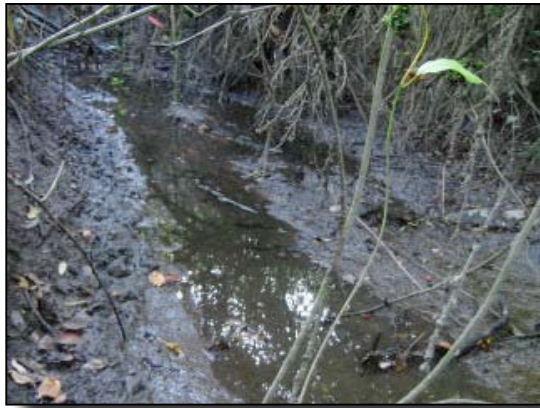
Reach 1 is approximately 138 m long extends from the confluence of the Colquitz River and Durrell Creek, to Wilkinson Road. The stream passes by a residential property on the right and Loenholm Road on the left. The channel is ditch-like with steep, actively eroding, bare banks. Accessible floodplain is non-existent and it is unlikely that the water escapes the channel unless under extremely high flows. At the time of assessment, there was very little water in the channel. The clay-based substrate is easily erodible and as a result has been channelized. Therefore, the channel was classified as a ditch.

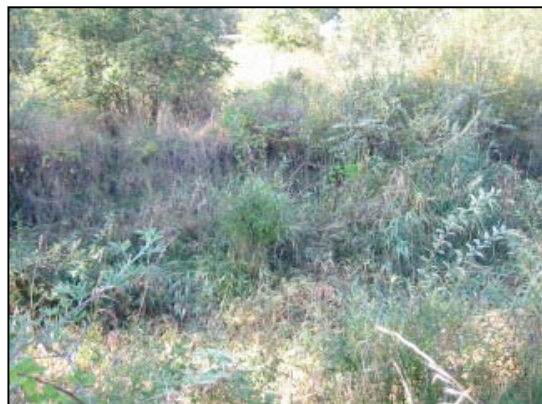
Reach 2 is approximately 436 m long and extends from Wilkinson Road, through the Wilkinson Correctional Centre property, to Charlton Road. Just upstream of Wilkinson Road, the banks of Durrell Creek have been graded back thus widening the channel and disrupting the width/depth ratio. The channel changes slightly upstream of the BC Hydro tower on the Correctional Centre property into one that has been dug-out, ditched, and significantly altered. The excavation of the channel was conducted by the Municipality of Saanich in 2002, along with

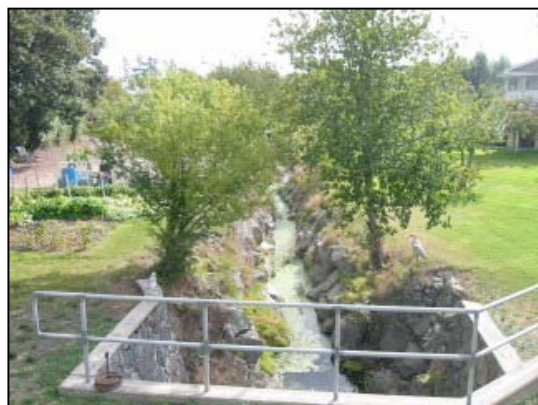
Reach 3 is approximately 128 m long. It extends from the upstream edge of the Wilkinson Correctional Centre at Charlton Road, to Interurban Road. The stream passes through the middle of one residential property (4231 Interurban Road) before going into a culvert underneath Interurban Road. The channel banks are armoured for the entire length of the reach with a rock-lined vertical wall. The banks are bare and oversteepened with a shed abutting the left bank, as well as a paddock area. A small bridge crosses the channel from the left bank to a field on the right

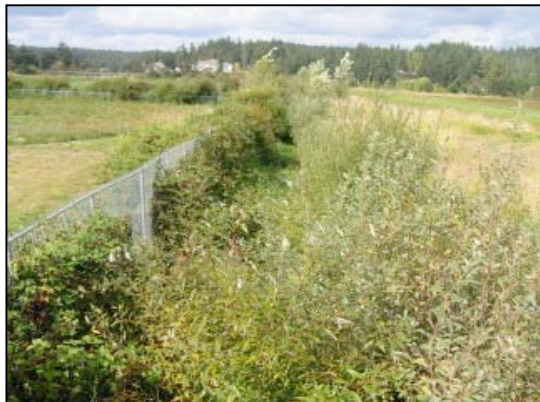
Reach 4 is approximately 1123 m long, extending from Interurban Road through primarily agricultural land, to Granville Avenue. For the majority of the reach, the ditched and straightened channel runs between agricultural fields and seasonally accesses the fields as floodplain. A small, vegetated terrace is present on the left bank just upstream of the culvert under Granville Avenue. Upstream of the terrace, the channel narrows and flows between horse paddocks on the right bank, and cow pastures on the left. As a result of the straightening and ditching, Reach 4

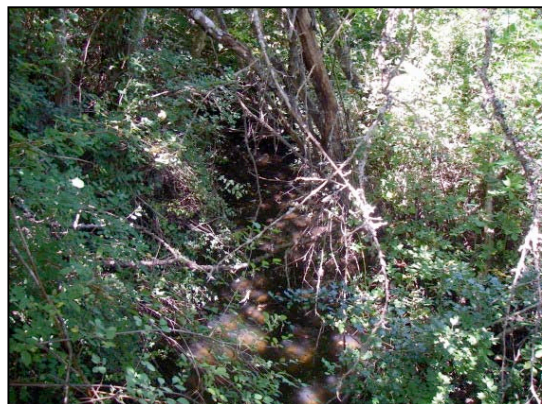
Reach 1 is approximately 386 m long. It extends from its entrance point into Quick's Bottom, upstream through park and residential property to Markham Road. Due to prior ditching and excavation, this section of Viaduct Creek is a straight narrow channel with a flat bottom. Floodplains accessible within this reach are being utilized. The Rosgen classification for this reach is an artificially straightened "C6," as the dominant substrate is silt/clay and the channel retains some "C" characteristics such as gradient and floodplain access. Although the banks are undercut in some

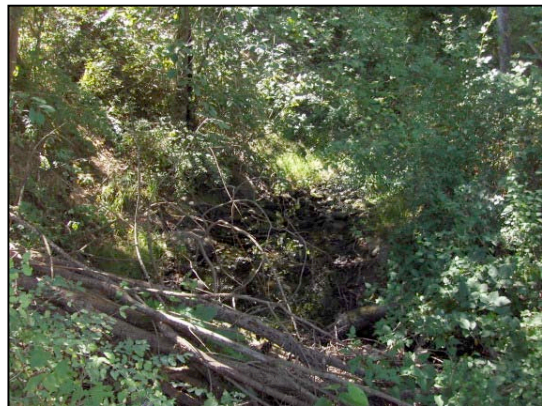
Reach 2a is approximately 287 m long and extends from the Markham Road bridge to the property boundary of 4484 Markham Road (where the tributary from Layritz Park enters). This section of Viaduct Creek travels through two residential properties and a small portion of the Vancouver Island Technology Park property. The banks are clay, but within the channel cobble dominates and bedrock outcrops appear in places. The Rosgen channel type is a “G3” due to the cobble substrate, gully shape and moderate gradient. In this reach, the banks are overly steepened and erosion is
