Colquitz River Watershed

Proper Functioning Condition Assessment

Appendices

July 2009

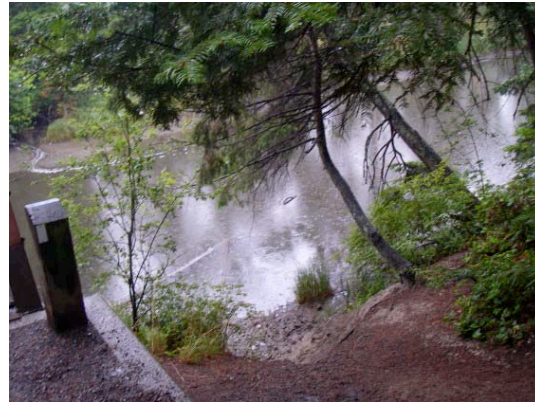
Colquitz River Reach 1, Photo 2, 2007-07-17. Facing the pedestrian bridge crossing closest to the Inlet. Noted erosion occurring adjacent to the bridge. In addition, residential stormwater drainage is entering the creek (top-left in picture).

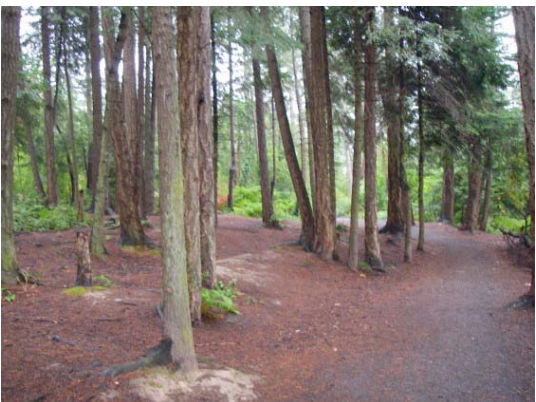
Colquitz River Reach 1, Photo 5, 2007-07-17. Large amount of off-path trampling is noted above; Area is at risk for considerable top-soil erosion leading to further reduced vegetation.

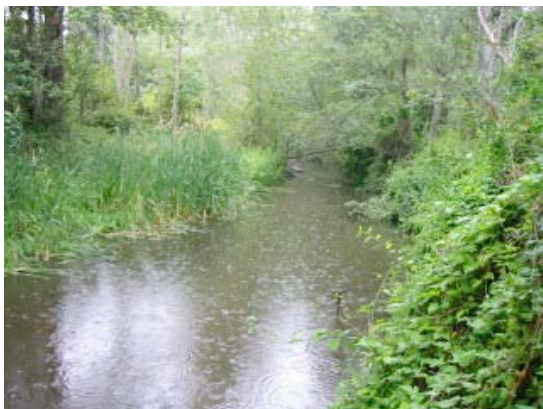
Colquitz River Reach 4, Photo 3, 2007-07-18.
Looking downstream. Although the reach is
heavily vegetated, its composition mainly consists
of invasive species.

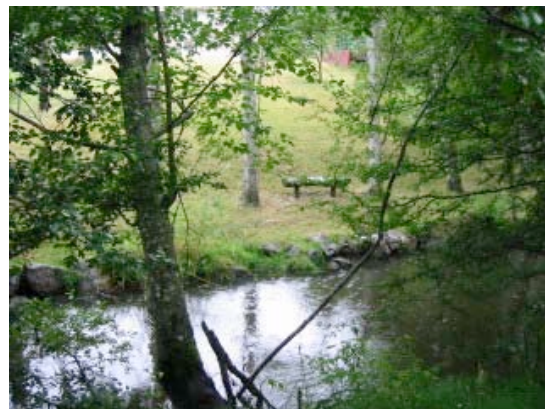
Colquitz River Reach 4, Photo 4, 2007-07-18.
Facing upstream. Large amounts of reed canary
grass (left) and Himalayan blackberries (right)
noted.

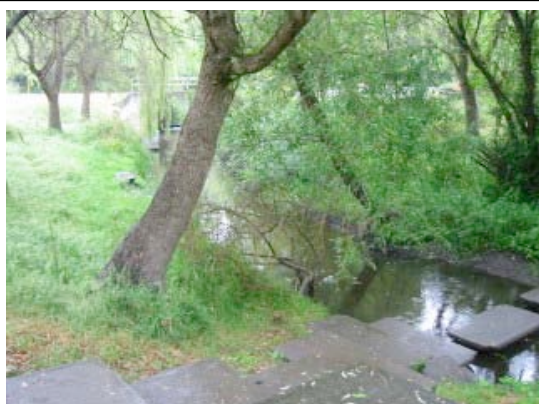
Colquitz River Reach 7, Photo 3, 2007-07-18.
Due to the concrete path and trampling, some
streambank erosion has occurred on the right
bank. Large Willow trees alongside channel are
preventing riparian plant growth.

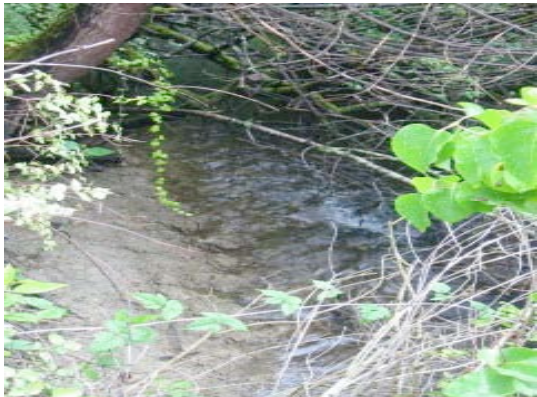
Colquitz River Reach 9, Photo 3, 2007-07-23.
Streambank erosion and invasive species noted.

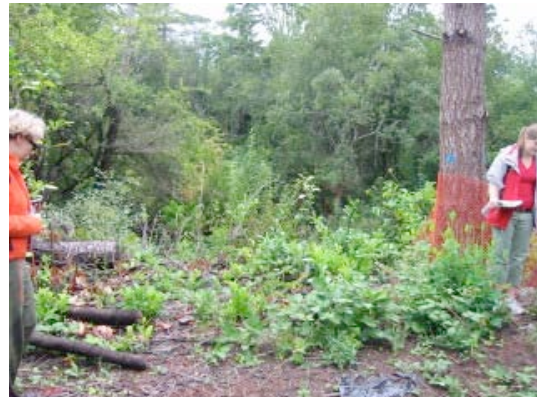
Colquitz River Reach 9, Photo 4, 2007-07-23.
Clearing of the property (corner of Grange and Gerda Road) and deposition of material is preventing vegetation growth and is accelerating bank erosion.

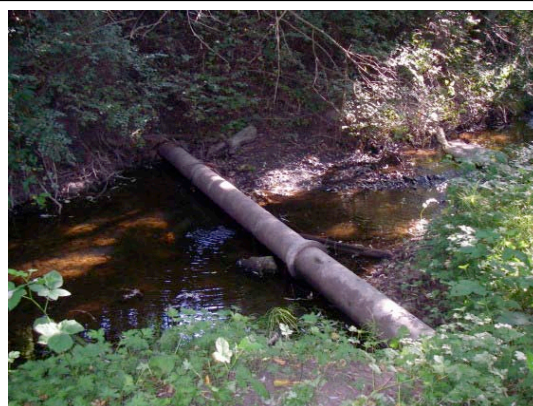
Swan Creek Reach 1, Photo 4, 2007-08-06.
Facing upstream. Noted pipeline crossing was
either installed in the creek bed itself or
surrounding material has eroded and exposed the
pipe.

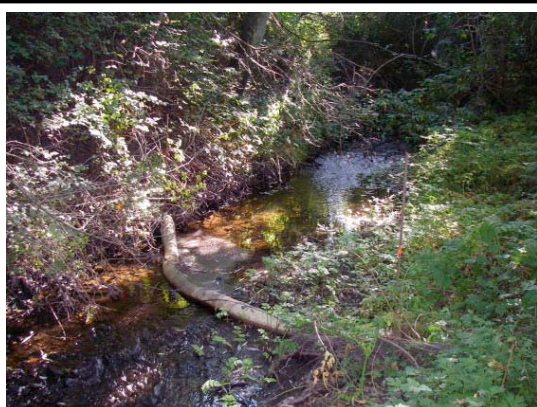
Swan Creek Reach 1, Photo 5, 2007-08-06.
Facing upstream. An aging spill boom was noted
still in place.

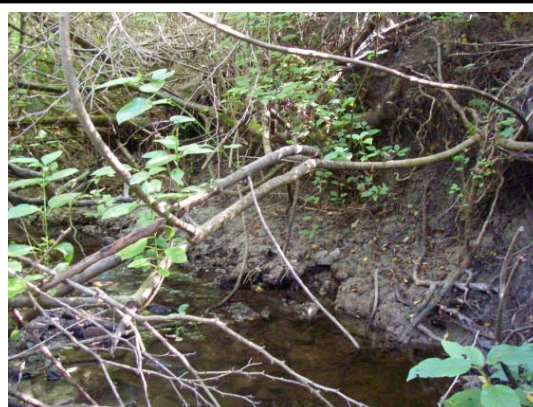
Swan Creek Reach 2, Photo 1, 2007-08-06.
Banks are eroding and downcutting.

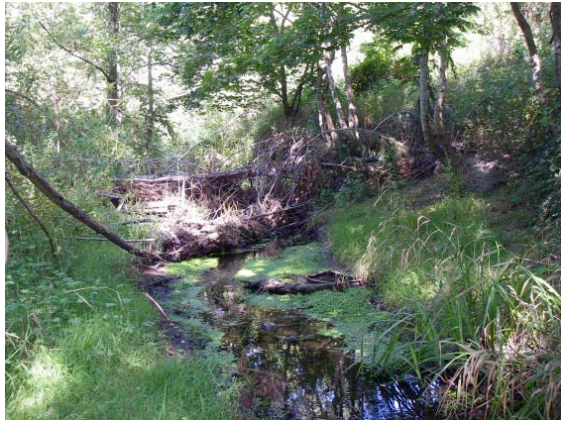
Swan Creek Reach 4, Photo 2, 2007-08-06. Facing downstream. Large amount of debris has been piled up from prior year storms.

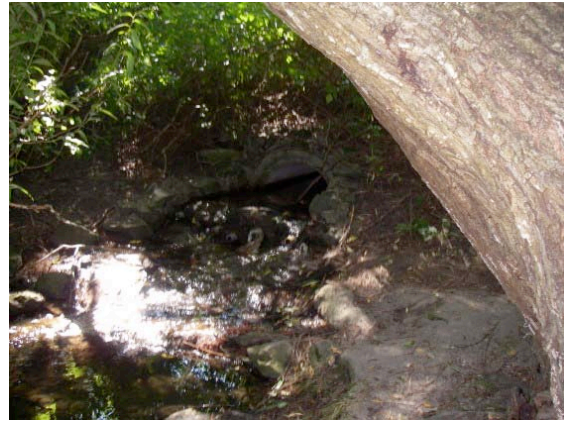
Swan Creek Reach 4, Photo 3, 2007-08-06. Facing upstream. A culvert is discharging nearby stormwater into the creek.

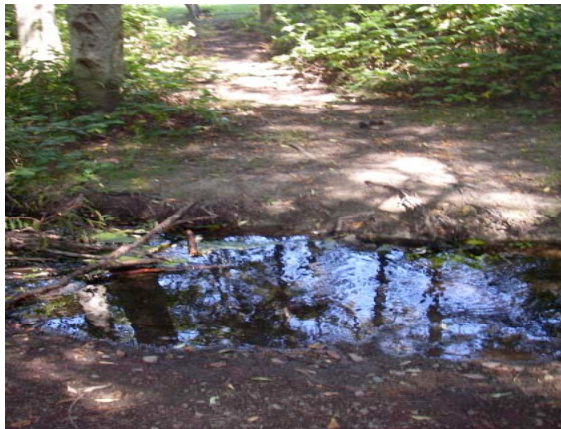
Swan Creek Reach 4, Photo 5, 2007-08-06. Streambed and riparian vegetation have been trampled.

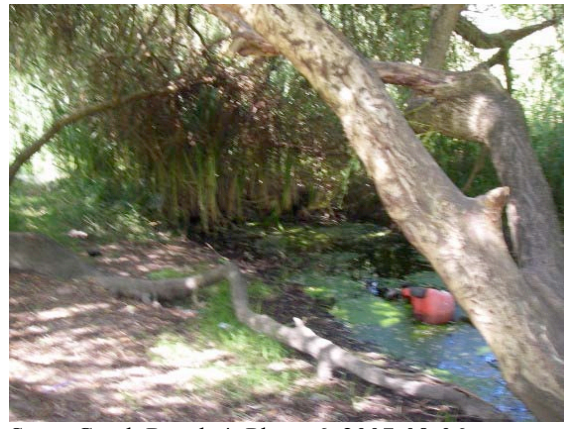
Swan Creek Reach 4, Photo 6, 2007-08-06. Facing downstream under large willow tree. Trash has been dumped in the channel and along the banks.

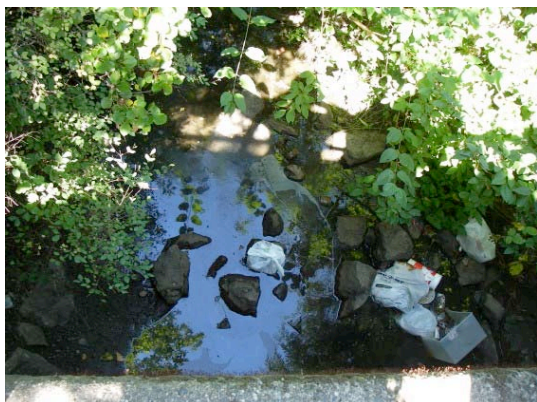
Swan Creek Reach 7, Photo 3, 2007-08-06. Ralph Street Culvert Crossing. Facing downstream. Garbage noted in channel.

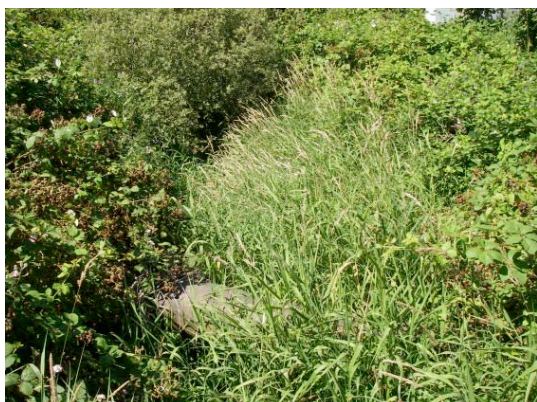
Swan Creek Reach 7, Photo 5, 2007-08-06. Kent Road pedestrian bridge facing downstream. Noted elevated pipe crossing parallel to the bridge. Area is inundated with invasive species.

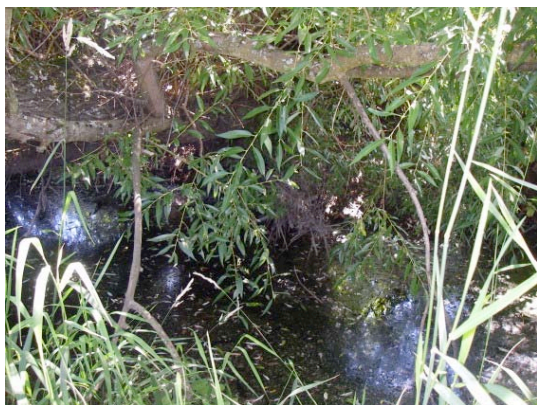
Swan Creek Reach 8, Photo 2, 2007-08-06.
Allotment gardens. Banks are steepened and bare in spots.

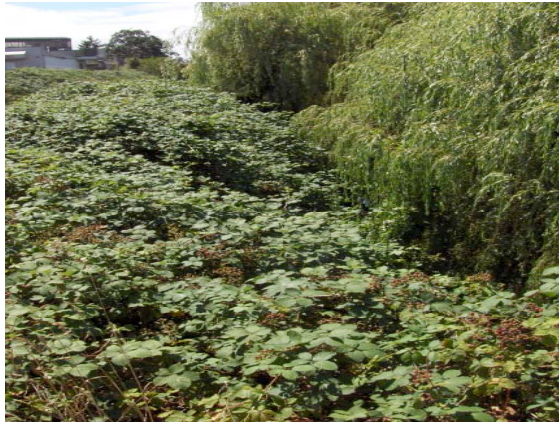
Blenkinsop Creek Reach 4, Photo 3, 2007-08-08. Facing downstream, standing on McKenzie Ave (London Drugs is to the right). Banks are heavily overgrown with invasive species.

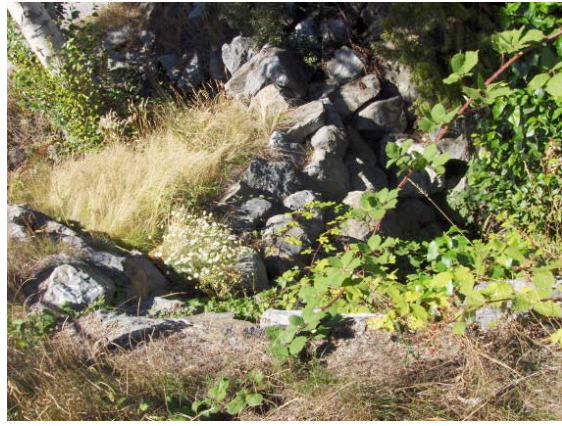
Blenkinsop Creek Reach 4, Photo 4, 2007-08-08. Creek is culverted from McKenzie and daylights again at Lochside Trail (adjacent to Lochside sub-station). Area has been ditched and lined with blast rock

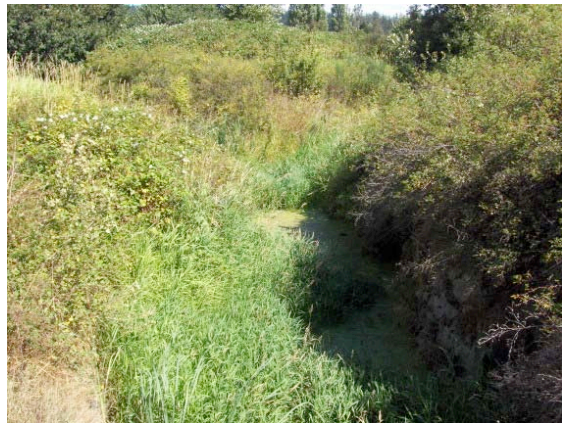
Blenkinsop Creek Reach 4, Photo 6, 2007-08-08. Looking upstream of dam. Area has been ditched and offers little in regards to diversity of vegetation.

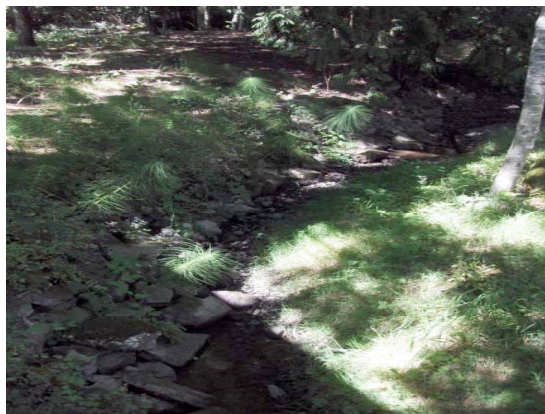
Viaduct Creek Reach 5, Photo 1, 2007-08-16.
Property of 478 Viaduct Avenue, facing upstream. Stream banks are armoured with rip-rap and contain little riparian vegetation.

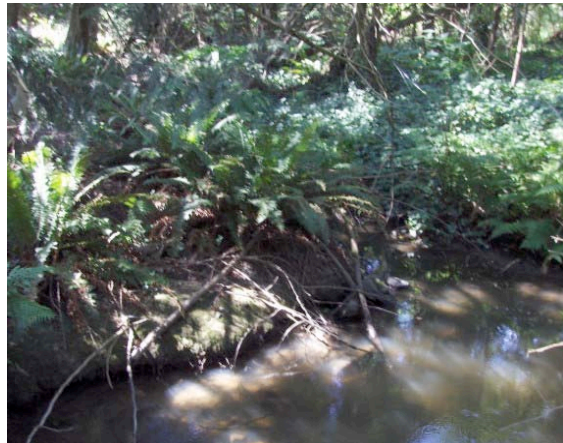
Viaduct Creek Reach 6, Photo 1, 2007-08-16.
Standing on pedestrian bridge, facing upstream.
Erosion is undercutting the bank.

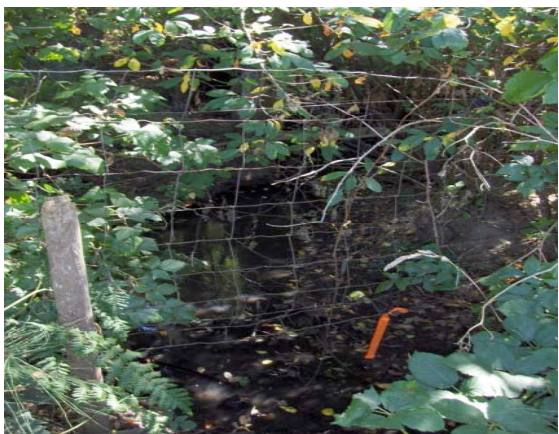
Viaduct Creek Reach 6, Photo 4, 2007-08-16.
Facing downstream, property line of 458 Viaduct
Ave. Channel has eroded.

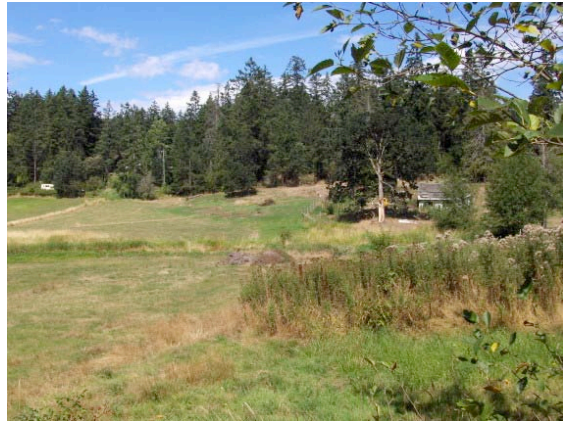
Viaduct Creek Reach 7, Photo 3, 2007-08-16.
Property of 458 Viaduct Ave. As seen in the background, channel has been ditched.

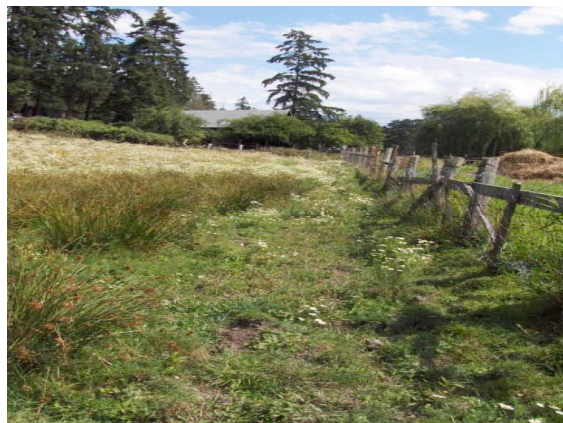
Viaduct Creek Reach 8, Photo 2, 2007-08-16.
Facing downstream towards property of 424 Viaduct Avenue. Area dries up in the summer and is grazed/trampled by cattle.

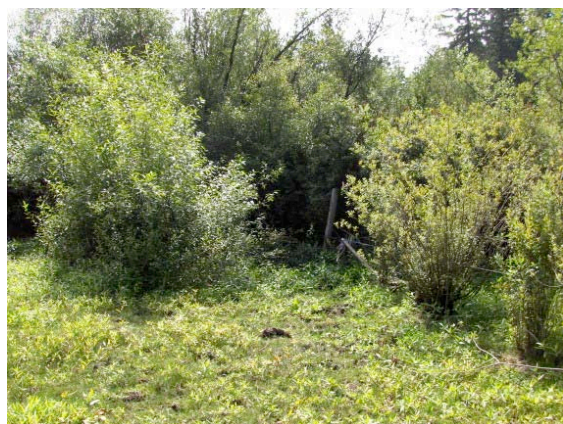
Viaduct Creek Reach 8, Photo 4, 2007-08-16.
Facing upstream on the property of 414 Viaduct Avenue. Area is trampled by horses.

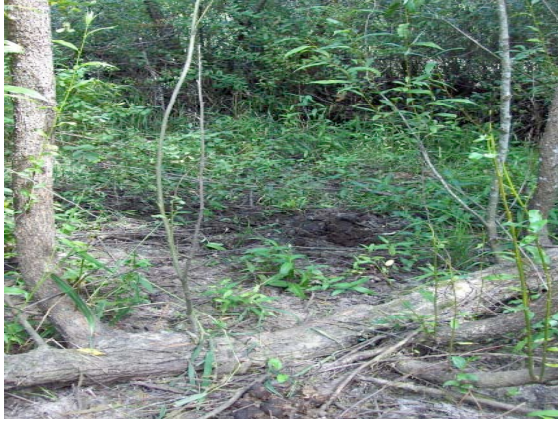
Viaduct Creek Reach 8, Photo 5, 2007-08-16.
Property of 414 Viaduct Avenue. Channel is
apparent and is completely dry. Noted horse
manure in the dry channel bed.

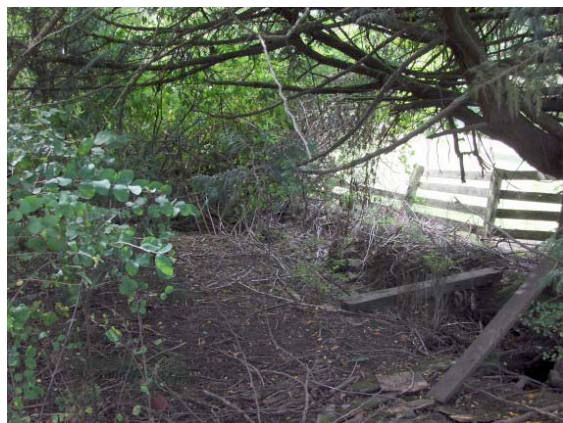
Viaduct Creek Reach 9, Photo 2, 2007-08-16.
Facing upstream on the property of 414 Viaduct
Avenue. Creek has seriously down-cut from large
flows.

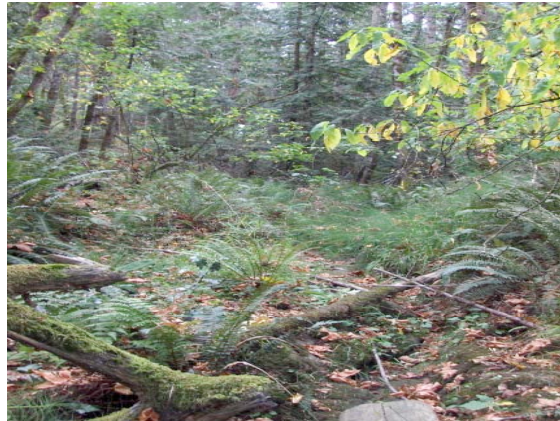
Viaduct Creek Reach 10, Photo 3, 2007-08-16.
Facing upstream. Creek is well vegetated, has
some erosion on the outside bends and has access to
a developed floodplain.

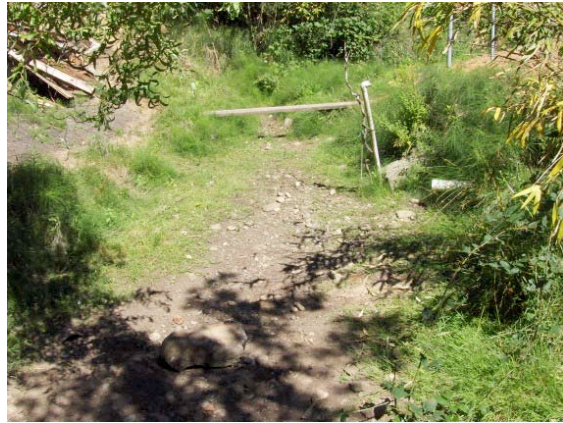
Viaduct Creek Reach 12, Photo 2, 2007-08-14. On property of 365 Viaduct Avenue, facing downstream. Creek-bed is completely dry and has limited riparian vegetation.

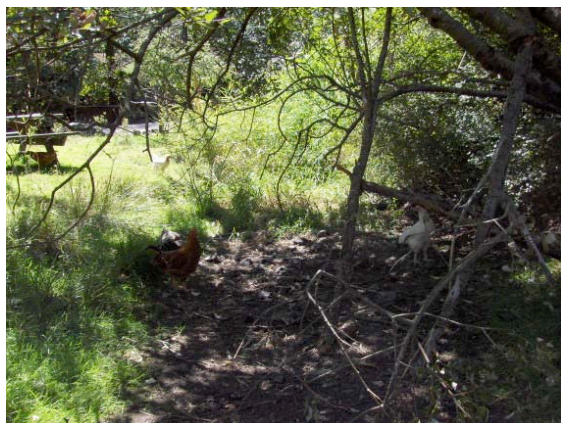
Viaduct Creek Reach 12, Photo 3, 2007-08-14. On property of 365 Viaduct Avenue, facing upstream. Noted chickens grazing in the channel. Channel is too straight and too wide.

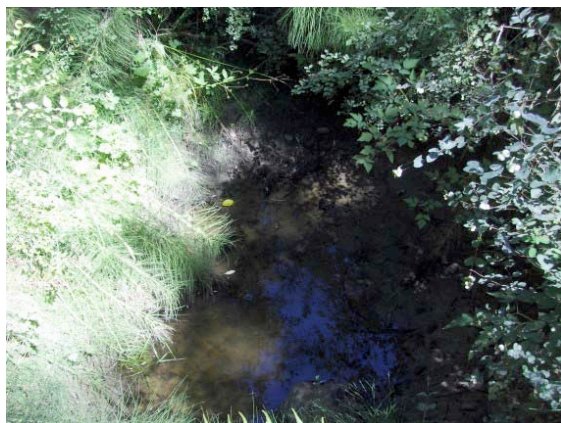
Viaduct Creek Reach 12, Photo 5, 2007-08-14. Facing upstream past property line. Some stream bank erosion noted. A working water pump was noted to the left.
