MINERS BAY DOCK FACILITY

CONDITION ASSESSMENT REPORT

Capital Regional District

M&N Project No. 8985 VC15

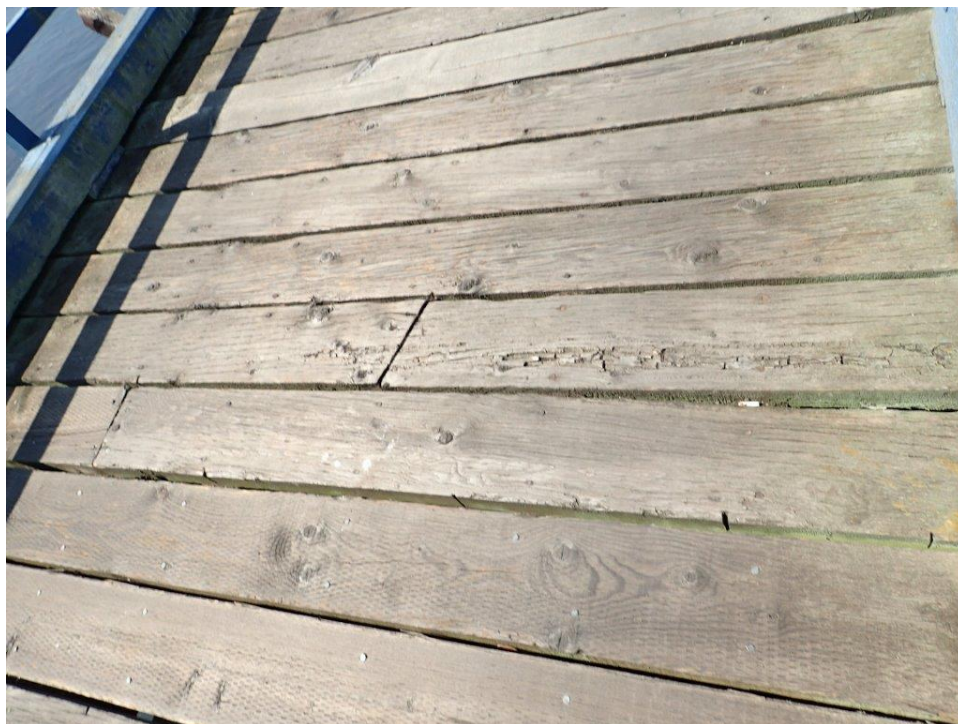
Photograph 5: Deck Rot at Bent 17

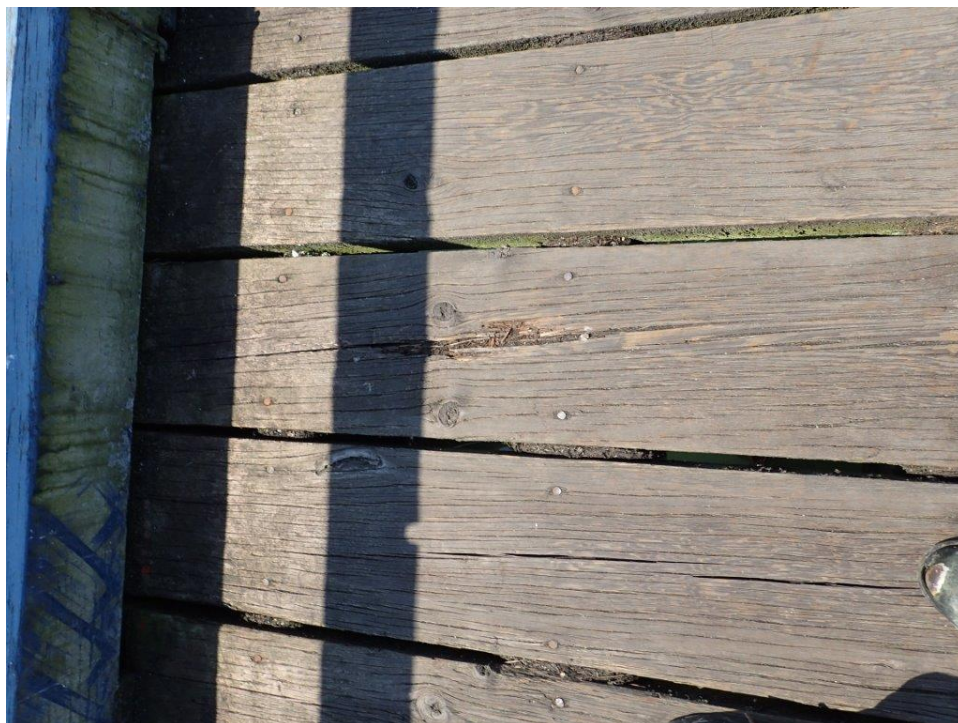
Photograph 6: Deck Rot at Bent 22

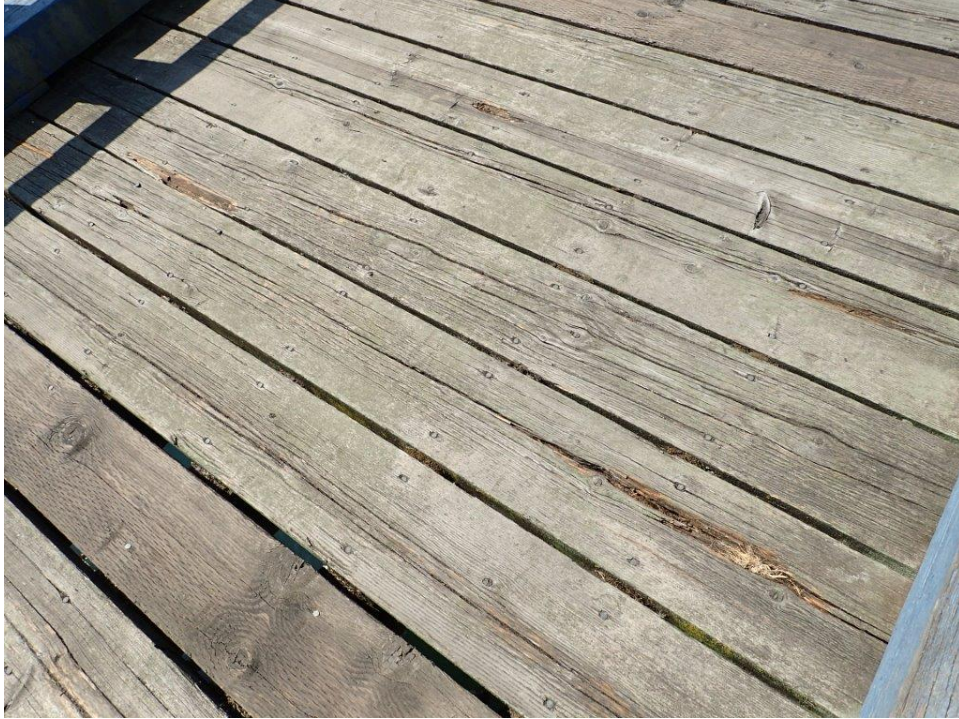
Photograph 9: Deck Rot between Bent 29 to 30

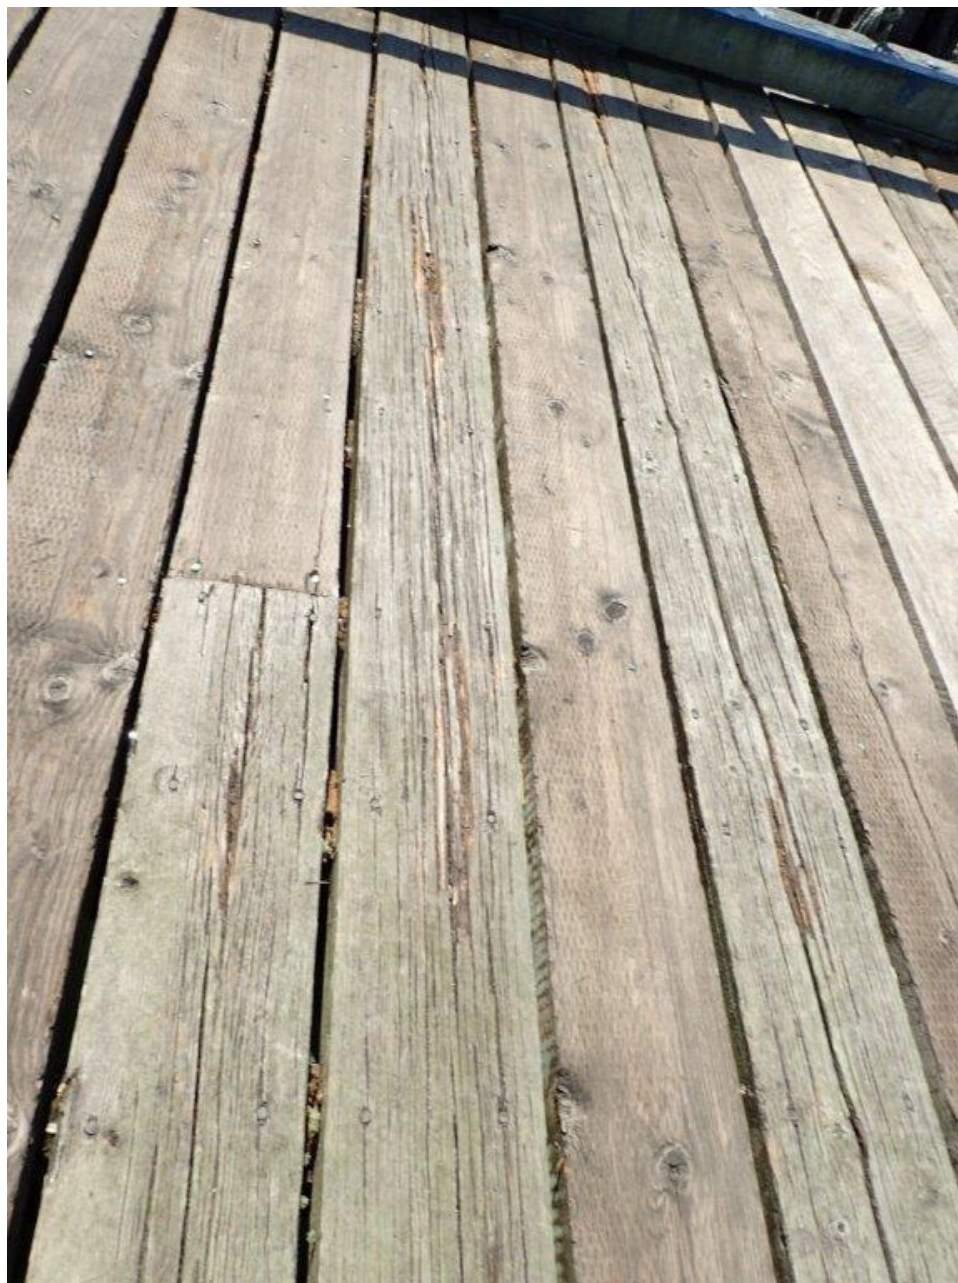
Photograph 10: Deck Rot at Bent 31

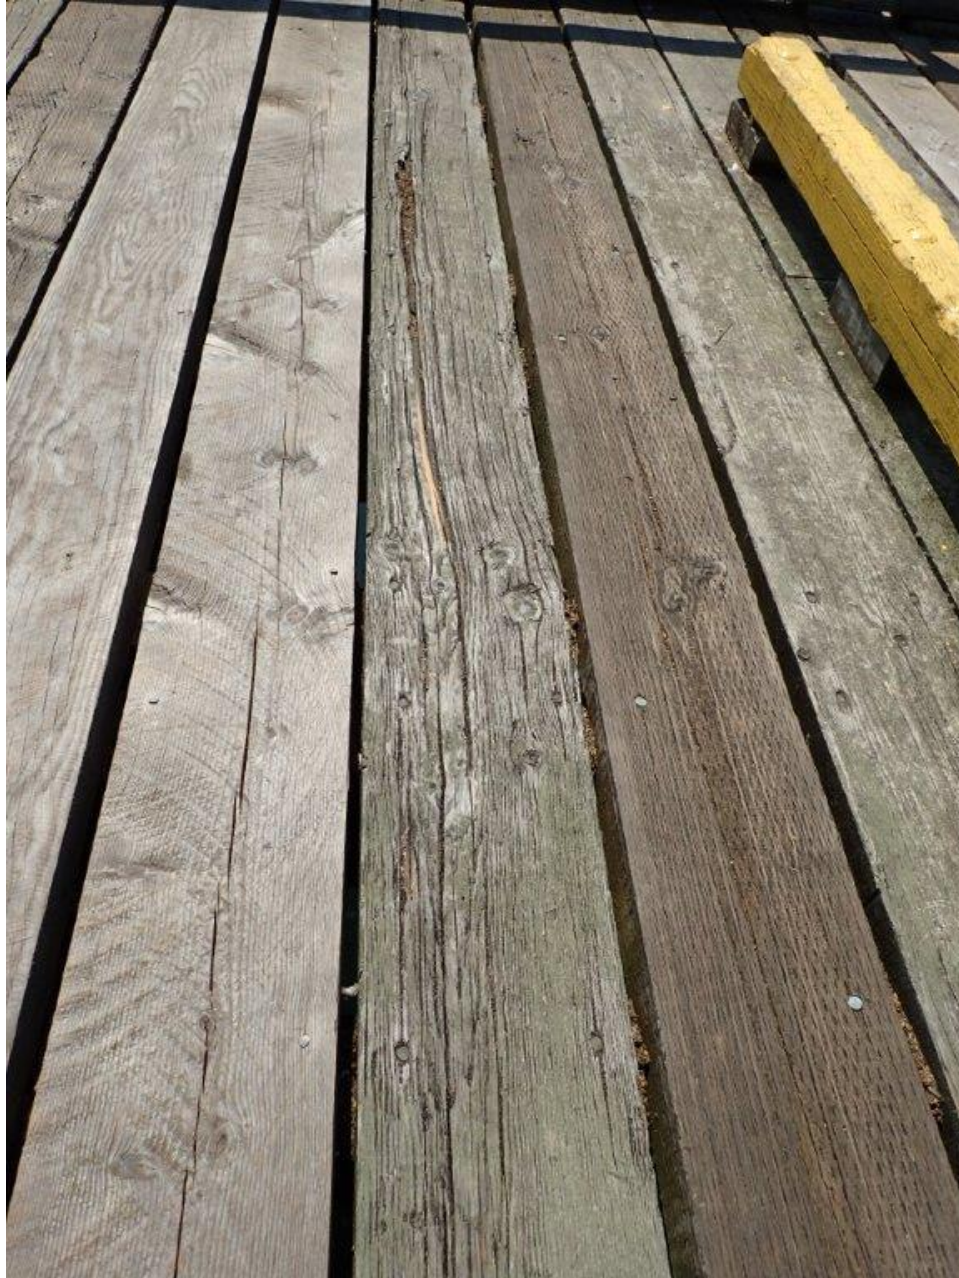
Photograph 11: Deck Rot between Bent 31 to 32

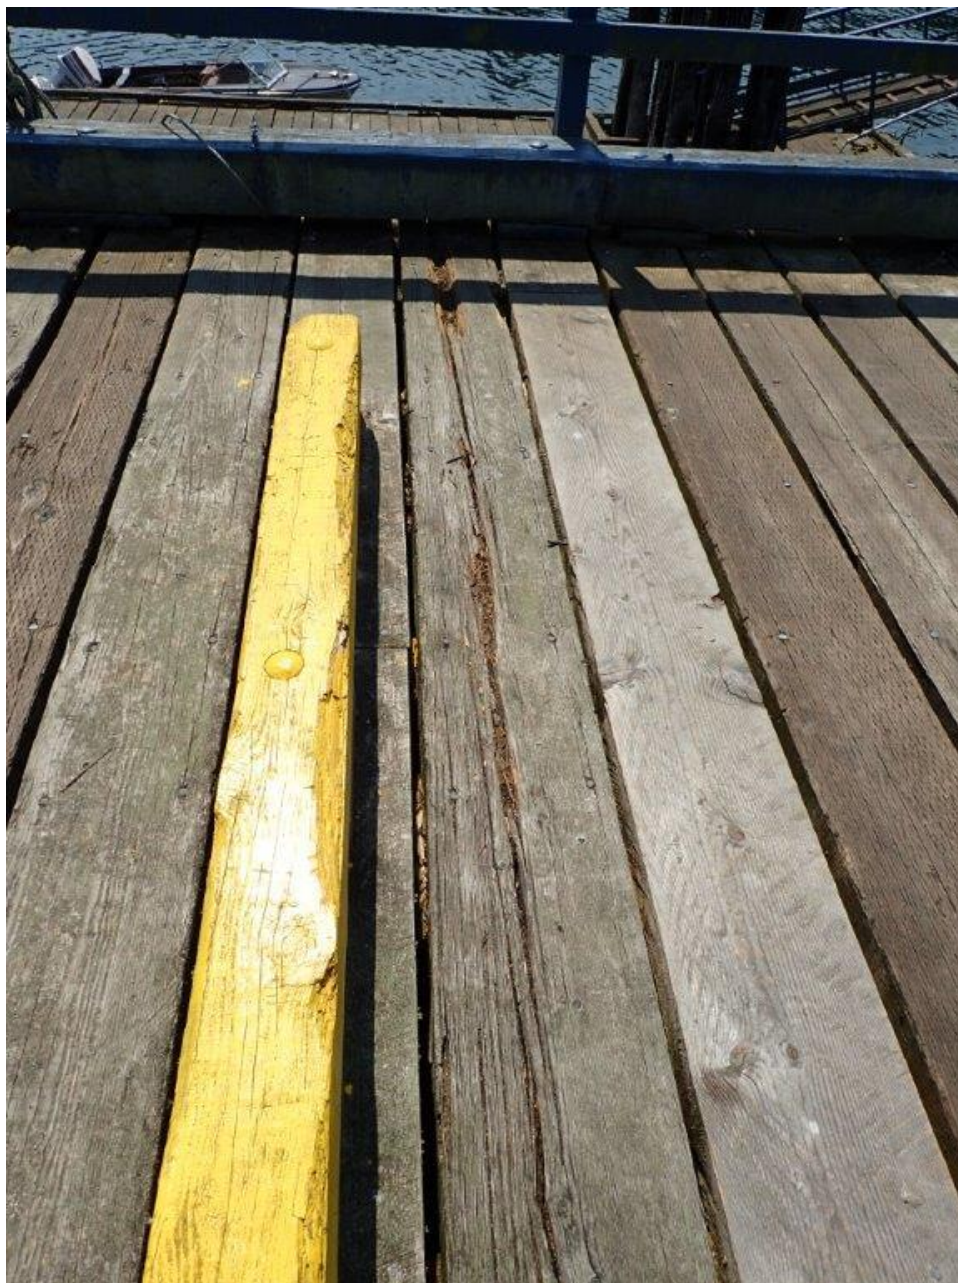
Photograph 12: Deck Rot at Bent 32

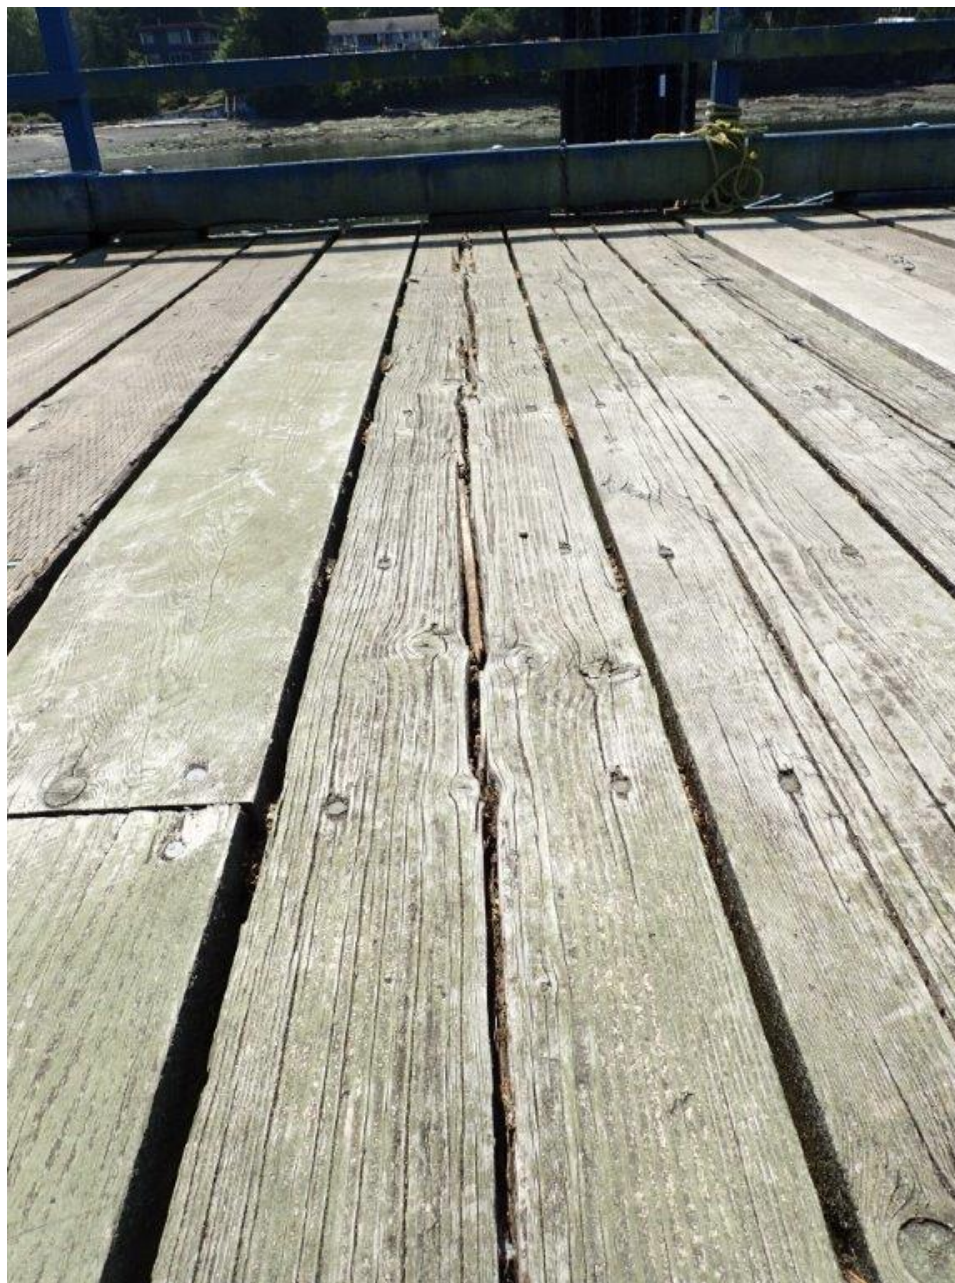
Photograph 13: Deck Rot at Bent 33

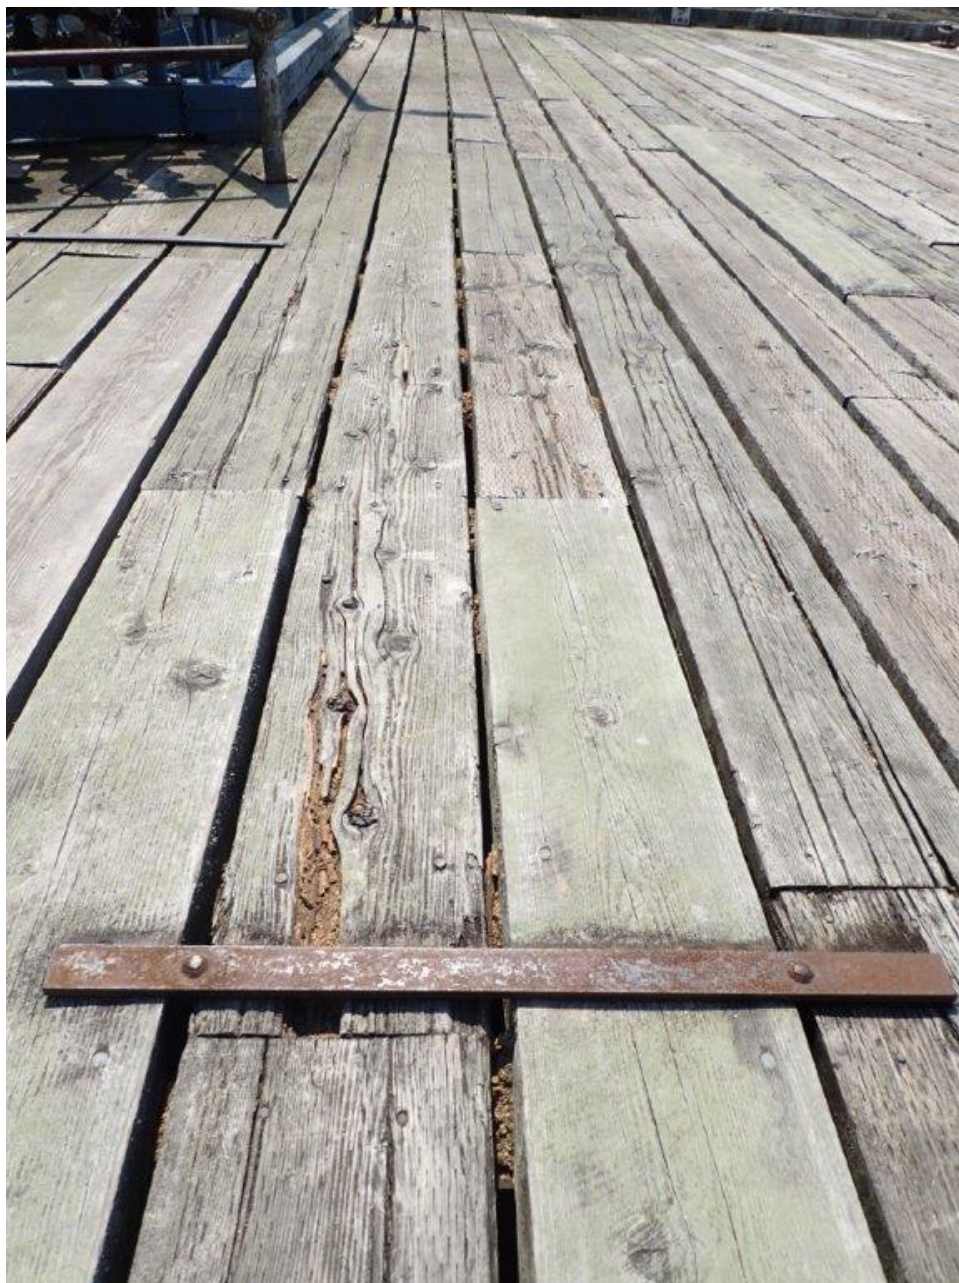
Photograph 14: Deck Rot at Bent 37

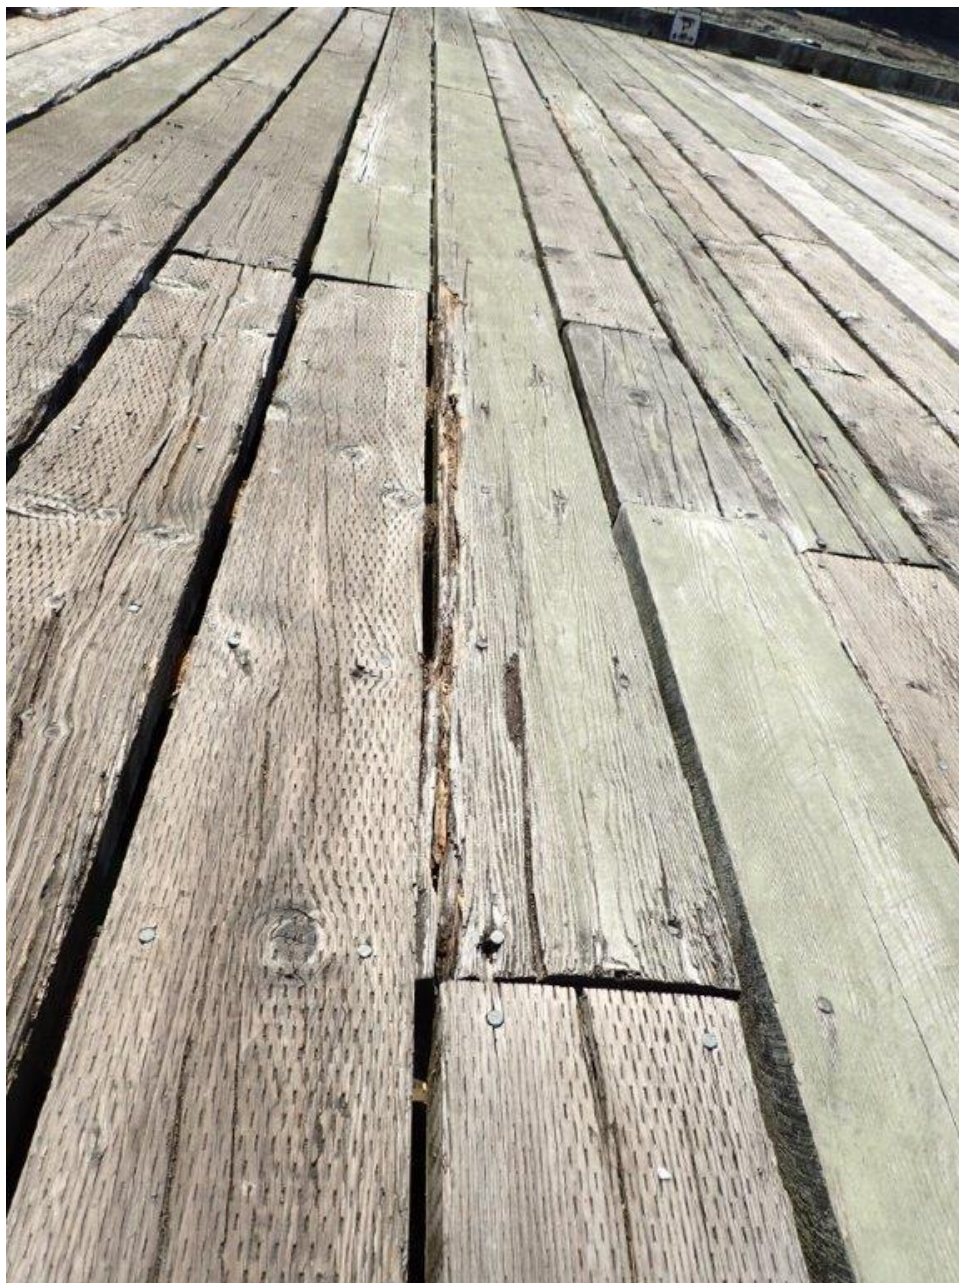
Photograph 15: Deck Rot at Bent 37

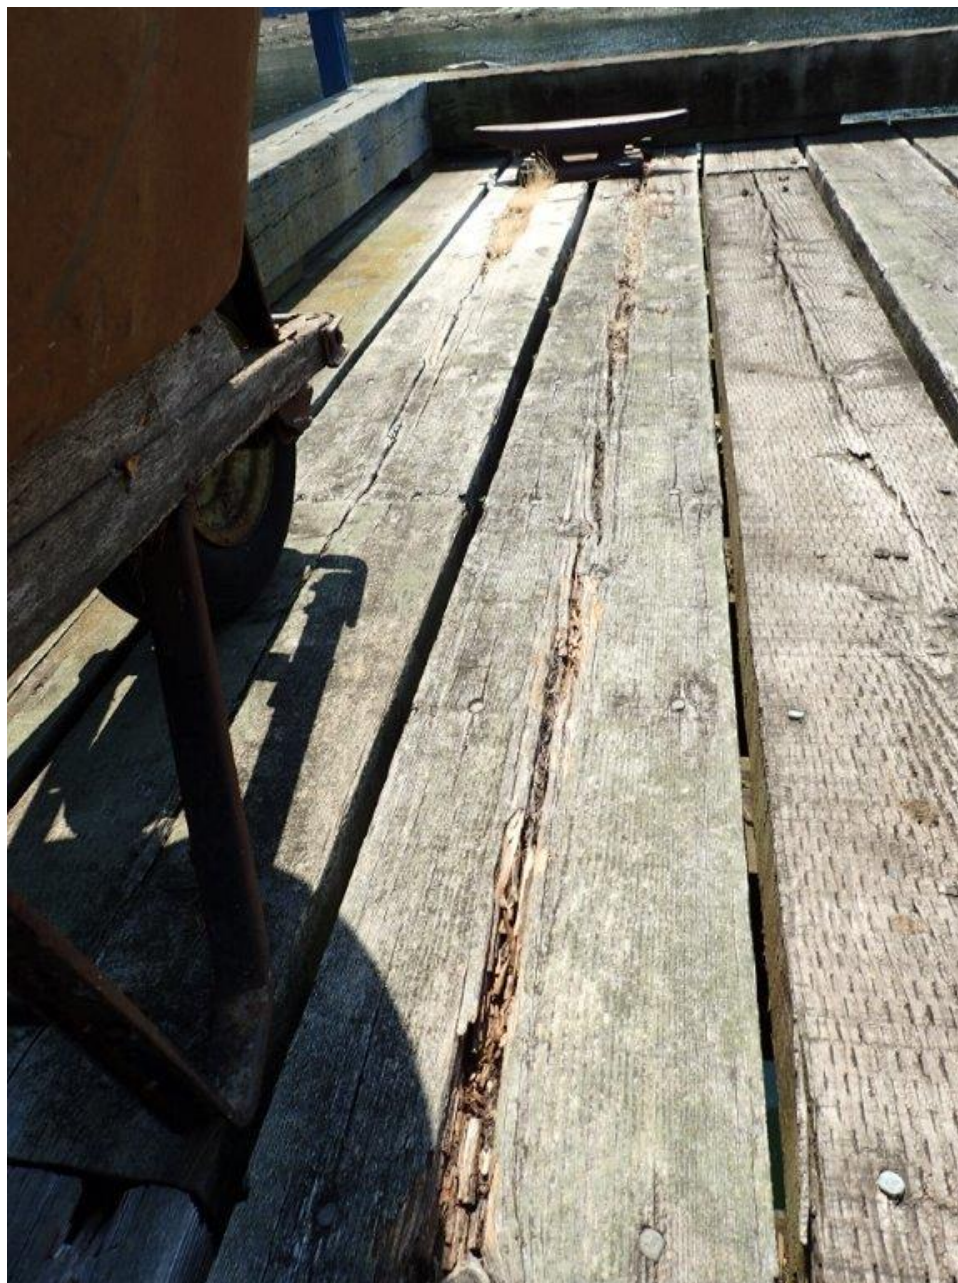
Photograph 16: Deck Rot at Bent 37

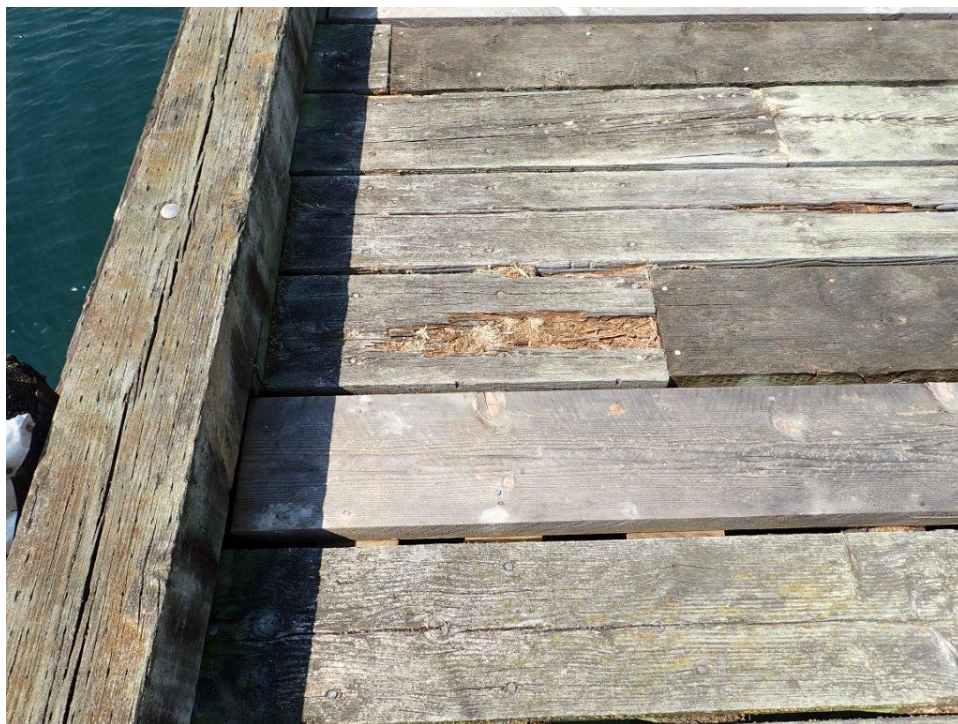
Photograph 17: Deck Rot at Bent 39

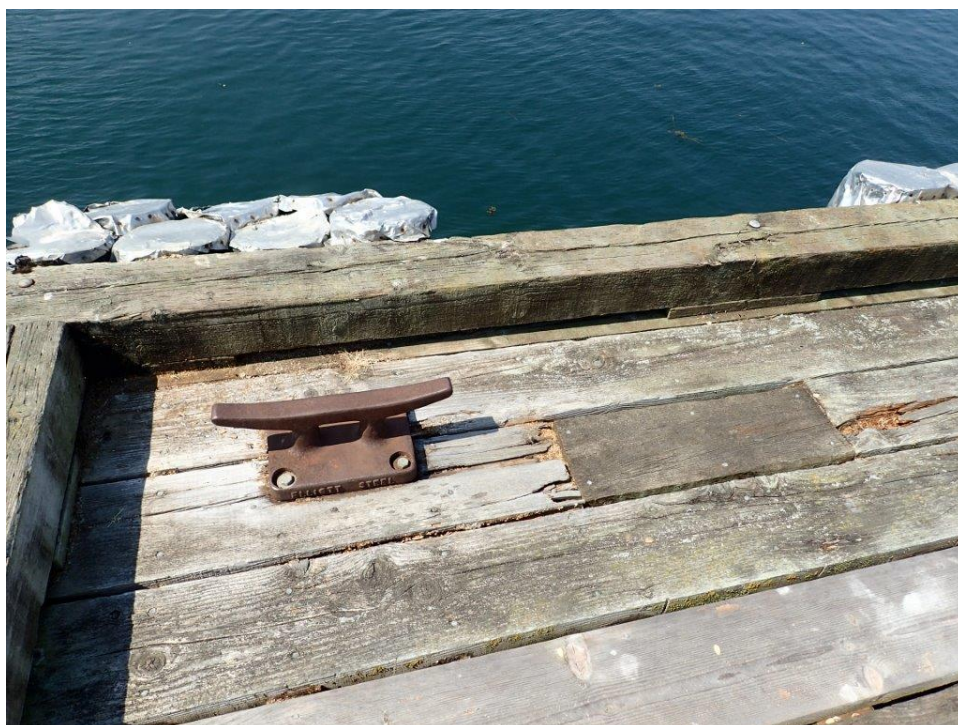
Photograph 18: Deck Rot at Bent 40

minute loading zone on Float B. A few times a year a vessel berths along the end of the wharfhead. Based on the current condition of the cleat supports it is recommended to repair these supports before vessels are allowed to berth along the wharfhead.

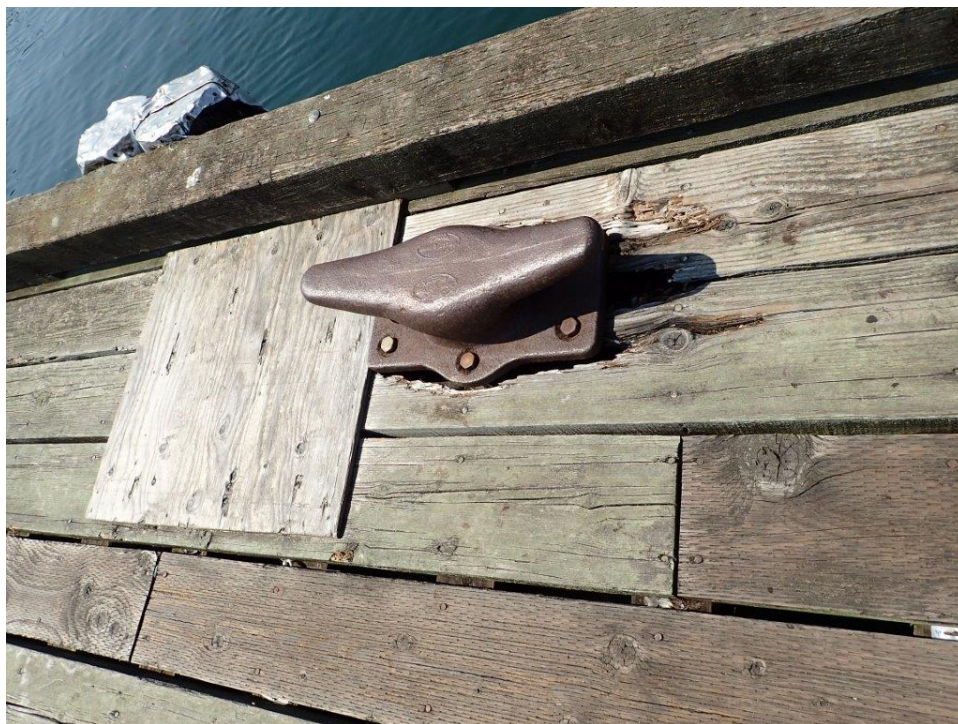
Photograph 19: Deck Rot and Hole Patch at Bent 40 and Cleat

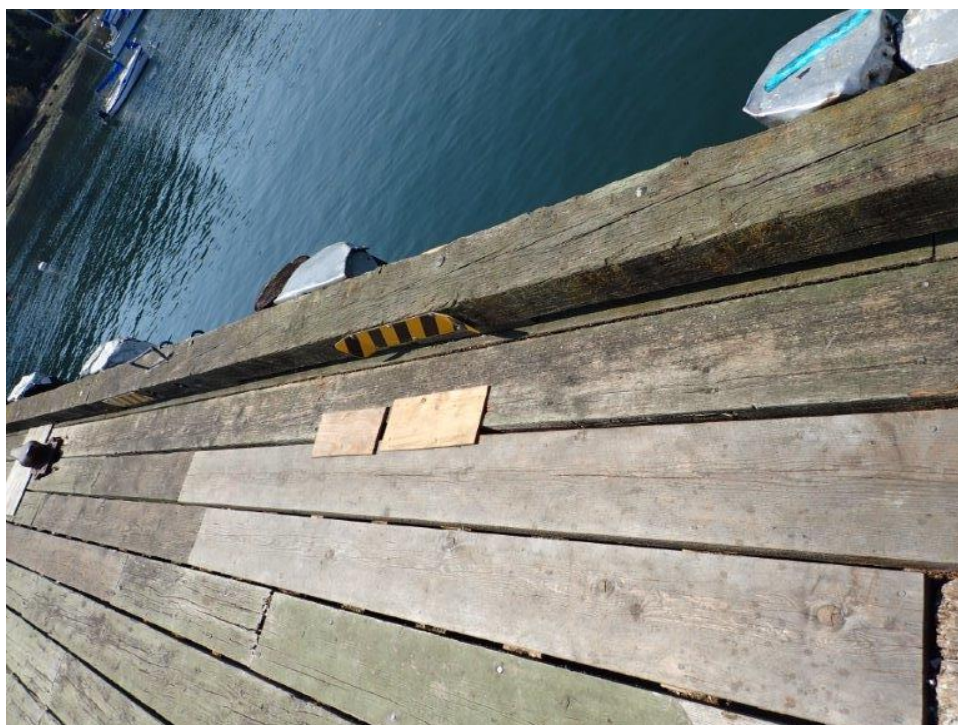
Photograph 20: Deck Rot at Patches

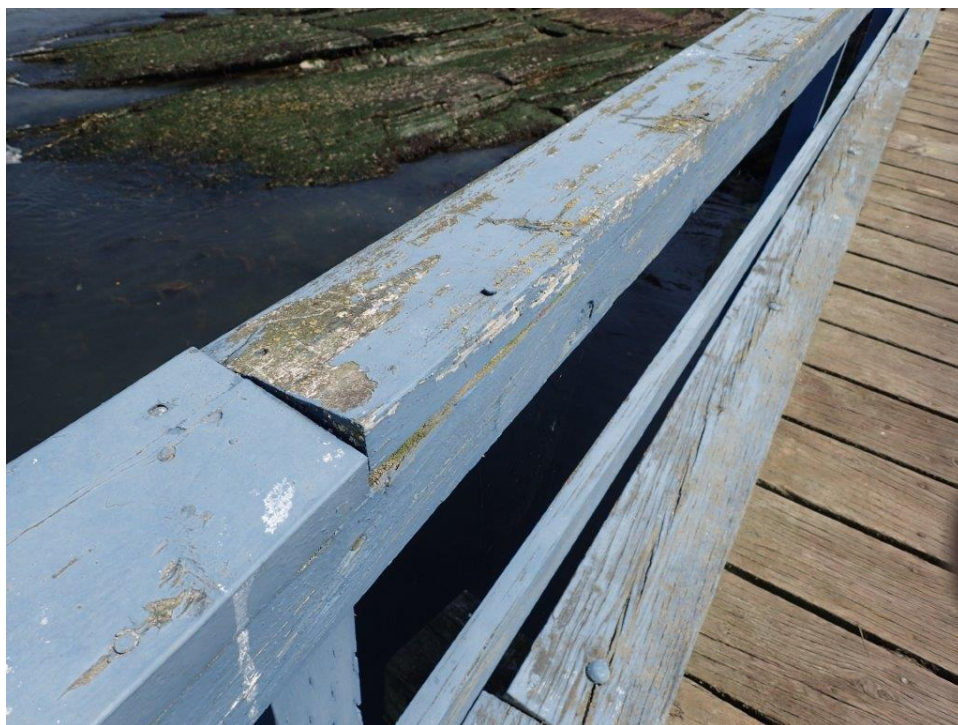
Photograph 21: Warped Handrail at Bent 19

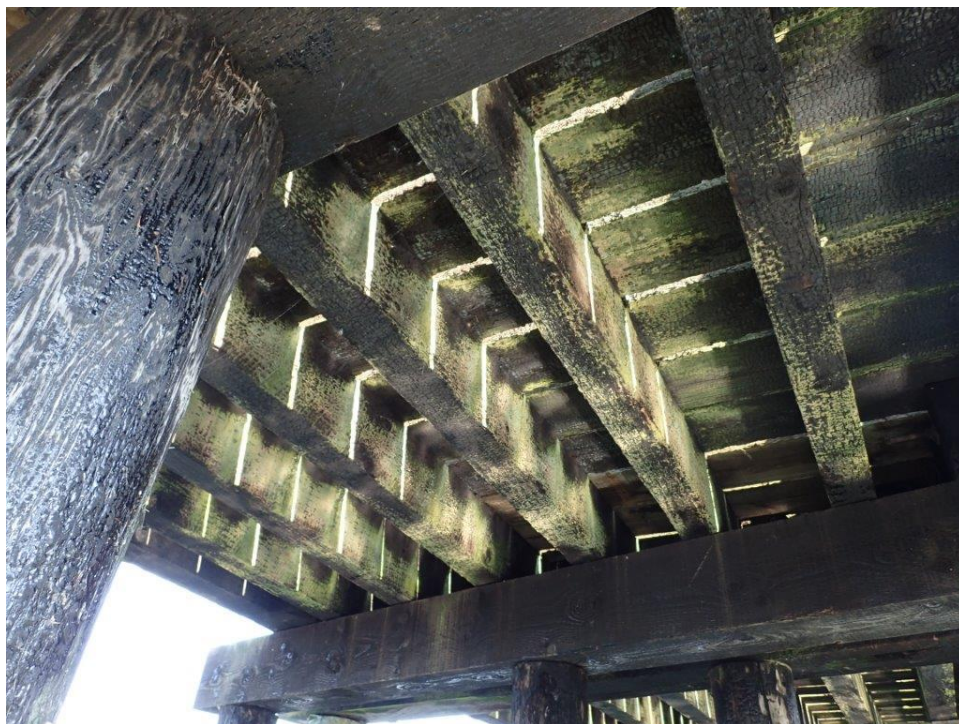
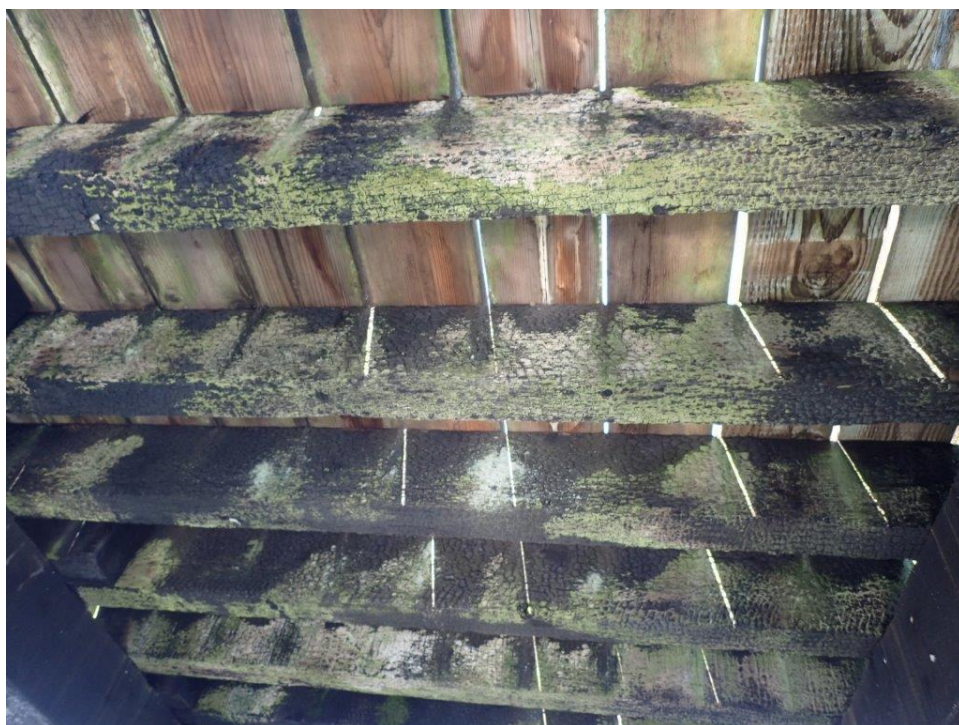
Location	Damage/Condition	Comments	Recommendations
Bent 24 to 29	Burnt stringers	Photographs 27 to 28	Monitor

Photograph 27: Burnt Stingers between Bent 24 to 29

Photograph 28: Burnt Stingers between Bent 24 to 29

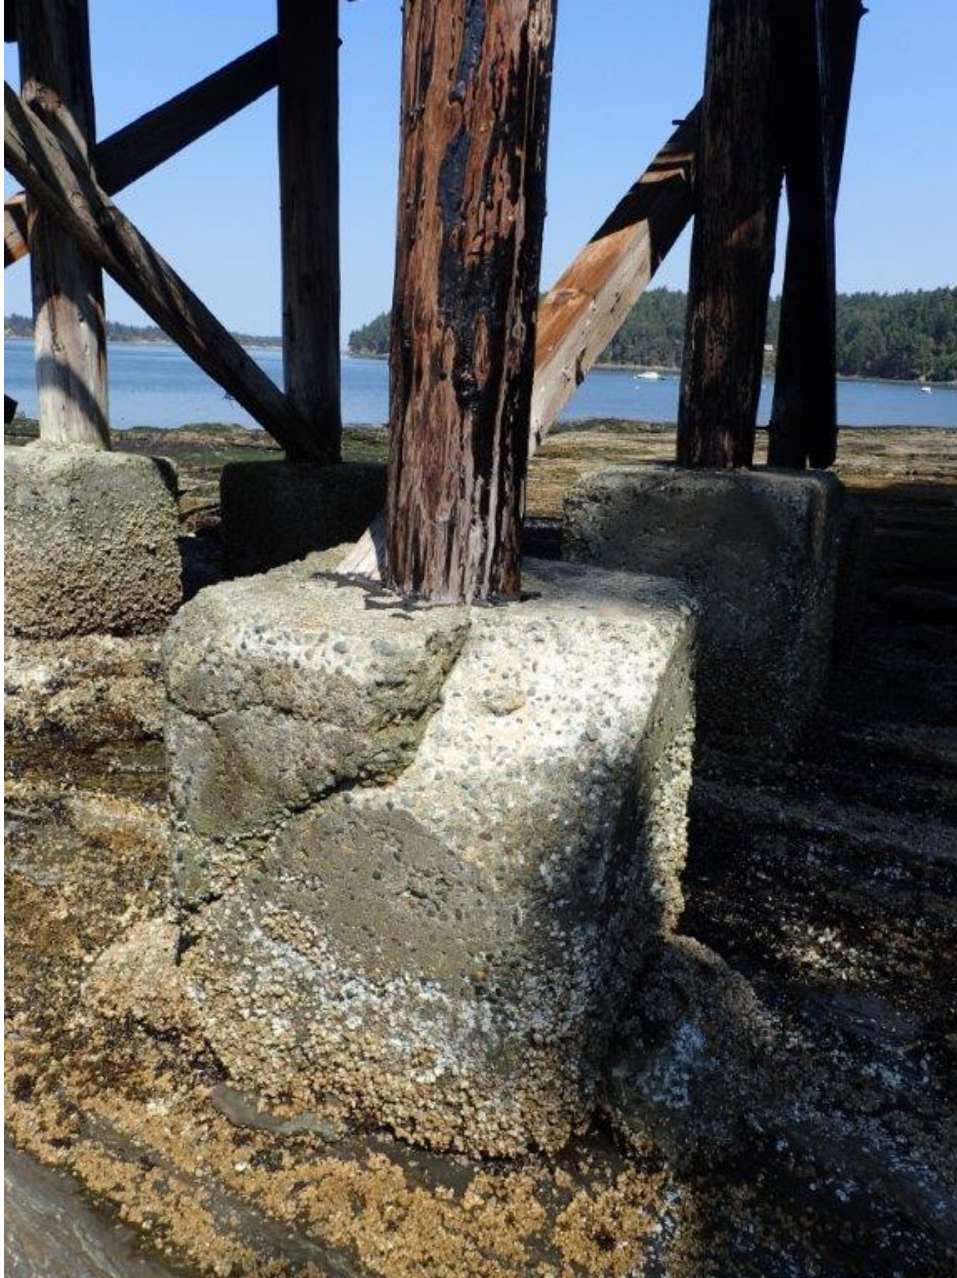
Photograph 30: Concrete Spall at Pile 5C

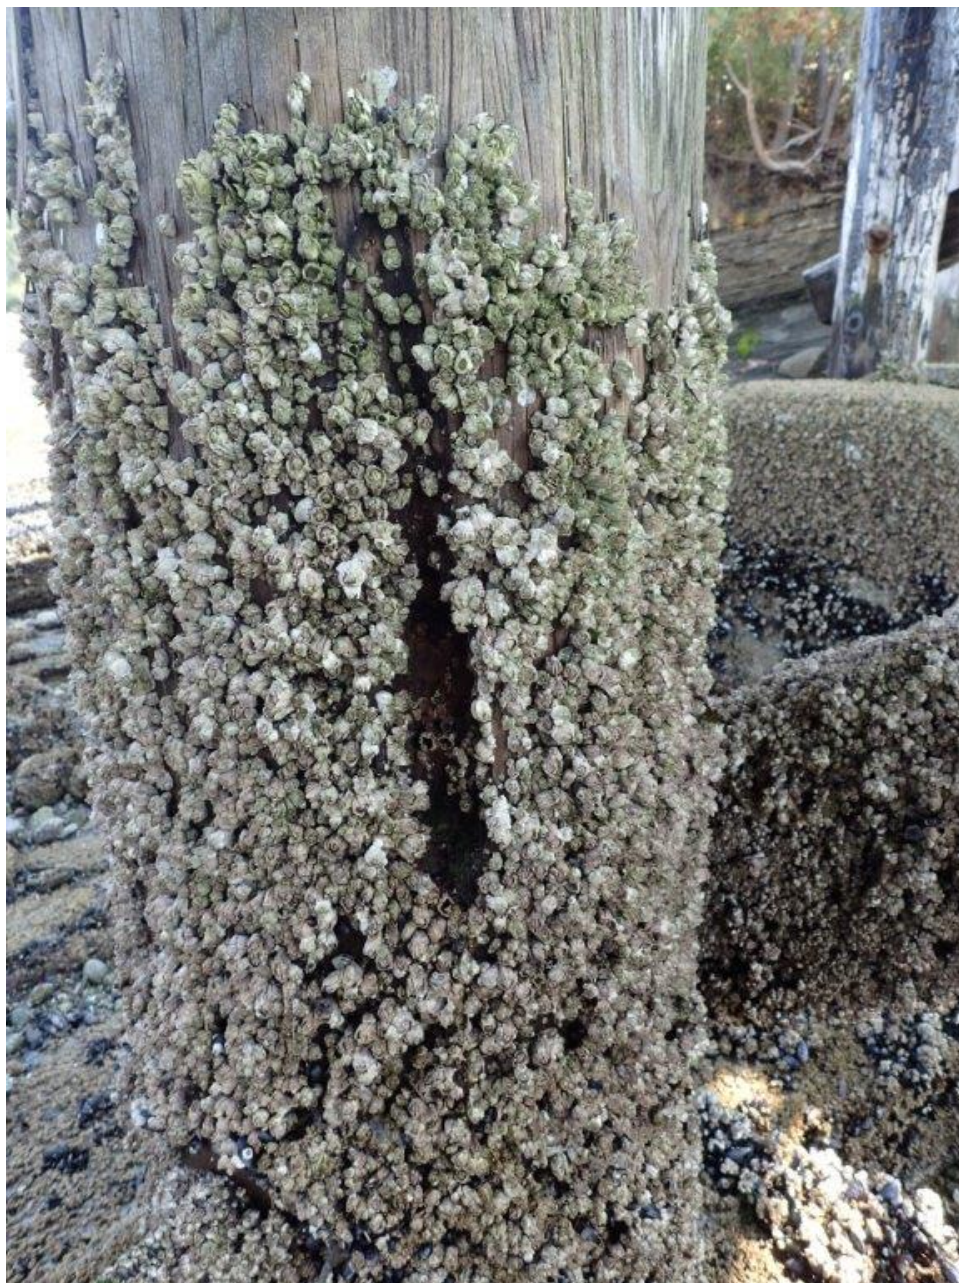
Photograph 31: Gouge in Pile 8A

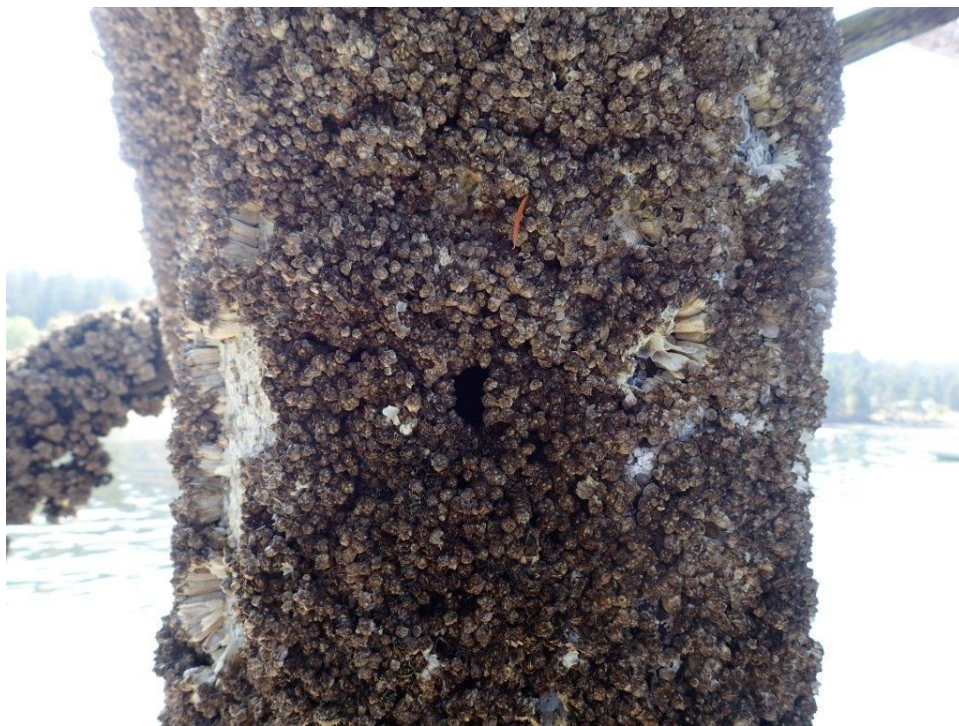
Photograph 32: Pile 18B Hole and Severe Marine Borer Damage

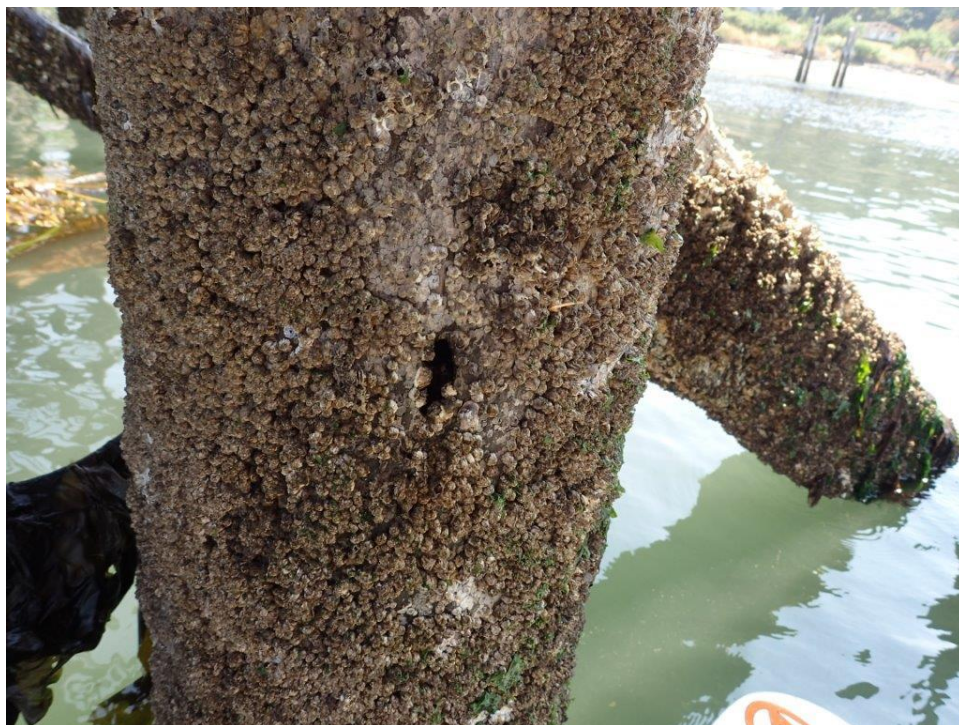
Photograph 33: Pile 21B Hole

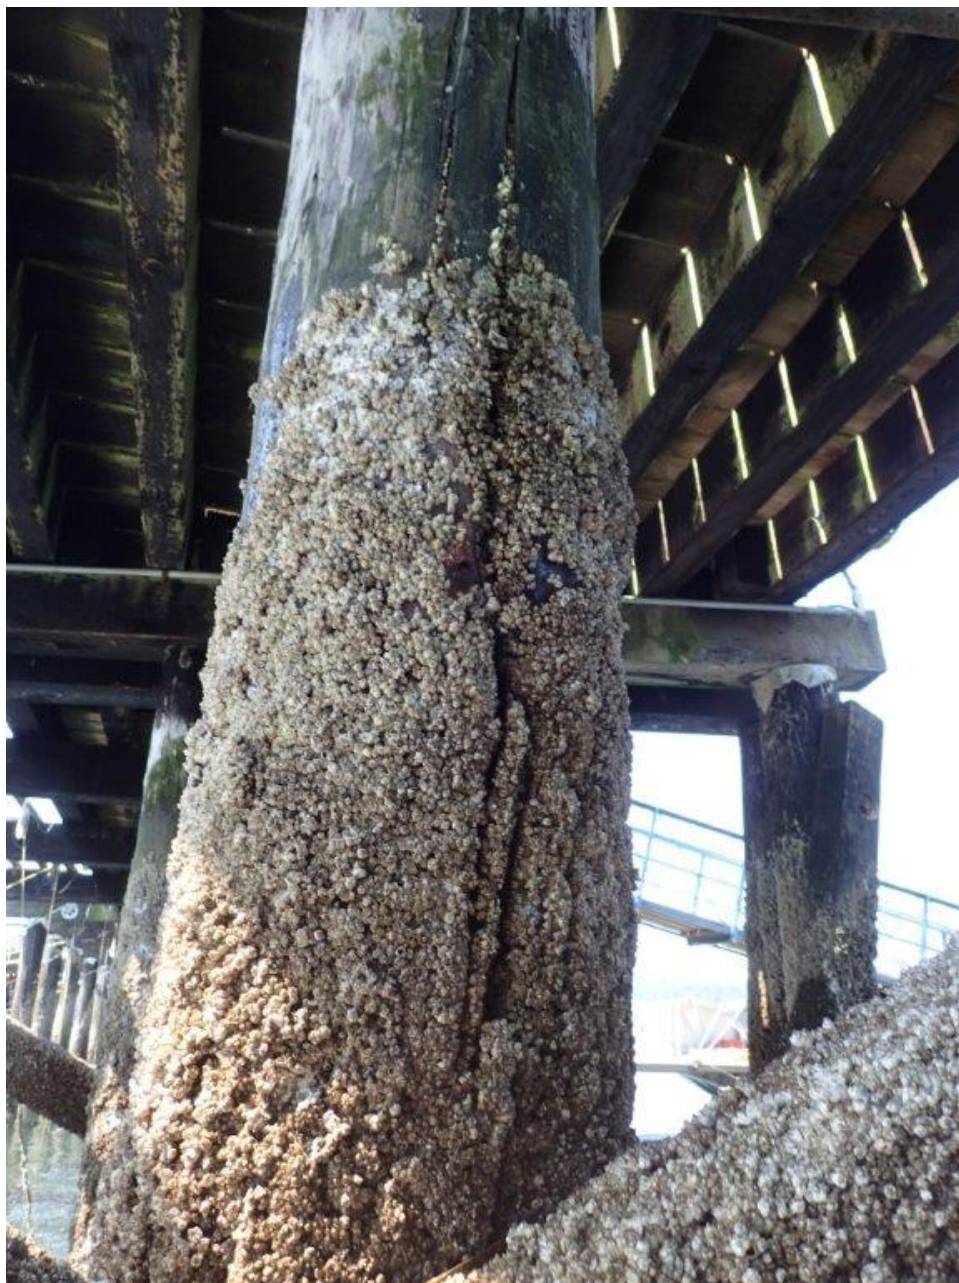
Photograph 34: Cracking in Pile 24B

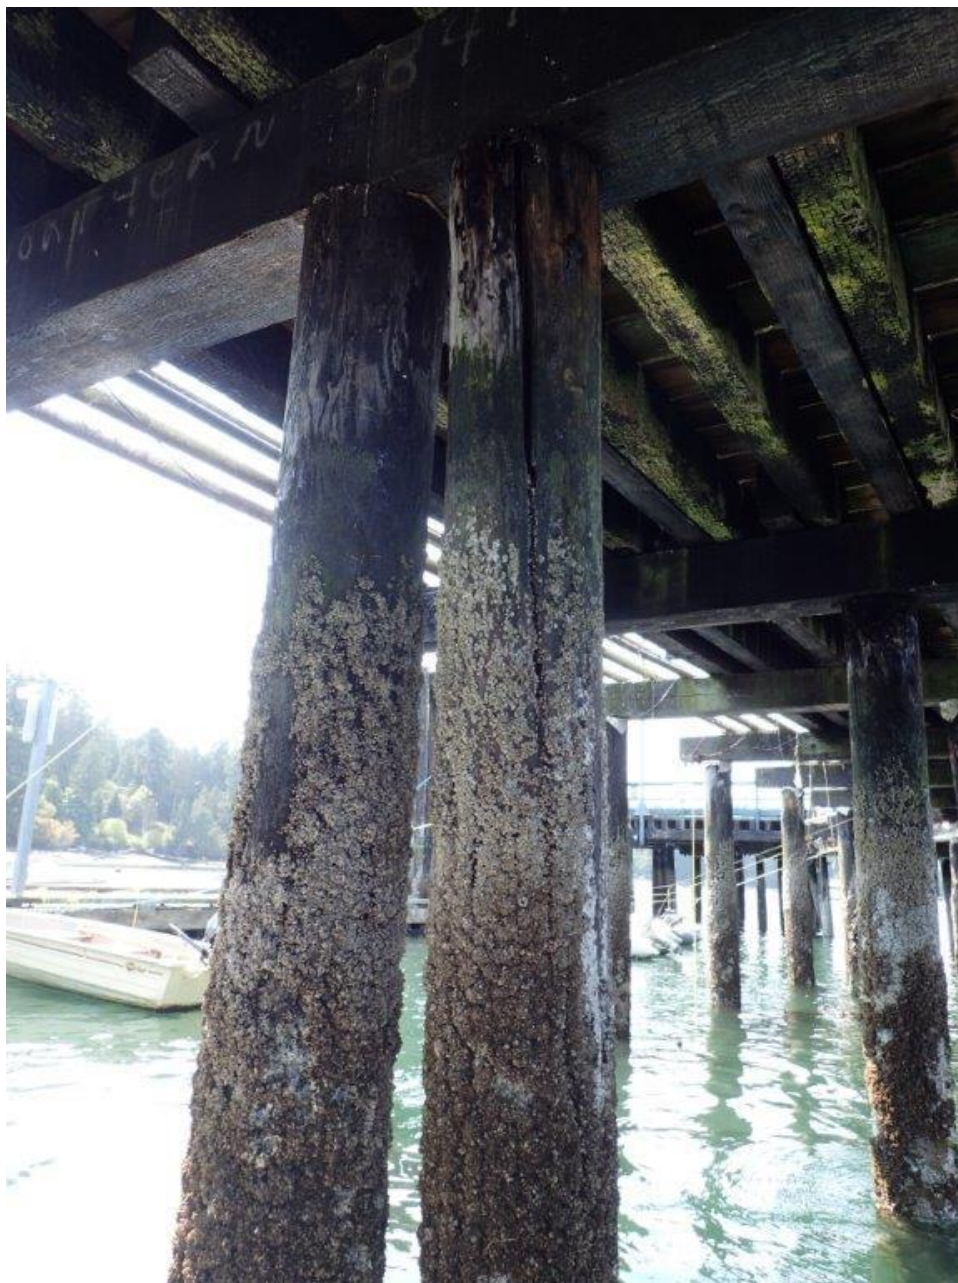
Photograph 36: Cracking in Pile 28B1

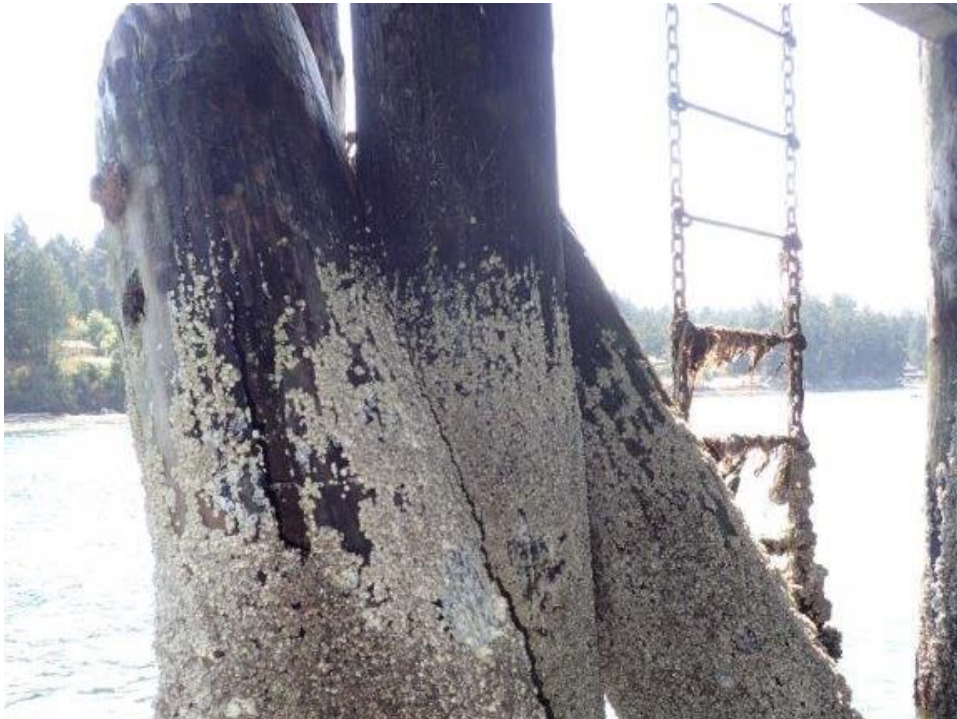
Photograph 40: Pile 38H Batter Severe Marine Borer Damage
