MINERS BAY DOCK FACILITY

CONDITION ASSESSMENT REPORT

Capital Regional District

M&N Project No. 8985 VC15

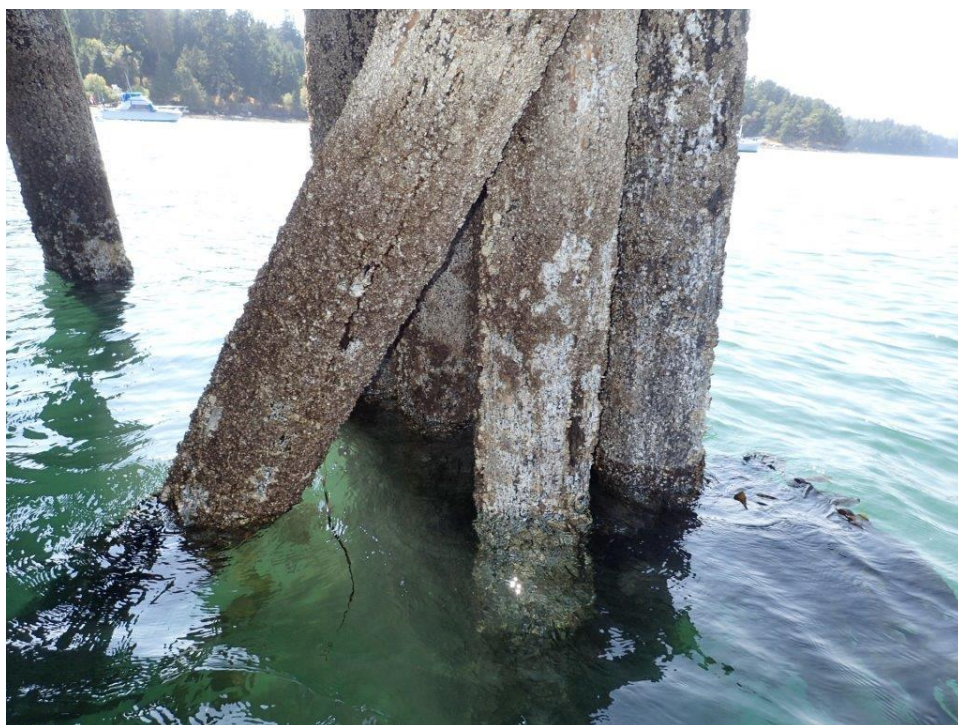
Location	Damage/Condition	Comments	Recommendations
Piles			
Bent 2 Pile B	Crack		Monitor
Bent 3 Pile A	Crack		Monitor
Bent 5 Pile A	Concrete foundation spall		Monitor
Bent 5 Pile C	Concrete foundation spall	Photograph 30	Monitor
Bent 6 Pile C	Concrete foundation spall		Monitor
Bent 8 Pile A	Gouge	Photograph 31	Monitor
Bent 18 Pile B	Hole with severe marine borer damage	Photograph 32	Replace
Bent 21 Pile B	Hole	Photograph 33	Monitor
Bent 24 Pile B	Cracking with severe marine borer damage	Photograph 34	Replace
Bent 25 Pile C	Hole 1" in diameter		Monitor
Bent 28 Pile B1	Cracking	Photograph 36	Monitor
Bent 32 Pile C	Cracking with severe marine borer damage		Replace
Bent 38 Pile H	Batter Pile severe marine borer damage	Photograph 40	Replace
Bent 38 Pile B	Marine borer damage 30% section loss		Replace
Bent 40 Pile A	Severe marine borer damage		Replace
Bent 40 Pile A	Batter pile severe marine borer damage	Photograph 44	Replace

Photograph 44: Pile 40A Batter Severe Marine Borer Damage

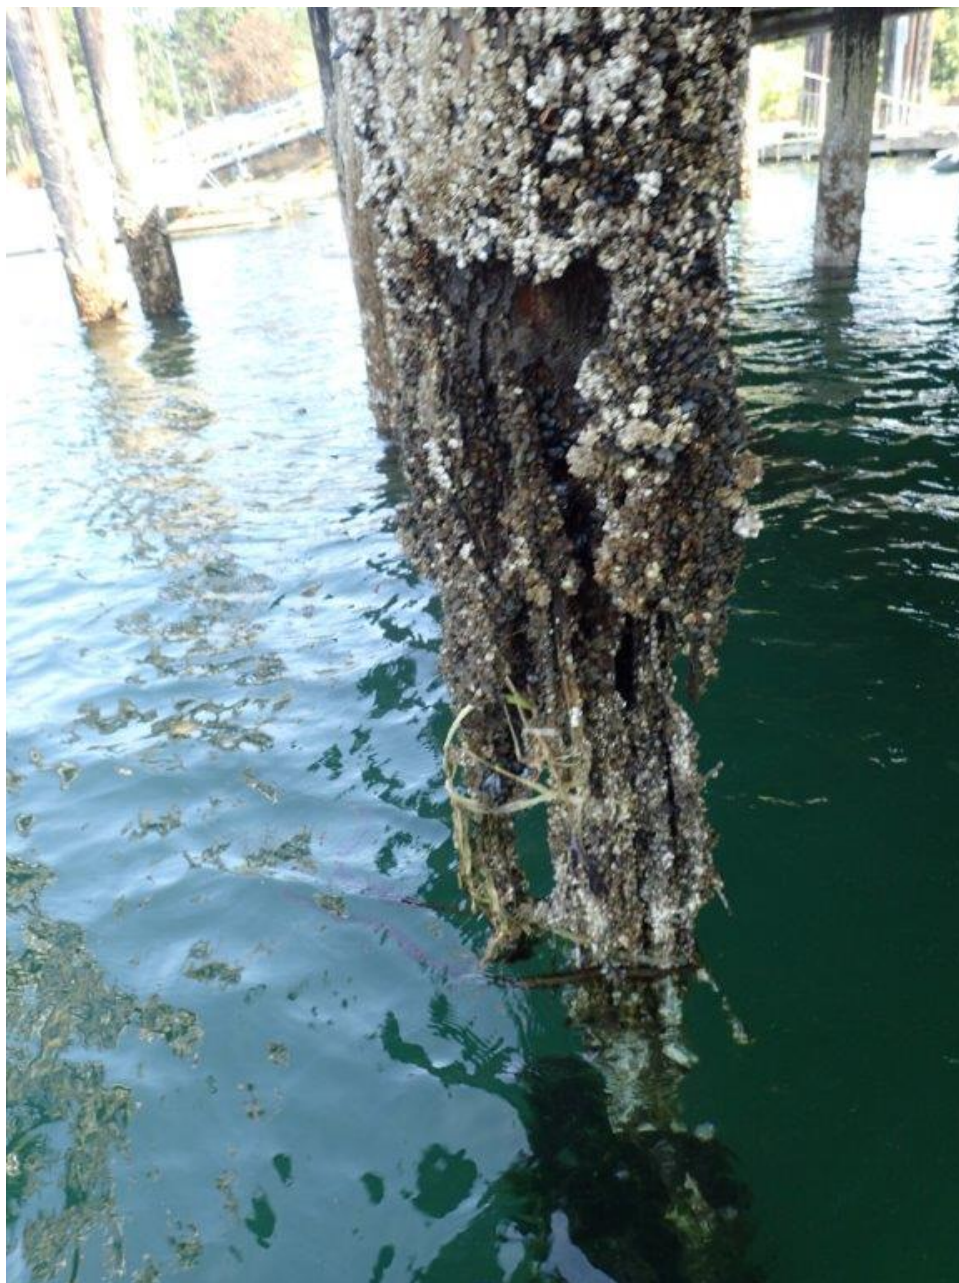
Bent 39 Pile A	Severe marine borer damage	Photograph 45	Replace
Bent 38 Pile A	Batter pile severe marine borer damage	Photograph 46	Replace
Bracing			
Bent 25	Broken	Photograph 35	Repair

Photograph 45: Pile 39A Severe Marine Borer Damage

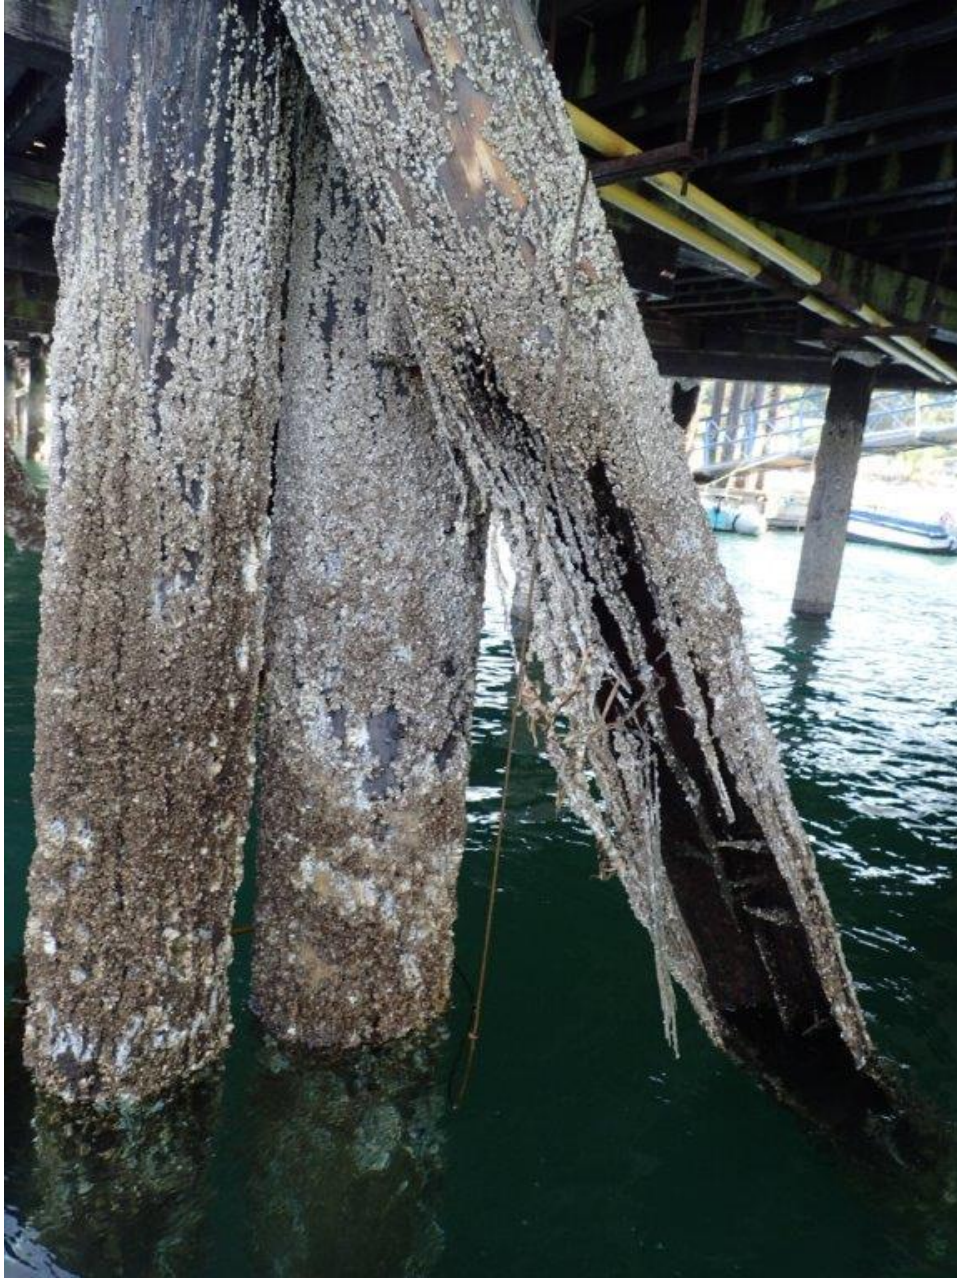
Photograph 46: Pile 38A Batter Severe Marine Borer Damage

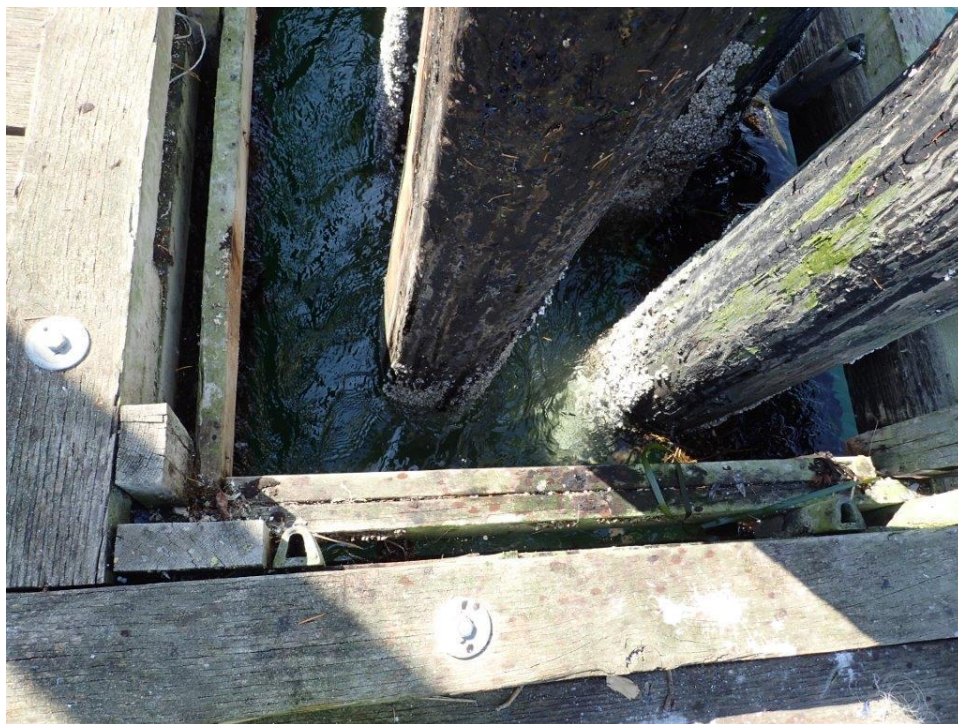
Piles 1A, 1B, 1C, 1D, 2A, 2B, 2C, 3A, 3C, 4A, 4C, 5A, 5C, 6C	Abrasion from the floats	Photograph 52	Monitor
Piles 4D and 6A	Severe abrasion from floats	Photograph 53	Replace
Pile 2D	Cavity approximately 100mm penetration x 75mm high x 25mm wide		Monitor
Pile Well			
All	Poor condition and requires UHMW on multiple sides of the pile well	Photograph 52	Replace worn rub boards and add UHMW pads

Photograph 52: Typical Pile Well Condition

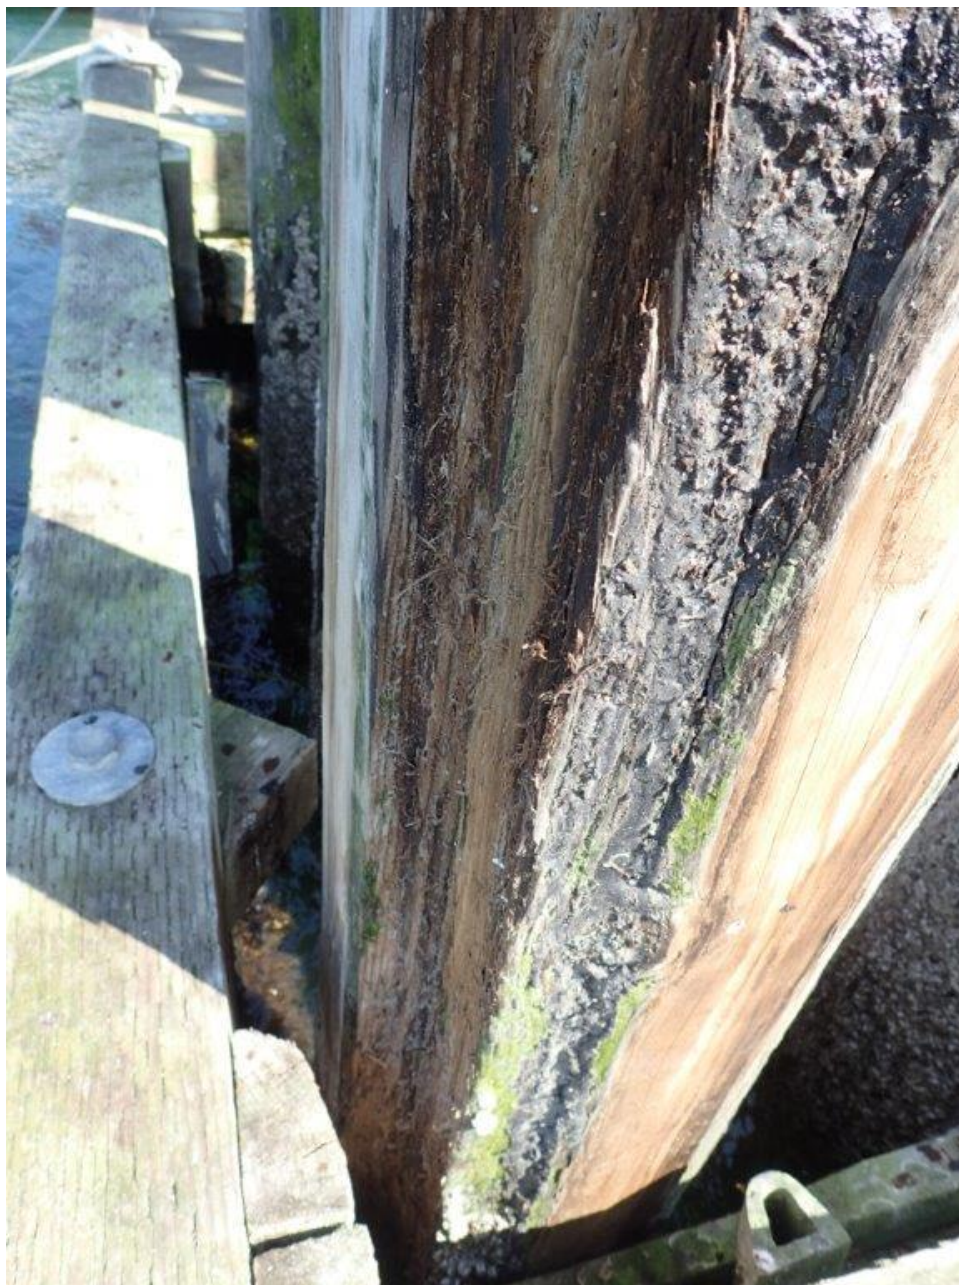
Photograph 53: Guide Pile Abrasion

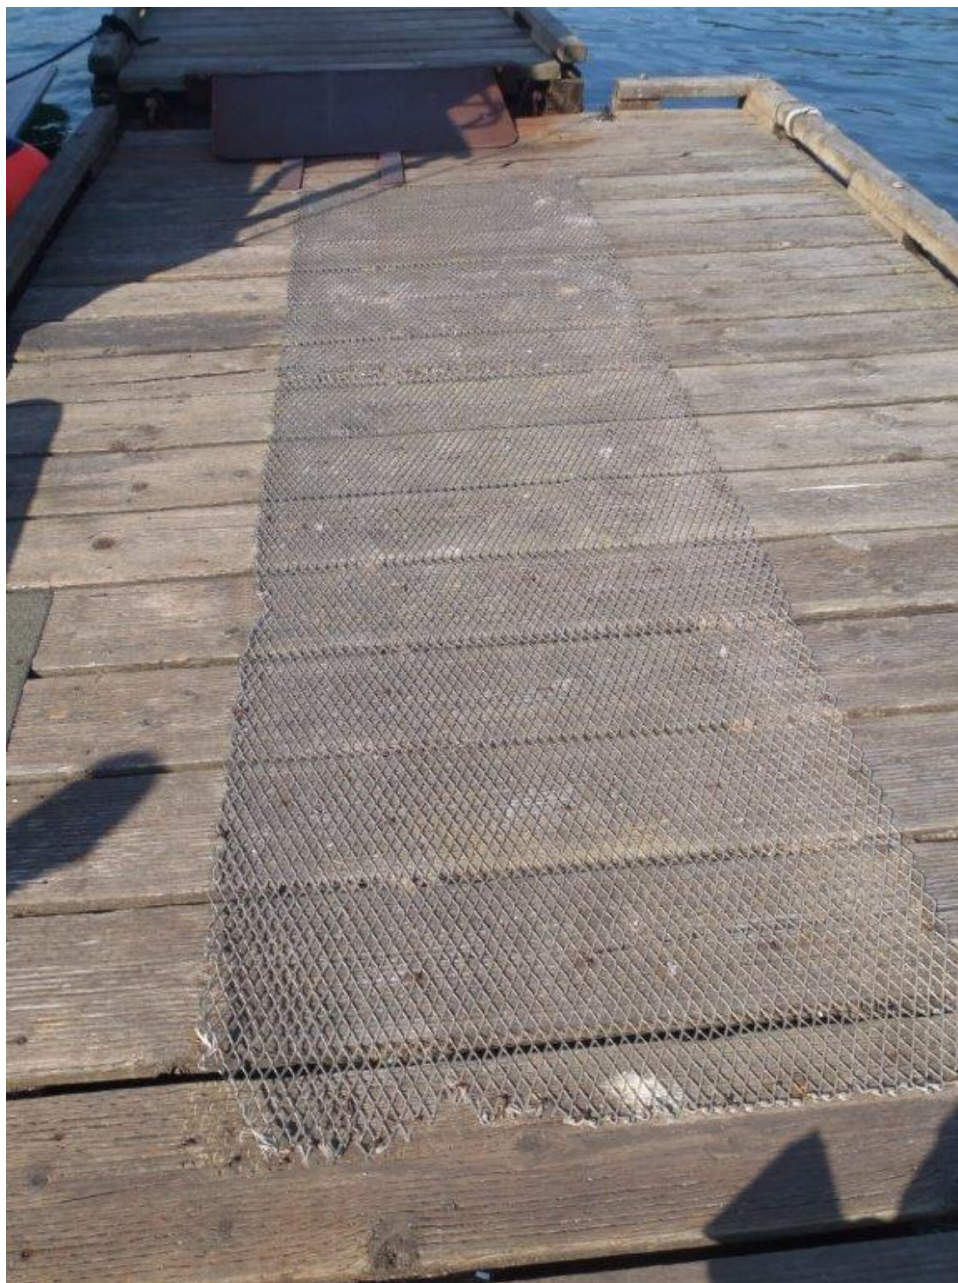
Typical	Grating on deck is disconnecting from the timber boards.	Photograph 55	Remove grating and install a lower gauge of grating
South Side	Missing board	Photograph 59	Replace
Middle	Heavy abrasion from gangway landing	Photograph 57	Repair gangway landing to prevent abrasion
Rub Boards			
Typical	Worn boards		Monitor
Anchor Chains			
Typical	Chains have 15% loss, Fair Condition		Monitor
Floats			
Typical	Foam billets are encapsulated, good condition		Monitor
Connection			
Between Float B and C	Poor Condition	Photographs 60 and 61	Repair
Transition Plate	Rusted		Replace
Decking and rub rails	Significant abrasion		Replace

Photograph 55: Float B Deck Condition

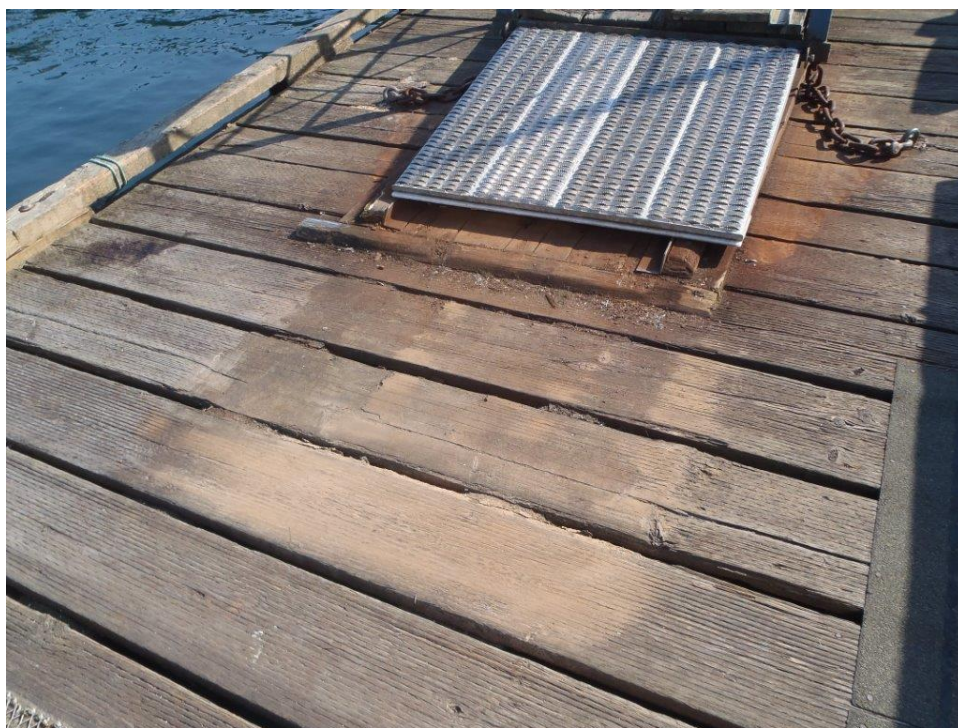
Photograph 57: Float B Deck Worn out due to transition plate

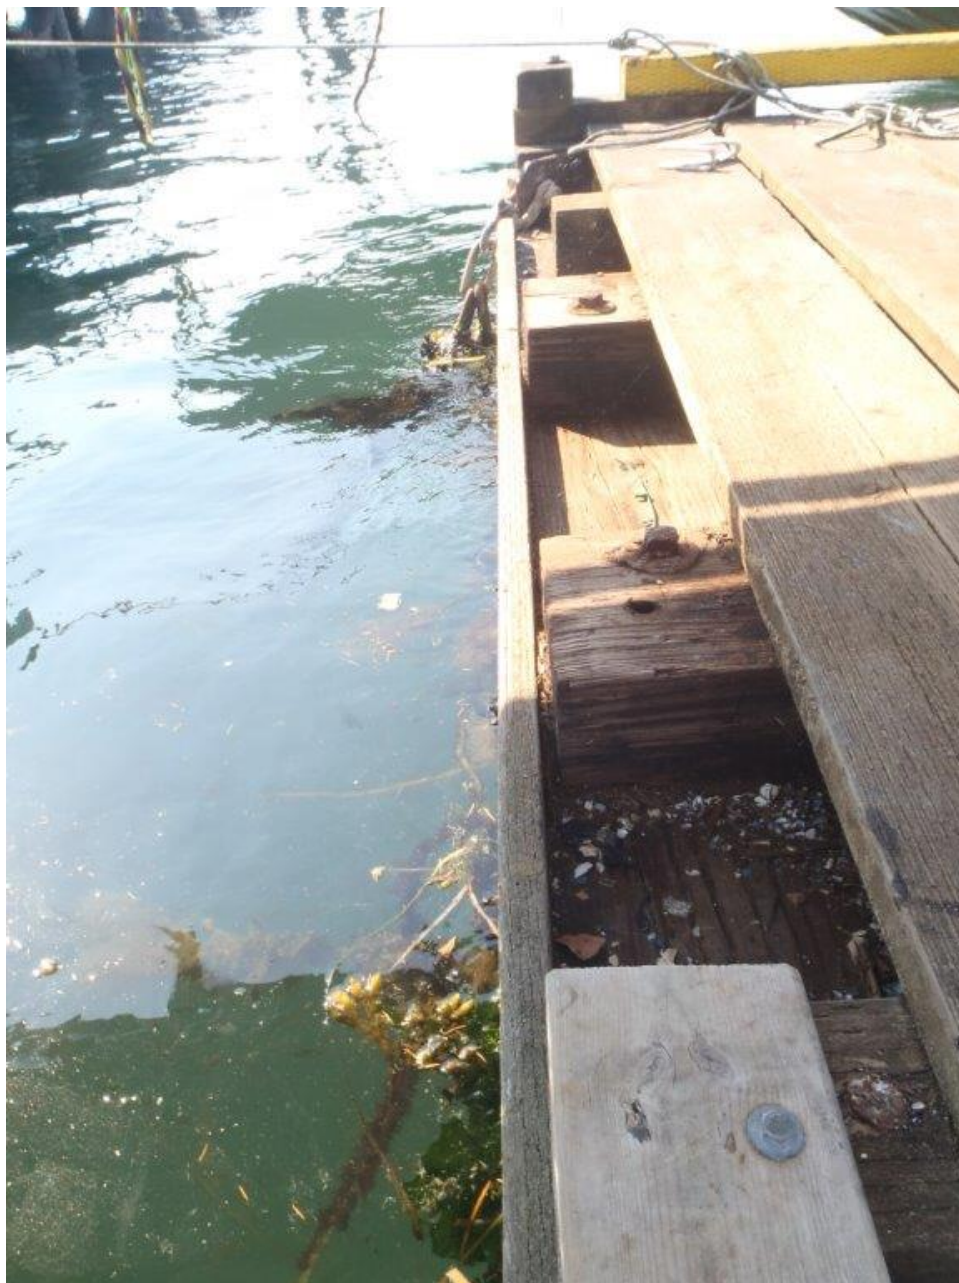
Location	Damage/Condition	Comments	Recommendations
Typical condition of floats photograph 54 to 55			
Bull Rails			
Typical	Fair condition	Photograph 56	Monitor
South Side	Missing bull rail	Photograph 59	Repair
Decking

Photograph 59: Float B missing Bull Rail and Deck Board

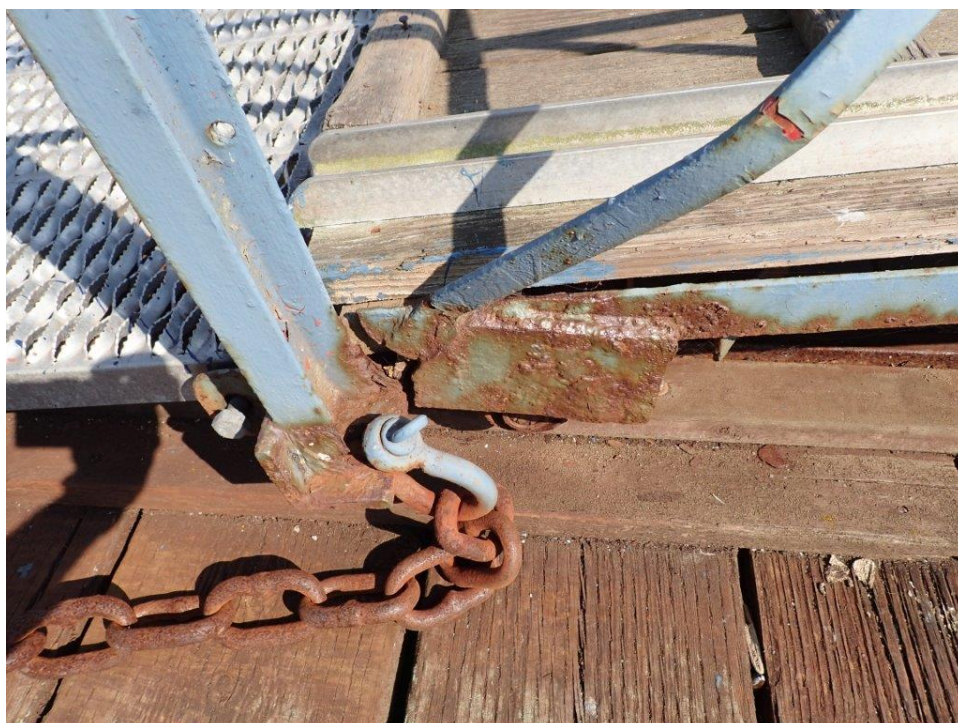
Location	Damage/Condition	Comments	Recommendations
Overall		Photograph 25	
Frame	Some loss of paint and rust	Photograph 86	Clean and repaint
Frame	Broken brace on both sides	Photographs 83 and 84	Repair
Frame	Rusted beams and braces	Photograph 86	Repair
Guide Rails	Rusted	Photograph 87	Repair
Roller	Rusted	Photograph 87	Replace
Landing platform	Poor condition	Photograph 82	Replace

Photograph 83: Gangway B Broken Support

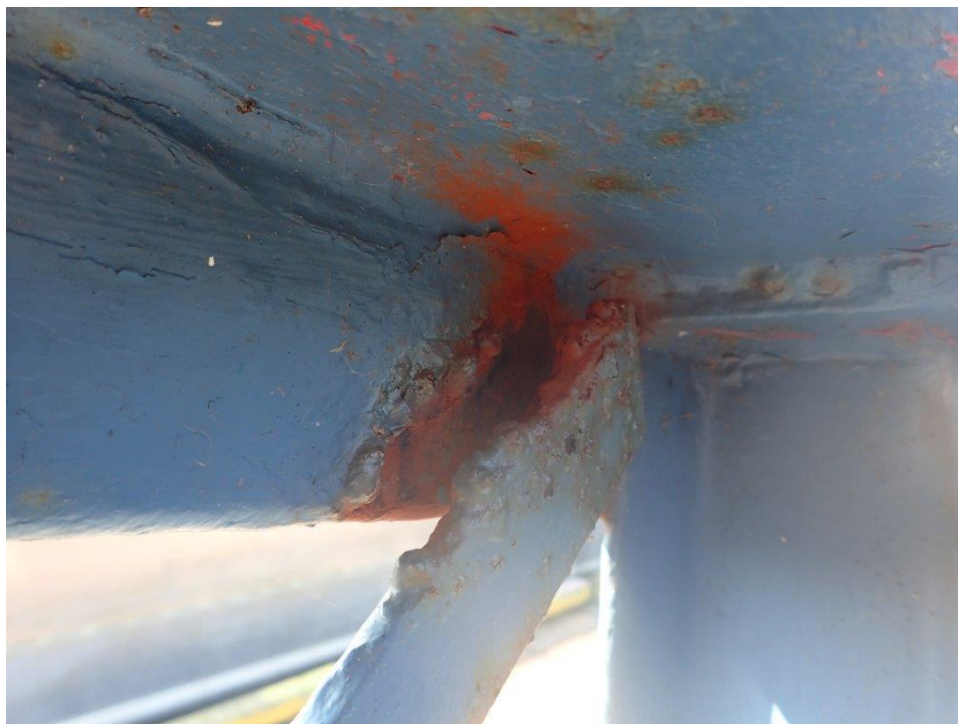
Photograph 84: Gangway B Broken Brace

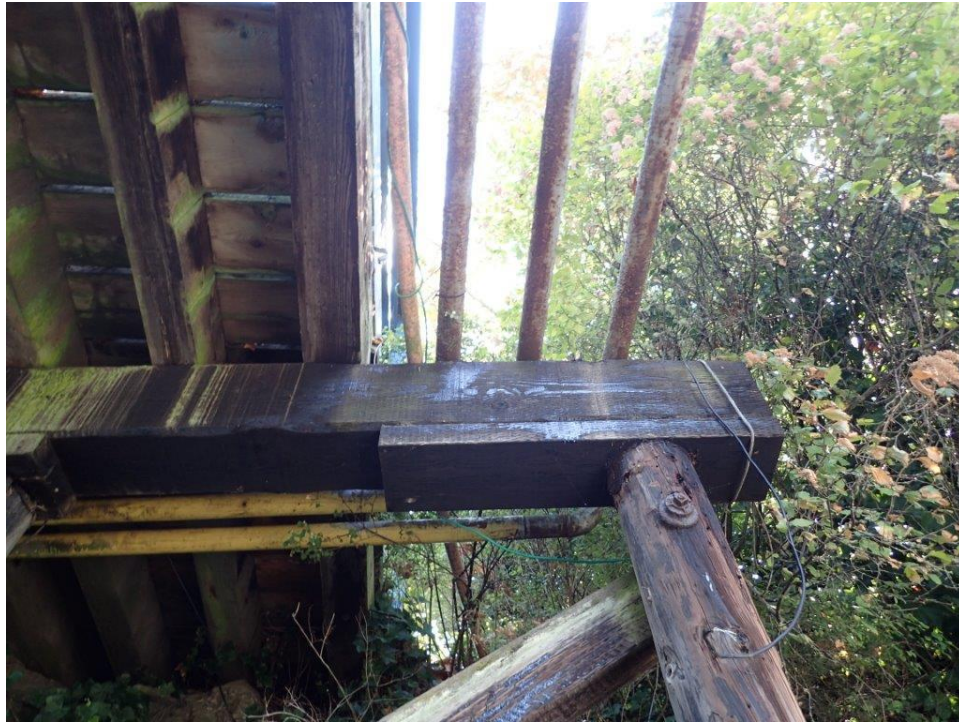
Photograph 91: Broken Electrical Wire at Bent 16

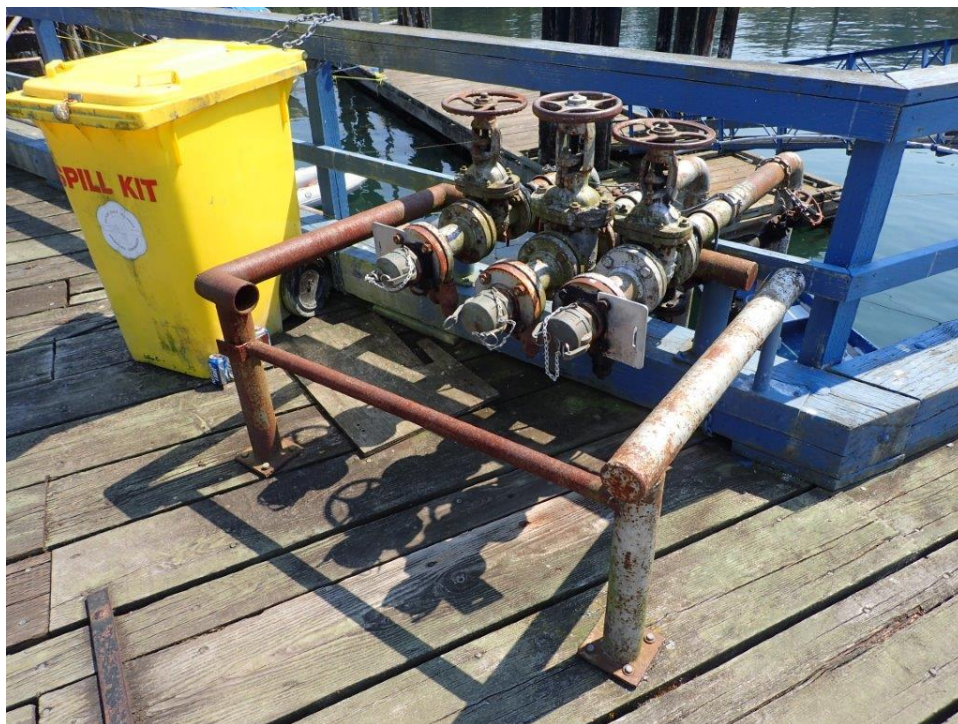
The facility in the past provided a fuel filling service for boat traffic. The float and fuel pumps have since been removed and the system decommissioned, however the pipe lines still run along the southern side of the approach. These lines are starting to rust but are in Fair Condition and do not, at this time, need to be removed. Close monitoring of these pipes is recommended to prevent damage.

Photograph 106: Decommissioned Fuel Lines

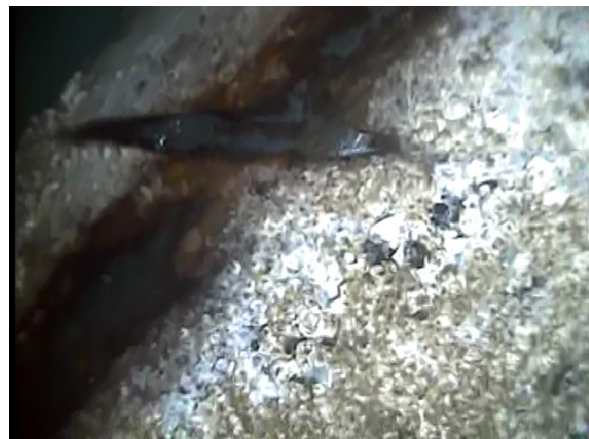
C) Float contact on wooden pile, wear approx 12mm. Steel pile wear from float approx 2mm, weld seam flush with pile surface. Scattered areas on steel pile, exposed corrosion to 1mm depths.

Ch.2: 2:25 Steel pile

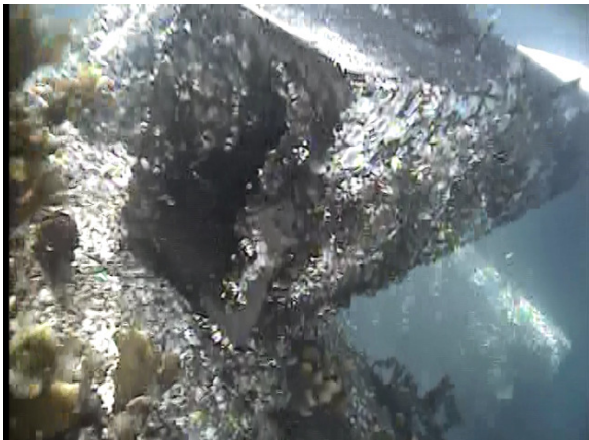
- A) Pile row #6 angle cross timber, hollowed out at end in way of piling C
- B) Crack lines evident in pile 6B at concrete pile foot

Cross timber

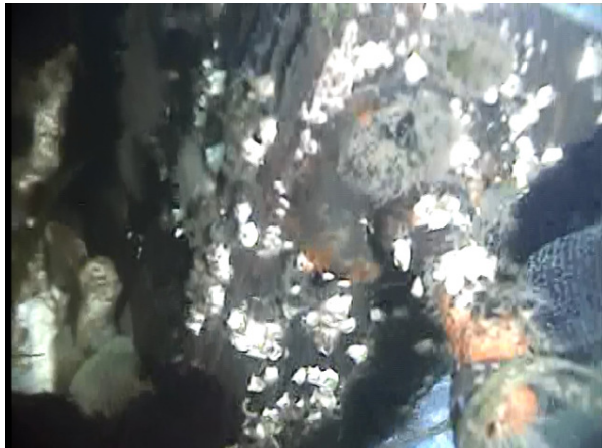
C) Scattered timber bolts found to be corroded, many remaining in fair condition, floats appear secure and solid. Side horizontal timbers are deteriorated and loose, mainly at the west end of the float.

39:33 Corroded nut

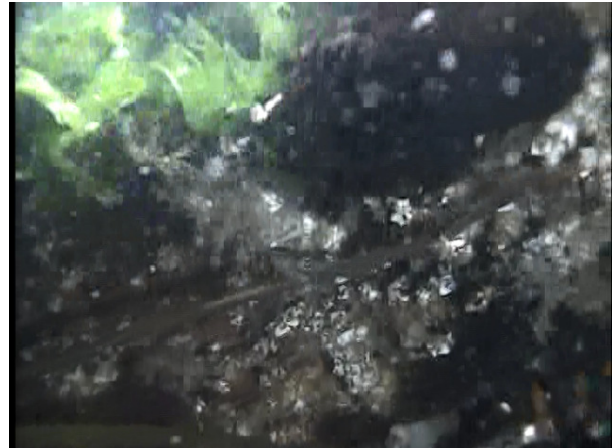
40:55 Deteriorated timber

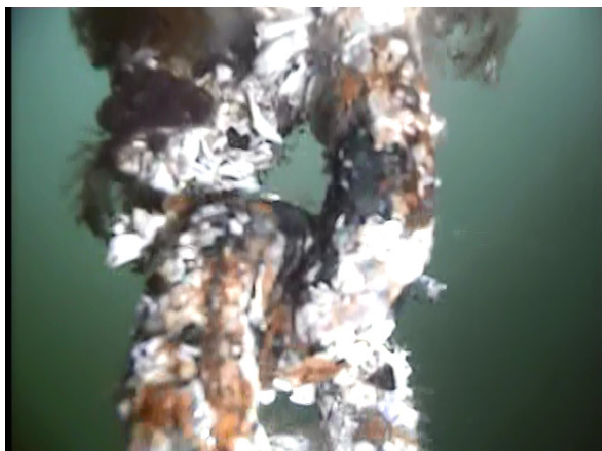
A) Anchor chain condition wear average approx 1mm with exception to the connection at float A anchor block extending from the north corner to offshore block. The shackle connection is approx 70% worn through. Anchor chain anodes sighted are 30% depleted.

02:30 Typical anchor chain wear

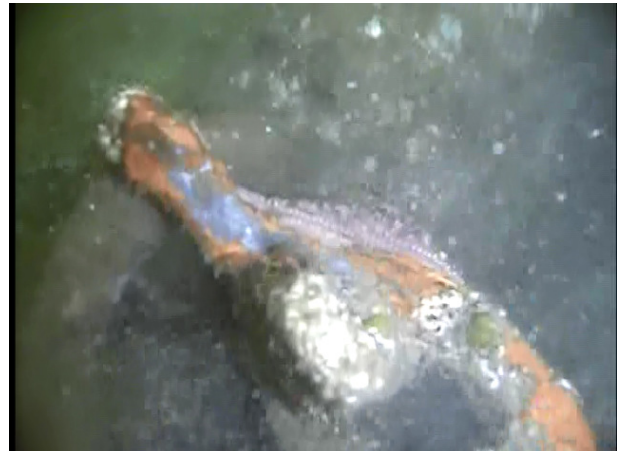
08:52 Severe shackle link wear

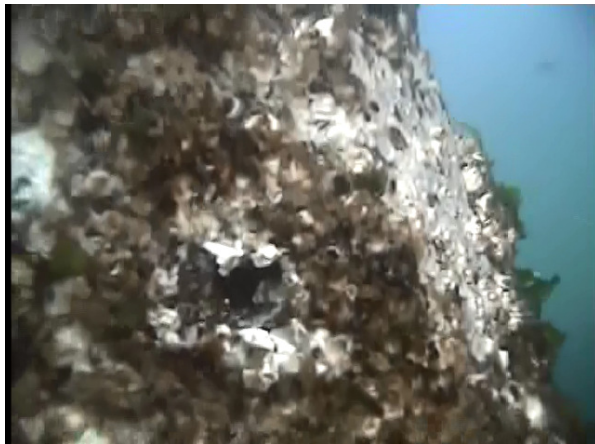
A) Row 18 Piles A and B small cavities and cracks

Ch2: 51:55 Cavity 40mm deep x 25mmW

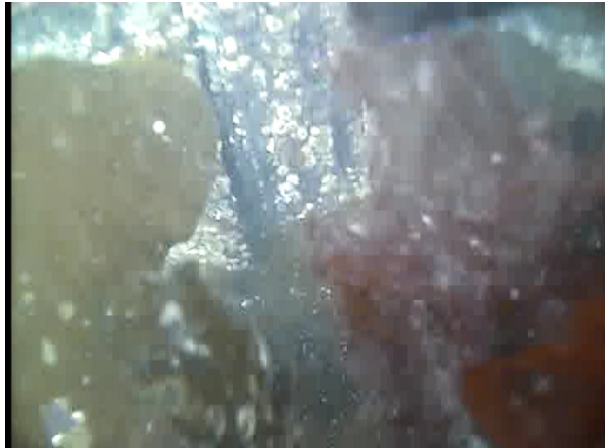
Ch2; 53:14, 2 cracks 50mm deep x 150mmH
