Talbot Mackenzie & Associates

July 11, 2016

Re: 88.0 cm d.b.h. Horse Chestnut

Assignment: To conduct a health and risk assessment on an 88.0 cm d.b.h. Horse chestnut tree located at the North side of the property at 955 Hillside Avenue. Prepare a report on our findings giving recommendations for mitigating any associated risk. Review the proposed new building plans for the property and provide recommendations for mitigating any potential impacts the proposal may have on the tree, should we find it suitable to retain.

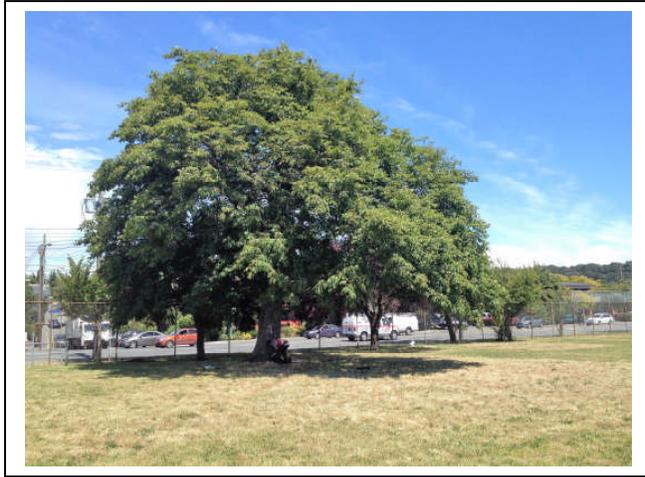
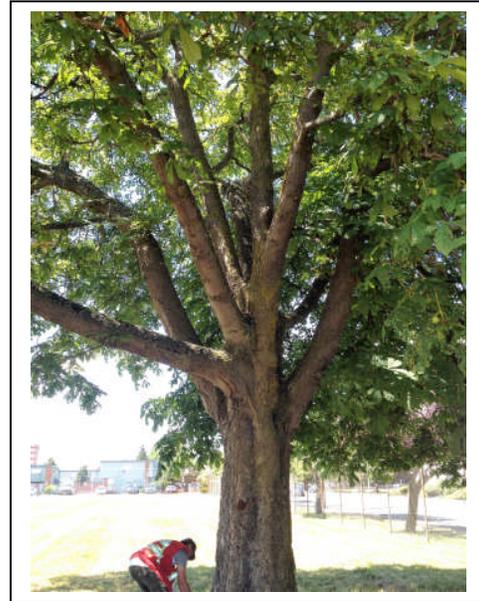
Methodology: We visually examined the above mentioned tree on June 16, 2016 and for the purpose of detecting internal decay or signs of fungal infection resistograph readings were taken at the soil line, at the root collar from all sides of the tree.

At the base of the tree in two places we found fruiting bodies of the fungal decay pathogen *Ganoderma*. Resistograph readings taken at the base of the tree encountered significant drops in resistance on three sides of the tree indicating the fungal infection has weakened the wood tissue quality in these areas. This type of decay is a white rot in which both lignin and cellulose are degraded together resulting in a great loss of strength at an early stage of infection and leading to transverse trunk fractures. A relatively large volume of decaying wood is required to support fruiting; therefore, when a basiocarp (fruiting body) develops on a living tree, extensive decay is often present.

Location of tree, taking resistograph readings from the lower trunk.

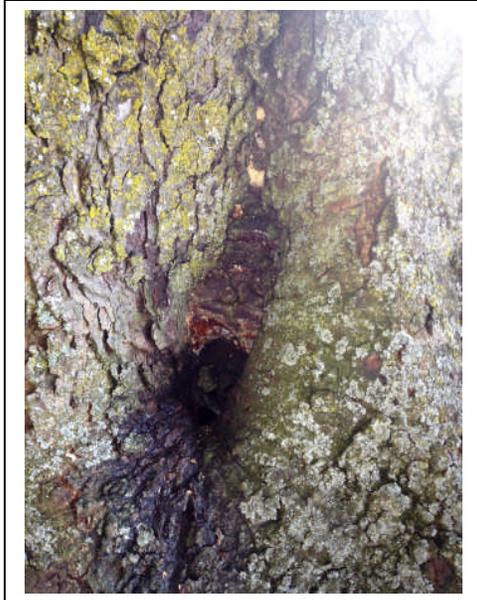
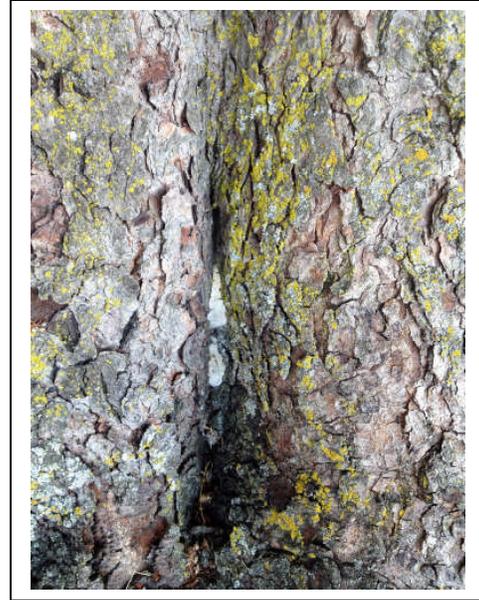
Fruiting bodies of the fungal decay pathogen *Ganoderma* found in two places on the lower trunk.

Recommendations: In our opinion, given the existing fungal infection and the low readings encountered with the resistograph, this is not a tree that we would recommend retaining in a high target area as is proposed in the new construction. As the tree is already infected with a decay pathogen and we anticipate there may be additional impacts from the proposed construction activity, we feel it would be a better option to remove this tree to eliminate all associated risk and replant with a healthy new tree that can better adapt to the new growing conditions that are going to be introduced.
