TABLE OF CONTENTS

BOWKER CREEK ASSESSMENT SUMMARY

REACH 1A
Reach # 1A – Creek mouth into Oak Bay to upstream (west) end of 1776 Beach Drive) (140m) 2733, 2717, and 2713 Somass Drive; 1725, 1762, and 1776 Beach Drive (privately owned)
Channel Description Channel banks are primarily concrete, mortared rock and concrete sandbags (Photos 1-6,8-10,12-15). The channel bottom is a mix of bedrock, heavily silted substrate of sand, gravel, cobble, and boulders, and extensive concrete and asphalt armouring (Photos 3,8,9,12,13,16). Thick algal mats and root mats from golden willow are present. Vertical armoured banks 1-2m tall, channel width 3.0m – 5.5m, wetted width 0.4m-3.5m (summer). The creek is channelized and straightened with a gradient range from 1.5-4% with a narrow strip of riparian vegetation (Photos 17 & 18). There is a 22m long pool downstream of the culvert which is suitable as a holding location for juvenile fish prior to entering the marine environment, and also for adults entering the stream to hold while awaiting higher flows and while maturing. Tidal influence occurs downstream of Beach Drive. Concrete box culvert at Beach Drive (3.0m wide x 2.2m tall x 15m long). Small a

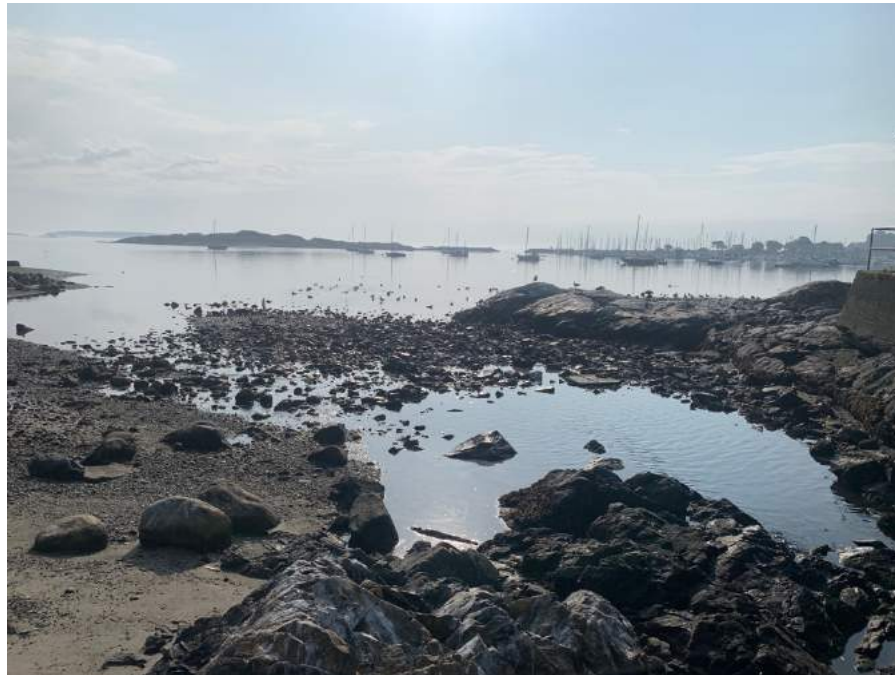
Photo 1A-1. Bowker Creek mouth, flowing into Oak Bay.

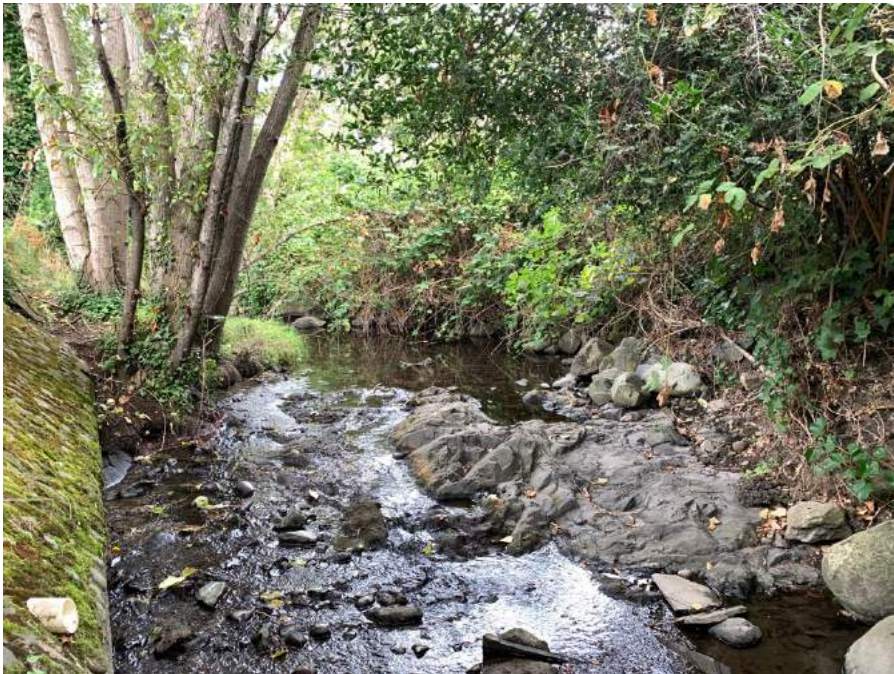
Photo 1B-1. Downstream end of Reach 1B, mortared wall on south side (1762 Beach Dr/2660 Shady Ln) and eroding soil bank on north side (1776/1790 Beach Dr). Bedrock and cobble creek bottom, creating natural weir with pool above (view upstream).

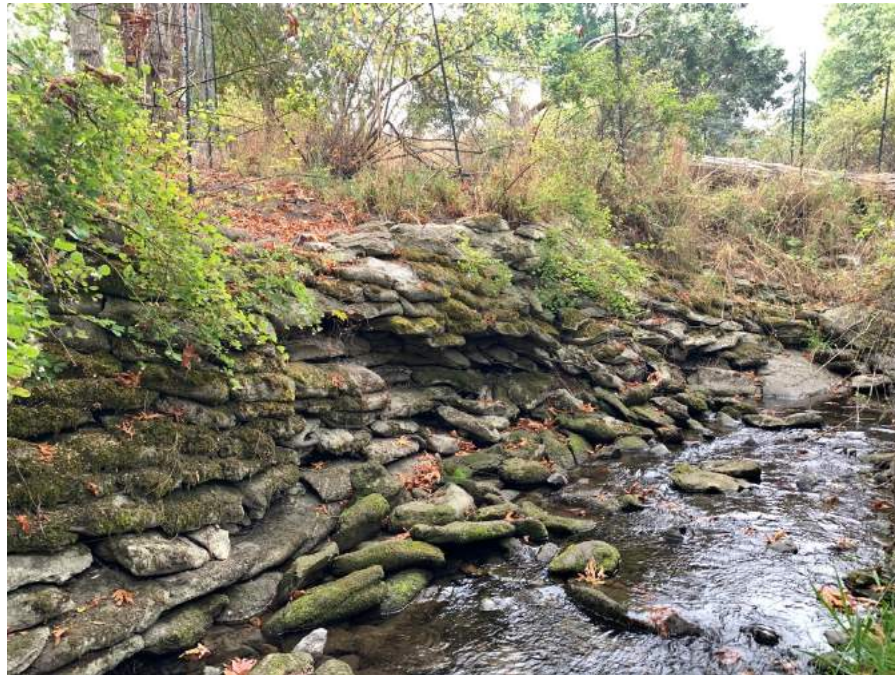
Photo 1C-1. Downstream end of Reach 1C, south bank, eroding concrete sandbags (view upstream).

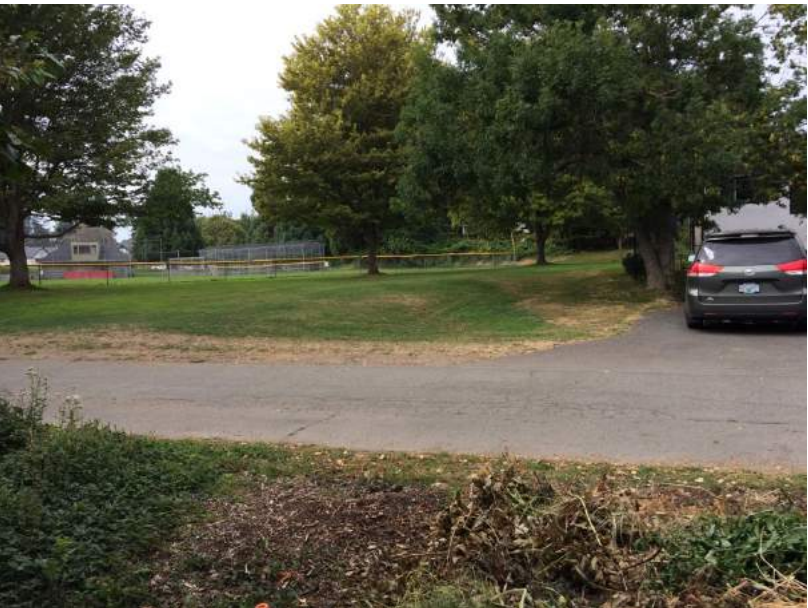
Photo 2-1. Firefighter’s Park from the top of Reach 1C at Monteith Street (view west/upstream).

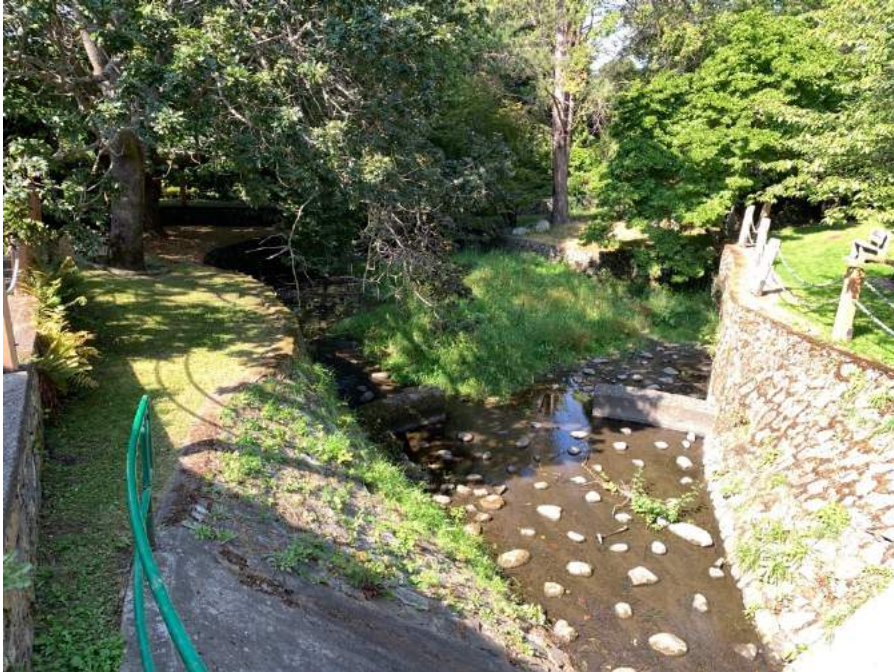
Photo 3A-1. Downstream end of Reach 3A, where it enters the culvert under Monterey St (view upstream) (see Photos 3A-17 & 18 for winter conditions).

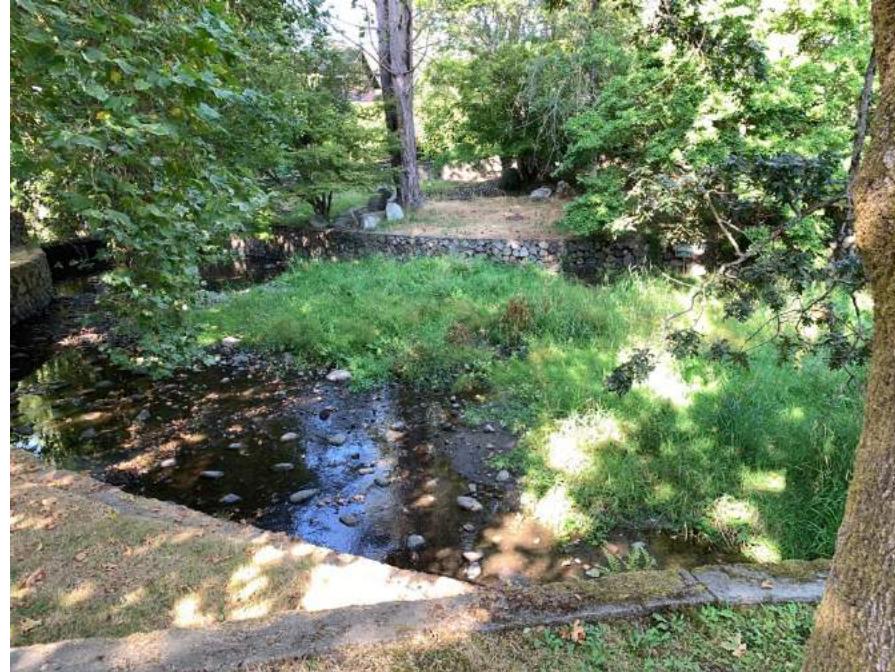
Photo 3A-2. Downstream former pond area with reed canary grass establishing. FoBC removing invasives and planting native species since weirs were removed (view across/upstream) (see Photos 3A-17 & 18 for winter conditions).

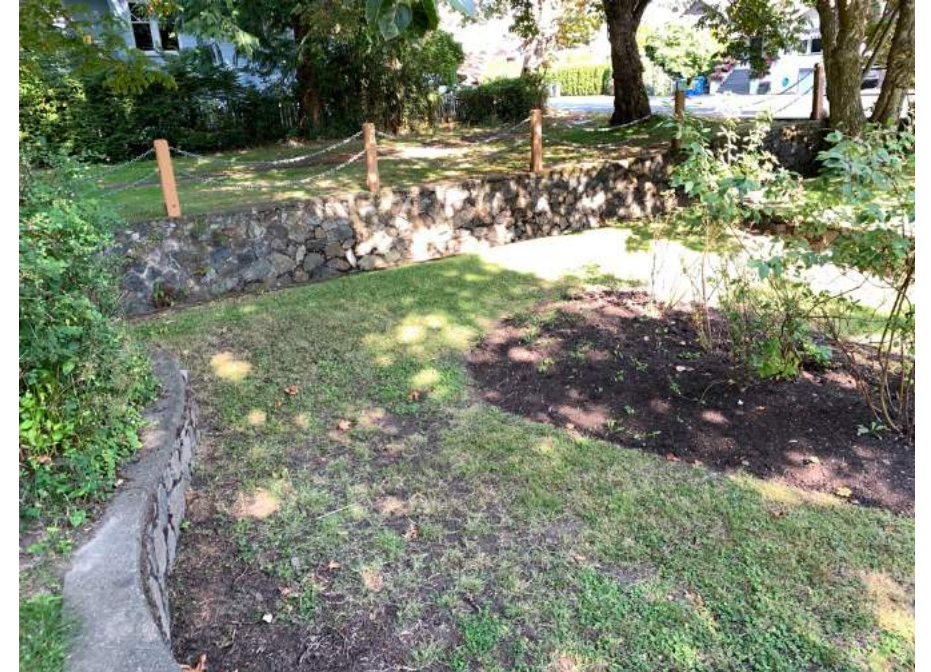
Photo 3A-3. Potential pilot project location for concrete wall removal and restoration of channel and slope upstream from Hampshire Road.

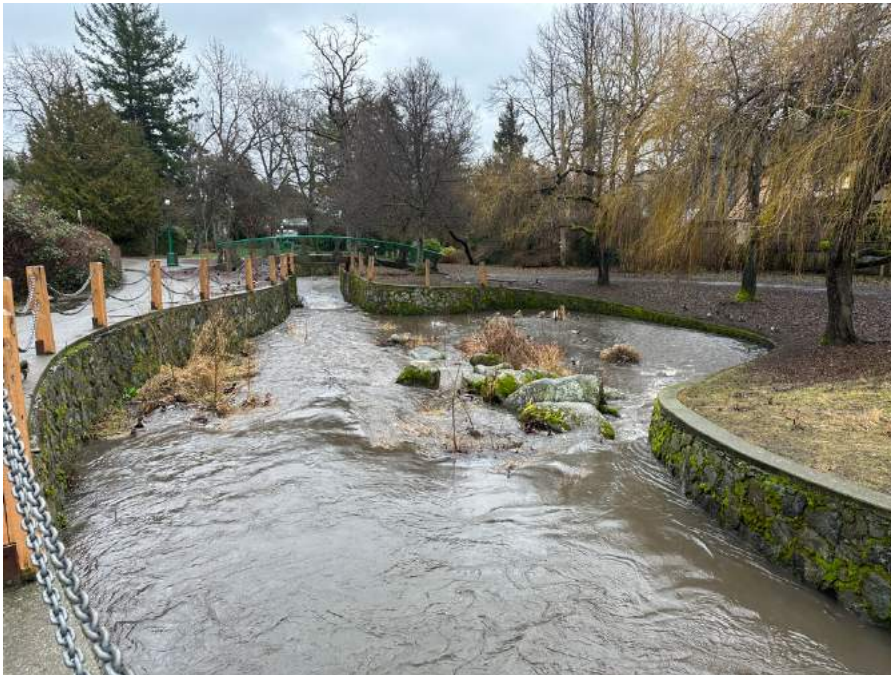
Photo 3A-13. Uppermost ponding area in winter conditions (view downstream) (see Photos 3A-6 & 7 for summer conditions).

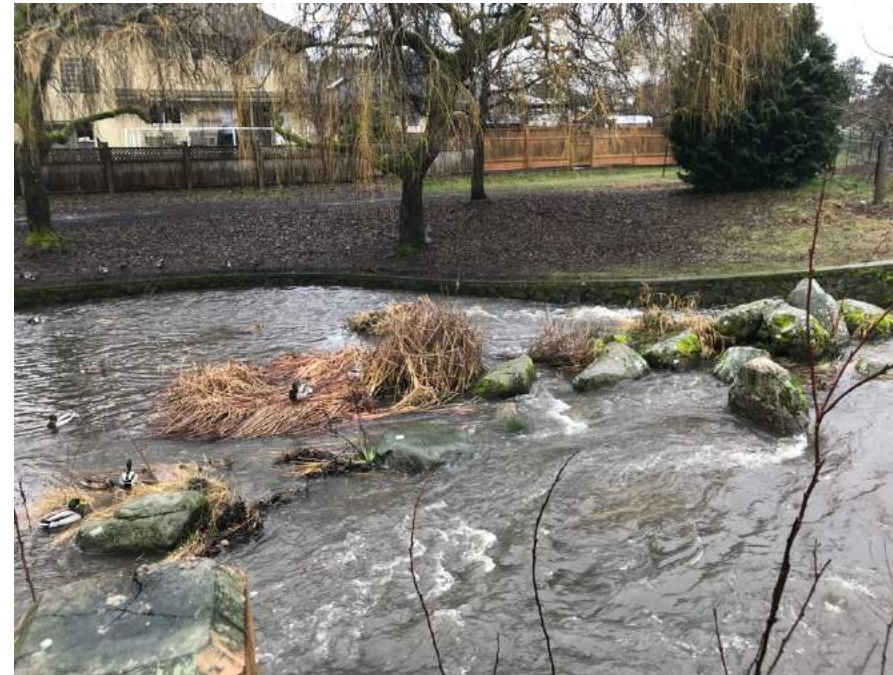
Photo 3A-14. Uppermost ponding area in winter conditions with ducks using instream boulders and vegetation for refuge (view across stream) (see Photos 3A-6 & 7 for summer conditions).

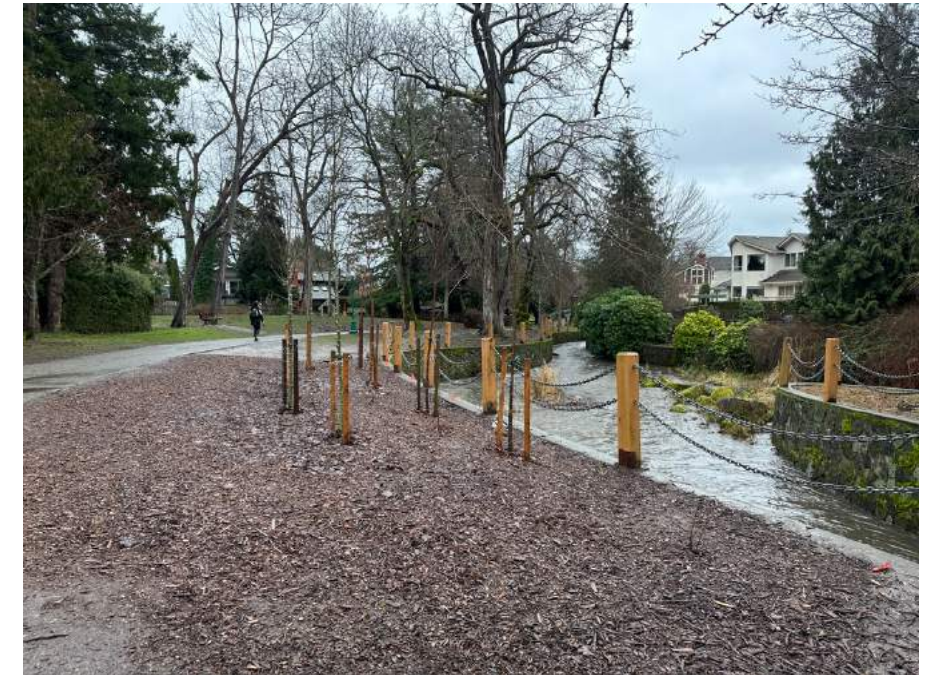
Photo 3A-15. A former area of bare earth with recent plantings and mulch. Fencing around the mulched area would provide protection from inadvertent trampling as the many small shrubs are not protected by posts and are hard to see (see Photo 3A-5 for Before).

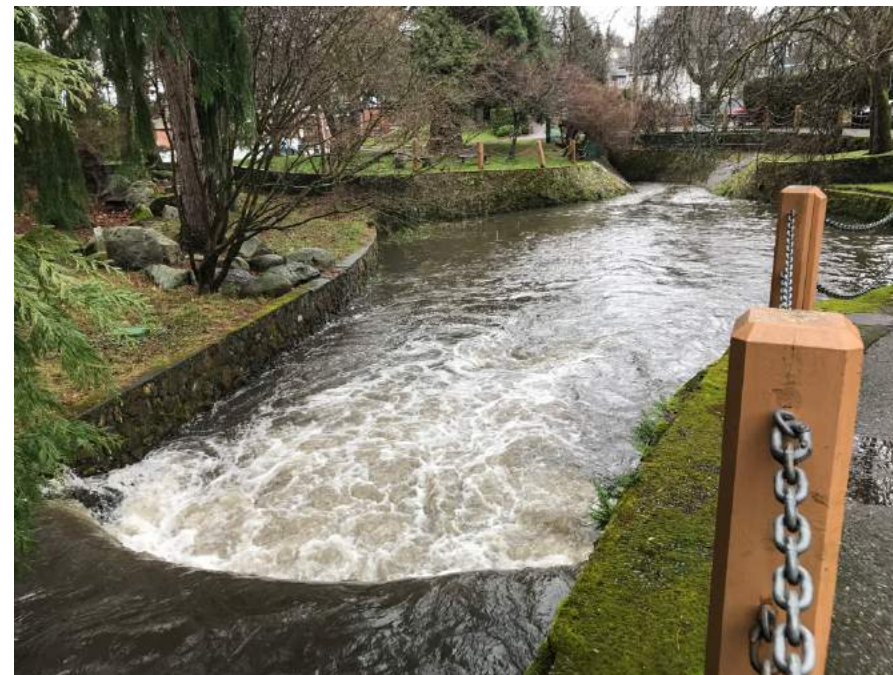
Photo 3A-17. Waterfalls over the weir locations in the lower end of the reach (view downstream to Monterey) (see Photos 3A-1 & 2 for summer conditions).

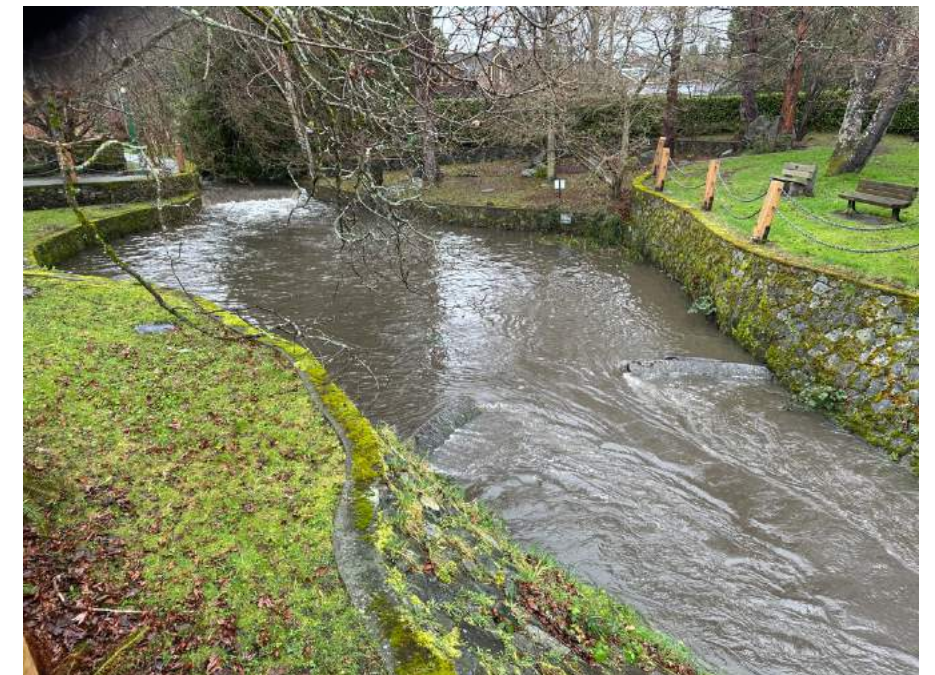
Photo 3A-18. Waterfalls over the weir locations in the lower end of the reach (view upstream) (see Photos 3A-1 & 2 for summer conditions).

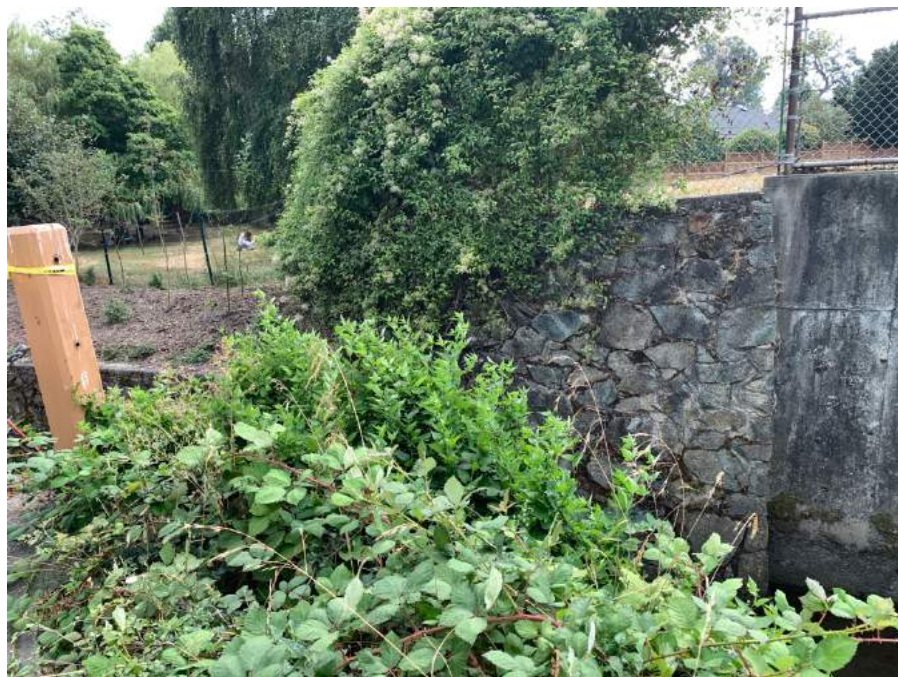
Photo 3B-1. Downstream end of Reach 3B, Himalayan blackberry, traveler's joy, and European bittersweet (view downstream).

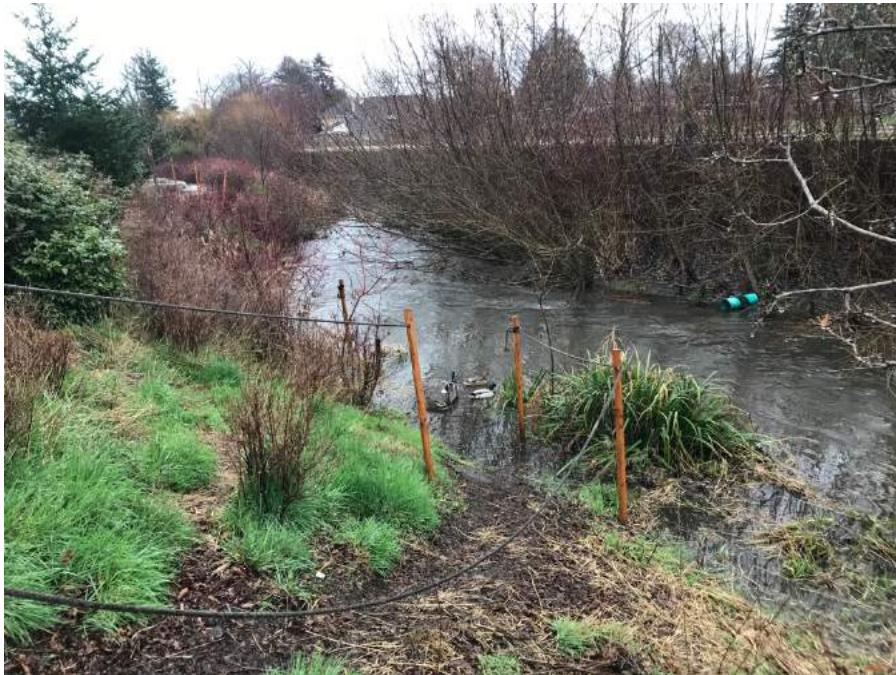
Photo 3B-15. Ducks taking advantage of instream vegetation for refuge from high flows. Ropes and posts define access points to reduce damage to vegetation from foot traffic (view downstream, mid-reach). Constructed willow bench on south wall (upper right).

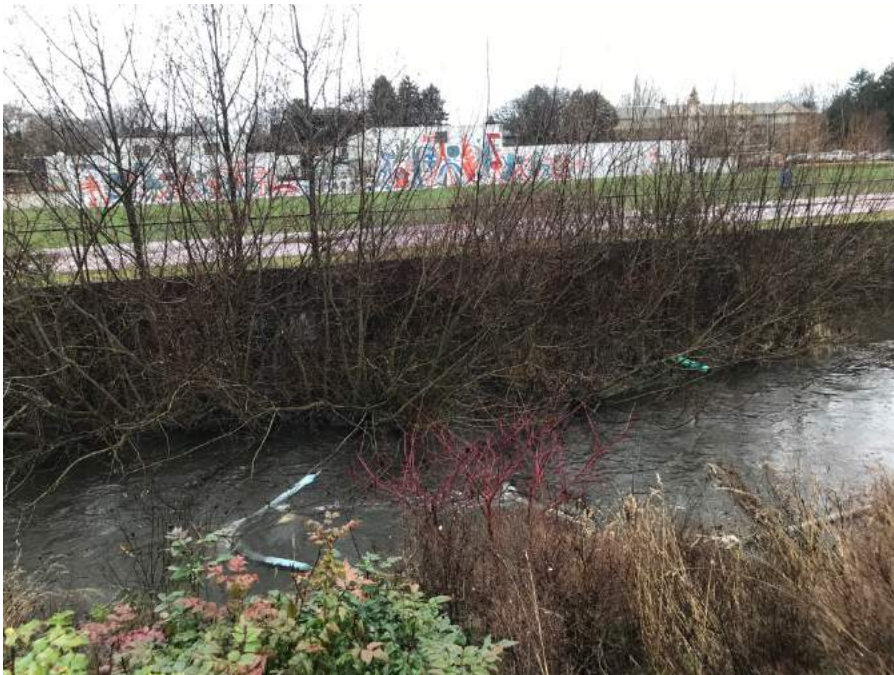
Photo 3B-16. Oil booms deployed for recent oil inputs (view south).

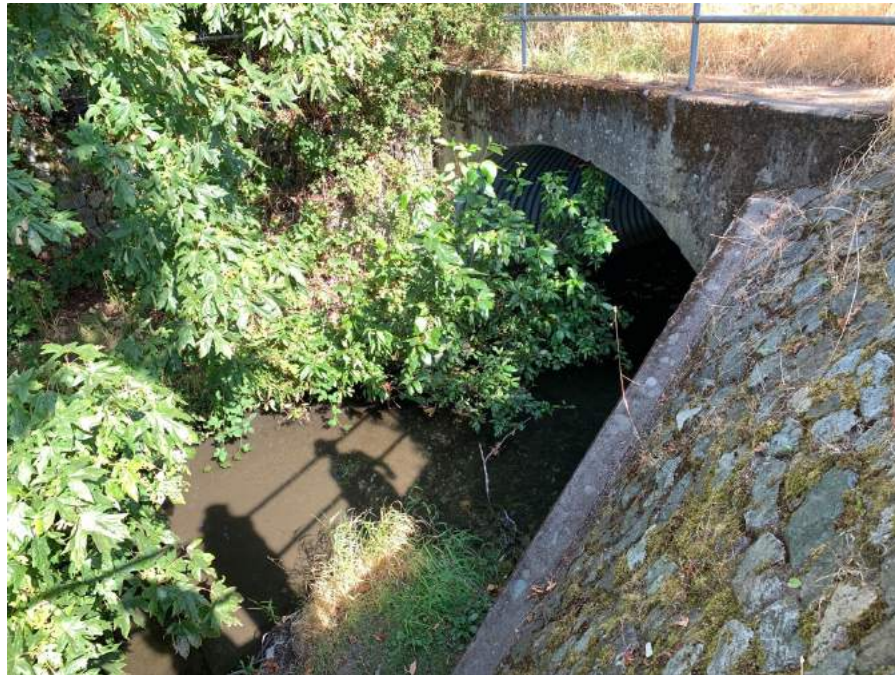
Photo 5A-1. Downstream end of Reach 5A culvert that flows under the Tennis Bubble (view downstream).

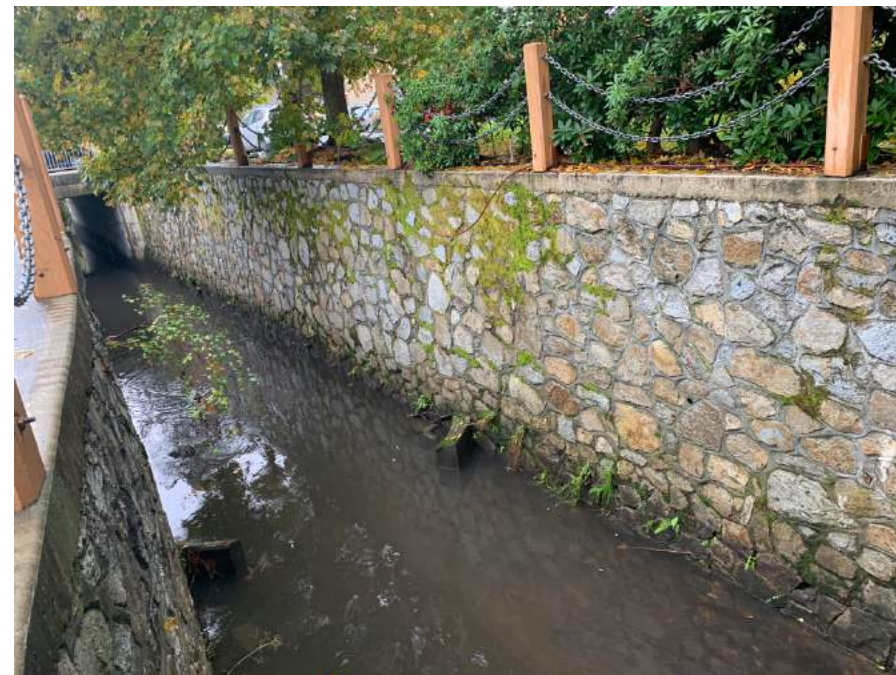
Photo 5B-5. Vertical masonry walls and small incomplete weir with limited substrate complexity, and sword fern growing from wall cracks (view downstream).

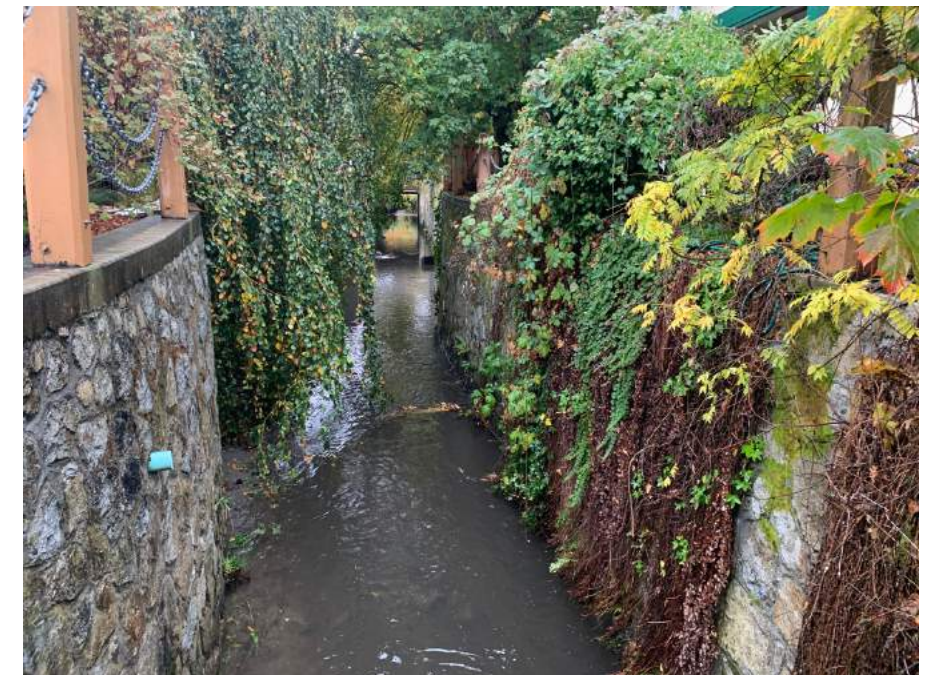
Photo 5B-6. View downstream from Cadboro Bay Road at English ivy, Himalayan blackberry, creeping Taiwan bramble, wisteria and other mostly ornamental species. While invasive, the vegetation likely provides some greater complexity and cooling of the walls in comparison with bare walls.

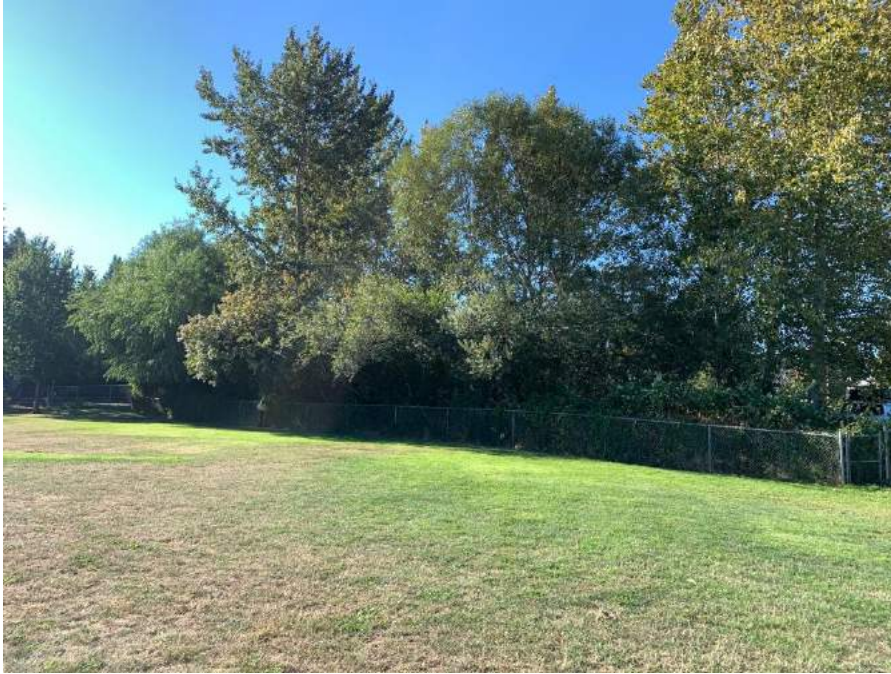
Photo 7A-1. Lower end of reach (45m section downstream of footbridge), restoration demonstration area, fencing and mown grass to the top of bank (see Photo 7A-13 for winter view).

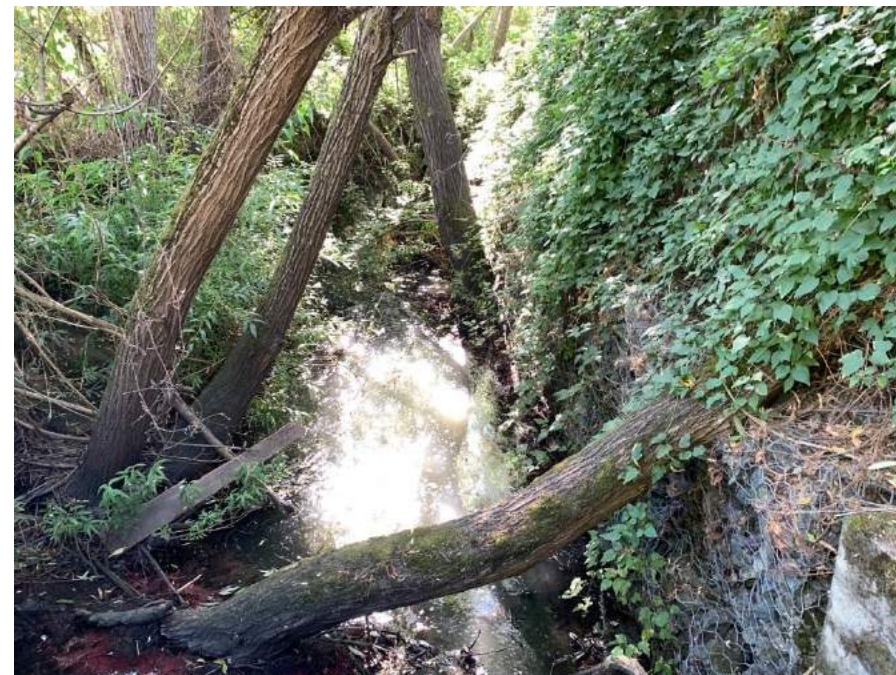
Photo 7A-11. Downstream of Haultain Street: gabions, European bittersweet, and English ivy on the west bank, and golden willow at the base of the east bank (see Photo 7A-24 for winter conditions).

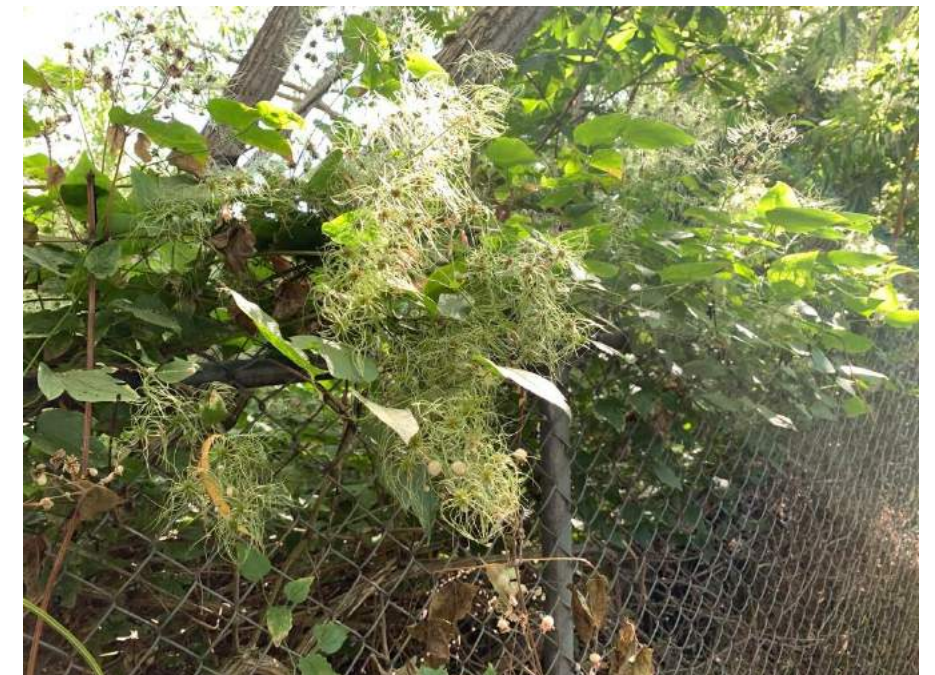
Photo 7A-12. Traveller's joy on fence, adjacent to the creek, growing throughout the golden willow canopy (downstream of Haultain Street).

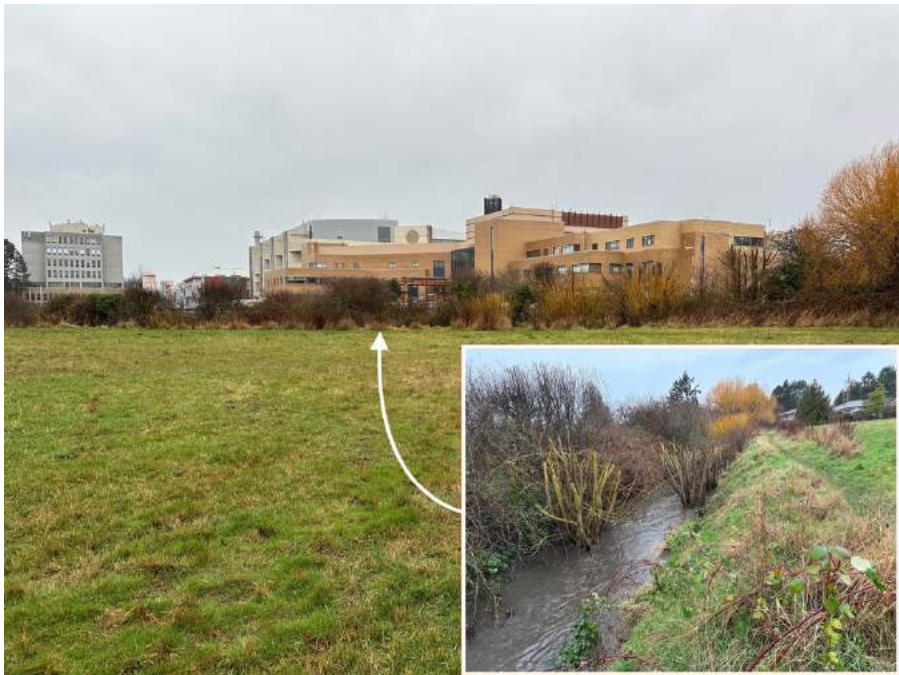
Photo 7A-18. All the higher vegetation (including native trees/shrubs & golden willow) along the section of creek adjacent to the hospital heliport have been extensively pollarded (view southwest) (see Photo 7A-10 for condition before cutting). Inset: Additionally, much of the northeast bank is devoid of shrubs and trees (view upstream).

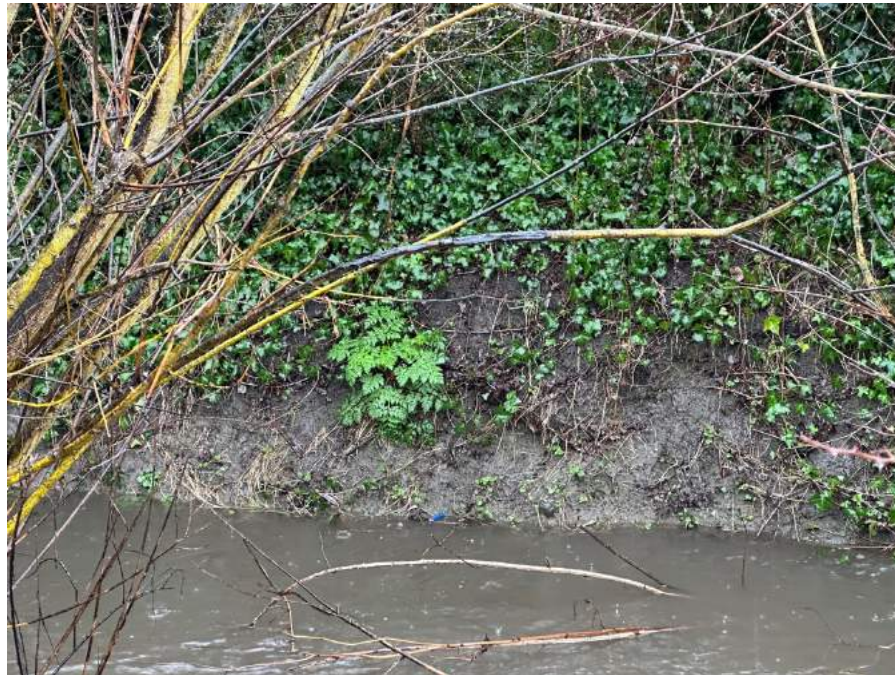
Photo 7A-19. Poison hemlock and English ivy on the west bank adjacent to the hospital heliport and otherwise bare vertical banks common to many reaches.

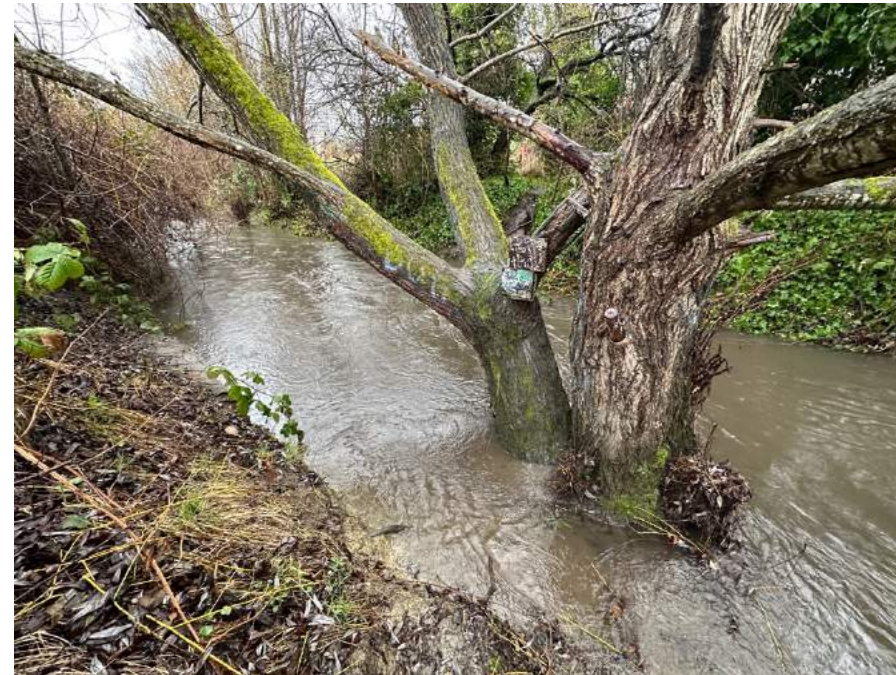
Photo 7A-20. Winter conditions in rainfall with many golden willows that grow at the base of banks submerged (view downstream).

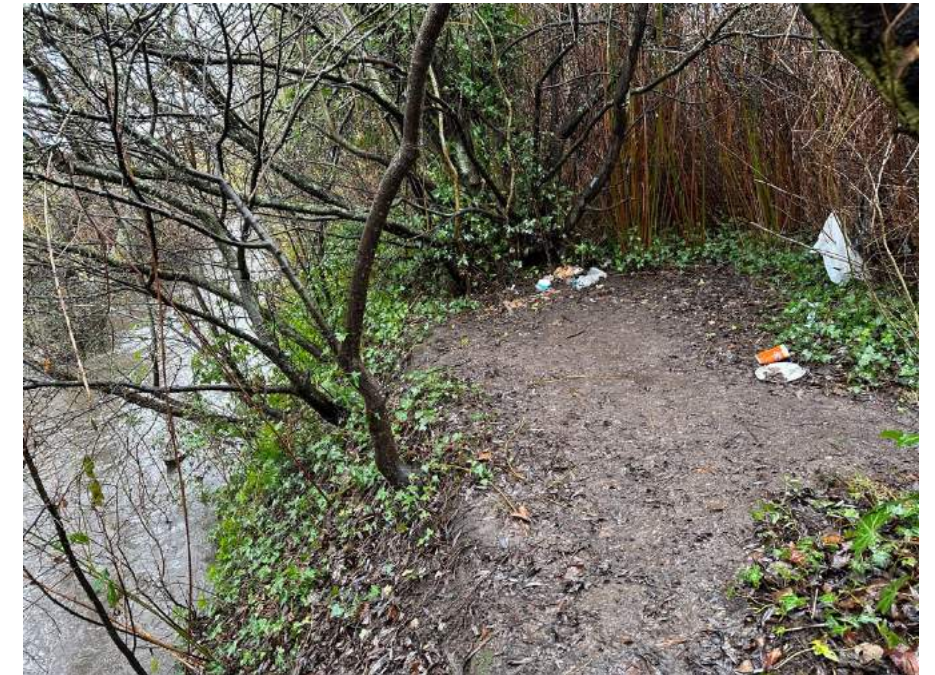
Photo 7A-21. Informal gathering spots at the side of the creek create bare patches in vegetation (albeit invasive) and accumulate trash, contributing to sedimentation and pollution of the creek (view downstream).

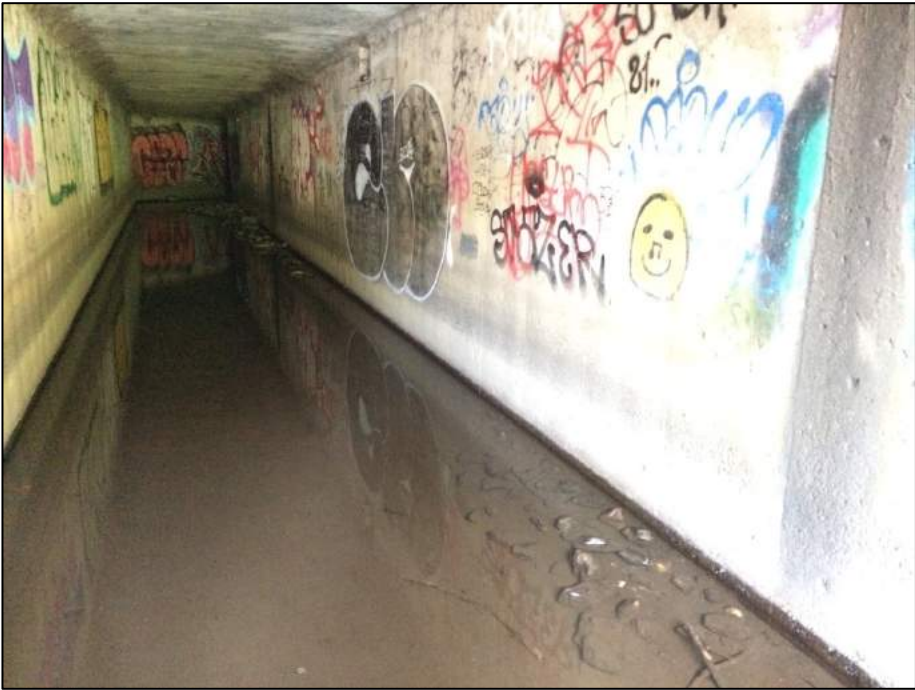
Photo 8-1. View into culvert from Reach 7B at Richmond Road (view upstream).

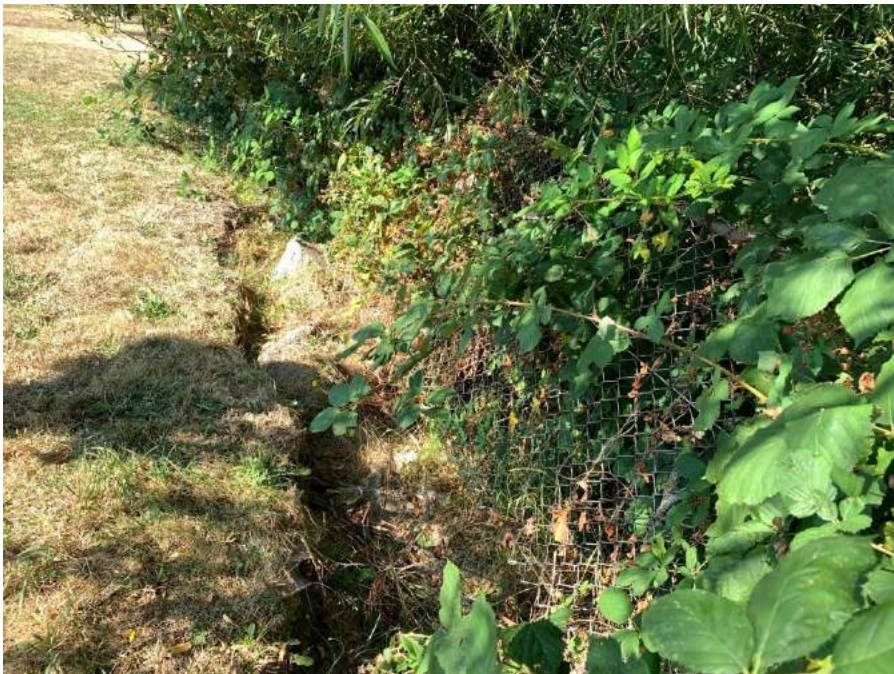
Photo 9-10. Cracks at top of bank, where slope is migrating on the west bank between Newton Street and the school footbridge at mid-reach (see Photos 9-23 & 9-24).

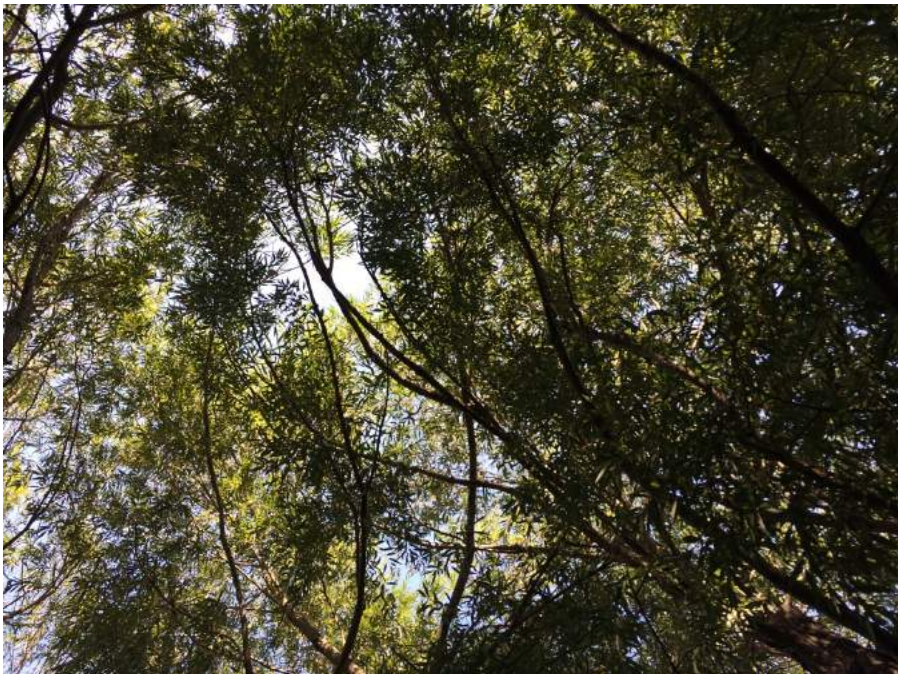
Photo 9-11. Overhead canopy in this reach (while mostly invasive willow) is close to 100%, providing shade for reduced water temperatures.

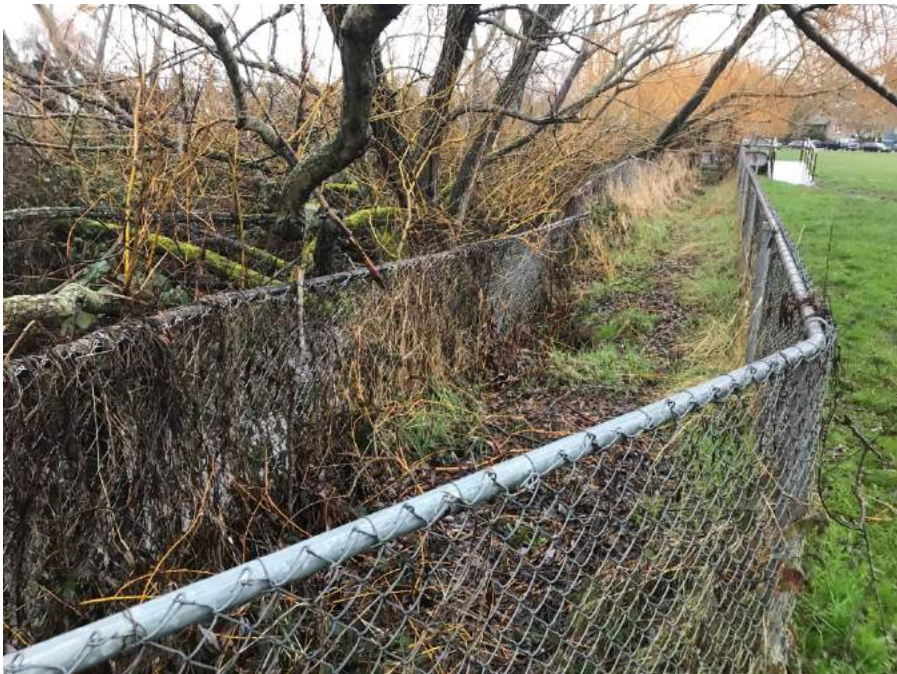
Photo 9-22. Double chainlink fences on the west bank above the school footbridge demonstrate the ongoing erosion and slope failure at vertical banks (view downstream).

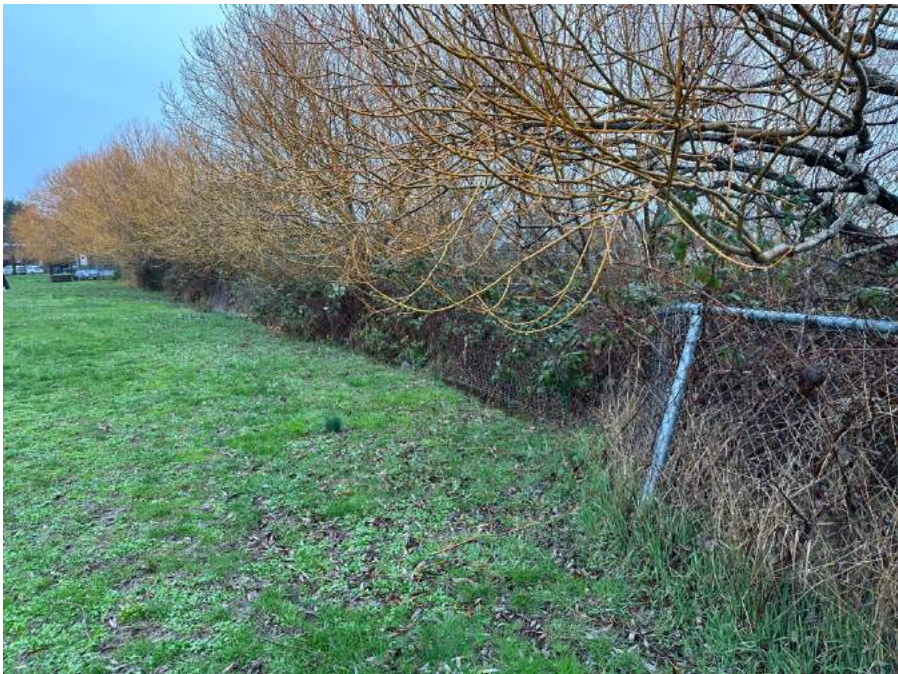
Photo 9-23. Leaning chainlink fence and slope cracking along 20 m of the west bank below the school footbridge demonstrate the ongoing erosion at vertical banks (view upstream) (see Photos 9-10 & 9-24).

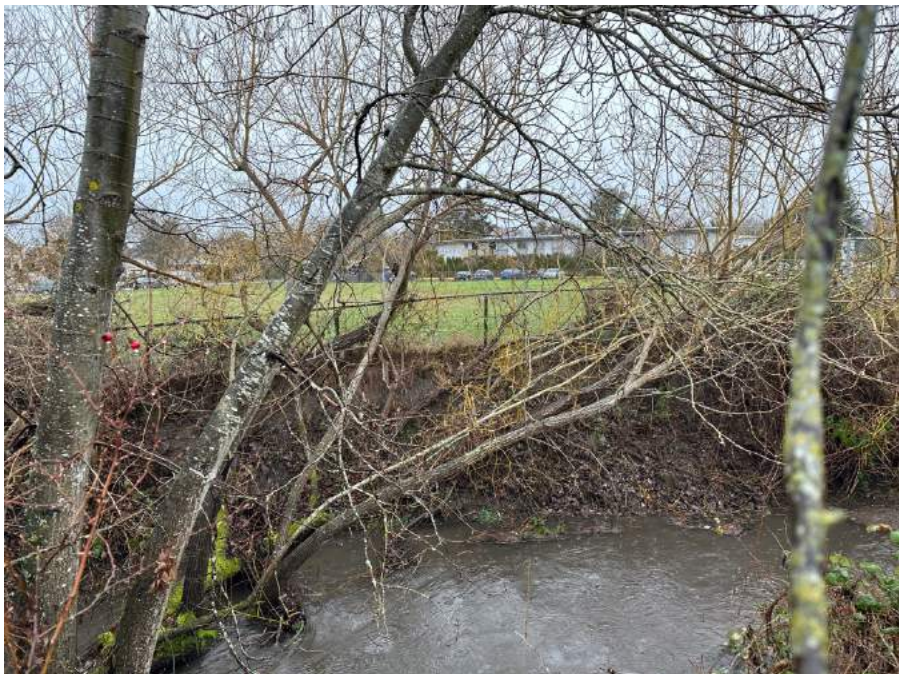
Photo 9-24. Vertical bare slopes at leaning chainlink fence and slope cracking along west bank below the school footbridge demonstrate the ongoing erosion (view west) (see Photos 9-10 & 9-23).

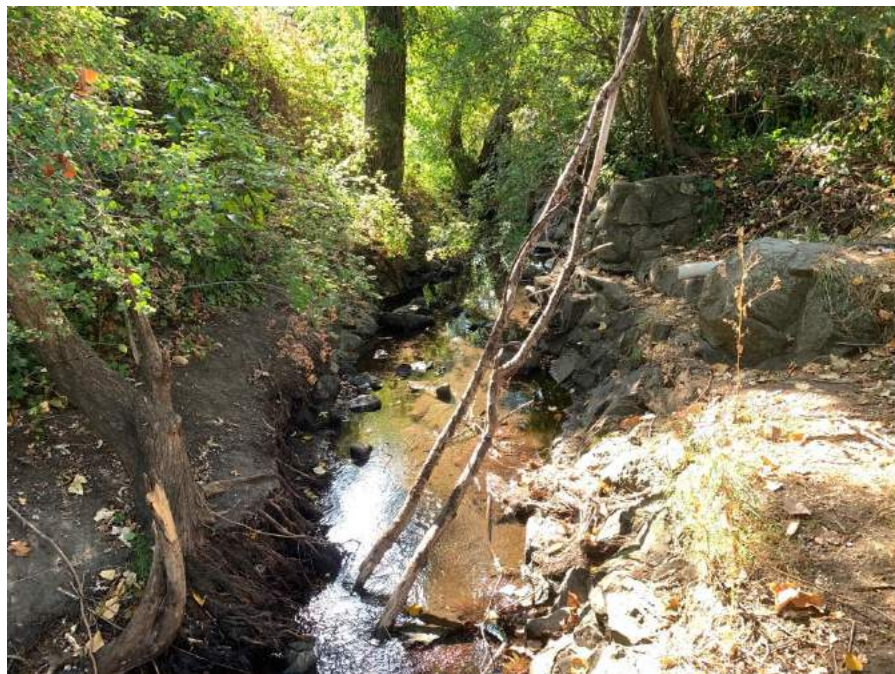
Photo 12B-10. Armoring and old foundation materials with perimeter drain from residences to the east (rain garden potential in the upland area, prior to discharge) (view upstream).

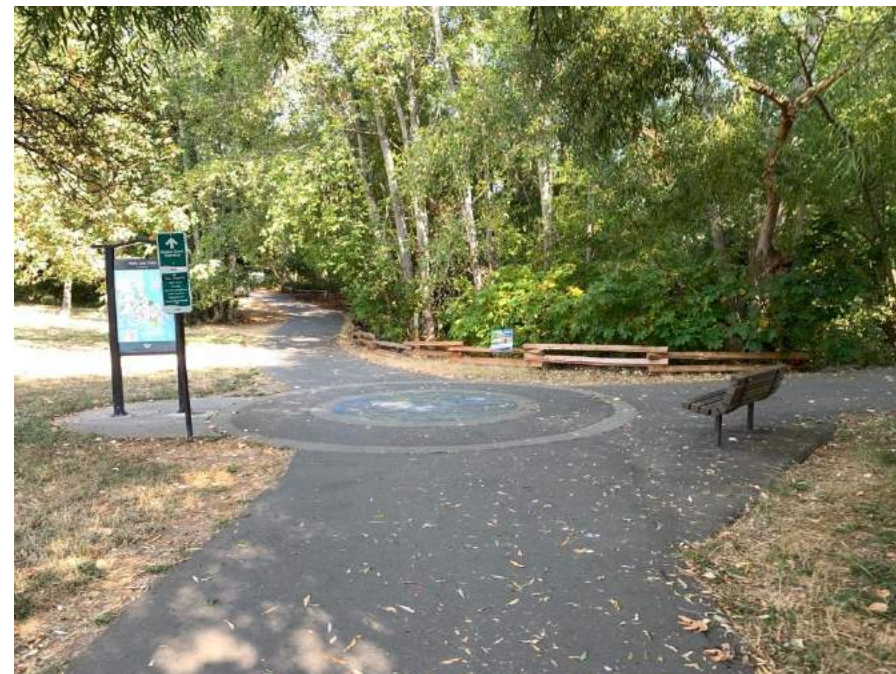
Photo 12B-11. West bank interpretive signage and community-building hub, with split rail fencing (upper right) to protect volunteer restoration riparian area by Friends of Browning Park (view upstream/north).

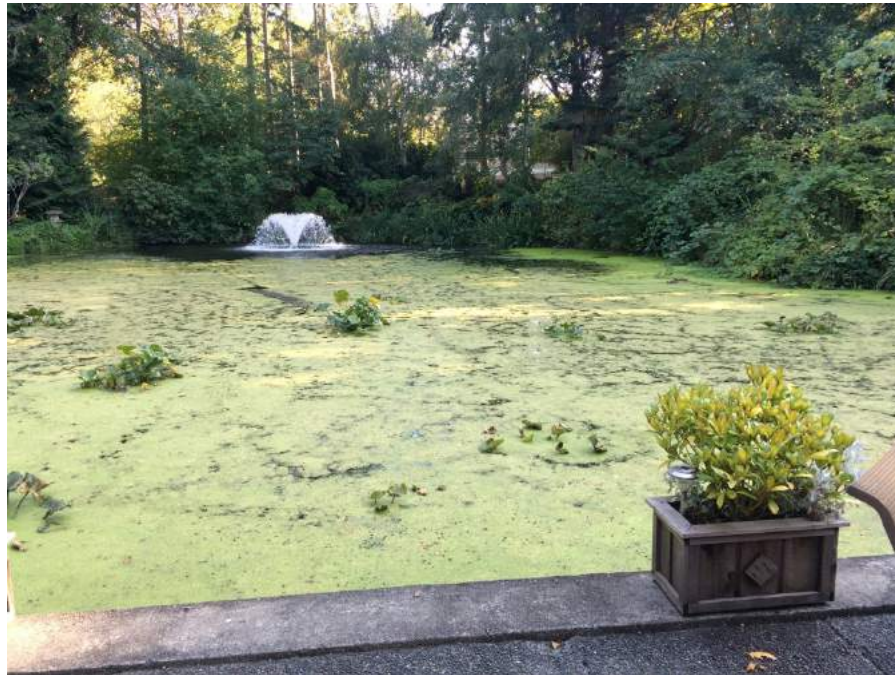
Photo 15A-1. UVic University Club pond with aerating pump. Diverse riparian structure and mostly native vegetation on east, south, and west sides and patio along north side (view south).

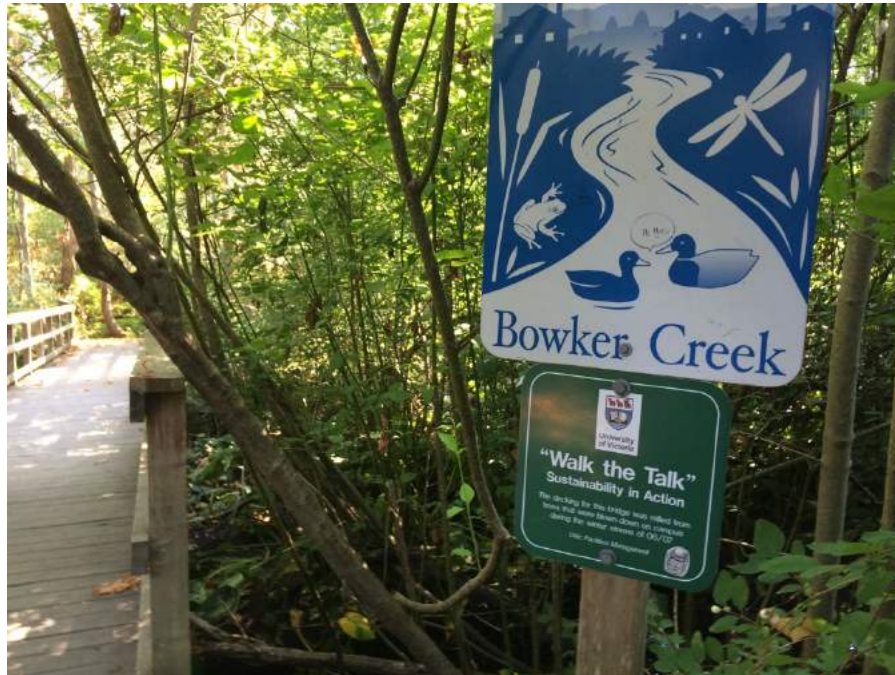
Photo 15B-1. Footbridge over Bowker Creek in broad wetland area.
