TABLE OF CONTENTS

BOWKER CREEK ASSESSMENT SUMMARY

REACH 1A
Reach # 1A – Creek mouth into Oak Bay to upstream (west) end of 1776 Beach Drive) (140m) 2733, 2717, and 2713 Somass Drive; 1725, 1762, and 1776 Beach Drive (privately owned)
Channel Description Channel banks are primarily concrete, mortared rock and concrete sandbags (Photos 1-6,8-10,12-15). The channel bottom is a mix of bedrock, heavily silted substrate of sand, gravel, cobble, and boulders, and extensive concrete and asphalt armouring (Photos 3,8,9,12,13,16). Thick algal mats and root mats from golden willow are present. Vertical armoured banks 1-2m tall, channel width 3.0m – 5.5m, wetted width 0.4m-3.5m (summer). The creek is channelized and straightened with a gradient range from 1.5-4% with a narrow strip of riparian vegetation (Photos 17 & 18). There is a 22m long pool downstream of the culvert which is suitable as a holding location for juvenile fish prior to entering the marine environment, and also for adults entering the stream to hold while awaiting higher flows and while maturing. Tidal influence occurs downstream of Beach Drive. Concrete box culvert at Beach Drive (3.0m wide x 2.2m tall x 15m long). Small a

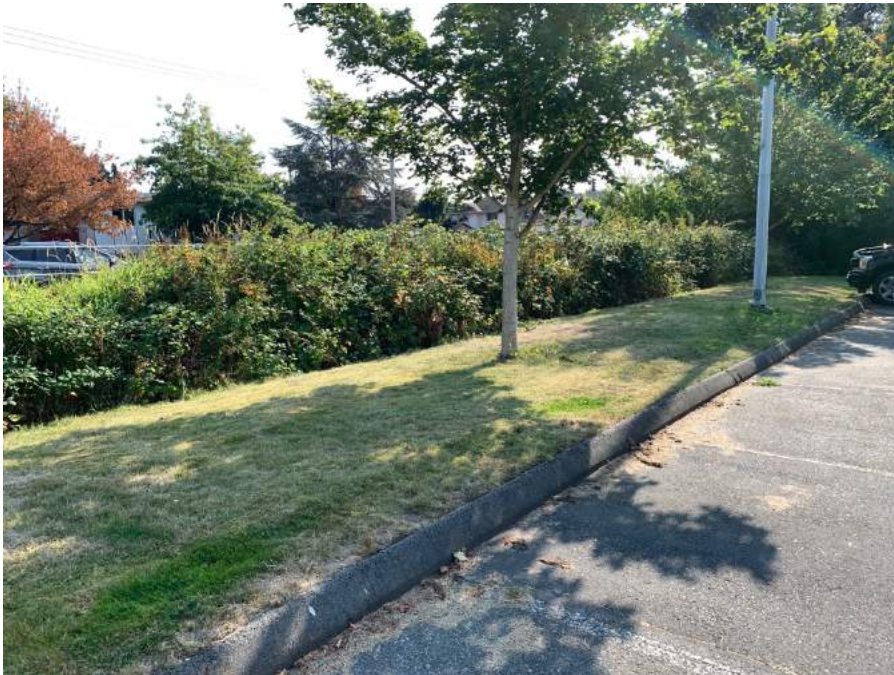
Photo 17A-1. Tributary swale along Cedar Hill Road (view downstream toward confluence).

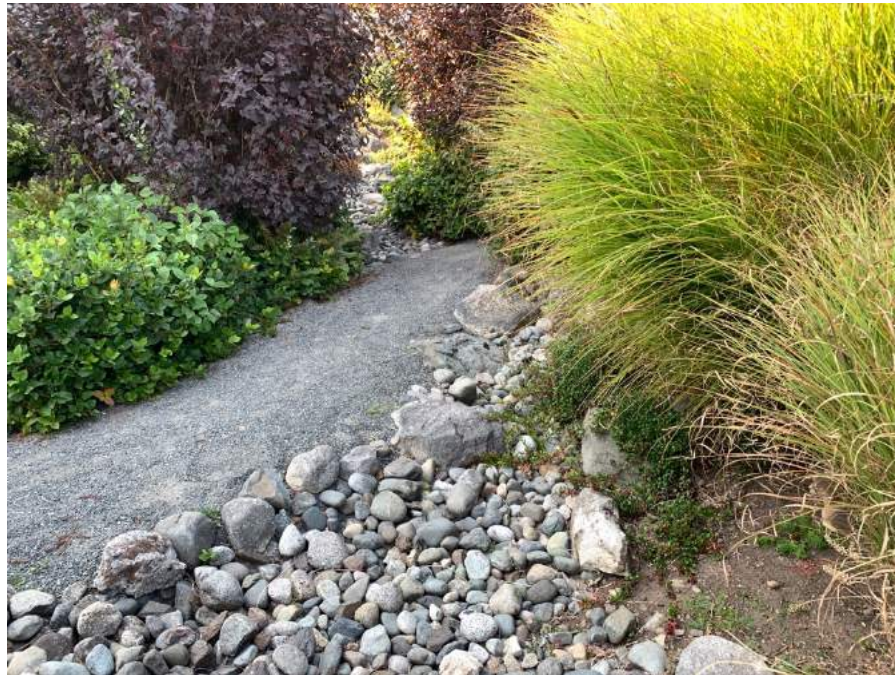
Photo 17D-1. Stormwater management rain garden at 1290 Tolmie Place.
