# Core Area Stormwater Quality Program

## 2020 Report

Capital Regional District | Parks & Environmental Services, Environmental Protection

July 2021

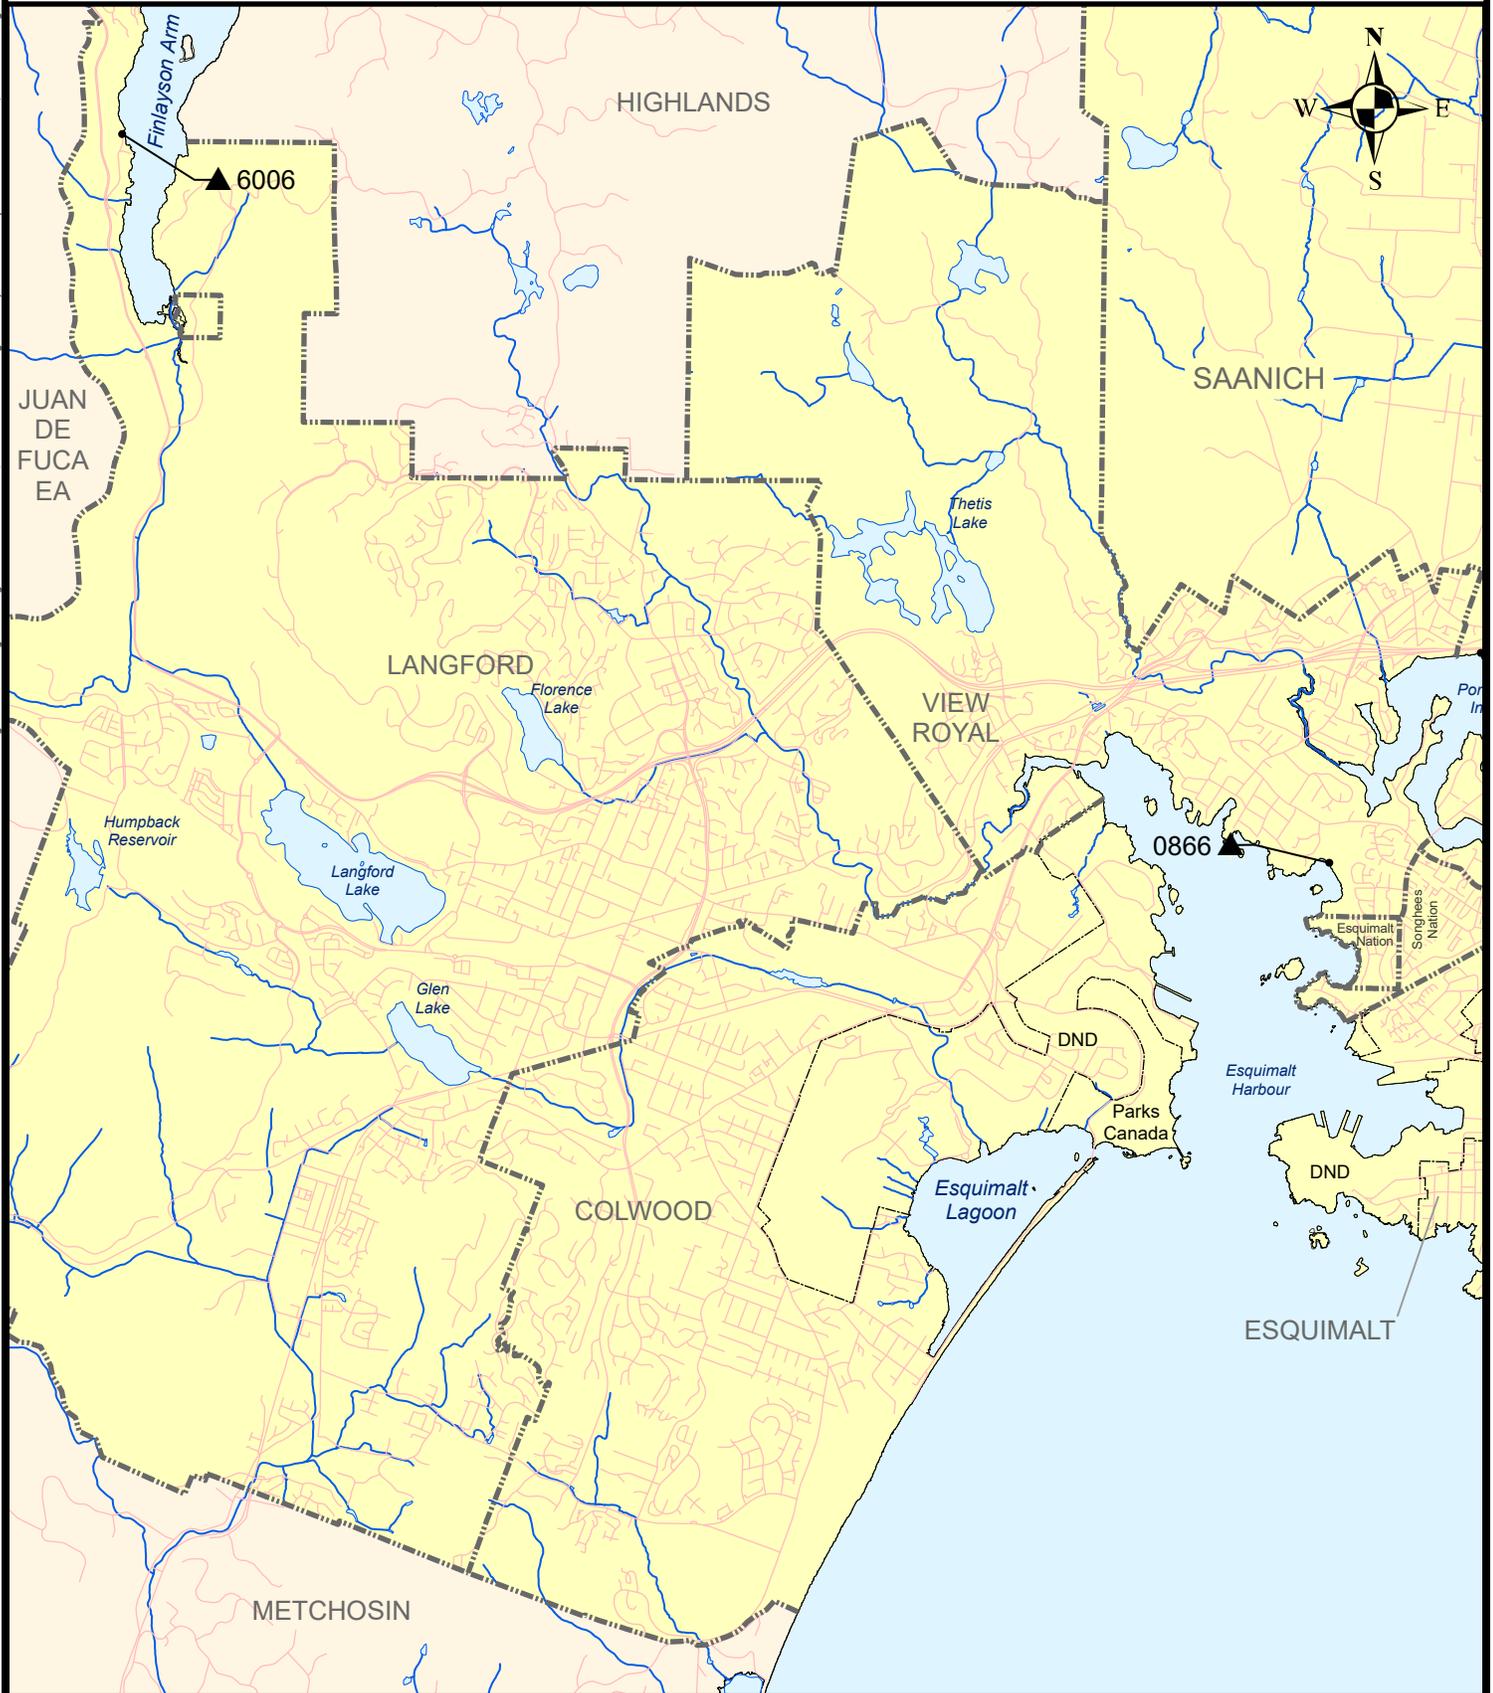
**Figure B - Core Area 2020**  
 Stormwater Discharges Requiring Action for Public Health and Environmental Concerns  
 (Metchosin to Esquimalt Border)

Staff make recommendations for corrective action to find and eliminate sources of chemical contamination when a rating remains high for two consecutive years and the parameter(s) of concern are determined. Based on data up to 2020, CRD recommends 21 discharges for corrective action in the core area (shown in Table C). Locations of high-rated discharges in 2020, and those identified for corrective action, are shown on figures B and C.
