**ENVIRONMENTAL RESTORATION  
CONCEPT PLANS FOR BOWKER  
CREEK: TRENT STREET TO PEARL  
AVENUE**

P.A. Harder and Associates Ltd.

**March 2002**

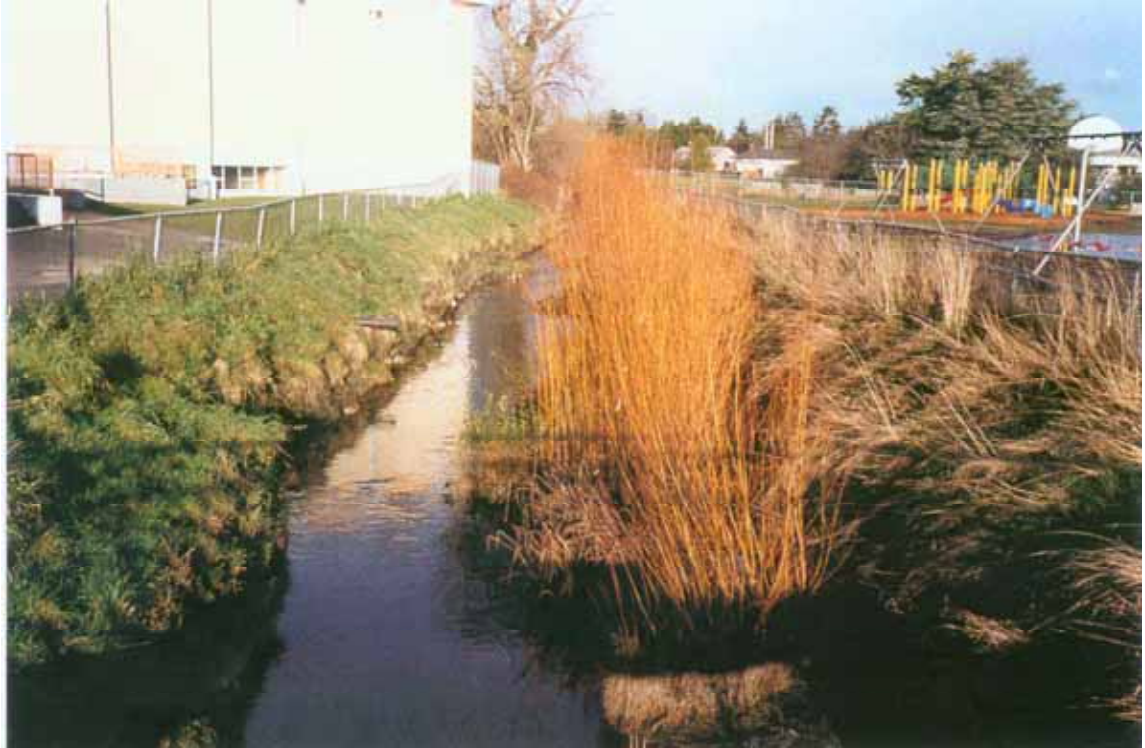
The total average width of the west bank (school side) from the wetted edge to the top of bank is approximately 2.8 m. The lower 0.8 m of the bank is close to vertical throughout most of this zone. The total height of the bank is approximately 2.5 m. A moderate degree of bank erosion is evident throughout this zone (Plate 1). The District has periodically stabilized banks in this area using concrete filled sand bags. Additional bank restoration is required to alleviate existing erosion on the west bank.

**PLATE 1: Zone 1 of Bowker Creek adjacent to St. Patrick School showing eroding west bank and golden willow growth in channel at base of east bank.**

The existing bank along the west side of the channel has no significant environmental values and is actively eroding. Soil conditions and slope characteristics of the existing bank slopes are not suitable for the establishment of a native riparian plant community. Re-constructing the bank using a vertical retention wall along the existing fence line would provide an opportunity for reclaiming up to 2.0 m of active floodplain habitat that could be planted with native plant species. This approach would require excavation of the existing bank back to the existing fence line, installation of vertical retaining wall and installation of a 0.6 m high planting bench. The planting bench would require a layer of rip rap placed at the existing wetted edge of the channel and back-filling with organic soils on the back side of the rip rap up the vertical retaining wall (Figure 2).

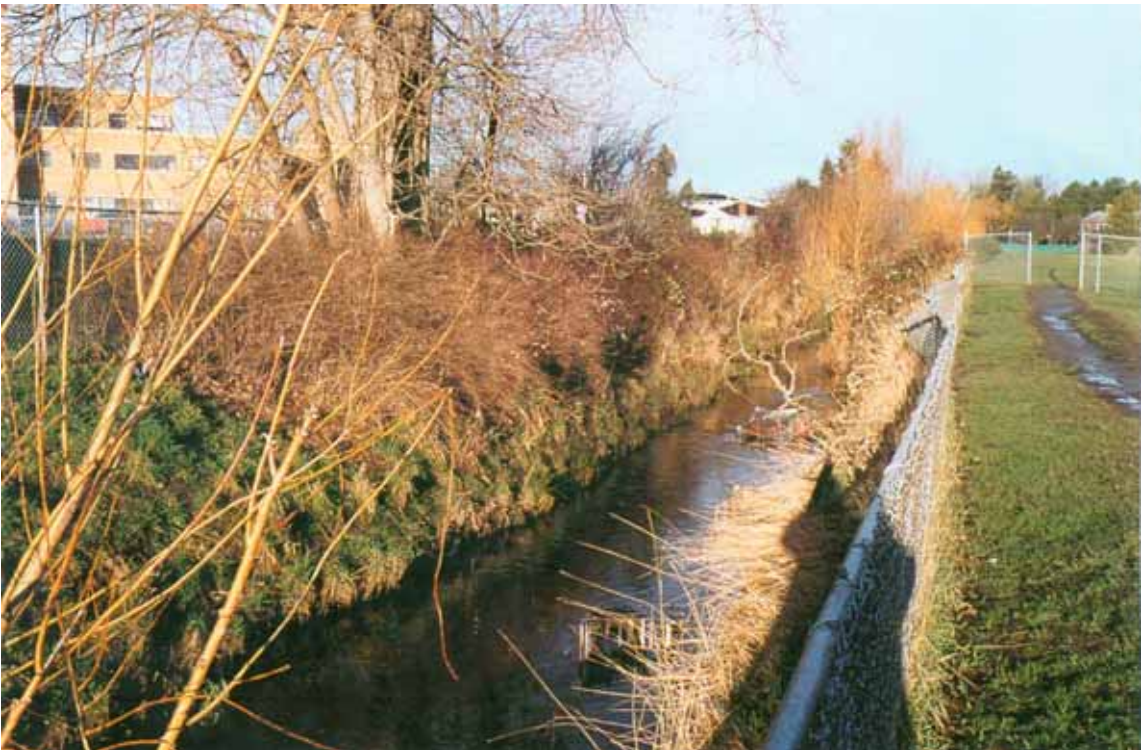
**PLATE 2. Upstream section of Zone 1 showing steep bank conditions and adjacent playing field on east side of creek.**

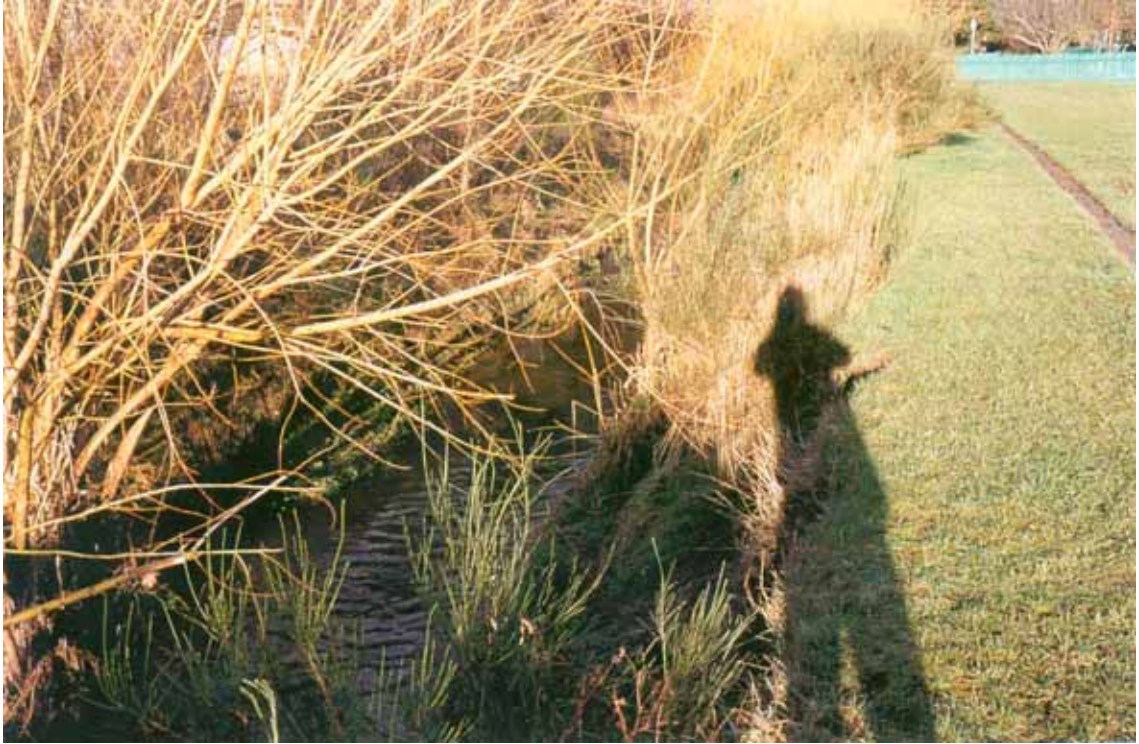
**PLATE 3. Zone 2 of Bowker Creek adjacent to Royal Jubilee Hospital showing eroding east bank and existing riparian vegetation community.**

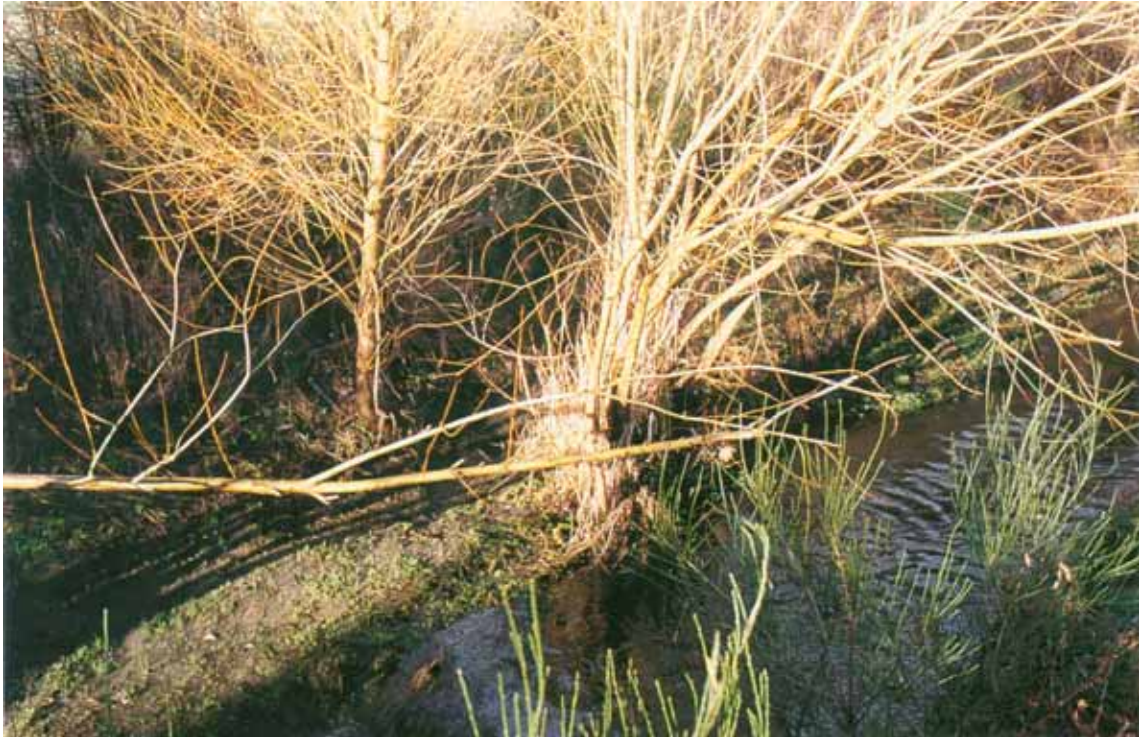
**PLATE 4. West bank of Bowker Creek in Zone 2 showing golden willow growth along edge of channel.**

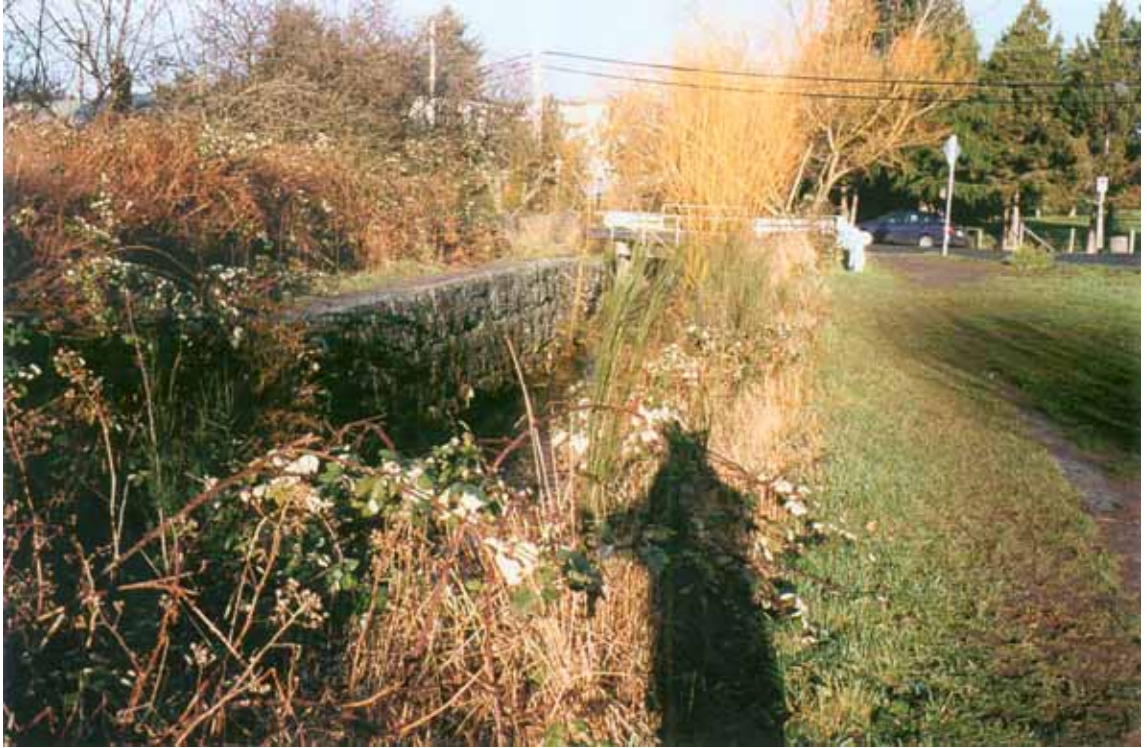
**PLATE 5. Zone 3 of Bowker Creek showing vertical retaining wall and existing riparian vegetation on west bank.**

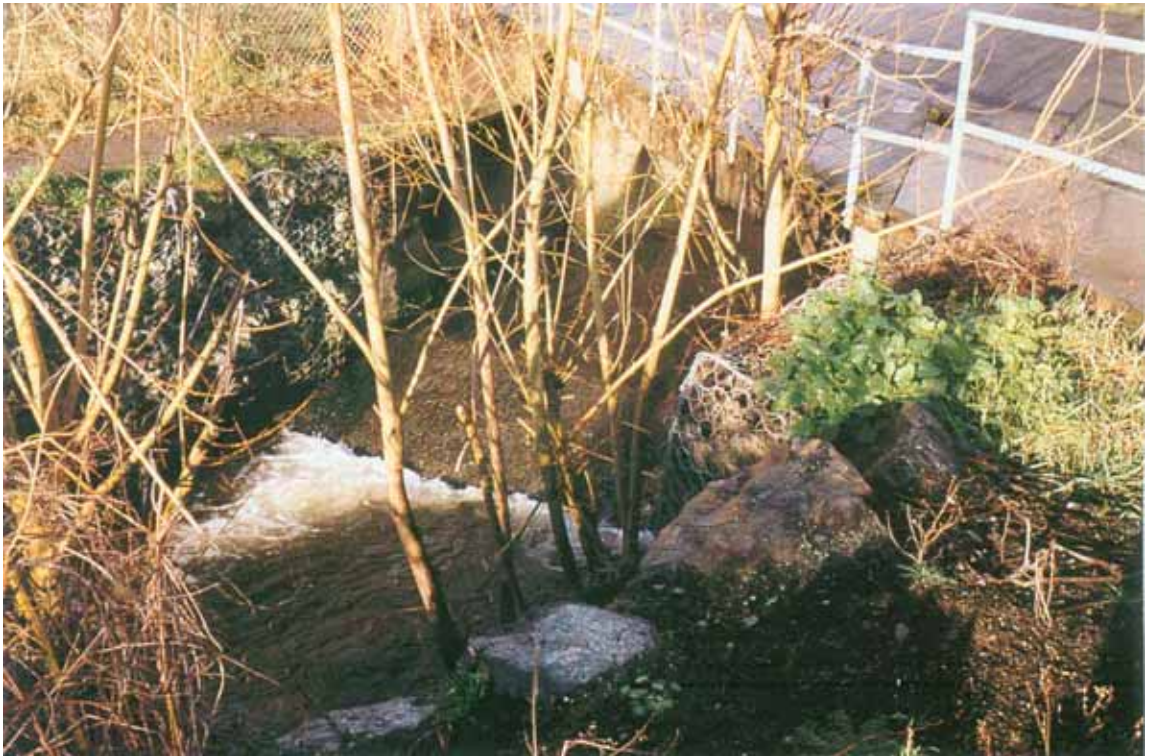
**PLATE 6. East bank of Bowker Creek in Zone 3 showing golden willow growth along gabion wall at the outlet of the Haultain Road culvert.**

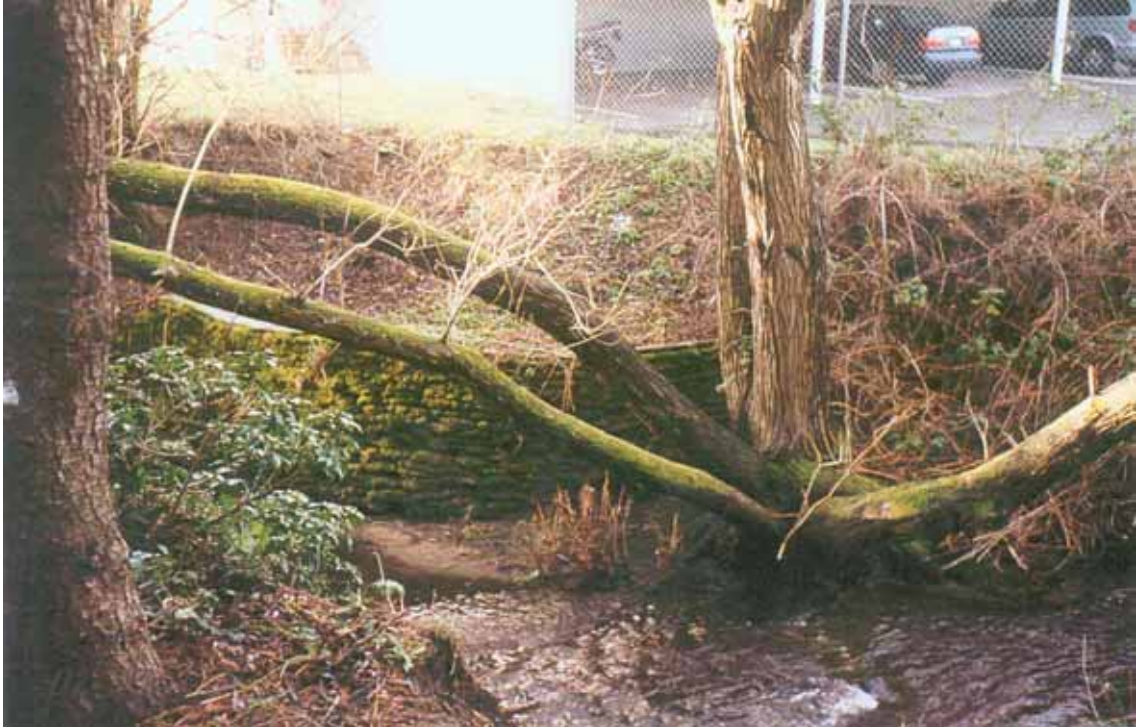
**PLATE 7. Zone 5 of Bowker Creek showing cement filled sand bags and mature golden willow growth on west bank adjacent to apartment building complex.**

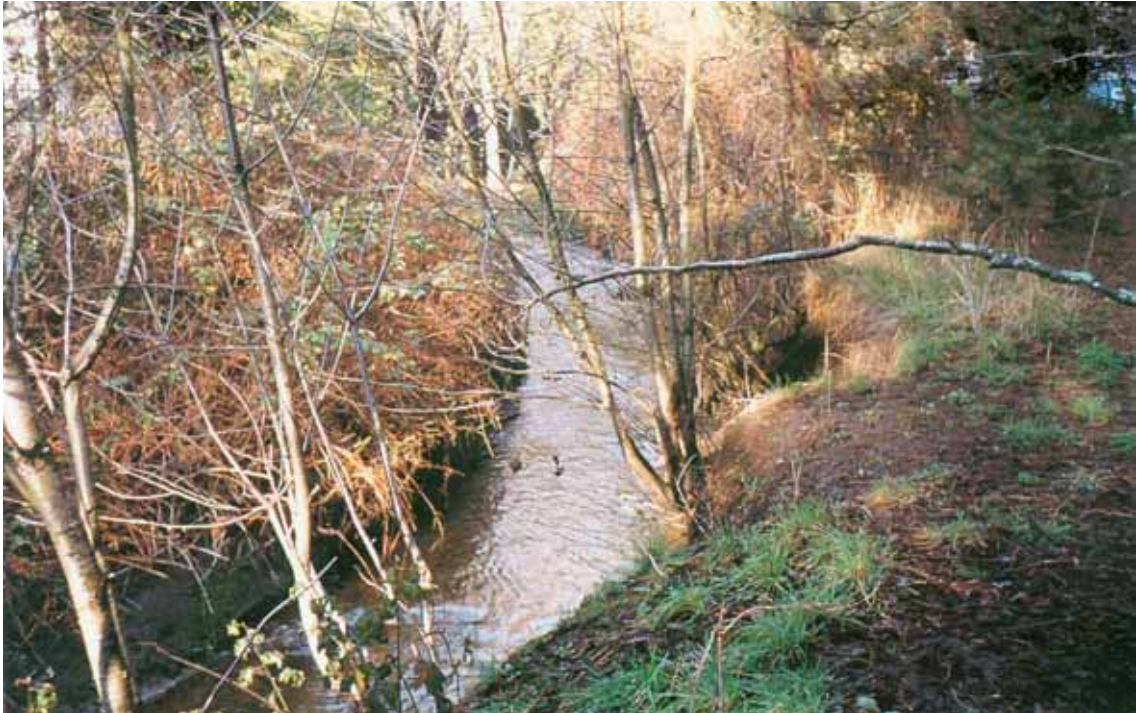
The average height of the west bank is approximately 3.0 m and the width of the bank between the wetted edge and the bank top is 1.8 m. The bank slope is steep (1.5: 1) in most sections and there are vertical sections in two locations where rock gabions and concrete filled sand bags have been used to stabilize the bank (Plate 7). There are several areas of active minor bank erosion in this zone. The east bank is approximately 2.9 m high and has an average width of 3.5 m between the wetted edge and the bank top. The bank slope is similar to the west bank and there are some near vertical sections of the bank that are being actively eroded (Plate 8).

**PLATE 8. Mid-section of Zone 4 Zone 4 showing eroding east bank (right side of photo) and existing riparian vegetation.**

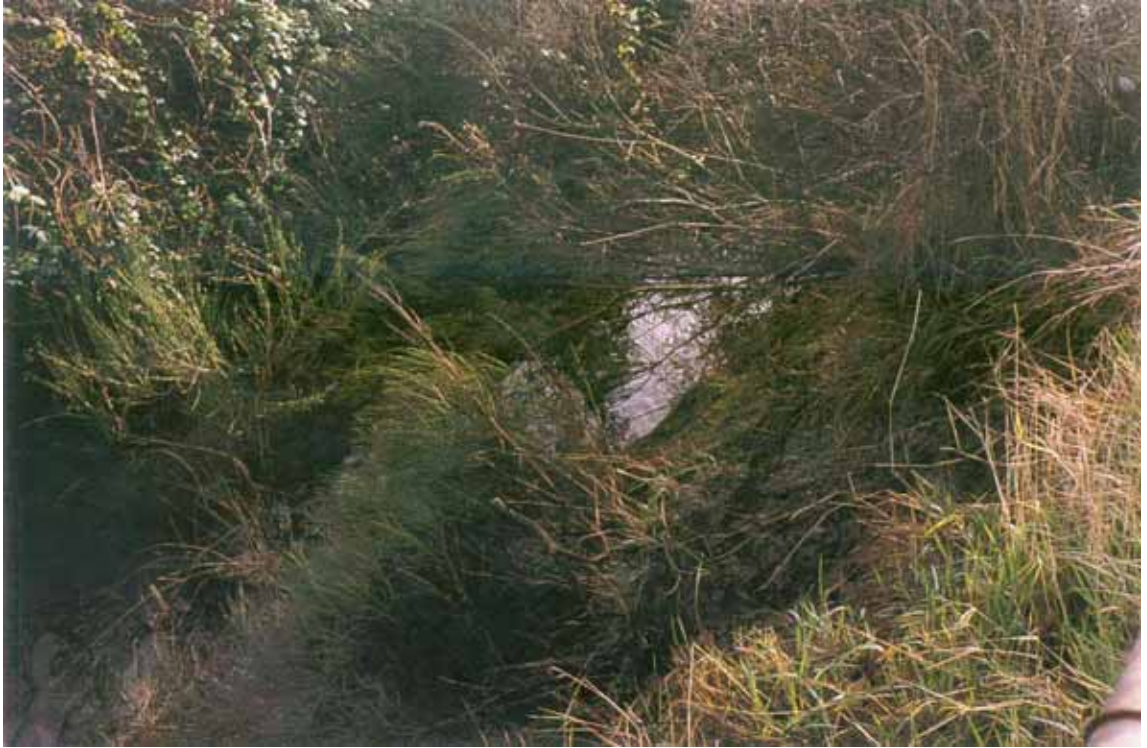
**PLATE 9. Existing bank conditions in Zone 5 of Bowker Creek showing predominance of Scotch broom and slumping bank on west side of channel.**

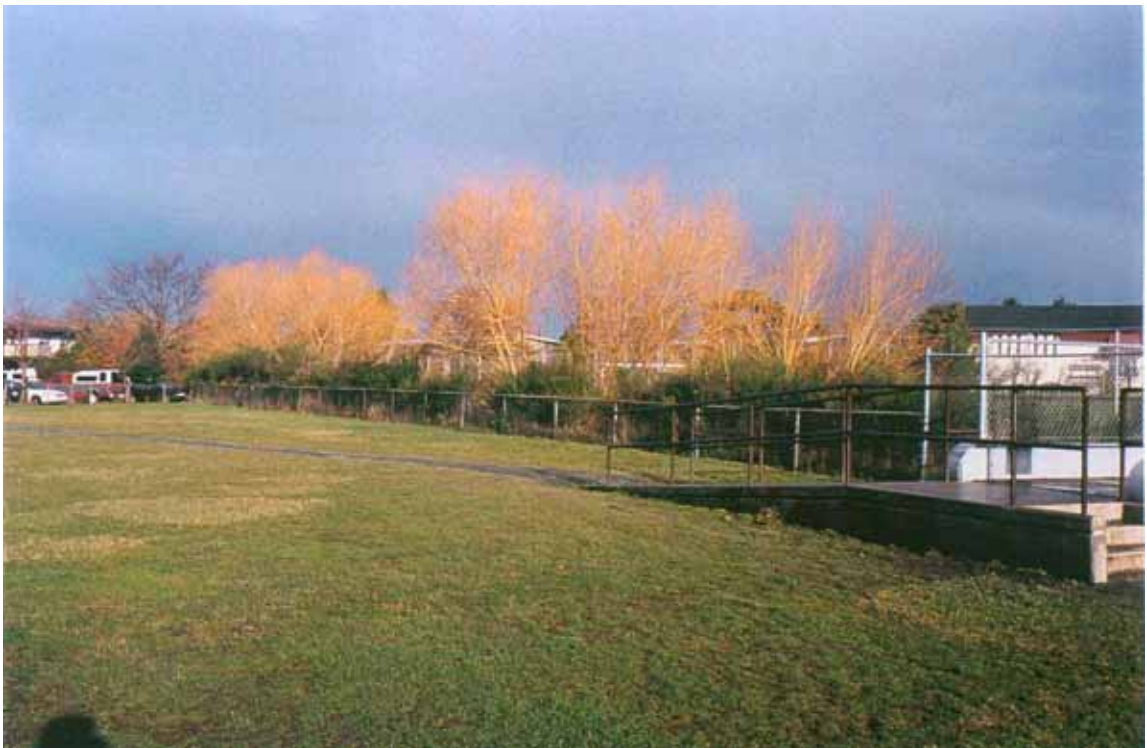
**PLATE 10. Zone 5 of Bowker Creek looking upstream from footbridge showing Scotch broom on west bank and golden willow growth on east bank.**

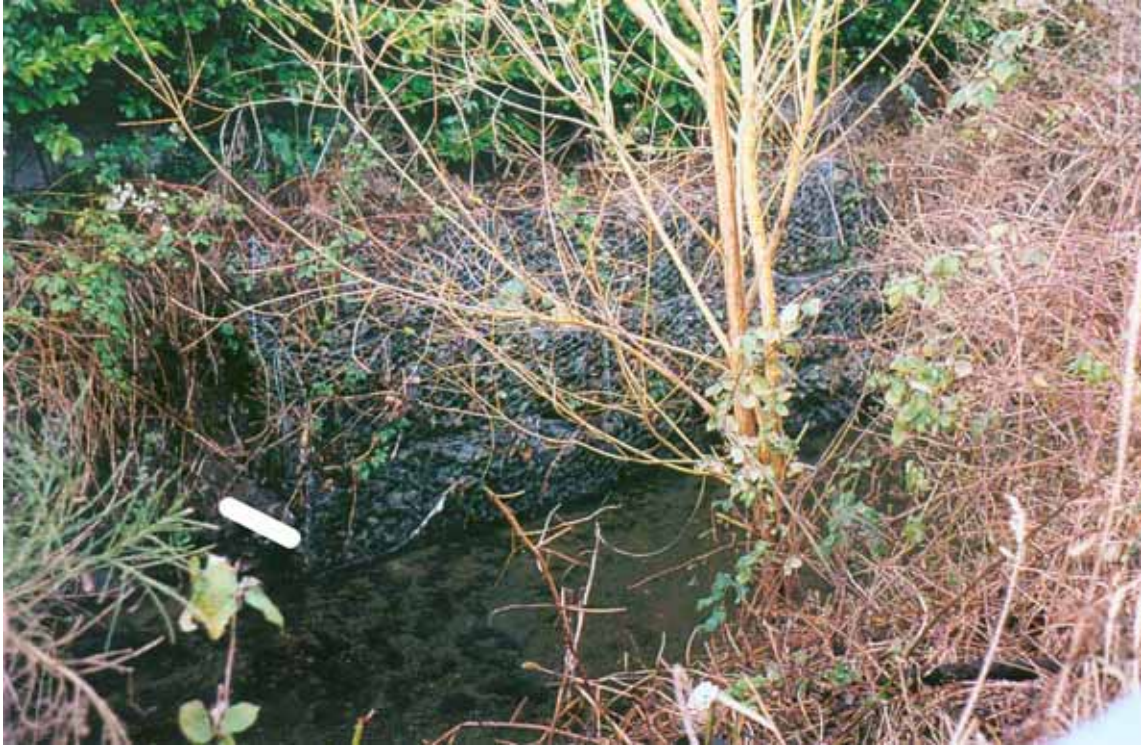
Sections of the west bank have been stabilized using rock filled gabions and rip rap (Plate 11). The west bank is approximately 2.8 m high. The width of the west bank from top of bank to the edge of water is generally less than 1.5 to 2.0 m. There are a some areas where the existing bank is prone to channel erosion.

**PLATE 11. Zone 6 of Bowker Creek showing gabion wall on west bank downstream of foot bridge with planted laurel hedge on top of bank.**

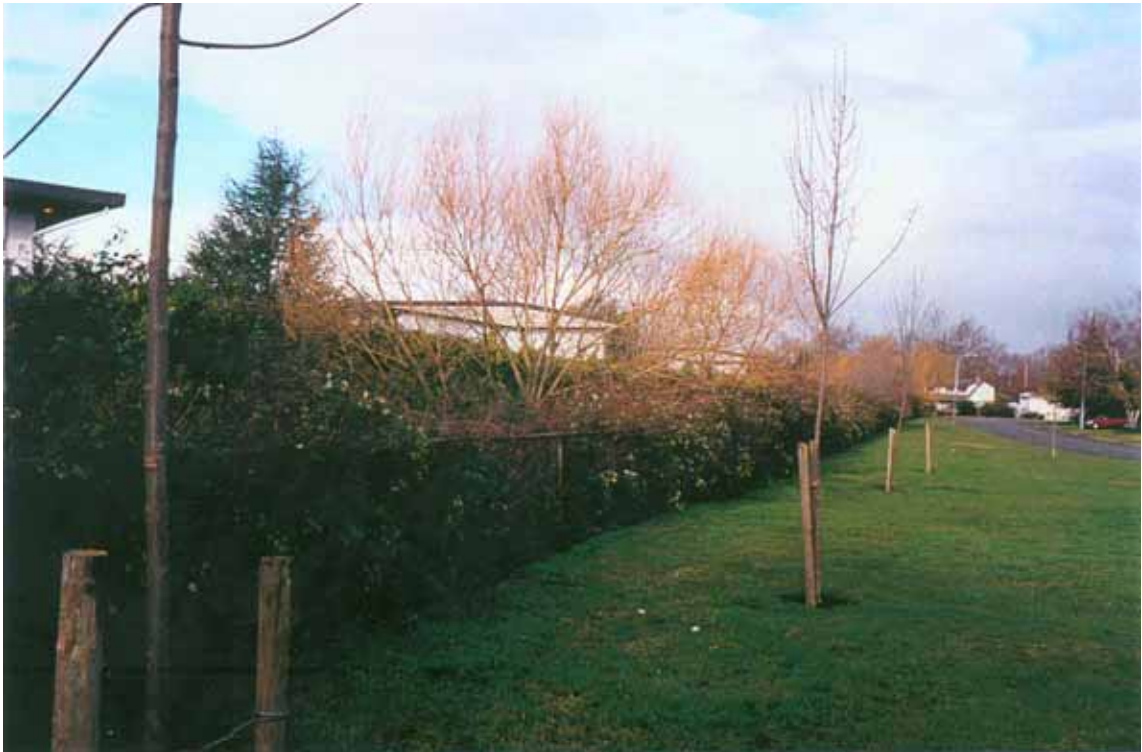
The west bank of the channel is developed multi-family residential area. Apartment buildings are situated very close to the top of the bank in some areas. The area on the east side of the channel is District property and has been landscaped as grass boulevard. Deciduous trees have recently been planted along the boulevard between the creek channel and Townley Road. There is a foot bridge that crosses the channel in the mid-section of this zone. The Townley Road sidewalk is situated 5 m back from the top of the stream bank (Plate 12).

**PLATE 12. Zone 6 of Bowker Creek showing blackberry thicket and golden willow growth along east bank of channel adjacent to Townley Street boulevard.**
