SUMMARY AS-BUILT PROJECT COMPLETION REPORT

SAANICH AND VIEW ROYAL, BC

DFO Authorization No. 11-HPAC-PA3-00772

AESC Project No.: 211-018-1

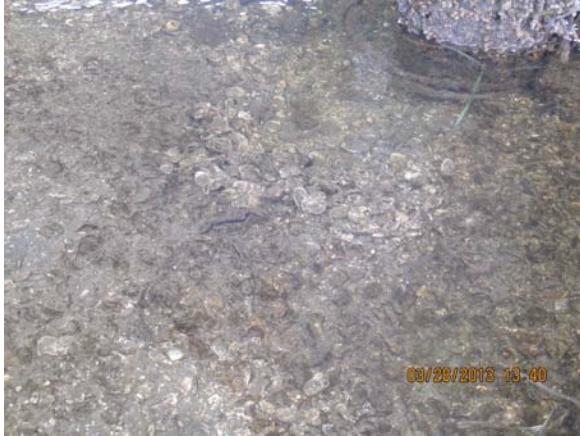
Photo 9.6-1 Olympia Oyster shell hash mixed with live Olympia Oysters around pre-existing bridge pile.

To do this, WFT was required to establish the salvage zones that would coincide with the permanent footprint of the bridge piers. During salvage, oysters were enumerated. A total of approximately 100,000 Olympia Oysters were salvaged (as determined by volume) from the impact zone and transplanted to the artificial reefs constructed of imported Japanese Oyster shell debris (i.e. shell hash). More detailed discussion on the compensation requirements for Olympia Oyster is provided in Section 11.1, below.

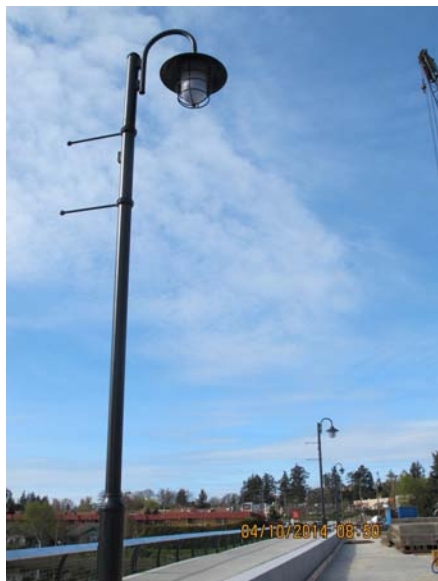
Photo 9.12-1 Elimination of overhead wiring.

As reported in Section 9.3, wires previously suspended over the pre-existing Craigflower Bridge deck were replaced and conveyed across the Gorge Waterway through ducts under the bridge. This eliminated the issue of bird wire strikes, primarily by migratory birds (including Trumpeter Swans).

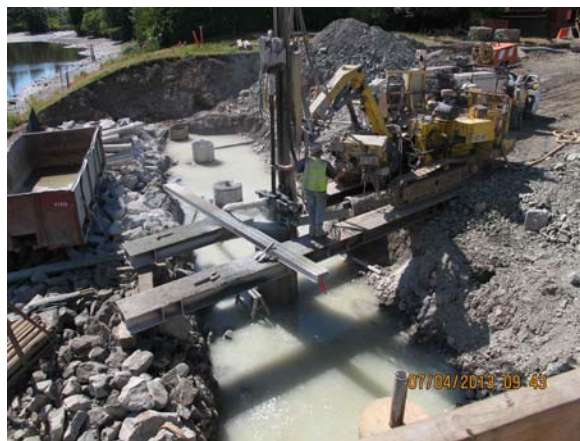
Photo 9.17-1 Contained concrete slurry during construction of the south abutment.

All concrete wastewater was contained to ensure it was not released to the Gorge Waterway. Ruskin maintained a CO₂ diffuser on-site during all concrete pours in the event of accidental release to the Gorge Waterway.

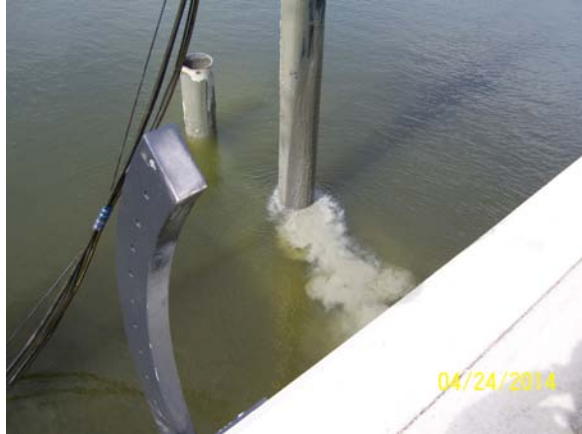
In some situations, floating booms were utilized to contain any possible petrochemical spills. However, due to tidal activity, it was not possible to effectively contain silt around the pile

installation area with floating curtains that draped for several metres, since the tidal movements carried the floating curtain up against the piles.

Photo 10.2-1 Sediment release during temporary work bridge pile pulling.

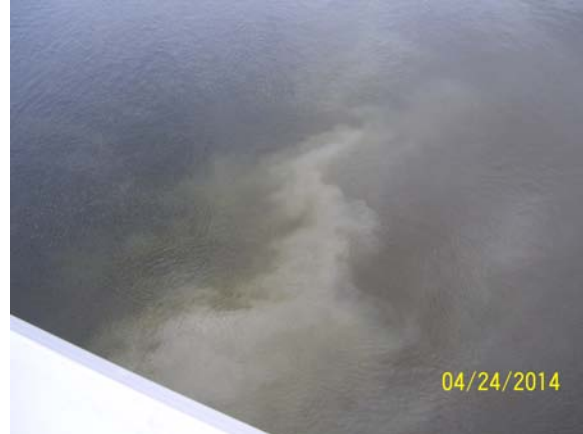
Photo 10.2-2 Dissipation of sediment released during temporary work bridge pile pulling.

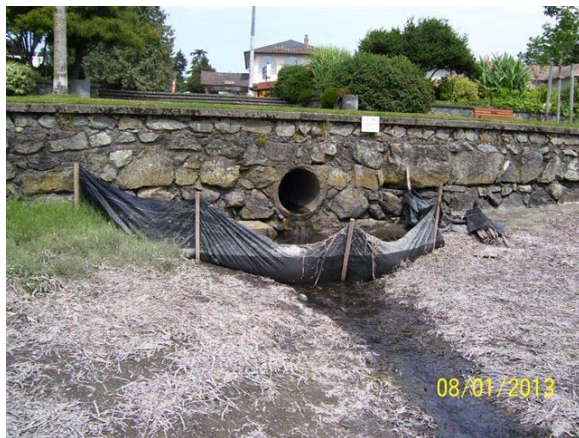
Photo 10.4-1 Storm outfall containment.

During road works along Gorge Road, construction crews inadvertently fractured a City waterline, which flooded the excavation and released overflow water to a nearby storm drain. This storm drain discharged water directly to the Gorge Waterway by way of a nearby outfall. Crews quickly responded by constructing a sandbag and silt fencing containment around the outfall to ameliorate the situation. The water release was quickly turned off and the break was repaired.

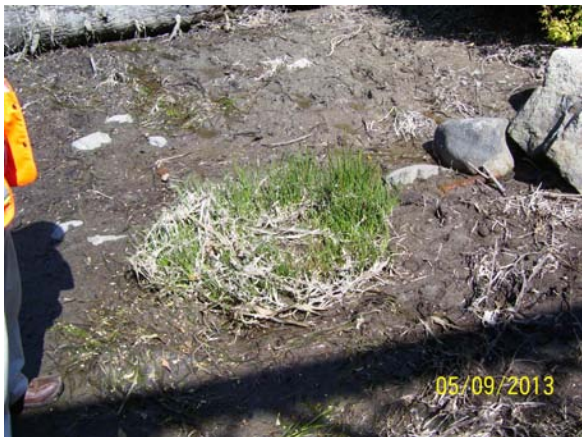
Less than 3m^2 of Saltmarsh (intertidal marsh habitat) was impacted by encroachment of construction. This Saltmarsh habitat was removed by hand and transplanted at a location immediately east (downstream) of the bridge. While not shown in Photo 11.2-2, the Saltmarsh relocation site is fenced to prevent trampling by beachcombers and pets.

Photo 11.2-1 Saltmarsh habitat to be salvaged.

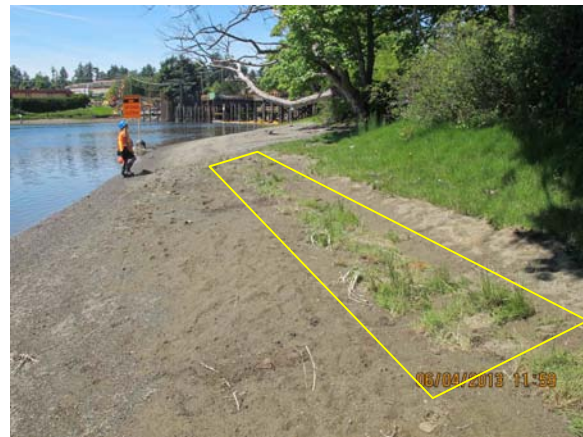
Photo 11.2-2 Highlighted Saltmarsh habitat relocation site.
