Geotechnical Data Report, Core Area Wastewater Treatment Program

GEOTECHNICAL DATA REPORT

Core Area Wastewater Treatment
Program

April 12, 2013

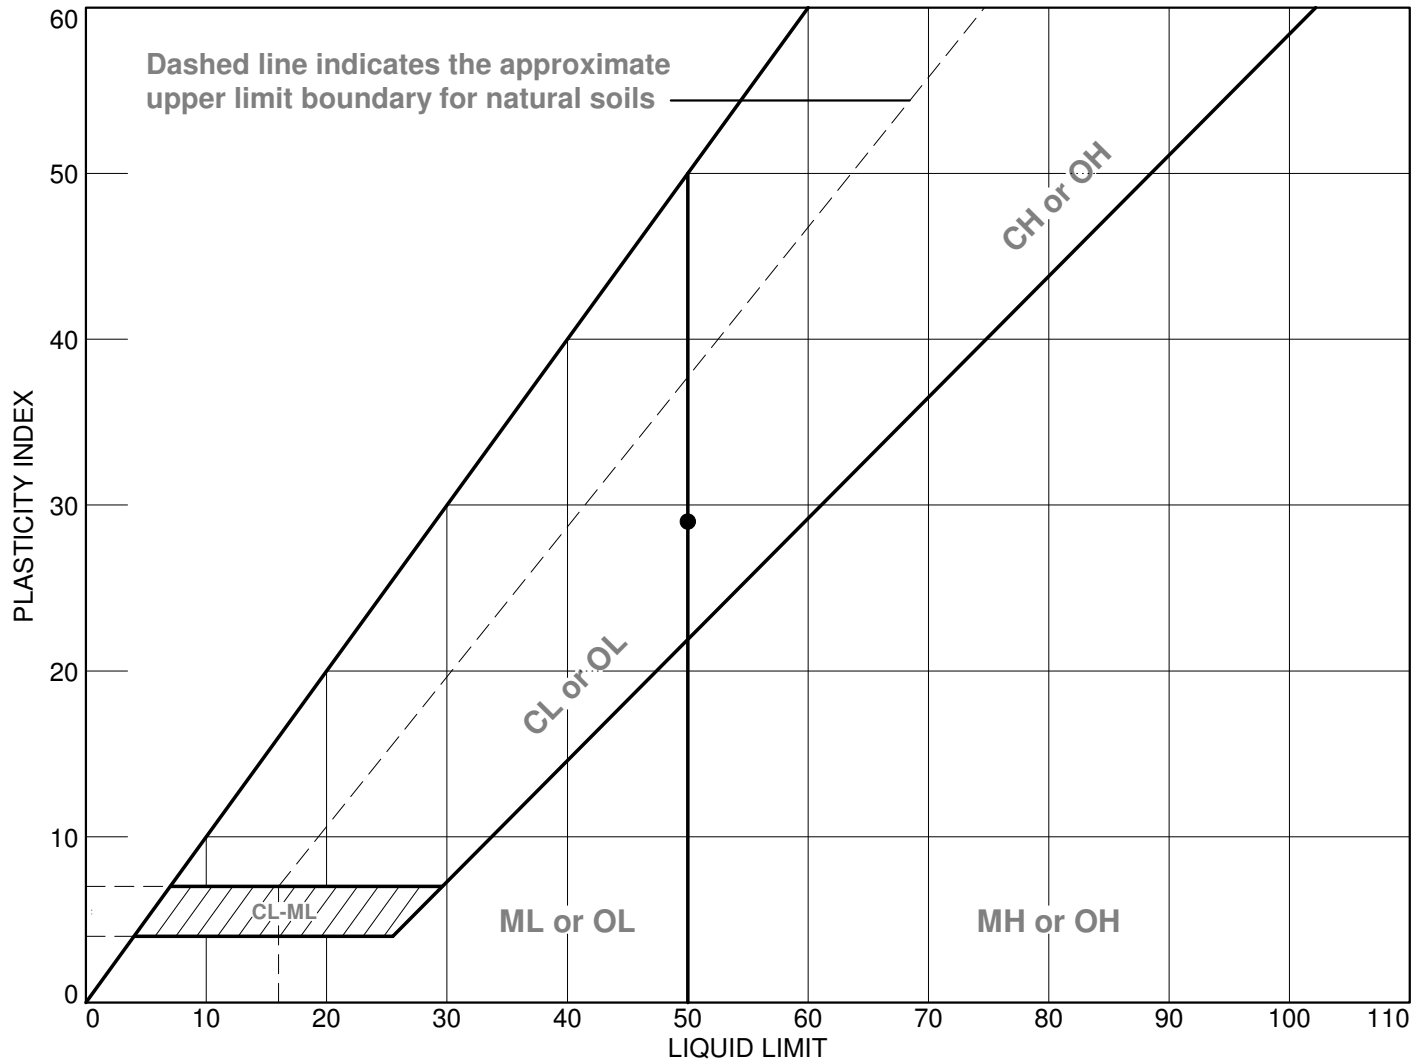
LIQUID AND PLASTIC LIMITS TEST REPORT

SOIL DATA								
SYMBOL	SOURCE	SAMPLE NO.	DEPTH	NATURAL WATER CONTENT (%)	PLASTIC LIMIT (%)	LIQUID LIMIT (%)	PLASTICITY INDEX (%)	USCS
●	BH12-1	1-4	3.3m	29.0	21	50	29	CL-CH

An index soil test called Atterberg Limits is used to describe the plastic limit and liquid limit of a soil. As water is added to a dry soil, the soil changes from a solid to a semi-solid, then to a plastic, and finally to a liquid. The moisture content in the soil at the threshold between semi-solid and plastic state is called the plastic limit. The moisture content in the soil at the threshold between plastic and liquid state is called the liquid limit. Subtracting the plastic limit from the liquid limit yields the plasticity index.

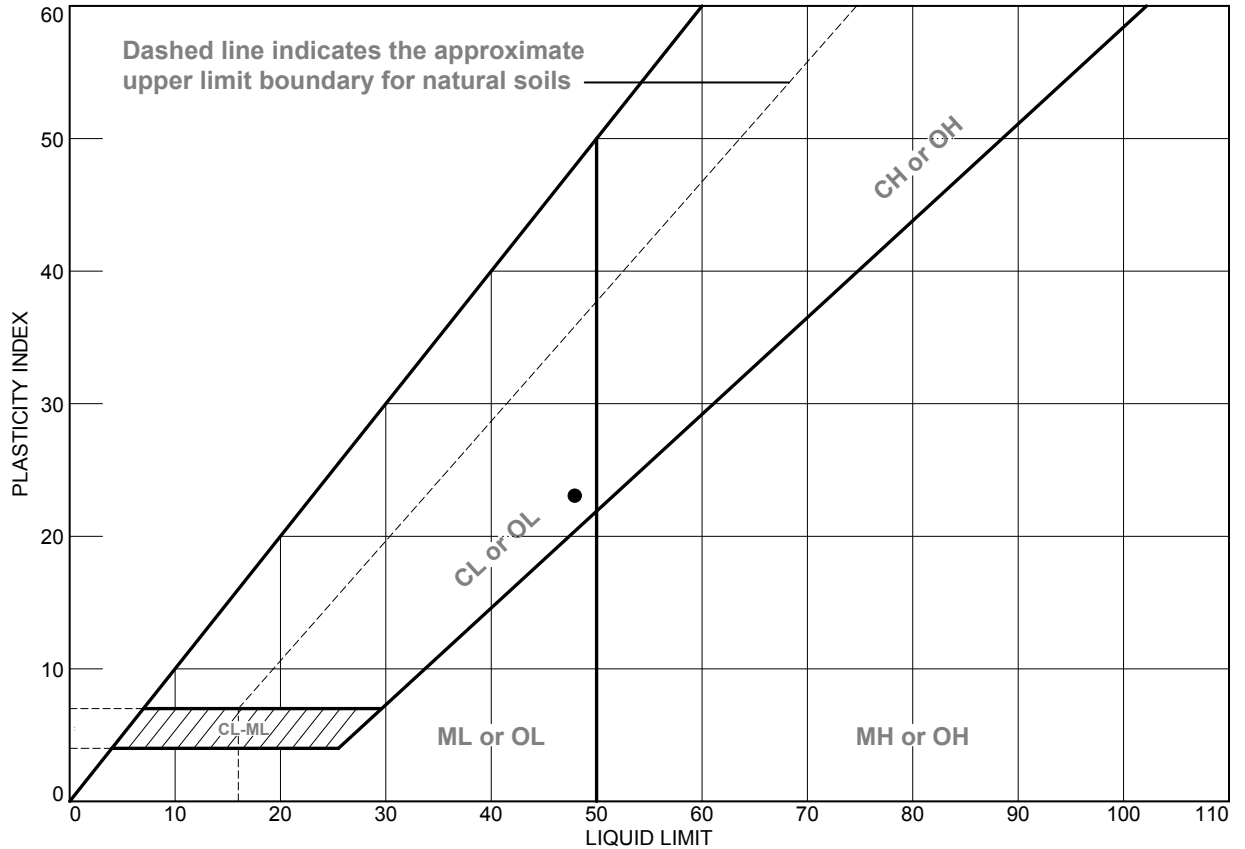
SOIL DATA								
SYMBOL	SOURCE	SAMPLE NO.	DEPTH	NATURAL WATER CONTENT (%)	PLASTIC LIMIT (%)	LIQUID LIMIT (%)	PLASTICITY INDEX (%)	USCS
●	BH12-2	2-4	4.8m	33.0	25	48	23	CL

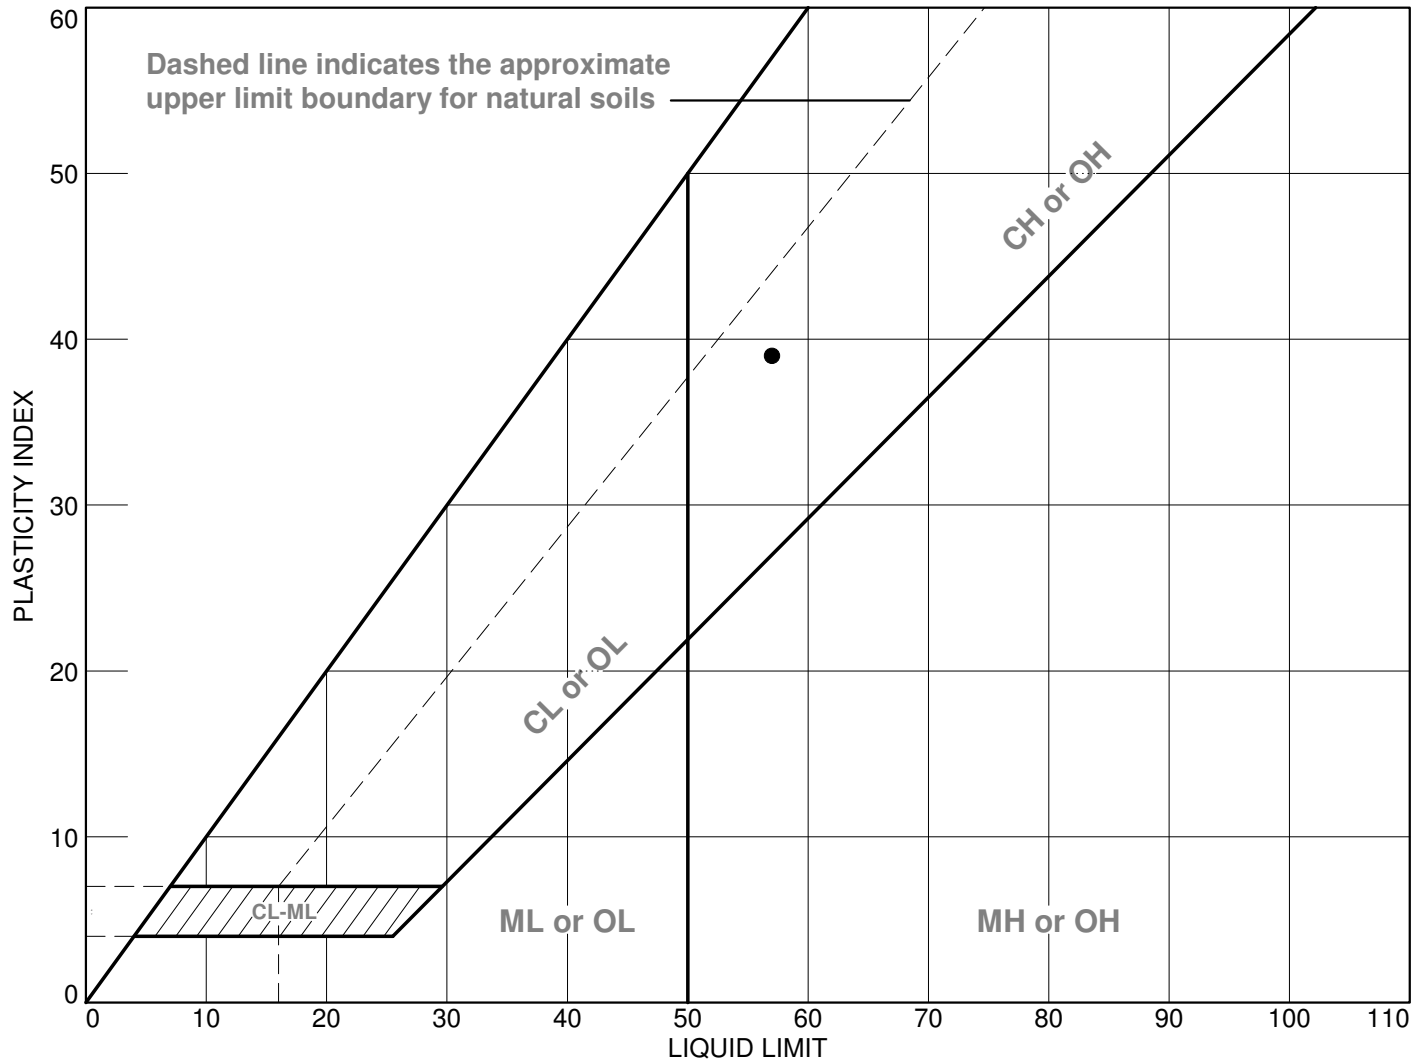
SOIL DATA								
SYMBOL	SOURCE	SAMPLE NO.	DEPTH	NATURAL WATER CONTENT (%)	PLASTIC LIMIT (%)	LIQUID LIMIT (%)	PLASTICITY INDEX (%)	USCS
●	BH12-3	3-3	4.8m	41.0	18	57	39	CH

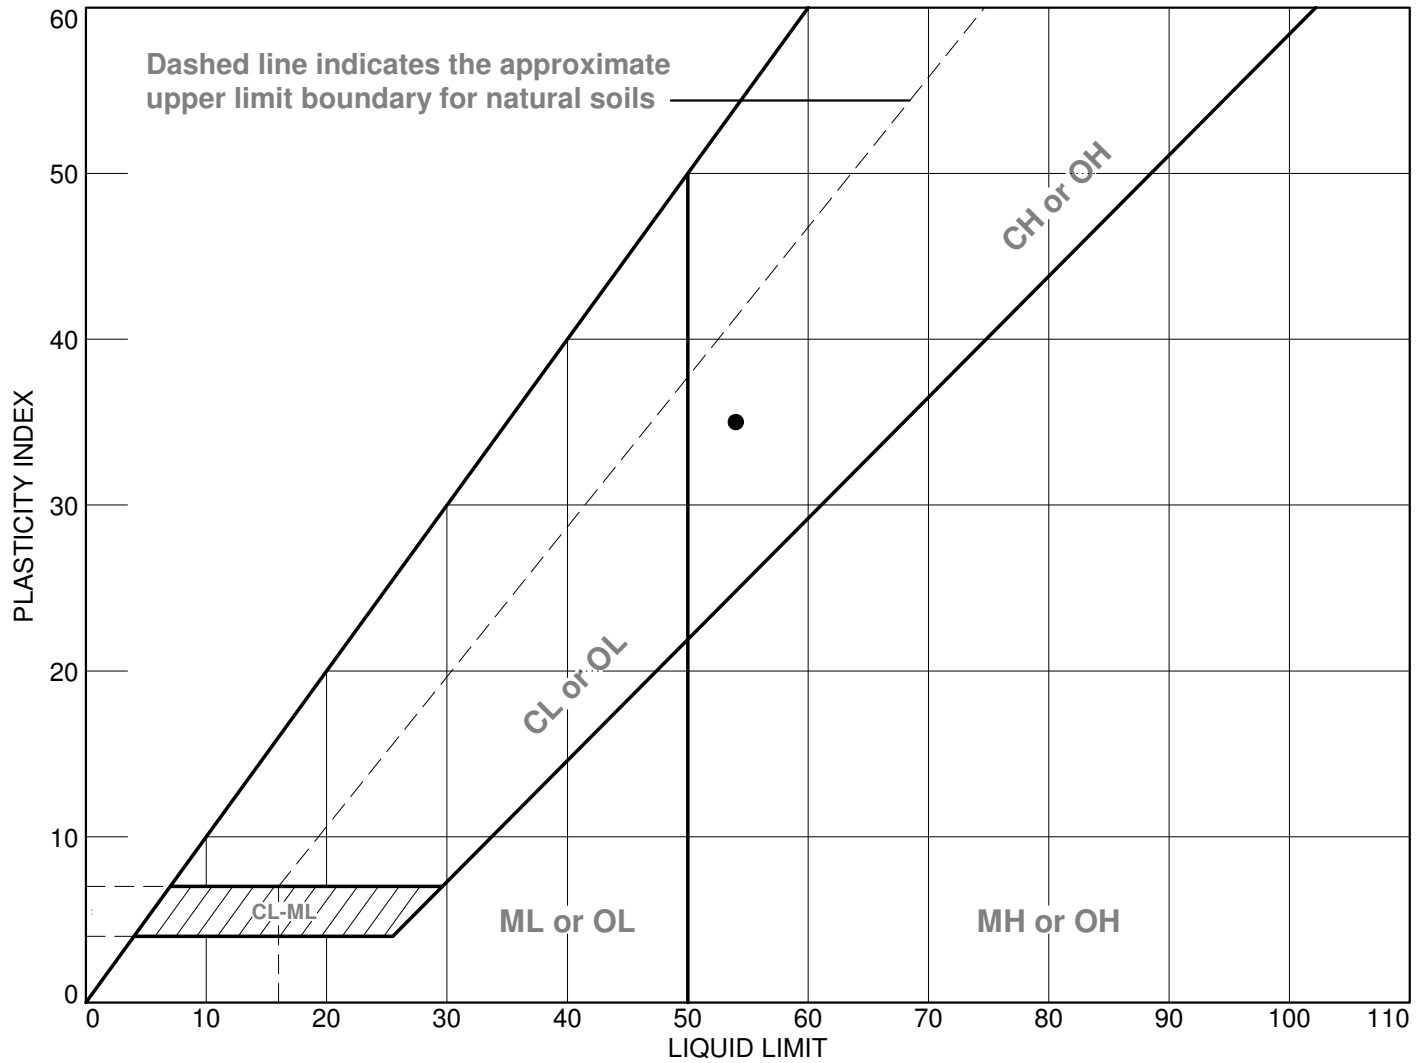
SOIL DATA								
SYMBOL	SOURCE	SAMPLE NO.	DEPTH	NATURAL WATER CONTENT (%)	PLASTIC LIMIT (%)	LIQUID LIMIT (%)	PLASTICITY INDEX (%)	USCS
●	BH12-4	4-4	4.8m	36.0	19	54	35	CH

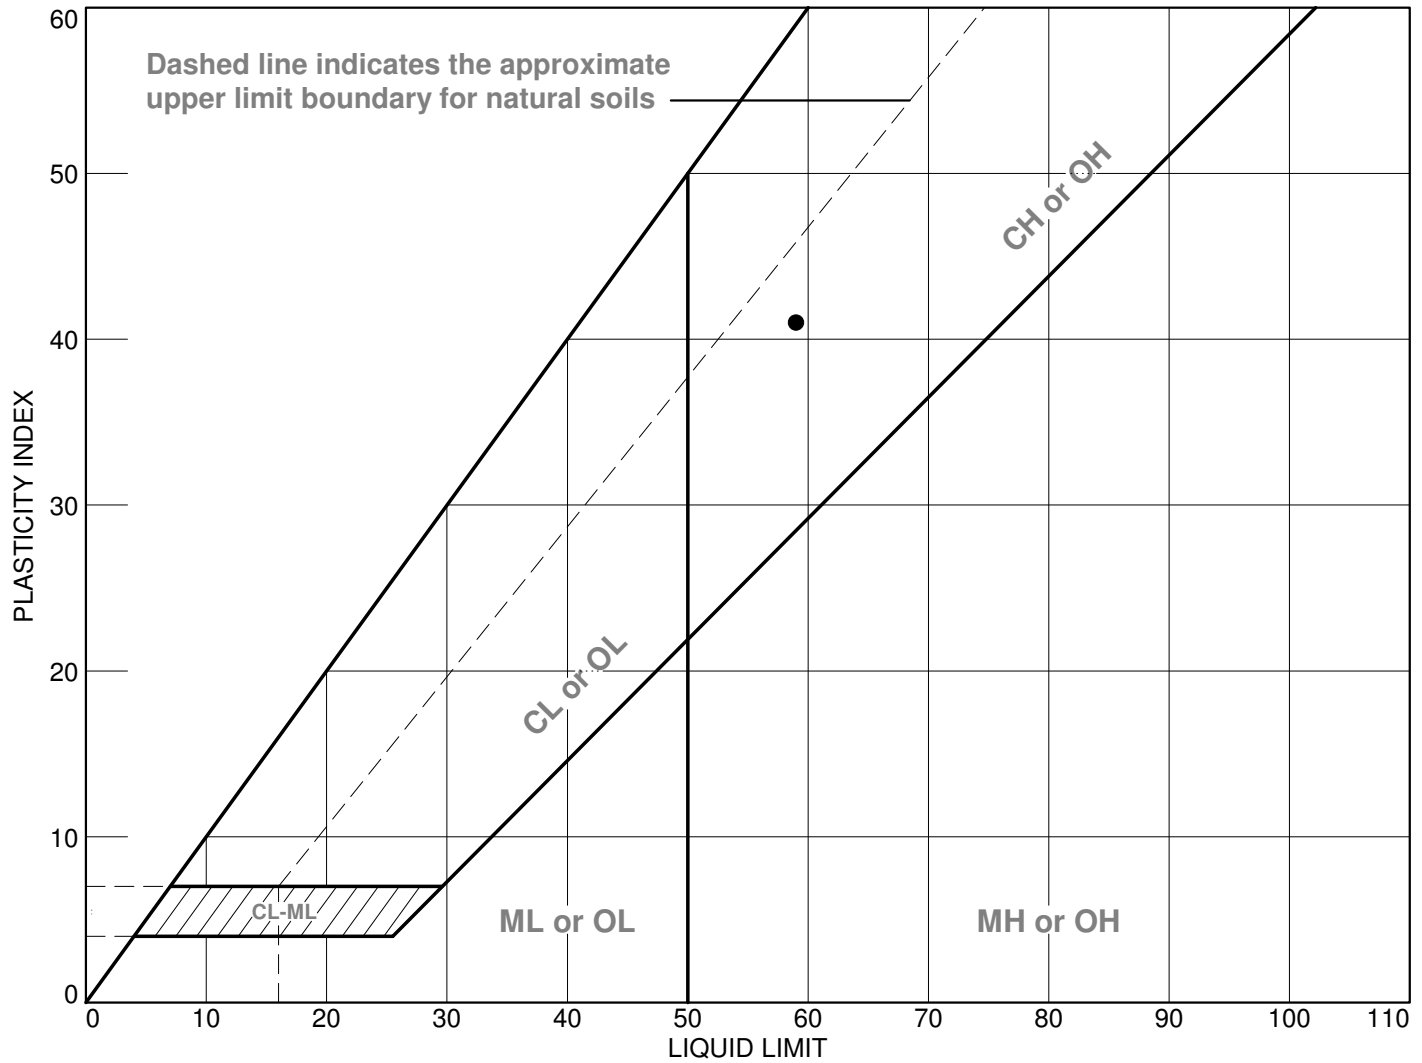
SOIL DATA								
SYMBOL	SOURCE	SAMPLE NO.	DEPTH	NATURAL WATER CONTENT (%)	PLASTIC LIMIT (%)	LIQUID LIMIT (%)	PLASTICITY INDEX (%)	USCS
●	BH12-7	7-4	4.8m	36.0	18	59	41	CH

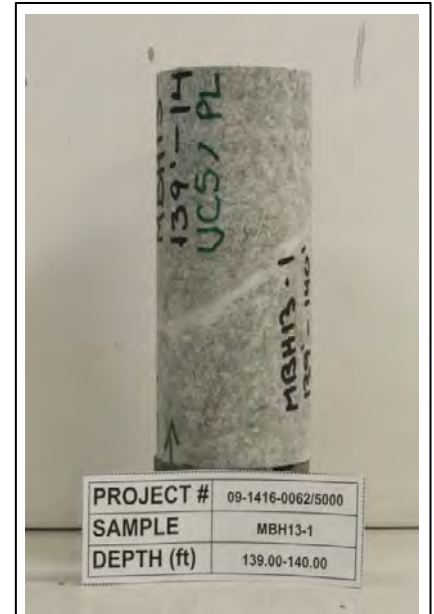
BEFORE TEST

Failure Mode	Notes
Type: <u>1,2</u>	- Water content as received
Degrees:* <u>20</u>	Mode:
	(1) Diagonal shear plane(s)
	(2) Vertical fracture(s)
	(3) Vertical splitting
	(4) Shear along foliation /discontinuity
	(5) Conical
* Degrees measured with respect to core axis.	(6) Spalling
	(7) Other

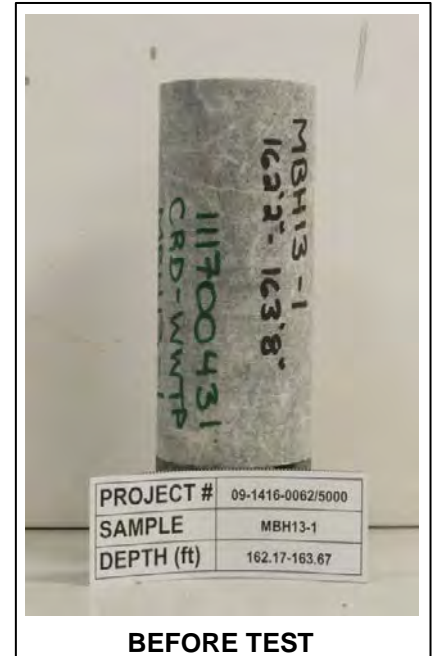
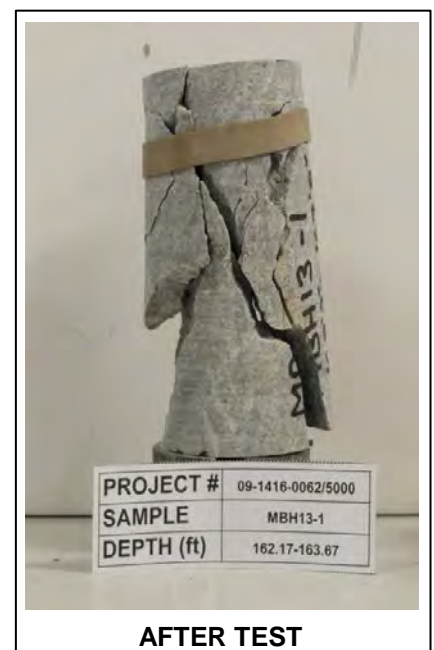
Failure Mode	Notes
Type: <u>1,2</u>	- Water content as received
Degrees.* <u>25</u>	Mode:
	(1) Diagonal shear plane(s)
	(2) Vertical fracture(s)
	(3) Vertical splitting
	(4) Shear along foliation /discontinuity
	(5) Conical
* Degrees measured with respect to core axis.	(6) Spalling
	(7) Other

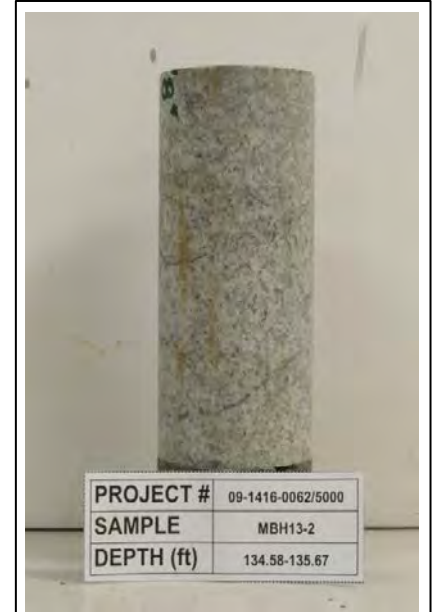
BEFORE TEST

Failure Mode	Notes
Type: <u>4</u>	- Water content as received
Degrees:* <u>22</u>	Mode:
	(1) Diagonal shear plane(s)
	(2) Vertical fracture(s)
	(3) Vertical splitting
	(4) Shear along foliation /discontinuity
	(5) Conical
* Degrees measured with respect to core axis.	(6) Spalling
	(7) Other

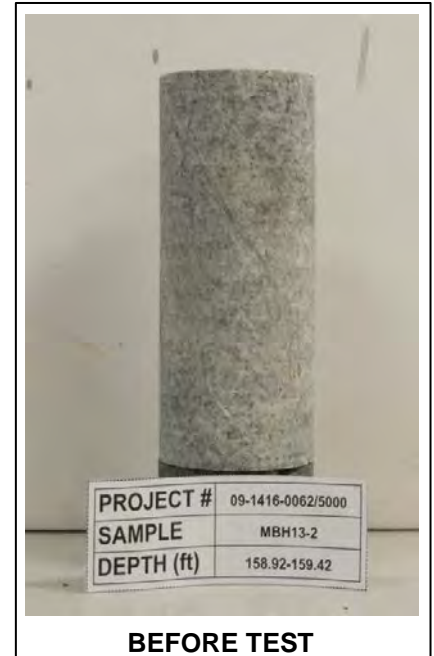
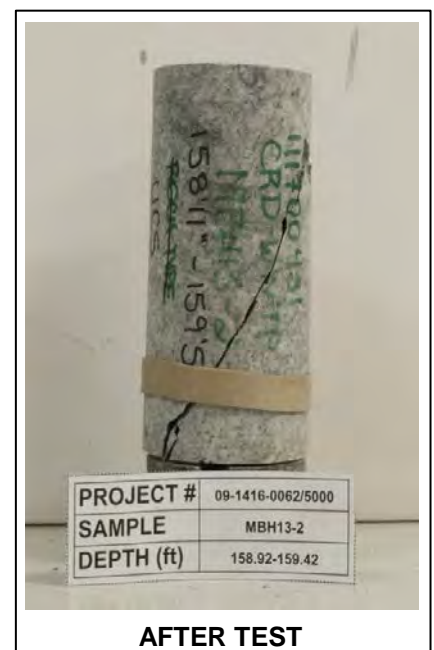
Failure Mode	Notes
Type: <u>4</u>	- Water content as received
Degrees:* <u>30</u>	Mode:
	(1) Diagonal shear plane(s)
	(2) Vertical fracture(s)
	(3) Vertical splitting
	(4) Shear along foliation /discontinuity
	(5) Conical
* Degrees measured with respect to core axis.	(6) Spalling
	(7) Other

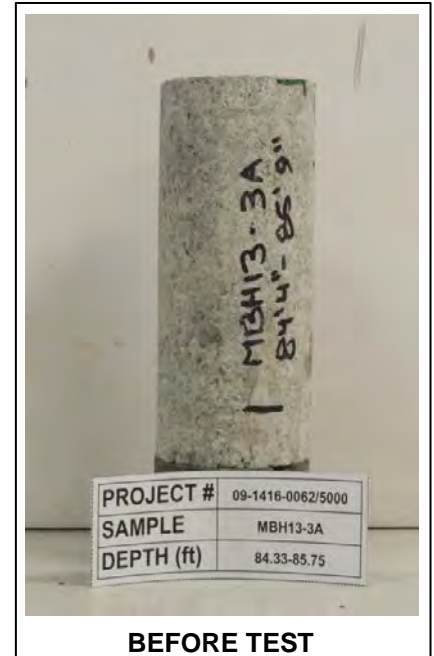
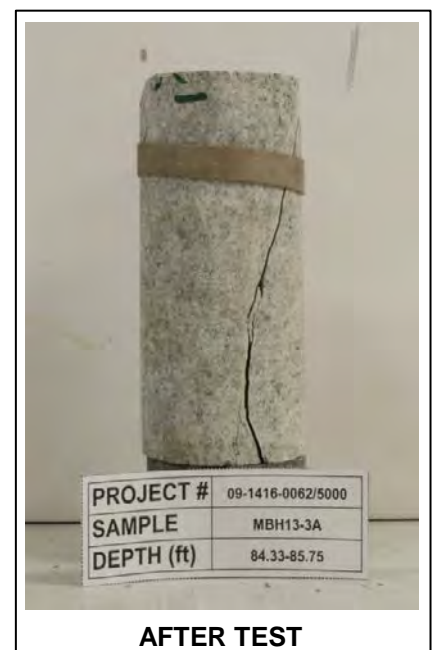
Failure Mode	Notes
Type: <u>4</u>	- Water content as received
Degrees:* <u>15</u>	Mode:
	(1) Diagonal shear plane(s)
	(2) Vertical fracture(s)
	(3) Vertical splitting
	(4) Shear along foliation /discontinuity
	(5) Conical
* Degrees measured with respect to core axis.	(6) Spalling
	(7) Other

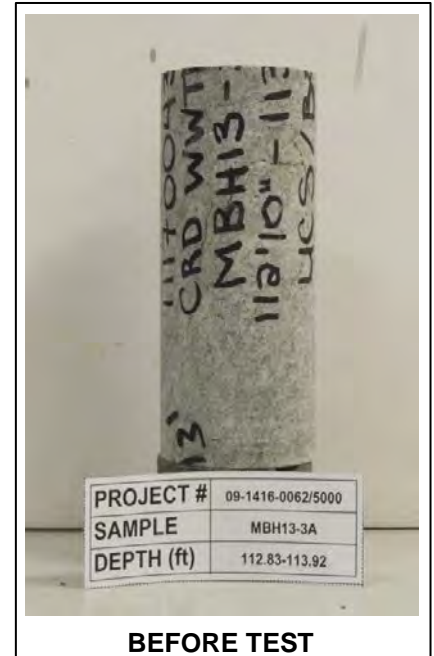
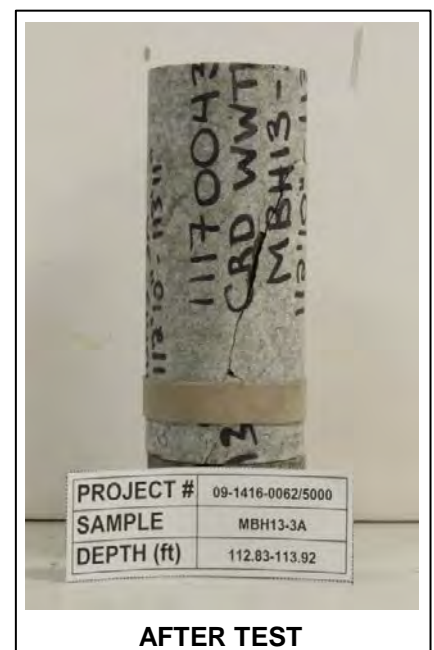
Failure Mode	Notes
Type: <u>1</u>	- Water content as received
Degrees:* <u>20</u>	Mode:
	(1) Diagonal shear plane(s)
	(2) Vertical fracture(s)
	(3) Vertical splitting
	(4) Shear along foliation /discontinuity
	(5) Conical
* Degrees measured with respect to core axis.	(6) Spalling
	(7) Other

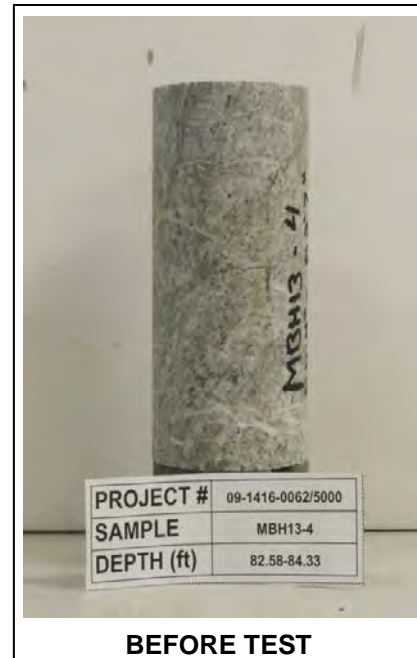
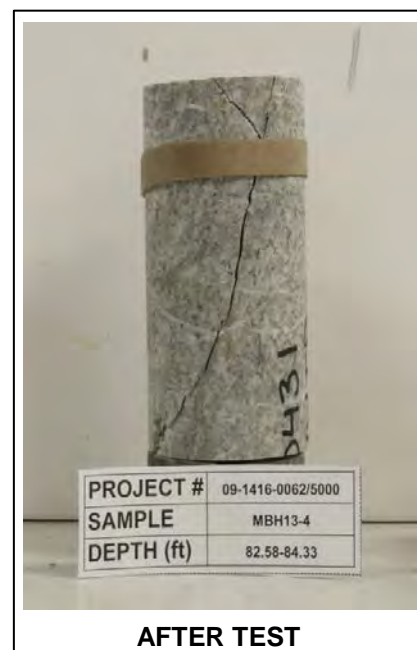
Failure Mode	Notes
Type: <u>4</u>	- Water content as received
Degrees:* <u>18</u>	Mode:
	(1) Diagonal shear plane(s)
	(2) Vertical fracture(s)
	(3) Vertical splitting
	(4) Shear along foliation /discontinuity
	(5) Conical
* Degrees measured with respect to core axis.	(6) Spalling
	(7) Other

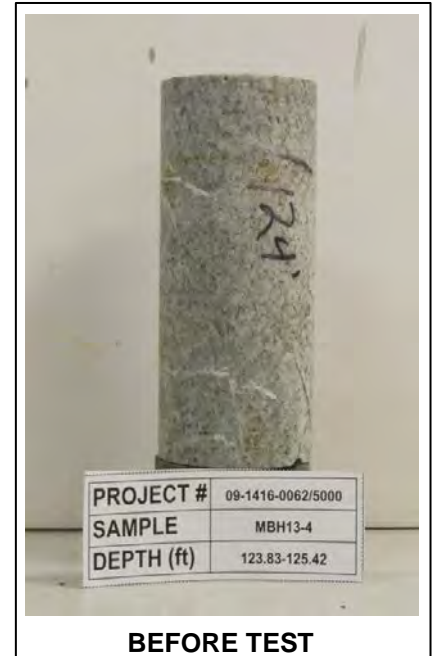
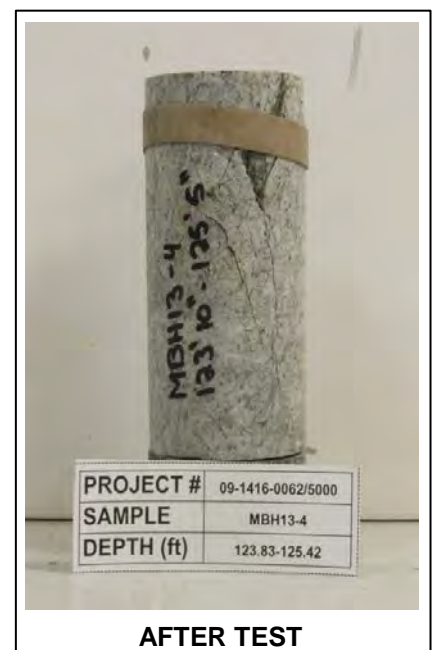
Failure Mode	Notes
Type: <u>2,1</u>	- Water content as received
Degrees:* <u>30</u>	Mode:
	(1) Diagonal shear plane(s)
	(2) Vertical fracture(s)
	(3) Vertical splitting
	(4) Shear along foliation /discontinuity
	(5) Conical
* Degrees measured with respect to core axis.	(6) Spalling
	(7) Other

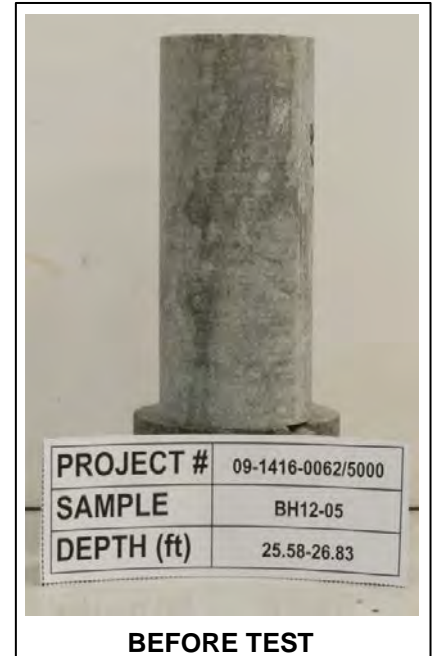
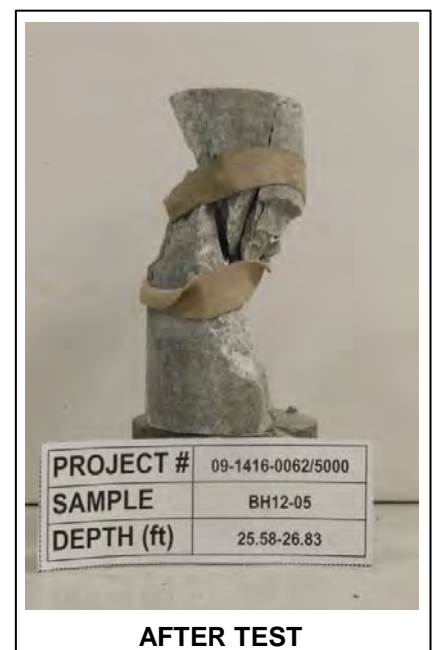
Failure Mode	Notes
Type: <u>1</u>	- Water content as received
Degrees:* <u>22</u>	Mode:
	(1) Diagonal shear plane(s)
	(2) Vertical fracture(s)
	(3) Vertical splitting
	(4) Shear along foliation /discontinuity
	(5) Conical
* Degrees measured with respect to core axis.	(6) Spalling
	(7) Other

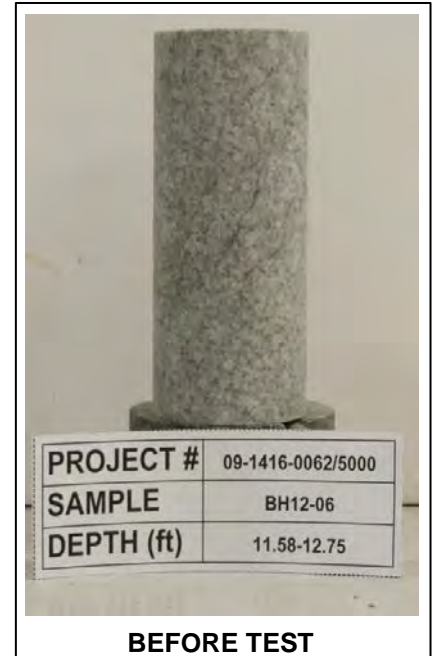
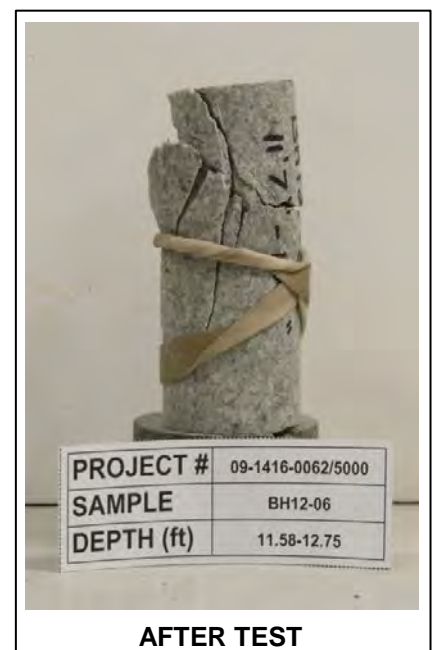
Failure Mode	Notes
Type: <u>2,1</u>	- Water content as received
Degrees:* <u>10</u>	Mode:
	(1) Diagonal shear plane(s)
	(2) Vertical fracture(s)
	(3) Vertical splitting
	(4) Shear along foliation /discontinuity
	(5) Conical
* Degrees measured with respect to core axis.	(6) Spalling
	(7) Other

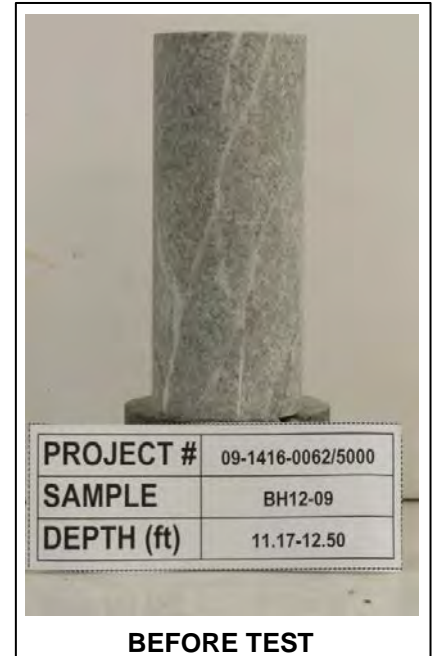
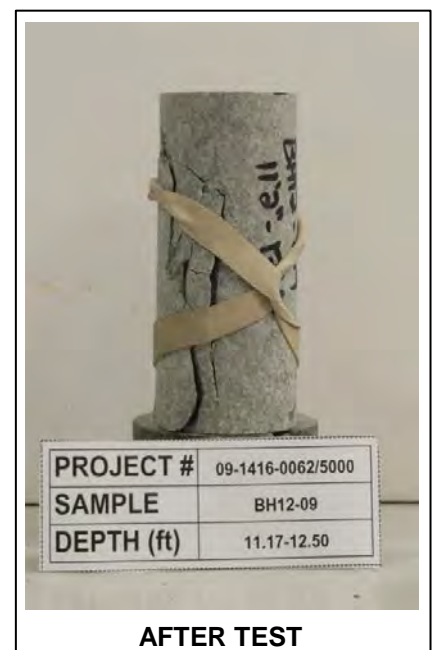
Failure Mode	Notes
Type: <u>6,2</u>	- Water content as received
Degrees.* _____	Mode:
	(1) Diagonal shear plane(s)
	(2) Vertical fracture(s)
	(3) Vertical splitting
	(4) Shear along foliation /discontinuity
	(5) Conical
* Degrees measured with respect to core axis.	(6) Spalling
	(7) Other

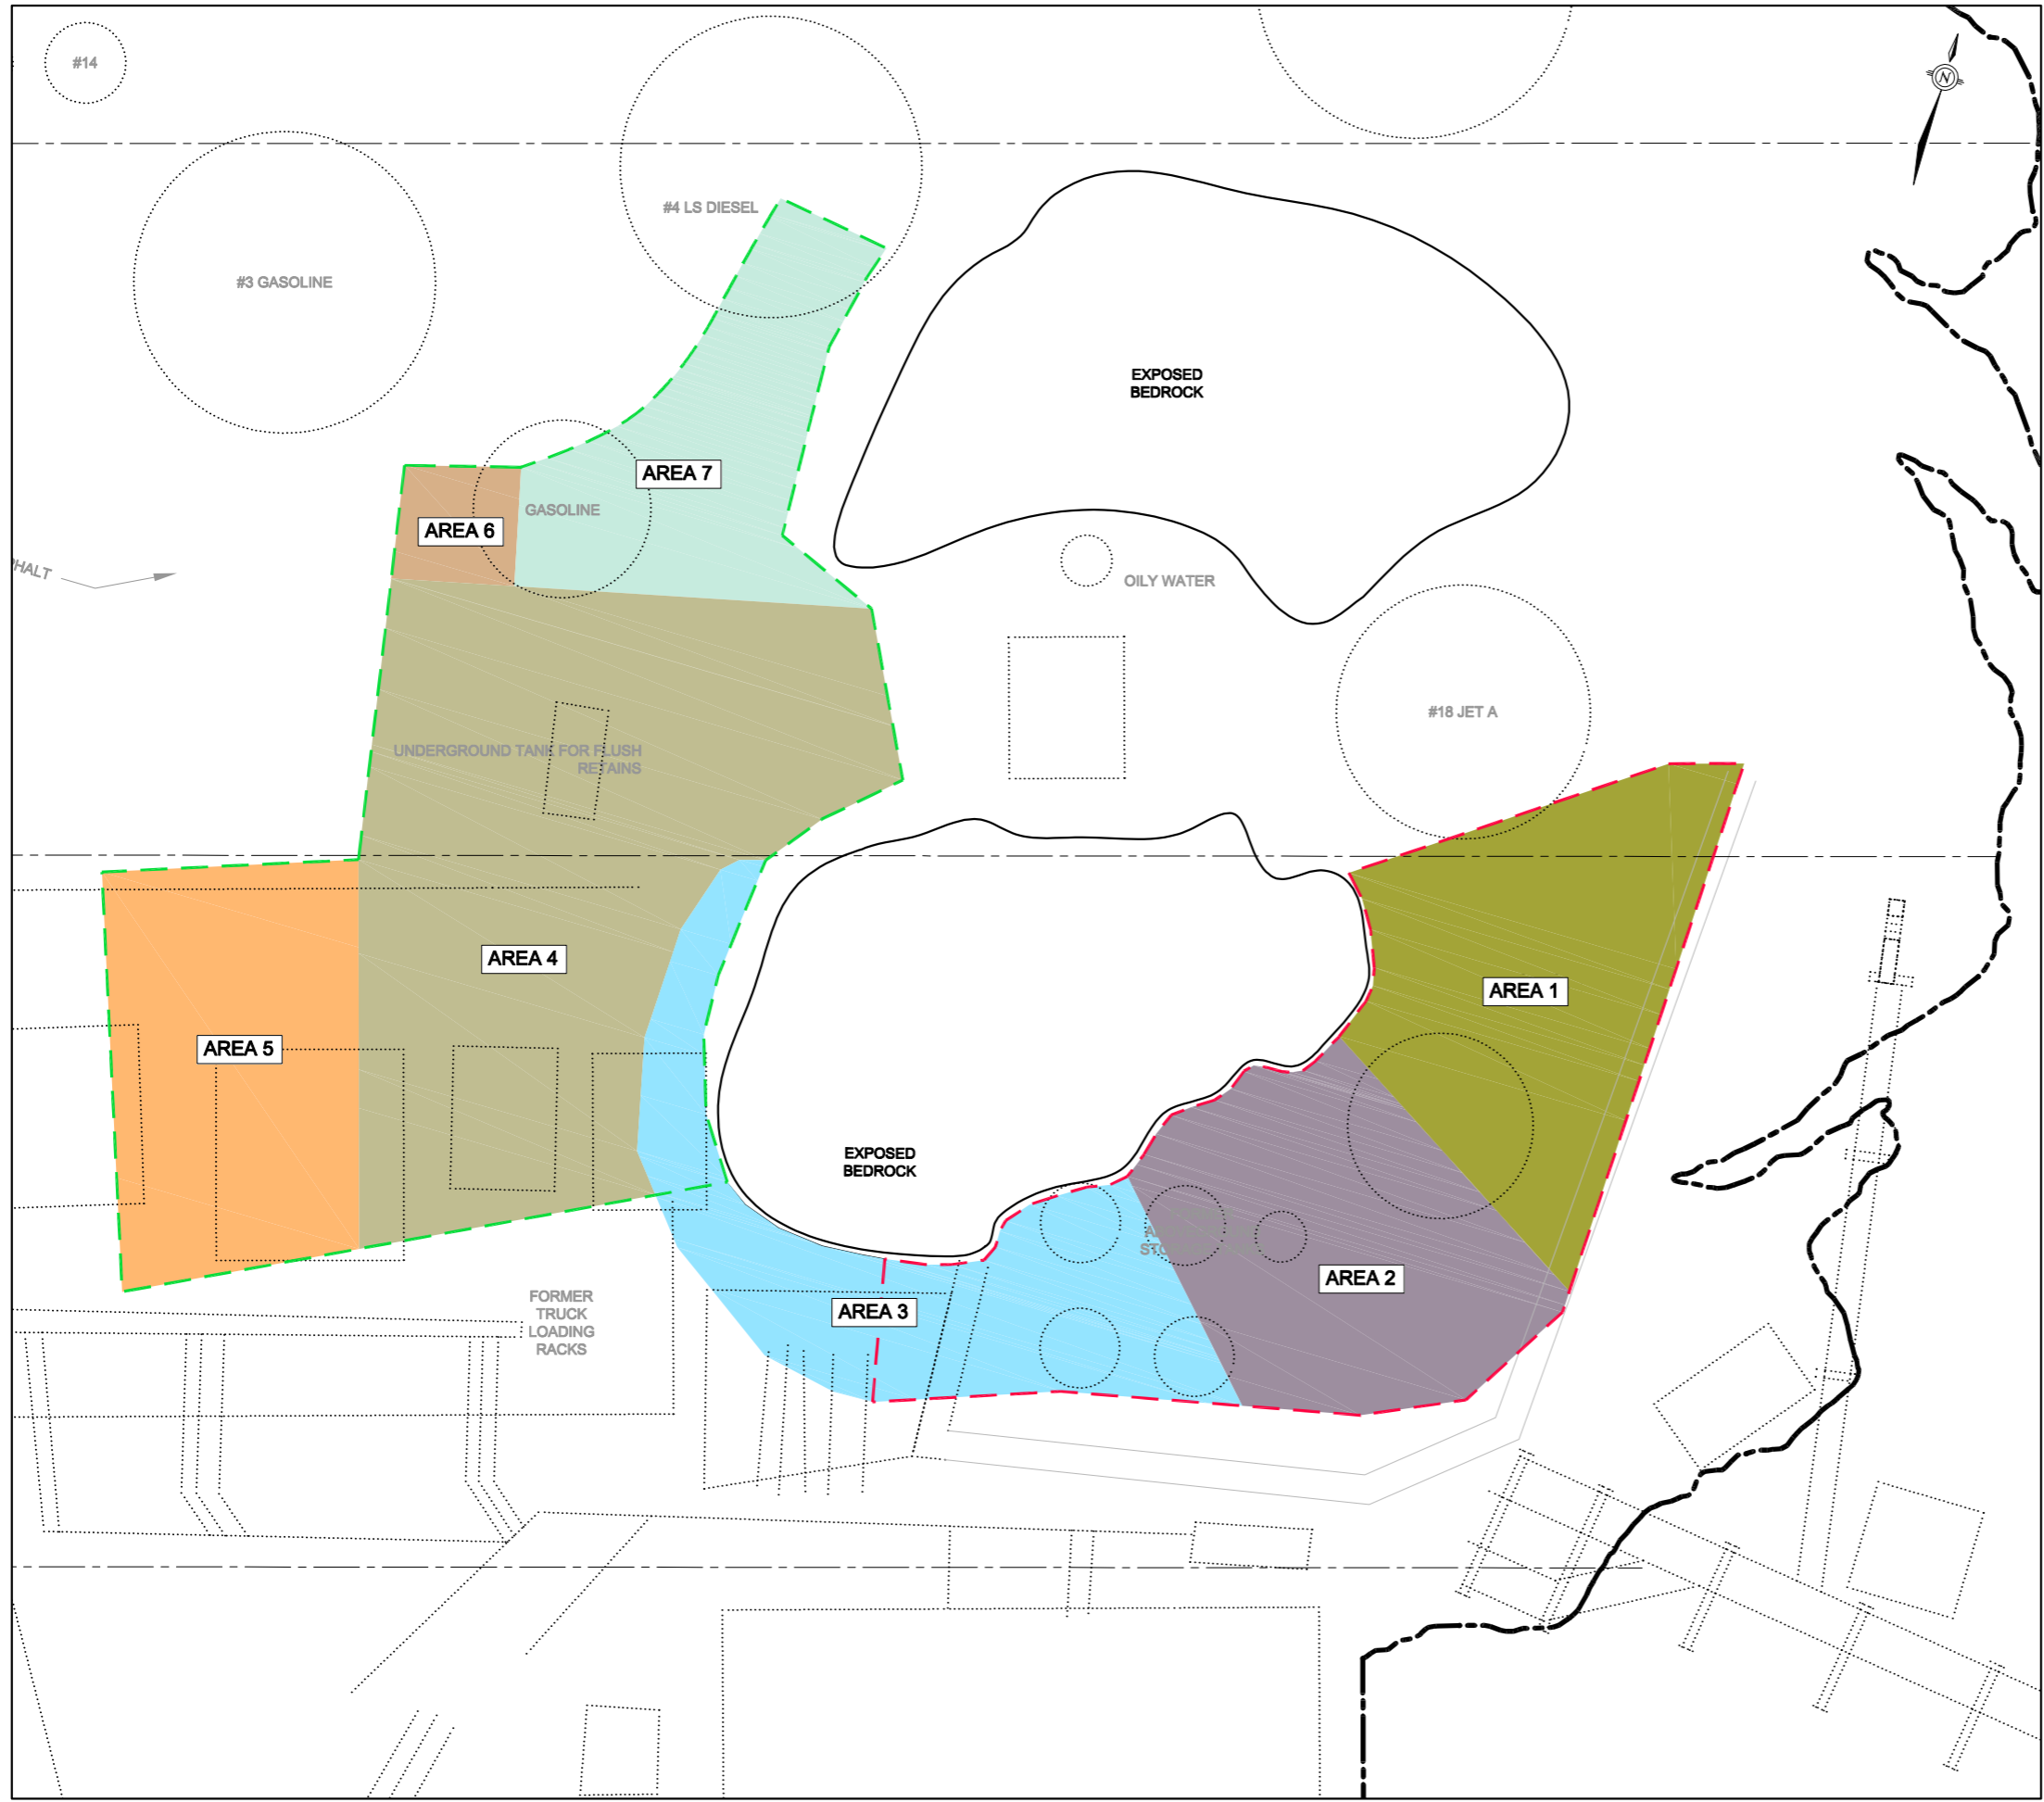
AREA	BACKFILL
1	SP12-02-03, SP12-02-04, SP12-02-05 AND SP12-02-06 ON BEDROCK
2	BLAST ROCK FROM AREA B, COVERED WITH SP12-02-03, SP12-02-04, SP12-02-05 AND SP12-02-06
3	SP12-03-01 AND SP12-03-02
4	3" MINUS (FILL 3)
5	LAYERED
	3" MINUS (FILL 3)
	FINE SAND (FILL 4)
	3" - 6" CLEAR
6	SP12-05
7	SILTY BACKFILL (FILL 1)

As a result of the remedial work completed at the site, the existing soil conditions at the site differ from those described on the test hole logs in the Stage 2 PSI report by Golder Associates (included in **Appendix F**). Drawings by Golder Associates showing the extents of the remedial work and describing the nature of backfill materials are provided in **Appendix G**.
