**Re: Data Report for the Forage Fish Survey and the Beach Profiling at Esquimalt Lagoon;
P.O. #200068972 and P.O. #200073028**

Below is a data report summarizing the objectives, methods and results for 1.0) the forage fish survey and 2.0) the beach profiling conducted at Esquimalt Lagoon between November 2009 and March 2010.

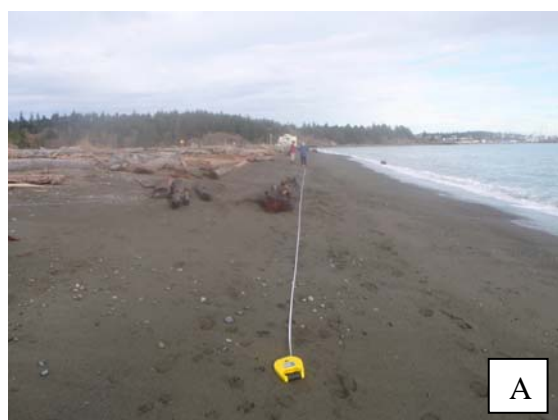
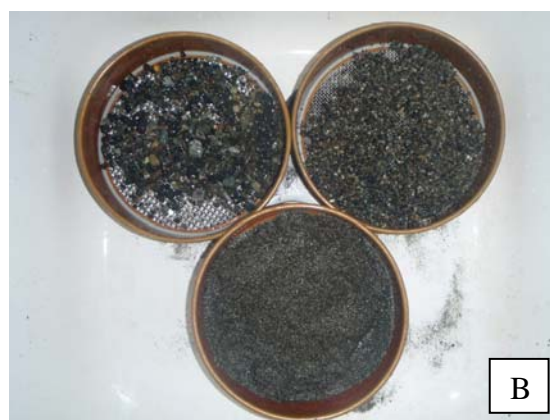
Sediment samples were collected from each of the sample sites on November 27 and 28, 2009, December 15 and 16, 2009 and January 25, 2010. A 30m transect was laid parallel to the shoreline within the upper intertidal zone (Photo A). A composite beach spawn sample of 2000mL of sediment from the top 2-3 cm of substrate within 2.5m on either side of the transect was collected. Each composite sample was then stored at a cool temperature and sieved (using fresh water) through graduated screens (4mm, 2mm, 0.5mm) (Photo B). The 0.5mm fraction was retained for examination of eggs using a winnowing technique that involves swirling sediment with a cover of water to bring the lighter fraction to the surface. This fraction would have included any beach spawner eggs, which adhere to sand grains and fragments of shell.

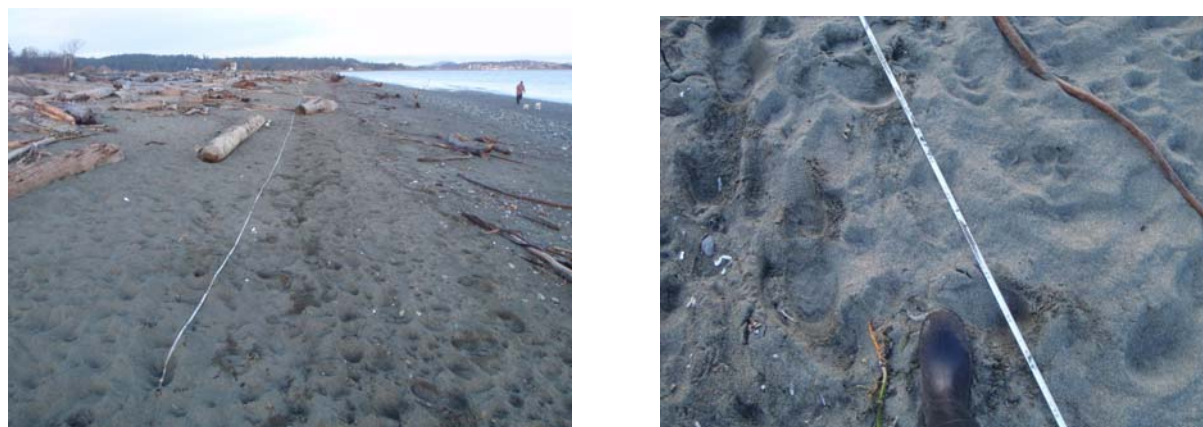
Figure 1.2. Photographs of beach spawn sample sites. **Left: T1** November 2009; **Right:** close view of substrate at T1.

No eggs were found in any of the samples. Suitable substrate for forage fish (*A. hexapterus* and *H. pretiosus*) beach spawn exists at all of the locations (sand lance spawn on pure sand and a mixture of sand and fine gravel with very few fines similar to surf smelt). The composite samples from T1 to T5 contained material of similar grain size comprised of predominantly medium to coarse sand with some small pebble. The substrate along T6 – T8 was comprised of fine to medium sand with higher pebble content. Shell hash was present at T6 along with some organics including small wood fibre. The substrate at T9 was a mixture of fine to coarse sand and shell hash, with a higher percentage of wood fibre and organics than at T6. The amount of fines at T6, T7 and T9 varied between November and January making these sites less suitable on a consistent basis.

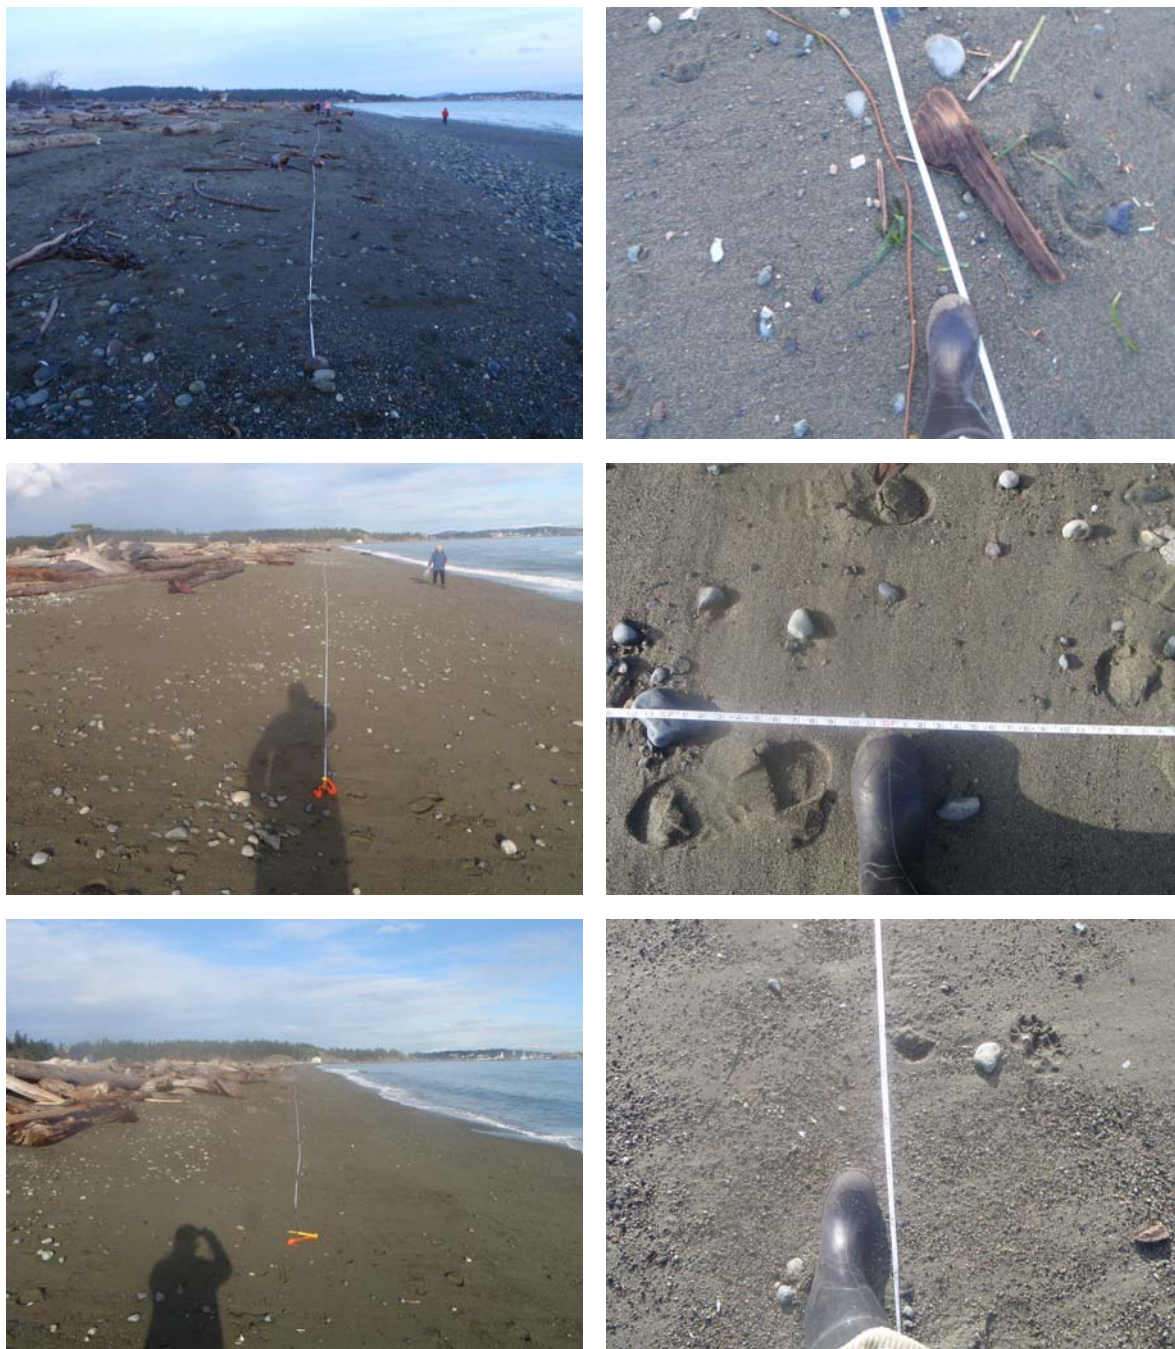
Figure 1.2 continued. **Top left: T2** November 2009; **Top right:** close view of substrate at T2. **Middle left: T3** January 2010; **Middle right:** close view of substrate at T3. **Bottom left: T4** January 2010; **Bottom right:** close view of substrate at T4.

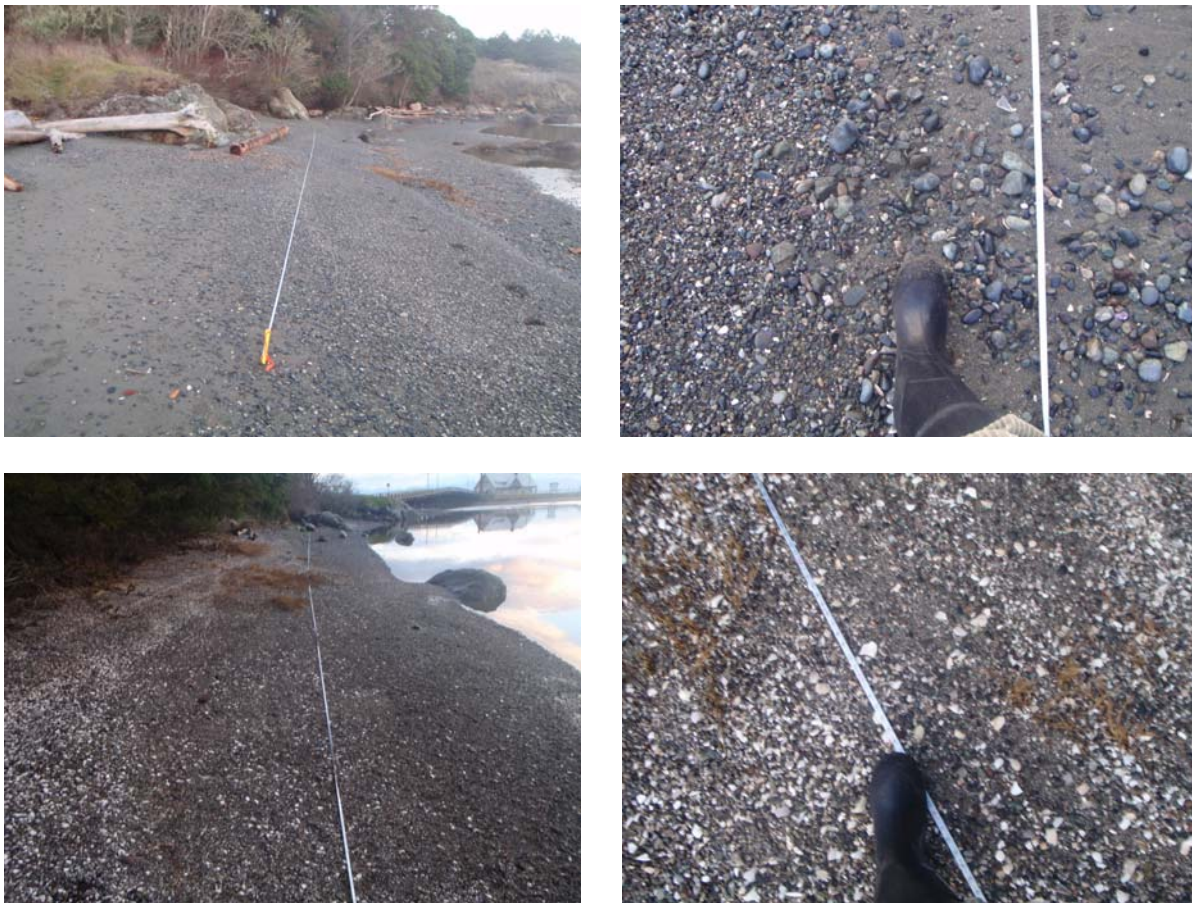
Figure 1.2 continued. **Top left: T8** January 2010; **Top right:** close view of substrate at T8. **Bottom left: T9** January 2010; **Bottom right:** close view of substrate at T9.

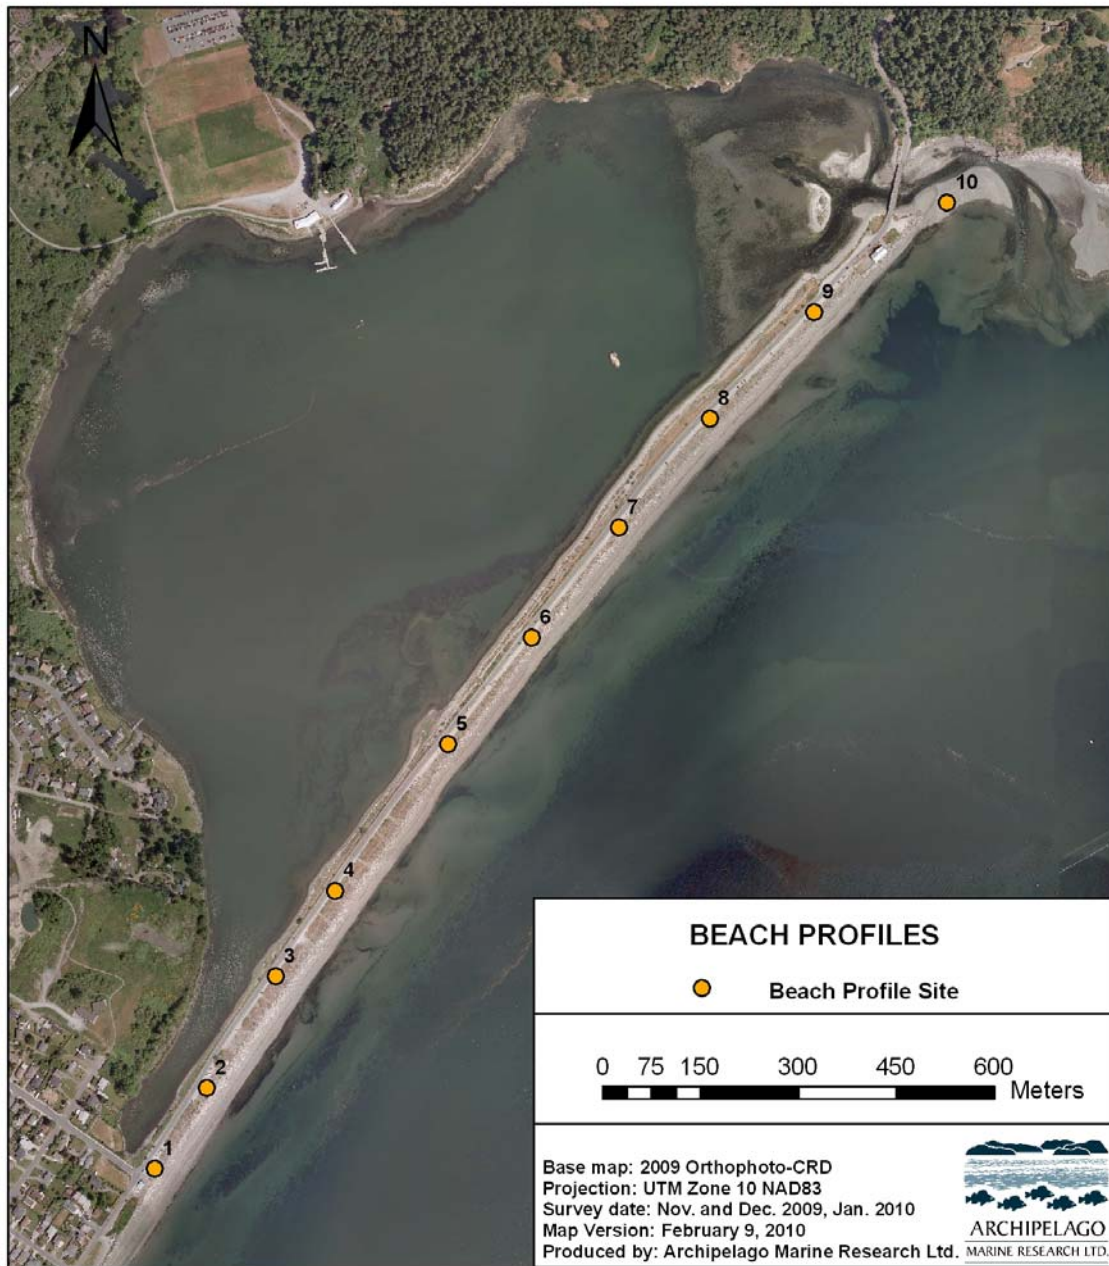
Figure 2.1. Across shore beach profile locations along the Coburg Peninsula at Esquimalt Lagoon.

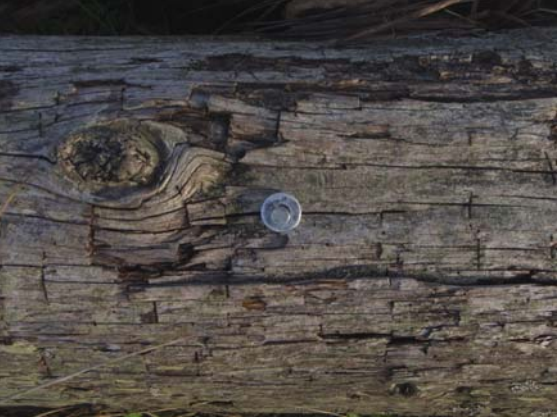
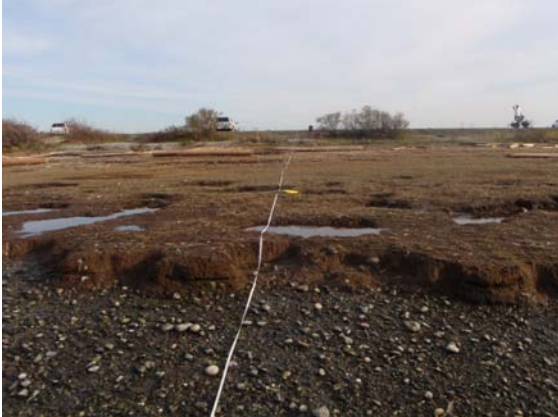
<p>Photo 1: Example of new transect marker (nail and washer) placed in a log located along the shoreward side of the dune restoration area</p>	<p>Photo 2: Transect on the lagoon side of Coburg Peninsula taken from the waterline facing the road</p>

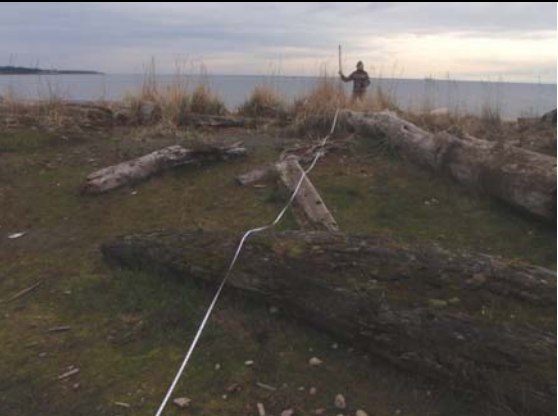
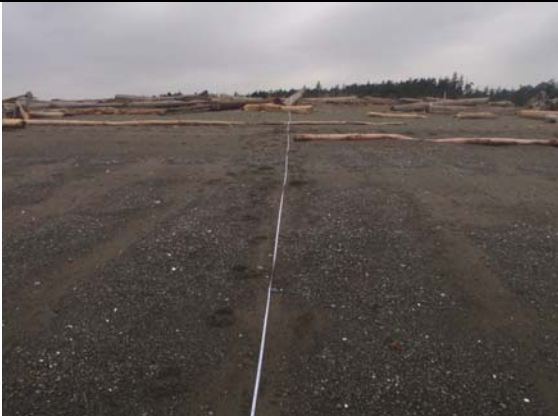
<p>Photo 3: Transect spanning through the dune grass restoration area on the ocean side of Coburg Peninsula</p>	<p>Photo 4: Transect through the bare beach on the ocean side of Coburg Peninsula.</p>

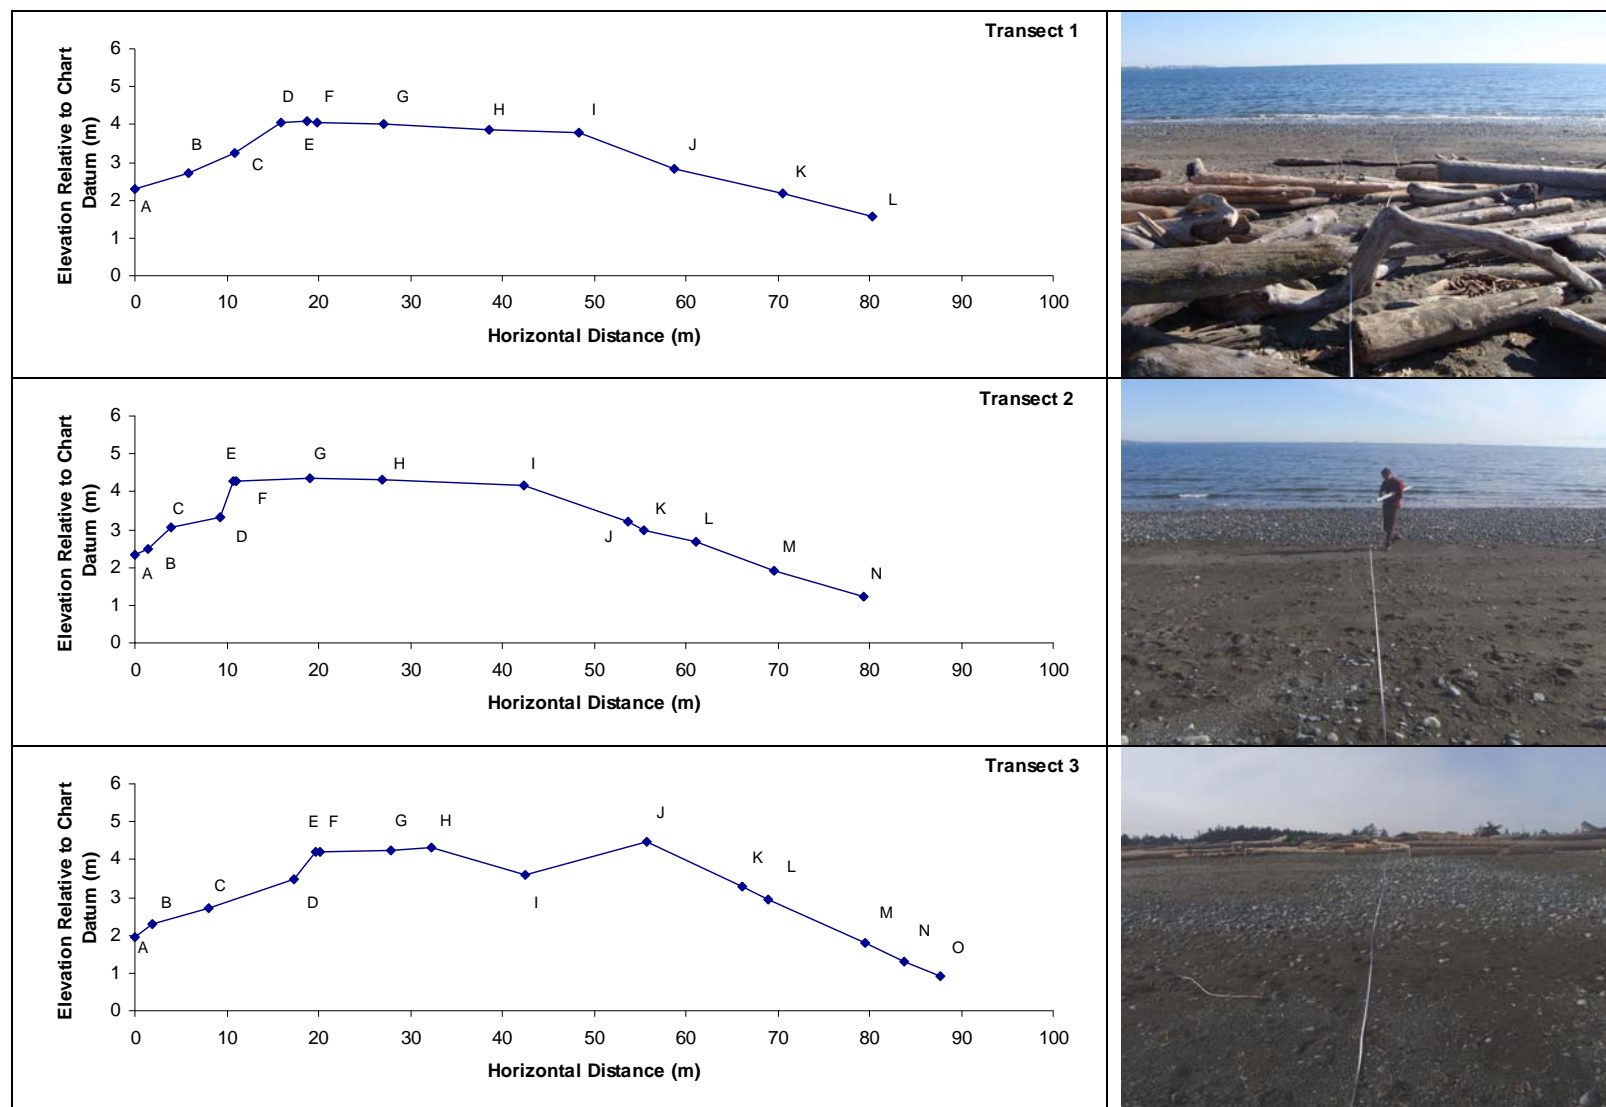
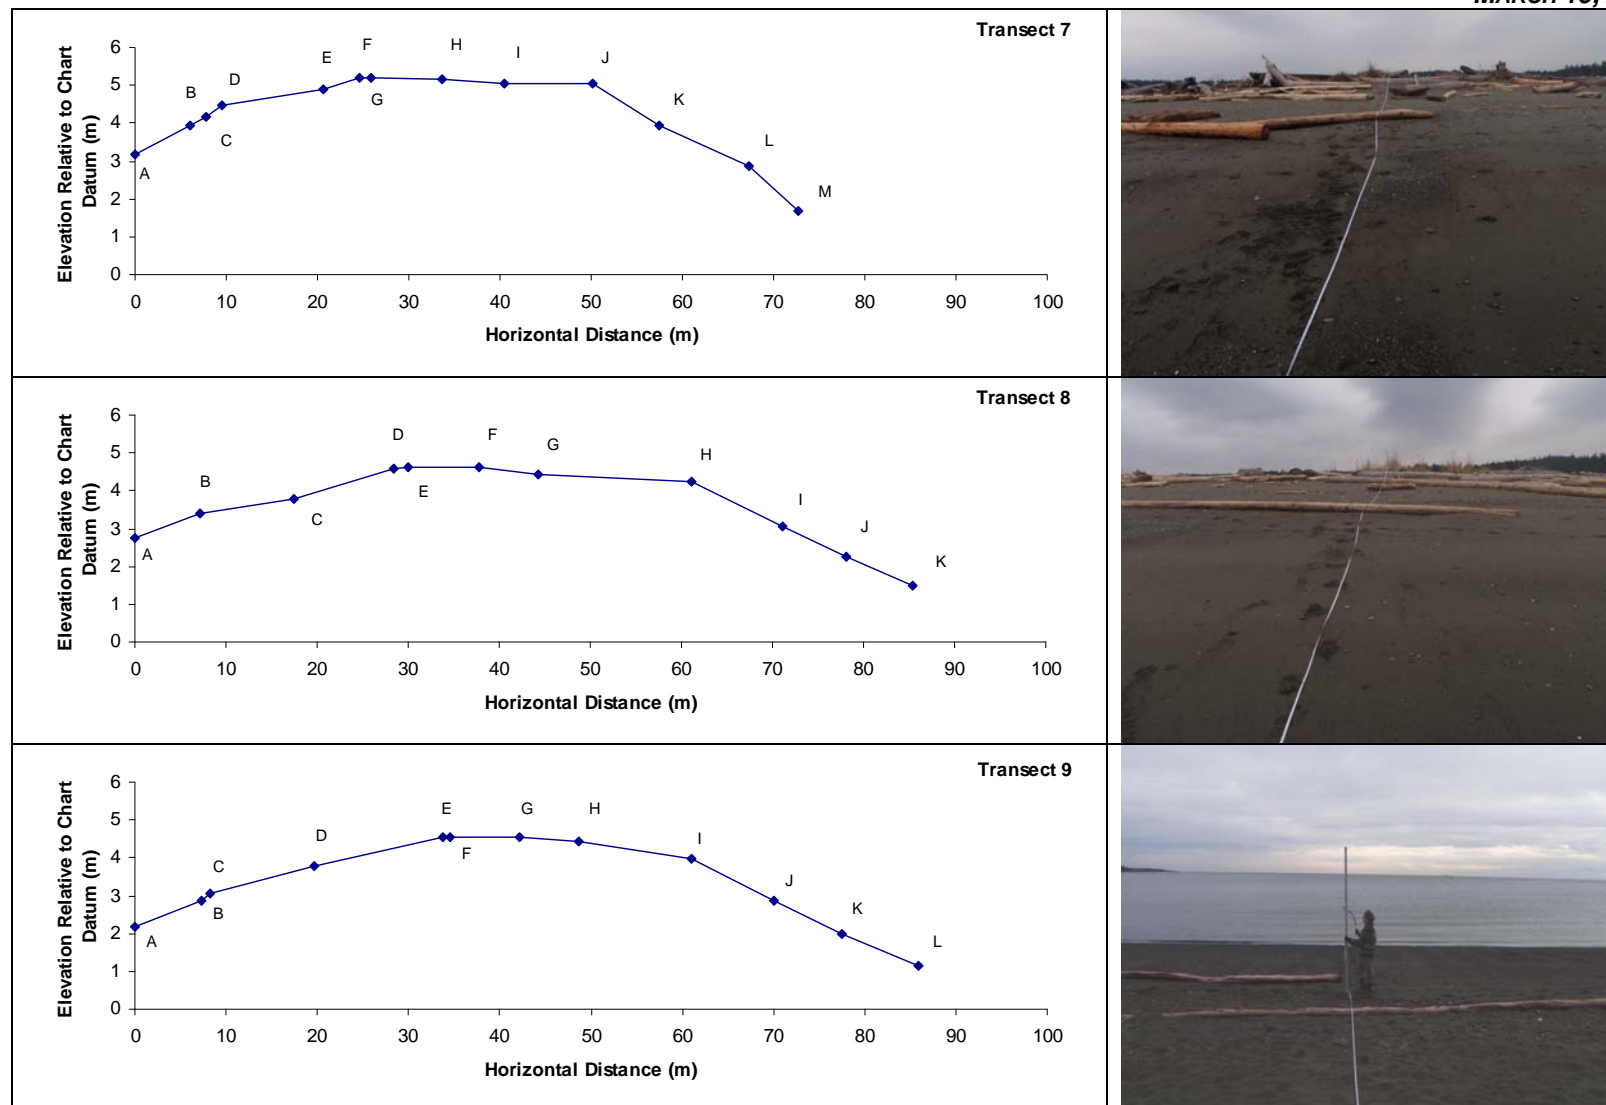
Table 3: Coburg Peninsula Beach Profiles

Table 3 shows an across shore profile and a representative photograph for each of the 10 transects. Each transect starts at the waterline on the lagoon side (A) of Coburg Peninsula and ends at the waterline on the ocean side of Coburg Peninsula. Table 4 provides a summary of the transect information with letters corresponding to the start of each interval. Table 5 outlines the sediment size categories and sediment codes used in Table 4. Table 6 are the transect locations in UTM's.

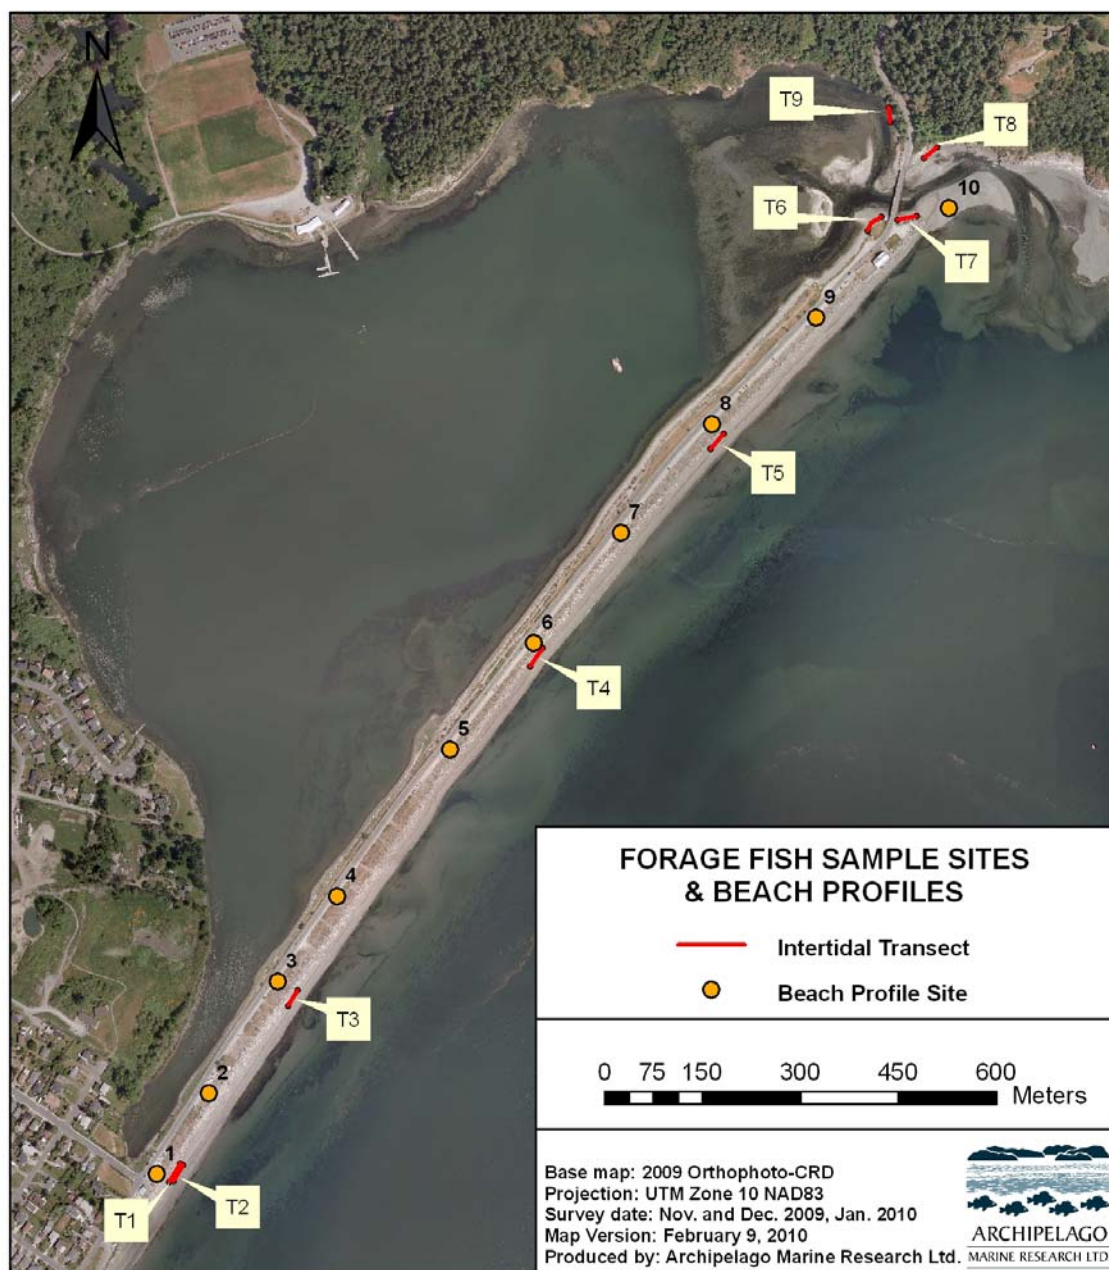
Appendix Figure 1. Location of forage fish sample sites in relation to the beach profiles at Esquimalt Lagoon.

Table 1 provides the transect coordinates for the start and end of each 30m. Transect 1 and Transect 2 were located 6m from each other at the beach profile site 1 as shown in Appendix Figure 1. Table 2 summarizes the sample and processing activity from November 26, 2009 to March 19, 2010.
