***Cataloguing and Analyzing Urban Waterways & their Riparian Zones:
A Baseline Data Project in Esquimalt Gorge Park and Cuthbert Holmes Park***

This study was done in partial fulfilment of the requirements for the Gorge Waterway Action
Society Youth Community Partnership Program

January - March 2021

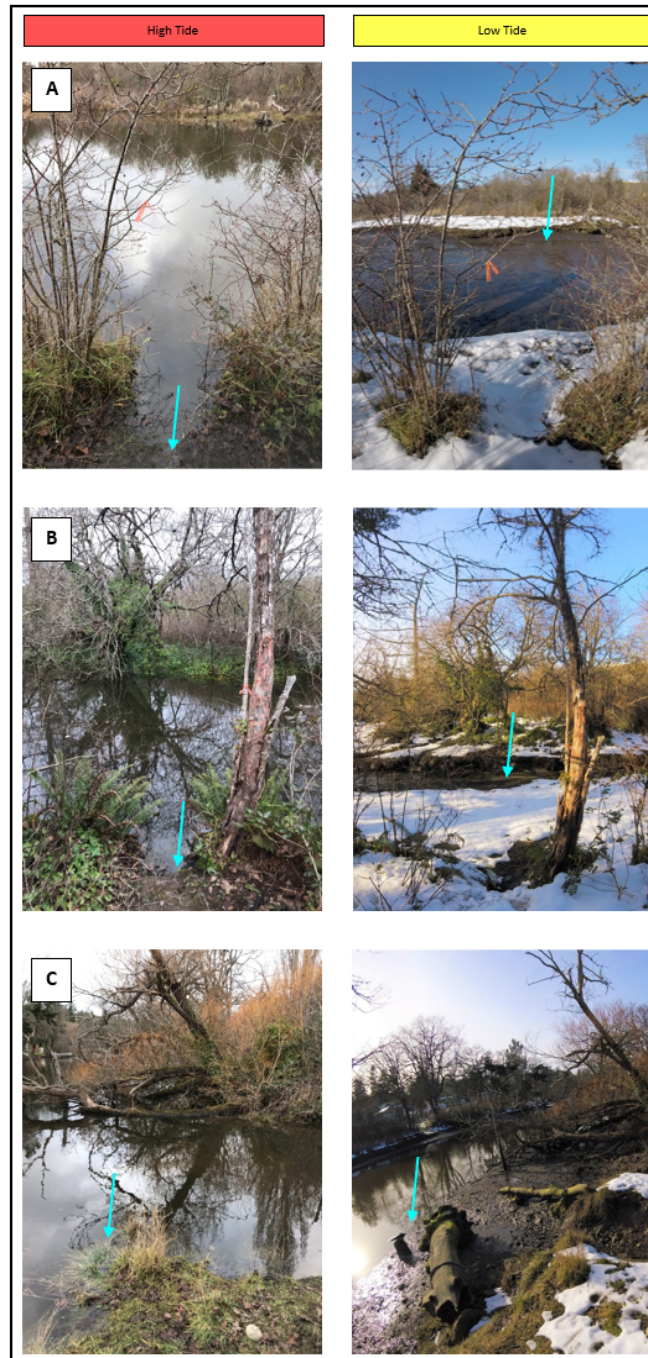
Figure 4. Water sampling locations in Cuthbert Holmes Park during high and low tide. Water level indicated by blue arrow. A) Mudflats (Site #4) water sampling location. B) Restored Tidal Shelf (Site #3) water sampling location. C) Dendritic Channels (Site #2) water sampling location. Photos: Aniesha Schencks.

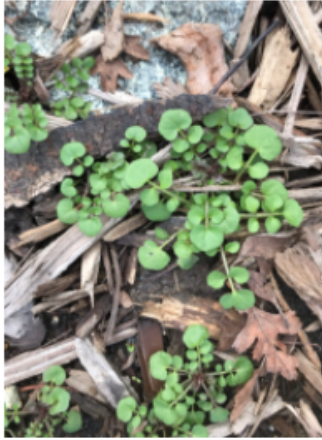
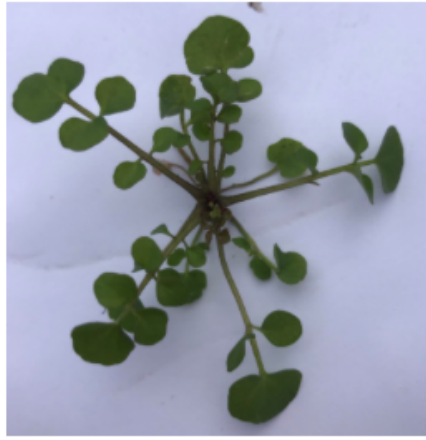
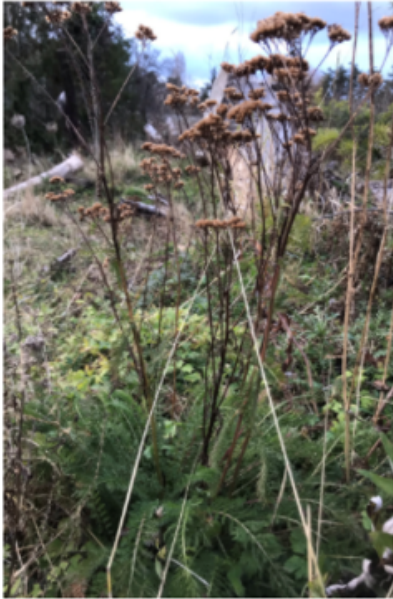
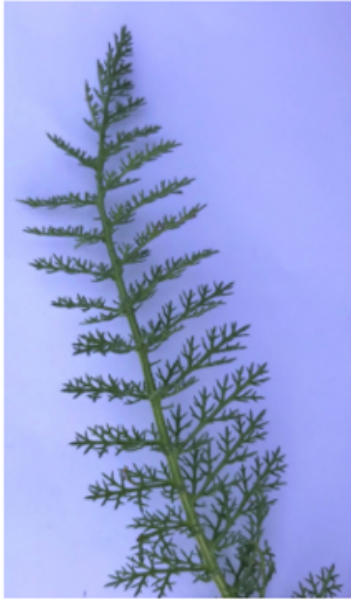
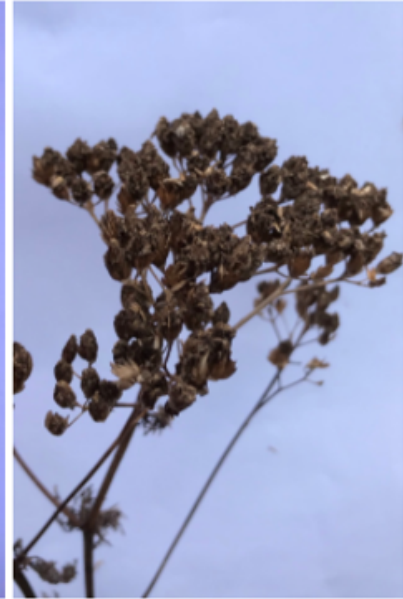
Figure 8. Examples of species photos taken at the two vegetation sampling sites in Esquimalt Gorge Park and Cuthbert Holmes Park near Victoria, BC. Each specimen had two types of pictures taken; “as-is” pictures (i.e. how the plant looks in-space growing) and close-up pictures of plant parts for identification in the ‘[Species Catalogue](#)’. Close-up pictures were taken with a white sheet of paper behind the subject to aid identification. Photos: Aniesha Schencks

- Photos were taken of each unique vegetative species. Species photos were included in the Sites #1 - 2 '[Species Catalogues](#)'.
 - At least one photo of the species was taken as-is and additional close-up photos were taken of plant parts which were helpful for identification (e.g. flowers, berries, seed pods, leaves / leaflets, stem, branches, bark pattern / colour, cones, needles) ([Figure 8](#)).

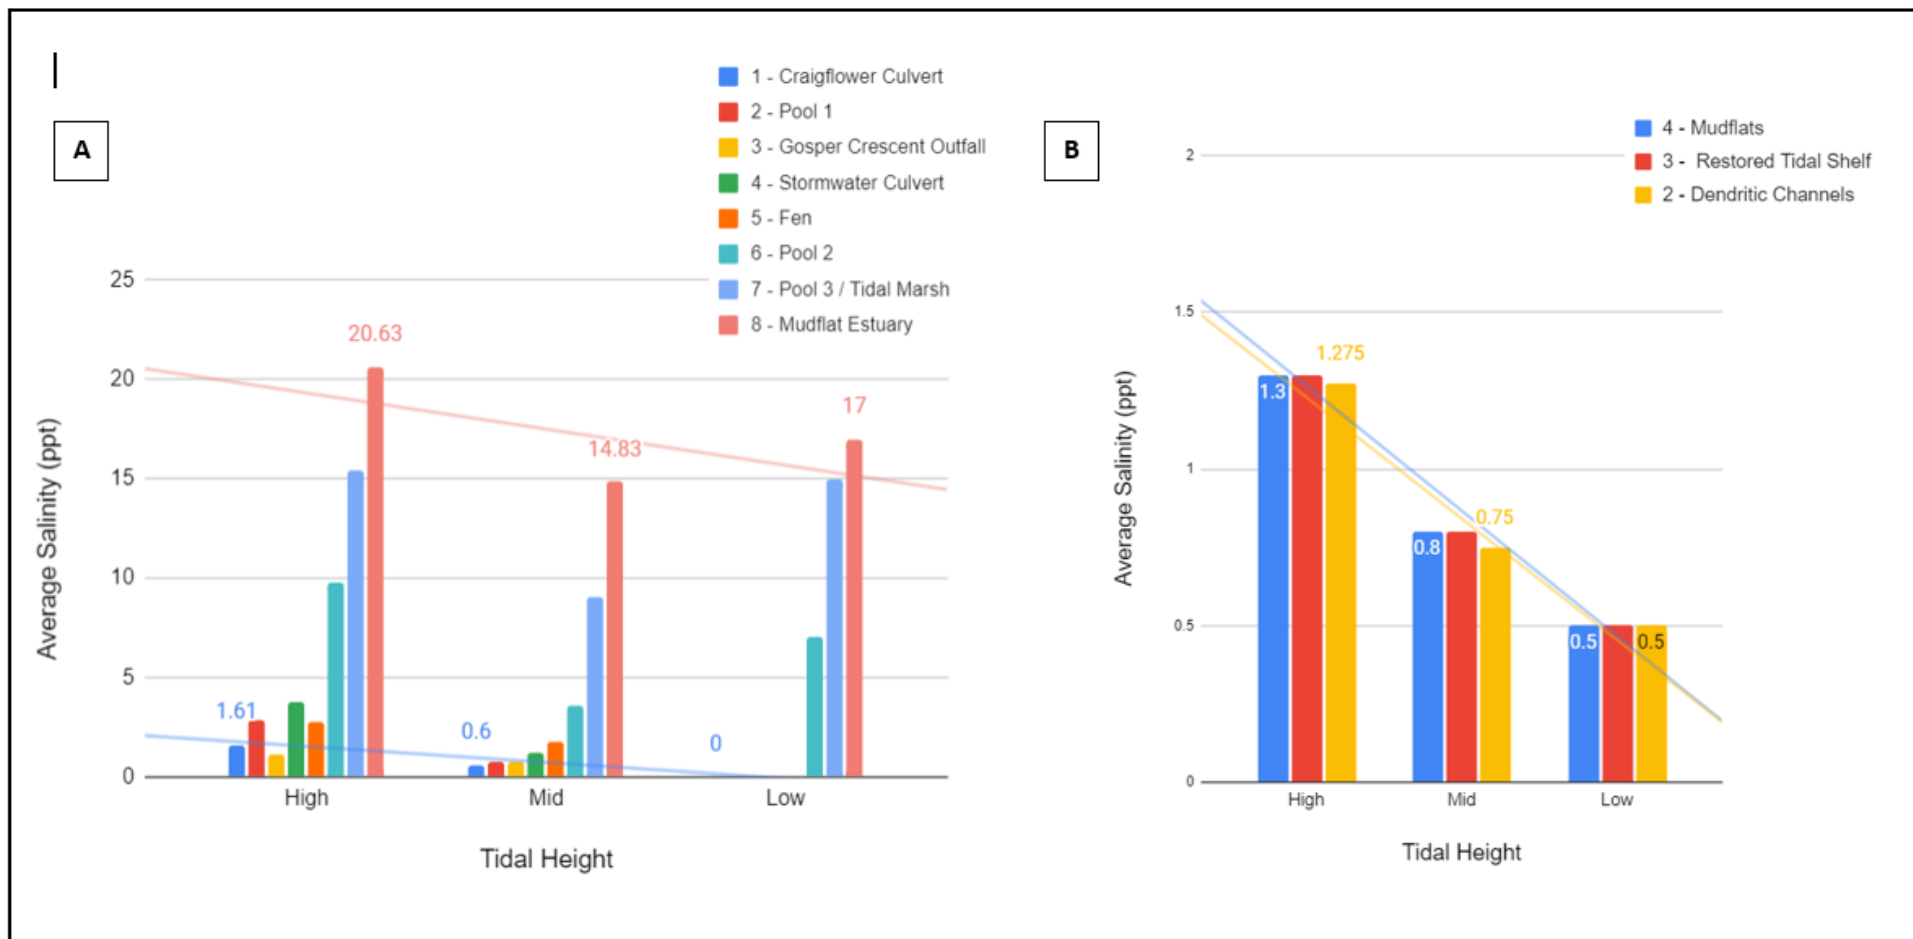
Figure 16. Average salinity (ppt) compared to general tidal height (i.e. high, mid and low) for Esquimalt Gorge Park and Cuthbert Holmes Park regions. A) Average salinity values for the eight sites along the creek in Esquimalt Gorge Park, Esquimalt, BC. B) Average salinity values for the three sites in Cuthbert Holmes Park, Saanich, BC. Note: Tidal heights defined as: Low (0 - 0.6), Mid (0.7 - 1) and High (> 1.1) (Clarke, 2021).

Additionally, in the Esquimalt Gorge Park region, it was found that tidal height corresponded with ranges in salinity values across water sampling sites: higher average salinity with higher tides (1.14 - 20.63 ppt), intermediate values with intermediate tides (0.60 - 14.83 ppt) and lower values with lower tide heights (0.00 - 17.00 ppt). Similarly, this trend was found in the Cuthbert Holmes region: higher average salinity with higher tides (1.27 - 1.30 ppt), intermediate values with intermediate tides (0.75 - 0.80 ppt) and lower values with lower tide heights (0.50 ppt) ([Table 8](#); [Figure 16](#)).

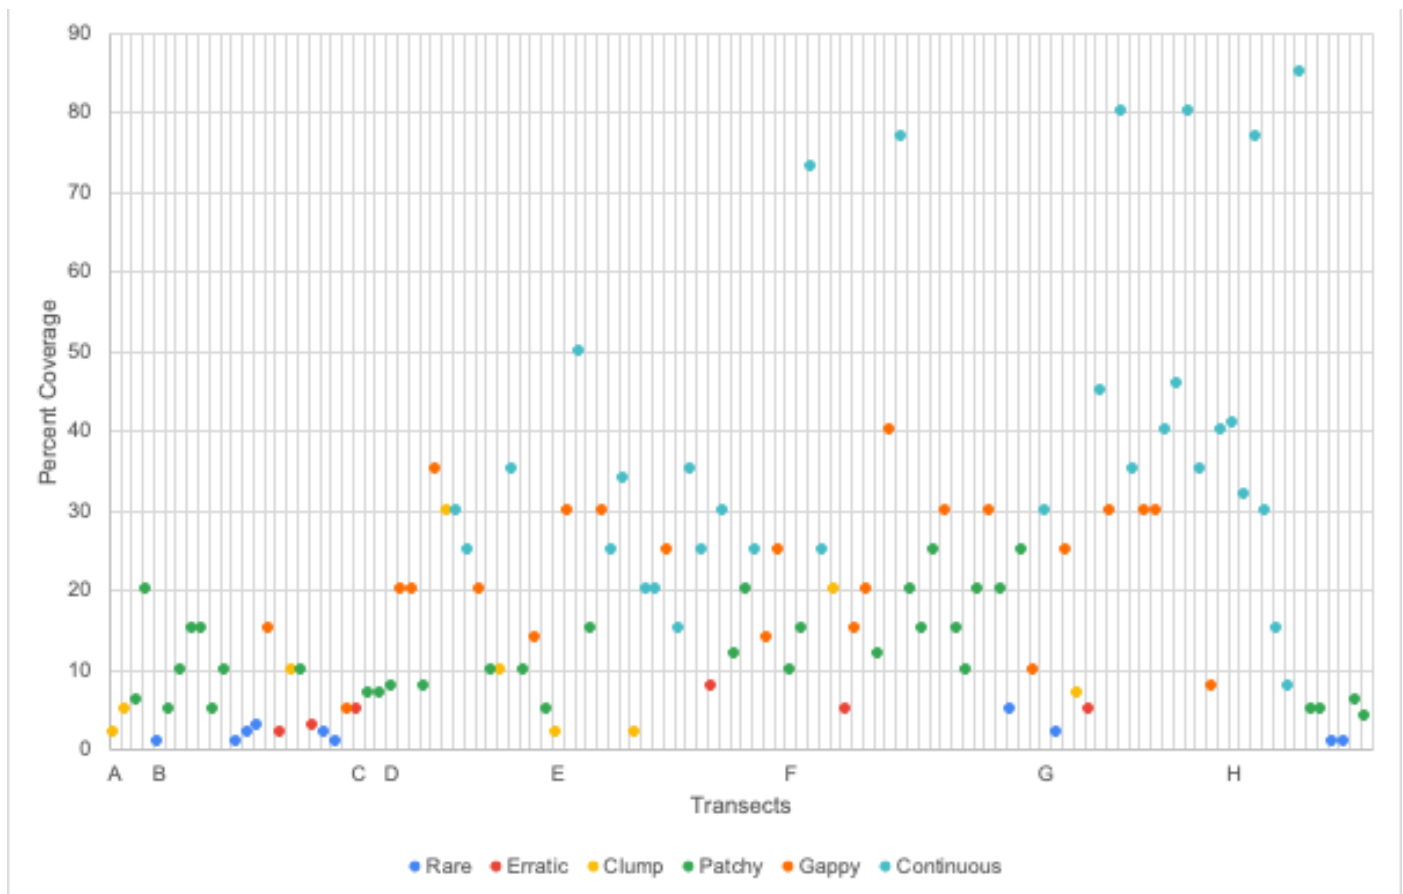
Figure 17. Spreading pattern of Creeping Buttercup (*Ranunculus repen*) based on percent cover and pattern type (rare, erratic, clump, patchy, gappy and continuous) in Cuthbert Holmes Park (Site #2), Saanich, BC. Note: Pattern types are defined as: rare - limited to a few individuals; erratic - too few individuals to make discrete patches; clump - one patch of species within quadrat, with sparse to moderate abundance; patchy - more than one clump, low dense abundance; gappy - widespread but with gaps; and continuous - widespread occurrence of species, could have low to dense abundance.

Creeping buttercup (*Ranunculus repen*) was the most prevalent invasive species found at both sites ([Figure 17](#)). Its presence dominated the Cuthbert Holmes Park with a total relative abundance (based on percent cover) of 38.85% compared to 0.93% within Esquimalt Gorge Park. *R. repen* is a threat to species diversity since it has the ability to grow quickly, with individual plants able to cover areas up to 40 ft² within one year and can have detrimental effects on neighbouring plants by depleting potassium in the soil (a micronutrient required by most plants for growth) (O'Keeffe *et al.*, 2002; King County, 2019). At the Cuthbert Holmes Site, *R. repen* was dominant in transects E - H (NW transects) and less so

in transects A - D (SE transects) ([Figure 17](#)). This may indicate that the plant originated near transect H and is spreading SW throughout the site, or that the conditions near transect H are more favourable to *R. repen* and possibly other invasive species. Not only is the percent cover much higher in transects E - H, the distribution pattern was mostly continuous *i.e.* widespread occurrence of species with low to dense abundance. This information may be used to target key areas within both regions for eradication efforts of *R. repen* and other invasive species.
