# CRD Pilot Harbours Ecological Inventory

Contract EPRO2019-155

February 2020

**Prepared for:** Capital Regional District  
Kitty Lloyd, Jody Watson  
625 Fisgard Street,  
Victoria, BC V8W 2S6

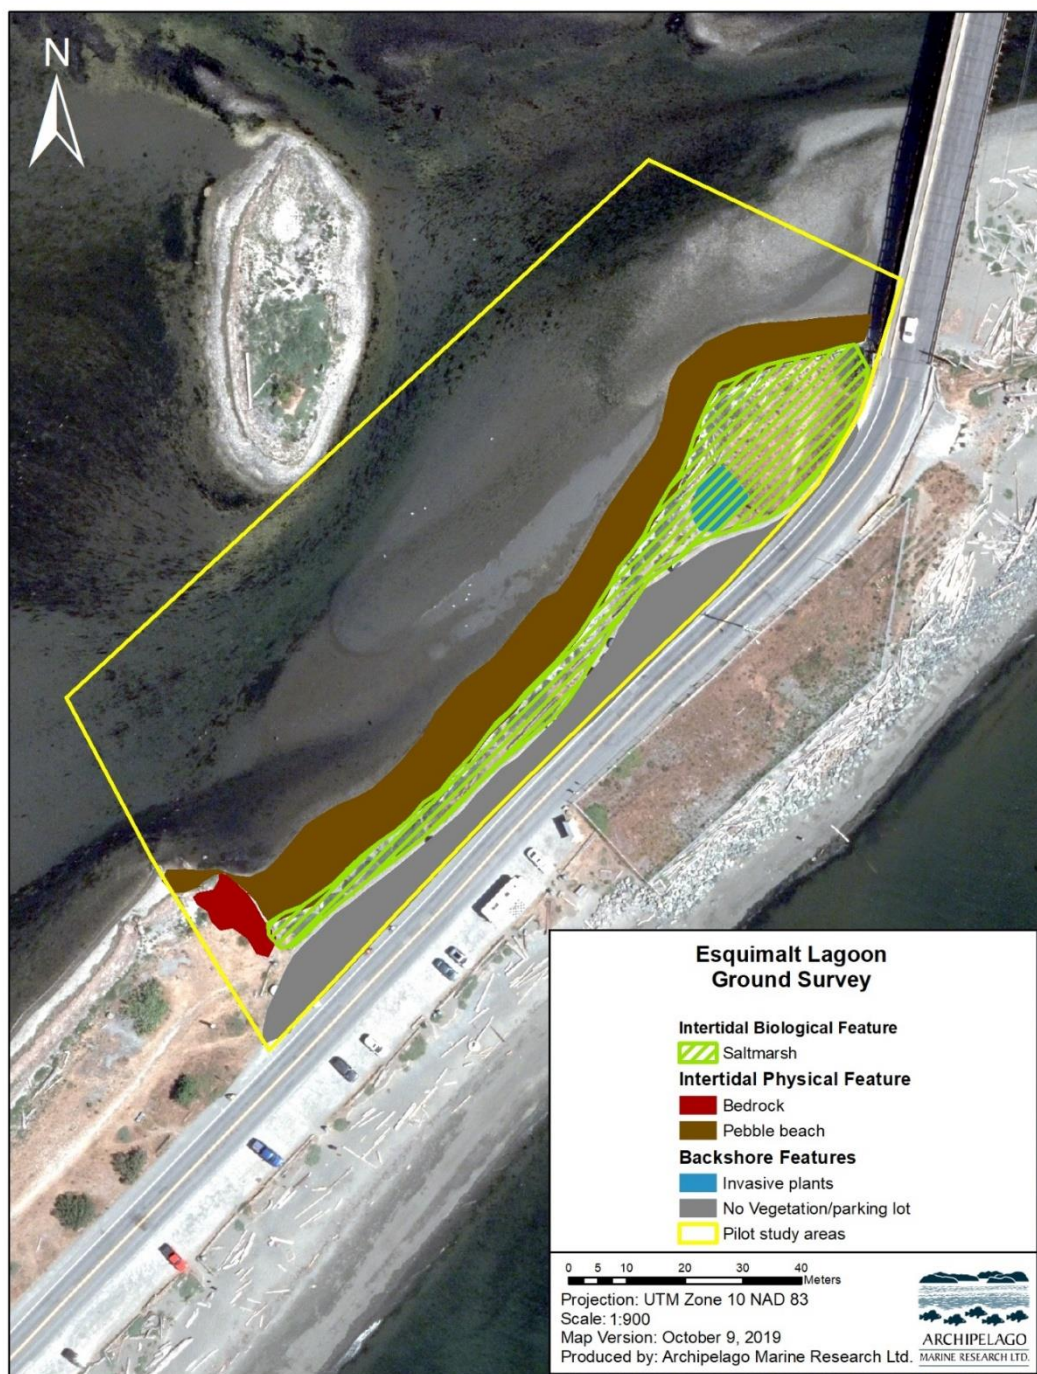
#### a. Esquimalt Lagoon Ground Survey Classification

**Esquimalt Lagoon**

Zone	Feature Name	Description
Intertidal Physical Polygon	Bedrock	Small bedrock outcrop, patches of splashzone plants on top, lichens; shell hash/pebble beach pocket at toe
	Pebble beach face	-- swash line of eelgrass on upper beach
Intertidal Biological Polygon	Salt Marsh	
Backshore Polygon	Invasive plants	Note cultural material along eroding upper edge of beach face at lower boundary of the polygon, above the scattered salt marsh plants at logline
	No vegetation	
Intertidal Line	Shoreline

Physical features observed during the Esquimalt lagoon ground survey include intertidal bedrock, a pebble beach, tidal flat and sand and shell. Intertidal biological features include saltmarsh and green algae. Subtidal green algae was observed in the subtidal zone. Backshore observations include invasive plants, a parking lot and rip rap (See Appendix A for further details from the ground survey).

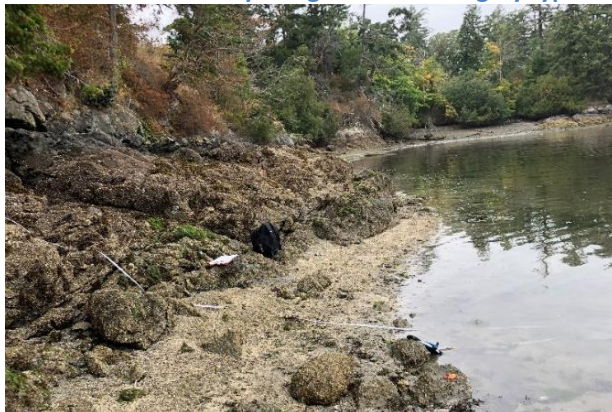
**Bedrock ramp, Smart Island**

- Natural shoreline, with sparse cover of acorn barnacle, rockweed, and foliose green algae and invertebrates.
- High, moderate and low accuracy score for UAV, orthophoto and drone imagery interpretation respectively.

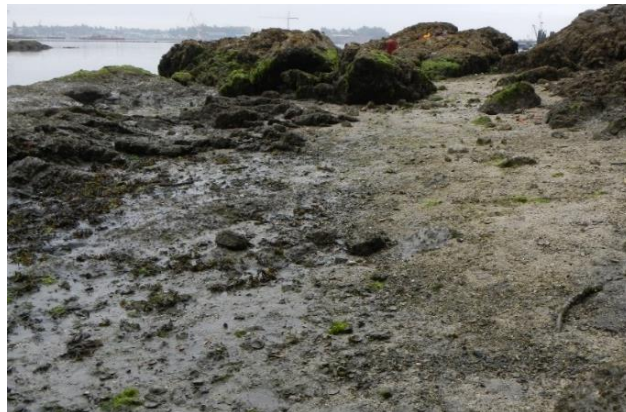
**Shell hash beach, Smart Island**

- Natural shoreline.
- Sediment beaches or flats which are primarily composed of shell hash.
- Shell hash was not classified from any of the imagery types (omission).

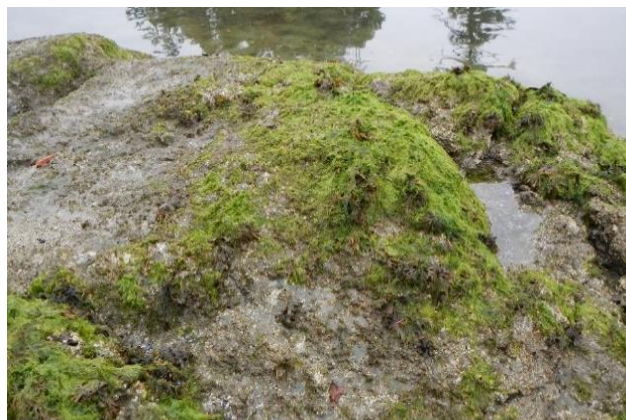
**Green algae (intertidal), Smart Island**

- Usually observed at < 100% cover.
- On immobile substrate (bedrock outcrop in this example).
- High classification accuracy score when rolled up into 'rockweed, green or red algae (intertidal)' category using UAV and orthophoto imagery. Not classified using satellite imagery.

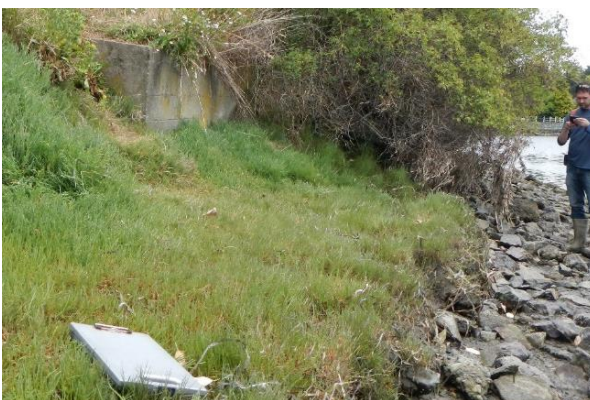
**Salt marsh, Gorge Park**

- Salt-tolerant herbs/grasses/sedges in the upper intertidal zone and logline.
- only small areas of salt marsh were observed at any of the pilot study sites.
- high classification accuracy using UAV and orthophoto imagery. Not mapped using satellite imagery.

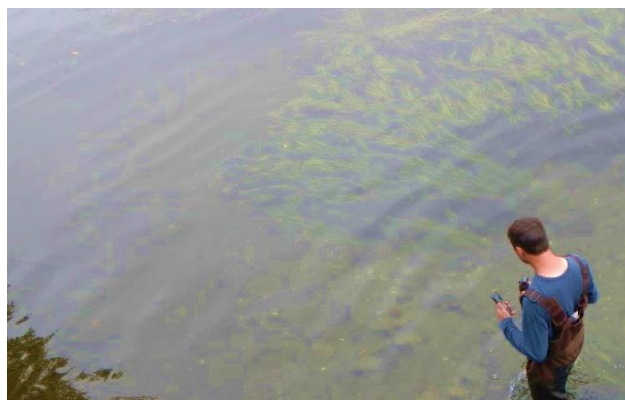
**Subtidal eelgrass, Gorge Park**

- Often mixed with green or brown algae
- May be sparse cover.
- Only eelgrass in the shallow subtidal areas are visible in aerial imagery or on the ground.
- High and moderate classification accuracy using UAV and orthophoto imagery respectively.

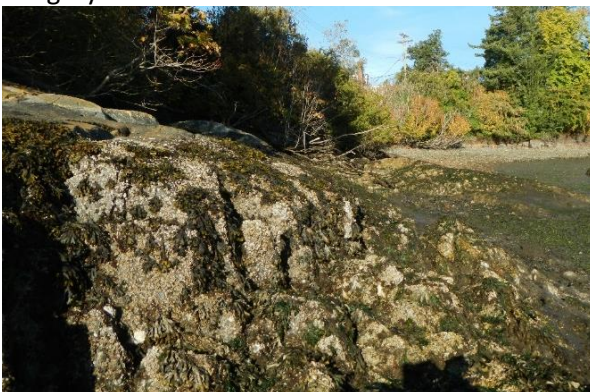
**Barnacle/Rockweed, Rose Bay**

- Usually co-occurring frosting of barnacle with variable cover of rockweed.
- Rose Bay example included scattered tufts of filamentous red algae and several common invertebrates.
- High classification accuracy score when rolled up into 'rockweed, green or red algae (intertidal)' category using UAV and orthophoto imagery. Not classified using satellite imagery.

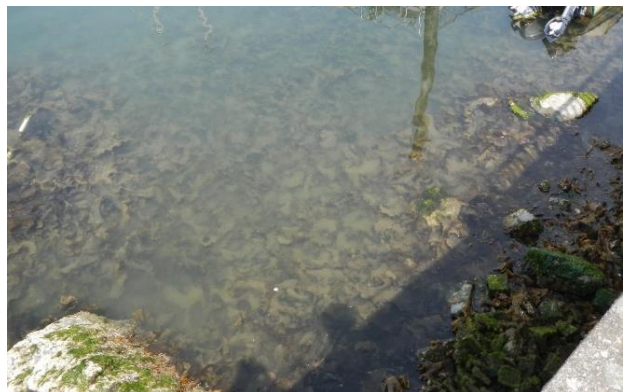
**Subtidal Bladed kelp, Coast Harbourside**

- Nearshore subtidal understory kelps.
- Not observed at any other pilot study site.
- High classification accuracy using drone imagery (only assessed at one site). Accuracy assessment not completed for other imagery types.
