**SUBTIDAL SURVEY OF PHYSICAL AND BIOLOGICAL FEATURES
OF ESQUIMALT HARBOUR**

**REPORT
& MAP FOLIO**

**DRAFT VERSION - November 2000
REVISED AND UPDATED - February 2004**

Prepared by: Archipelago Marine Research Ltd.
525 Head Street
Victoria, BC
V9A 5S1

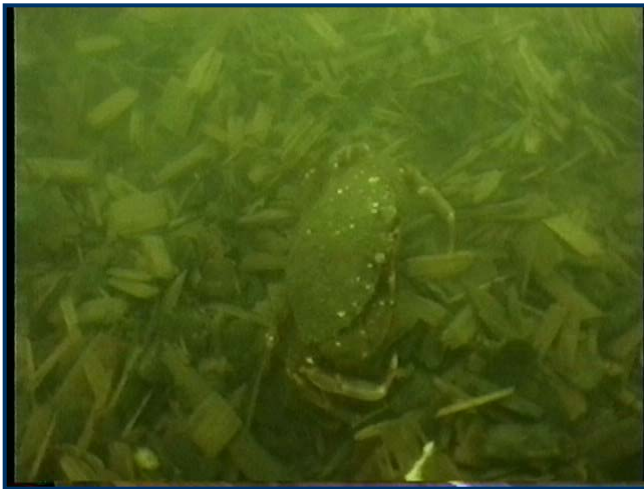
Crab (*Cancer* sp.) with dense bark debris.

As noted in Section 3.3, about 16% of the harbour seabed is impacted by a bark and wood debris (>30% cover). Of this area, approximately 37 hectares are impacted by heavy (>80%) wood and bark debris cover. The largest areas of organic debris are former and current log booming areas located in Plumper Bay/Thetis Cove and the upper part of the harbour north of Smart Island (Figure 8). Decomposing organic material generates anoxic sediments with impacts to benthic community structure, and possibly mobilize sediment contaminants. It is likely that the eelgrass bed in Thetis Cove has been adversely impacted, both in terms of bed size and plant density, by bark and wood debris. Figure 23 shows the distribution of anaerobic bacterial mats (*Beggiotoa* sp.) on the seabed sediments within the harbour. These mats are concentrated in areas of highest organic debris areas (Plumper Bay) as well as in dredge pockets in Lang Cove and south of the Graving Dock (see below). Despite the degraded nature of these areas, some invertebrate species (crab, plumose anemones) are relatively abundant in former log storage areas.
