February 3, 2020

File: 16-1856

**RE: ENGINEER'S ORDER CLOSE-OUT REPORT: GARDOM POND DECOMMISSIONING - CONTRACT 16-1856**

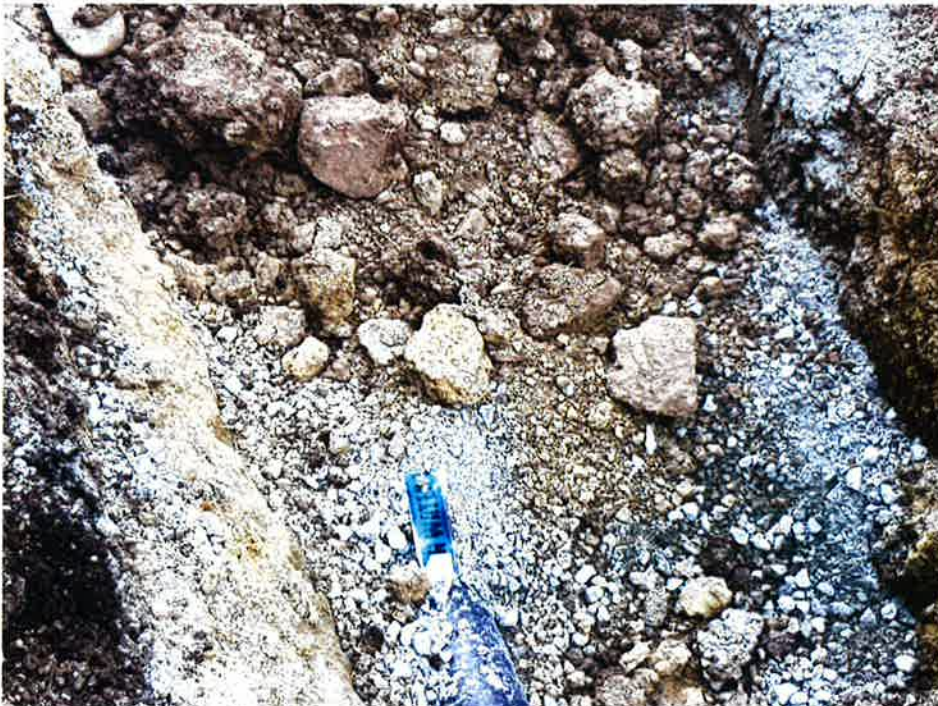
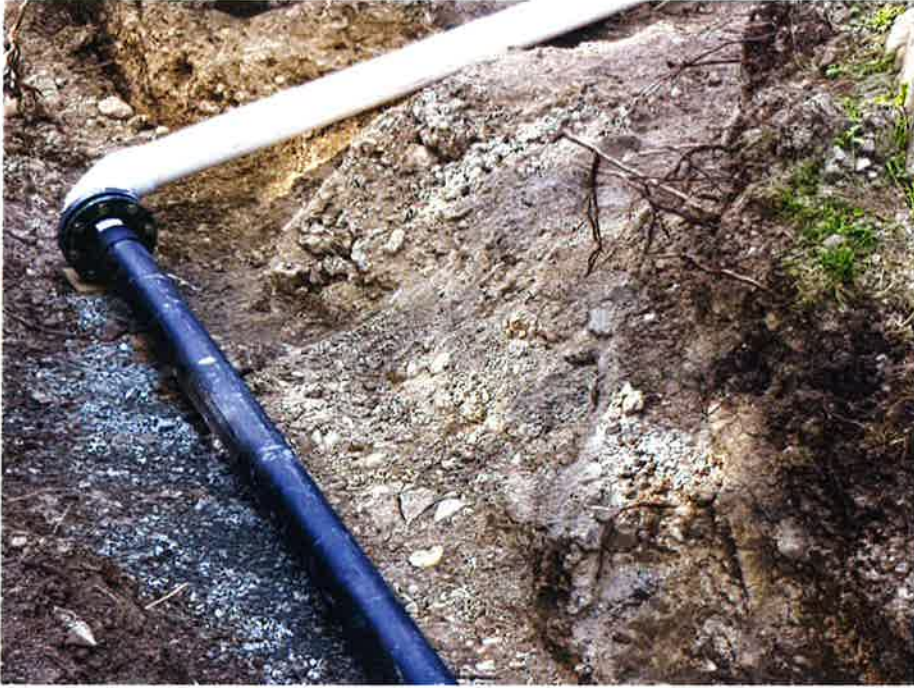
We have requested life expectancy of composite inlet structure from a supplier.

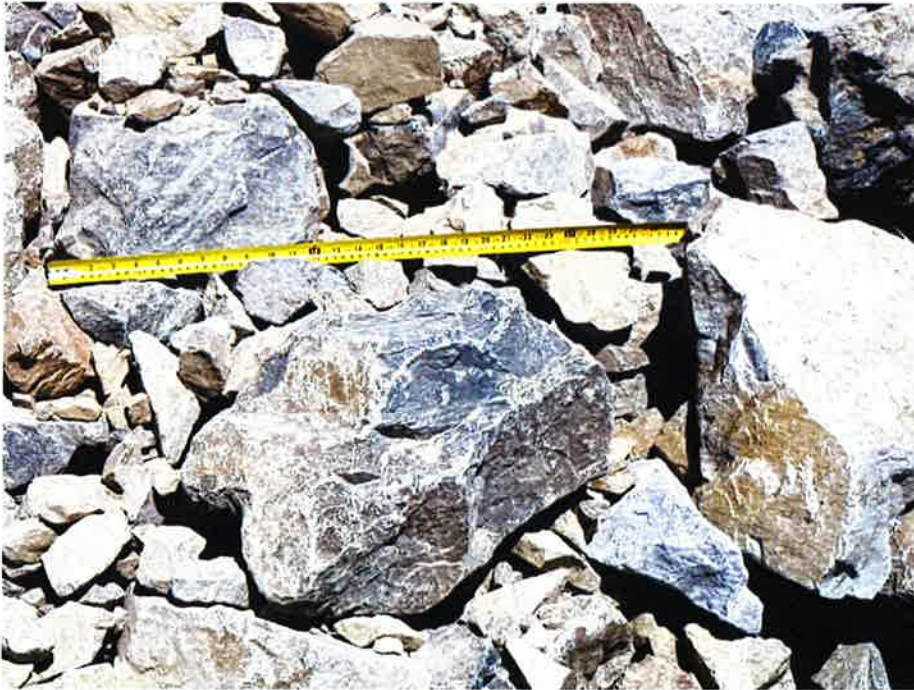
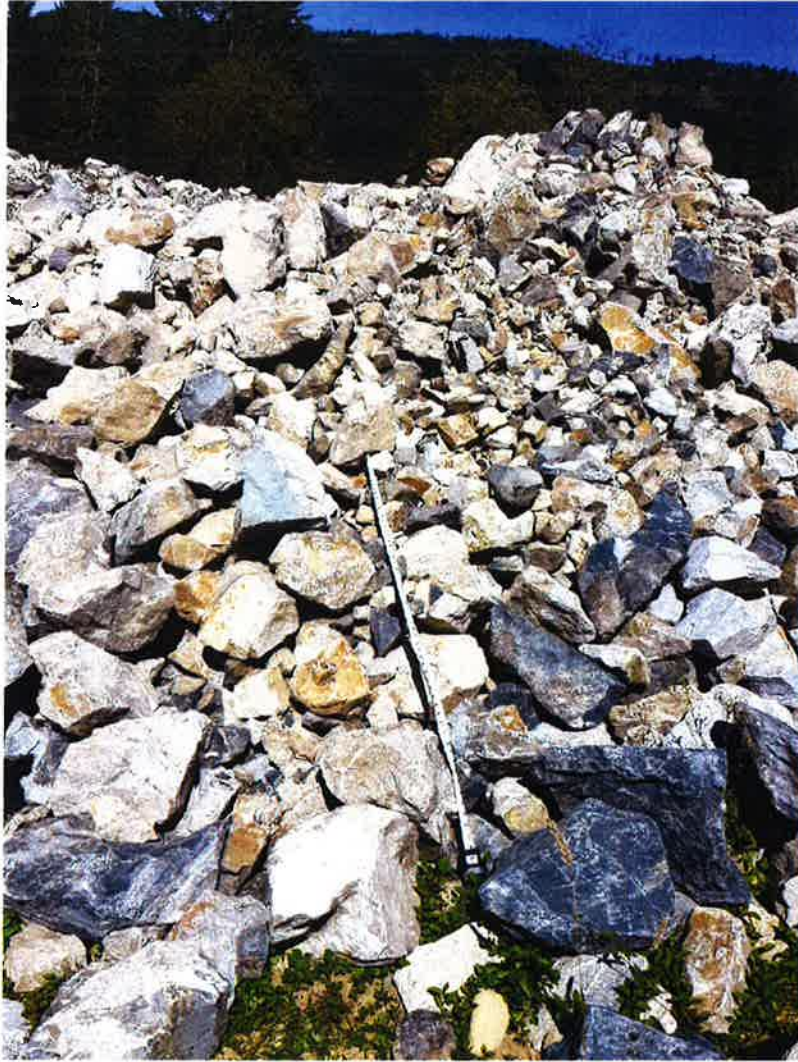
### **Landscape Area to Harbour Hill Drive**

Riprap has been extended up the hill to the downhill end of the riprap area. Shawnigan Lake riprap was used at the upper 20 metres or so – some of the steeper area. Work looks good. Will confirm ditch dimensions later.

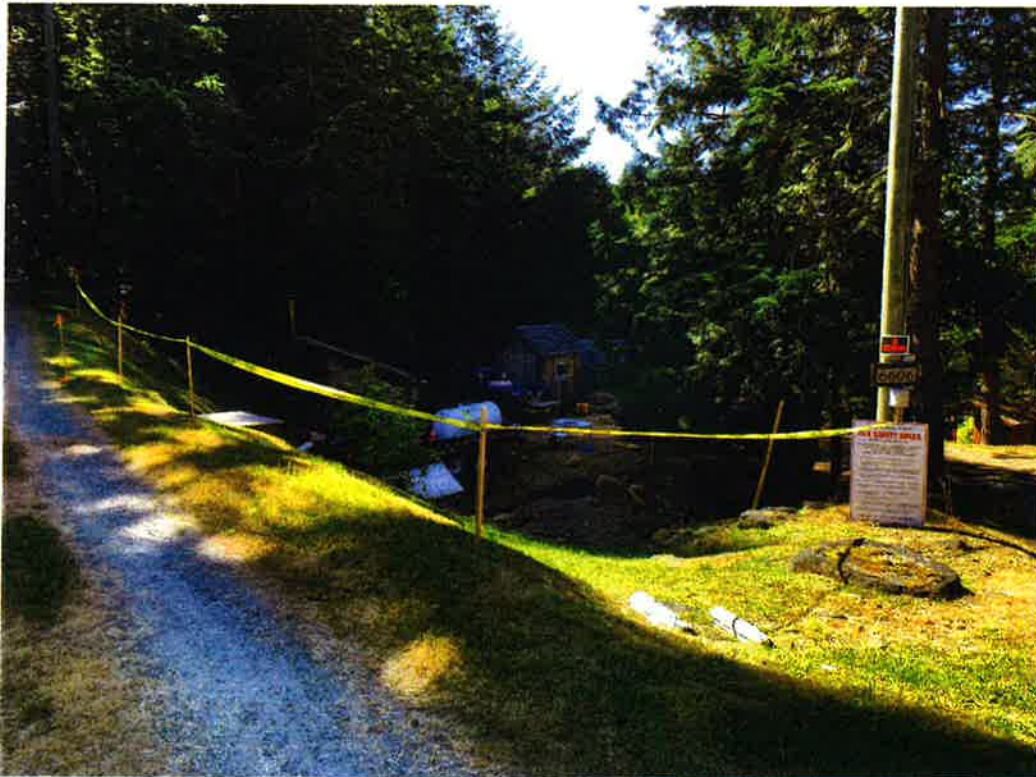
Looking down from crest of dam. Water trailer now on site.

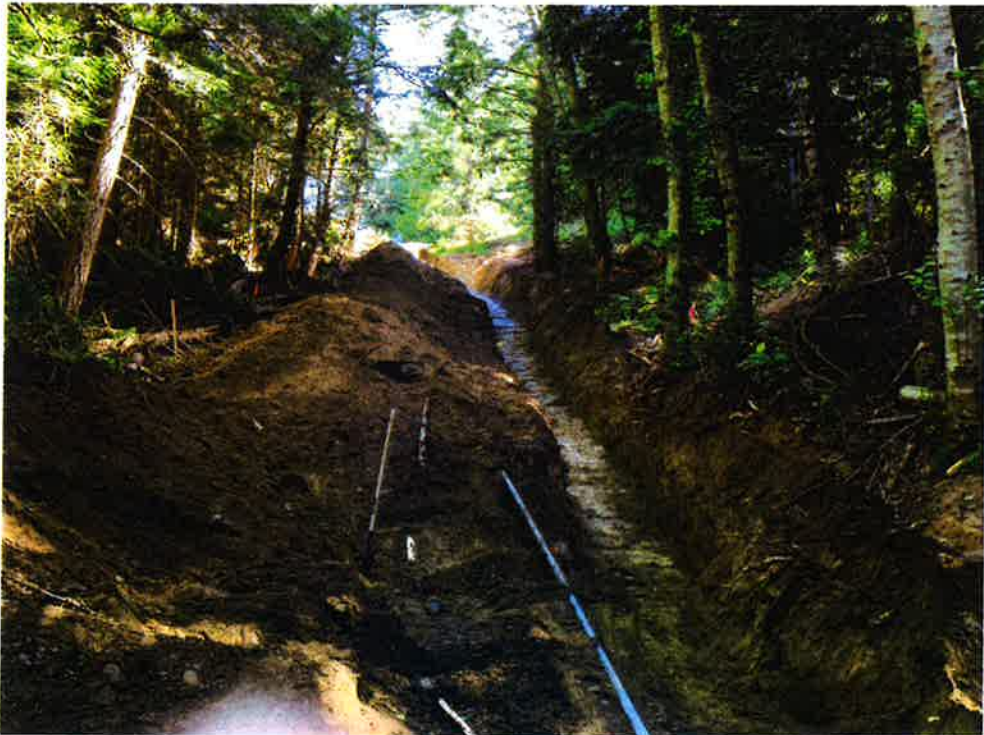
RPID diversion ditch. Mostly completed. 2" line (right) and 4" line (left by shovel) exposed.

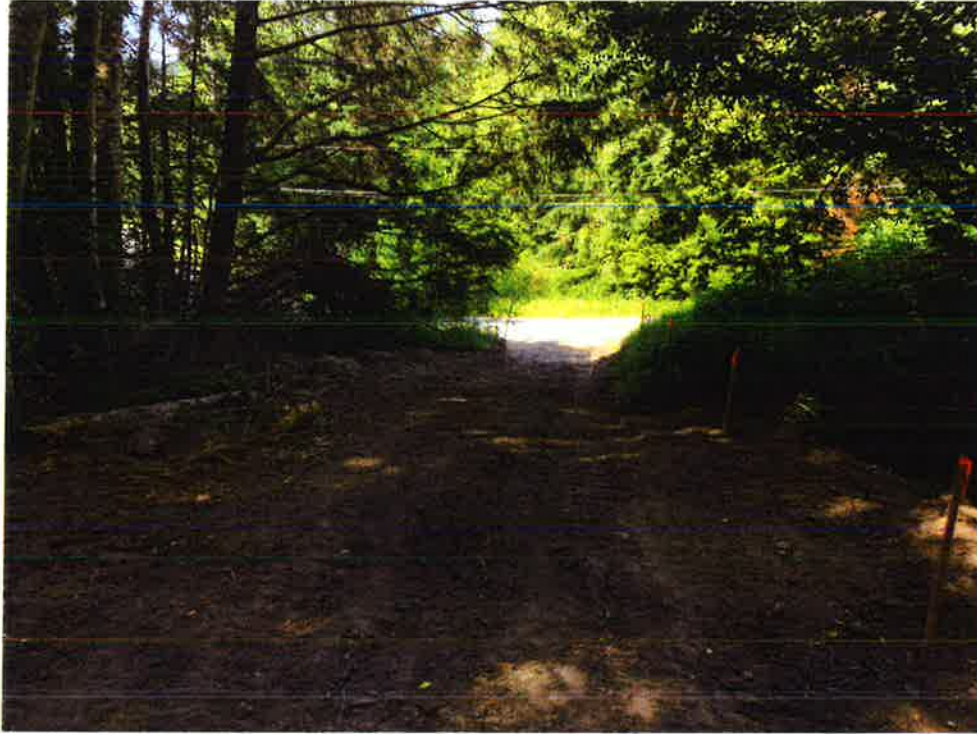
ADVANCED ENERGY SYSTEMS MANAGEMENT CORP.  
Gardom Pond Dam Decommissioning – Weekly Progress Report  
Contract 16-1856C  
Cleared area for channel out to Harbour Hill and temporary culvert.

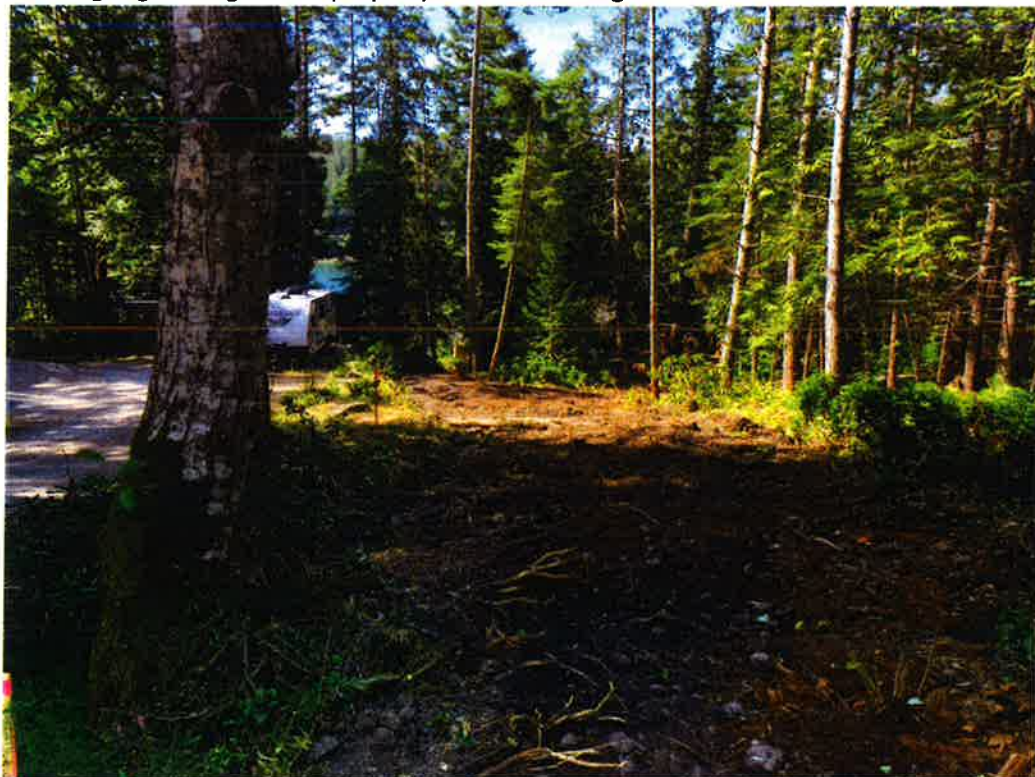
Clearing & grubbing on AI's property down to nesting trees.

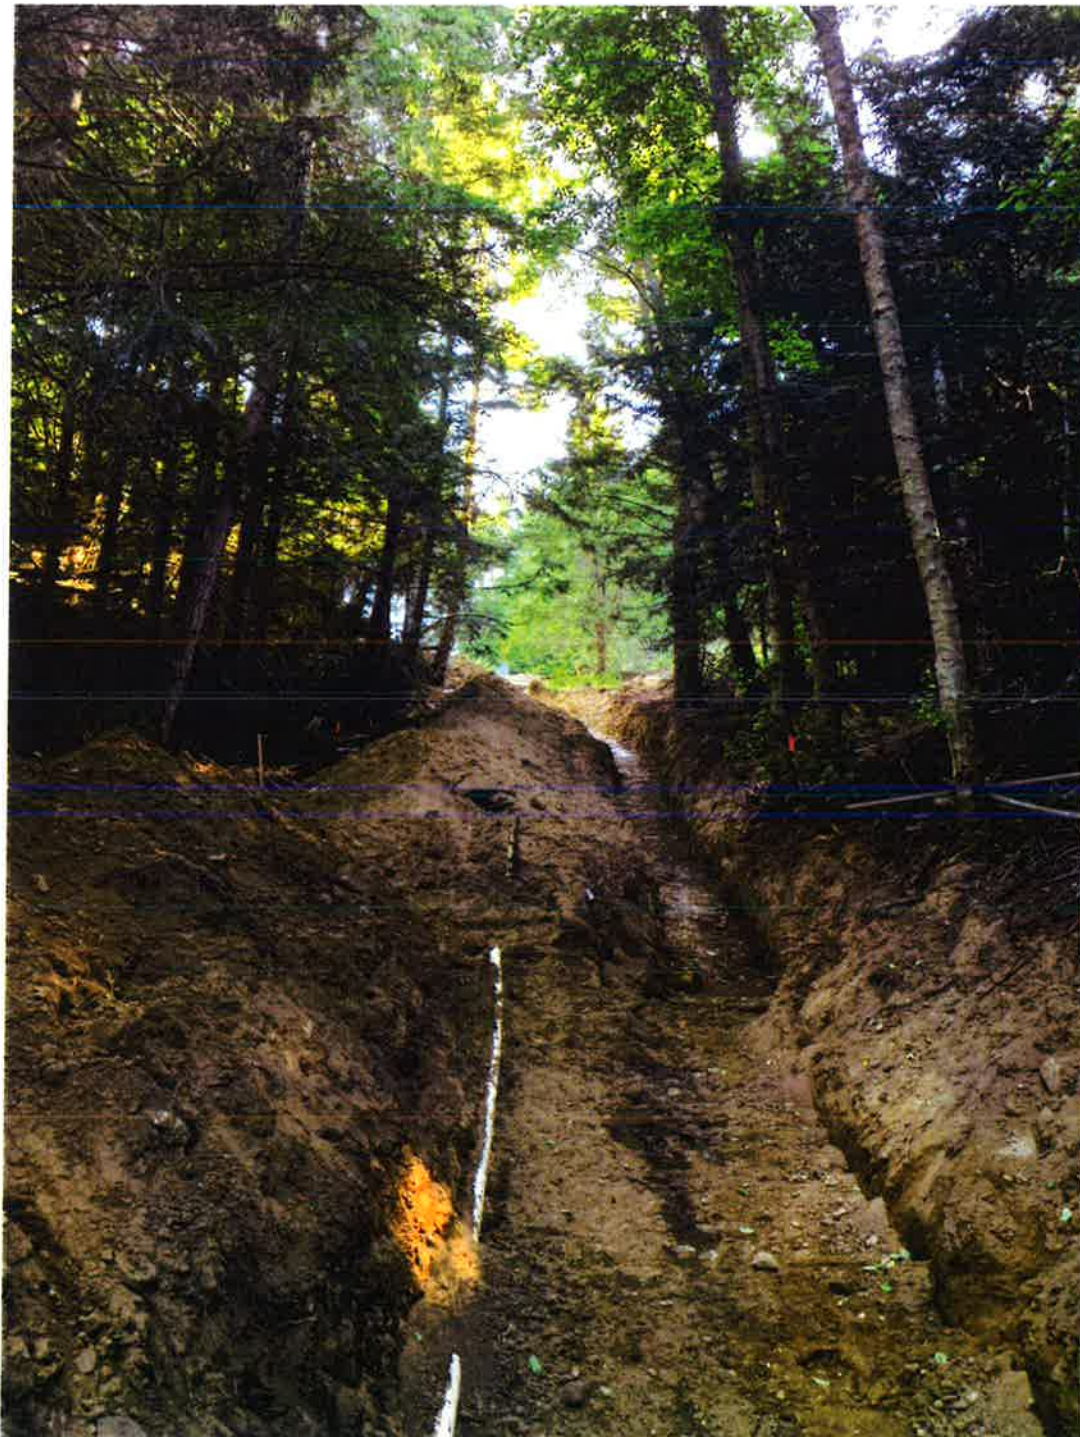
ADVANCED ENERGY SYSTEMS MANAGEMENT CORP.  
Gardom Pond Dam Decommissioning – Weekly Progress Report  
Contract 16-1856C  
Completed RPID diversion trench.

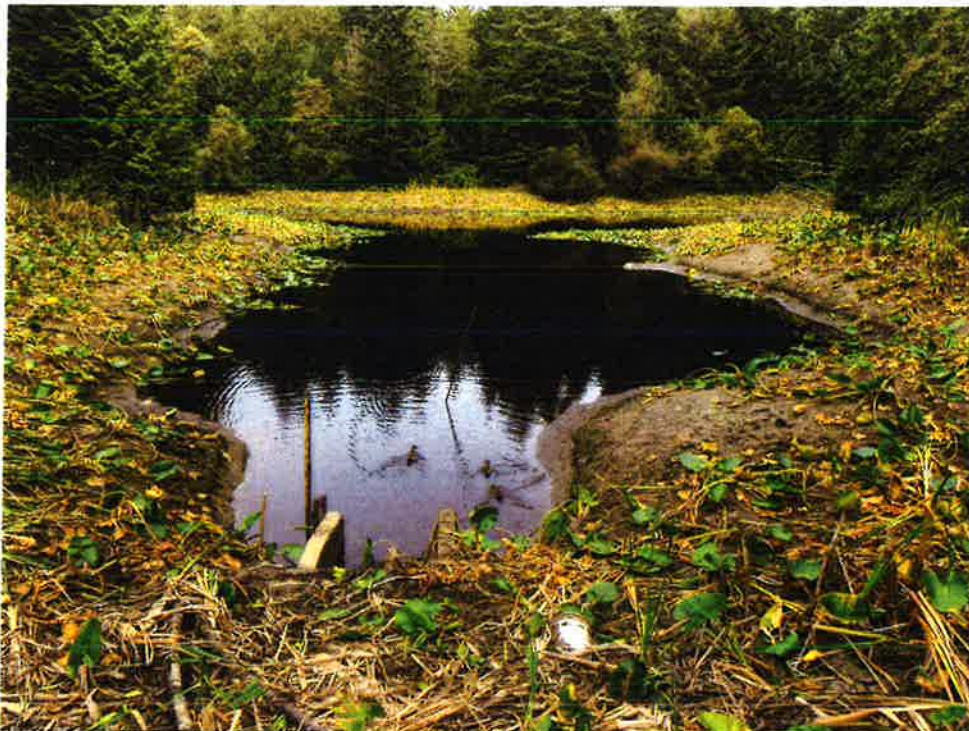
ADVANCED ENERGY SYSTEMS MANAGEMENT CORP.  
Gardom Pond Dam Decommissioning – Progress Report  
Contract 16-1856C  
**Pond drained to 83.85**

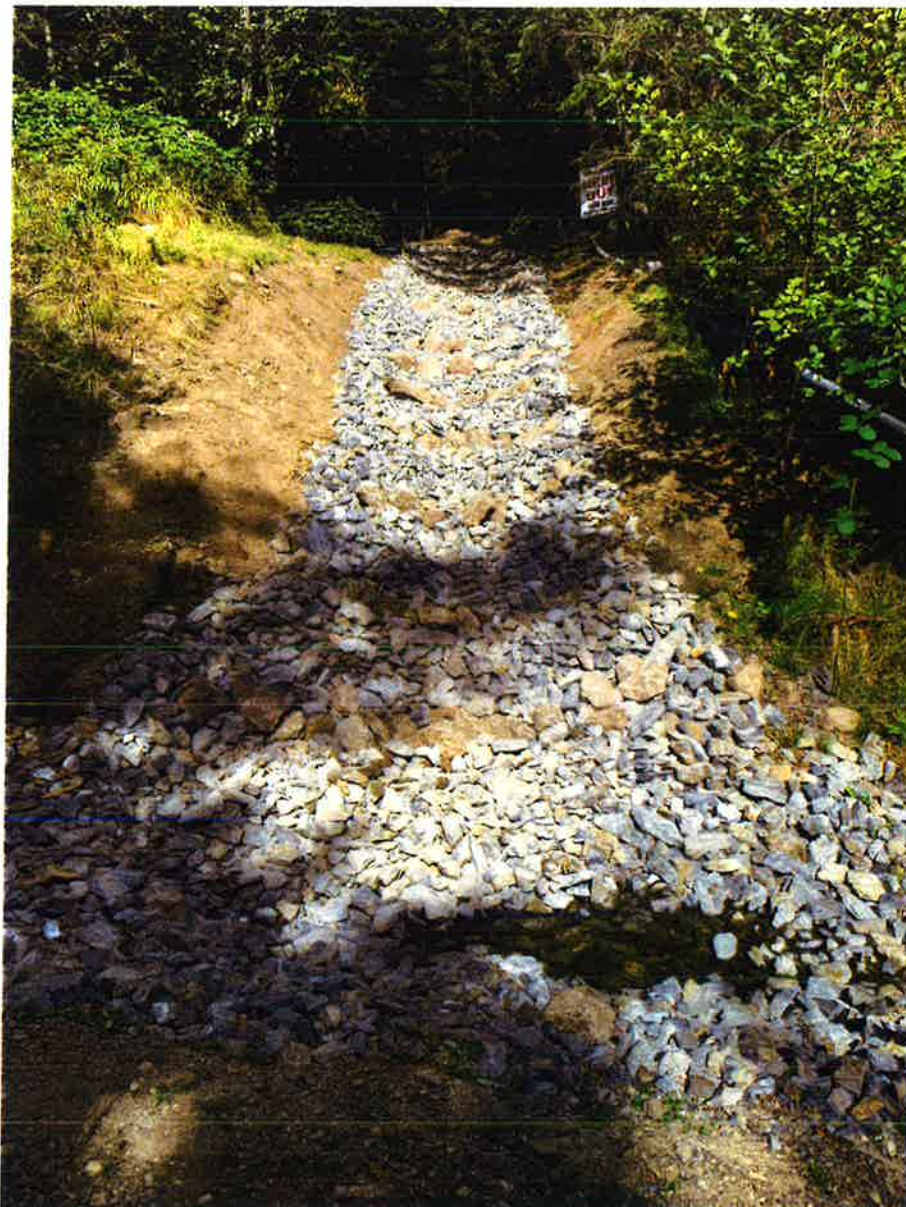
ADVANCED ENERGY SYSTEMS MANAGEMENT CORP.  
Gardom Pond Dam Decommissioning – Progress Report  
Contract 16-1856C  
**Larger Rocks Added to Steep Section of Riprap Channel**

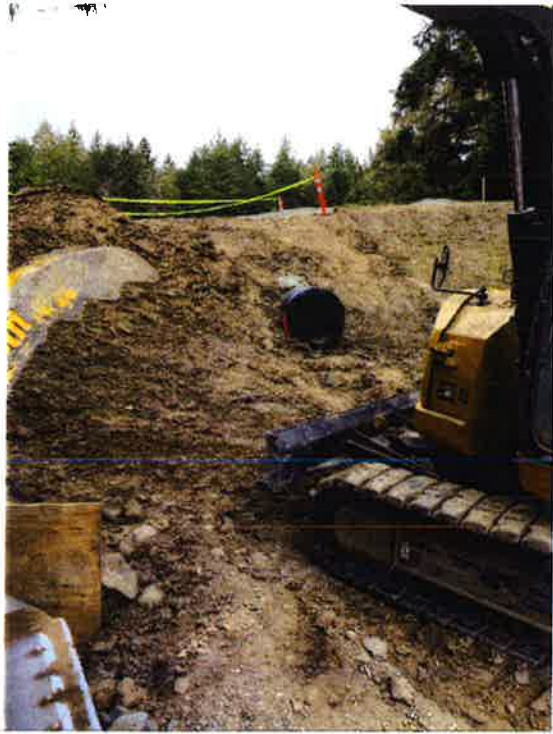
ADVANCED ENERGY SYSTEMS MANAGEMENT CORP.  
Gardom Pond Dam Decommissioning – Progress Report  
Contract 16-1856C  
**South of Dam Embankment Directly after 900mm Culvert Installation**

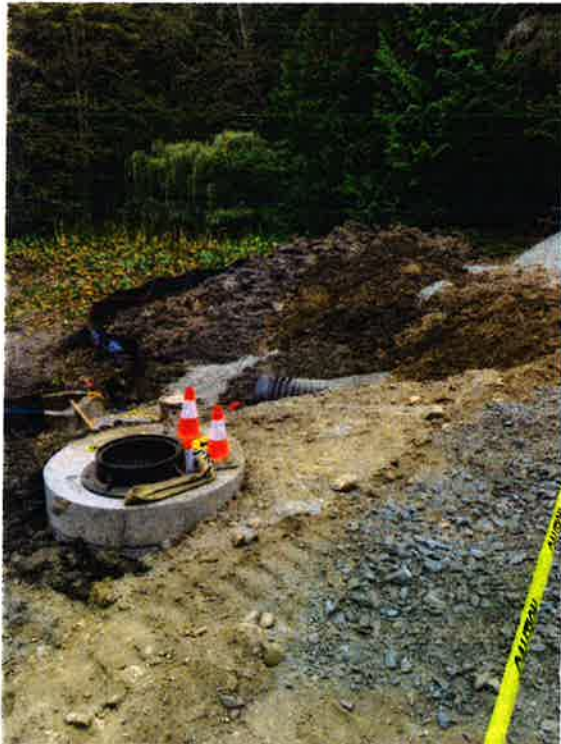
**North of Dam Embankment Directly after 900mm Culvert Installation**

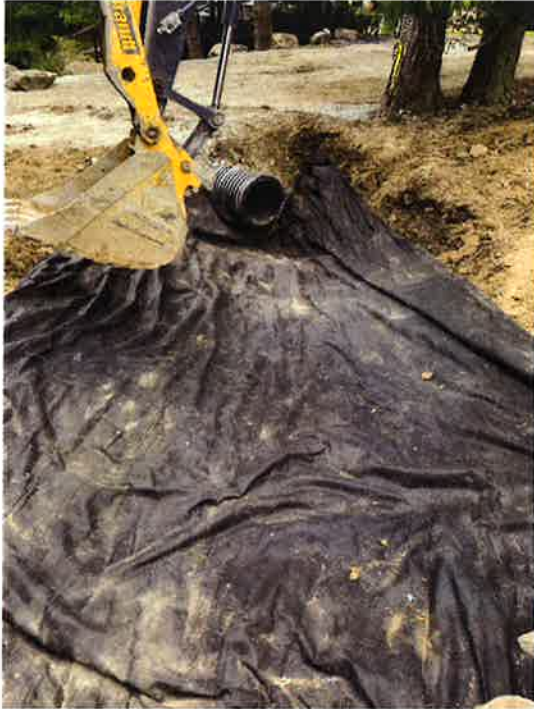
ADVANCED ENERGY SYSTEMS MANAGEMENT CORP.  
Gardom Pond Dam Decommissioning – Progress Report  
Contract 16-1856C  
**Starting on Channel Between 900mm and 600mm Culverts**

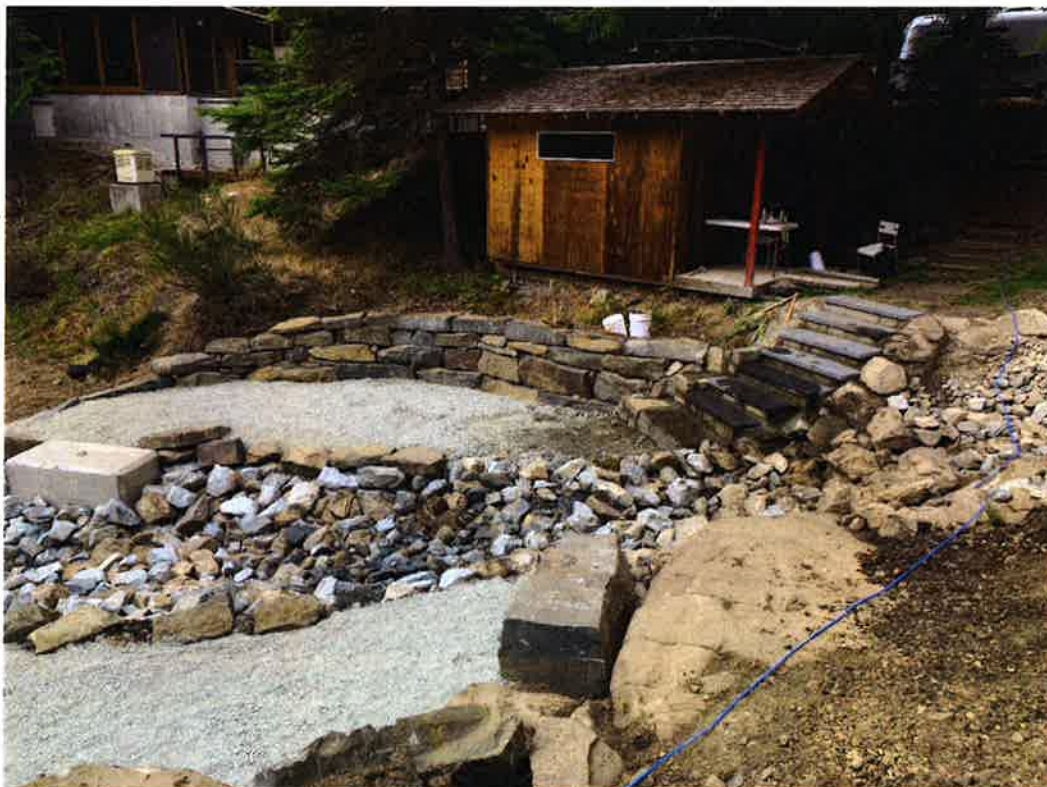
**Landscaping Area after Stairs Completed**

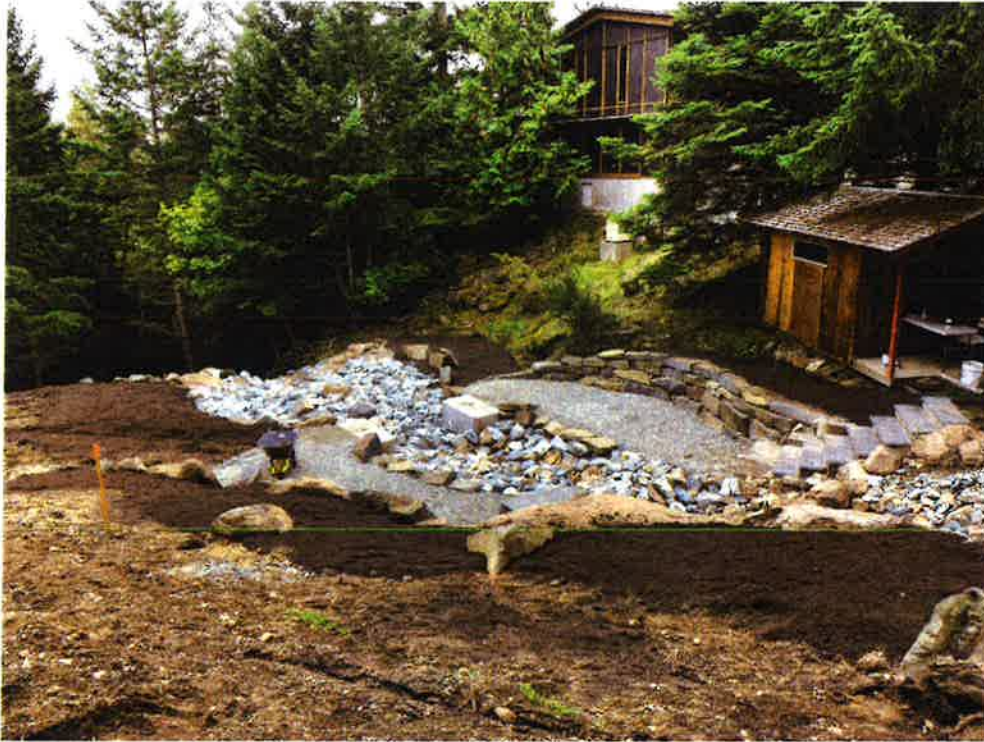
ADVANCED ENERGY SYSTEMS MANAGEMENT CORP.  
Gardom Pond Dam Decommissioning – Progress Report  
Contract 16-1856C  
Landscape area with topsoil

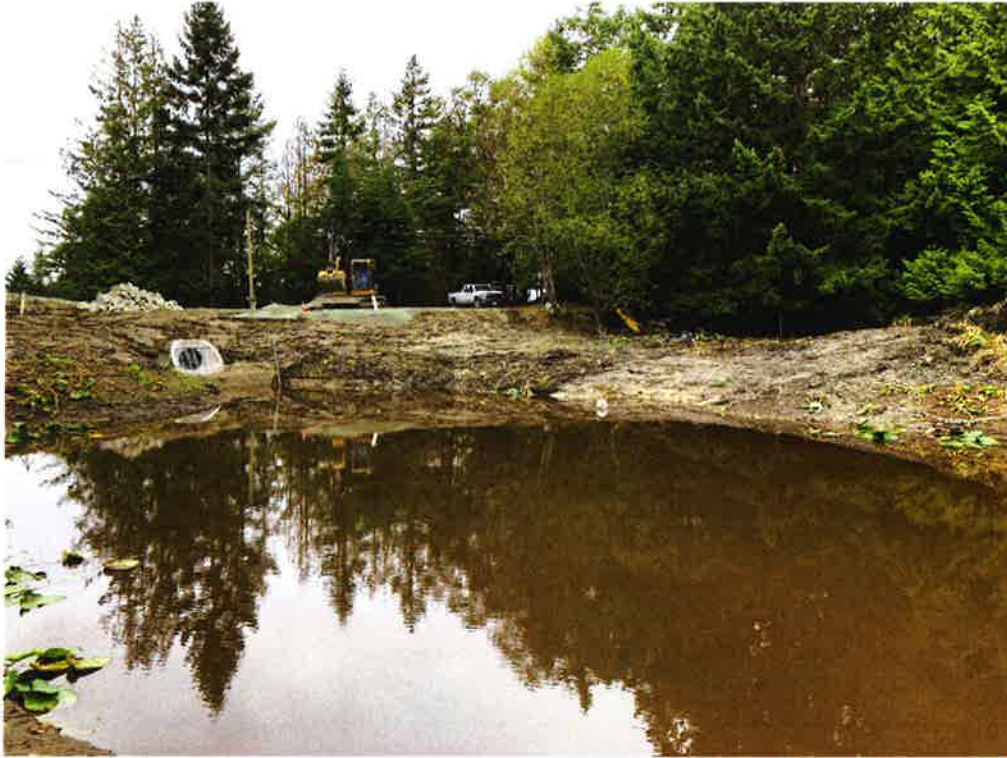
ADVANCED ENERGY SYSTEMS MANAGEMENT CORP.  
Gardom Pond Dam Decommissioning – Progress Report  
Contract 16-1856C  
**Headwall and hydrant intake**

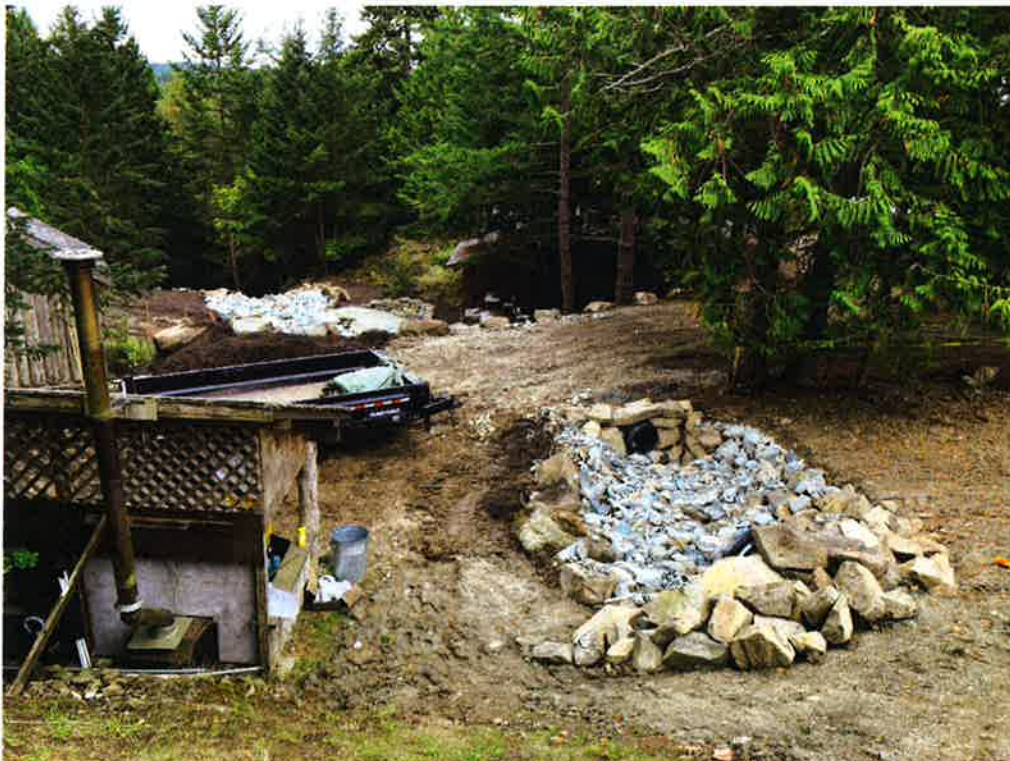
**South of dam embankment**

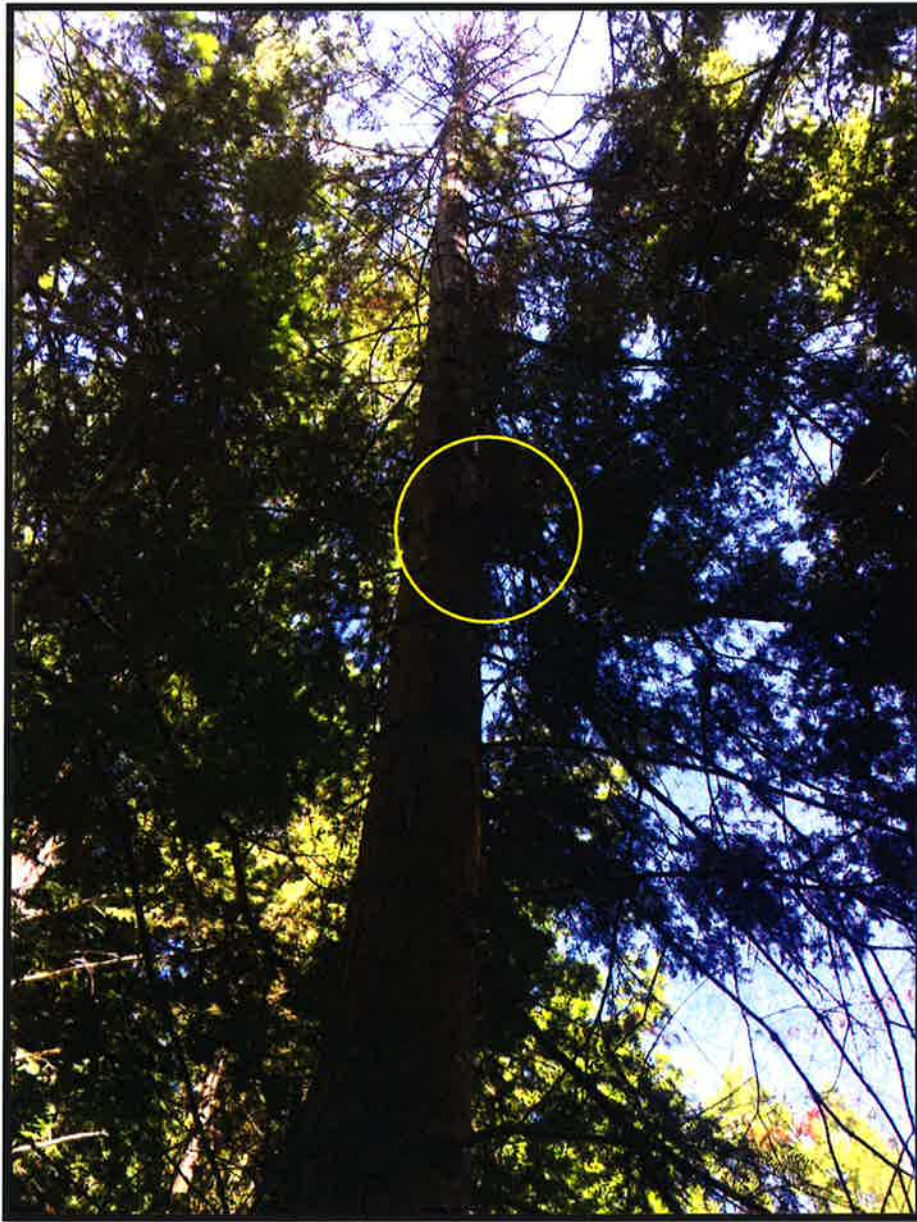
**Photo 1.** Tree with visible nest structure – the first of two trees being re-assessed during this follow-up nesting bird survey. The nest structure is circled with yellow.

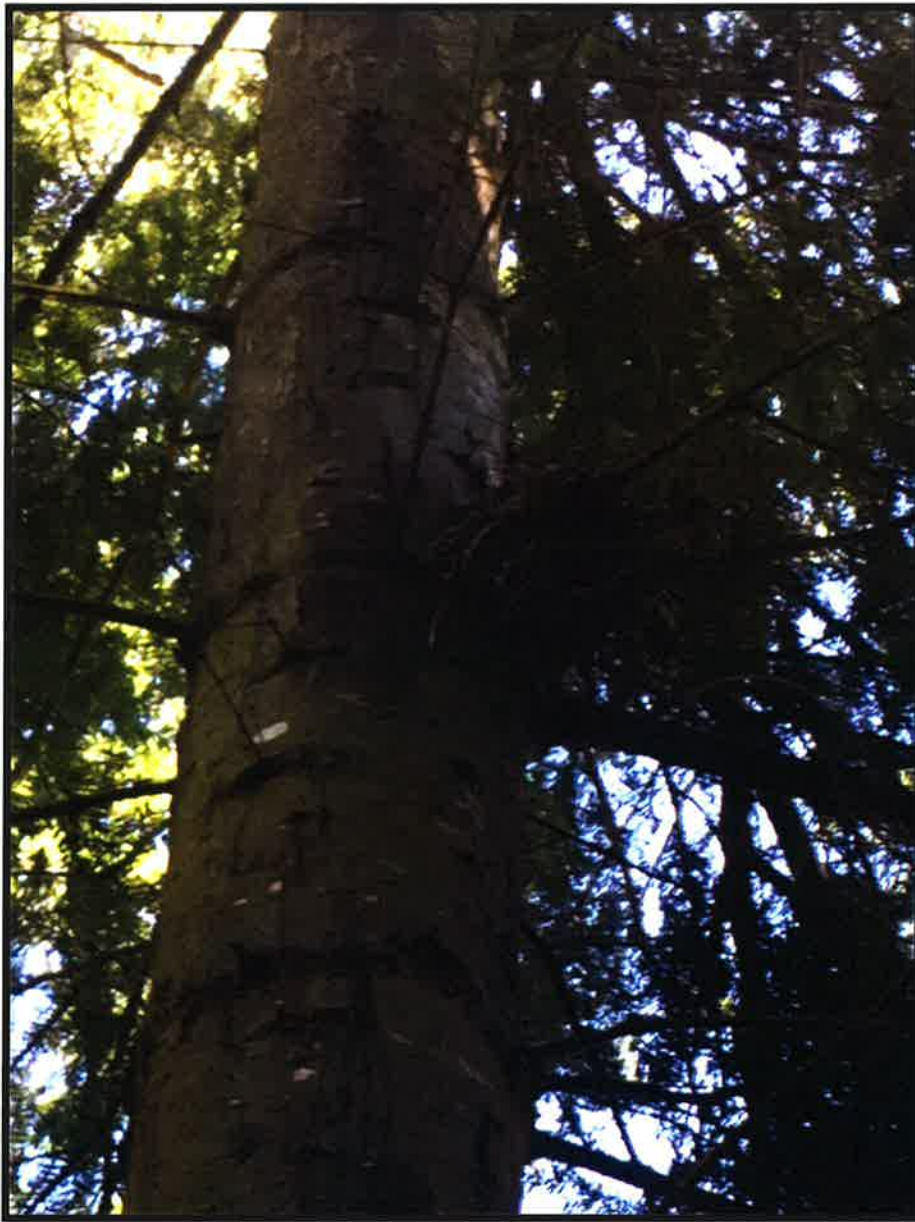
**Photo 2.** Closer view of nest structure in first tree.

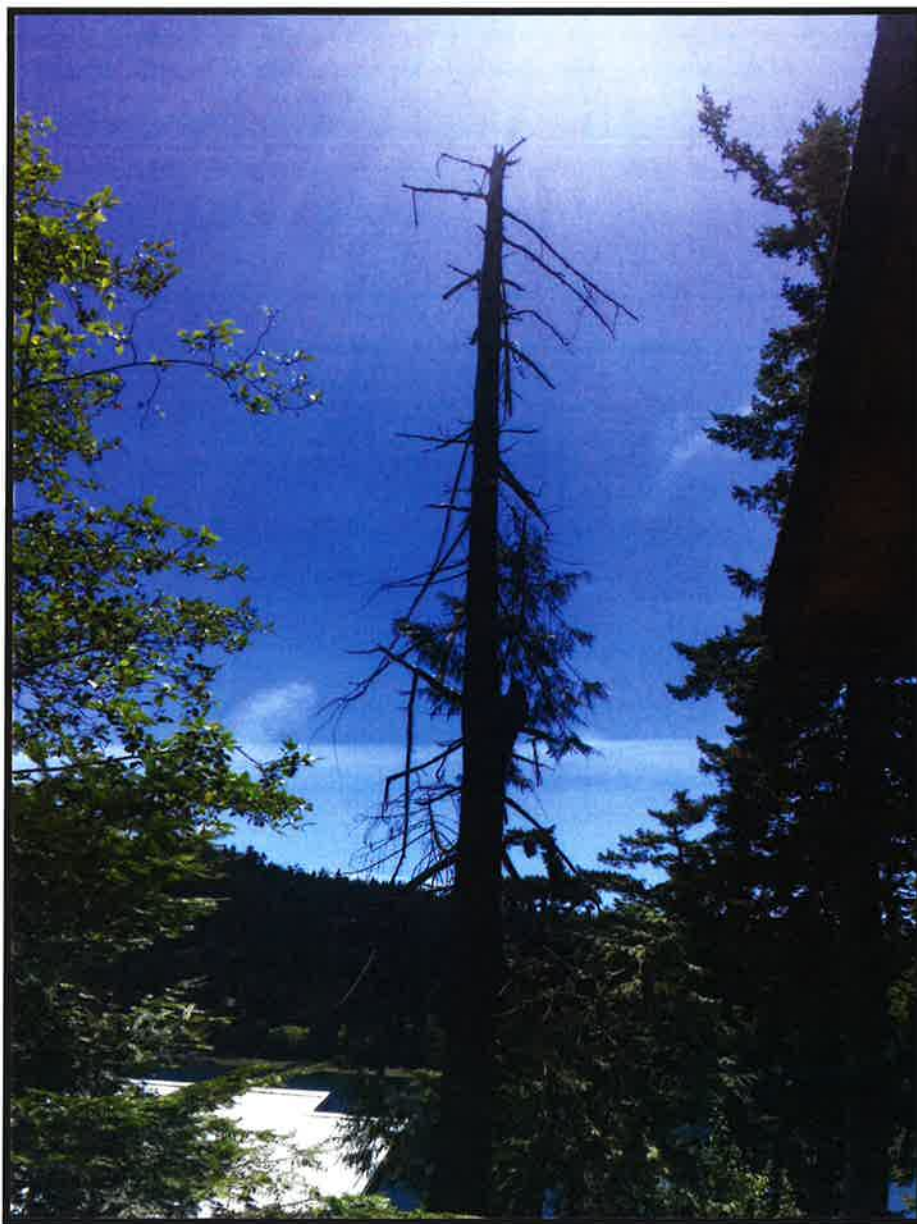
The second tree was a good quality wildlife tree, with no nest structures but good habitat potential. The tree had excavated cavities present, indicating internal decay, and had a structure suitable as a hunting perch. See photos below. The

**Photo 3.** Wildlife tree with potential high quality nesting locations – the second of two trees re-assessed during the follow-up nesting bird survey.

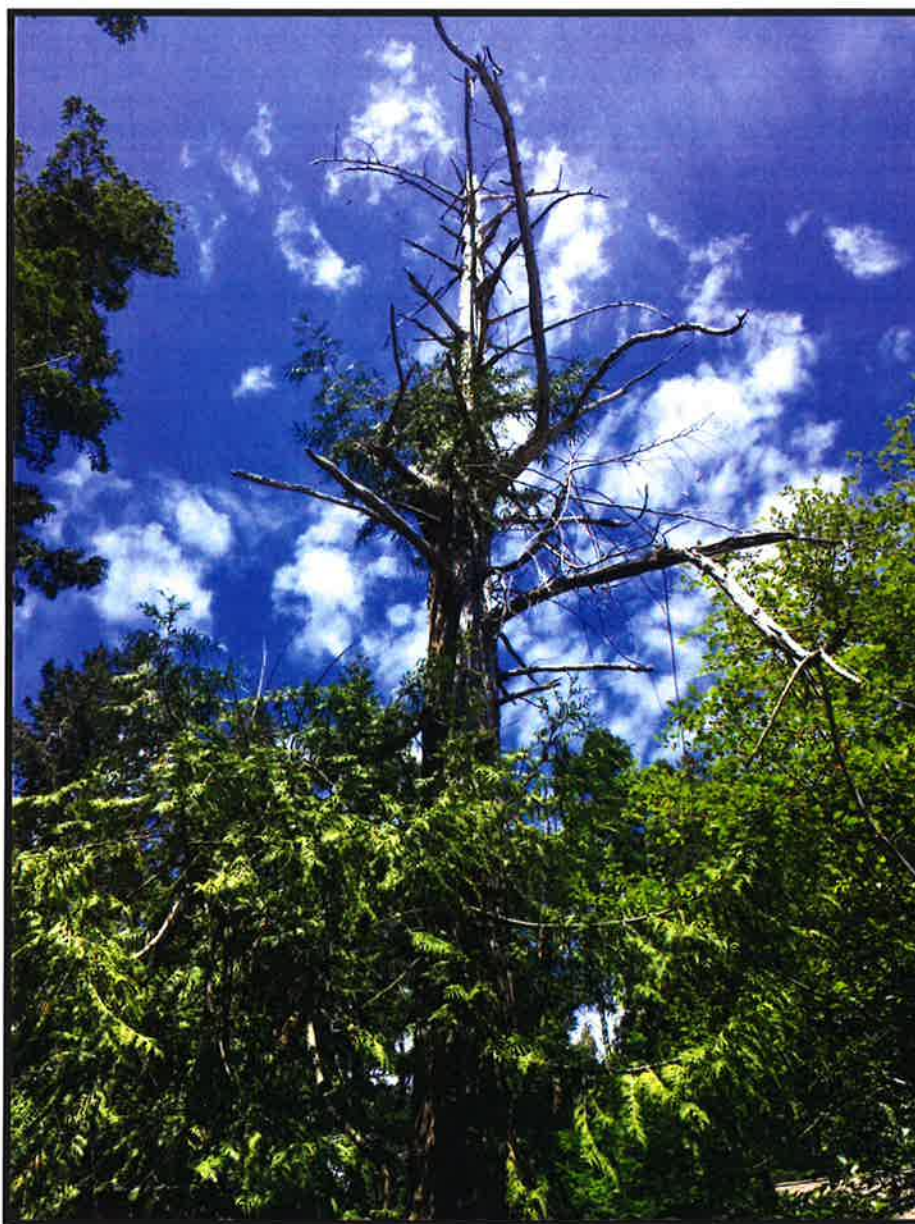
**Photo 4.** The second tree was suitable as a hunting perch.

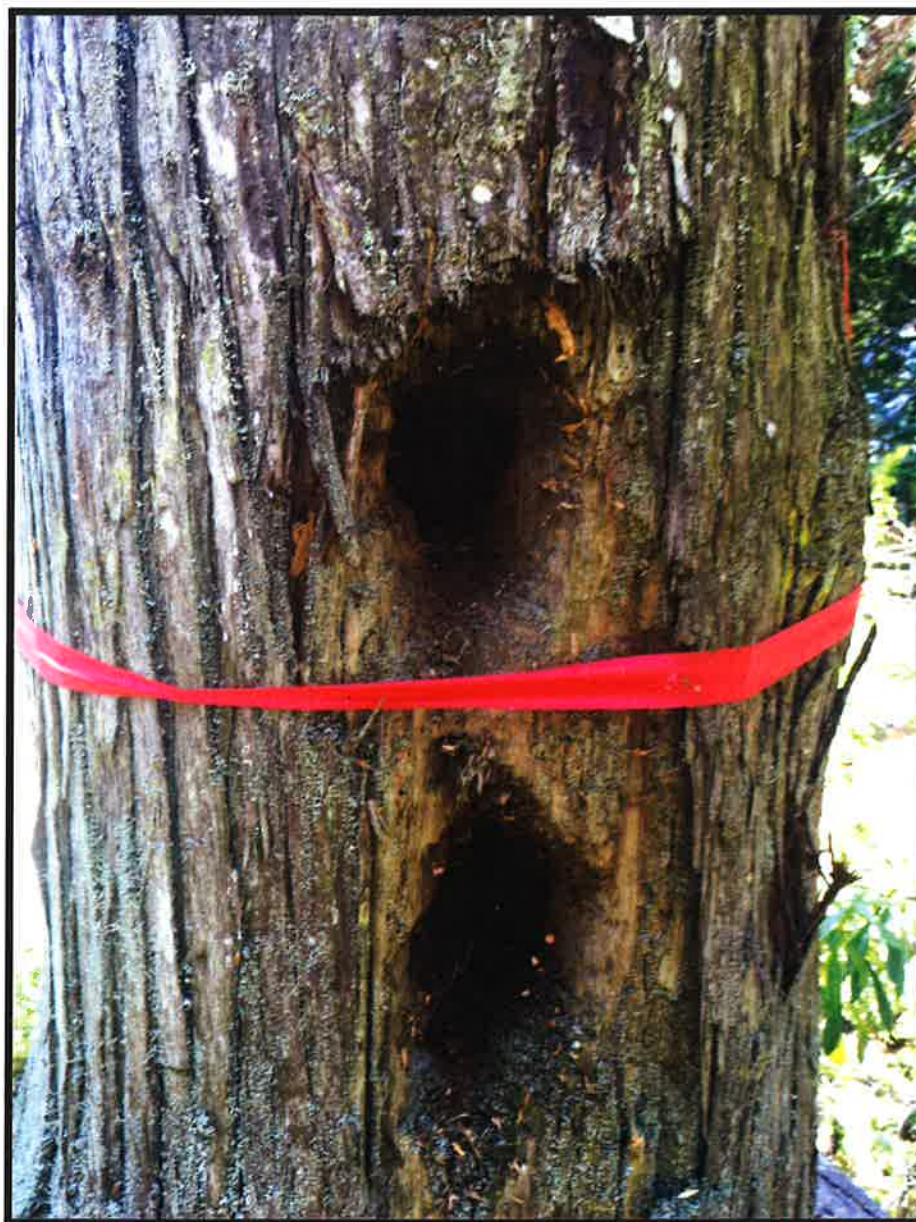
**Photo 5.** The second tree had excavated cavities present.

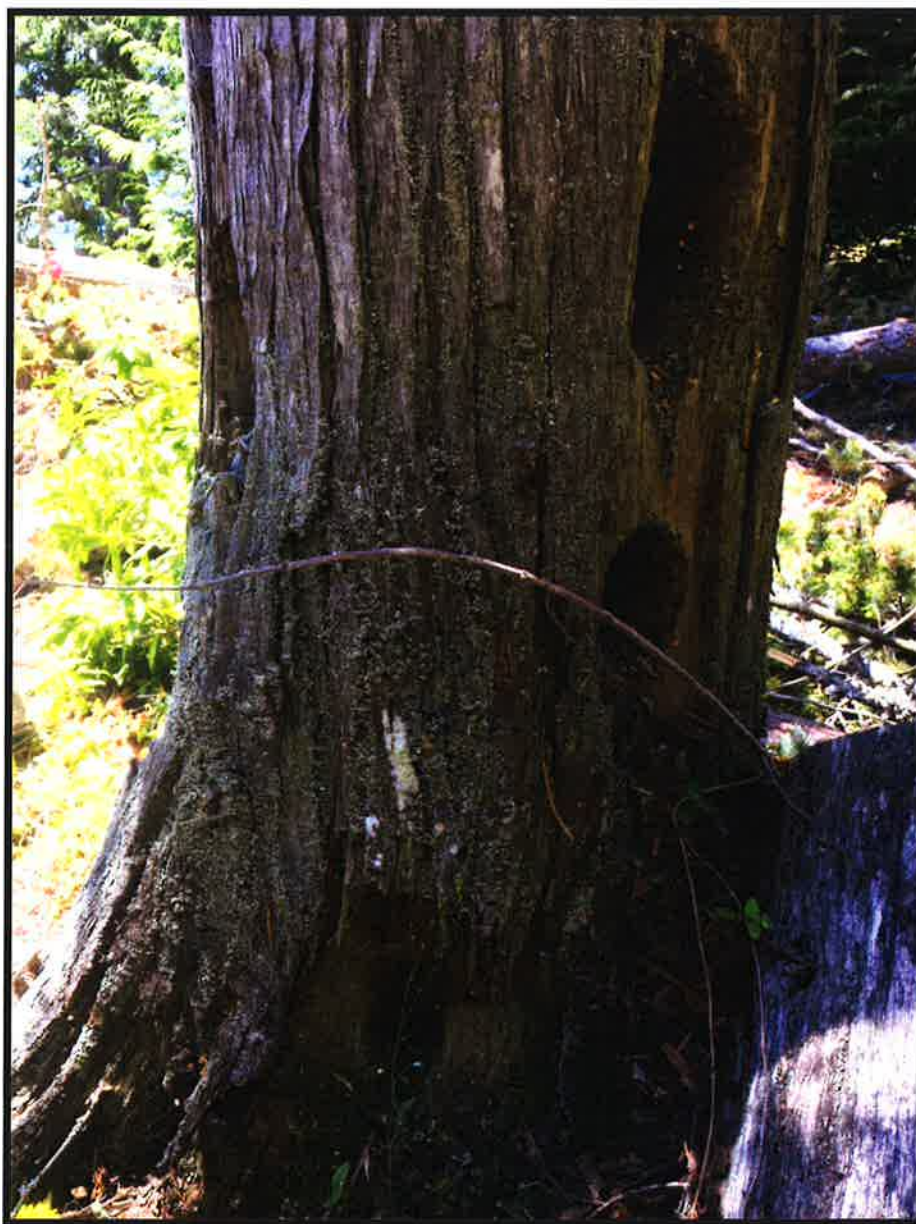
**Photo 6.** The second tree had excavated cavities present.

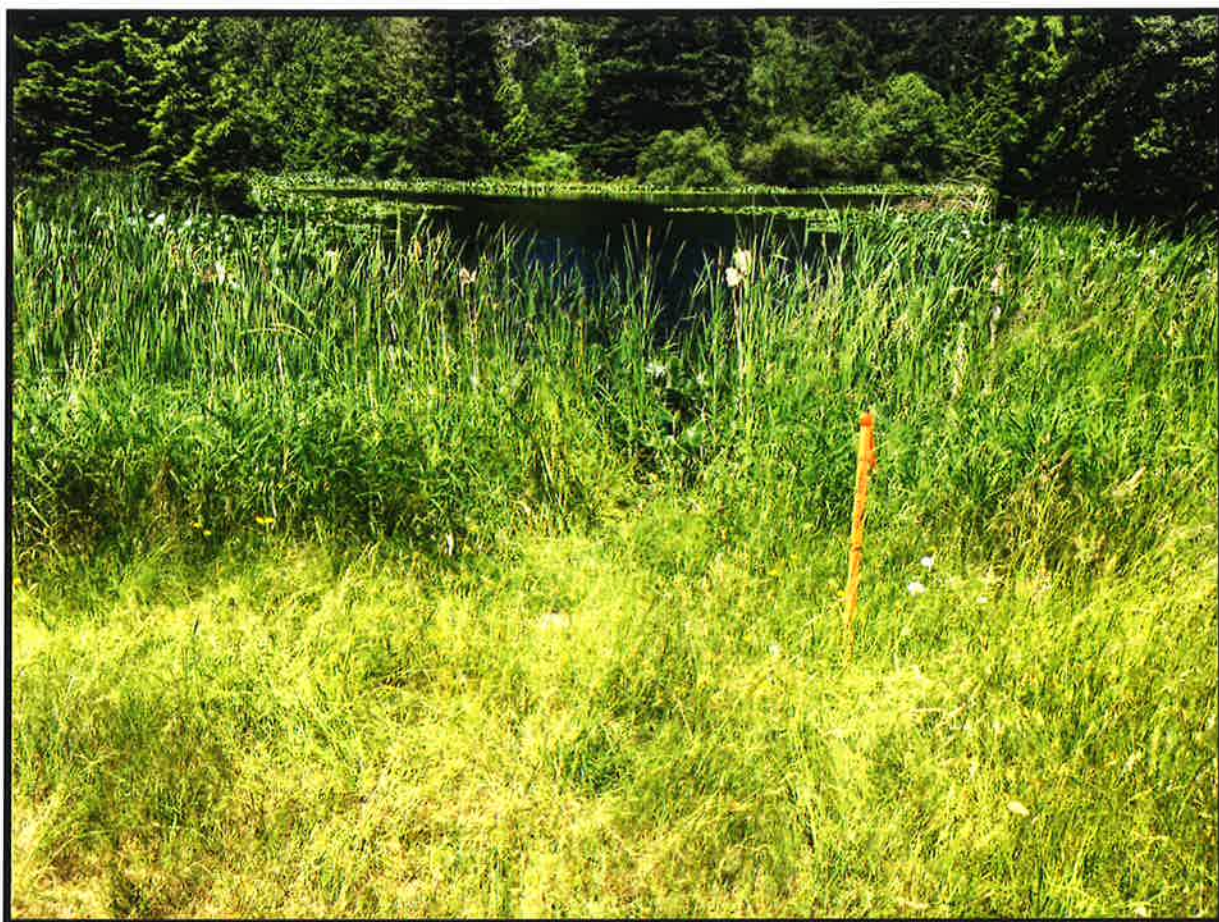
The Titus EM combed through the Cattails by hand, and remained at the site for approximately 30 minutes after the survey. No nest structures were found, and no nesting activity was observed. Nesting activity was observed in other locations in the Cattail around the pond, but the locations were >50 m from the area to be cleared and should not be of concern.

**Photo 7.** Gardom Pond cattails at the second nesting bird survey location.
