February 3, 2020

File: 16-1856

**RE: ENGINEER'S ORDER CLOSE-OUT REPORT: GARDOM POND DECOMMISSIONING - CONTRACT 16-1856**

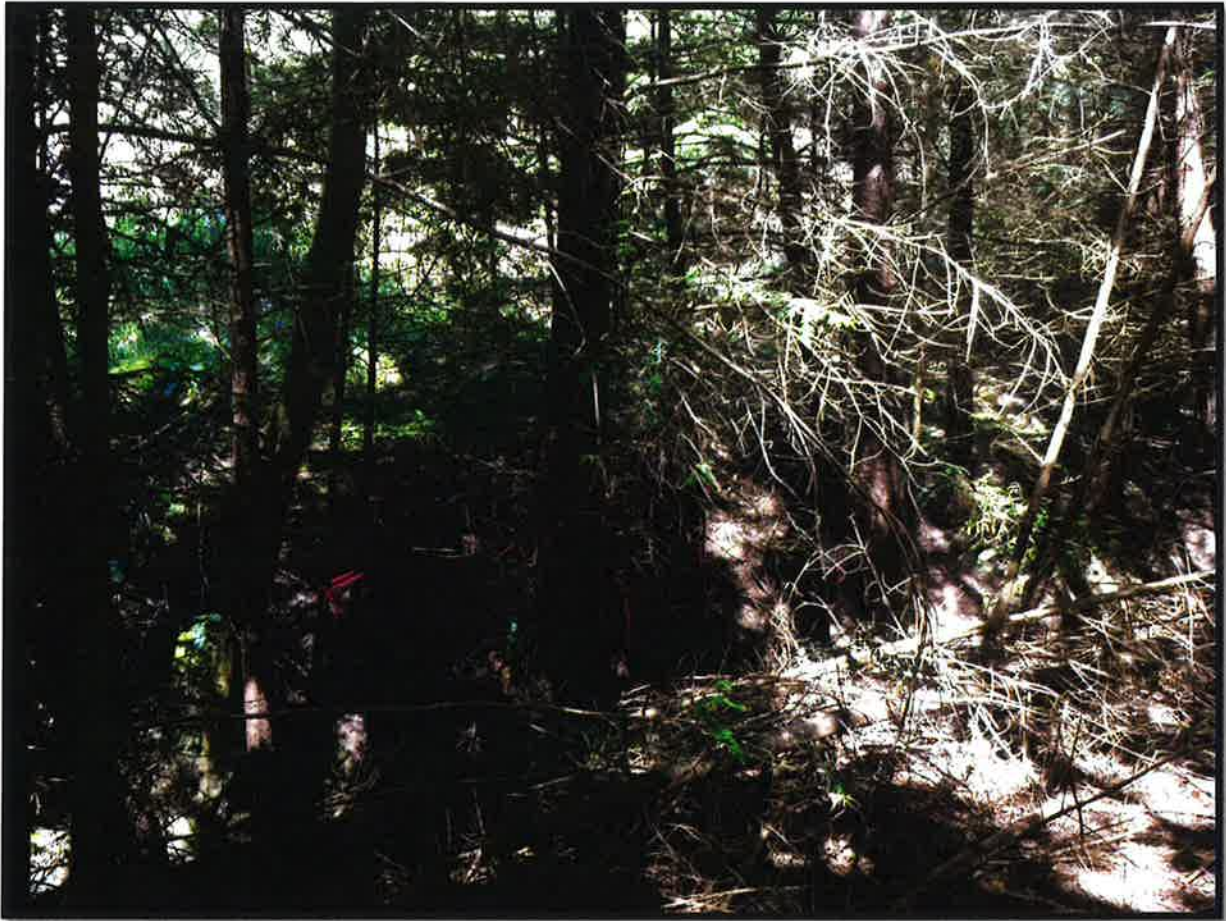
None of the trees inspected (small or larger diameter) had nesting bird activity or nest structures observed.

**Photo 8.** Small diameter trees flagged for removal at the final nesting bird survey location.
