Project No: 60285876 Task #3

**Re: Gardom Pond Dam Evaluation – North Pender Island
Low Level Outlet Investigation, October 2017**

**Gardom Pond Dam
Low Level Outlet Chamber Inspection
Photo Album
October 2017**

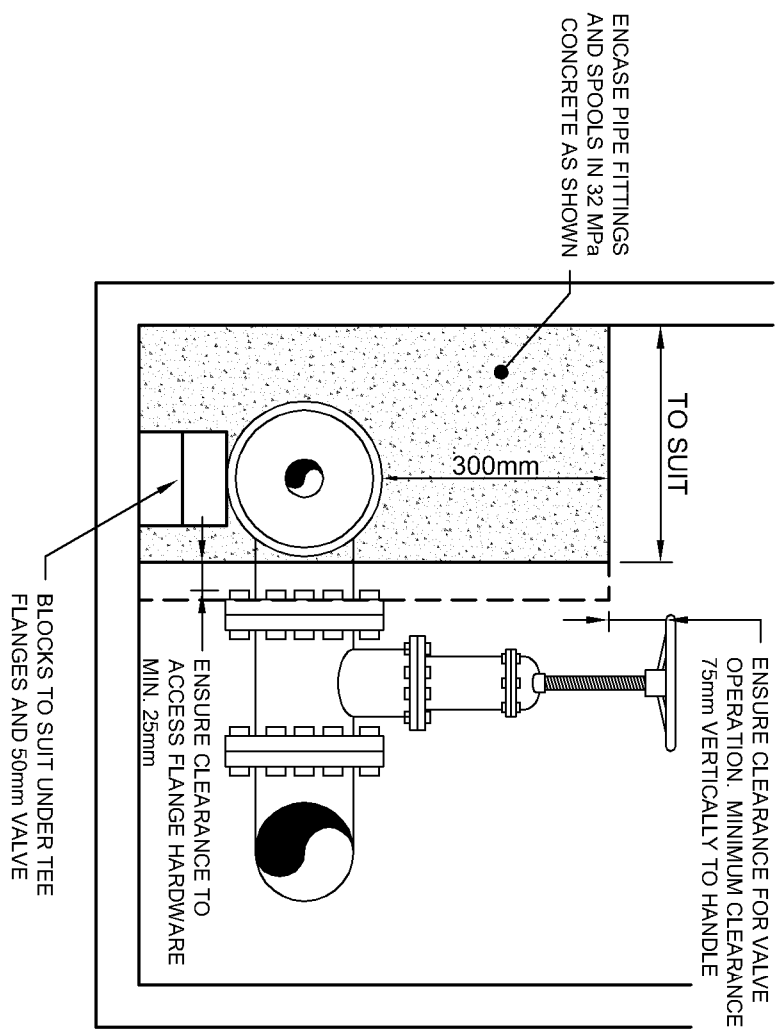
**PROPOSED CONCRETE ENCASUREMENT
 OF
 50mm DIA. IRRIGATION OUTLET**

The surficial qualitative assessment of the Low Level Outlet's piping and fittings identified the short 50 mm irrigation outlet pipe spool, located between the 150 mm reducing tee and the 50 mm gate valve, to have visual signs of metal corrosion; with characteristics of spalling, scarring and pitting of the pipe's surface. The full extent and depth of the identified corrosion within the base metal and the potential risk of failure is not determinable from our qualitative assessment.

To provide a measure of protection against possible failure of the 50 mm diameter spool piece was discussed with CRD staff. It would involve capping the irrigation outlet pipe downstream of the 50 mm diameter gate valve and encasing the irrigation outlet and main outlet tee in concrete. Refer to attached Figure #1. It should be recognized that this is a short term solution that should provide a cost effective solution to mitigate the potential risks of the irrigation pipe failing by corrosion until the dam is scheduled to be decommissioned in 2018.
