## Dallas Road Cliffs, Historic Foreshore Erosion Assessment

Historic Foreshore Erosion  
Assessment

Prepared by:  
Stantec Consulting Ltd.  
500-4730 Kingsway  
Burnaby, BC V6H 0C6

May 30, 2017

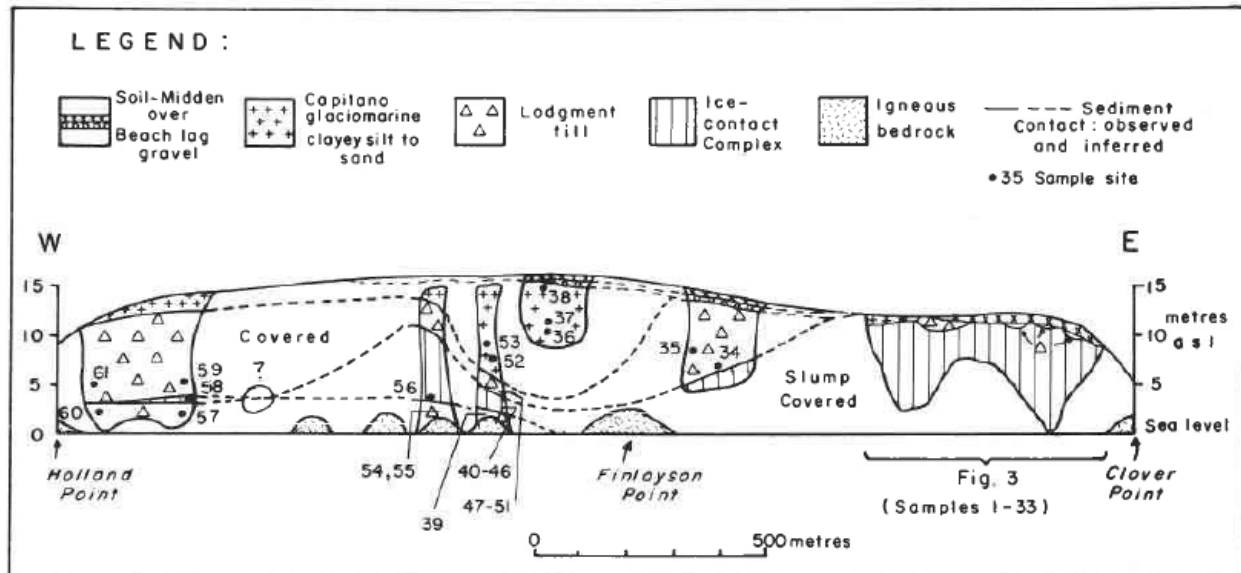
Figure 2 Geological cross-section of the sea cliff between Holland Point and Clover Point (source: Hickock et al. 1981).

During the last major glaciation (25,000-10,000 ybp) glaciers formed in the Vancouver Island Mountains and Coast Mountains and advanced down the Strait of Georgia to southeastern Vancouver Island after 19,000 ybp. During the glacial maximum (~15,000 ybp) southern Vancouver Island was completely covered by an ice sheet that flowed south-southwesterly across Juan de Fuca Strait and deposited Cordilleran till (Alley and Chatwin 1979). As the climate began to ameliorate, deglaciation was by downwasting and southern Vancouver Island was ice-free by 12,500 ybp (Clague 1981). During this period, the coastline was depressed due to glacio-isostatic effects such that marine waters invaded lowland areas below 75 metres elevation and glaciomarine sediments were deposited (Mathews et al. 1970). However, present sea level was attained as early as 11,700 ybp at Victoria (Clague 1981). A detailed study of the sediments overlying the bedrock along the sea cliff between Holland Point and Clover Point (Hicock et al. 1981) identified four general soil types (Figure 2):

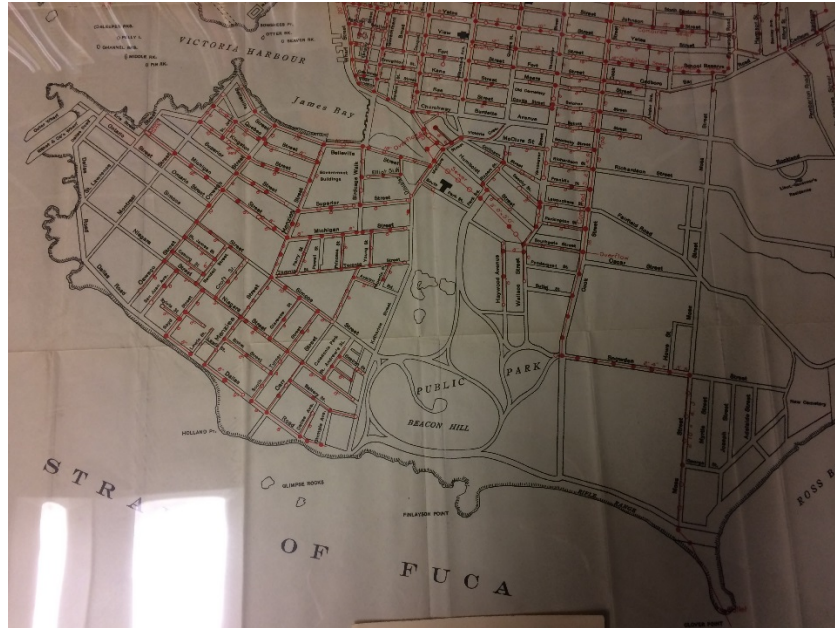
**Figure 3 Plan of the City of Victoria sewerage system dated December 1902 (source: City of Victoria Engineer's Office. 1902).**

A 1902 map of the City of Victoria's sewer system was located at the City Archives showing the extent of the system around the James Bay neighbourhood area (Figure 3). These documents and history of the sewer system in Victoria indicate a long period of reliable operation including pipes installed in Dallas Road.
