LYALL HARBOUR BOOT COVE WATER LOCAL SERVICE COMMITTEE

Money Lake Dam #1 Engineering Assessment Lyall Harbour/Boot Cove, Saturna Island

OCTOBER 13, 2016
ISSUED FOR USE
FILE: V13103344-02

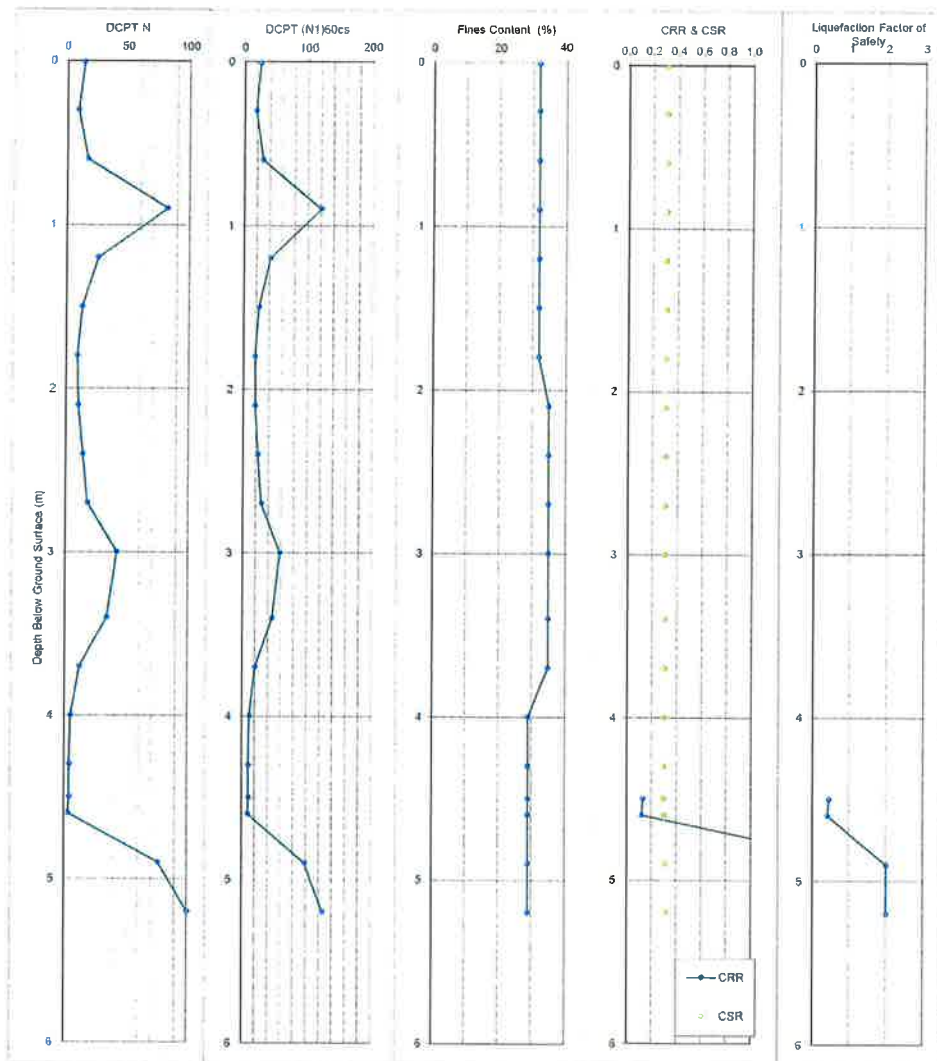
Earthquake	Borehole	Depth of liquefiable soils below ground surface ⁽¹⁾ (m)	Calculated FoS	Figure
1/2475	MW16-02	4.5 – 4.9	0.4 – 0.5	F1
	MW16-03	6.2 – 7.6	0.8 – 0.9	F2
	BH16-04	1.2 – 3	0.2 – 0.4	F3
Subduction	MW16-02	4.5 – 4.9	0.5 – 0.6	F4
	MW16-03	6.2 – 7.6	1.0	F5
	BH16-04	1.2 – 3.0	0.3 – 0.5	F6
