**SKANA WATER SERVICE COMMITTEE**  
Notice of Meeting on **Tuesday, April 12, 2016 at 9:30am**  
Main Conference Room, 479 Island Highway, Victoria, BC

### **SUBJECT**      **CONDITION ASSESSMENT OF POTABLE WATER STORAGE TANKS**

This document entitled *Structural Assessment of Skana Water System Tanks* was prepared by Stantec Consulting Ltd. for Capital Regional District (CRD), and for the attention of Mr. Gary Plevin, AScT. The material in it reflects Stantec's best judgment in light of the information available to it at the time of preparation. Any use, which a third party makes of this report, or any reliance on or decisions made based on it, are the responsibilities of such third parties. Stantec Consulting Ltd. accepts no responsibility for damages, if any, suffered by any third party as a result of decisions made or actions based on this report.

## **ASSESSMENT OF SKANA WATER SYSTEM TANKS, MAYNE ISLAND, BC**

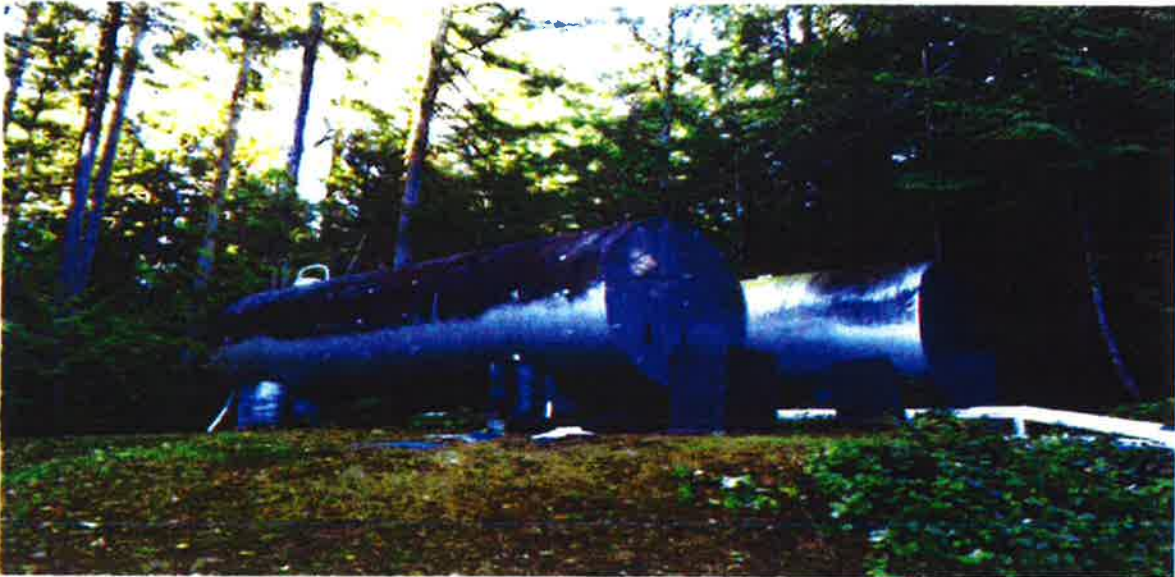
**Photo 1:** View of elevated tanks from access road leading into project site. Tank#1 in foreground and Tank #2 background as noted by numbering.

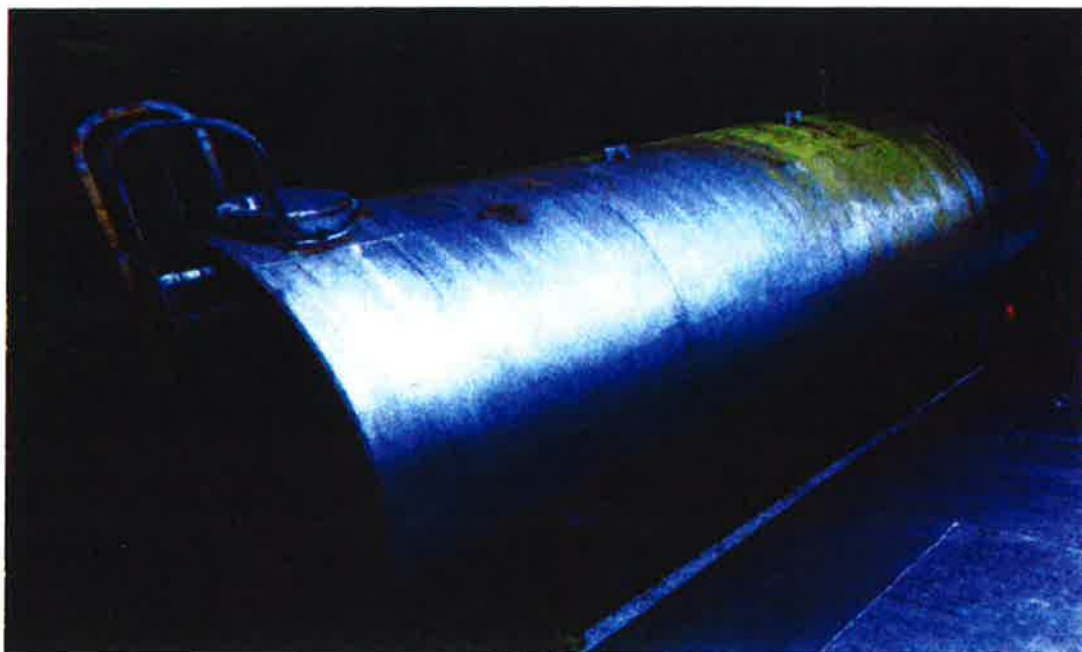
**Photo 4:** View of access hatch (Tank #2).

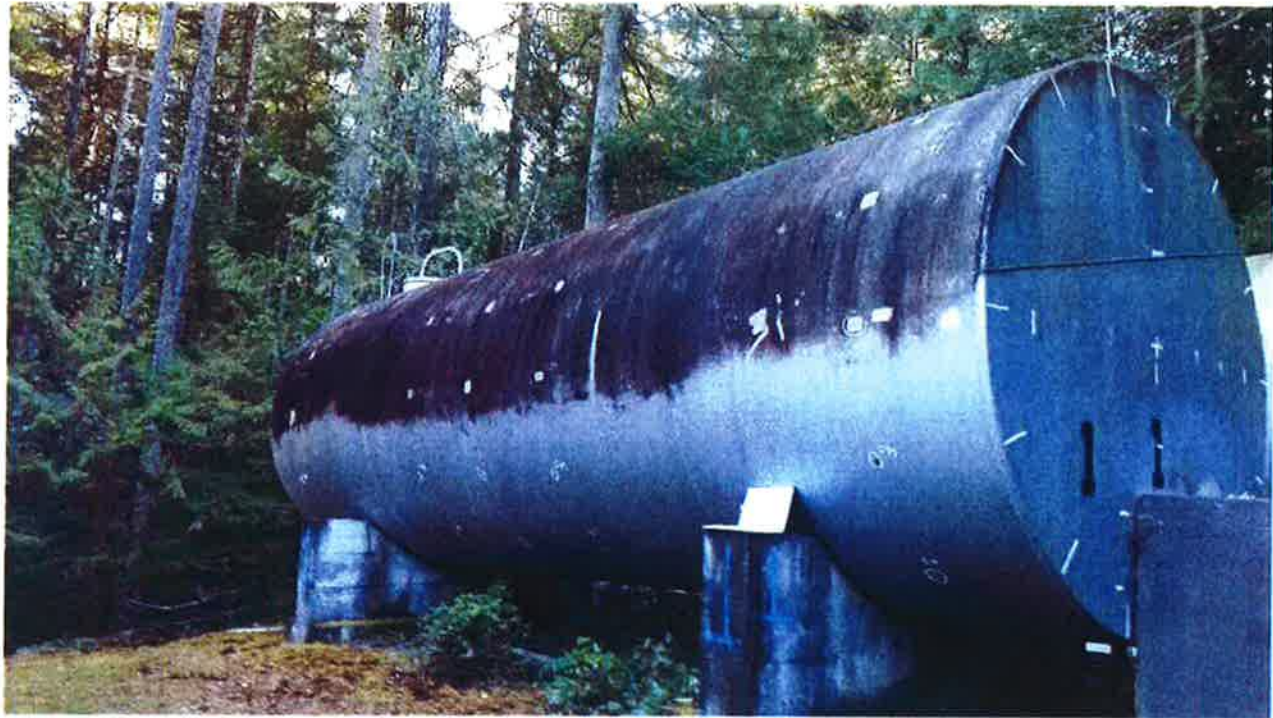
**1.1 External visual inspection of tank #1, documenting corrosion, coating deterioration, cracking or other issues.**

- 1.2 Corrosion on tank # 1 was found to be generally localized to the 5 o'clock to 7 o'clock location (from the west tank end). With few corrosion colonies extending from this location. The majority of the corrosion (5 o'clock to 7 o'clock location) was found to extend down the entire length of the tank. Severe pitting was noted up to 5mm in depth on the east tank end with an average of 2.5mm pitting noted throughout the entire west to east tank bottom. See images -1 and 3. This area will require attention if significant tank life extension is desired – See ultrasonic testing results.

- 1.3 Minor and inconsistent corrosion was also noted around the tank saddles. See Image -2.
- 1.4 Severe coating degradation was noted throughout the areas of corrosion mentioned above; however the rest of the tank was noted only to be covered in mildew caused by weather with no significant recorded coating failure.

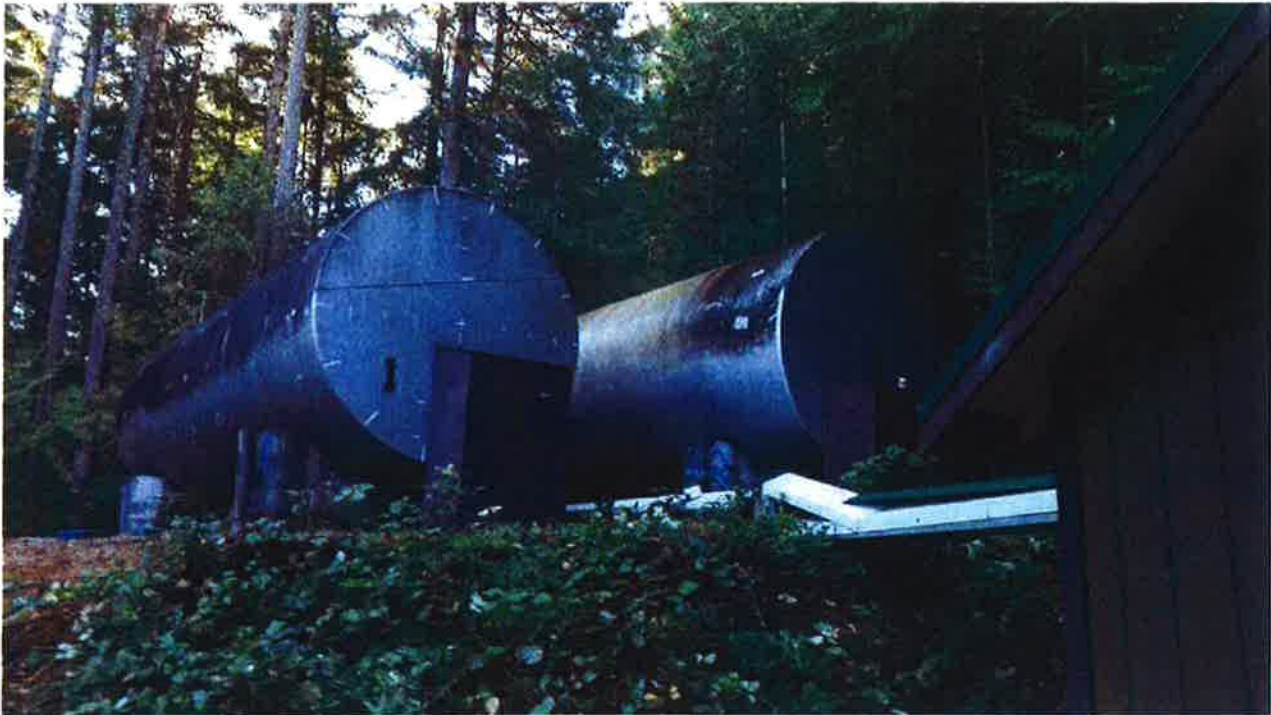
**1.1 External visual inspection of tank #2, documenting corrosion, coating deterioration, cracking or other issues.**

- 1.2 Corrosion on tank # 2 was found to be generally localized to the 5 o'clock to 7 o'clock location (from the west tank end). With noted corrosion colonies extending from this location. The majority of the corrosion (5 o'clock to 7 o'clock location) was found to extend down the entire length of the tank. Severe pitting was noted up to 5mm in depth on the tank bottom, with an average of 2.5mm pitting noted throughout the entire west to east tank areas. See image-1 below. This area will require attention if significant tank life extension is desired – See ultrasonic testing results.

- 1.3 Minor and inconsistent corrosion was also noted around the tank saddles
- 1.4 Severe coating degradation was noted throughout the areas of corrosion mentioned above; however the rest of the tank was noted only to be covered in mildew caused by weather with no significant recorded coating failure.
