SOUTHERN GULF ISLANDS HARBOURS COMMISSION
Notice of Meeting on **Tuesday, July 25, 2023 at 9:30 a.m.**
Saanich Peninsula Wastewater Treatment Plant Meeting Room,
9055 Mainwaring Road, North Saanich, BC

Southern Gulf Islands Harbours DOCK INSPECTION REPORT

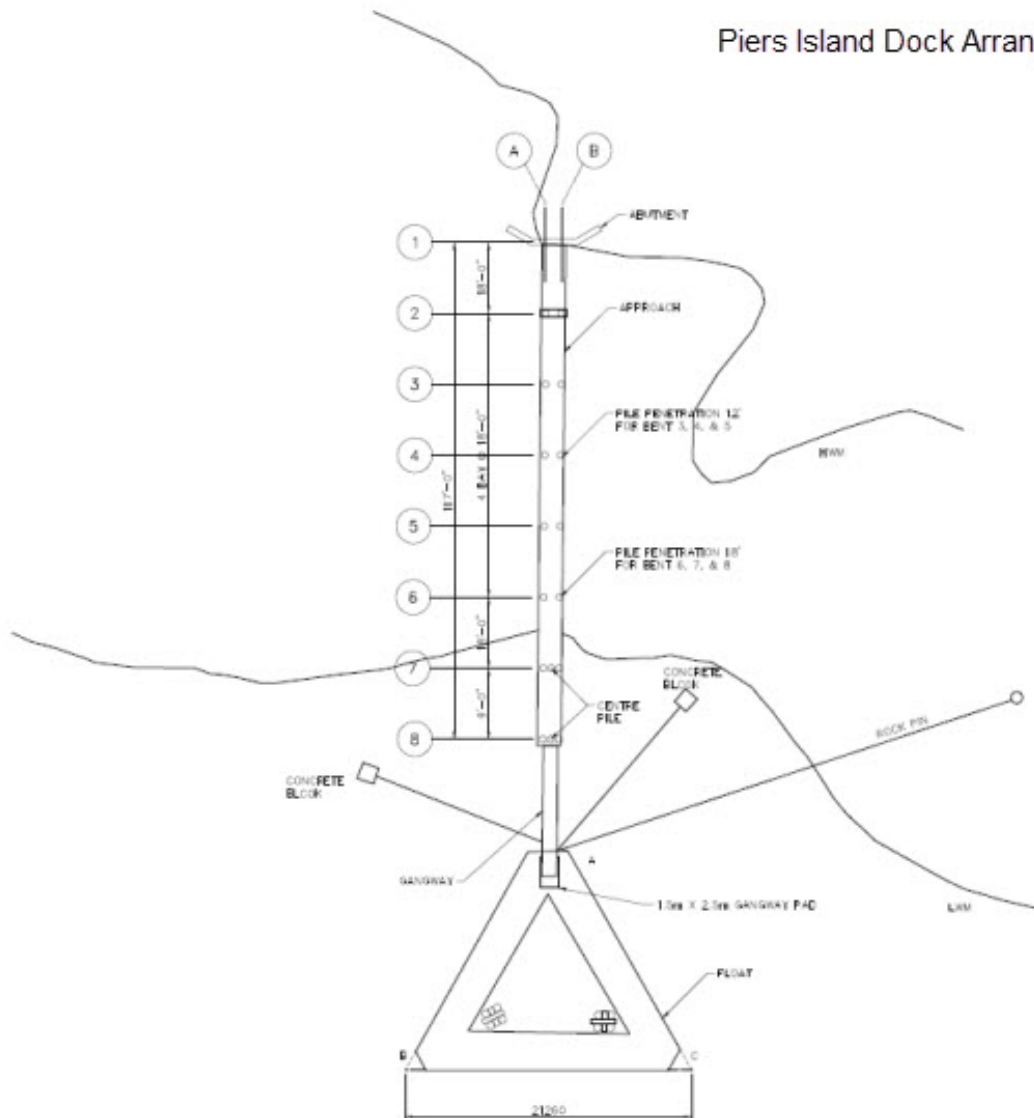
APPROACH	<input type="checkbox"/> Signage <input type="checkbox"/> Envelope Supply <input type="checkbox"/> Notices Posted <input type="checkbox"/> Rates Posted			
	<p>The railings and bull rails are unpainted and these and the decking have been pressure washed. There are only 2 areas of rot, there is a small area on a deck board and another area on the bull rail. No action is presently required.</p>			
WHARF HEAD	<input checked="" type="checkbox"/> Signage <input checked="" type="checkbox"/> Envelope Supply <input checked="" type="checkbox"/> Notices Posted <input checked="" type="checkbox"/> Rates Posted			
	<p>N/A</p> <p>The notice board is located on the float along with the signage.</p>			
GANGWAY FLOATS	<p>The gangway is a heavy old steel structure with solid wheels and no way to service or replace the roller bearings. The decking is in fair but worn condition and the expanded aluminum non-skid grating requires upgrading. Refastening of this grating is required sooner than later.</p> <p>The triangular float is in fair condition with good flotation. the inside piles and open pile wells are in good condition except that one piece of UHMW rub board has fallen off and a replacement is required. The expanded aluminum grating used as a non-skid requires refastening as required.</p> <p>The emergency landing area requires the length of yellow paint to be extended an additional 6 feet (1.8m).</p>

OTHER INSPECTIONS	<input type="checkbox"/> Lighting	N/A	<input checked="" type="checkbox"/> Life Rings / Heaving Lines	good
	<input checked="" type="checkbox"/> Extinguishers (expiry dates)	Aug 2023	<input type="checkbox"/> Unpaid Moorage	
COMMENTS/INSTRUCTIONS	<p>> The expanded aluminum grating used as a non-skid surface on the gangway, requires upgrading or refastening, sooner than later.</p> <p>> Refasten expanded aluminum grating on the float where required.</p> <p>> The missing piece of UHMW rub board in the open pile well (SE corner) requires replacement.</p> <p>> Yellow paint is required to extend the length of painted bull rail by 6 feet (1.8m), for the Emergency Landing/Loading Zone.</p>
