# Core Area Stormwater Quality Program

## 2020 Report

Capital Regional District | Parks & Environmental Services, Environmental Protection

July 2021

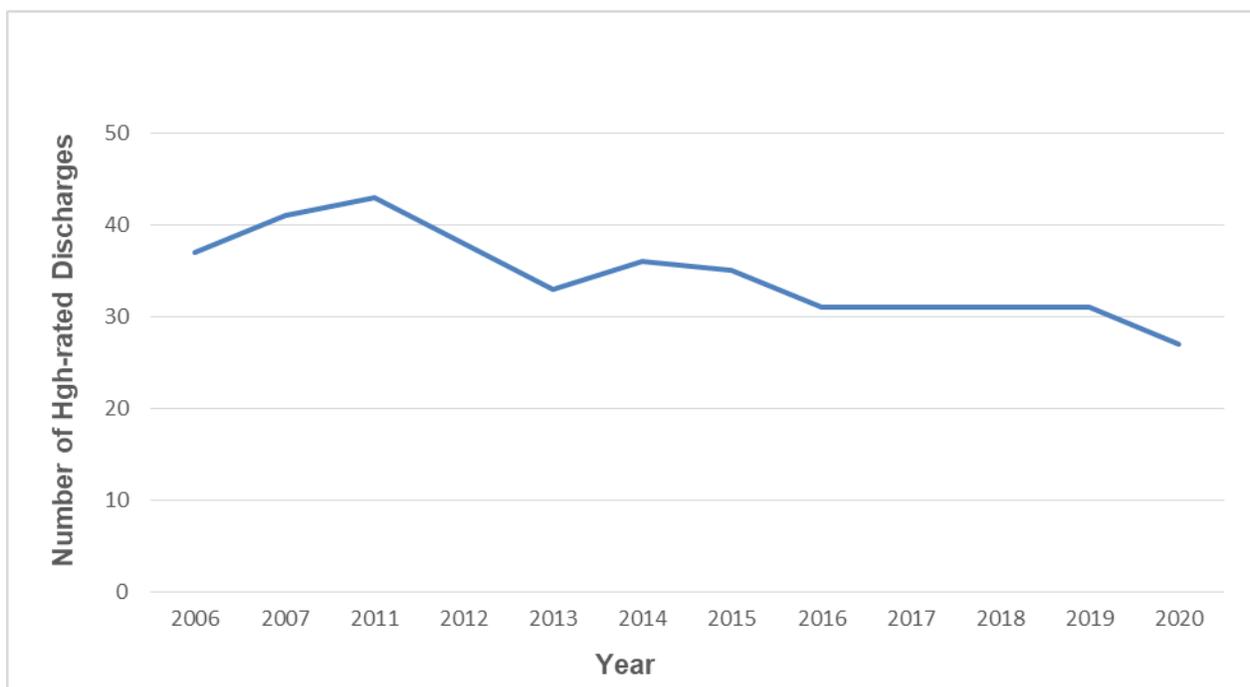
**Figure A. Number of Discharges Assigned a High Public Health Concern Rating Over Time**

The number of high-rated discharges decreased in 2020 (Figure A and Table A). The decline in high-rated discharges since 2011, despite aging infrastructure and continuing development and renovations (which create the potential for stormwater-sewage cross-connections), highlight the ongoing efforts by the municipalities to replace, repair and reline old infrastructure, and work with residents and property owners to repair cross-connections. Notably, sewage forcemain upgrades along the shoreline, as part of the CRD sewage treatment project, may have resulted in lower bacterial counts in some storm drains.

Of the 27 high-rated discharges in the core area, 15 have remained high-rated for at least five years (see Appendix E). The causes of contamination in these discharges are often costly or difficult to repair or remediate, and some discharges have multiple sources of contamination in a single catchment, making it difficult to track.

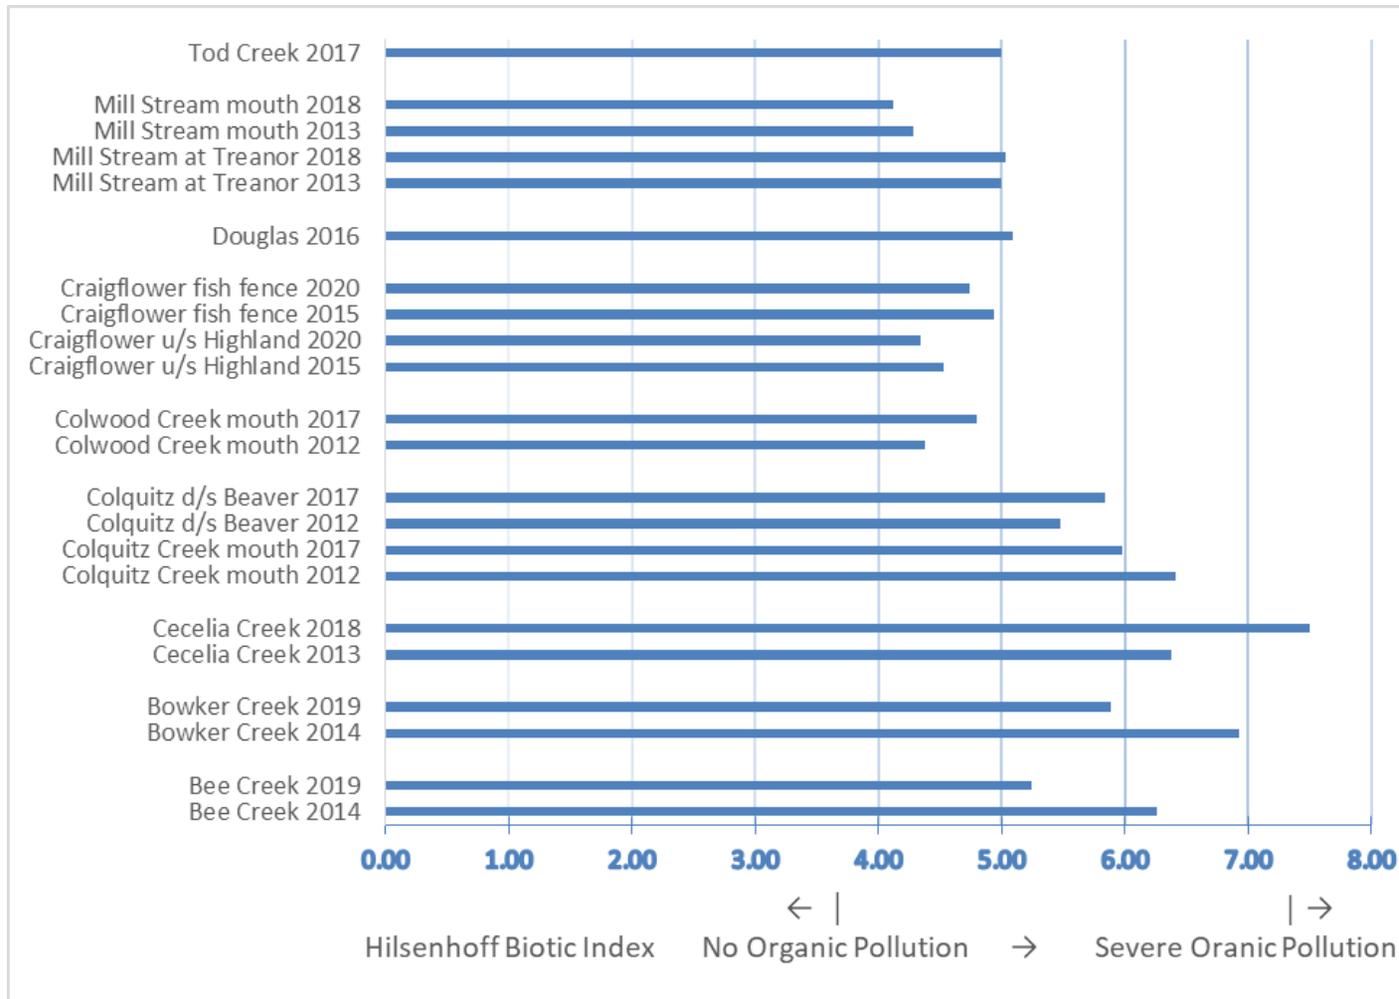
**Figure D. CRD Core Streams Benthic Macroinvertebrate Data Overtime Represented by Hilsenhoff Biotic Indices**

**Note:** The Hilsenhoff Biotic Index is a measure of benthic invertebrate communities that indicates higher organic pollution with increasing score.
