**Project No: 60285876 Task #3**

**Re: Gardom Pond Dam Evaluation – North Pender Island  
Low Level Outlet Investigation, October 2017**

**Gardom Pond Dam  
Low Level Outlet Chamber Inspection  
Photo Album  
October 2017**

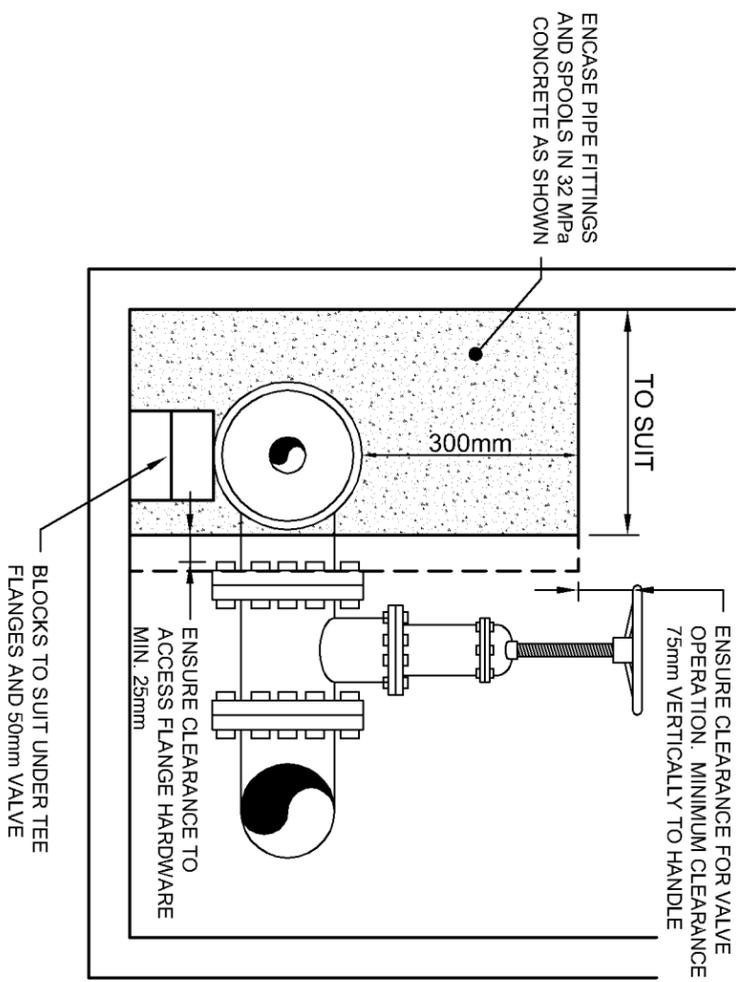
**PROPOSED CONCRETE ENCASUREMENT  
OF  
50mm DIA. IRRIGATION OUTLET**

The surficial qualitative assessment of the Low Level Outlet's piping and fittings identified the short 50 mm irrigation outlet pipe spool, located between the 150 mm reducing tee and the 50 mm gate valve, to have visual signs of metal corrosion; with characteristics of spalling, scarring and pitting of the pipe's surface. The full extent and depth of the identified corrosion within the base metal and the potential risk of failure is not determinable from our qualitative assessment.

We note this 50 mm diameter piping is pressurized upstream of the gate valve as a result of the dam's static water elevation and the extent of internal corrosion is not known, if any. To verify the pipe's integrity quantitatively would require further specialized investigations. This would incur additional consulting costs and may require the reservoir to be drained to conduct any pipe testing.

To provide a measure of protection against possible failure of the 50 mm diameter spool piece was discussed with CRD staff. It would involve capping the irrigation outlet pipe downstream of the 50 mm diameter gate valve and encasing the irrigation outlet and main outlet tee in concrete. Refer to attached Figure #1. It should be recognized that this is a short term solution that should provide a cost effective solution to mitigate the potential risks of the irrigation pipe failing by corrosion until the dam is scheduled to be decommissioned in 2018.
