**ENVIRONMENTAL RESTORATION  
CONCEPT PLANS FOR BOWKER  
CREEK: TRENT STREET TO PEARL  
AVENUE**

P.A. Harder and Associates Ltd.

**March 2002**

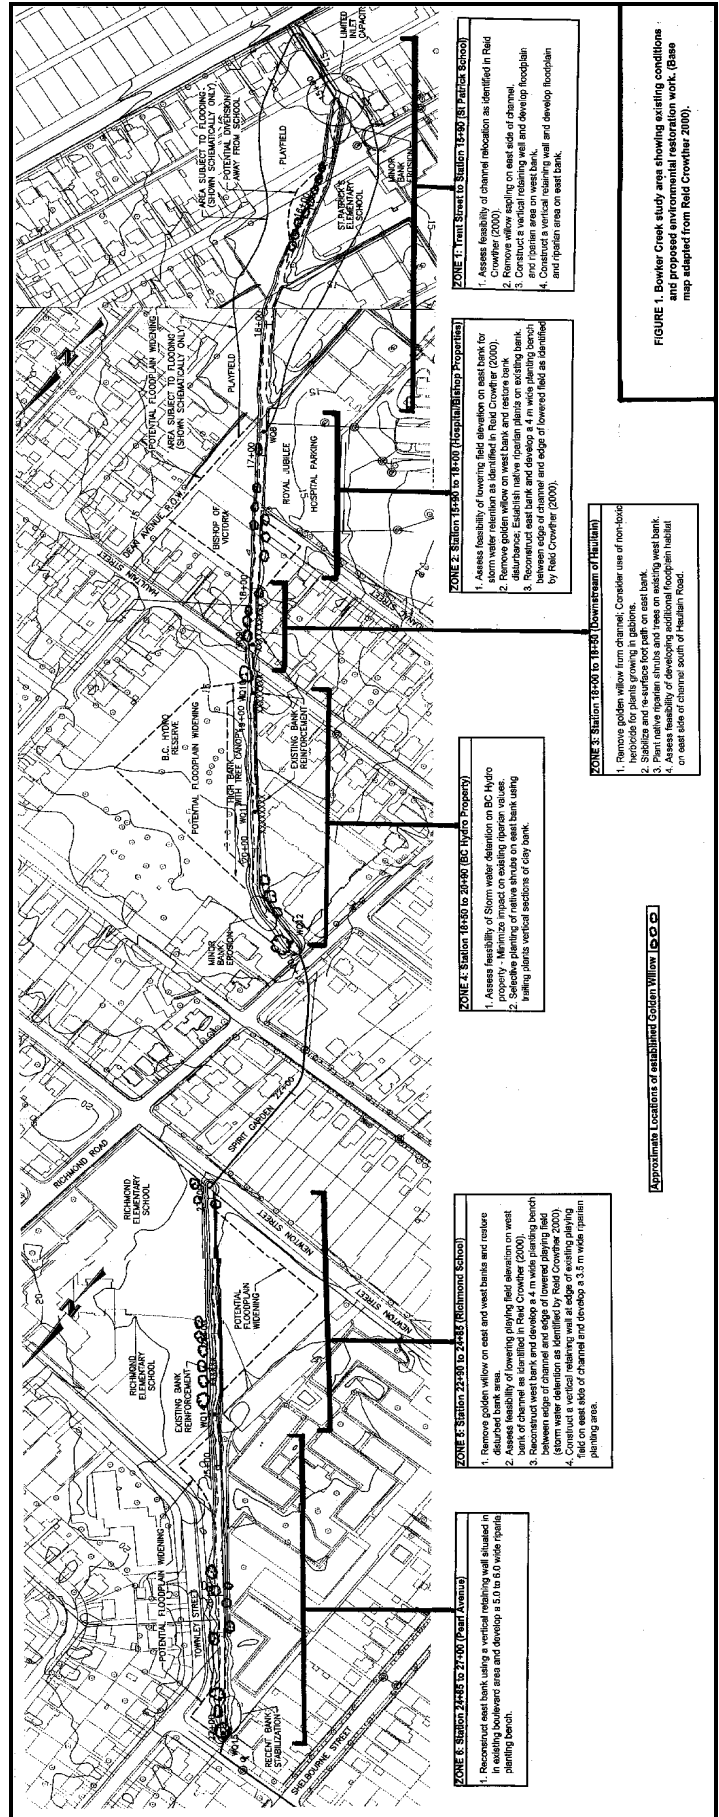
**FIGURE 1. Bowker Creek study area showing existing conditions and zone designation for proposed environmental restoration work.**  
 (see pages 46-47 for a larger version of this map).

The proposed golden willow eradication work could be done in phases using the identified stream zones as project areas. It is recommended that Zone 1 (Figure 1) be completed as a first priority since the willow in this area are still in sapling stage and bank disturbance would be minimal. Additional willow removal work in Zones 2 to 6 should be further assessed in context with other riparian restoration work that may be undertaken in these zones.

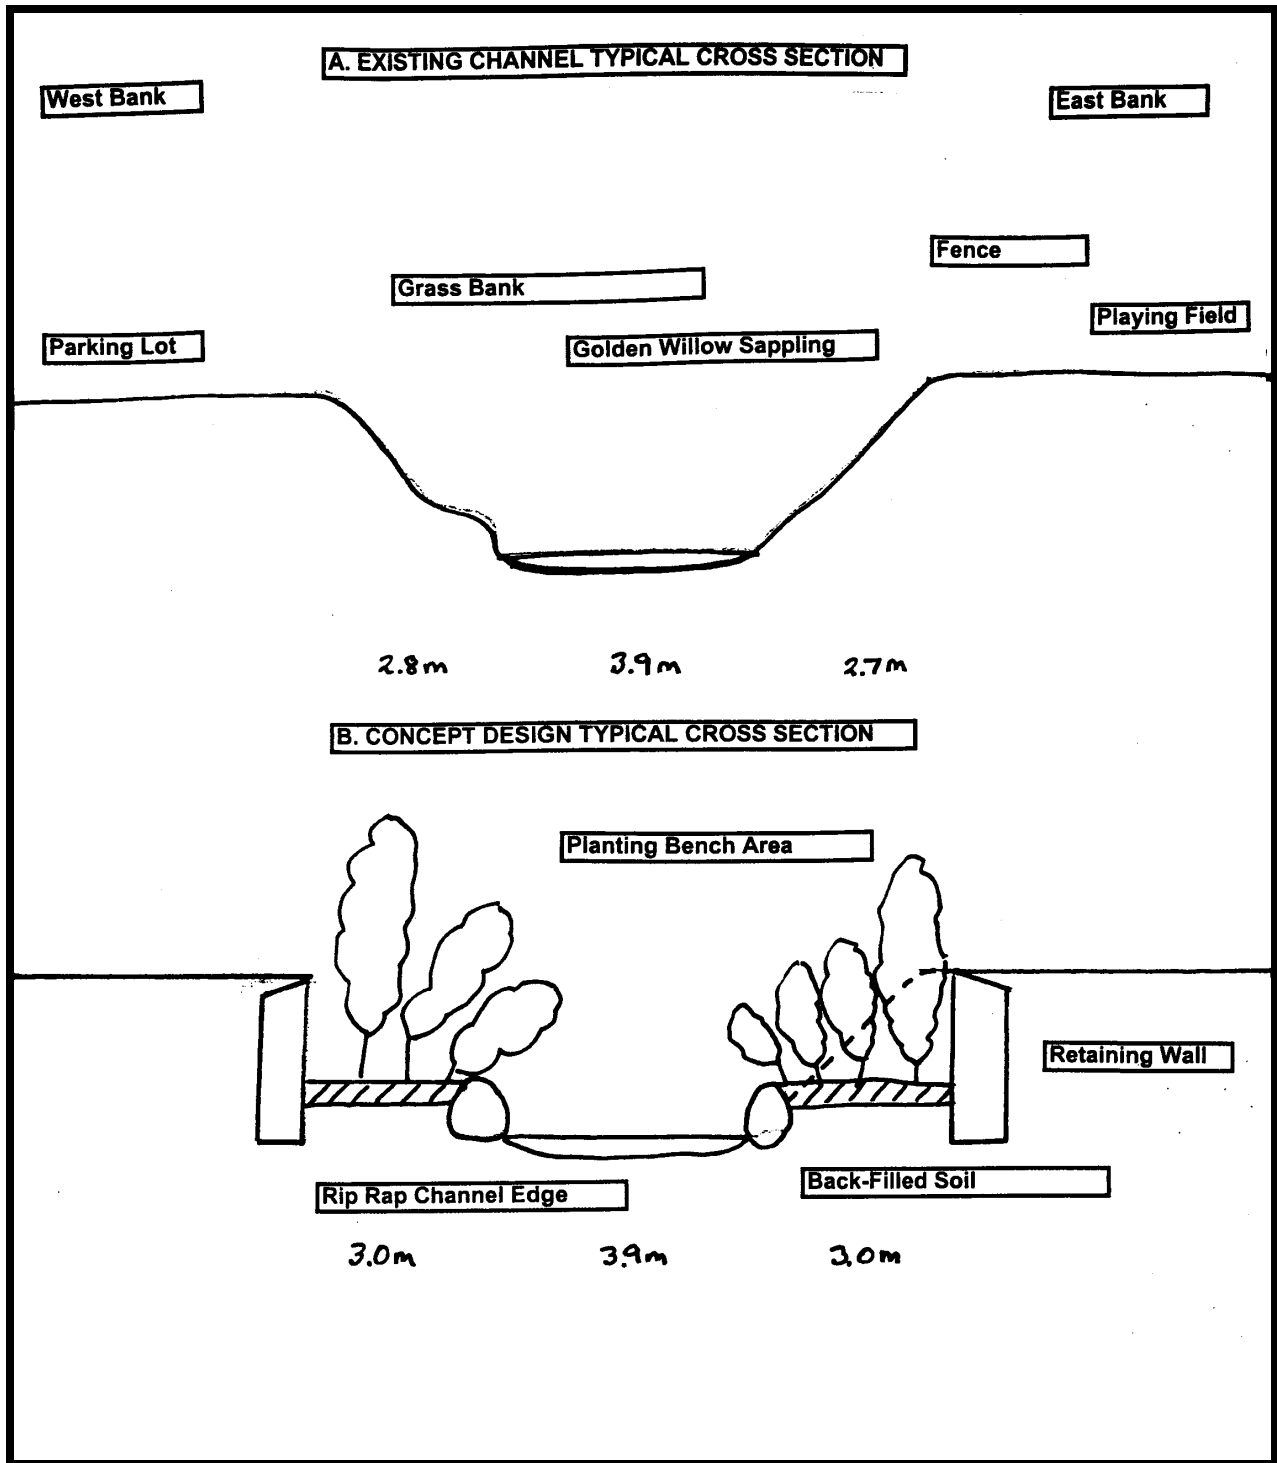
FIGURE 2. Typical cross section of Bowker Creek in Zone 1 showing concept design for proposed bank reconstruction and riparian restoration work.

The existing bank along the west side of the channel has no significant environmental values and is actively eroding. Soil conditions and slope characteristics of the existing bank slopes are not suitable for the establishment of a native riparian plant community. Re-constructing the bank using a vertical retention wall along the existing fence line would provide an opportunity for reclaiming up to 2.0 m of active floodplain habitat that could be planted with native plant species. This approach would require excavation of the existing bank back to the existing fence line, installation of vertical retaining wall and installation of a 0.6 m high planting bench. The planting bench would require a layer of rip rap placed at the existing wetted edge of the channel and back-filling with organic soils on the back side of the rip rap up the vertical retaining wall (Figure 2).

Golden willow is becoming established along the lower bench of the east bank. This species grows and spreads rapidly and the root systems tend to encroach into active stream channel areas. These

willow plants should be removed throughout the entire length of Zone 1. Mechanical excavation will be required to effectively remove the root structures. Construction mitigation measures would be required to ensure downstream water quality is maintained. This work would not compromise any other flood control initiatives in this zone.

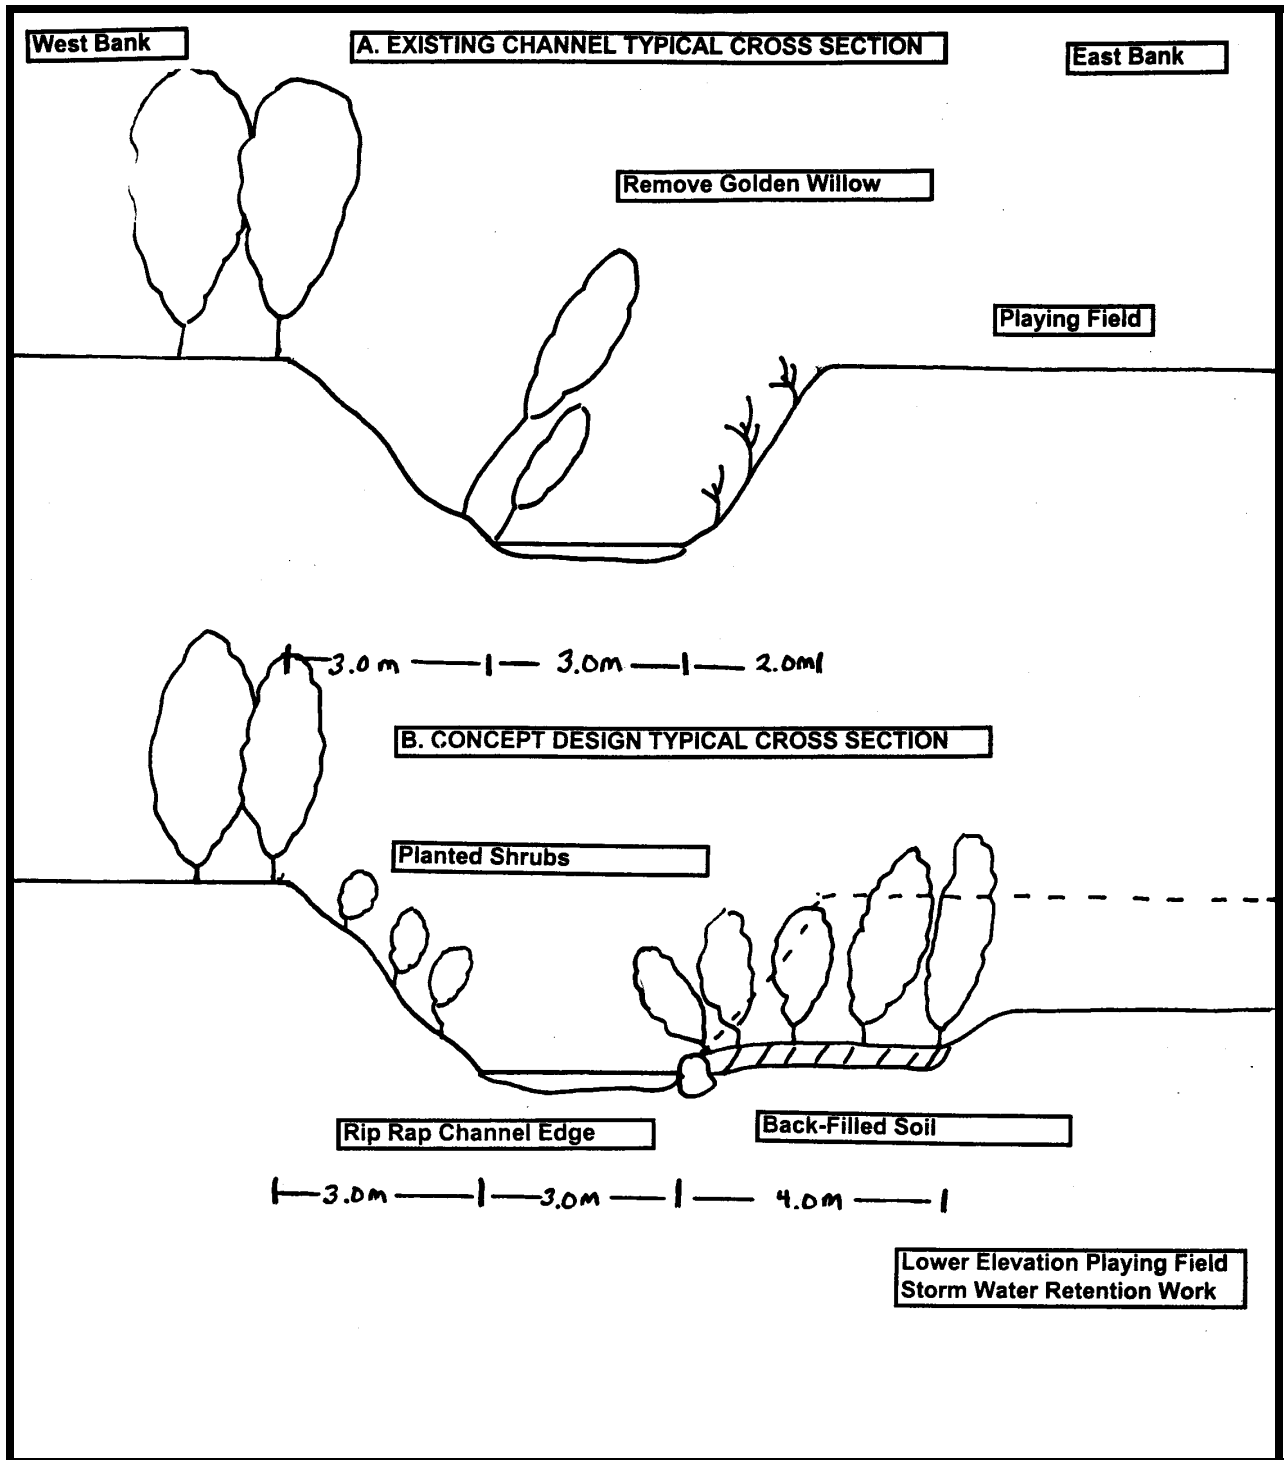
**FIGURE 3. Typical cross section of Bowker Creek in Zone 2 showing concept design for proposed bank reconstruction and riparian restoration work**

The west bank is well vegetated and there is no sign of significant erosion. Existing riparian vegetation on the west bank is moderately diverse and provides partial shading to the creek channel. Approximately 30% of the west bank is vegetated with broom. It may be feasible to control further spread of the broom on the west bank with a systematic removal program using hand labour. There are several young golden willow trees growing along the base of the west bank (Plate 4). Future growth of these trees may result in further constraints on the hydraulic capacity of the channel. Therefore, consideration of tree removals may be warranted.

Existing bank and riparian conditions on the west bank have moderately high environmental values. Therefore, there is a lower priority to reconstruct the existing bank and completely restore riparian vegetation on this side of the channel. However, additional floodplain area and an improved riparian plant community could be achieved if the bank was reconstructed (Figure 3). Property owner approval and cooperation would be required for this potential work. Estimated quantities and costing guidelines for the bank excavation and reconstruction work are presented in Appendix 1.

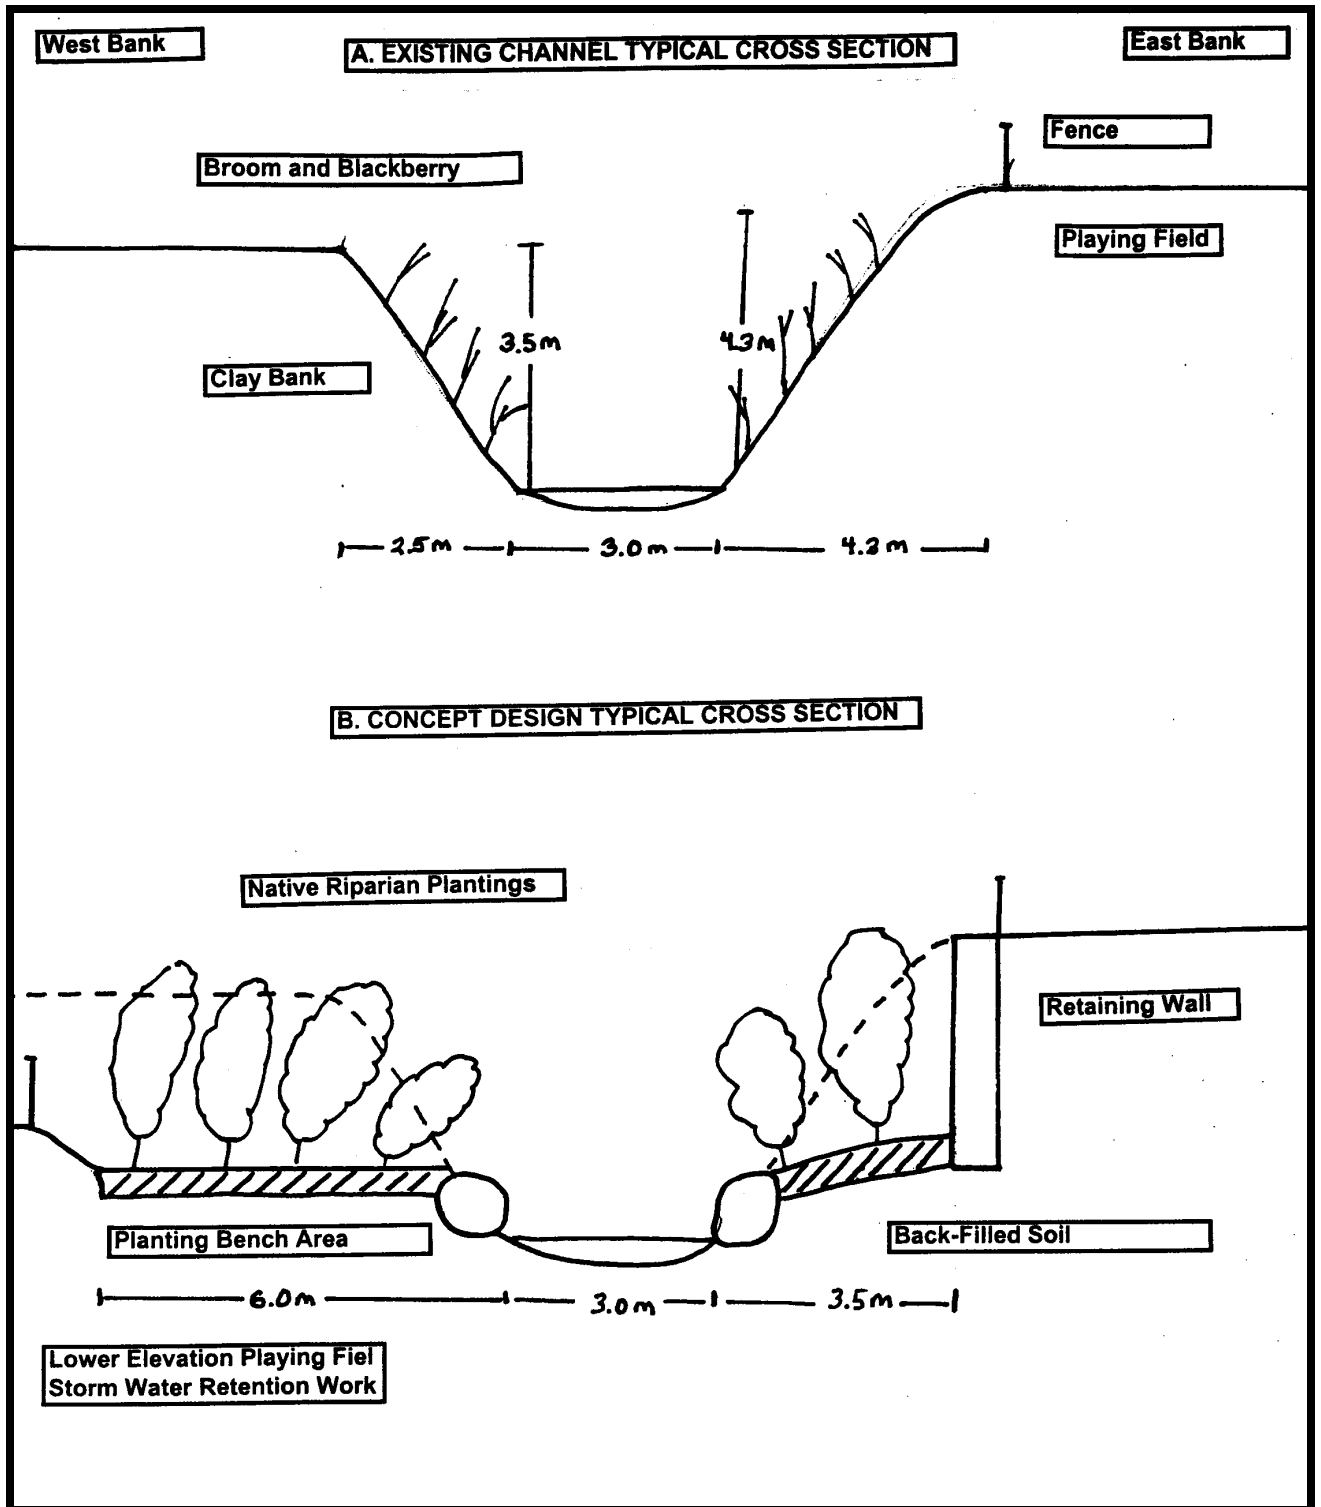
FIGURE 4. Typical cross section of Bowker Creek in Zone 5 showing concept design for proposed bank reconstruction and riparian restoration work

Functional floodplain habitat and a restored native riparian vegetation community could be restored if the existing banks were reconstructed. Floodplain and riparian planting area on the east bank could be maximized without affecting existing land use if a vertical retaining wall design was used (Figure 4). The same effect could be achieved on the west bank if the bank was excavated and reconstructed with a low elevation planting bench. It may be possible to complete this work without using a vertical retaining wall if the work was incorporated into a design for the proposed storm retention work at this site (Figure 4). Estimated quantities and costing guidelines for the bank excavation and reconstruction work are presented in Appendix 1.

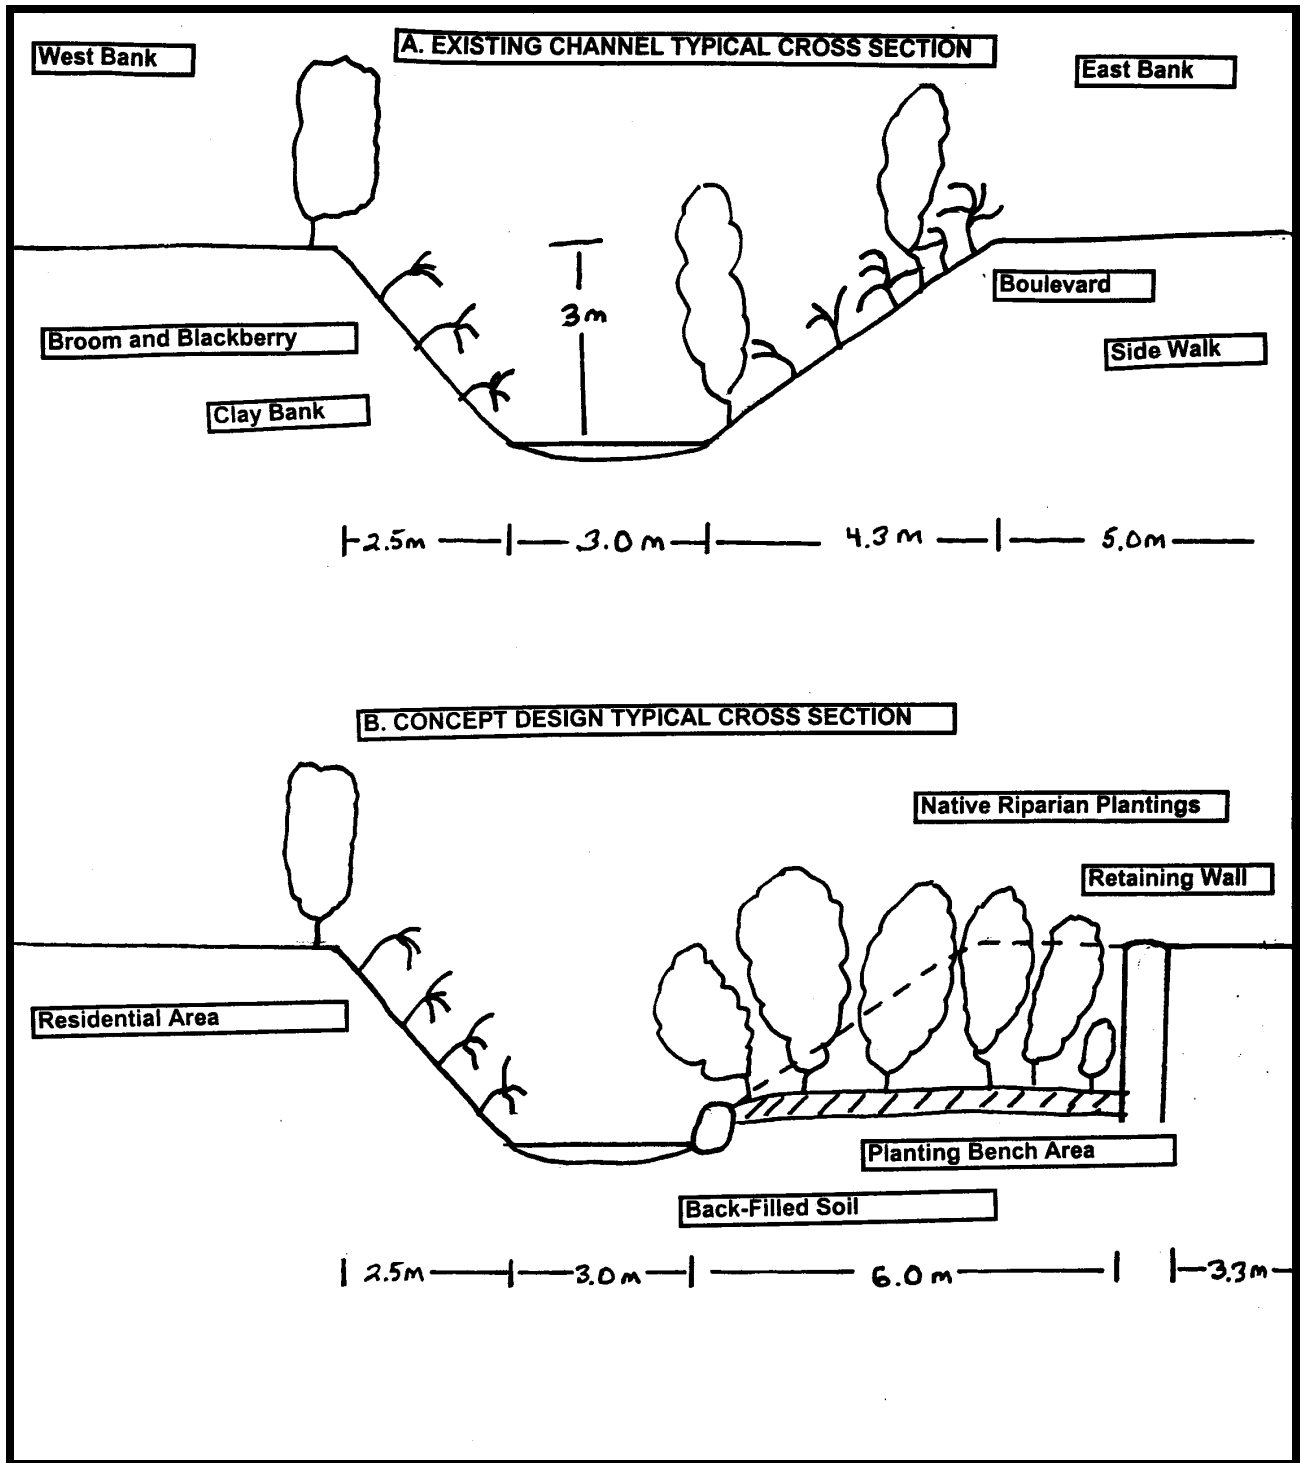
FIGURE 5. Typical cross section of Bowker Creek in Zone 6 showing concept design for proposed bank reconstruction and riparian restoration work.

Property constraints preclude the possibility of bank reconstruction work and floodplain development on the west bank. The east bank could be reconstructed to provide new floodplain and riparian area. The existing east bank could be reconstructed using a similar design concept to that presented for the east bank of Zone 5. New floodplain area would be maximized if the vertical retaining wall was situated near the edge of the existing sidewalk. This would necessitate excavation of the existing bank materials on the stream side of the fence and a 3 to 4 m wide section of boulevard area between the existing fence and sidewalk (Figure 5). Estimated quantities and costing guidelines for the bank excavation and reconstruction work are presented in Appendix 1.

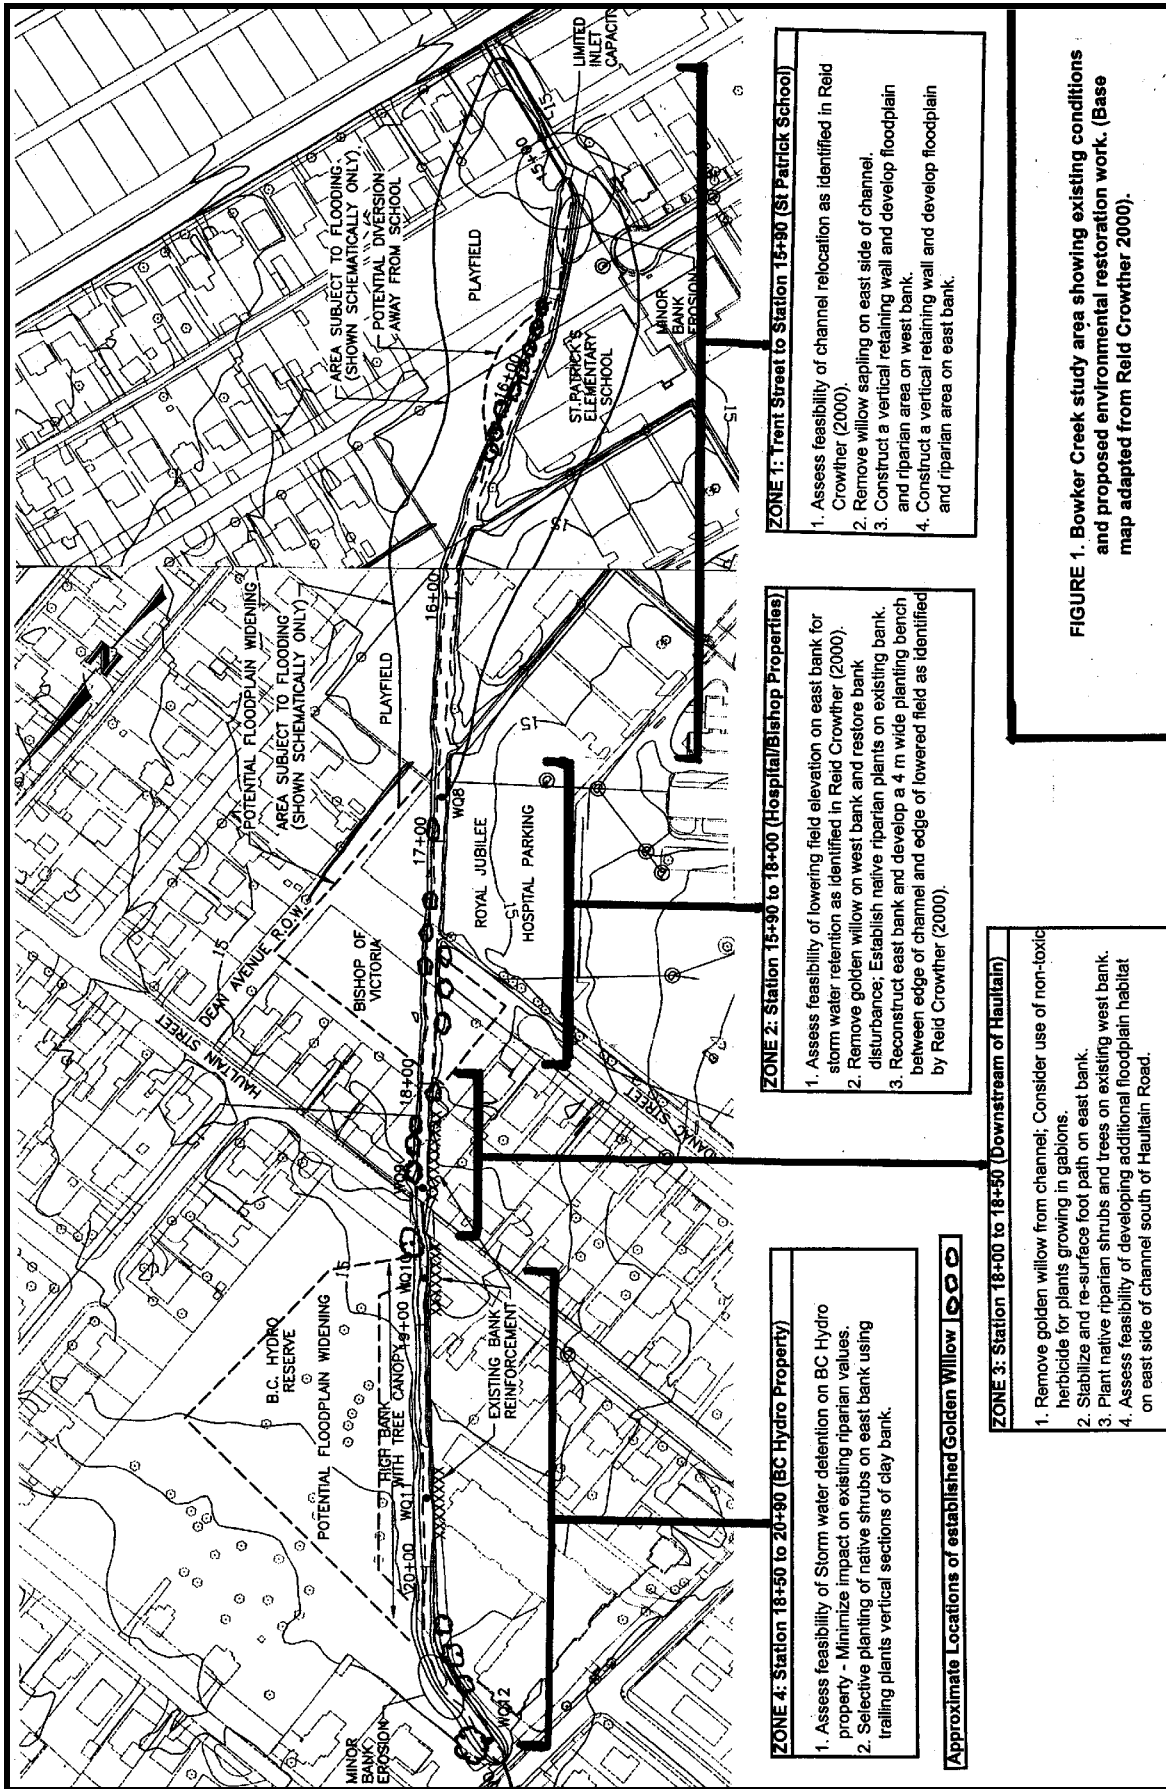
FIGURE 1. Bowker Creek study area showing existing conditions and proposed environmental restoration work. (Base map adapted from Reid Crowther 2000).

There are several areas where the removal of golden willow would improve flow conveyance in the existing channel (Figure 1).
