Colquitz River Watershed

Proper Functioning Condition Assessment

July 2009

The District of Saanich

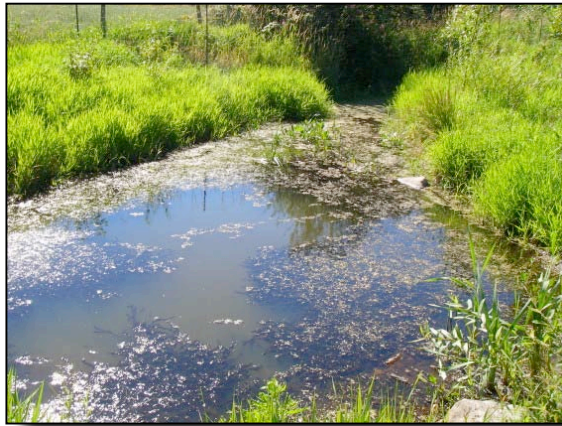
Reach 2b Viaduct Creek: The upstream property line of 4484 Markham Road to the weirs at the outlet of Viaduct Flats

Reach 2b is approximately 439 m long. The reach extends from the property boundary of 4484 Markham Road downstream of the confluence with an unnamed tributary draining Layritz Park, through a section of park and trail, to the weirs downstream of Viaduct Flats. The channel is a ditch with flat and steep sides.

In the lower section of this reach, downstream of the stormwater ponds, bank erosion is severe. The majority of floodplain occurring within this reach is in the upper portion of the channel near Viaduct Flats. Consequently, the Rosgen channel

Reach 2b of Viaduct Creek is Functional-At-Risk with a downward trend due to the lack of floodplain accessibility, eroding banks, reduced vegetative cover, and the head cut occurring in the Layritz Park tributary.

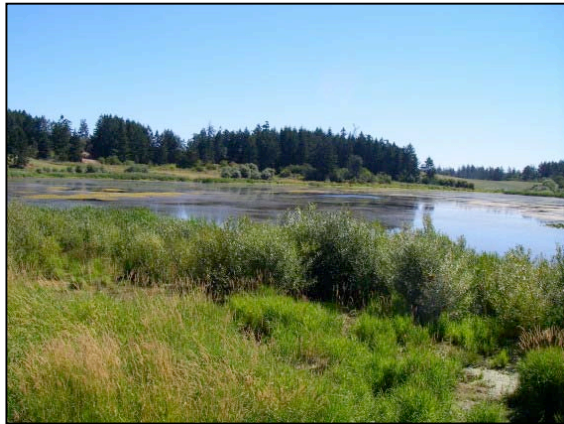
Reach 3 Viaduct Flats: The weirs upstream of Viaduct Creek to the upstream end of Viaduct Flats

Reach 3 extends from the weirs at the upstream end of Viaduct Creek and includes Viaduct Flats. Before it was converted back into a wetland and park attraction, Viaduct flats was a potato field that seasonally flooded during the winter months. This wetland is sheltered by surrounding hills with nearby forest, and is therefore exposed to only a small wind fetch. Well-known bird habitat, Viaduct flats is home to an abundance of waterfowl and other bird species including Canada geese, Great Blue Herons, Mallard ducks, and red-winged blackbirds. Viaduct Flats receives water from Viaduct Creek, Conway

Reach 3 is in Proper Functioning Condition and is in good shape resulting from continued supportive management after restoration initiatives. Invasive species have been well-managed to date and it is recommended that this management continue especially as Himalayan blackberry (*Rubus armeniacus*), reed canary grass (*Phalaris arundinacea*), and Scotch broom (*Cytisus scoparius*) have been seen growing in the area. Other improvements would include the addition of large woody debris into the open water area itself, thereby providing additional cover and perches for birds and habitat complexity for fish and other aquatic life.

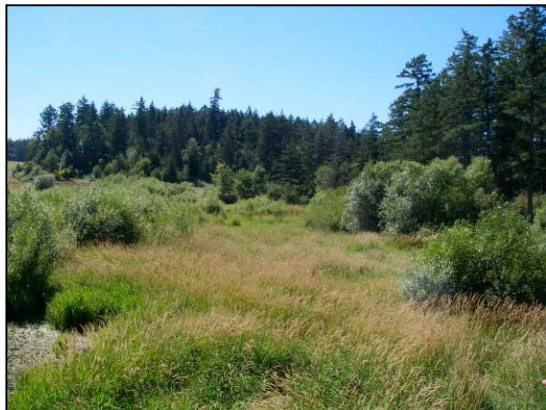
Reach 4 Viaduct Creek: The inlet at Viaduct Flats to Interurban Road

Reach 4 is approximately 60 m long and extends from the inlet of Viaduct Flats, upstream through wetland areas, and into a ditch (alongside a trail) where the creek crosses Interurban Road.

Alongside the trail, the creek is ditch-like and straight, with a few large rocks upstream of the bridge. The flow of water at the time of assessment was almost non-existent and too low to support fish. In the high flow winter months, the water extends over the channel banks (downstream of the parking lot bridge) into a grassy field and eventually discharges into

Reach 4 is Non-functional as it is a ditch and portrays none of the stream characteristics expected for a functioning “C” channel. This channel is simply conveying water downstream.

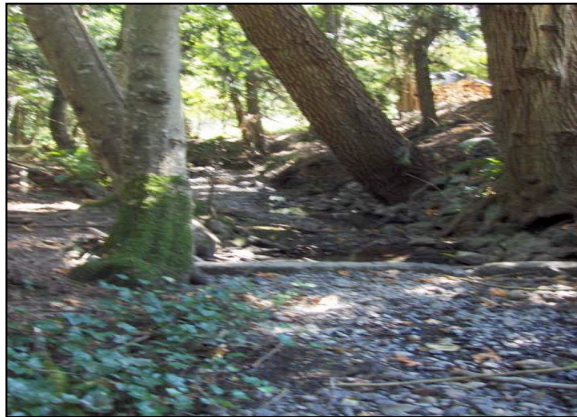
Reach 5 Viaduct Creek: Interurban Road to the wooden plank bridge at 478 Viaduct Avenue West

Reach 5 is approximately 104 m long and extends from Interurban Road upstream through residential property to the footbridge at 478 Viaduct Avenue West (downstream of the Goward Springs A-Viaduct Creek confluence). On the property of 490 Viaduct Avenue West, the right (and a portion of the left) bank is armored with rock in an attempt to control erosion that is undercutting the driveway. On the left bank, lawn is maintained to the edge of the creek bank with few shrubs present. A large compost pile was also noted along the lawn area. There is evidence of flow control

measures or restoration-perhaps a fisheries project- about halfway through this reach in the form of a log weir and a concrete weir. The dominant gravel substrate of this reach was likely added during the restoration work, thereby covering the previously silt/clay-dominated channel. The log weir is failing as water flow is skirting the edge of the weir on the right bank causing obvious erosion. Conversely, the concrete weir has allowed for the build up of sediment, and has subsequently raised the channel creating access to the surrounding floodplain area. Downstream of the concrete weir, the stream bank conditions vary from sparsely vegetated to actively eroding and downcutting. The driveway, buildings, and woodpile at 478 Viaduct Avenue West are located close to the edge of the bank. Furthermore, drainage pipes from the driveway discharge into Viaduct Creek causing localized erosion of the bank adding to the already heavily eroded channel. Although constrained on the right bank by residential properties, the channel has meander and was thus classified as a Rosgen “C4” channel type.

Reach 5 of Viaduct Creek is Functional-at-Risk with no apparent trend as the upper portion is stable while the lower portion is actively eroding.

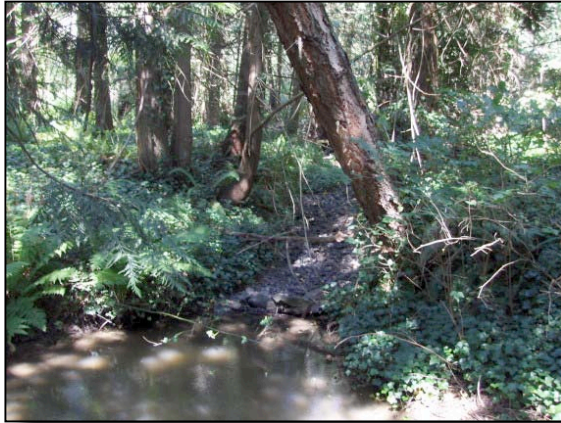
Reach 6 Viaduct Creek: The footbridge at 478 Viaduct Avenue West to the fence at 458 Viaduct Avenue West

Reach 6 is approximately 157 m long and extends from the discharge point of Goward Springs A Creek into Viaduct Creek, upstream of the 478 Viaduct Avenue West footbridge, to the property boundary of 458 Viaduct Avenue West. The channel in this reach is eroded and under cut. The floodplain is small and is not being accessed due to the downcutting of the channel. The Rosgen channel type is a “C6” as it does have some meander, but is in poor condition due to the erosion occurring. The evidence of heavy erosion may have resulted from the draining of a wetland upstream (see

Reach 6 is Non-functional due to the current erosion, downcutting, and inability of the channel to dissipate the flows it receives.

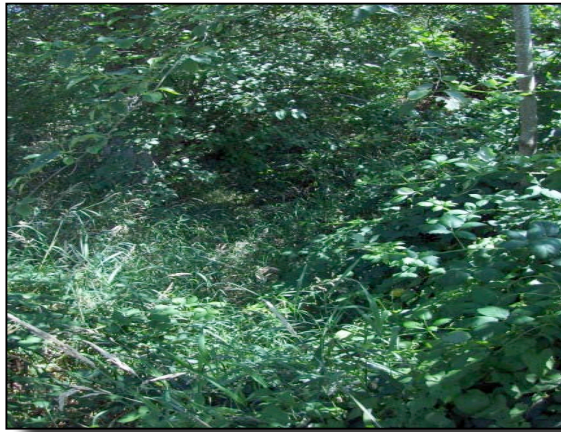
Reach 7 Viaduct Creek: The fence at 458 Viaduct Avenue West to where creek enters the wetland area at 458 Viaduct Avenue West

Reach 7 is approximately 28 m long. It extends from the property boundary of 458 Viaduct Avenue West, through two residential properties (one on each side of the creek) to where the creek enters the wetland area upstream of the pedestrian footbridge. Created by ditching, this reach is narrow and incised with steep banks, thus resembling a Rosgen “G6” channel. The channel and bank substrate consist of silt/clay with some peat. The banks are heavily vegetated with reed canary grass (*Phalaris arundinacea*), with no signs of erosion. This is likely due to the wetland upstream attenuating the water.

Furthermore, the floodplain area is not accessible due to incision of the creek. The channel has been dug in the past 15-20 years to drain the wetland in order to use the land for farming purposes. Both the left and right banks have lawns encroaching up to the edges.

Reach 7 is in Proper Functioning Condition as there are no major issues of concern in this reach likely due to the wetland upstream attenuating flows. It is, however, far from desired future condition.

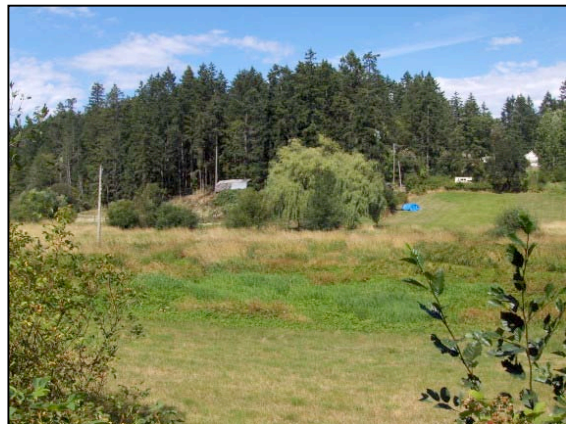
Reach 8 Viaduct Creek: Where the creek enters wetland area at 458 Viaduct Avenue West to the confluence of Viaduct Creek and Excelsior Creek at 414 Viaduct Avenue West

Reach 8 is a 0.9 ha wetland extending from the footbridge on 458 Viaduct Avenue West through a large hay field, a cow paddock, and a horse pasture, to the confluence of Excelsior Creek and Viaduct Creek. This reach is lentic in nature with a large wetland area located on the property of 455 Green Mountain Road. A ditch has been dug through this wetland, likely for drainage purposes and access to arable land within the last 15-20 years (Askew, *pers. comm.*). However, this is the only section where a channel is present. In this location, haying or mowing occurs along the wetland area, nearly to the edge

of the channel. Upstream of the ditched channel, a cow paddock followed by a horse pasture line the low-lying wetland depression. Extreme trampling has occurred in these locations especially by the horses that are not restricted by fencing as the cows are. Manure is also present within the wetland depression potentially affecting water quality downstream when flooding occurs during the winter months.

Reach 8 is Functional-at-Risk with no apparent trend due to the excessive trampling and grazing in the upper section and the past ditching in the lower section. Improvements can be made by planting native vegetation, such as red osier dogwood (*Cornus stolonifera*), and willows (*Salix spp.*) to shade out the reed canary grass (*Phalaris arundinacea*). A second phase of planting with trees and riparian shrubs will restore some of the wetlands natural vegetation. Placing a weir in the ditch-like channel will allow for continued downstream flow as well as re-establishing the hydrology of the landscape. A grazing management plan coupled with exclusionary fencing should be implemented to allow for wetland and vegetation recruitment and succession in the paddock areas.

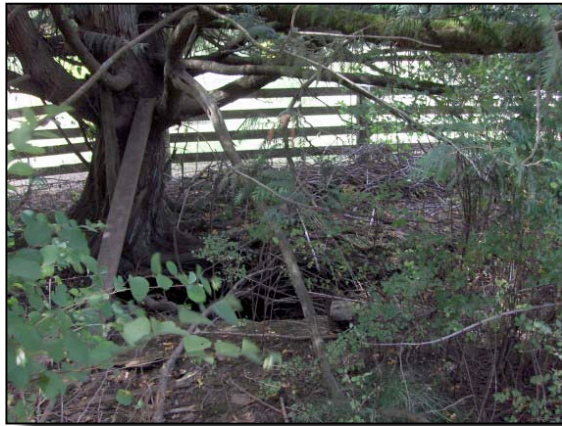
Reach 9 Viaduct Creek: The confluence of Viaduct Creek and Excelsior Creek to Viaduct Avenue West road crossing

Reach 9 is approximately 132 m long and extends from the confluence of Viaduct Creek and Excelsior Creek (at 414 Viaduct Avenue West), along the property line between 414 and 402 Viaduct Avenue West, to the Viaduct Avenue West crossing. This channel is bare, undercut, heavily eroded, and ditch-like. Additionally, the incised characteristics of the channel prevent the creek from accessing its floodplain. The Rosgen channel type is a “G6” with a slope between 2-4%.

Reach 9 is Non-functional due to its heavily eroding and undercutting banks indicative of a system unable to manage and attenuate peak flows. Vegetation has also become scarce along the banks due to a drop in the water table caused by the dredging of the channel.

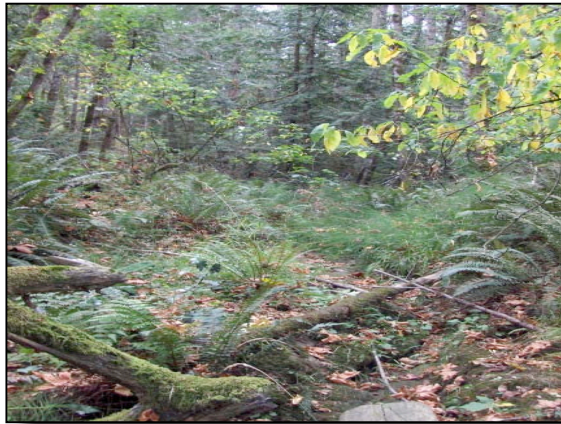
Reach 10 Viaduct Creek: Viaduct Avenue West crossing to the headcut upstream of 389 Viaduct Avenue West

Reach 10 is approximately 17m long. It extends from Viaduct Avenue West road crossing, through residential property to a headcut upstream of 389 Viaduct Avenue West. The stream bank conditions of this reach are densely vegetated with some erosion occurring on the outside bends. It contains highly variable substrate beginning with bedrock in the first portion of the reach, through sections of cobble and boulder, then to a silt substrate closer to the upstream end of the reach. There are sections of accessible and utilized floodplain throughout that are sufficient for the channel type. The slope is

steep and in a small section downstream of 389 Viaduct Avenue West there is evidence of slight downcutting. Deer tracks were noted adjacent, and within, the channel along with the presence of large wood. At the end of the reach, **a headcut was observed** of approximately 60 cm depth. Reach 10 is a Rosgen “B1-6” type channel.

Reach 10 is functioning well and is in Proper Functioning Condition.

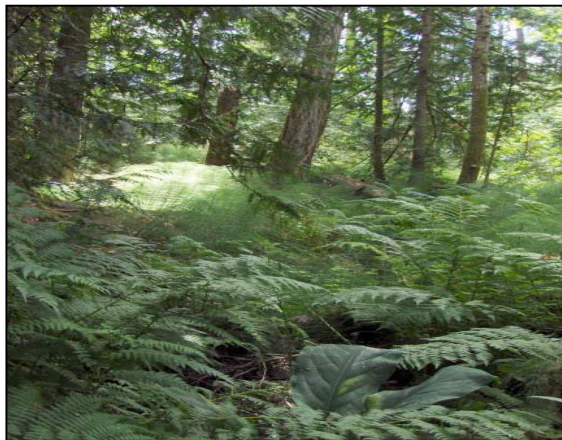
Reach 11 Viaduct Creek: The headcut upstream of 389 Viaduct Avenue West to the bedrock outcrop downstream of 365 Viaduct Avenue West

Reach 11 is approximately 68 m long. It extends from the headcut upstream of 389 Viaduct Avenue West through a forested area to where the tree canopy opens up at the bedrock outcrop downstream of 365 Viaduct Avenue West. The channel continues upstream above the headcut with a gentler slope than Reach 10 downstream. A large, moist, seepage area is located on the right bank indicating good floodplain availability and utilization for this reach. The stream banks are thickly vegetated and no erosion was noted except for the headcut area. The Rosgen channel type is a “Bc6” as it shows some “C”

Reach 11 is in Proper Functioning Condition due to its accessible floodplain, generally stable channel, and vigorous native vegetation.

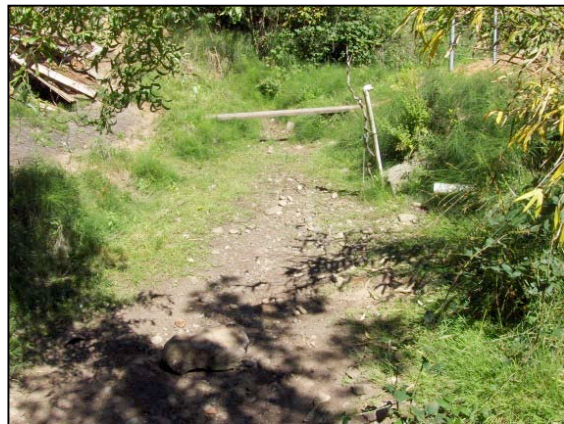
Reach 12 Viaduct Creek: The bedrock outcrop downstream of 365 Viaduct Avenue West to the driveway of 353 Viaduct Avenue West

Reach 12 is approximately 105m long. It extends from the bedrock outcrop where the tree canopy opens up downstream of 365 Viaduct Avenue West, to the driveway of 353 Viaduct Avenue West. This reach runs through the front yard of 365 Viaduct Avenue West alongside a horse paddock (on the right bank) and underneath the driveway via a culvert (approximately 600 mm diameter). At the time of assessment, no water was present in the channel and chickens were roaming the dry creek bed. The chickens and a nearby horse enclosure are close enough to the channel for excrement to enter the water during

high flow potentially affecting water quality downstream.

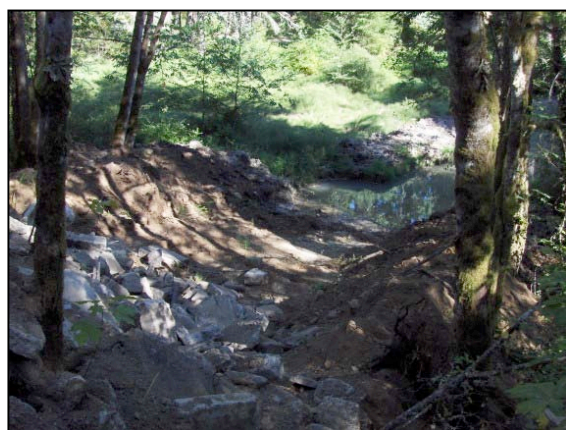
Reach 13 Viaduct Creek: The driveway of 353 Viaduct Avenue West to the property boundary between 335 Viaduct Avenue West and Logan Park

Reach 13 is a wetland approximately 0.23 hectares in size. It extends from the upstream end of the 353 Viaduct Avenue West driveway through 335 Viaduct Avenue West to the property break at Logan Park. This reach has lentic characteristics and is found in a large open area fringed by conifers. **In the spring of 2007, an attempt was made to cross the creek in order to build a driveway. As a result, a large section has been dug-out and concrete and other debris has been piled up against the edge of Viaduct Avenue West protruding into the wetland area.** The riparian-wetland area has

been narrowed up as a result of this degradation and berms have been created along the sides of the excavated area. These berms may be impeding flow downstream or changing the surface drainage pattern. Furthermore, there is uncertainty surrounding changes to the route of passage of overland flows because of this recent degradation. Any work in and around the creek should have proceeded only with a Section 9 of the Water Act permit which requires that proper plans be submitted to the Ministry of Environment for approval.

Reach 13 is Functional-at-Risk with a downward trend due to the extensive degradation that has occurred from the attempted driveway construction. As the destruction is so recent, it is difficult to determine what the long-term effects will be on this system in terms of remaining in balance with water and sediment supplies. In the meantime, there are improvements that can be made. In

the short term, immediate mitigation for erosion and sediment control should be implemented in order to prevent excess sediment from being transported downstream to the lower reaches. *The junk fill must be removed.* Over the long term, the area can be restored by replanting native riparian vegetation along the cut. Backfilling the excavated area with the currently bermed-up soil and replanting with riparian species would also aid in restoring the area to a more stable condition.

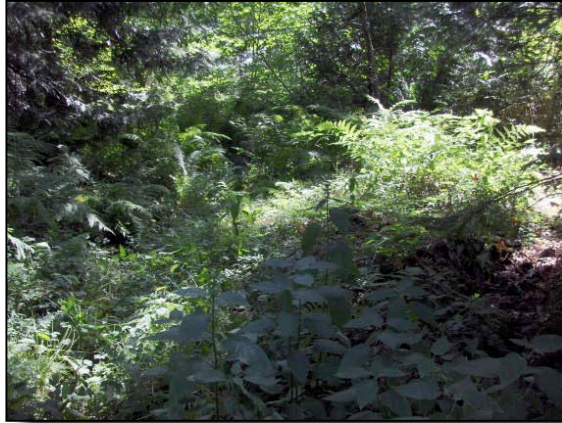
Reach 14 Viaduct Creek: The edge of the wetland to upstream of the pond near 235 Hector Road where the channel disappears at the headwaters

Reach 14 is approximately 172 m long and extends from the end of the wetland furthest from Viaduct Avenue West, through Logan Park, to the headwaters upstream of the pond near 235 Hector Road. There are multiple small, narrow channels that seem to have been initially formed by an old road whose ruts collected surface flow. The channels themselves are Rosgen type “E6” although they lack sinuosity due to their origins as wheel ruts. Floodplain is available, although it may not be accessed due to the low flows expected in a headwater. The reach is well vegetated on the banks although the

channels are bare and incised in places. Near the end of this reach, a small pond with **bullfrogs** and a grounded old rowboat were noted.

Reach 14 has not reached its potential of a wetland system with no existing channel that accommodates overland and subsurface flow. However, the vegetation is filling in and the reach will likely evolve out of its channelized state over time. This reach is Functional-at-Risk with an upward trend as it is in the process of restoring itself. In order to increase the recovery time of this system, large wood could be added to the area forcing the flows in the channel to dissipate over the entire area.

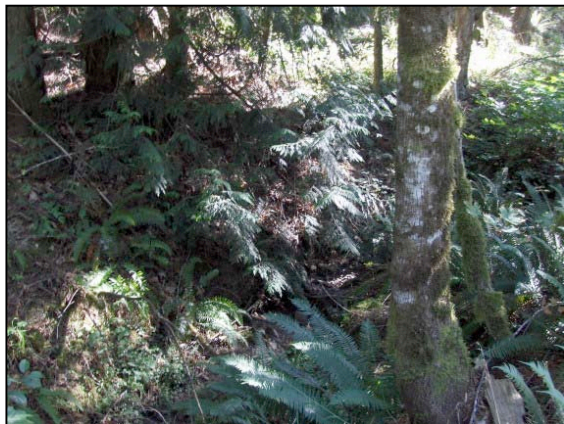
Reach 15 Viaduct Creek: The upstream boundary of 335 Viaduct Avenue West to the culvert under the trail at Logan Park

Reach 15 is approximately 135m long and extends from the upstream edge of the wetland alongside Viaduct Avenue West, to the culvert in Logan Park that passes underneath the park trail. The channel is narrow and the banks of this reach are steep. On the left bank, Viaduct Avenue West constrains the channel and the construction of this road may have played a part in creating the Rosgen channel type “G3”. The right bank is also constrained by bedrock outcrops and the channel is incised. Despite this, the upper section consists of available floodplain, although its presence decreases

proportionately downstream as the channel opens up into a wetland. Upstream, the culvert beneath the trail acts as a dam attenuating flows and is beneficial for the functioning of Reach 15.

Reach 15 is in Proper Functioning Condition as the reach represents a stable functioning system with appropriate vegetation and no notable degradation.

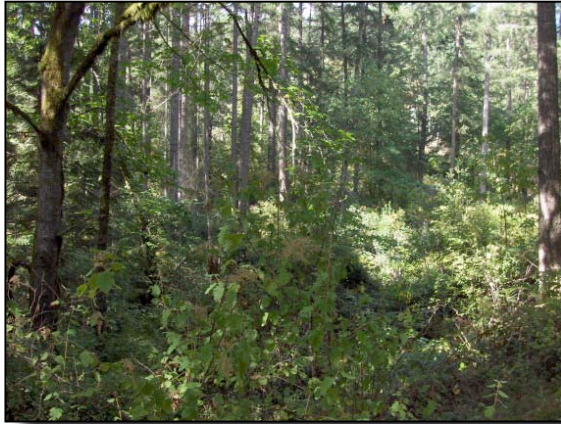
Reach 16 Viaduct Creek: The culvert under the trail in Logan Park upstream to the end of Logan Park

Reach 16 is a wetland approximately 0.44 ha in size. It extends from the culvert beneath the pedestrian trail in Logan Park, upstream to where the wetland area ends in the headwaters. Directly upstream of the trail exists an open and moist, wetland area. This wetland area is in very good shape and is protected within the boundaries of Logan Park.

Reach 16 is in Proper Functioning Condition, as the vegetation is diverse and vigorous. The wetland is functioning as it should, and there are no restoration requirements within this reach.
