Colquitz River Watershed

Proper Functioning Condition Assessment

Appendices

July 2009

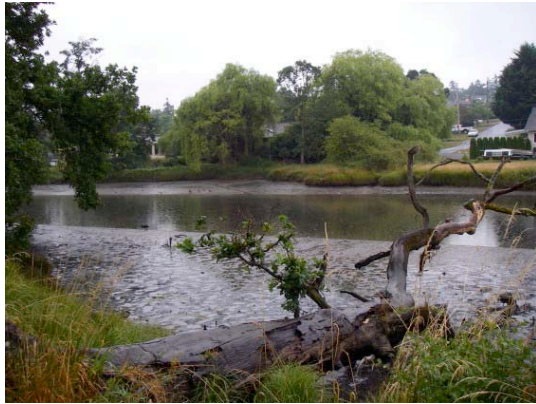
Colquitz River Reach 1, Photo 1, 2007-07-17. Facing upstream from Portage Inlet. The left hand bank consists mostly of residential lawns and little vegetation capable of handling high flows.

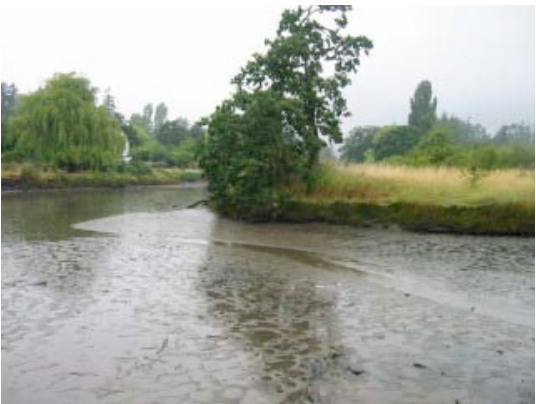
Colquitz River Reach 1, Photo 3, 2007-07-17. Small tributary entering Colquitz Creek. Area is subject to tidal fluctuations.

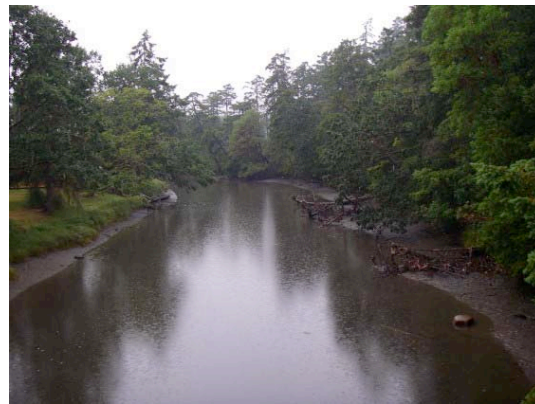
Colquitz River Reach 1, Photo 4, 2007-07-17. Facing upstream. Reach is highly vegetated on both sides.

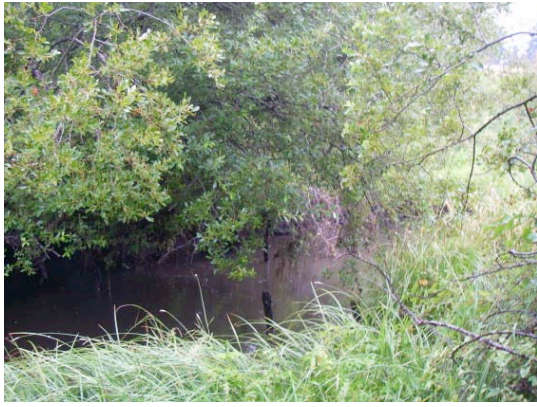
Colquitz River Reach 2, Photo 1, 2007-07-17.
Upstream of the second footbridge in Cuthbert Holmes Park. Although there are large amounts of vegetation along this reach, the streambanks are eroding due to high seasonal flows.

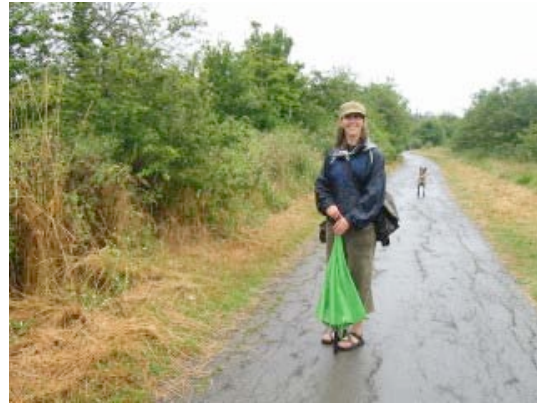
Colquitz River Reach 2, Photo 2, 2007-07-17.
The trail is a considerable distance from the creek, thus very little vegetation trampling occurs, other than areas the municipality mows.

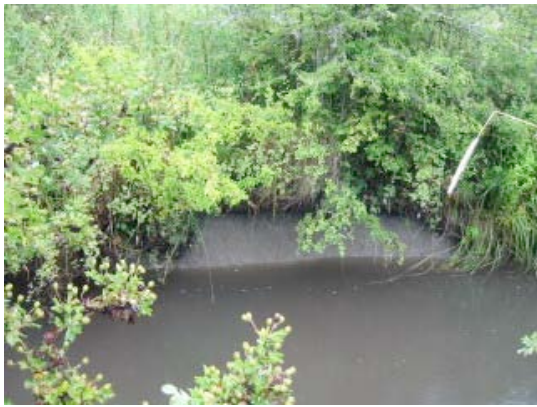
Colquitz River Reach 2, Photo 3, 2007-07-17.
As seen above, large amount of streambank erosion has occurred within this reach.

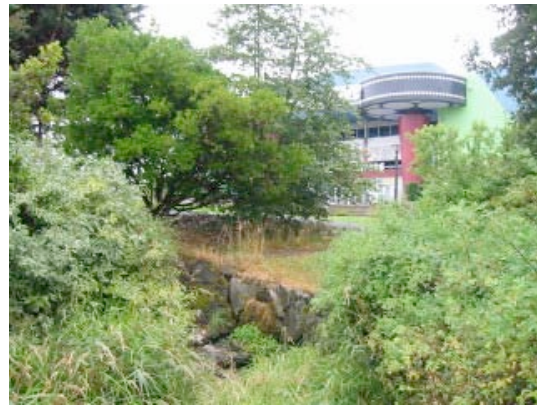
Colquitz River Reach 2, Photo 4, 2007-07-17.
Stormwater treatment pond in foreground. Cineplex Odeon in the background.

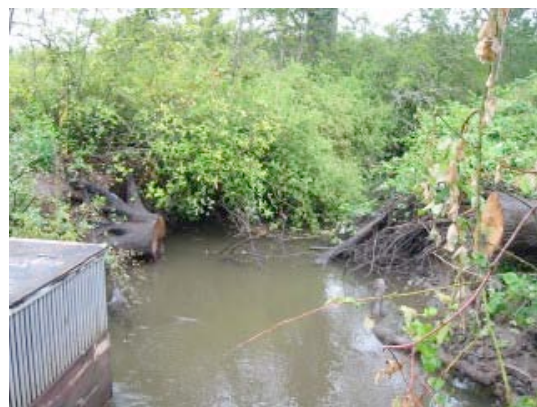
Colquitz River Reach 2, Photo 6, 2007-07-17. A fish fence and staff gauge has been installed in this reach. Recent storms have felled trees allowing for large woody debris to enter the channels.

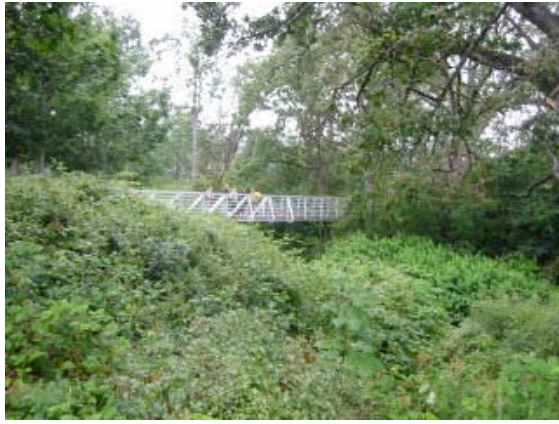
Colquitz River Reach 2, Photo 7, 2007-07-17.
Looking downstream towards the recently installed pedestrian bridge adjacent to the Tillicum Mall area. Large amounts of vegetation has grown over the channel.

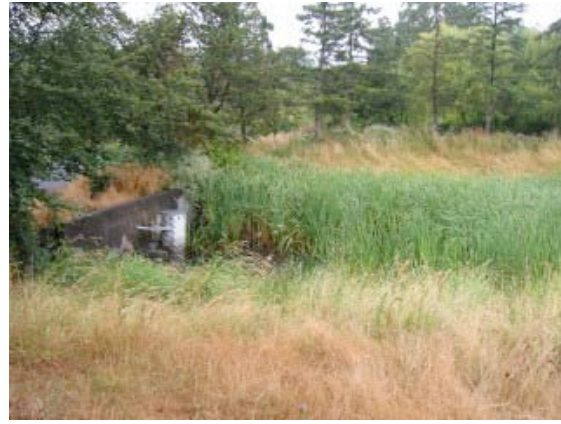
Colquitz River Reach 2, Photo 8, 2007-07-17.
Stormwater from Tillicum Mall parking lot enters into the stormwater wetland seen above and then drains into Colquitz Creek.

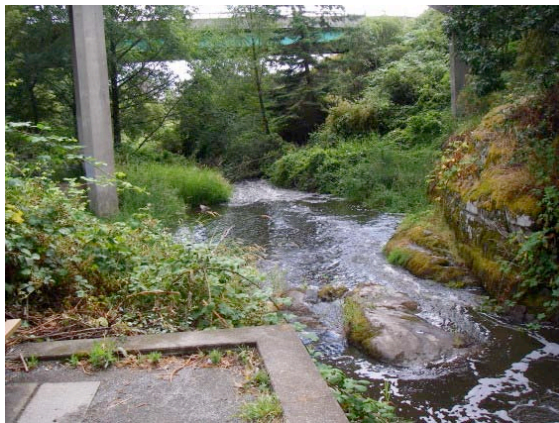
Colquitz River Reach 3, Photo 1, 2007-07-17.
Facing downstream, below the Trans Canada Highway bridge. Channel banks consist largely of bedrock (as seen in the photo).

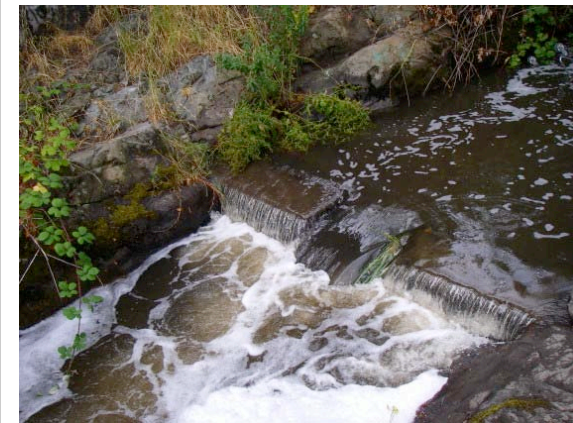
Colquitz River Reach 3, Photo 2, 2007-07-17.
Concrete weir installed to control water flow in the reach.

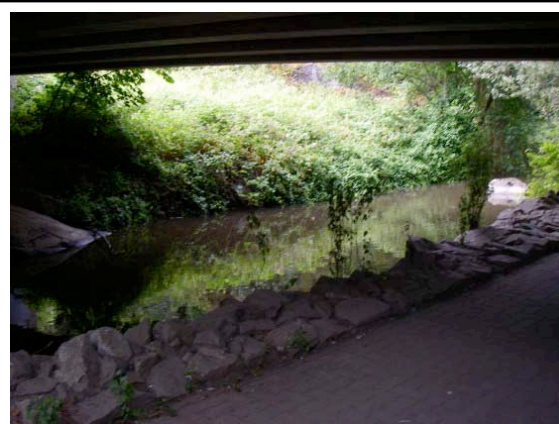
Colquitz River Reach 3, Photo 3, 2007-07-18.
Facing upstream. Channel underneath bridge has been completely armoured with rock and concrete.

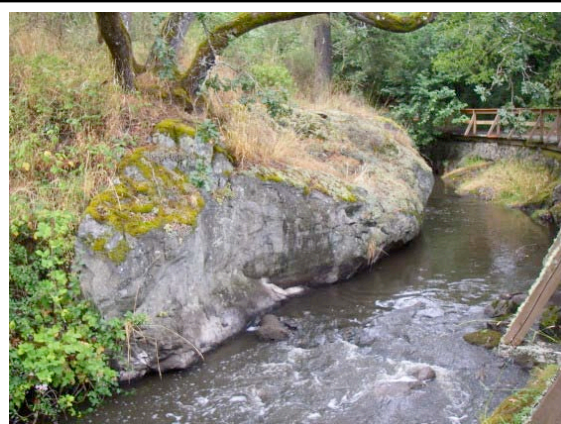
Colquitz River Reach 3, Photo 4, 2007-07-18.
Facing upstream, large amounts of natural bedrock on the left and a pedestrian walkway on the right.

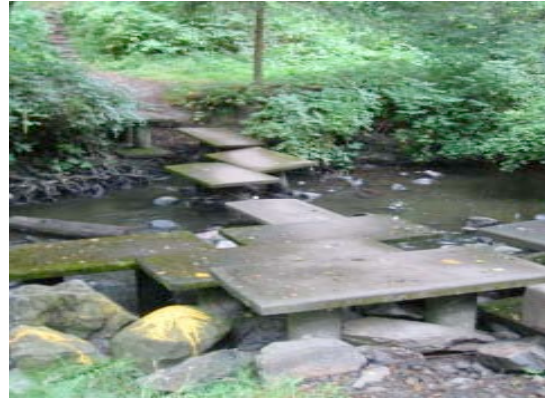
Colquitz River Reach 4, Photo 1, 2007-07-18.
Concrete steeping stones have been previously
installed to allow trail users to cross the creek.

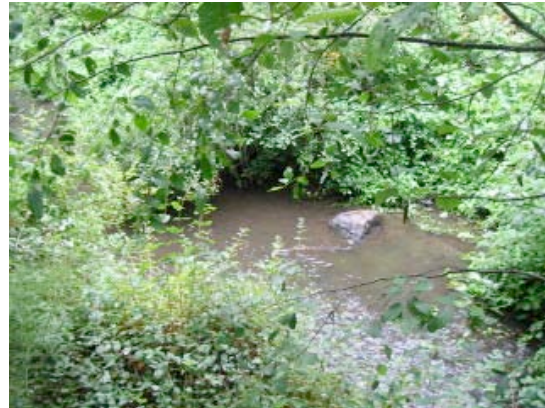
Colquitz River Reach 4, Photo 3, 2007-07-18.
Looking downstream. Although the reach is
heavily vegetated, its composition mainly consists
of invasive species.

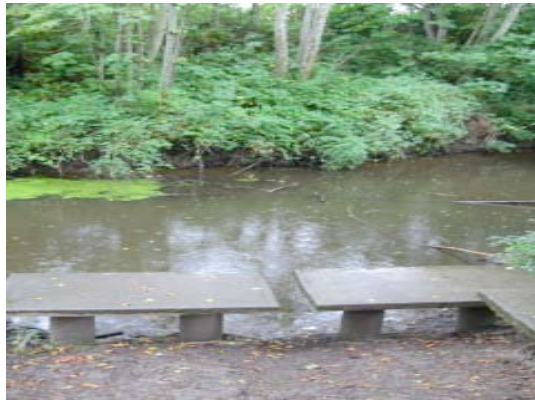
Colquitz River Reach 5, Photo 2, 2007-07-18.
Installation of raised concrete path has led to trampling and erosion of the streambank.

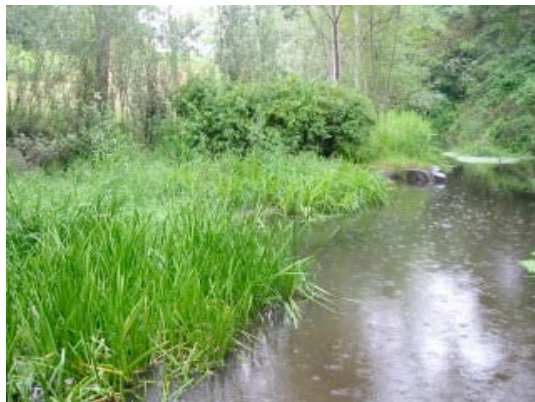
Colquitz River Reach 5, Photo 4, 2007-07-18.
Continued encroachment of vegetation within channel may lead to low DO levels and change the hydrology of the reach.

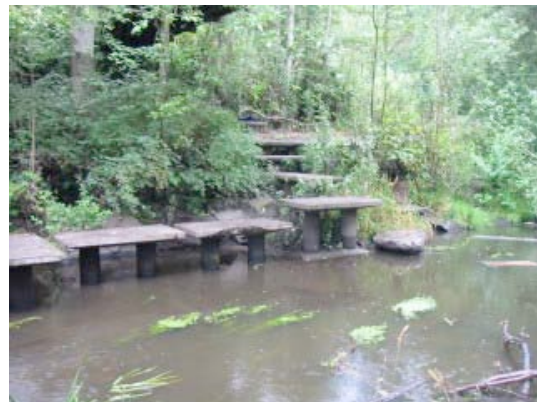
Colquitz River Reach 5, Photo 5, 2007-07-18.
The area may have been dug out to install the raised paths. This portion of the reach appears to be forming into a pond or pool.

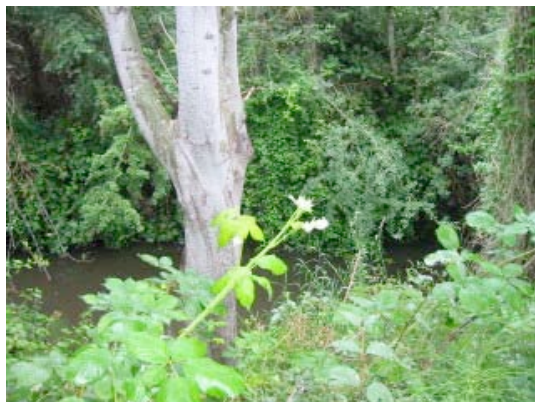
Colquitz River Reach 6, Photo 2, 2007-07-18.
Reach is heavily inundated with invasive species such as English Ivy (background) and Himalayan Blackberries (foreground).

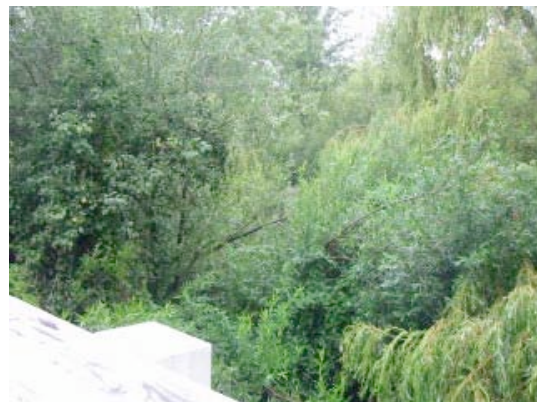
Colquitz River Reach 6, Photo 3, 2007-07-18.
Facing downstream on Interurban Road bridge crossing.

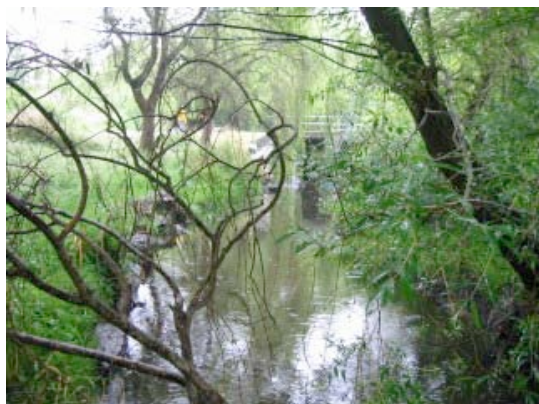
Colquitz River Reach 7, Photo 1, 2007-07-18.
Facing upstream towards the Violet Ave bridge.
Floodplain present on the right hand side.

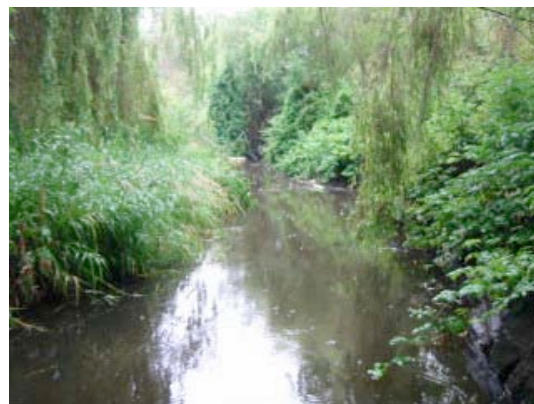
Colquitz River Reach 7, Photo 2, 2007-07-18.
Facing upstream. Noted large amount of invasive
species present.

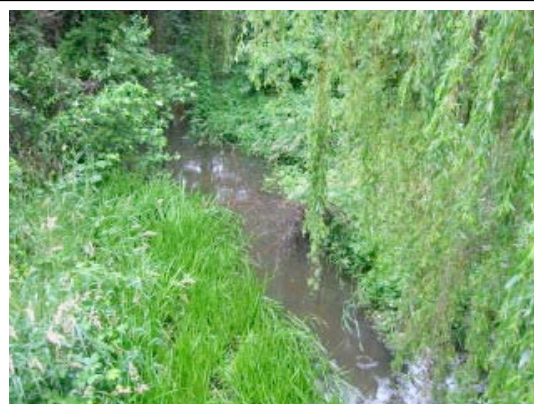
Colquitz River Reach 7, Photo 4, 2007-07-18.
Vegetation is encroaching on channel.

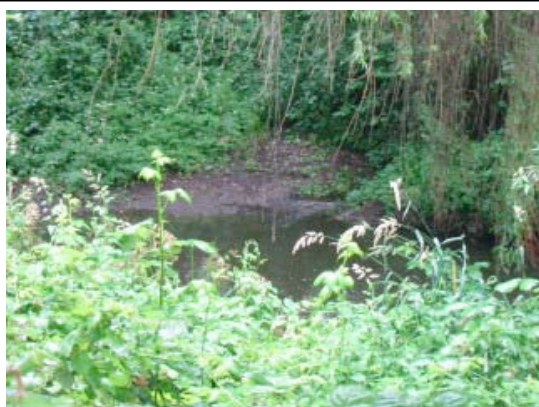
Colquitz River Reach 7, Photo 5, 2007-07-18.
Hyacinth Park. Channel forms into a ditch. As
seen above streambank erosion is occurring.

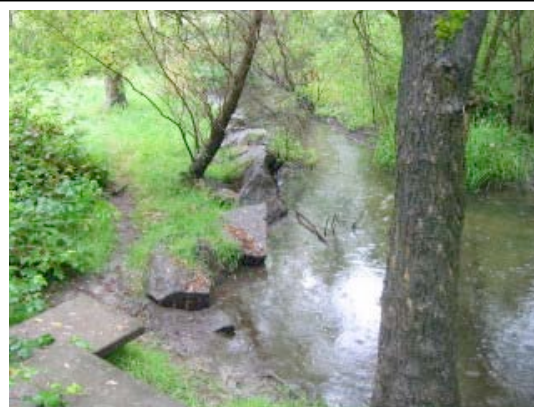
Colquitz River Reach 7, Photo 6, 2007-07-18.
Off path trampling is leading to streambank
erosion. Left side of the bank is armoured with
large rocks.

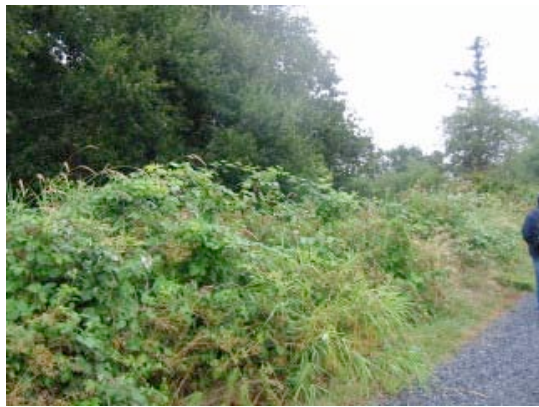
Colquitz River Reach 8, Photo 1, 2007-07-18.
Channel is on the West side of Panama Flats.
Area is over-grown with Himalayan Blackberries
and is difficult to access.

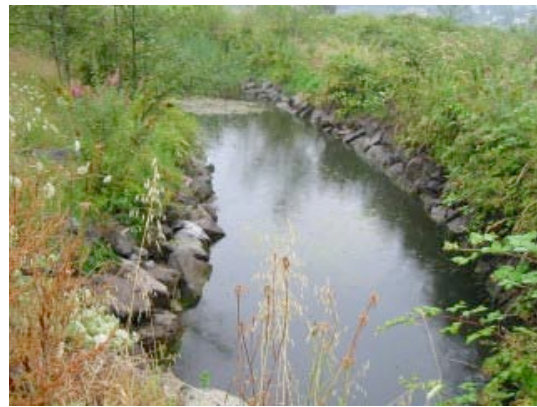
Colquitz River Reach 8, Photo 2, 2007-07-18.
Armoured channel connected to the isolated
stormwater pond (Photo's 3&4). This system is
not believed to be connected to the Colquitz.

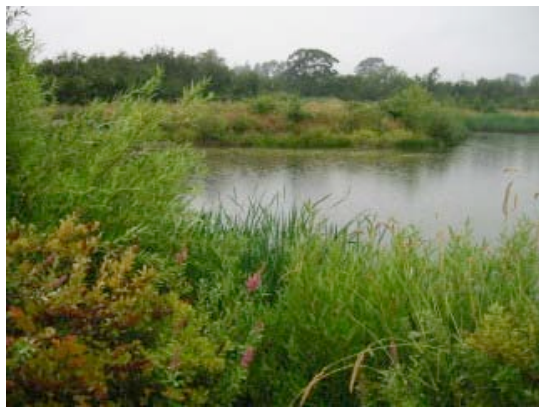
Colquitz River Reach 8, Photo 3, 2007-07-18.
Isolated stormwater pond.

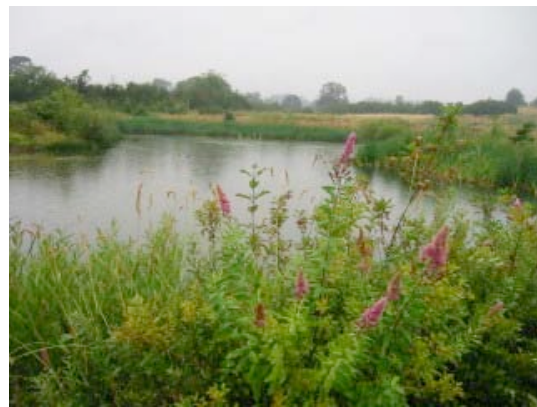
Colquitz River Reach 8, Photo 4, 2007-07-18.
Isolated stormwater pond.

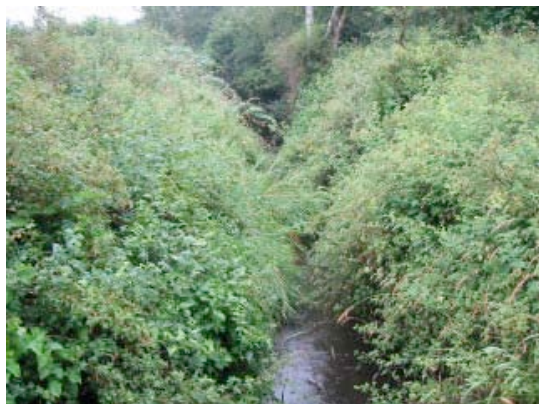
Colquitz River Reach 8, Photo 5, 2007-07-18. As
seen above the channel is a ditch and is inundated
with invasive species.

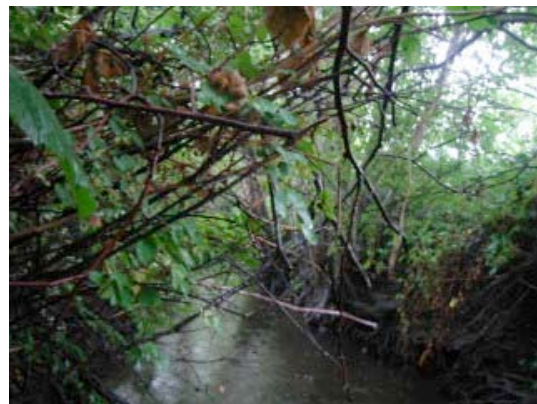
Colquitz River Reach 8, Photo 6, 2007-07-18.
Channel is a dug out ditch with gully
characteristics. Facing downstream.

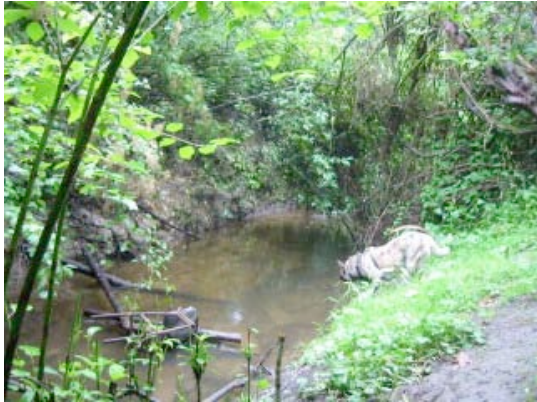
Colquitz River Reach 9, Photo 1, 2007-07-23.
Streambank is eroding and downcutting.

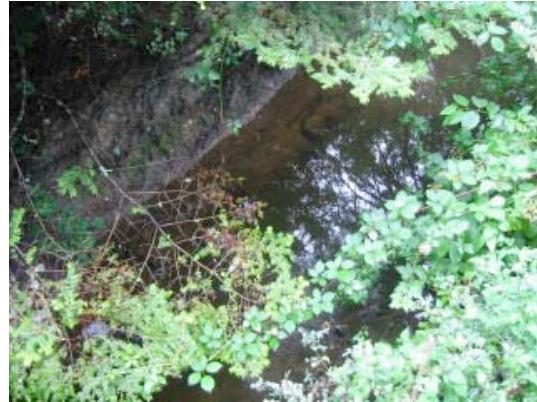
Colquitz River Reach 9, Photo 2, 2007-07-23.
Creek is entrenched and is eroding.

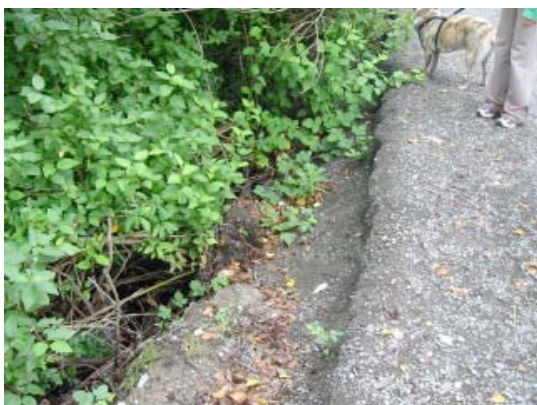
Colquitz River Reach 9, Photo 5, 2007-07-23.
Gravel bridge at Copley Park entrance. Roadside debris and bank erosion is entering creek.

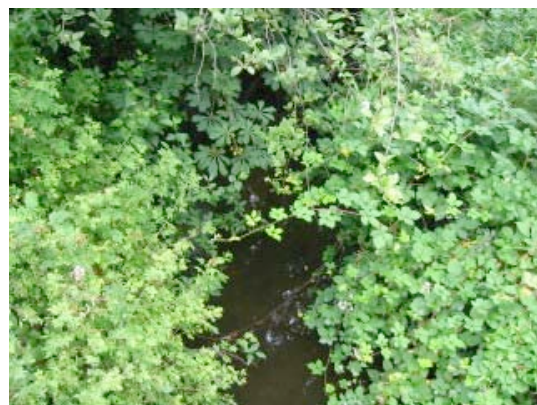
Colquitz River Reach 9, Photo 6, 2007-07-23.
Facing downstream at the gravel bridge. Area is heavily vegetated with invasive species.

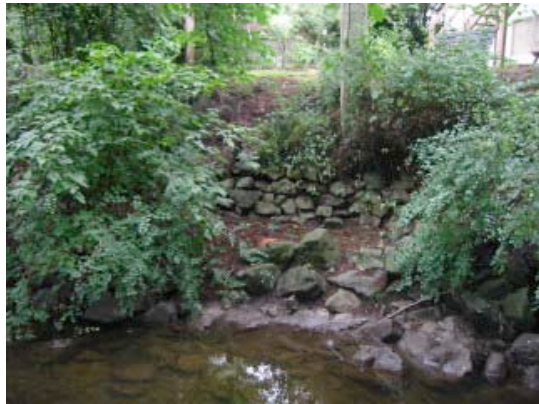
Colquitz River Reach 9, Photo 7, 2007-07-23.
Copley Park residence. Trampling from residence has led to decreased vegetation and erosion. Banks have been armoured with rock.

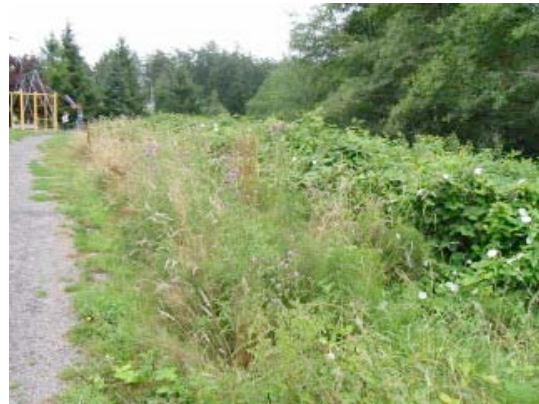
Colquitz River Reach 9, Photo 8, 2007-07-23.
Copley Park. As seen at the right side of the photo, the streambank is inundated with invasive species.

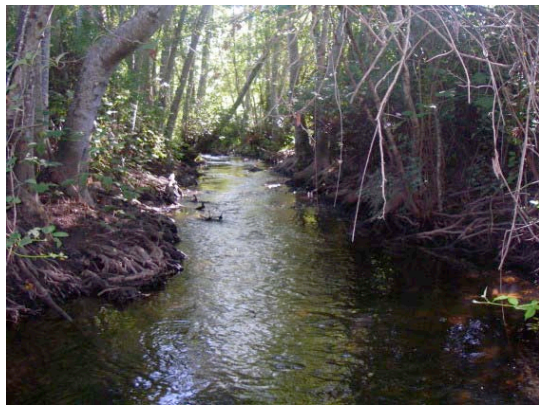
Colquitz Creek Reach 9, Photo 9, 2007-07-25.
Copley Park, facing upstream. Right bank is over-steepened. The left bank allows for some floodplain access and dissipation of energy.

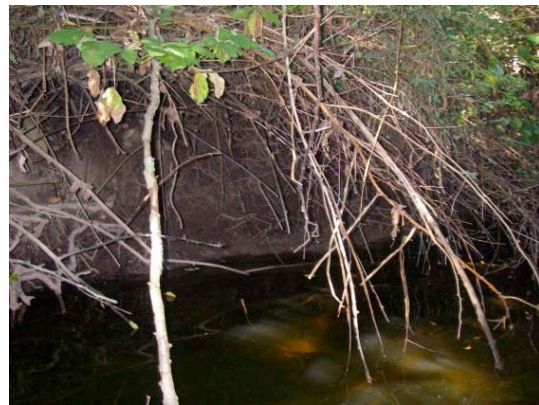
Colquitz Creek Reach 9, Photo 10, 2007-07-25.
Copley Park. The bank is over-steepened and eroded.

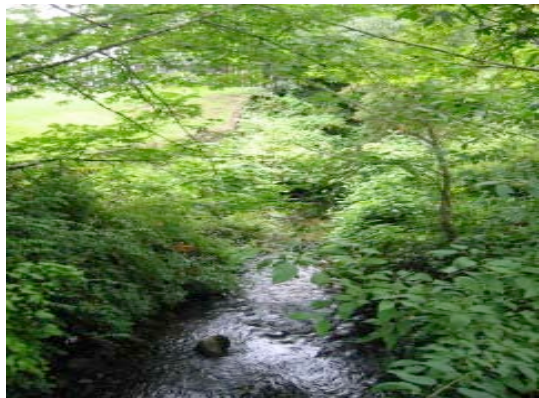
Colquitz River Reach 9, Photo 11, 2007-07-23.
Facing upstream at the Rosee Grove pedestrian bridge.

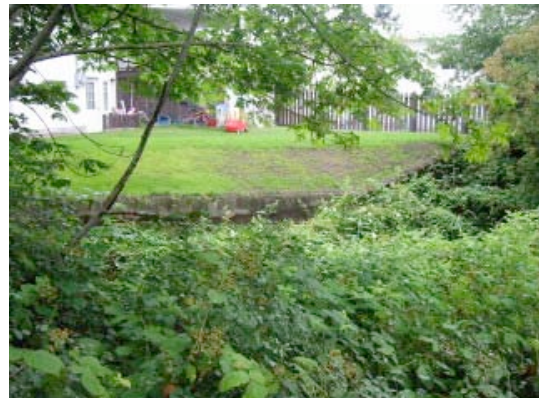
Colquitz River Reach 9, Photo 12, 2007-07-23.
Rosee Grove. Standing downstream from the pedestrian bridge. Seen above, trampling in the residential backyard is accelerating erosion.

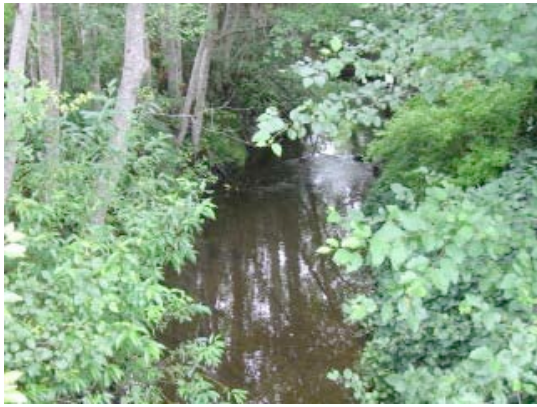
Colquitz River Reach 9, Photo 13, 2007-07-23.
Facing downstream from the Vanalman Avenue bridge.

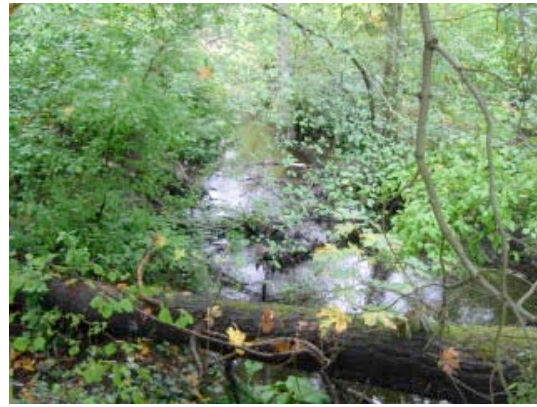
Colquitz River Reach 10a, Photo 1, 2007-07-23.
Rosee Grove facing upstream. Note large wood.

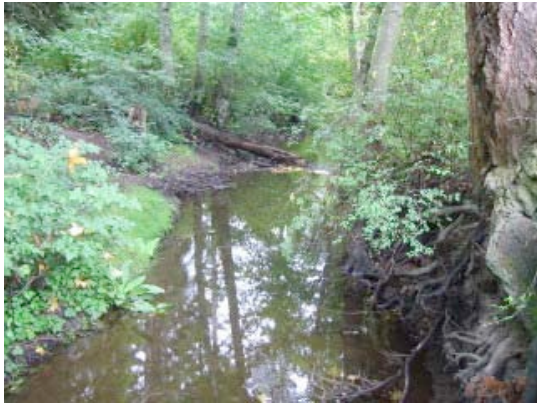
Colquitz River Reach 10a, Photo 2, 2007-07-23.
High flows have severely eroded the right bank. The left bank has had some floodplain access to dissipate energy.

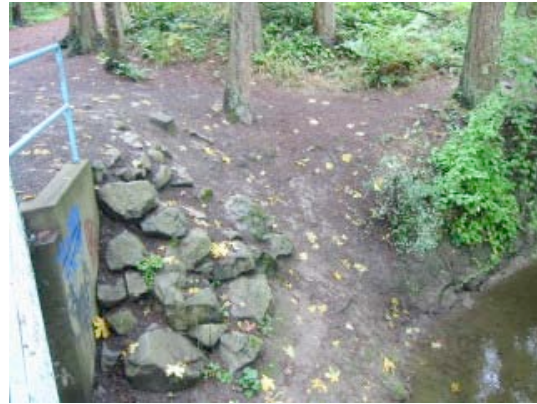
Colquitz River Reach 10a, Photo 3, 2007-07-23.
Trampling has aggravated the erosion occurring from high seasonal flows.

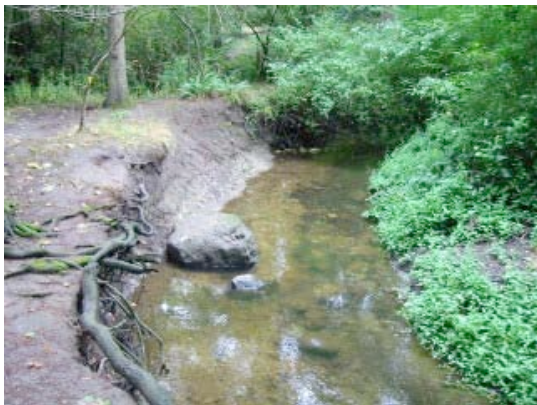
Colquitz River Reach 10a, Photo 4, 2007-07-23.
Large flows have eroded and down-cut the banks, exposing the root base.

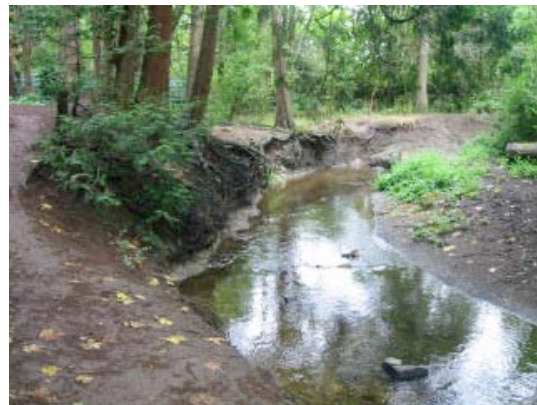
Colquitz River Reach 10a, Photo 5, 2007-07-23.
Severe erosion and trampling is occurring.

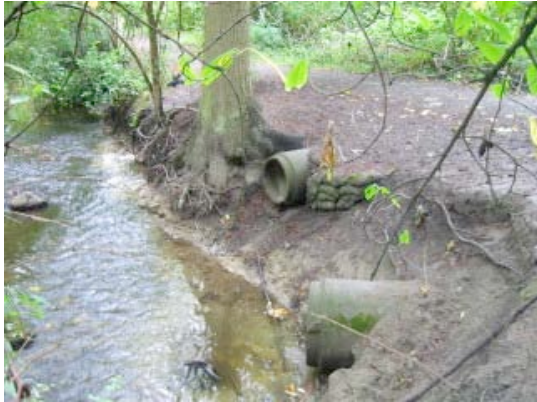
Colquitz River Reach 10a, Photo 6, 2007-07-23.
Two large culverts discharge stormwater directly into the creek thus increasing the volume of water and negatively impacting the hydrology.

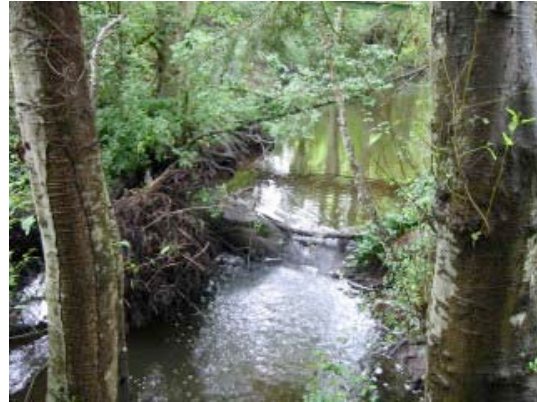
Colquitz River Reach 10a, Photo 7, 2007-07-23.
Rosee Grove, facing upstream. Tree root is acting as a weir, channeling water to the middle and aiding in controlling flows to an extent.

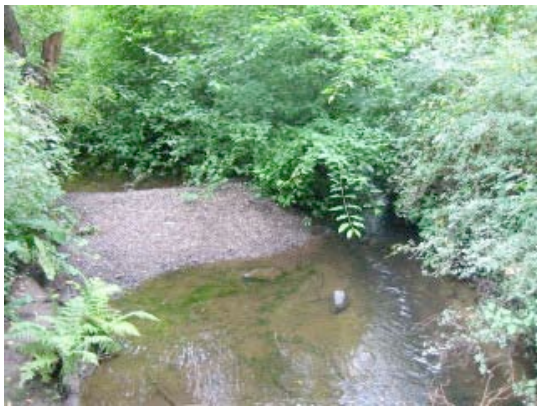
Colquitz River Reach 10a, Photo 8, 2007-07-23.
Gravel material likely placed in creek after building pedestrian bridge. The deposit is not revegetating.

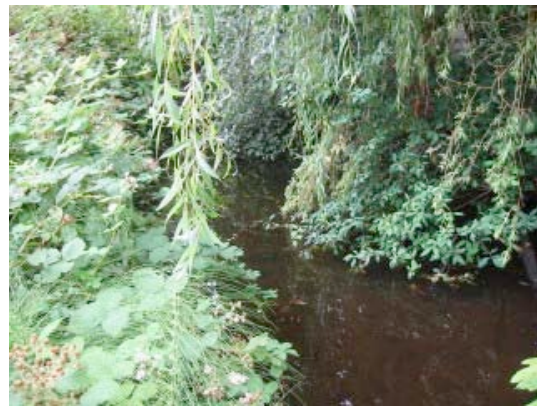
Colquitz River Reach 10a, Photo 9, 2007-07-23.
Facing downstream. Dense vegetation has buffered the banks against high flows and erosion.

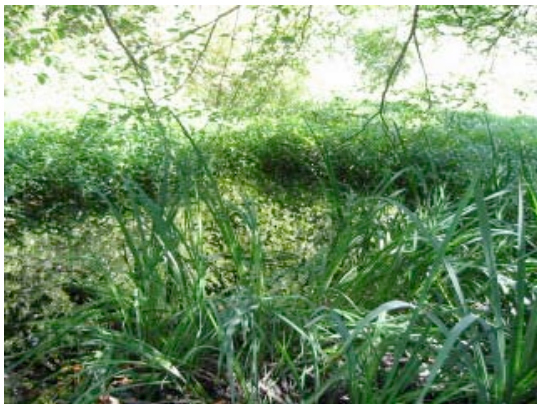
Colquitz River Reach 10b, Photo 1, 2007-07-23.
A small vegetated wetland, adjacent to creek.

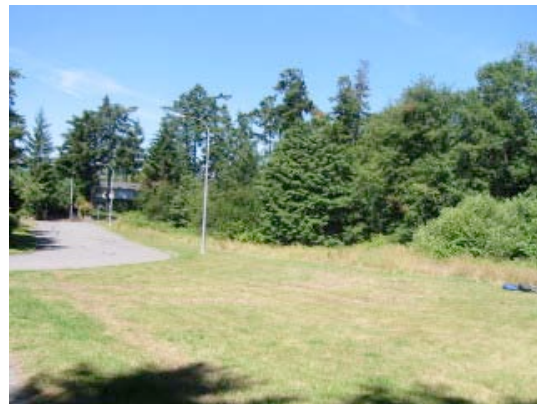
Colquitz River Reach 10b, Photo 2, 2007-07-23.
Wetland is located to the right (Vanalman Avenue and Northridge Crescent).

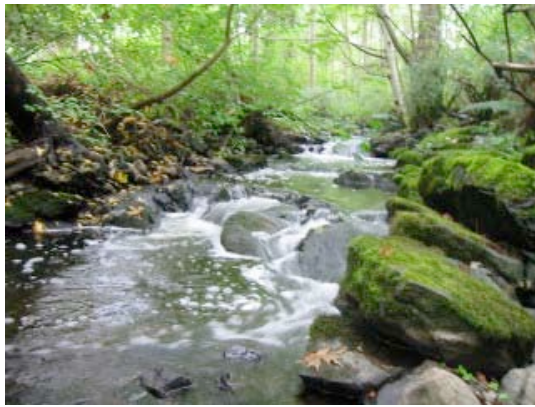
Colquitz River Reach 11, Photo 1, 2007-07-23.
Facing upstream, creek is lined with large rocks able to dissipate energy and reduce erosion that occurs with high flows.

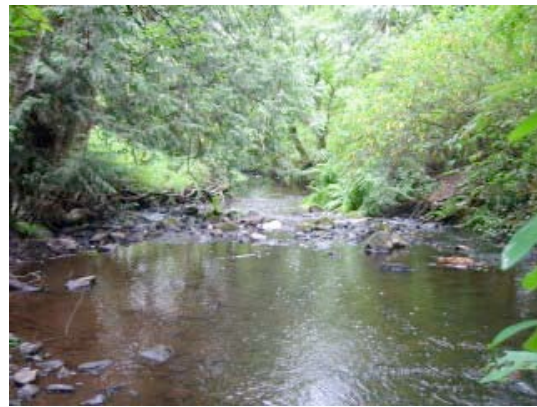
Colquitz River Reach 11, Photo 2, 2007-07-23.
Facing downstream. The hydrology of the creek is altered (hence the reach break) at this point due to the change in substrate.

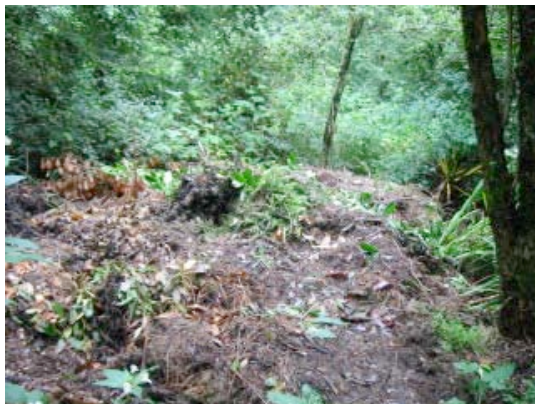
Colquitz River Reach 11, Photo 3, 2007-07-23.
Adjacent to Lindsay Road, residences have been dumping yard waste.

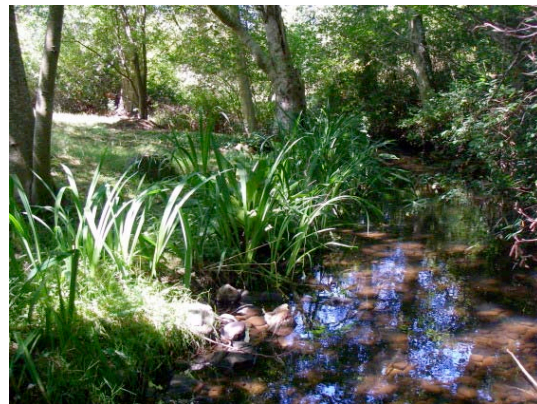
Colquitz River Reach 11, Photo 5, 2007-07-25.
Residential backyard maintenance (i.e. mowing, non-riparian species) is encroaching on the riparian plant growth.

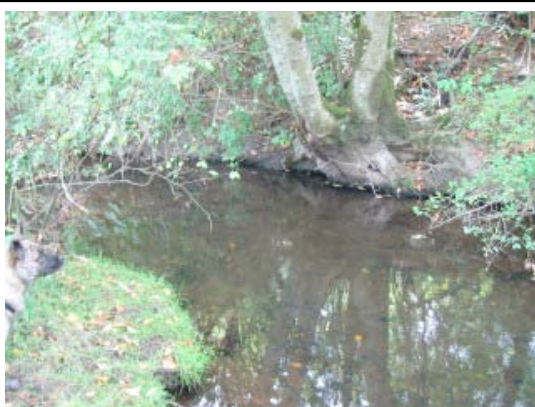
Colquitz River Reach 12, Photo 1, 2007-09-18.
Facing downstream from 4450 Wilkinson Road. Note the presence of floodplain on the left bank.

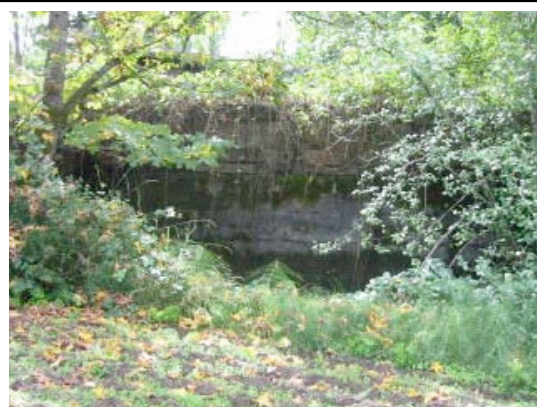
Colquitz River Reach 12, Photo 2, 2007-09-18.
Vertical concrete and wood wall constraining the creek channel.

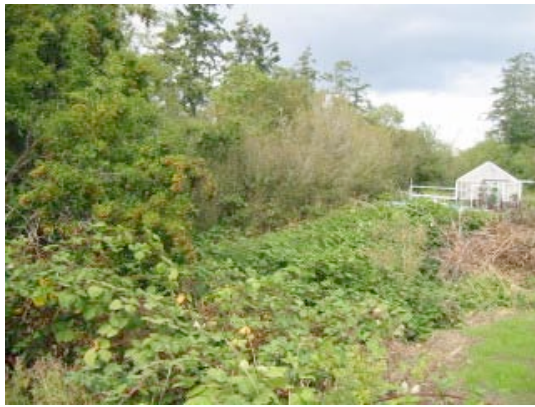
Colquitz River Reach 12, Photo 3, 2007-09-18.
Facing upstream toward Quick's Bottom.
Invasive species are abundant.

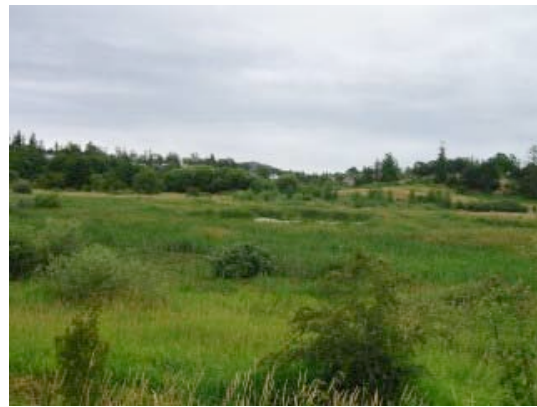
Colquitz River Reach 13, Photo 1, 2007-07-23.
Vantage point from the bird blind in Quick's
Bottom.

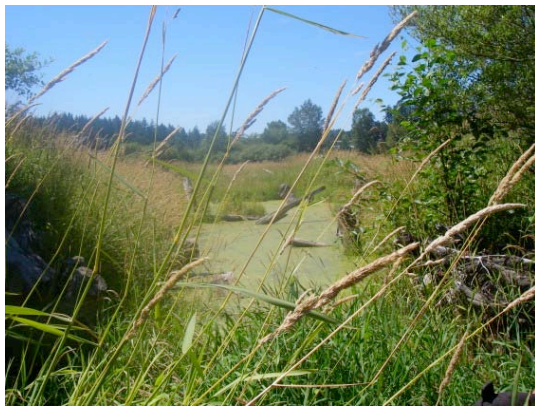
Colquitz River Reach 13, Photo 2, 2007-07-25.
Quick's Bottom wetland.

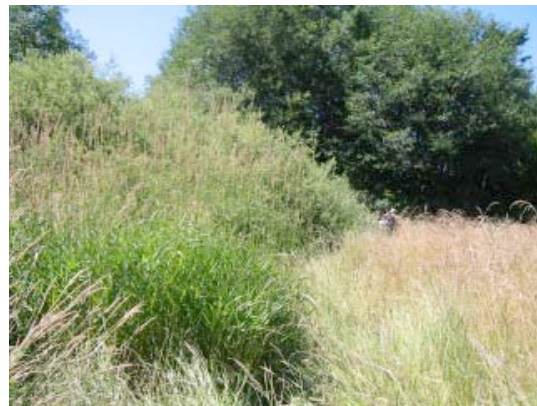
Colquitz River Reach 14, Photo 1, 2007-07-25.
Creek runs adjacent to Quick's Bottom wetland
(left side). Creek is heavily vegetated and reed
canary grass encroachment is narrowing channel.

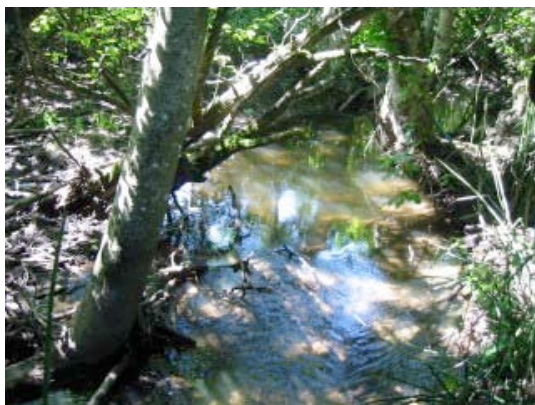
Colquitz River Reach 14, Photo 2, 2007-07-25.
Property of 4654 West Saanich Road. The creek
is heavily vegetated with large trees.

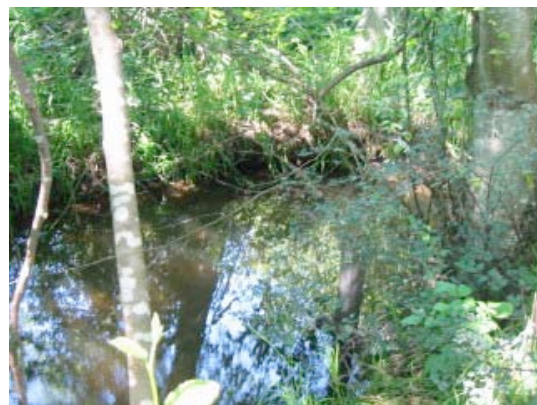
Colquitz River Reach 14, Photo 3, 2007-07-25.
Facing upstream on the property of 4654 West
Saanich Road.

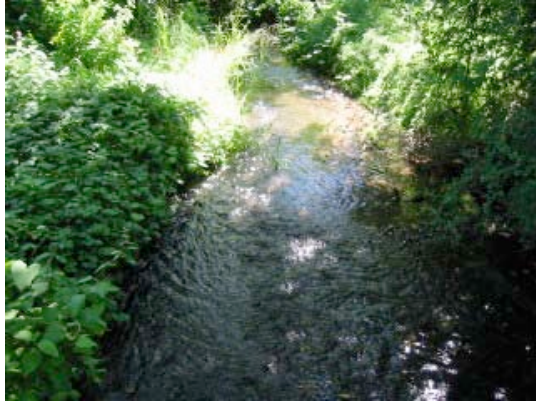
Colquitz River Reach 15, Photo 1, 2007-07-25.
Standing on pedestrian bridge facing upstream.

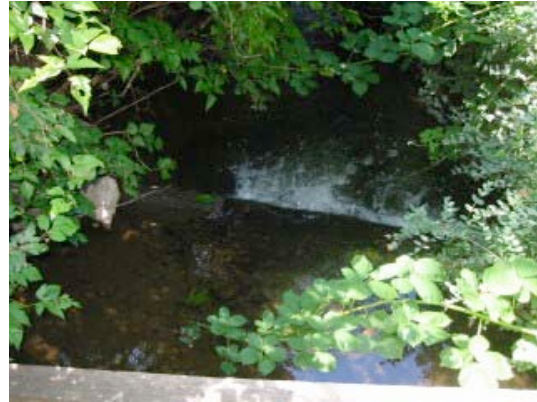
Colquitz River Reach 15, Photo 2, 2007-07-25.
Stranding on driveway of 4654 West Saanich Road facing downstream. Concrete weir is installed.

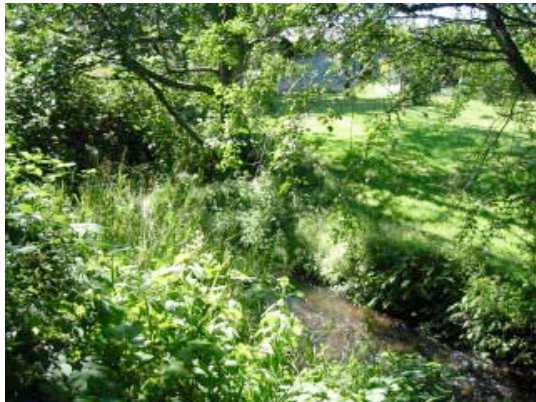
Colquitz River Reach 15, Photo 3, 2007-07-25.
Facing downstream on the property of 4624 West Saanich Road. Residential lawn and lawn maintenance has encroached upon riparian vegetation.

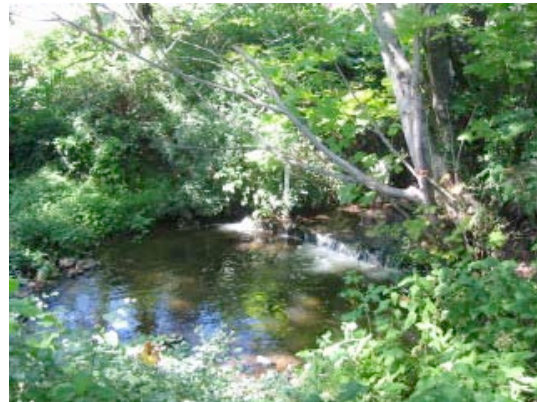
Colquitz River Reach 15, Photo 4, 2007-07-25.
Facing upstream on the property of 4634 West Saanich Road.

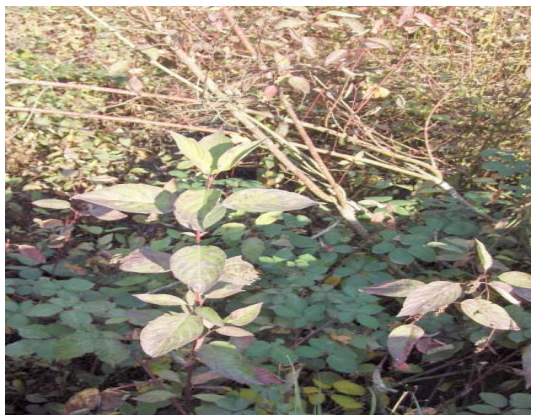
Colquitz River Reach 16, Photo 1, 2007-10-30.
Facing upstream from West Saanich Road crossing. Vegetation is abundant in the channel.

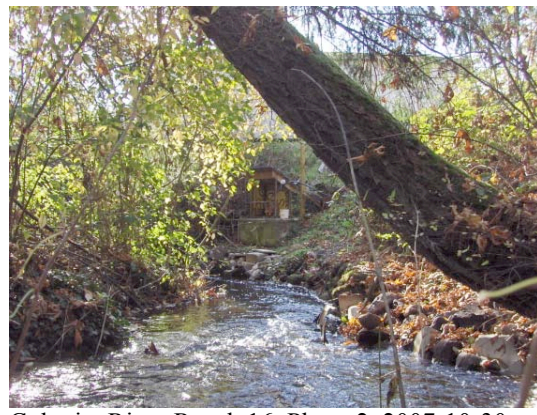
Colquitz River Reach 16, Photo 2, 2007-10-30.
Facing downstream at 4641 West Saanich Road. Note pump station in the background.

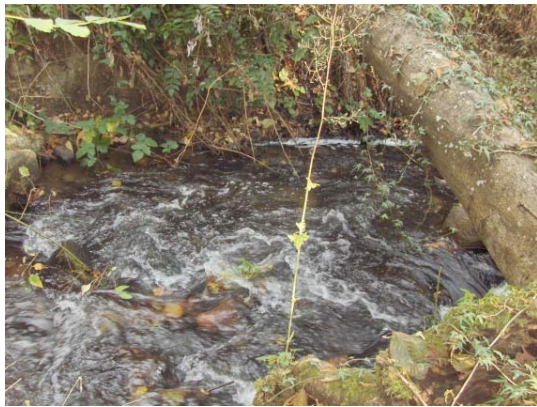
Colquitz River Reach 16, Photo 3, 2007-10-30.
Facing downstream at 4641 West Saanich Road.
Large wood still has root wad attached.

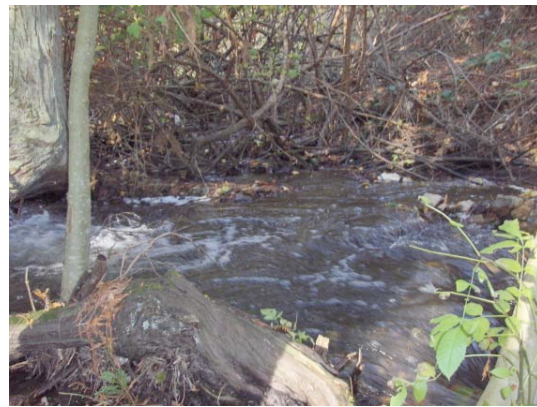
Colquitz River Reach 16, Photo 4, 2007-10-30.
Facing upstream at 4641 West Saanich Road just
below Hunt's Falls.

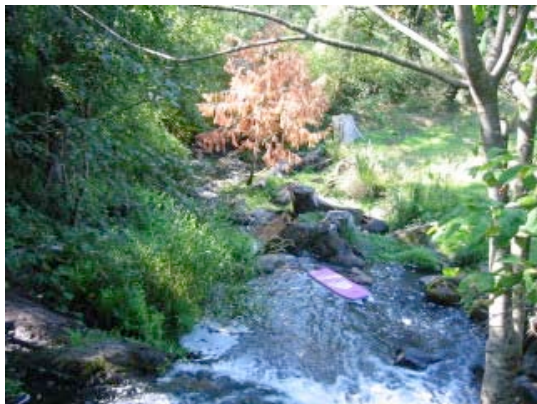
Colquitz River Reach 17, Photo 1, 2007-07-30.
Facing downstream. The channel is dominated by
bedrock and contains small cascades, waterfalls
and pools.

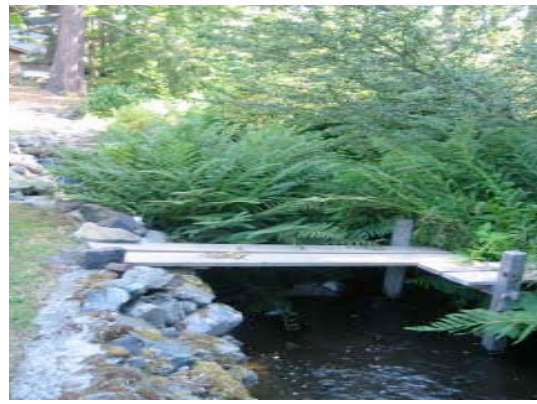
Colquitz River Reach 17, Photo 2, 2007-07-30.
Facing upstream towards pedestrian crossing.
Left bank is armoured with rip-rap and a
manicured lawn is set right to the waters edge.

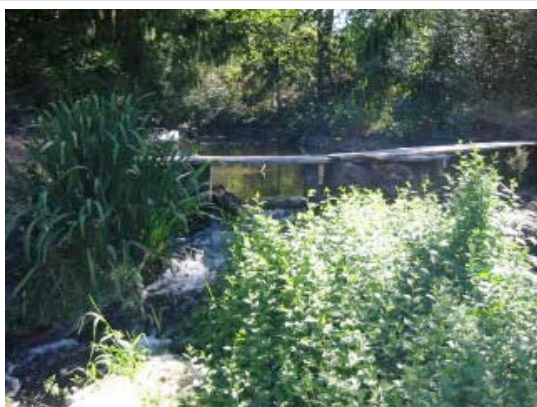
Colquitz River Reach 17, Photo 3, 2007-07-30.
Facing upstream. An old stop-log dam manages
the flows of the water.

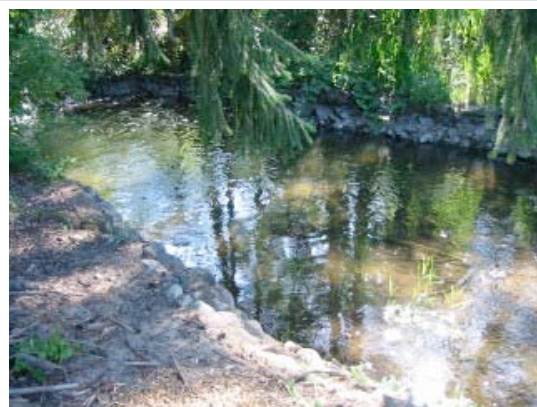
Colquitz River Reach 17, Photo 4, 2007-07-30.
Upstream of stop-log dam. Due to the dam a
small pond exists. Both sides are armoured with
rip-rap. Lots of silt present at bottom of pond.

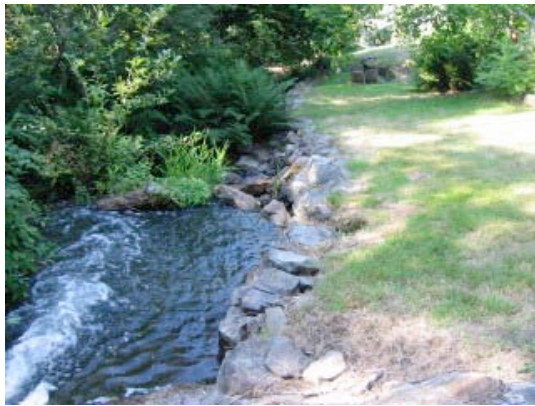
Colquitz River Reach 17, Photo 5, 2007-07-30.
Facing downstream with the 4525 Cheeseman Road property to the right. Note armoured banks with grass are eroding due to high flows and inappropriate vegetation.

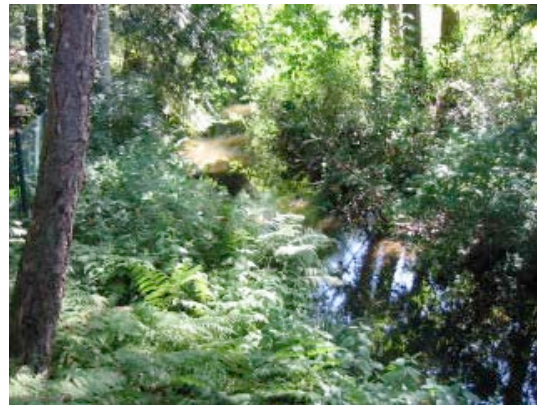
Colquitz River Reach 18, Photo 1, 2007-07-30.
Facing upstream. The creek is entrenched with a vertical left bank. High flows have heavily eroded the outside bend.

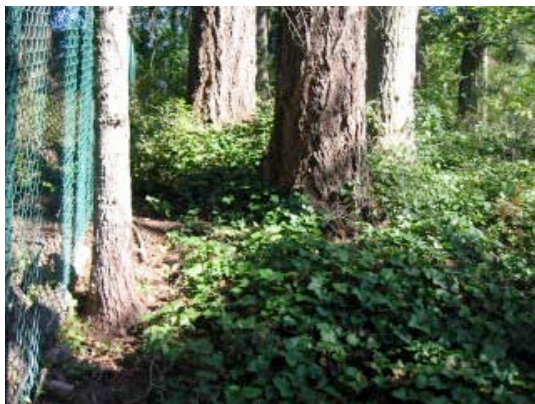
Colquitz River Reach 18, Photo 2, 2007-07-30.
Saanich parkland adjacent to the property of 4533 Cheeseman Road. English Ivy has over-run the park. The homeowners continually manage the English Ivy from encroaching.

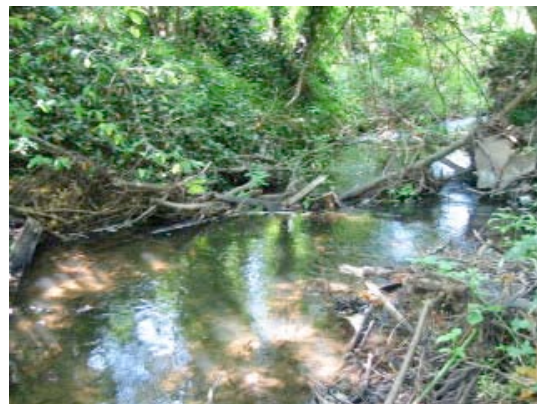
Colquitz River Reach 18, Photo 3, 2007-07-30.
Facing downstream. Woody debris has lined the channel providing some protection from erosion.

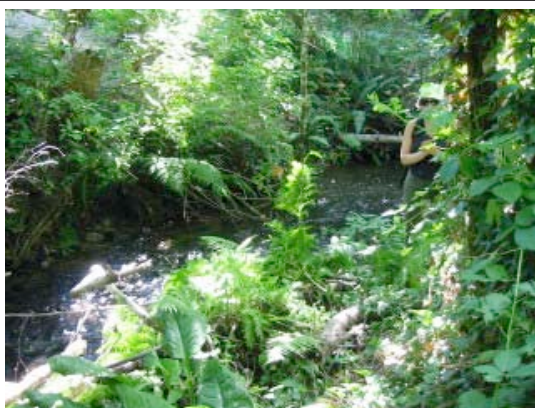
Colquitz River Reach 18, Photo 4, 2007-07-30.
Upstream from the property, facing downstream. Heavily vegetated upper banks, but erosion is occurring underneath the cover.

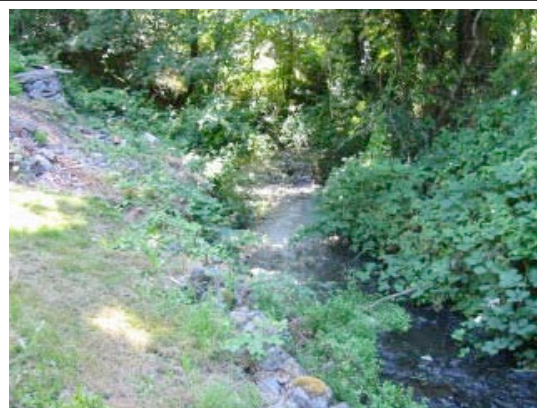
Colquitz River Reach 19, Photo 1, 2007-07-30.
Facing downstream. The creek is heavily vegetated with invasive species on the right. Opposite this is a lawn right up to the waters edge.

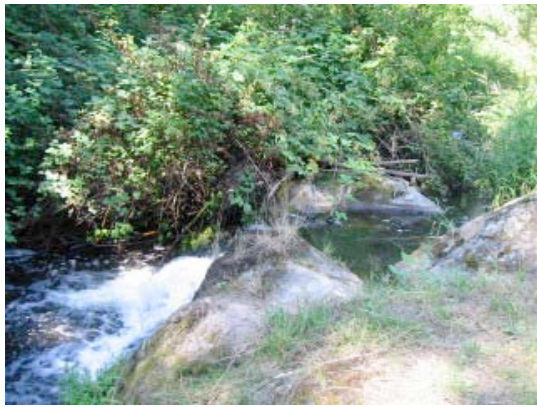
Colquitz River Reach 19, Photo 2, 2007-07-30.
Facing upstream. The reach break occurs at this point due to the changes in hydrology.

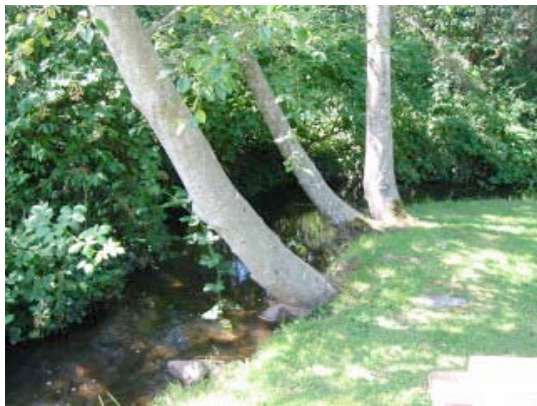
Colquitz River Reach 20, Photo 2, 2007-07-30.
Facing upstream. The right bank consists of a manicured lawn right to the waters edge. The opposite side is heavily vegetated with invasives.

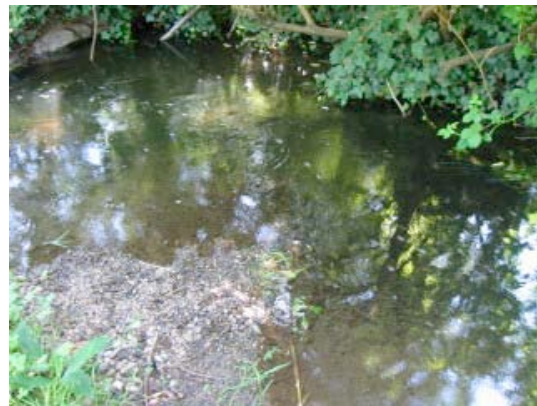
Colquitz River Reach 20, Photo 3, 2007-07-30.
Small point bar formation due to erosion and deposition processes.

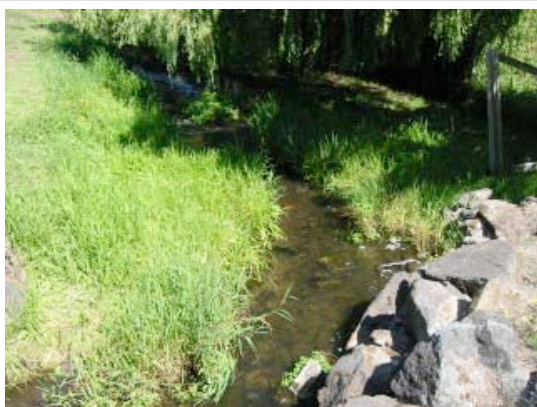
Colquitz River Reach 20, Photo 4, 2007-07-30.
Facing downstream. Streambank consists of lawn on both sides.

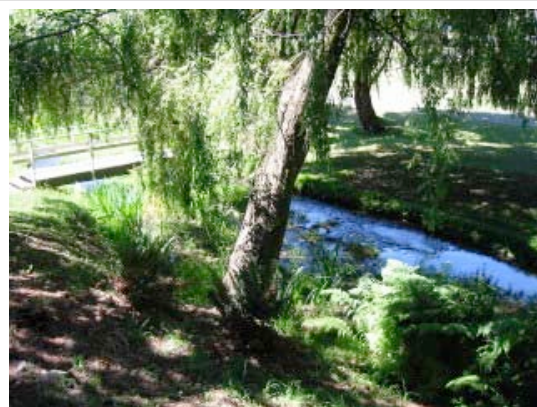
Colquitz River Reach 20, Photo 5, 2007-07-30.
Facing upstream. Streambank consists of lawn on both sides with undercutting and erosion occurring along both banks.
