Colquitz River Watershed

Proper Functioning Condition Assessment

Appendices

July 2009

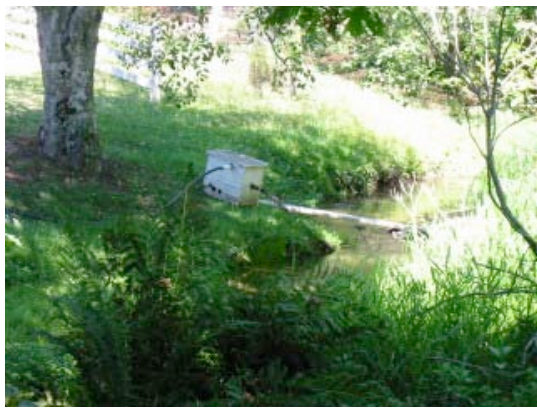
Colquitz River Reach 20, Photo 6, 2007-07-30.
Facing upstream. Property owners appear to be
pumping water from the creek.

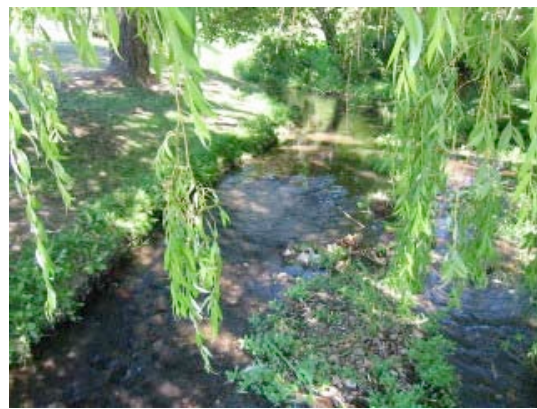
Colquitz River Reach 20, Photo 7, 2007-07-30.
On pedestrian bridge facing upstream. Banks are
eroding and under-cut. Channel is forming an
island from upstream erosion.

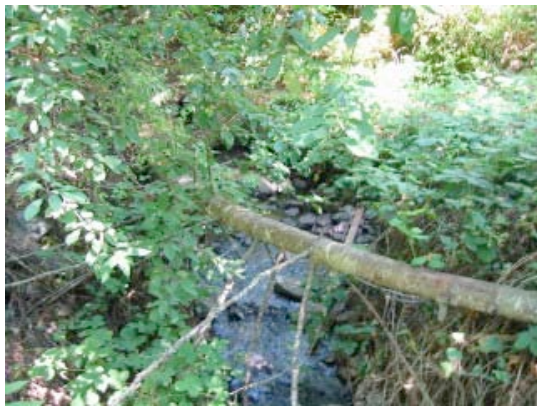
Colquitz River Reach 21, Photo 1, 2007-07-30.
Facing upstream. Channel consists mainly of
bedrock and silt/clay banks.

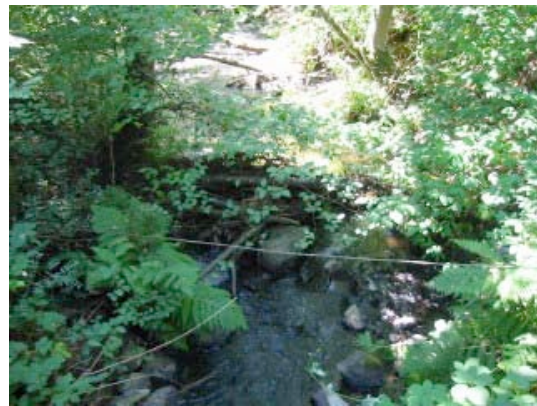
Colquitz River Reach 21, Photo 2, 2007-07-30.
Standing on first pedestrian bridge (nearest
Pipeline Road), facing downstream towards
entrance of park. Note fence crossing channel.

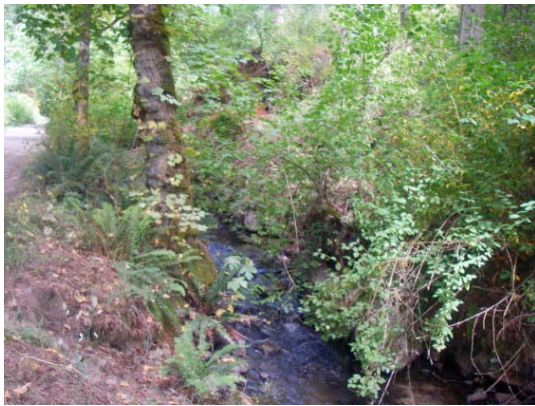
Colquitz River Reach 22, Photo 2, 2007-07-16. Standing on the second pedestrian bridge facing upstream. Channel is armoured due to pipeline installation (on right) and bedrock on the left.

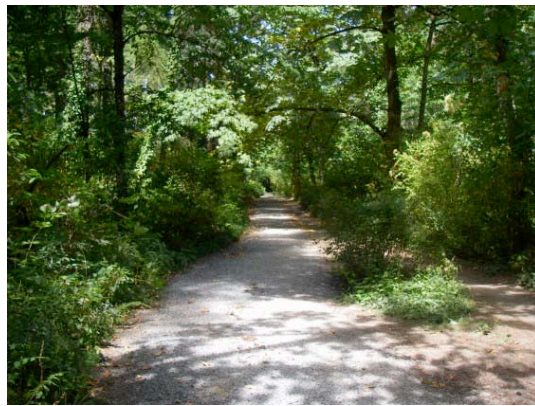
Colquitz River Reach 22, Photo 3 2007-07-16. Facing north next to 2nd pedestrian bridge. Trampling of vegetation and trail widening has occurred due to misuse of the trail by horses.

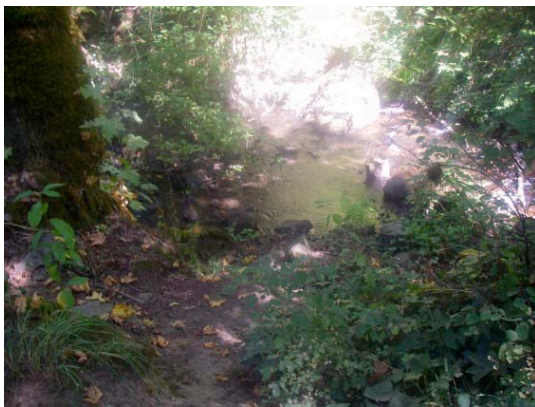
Colquitz River Reach 22, Photo 4, 2007-07-16. Facing east towards creek. Trampling and trail formation through the creek is due to horses.

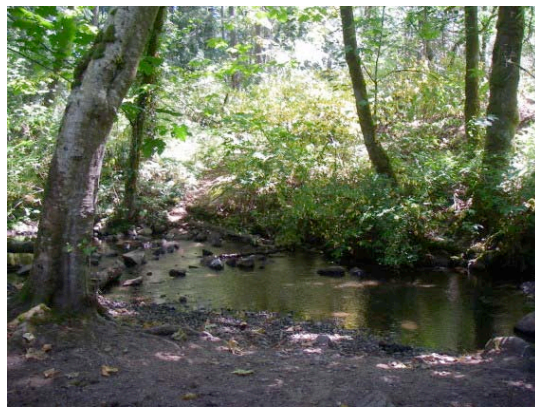
Colquitz River Reach 22, Photo 5, 2007-07-16. Facing northeast. Lack of riparian vegetation growth and soil erosion is due to trampling.

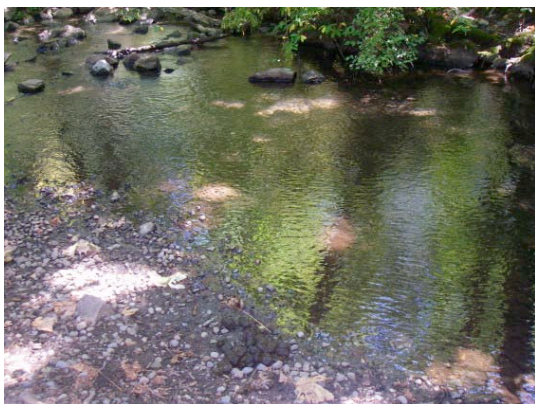
Colquitz River Reach 22, Photo 6, 2007-07-16. Facing northeast. Horse feces left next to the creek.

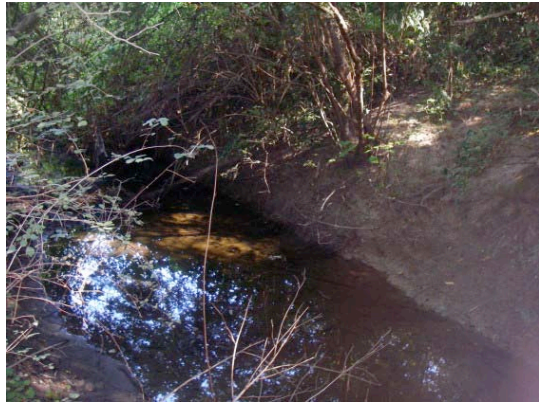
Swan Creek Reach 2, Photo 2, 2007-08-06.
Facing downstream. Lack of vegetation and high flows are eroding the banks.

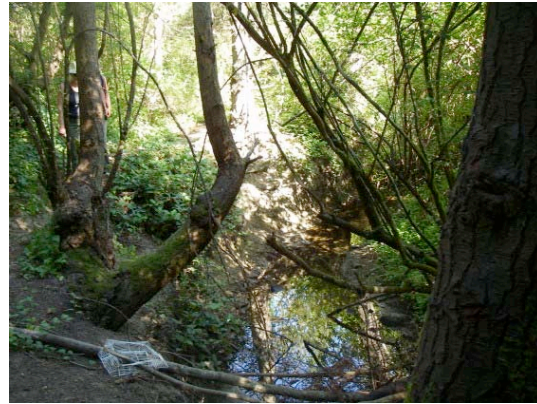
Swan Creek Reach 2, Photo 3, 2007-08-06.
Facing downstream. Channel has down-cut and is eroding throughout.

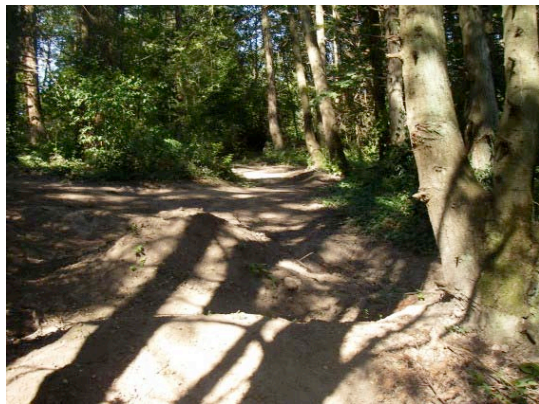
Swan Creek Reach 2, Photo 4, 2007-08-06. Bike users are modifying off trail areas for jumps and bike paths creating areas capable of being easily eroded.

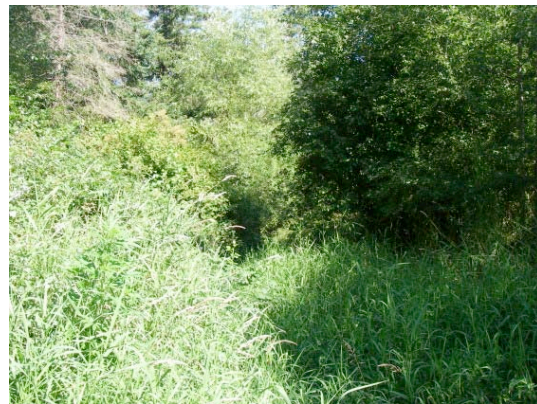
Swan Creek Reach 3, Photo 1, 2007-08-06.
Facing downstream. Reach is inundated with reed canary grass.

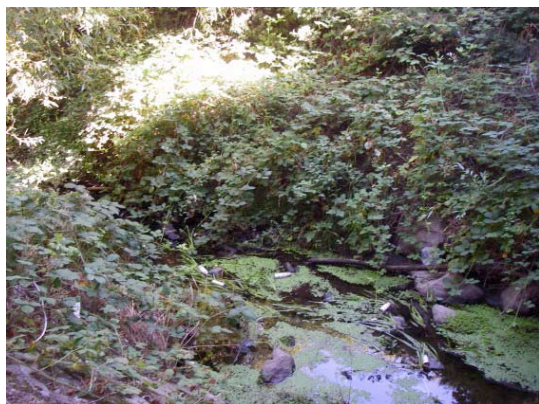
Swan Creek Reach 3, Photo 2, 2007-08-06.
Facing downstream beneath McKenzie Road overpass. Channel is lined with rocks and is over-grown with Himalayan blackberries.

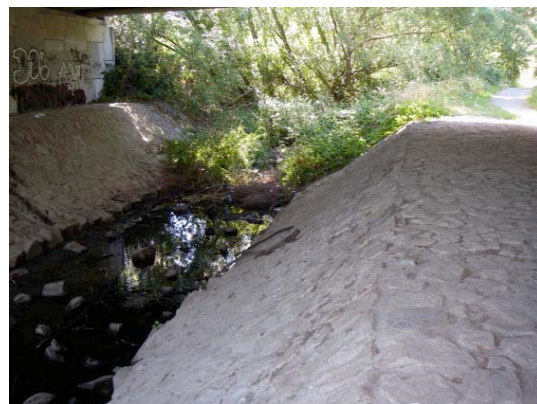
Swan Creek Reach 4, Photo 1, 2007-08-06.
Facing upstream underneath McKenzie Road overpass. Channel underneath overpass is completely lined with concrete.

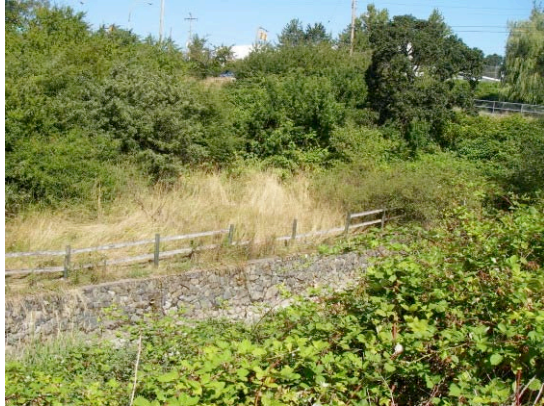
Swan Creek Reach 5, Photo 1, 2007-08-06.
Facing east toward channel. Channel is armoured on both sides with cement and rock.

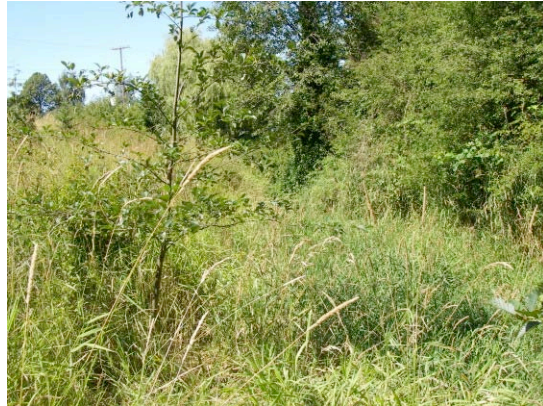
Swan Creek Reach 5, Photo 2, 2007-08-06.
Upstream of Carey Avenue facing north. Creek is heavily vegetated and banks are steep.

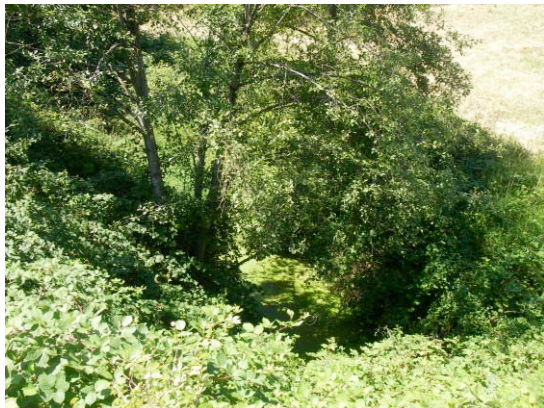
Swan Creek Reach 5, Photo 3, 2007-08-06.
Facing West (Glanford Avenue and McKenzie Avenue crossroads). Area is heavily vegetated with invasive species.

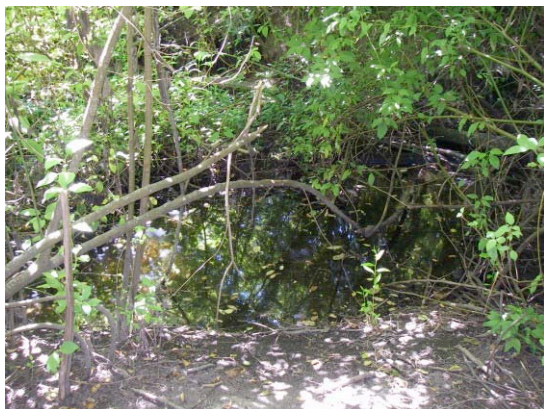
Swan Creek Reach 6, Photo 1, 2007-08-06.
Isolated trampling is occurring off the gravel path bordering Willowbrook subdivision.

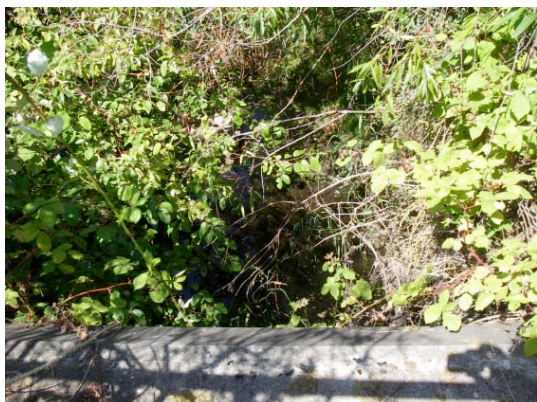
Swan Creek Reach 7, Photo 1, 2007-08-06. Jolly Place Culvert Crossing. Facing downstream towards McKenzie Ave. Channel is inundated with invasive species.

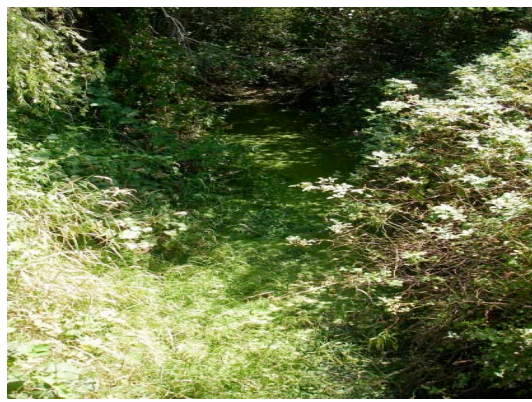
Swan Creek Reach 7, Photo 4, 2007-08-06. Ralph Street Culvert Crossing. Facing upstream. Channel is heavily vegetated with duckweed and algae.

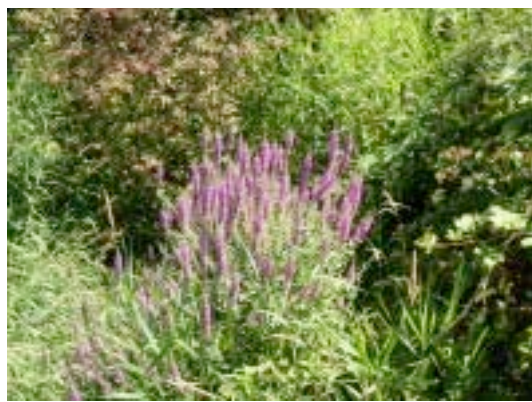
Swan Creek Reach 8, Photo 1, 2007-08-06. Kent Road pedestrian bridge facing upstream. Purple loosestrife in foreground subsequently removed by the District of Saanich.

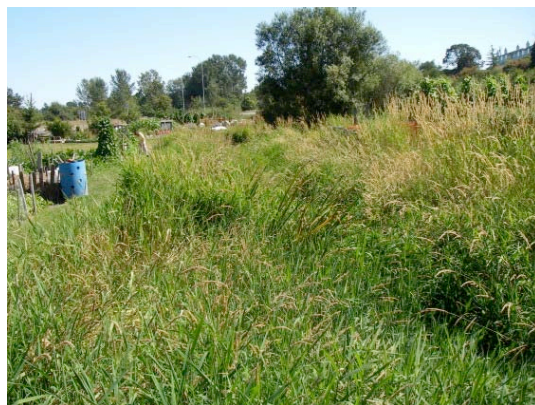
Swan Creek Reach 8, Photo 3, 2007-08-06.
Facing upstream on the Allotment gardens 2nd pedestrian bridge. Channel is heavily vegetated with reed canary grass.

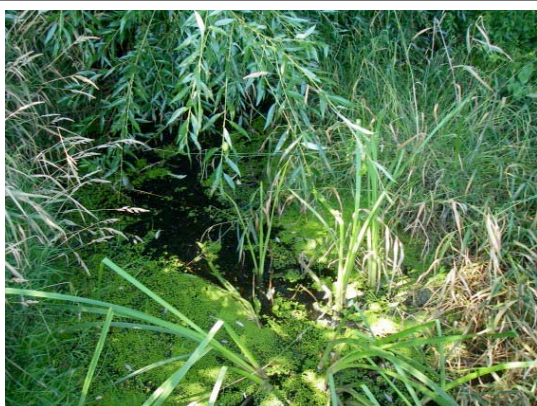
Swan Creek Reach 8, Photo 4, 2007-08-06.
Facing downstream on the Allotment gardens 2nd pedestrian bridge. Channel surface is overgrown with duckweed.

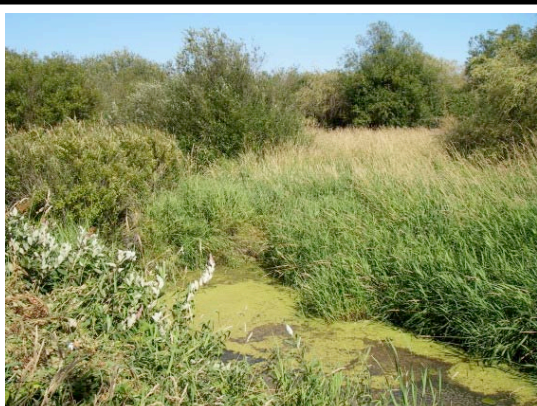
Swan Creek Reach 9, Photo 1, 2007-08-06.
Facing upstream on trail towards Swan Lake. Outlet is inundated with duckweed.

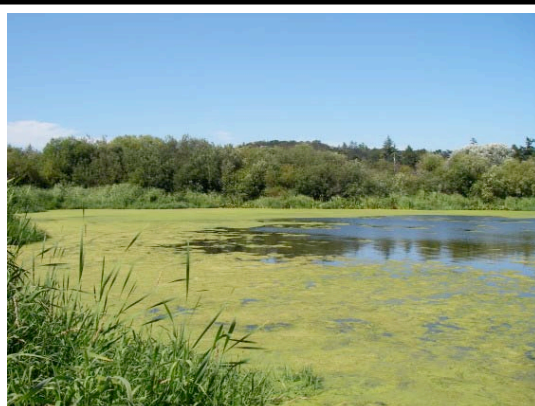
Swan Lake Reach 9, Photo 2, 2007-08-06. Swan Lake has a very high nutrient load and thus has become eutrophic.

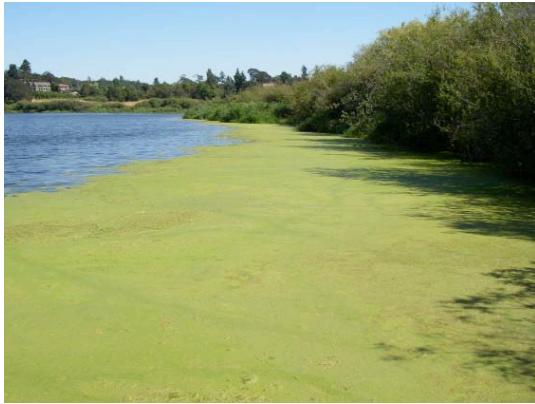
Swan Lake Reach 9, Photo 3, 2007-08-06.
Large amounts of algae and duckweed exist in
the lake.

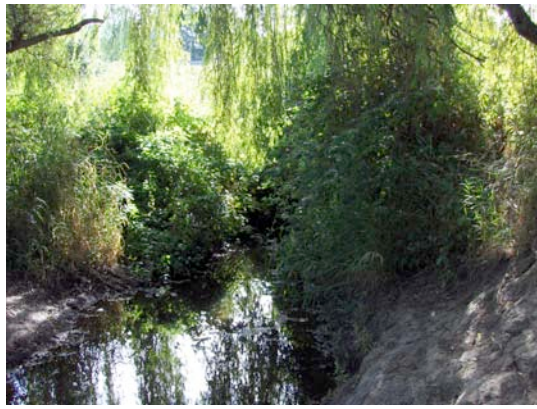
Blenkinsop Creek Reach 1, Photo 1, 2007-08-08.
Upstream of Swan Lake on pedestrian bridge.
Low vegetation in foreground due to trampling and high flows (see Photo 2 for close-up).

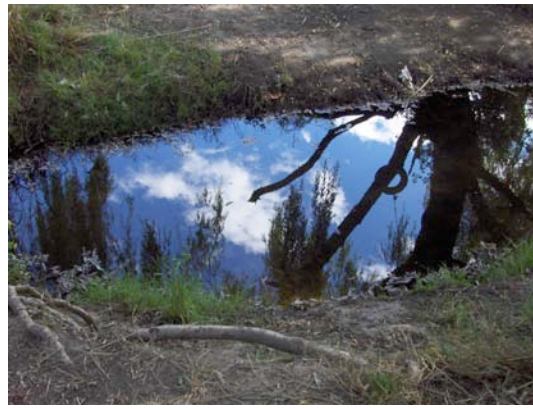
Blenkinsop Creek Reach 1, Photo 2, 2007-08-08.
Upstream of Swan Lake on pedestrian bridge.
Continual trampling and high flows has led to vegetation loss and streambank erosion.

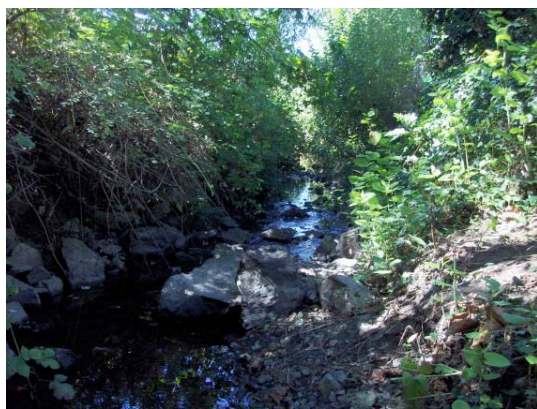
Blenkinsop Creek Reach 2, Photo 1, 2007-08-08.
Upstream of Swan Lake Trestle. Large rocks have been placed along the banks to prevent erosion. Residential yards back onto the creek.

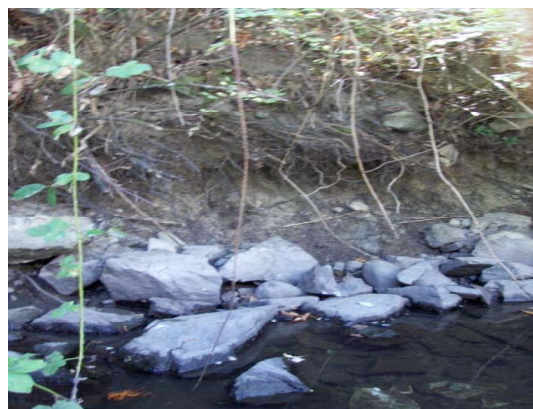
Blenkinsop Creek Reach 2, Photo 2, 2007-08-08.
High flows have eroded the stream banks even though they have been armoured with rock.

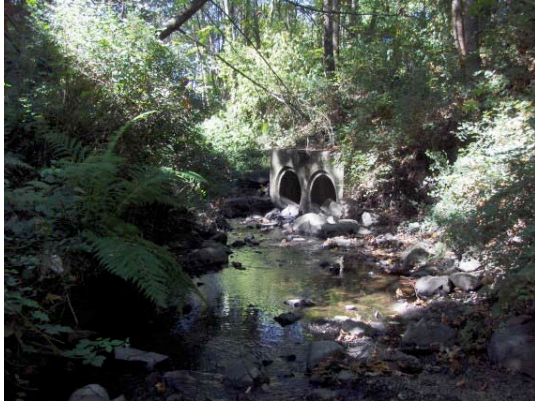
Blenkinsop Creek Reach 2, Photo 3, 2007-08-08. Facing downstream, the creek passes underneath Lochside trail through two large culverts. Streambed is full of blast rock material.

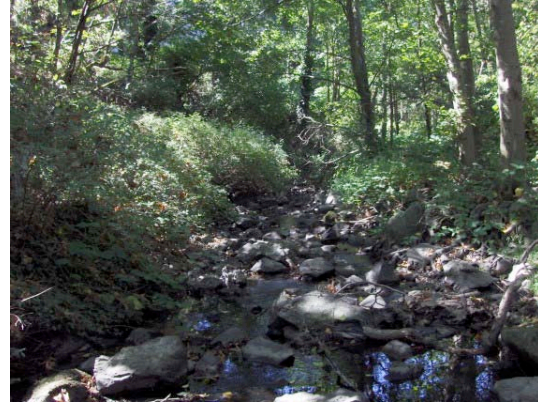
Blenkinsop Creek Reach 2, Photo 4, 2007-08-08. Facing Blenkinsop Creek upstream towards Quadra Street. Channel is full of rock but banks lack energy dissipating structures.

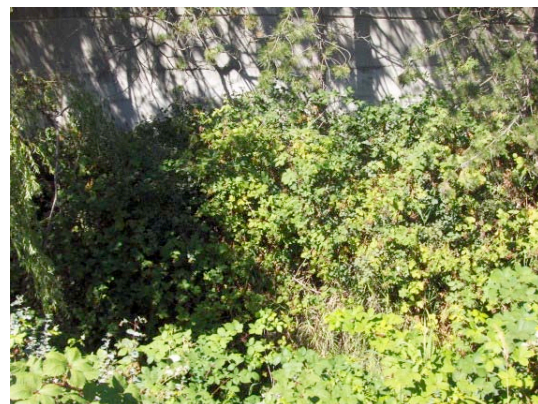
Blenkinsop Creek Reach 4, Photo 2, 2007-08-08. Upstream of McKenzie, behind London Drugs, the creek is heavily entrenched, constrained, and the banks are covered in invasive species.

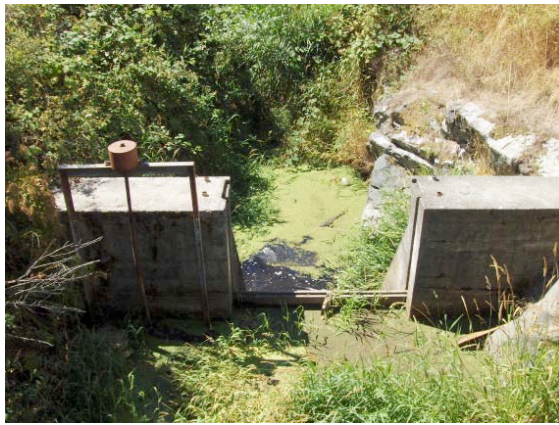
Blenkinsop Creek Reach 4, Photo 5, 2007-08-08. Blenkinsop Creek Dam. The dam controls flows and leads to flooding of upstream areas in the winter months.

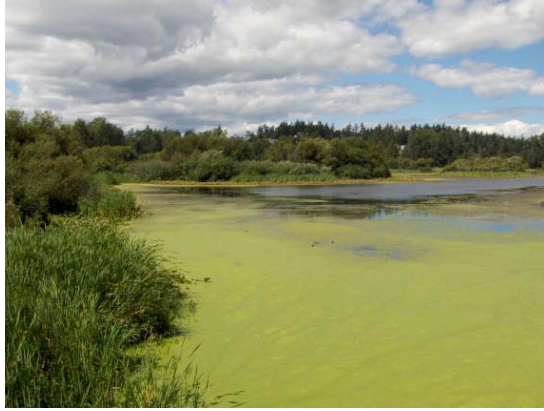
Blenkinsop Creek Reach 6, Photo 1, 2007-08-08.
Facing north on Lochside Trail. Blenkinsop Lake appears to have a high nutrient load (ie. excessive algae and duckweed) growth and is eutrophic.

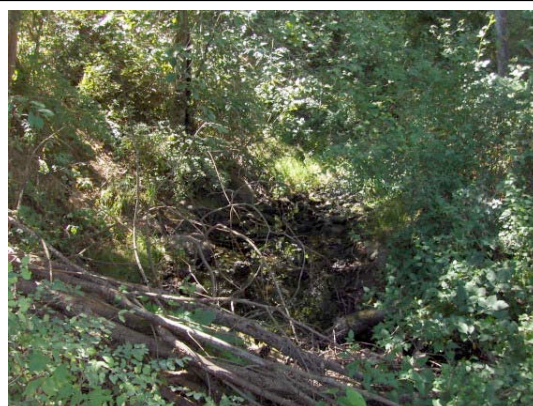
Viaduct Creek Reach 2a, Photo 1, 2007-08-08.
Facing upstream on property of 4484 Markham
Road. Large woody debris has piled up due to
high flows.

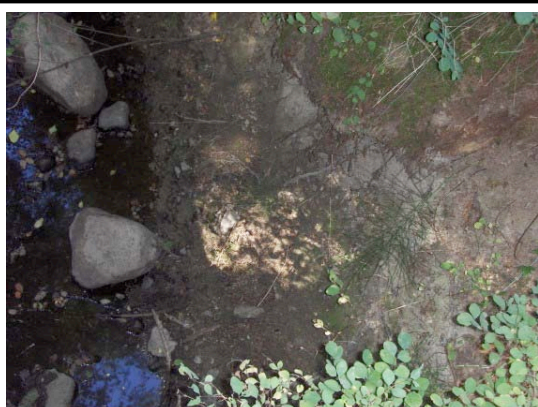
Viaduct Creek Reach 2a, Photo 2, 2007-08-08.
Lack of vegetation and peak water flows has
eroded and negatively impacted the stream banks.

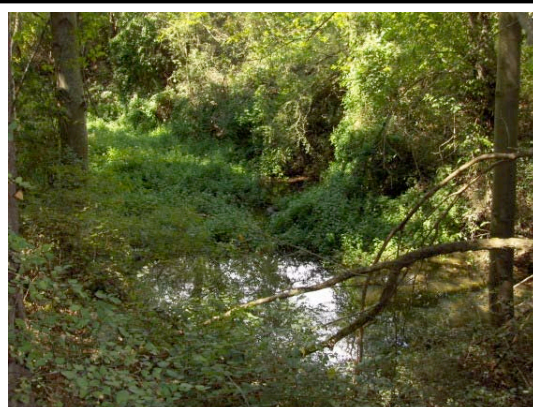
Viaduct Creek Reach 2a, Photo 3, 2007-08-08.
Property of 4484 Markham Road. Historically, a
ponding area, but due to upstream erosions it is
now filling up with sediment.

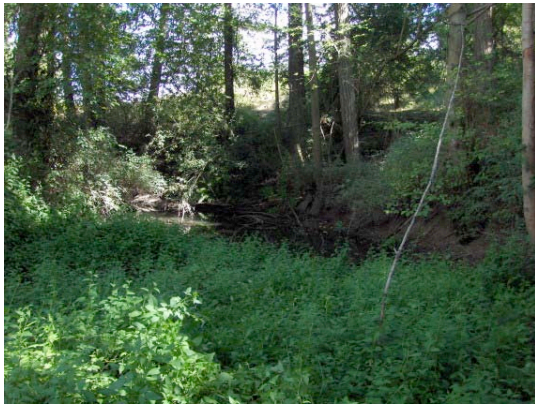
Viaduct Creek Reach 2a, Photo 4, 2007-08-08.
Pond area filled in with sediment and has re-vegetated.

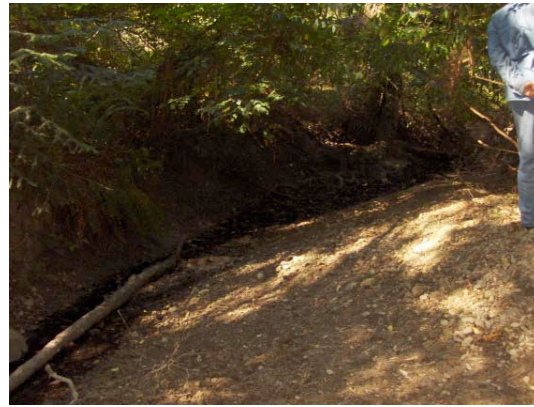
Viaduct Creek Reach 2a, Photo 5, 2007-08-08.
VITP Property. Facing downstream. Layritz Park tributary headcut has deposited a large sidebar and has begun to fill in the channel with sediment.

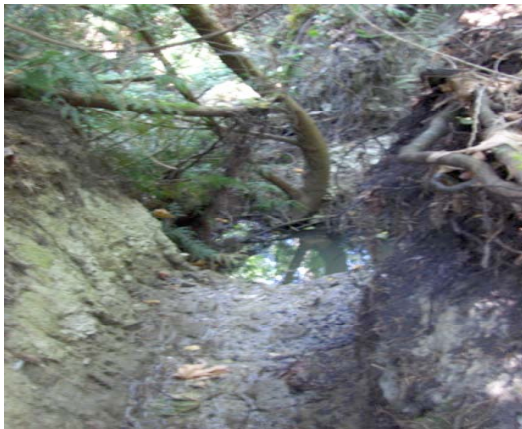
Viaduct Creek Reach 2a, Photo 6, 2007-08-08.
Layritz Park tributary, facing upstream.
Tributary has head-cut and has eroded the clay banks. Trees have collapsed into the stream bed.

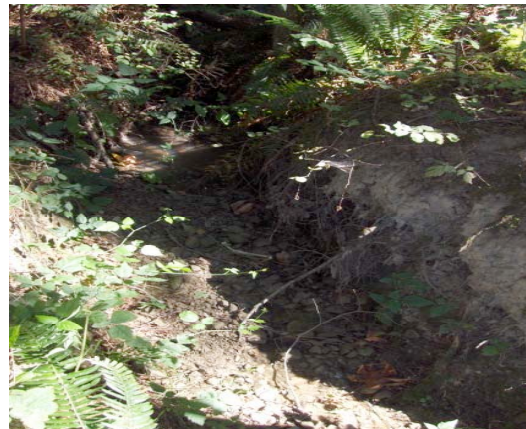
Viaduct Creek Reach 2a, Photo 7, 2007-08-08.
Layritz Park tributary, facing upstream.
Tributary has downcut.

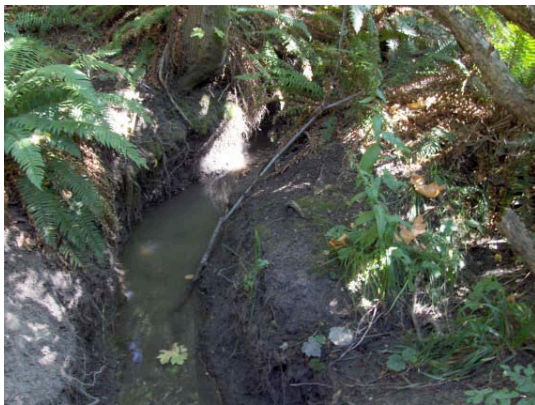
Viaduct Creek Reach 2a, Photo 8, 2007-08-08.
Layritz Park tributary, facing upstream.
Tributary has down-cut severely.

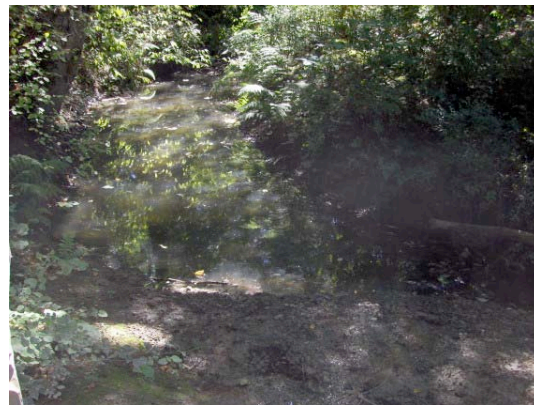
Viaduct Creek Reach 2a, Photo 9, 2007-08-08.
Facing upstream. Viaduct and Layritz Park tributary confluence. Layritz Park tributary enters into Viaduct creek.

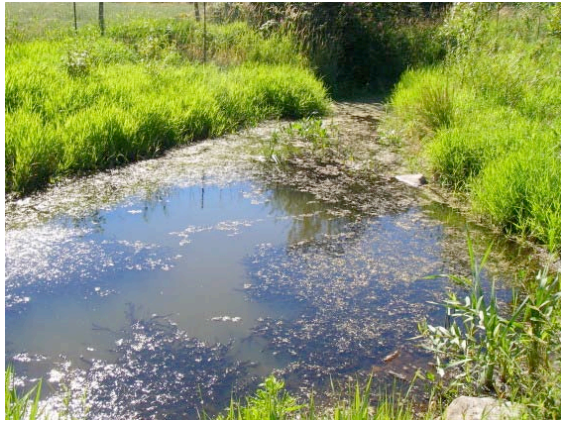
Viaduct Creek Reach 2b, Photo 1, 2007-08-01.
Pond area, facing downstream toward VITP.
Vegetation in this area consists mainly of reed
canary grass and thistles.

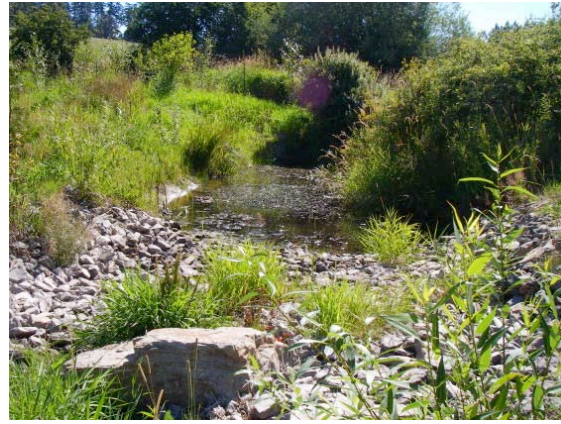
Viaduct Creek Reach 2b, Photo 2, 2007-08-01.
Facing downstream toward rock weir. Gardens and
Woodland Group has installed the rock weir and
restored a portion of the area.

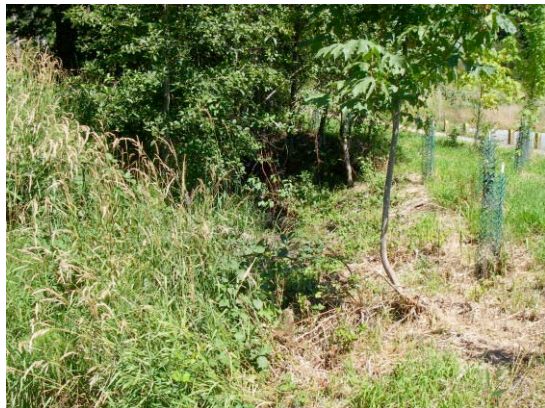
Viaduct Creek Reach 4, Photo 2, 2007-08-01.
Viaduct park entrance, facing upstream. Creek is inundated with reed canary grass.

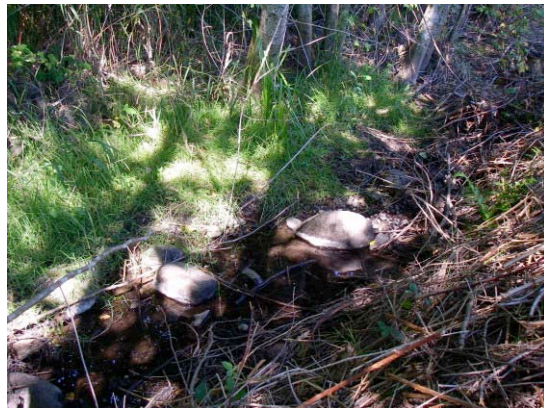
Viaduct Creek Reach 4, Photo 3, 2007-08-01.
Upstream of Viaduct park entrance. Very low water levels noted.

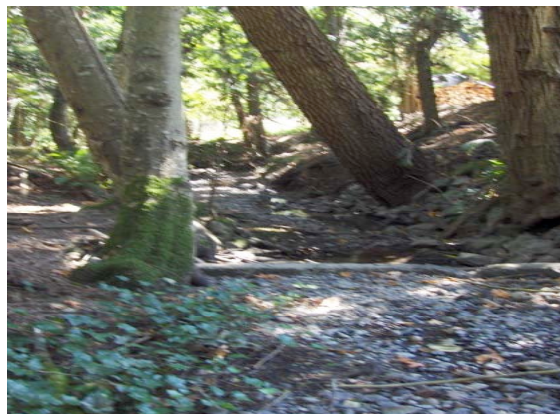
Viaduct Creek Reach 5, Photo 2, 2007-08-16.
Facing downstream toward concrete weir. Stream is armoured throughout as an attempt to stop the continued erosion.

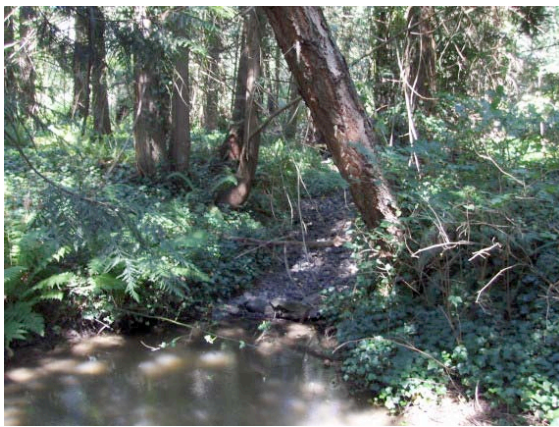
Viaduct Creek Reach 6, Photo 2, 2007-08-16.
Standing on pedestrian bridge, facing upstream
towards the Goward Springs and Viaduct Creek
confluence.

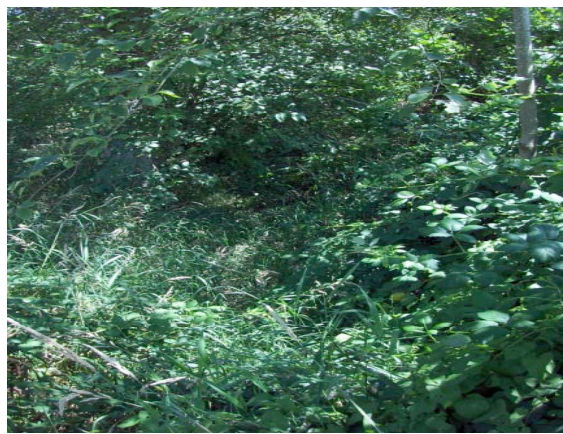
Viaduct Creek Reach 7, Photo 1, 2007-08-16.
Property of 458 Viaduct Ave, facing downstream.
Channel is heavily vegetated with reed canary
grass.

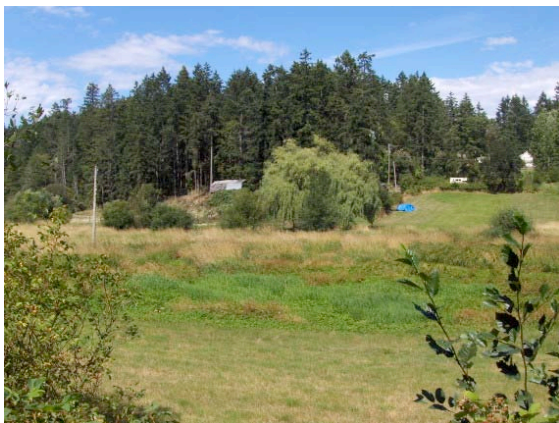
Viaduct Creek Reach 8, Photo 1, 2007-08-16.
Property of 455 Green Mountain Road. A ditch has been dug through the wetland to allow for drainage and usage of the surrounding farmland.

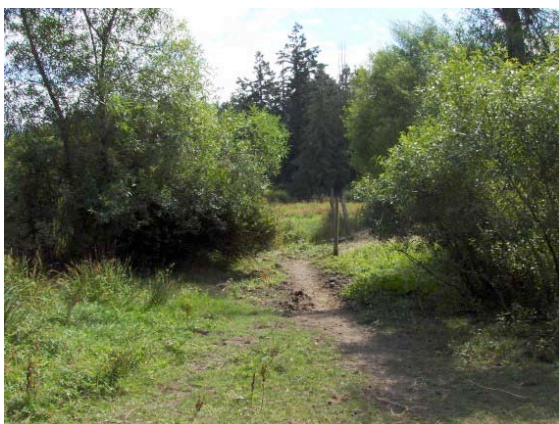
Viaduct Creek Reach 8, Photo 3, 2007-08-16.
Facing upstream on the property of 414 Viaduct Avenue. Area dries up in the summer and is grazed/trampled by horses.

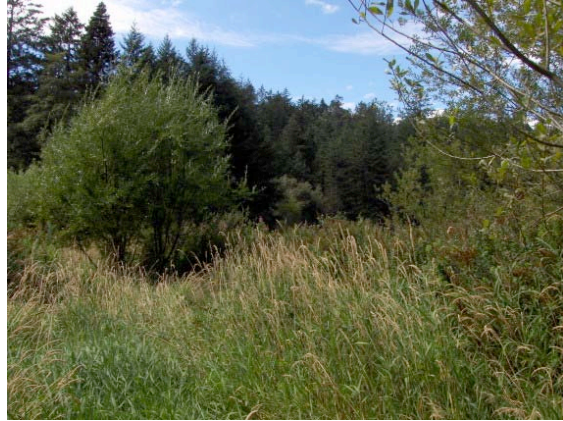
Viaduct Creek Reach 9, Photo 1, 2007-08-16.
Property of 402 Viaduct Avenue. Facing the
Viaduct Creek and Excelsior Creek confluence.
Due to the lack of trampling, the channel has re-
established itself.

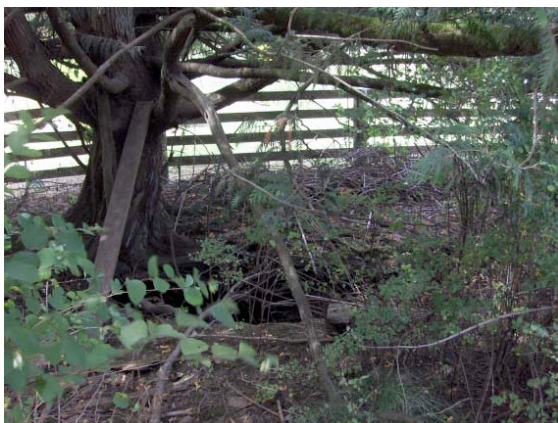
Viaduct Creek Reach 9, Photo 1, 2007-08-16.
Property of 414 Viaduct Avenue. Upstream of the
Viaduct Creek and Excelsior Creek confluence.
Viaduct Creek is heavily down-cut and eroded.

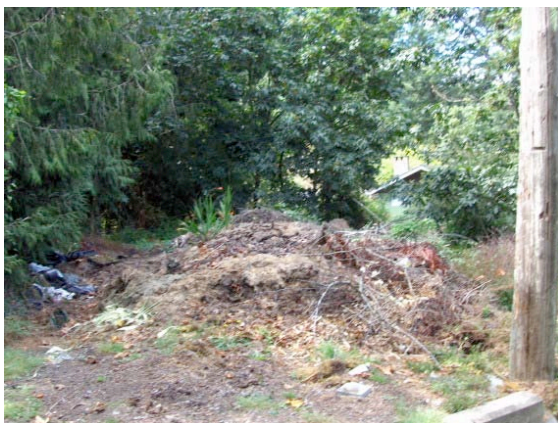
Viaduct Creek Reach 9, Photo 3, 2007-08-16.
Property of 414 Viaduct Avenue. Current property
owners have placed a large compost pile next to the
creek.

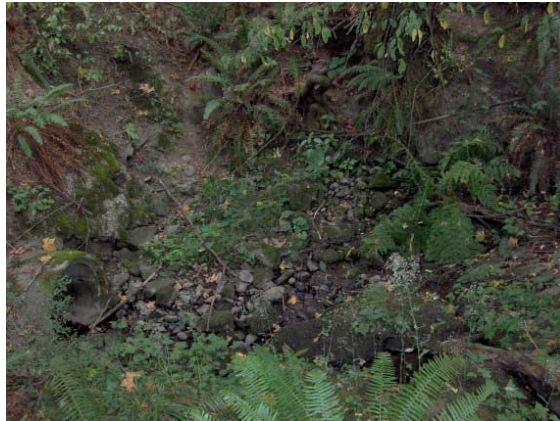
Viaduct Creek Reach 10, Photo 2, 2007-08-16.
Facing downstream towards Viaduct Avenue.
Noted large substrate and bedrock at culvert crossing.

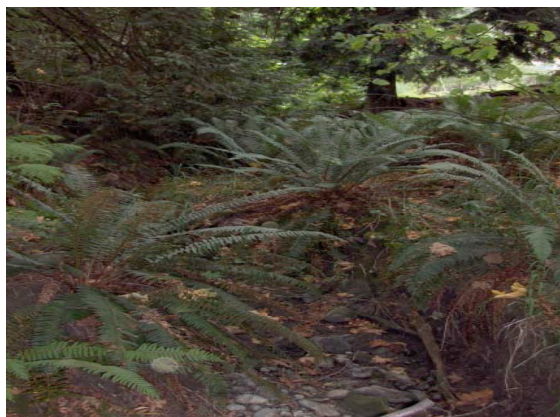
Viaduct Creek Reach 10, Photo 4, 2007-08-16.
Facing upstream, creek appears to have down-cut
due to a head-cut upstream.

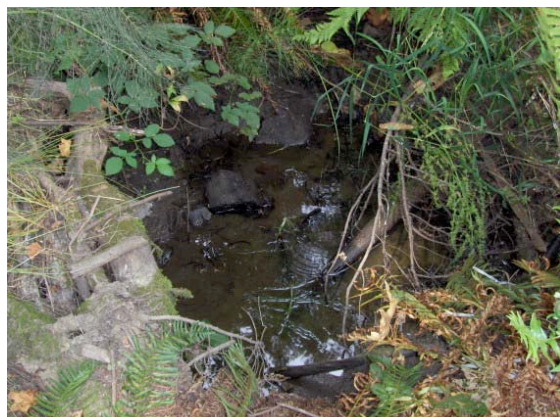
Viaduct Creek Reach 10, Photo 5, 2007-08-16. End
of Reach 10 due to a headcut approximately 60cm
in depth.

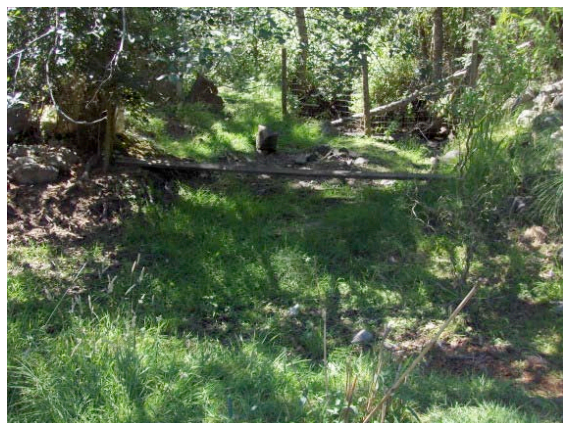
Viaduct Creek Reach 12, Photo 4, 2007-08-14. Facing upstream with the driveway behind the photographer. Creek-bed has some vegetation in the channel.

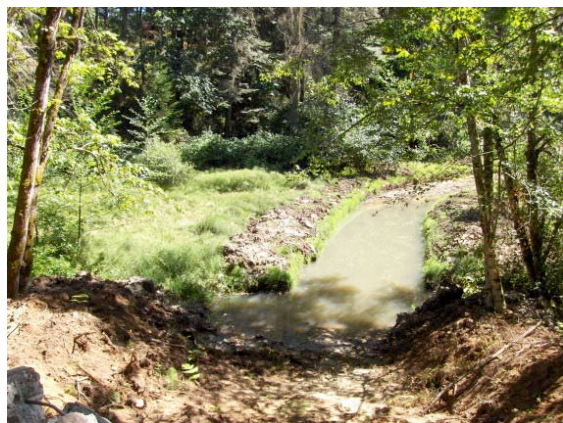
Viaduct Creek Reach 13, Photo 1, 2007-08-14. Facing property of 335 Viaduct Avenue. In 2007, 335 property owners attempted to dig a driveway to by-pass the driveway of property 345 Viaduct Ave.

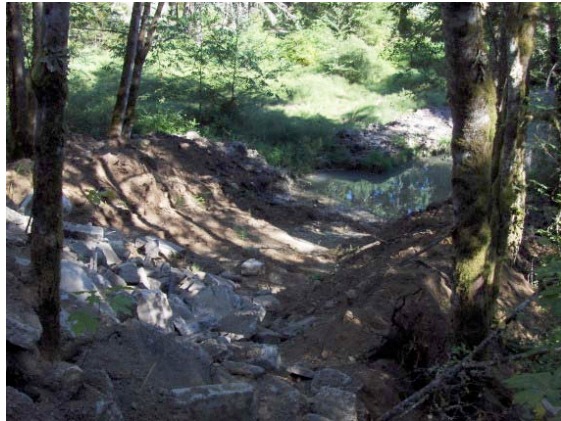
Viaduct Creek Reach 13, Photo 2, 2007-08-08. The riparian wetland area has been narrowed up and bermed, changing the hydrology of the creek.

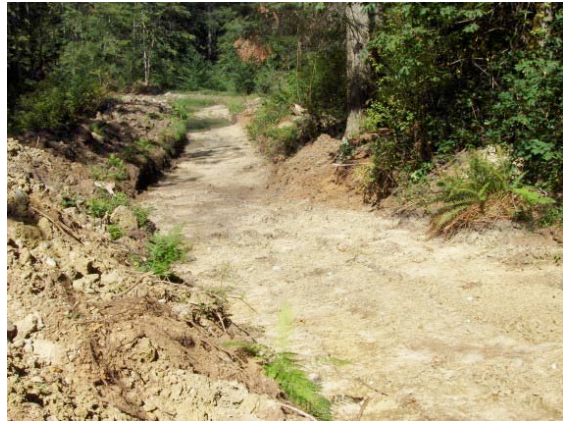
Viaduct Creek Reach 13, Photo 3, 2007-08-14. Facing Viaduct Avenue, the driveway extends from the road and connects to the driveway of 345 Viaduct Avenue.

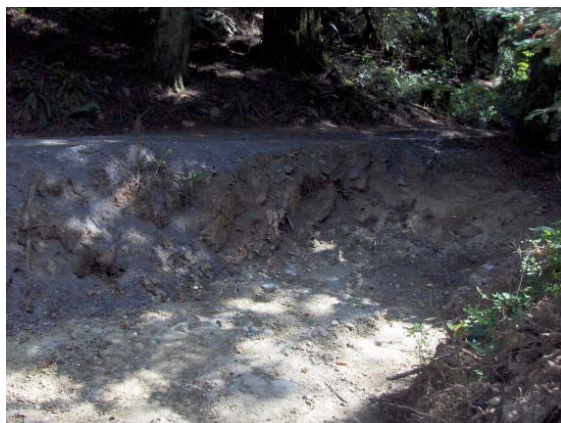
Viaduct Creek Reach 13, Photo 4, 2007-08-14. New driveway connecting to the existing driveway of 345 Viaduct Avenue.

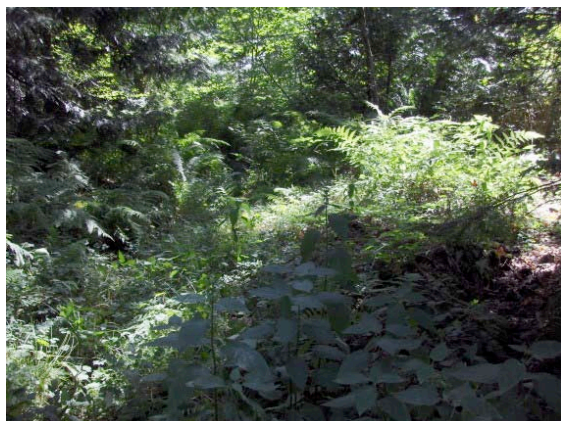
Viaduct Creek Reach 14, Photo 2, 2007-08-14. There are multiple small, narrow channels that seem to have likely been initiated by an old road whose ruts collected surface flow.

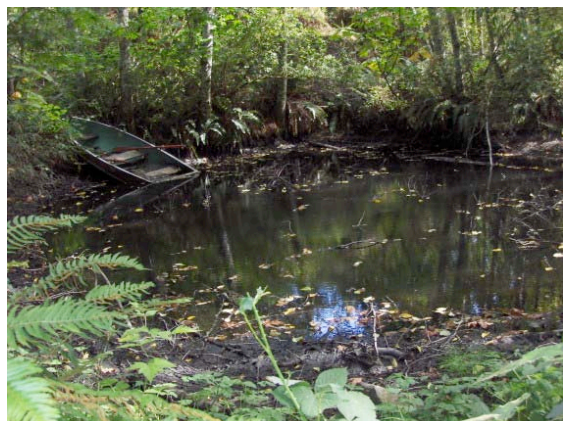
Viaduct Creek Reach 14, Photo 3, 2007-08-14. Facing upstream, pond near 235 Hector Road. Bullfrogs were observed in this pond.

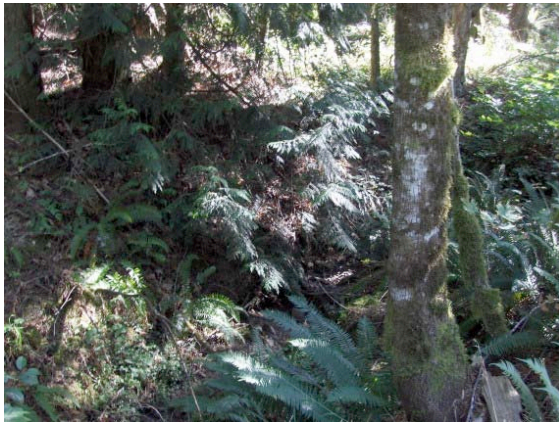
Viaduct Creek Reach 15, Photo 1, 2007-08-14.
Logan Park. Facing downstream.

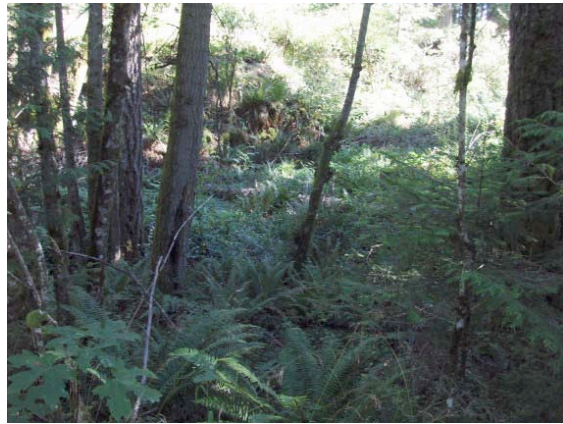
Viaduct Creek Reach 15, Photo 2, 2007-08-14.
Facing downstream from Logan Park trail culvert crossing. Channel is well vegetated with riparian vegetation.

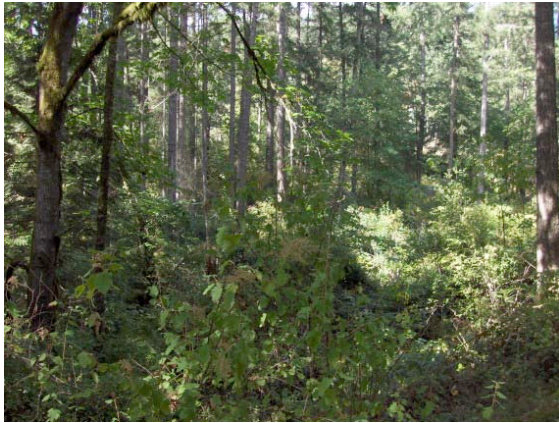
Viaduct Creek Reach 16, Photo 1, 2007-08-14.
Facing upstream from Logan Park trail culvert crossing. A definitive channel no longer exists.

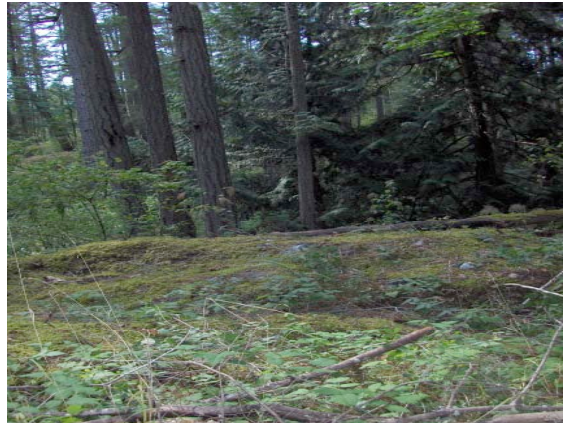
Viaduct Creek Reach 16, Photo 2, 2007-08-14.
Upstream from culvert trail crossing. Channel becomes a moist forested wetland.

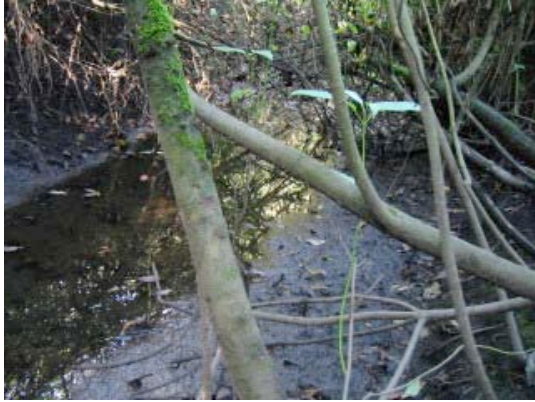
Durrell Creek Reach 1, Photo 1, 2007-09-18.
Facing downstream, toward its confluence with
Colquitz Creek near Loenholm Road.

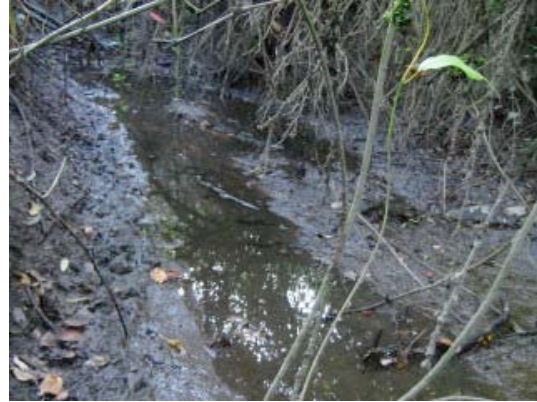
Durrell Creek Reach 1, Photo 2, 2007-09-18.
Facing upstream toward Wilkinson Road. Banks
are bare and muddy.

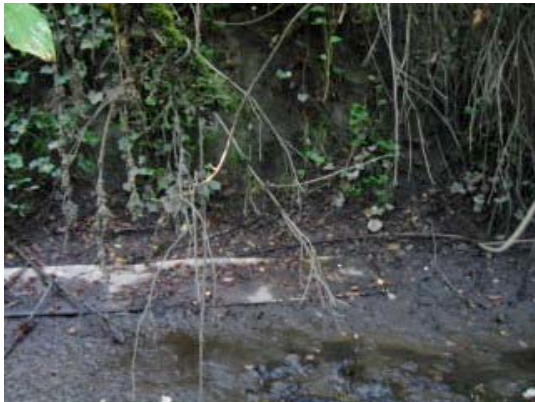
Durrell Creek Reach 1, Photo 3, 2007-09-18.
The banks are oversteepened and erosion is
evident. Note the presence of English ivy.

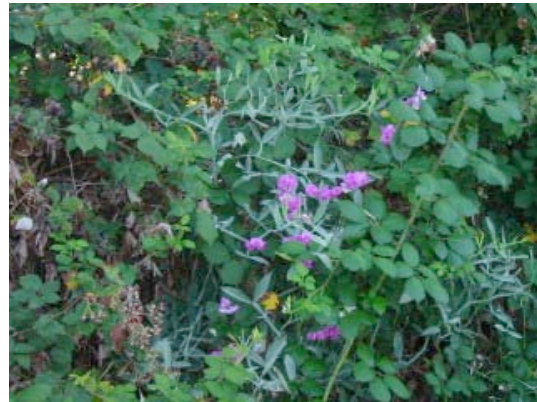
Durrell Creek Reach 1, Photo 4, 2007-09-18.
Looking downstream from Wilkinson Road at the
end of reach 1. Himalayan blackberry and a
variety of pea are in the forefront.

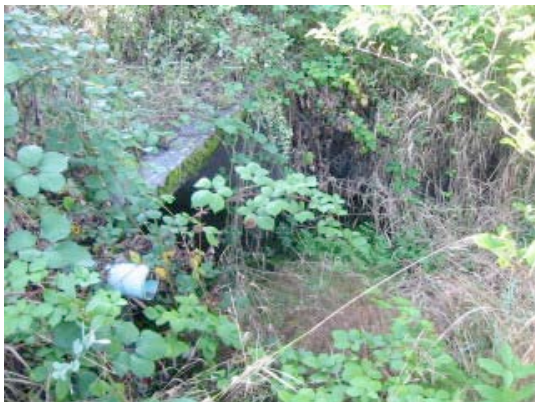
Durrell Creek Reach 2, Photo 1, 2007-09-18.
Culvert where the stream travels downstream
under Wilkinson Road.

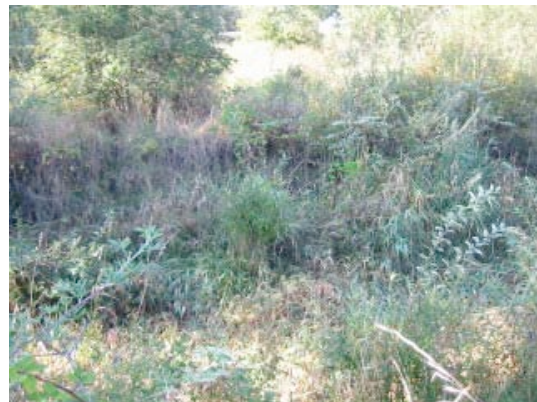
Durrell Creek Reach 2, Photo 2, 2007-09-18.
Upstream of Wilkinson Road. Banks are
vegetated and some floodplain is present on the
left bank.

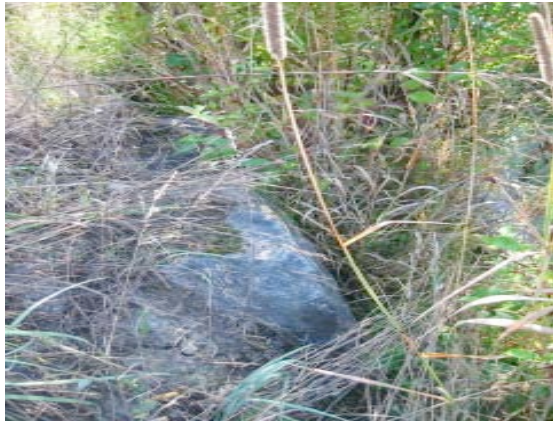
Durrell Creek Reach 2, Photo 3, 2007-08-08.
Facing downstream, standing on McKenzie Ave
(London Drugs is to the right). Banks are heavily
overgrown with invasive species.

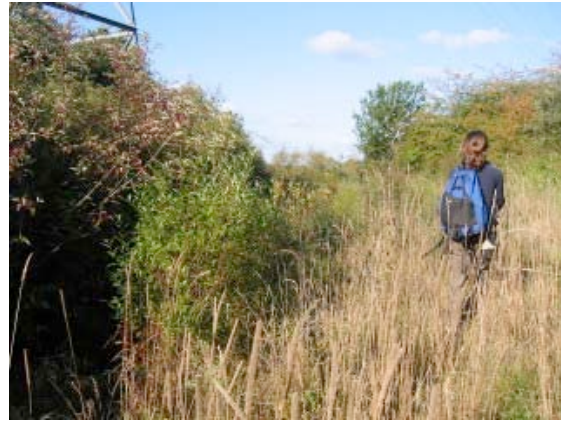
Durrell Creek Reach 2, Photo 4, 2007-09-18.
Looking upstream toward Wilkinson Road
Correctional Centre. Note presence of reed canary
grass and young willow.

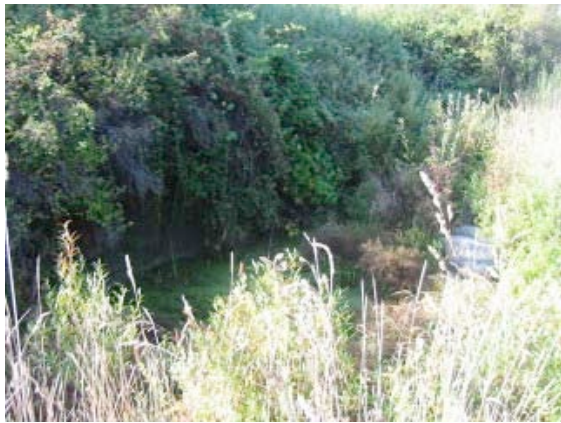
Durrell Creek Reach 2, Photo 5, 2007-09-18.
Small man-made pond adjacent to power tower.
Banks are oversteepened.

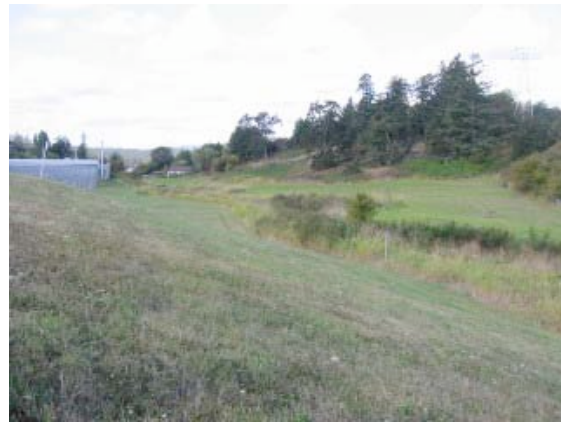
Durrell Creek Reach 2, Photo 6, 2007-09-18.
Looking upstream from Wilkinson Road
Correctional Centre. Mowing occurs near to the
edge of the channel.

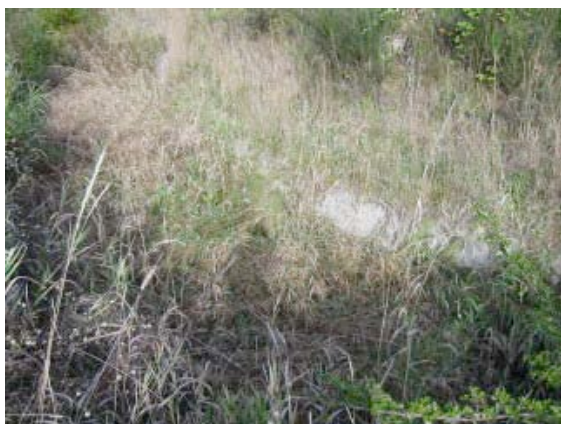
Durrell Creek Reach 2, Photo 7, 2007-09-18.
The channel through Wilkinson Road Correctional
Centre. Clay banks are steep and bare.

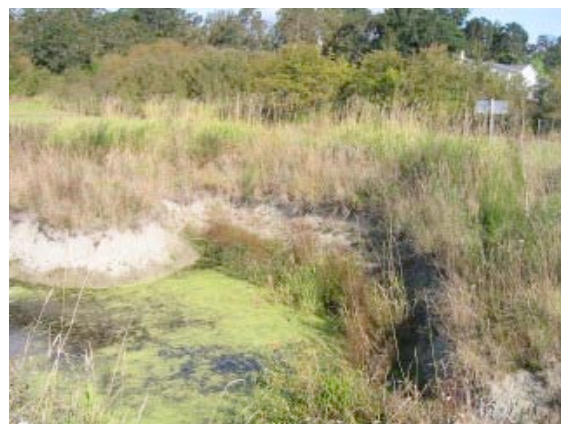
Durrell Creek Reach 2, Photo 8, 2007-09-18.
One of the man-made ponds within the correctional
centre property. Banks are vertical and bare.

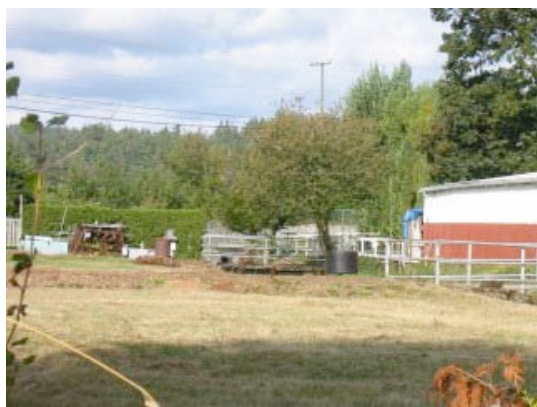
Durrell Creek Reach 3, Photo 1, 2007-09-18. Looking upstream from Wilkinson Road Correctional Centre. There is little vegetation present.

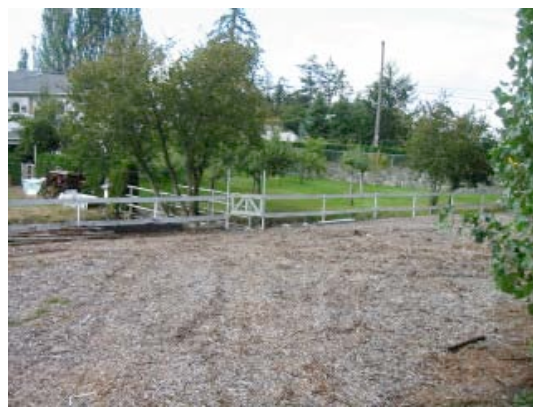
Durrell Creek Reach 3, Photo 2, 2007-09-18. Paddock area borders the left bank of the stream.

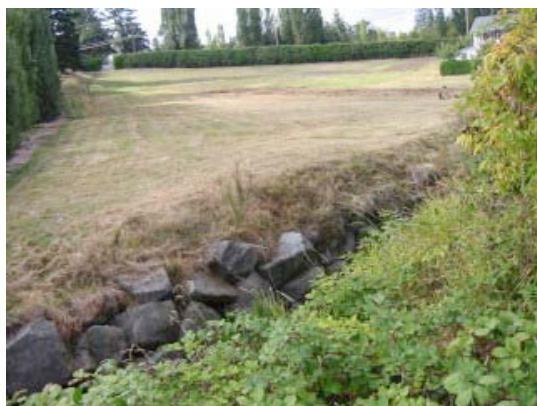
Durrell Creek Reach 3, Photo 3, 2007-09-18. Downstream end of reach 3. Banks are armoured with rock. No vegetation is present other than grass on the right bank.
