Colquitz River Watershed

Proper Functioning Condition Assessment

Appendices

July 2009

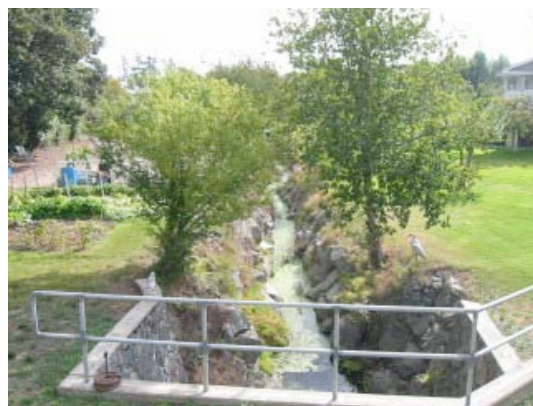
Durrell Creek Reach 3, Photo 4, 2007-09-18. Facing downstream from Interurban Road. Channel is armoured and there is little vegetation.

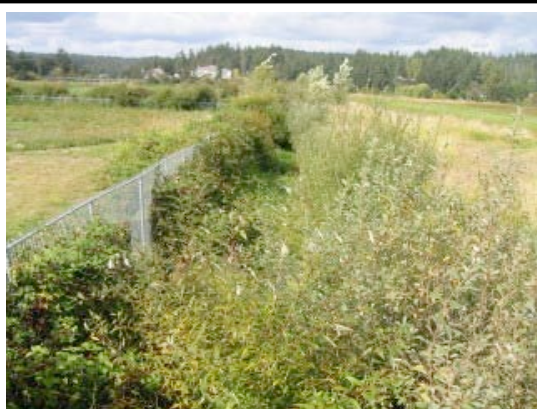
Durrell Creek Reach 4, Photo 1, 2007-09-18. Facing upstream from Interurban Road. Channel located in the middle of agricultural fields.

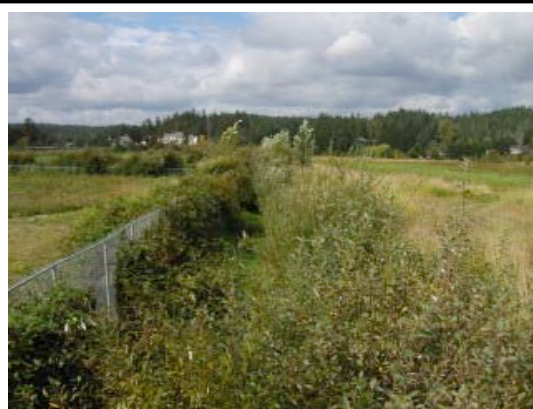
Durrell Creek Reach 4, Photo 2, 2007-09-18. Looking upstream. Channel is heavily vegetated.

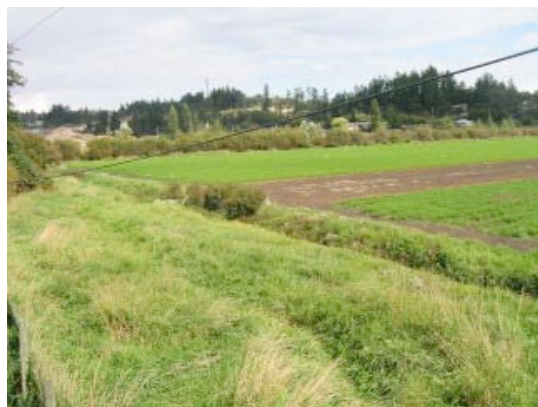
Durrell Creek Reach 4, Photo 3, 2007-09-18.
Facing downstream, from green trestle bridge.
The channel is located within the line of
vegetation in the background.

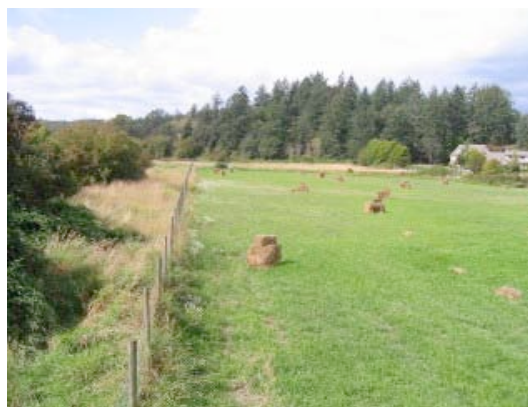
Durrell Creek Reach 4, Photo 4, 2007-09-18.
Facing upstream from the green trestle.

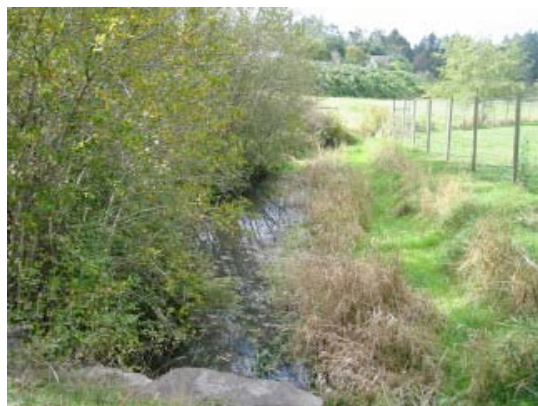
Durrell Creek Reach 4, Photo 5, 2007-09-18.
Facing upstream of Granville Avenue. Small,
terraced floodplain at left bank. Horse and cow
paddocks line both banks.

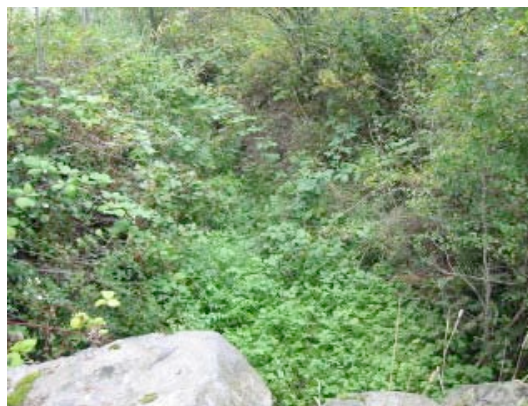
Durrell Creek Reach 4, Photo 6, 2007-09-18.
Looking downstream from Granville Avenue.
Flow is low and vegetation is encroaching upon
the channel.
