TABLE OF CONTENTS

BOWKER CREEK ASSESSMENT SUMMARY

REACH 1A
Reach # 1A – Creek mouth into Oak Bay to upstream (west) end of 1776 Beach Drive) (140m) 2733, 2717, and 2713 Somass Drive; 1725, 1762, and 1776 Beach Drive (privately owned)
Channel Description Channel banks are primarily concrete, mortared rock and concrete sandbags (Photos 1-6,8-10,12-15). The channel bottom is a mix of bedrock, heavily silted substrate of sand, gravel, cobble, and boulders, and extensive concrete and asphalt armouring (Photos 3,8,9,12,13,16). Thick algal mats and root mats from golden willow are present. Vertical armoured banks 1-2m tall, channel width 3.0m – 5.5m, wetted width 0.4m-3.5m (summer). The creek is channelized and straightened with a gradient range from 1.5-4% with a narrow strip of riparian vegetation (Photos 17 & 18). There is a 22m long pool downstream of the culvert which is suitable as a holding location for juvenile fish prior to entering the marine environment, and also for adults entering the stream to hold while awaiting higher flows and while maturing. Tidal influence occurs downstream of Beach Drive. Concrete box culvert at Beach Drive (3.0m wide x 2.2m tall x 15m long). Small a

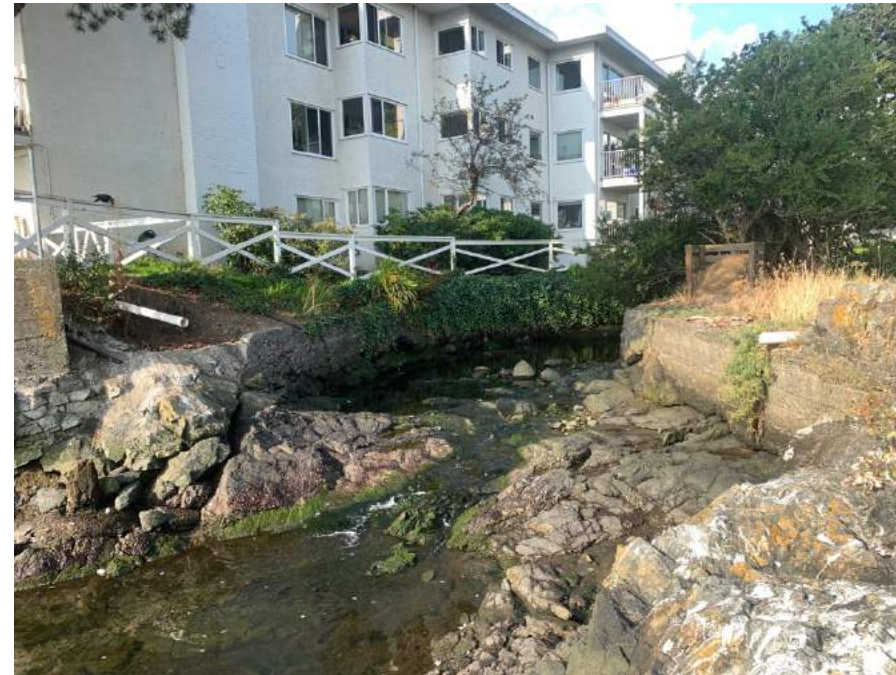
Photo 1A-2. Channel with concrete walls, non-native species in the riparian zone, erosion under the concrete wall at 1725 Beach Drive, near mouth of the creek (view upstream).

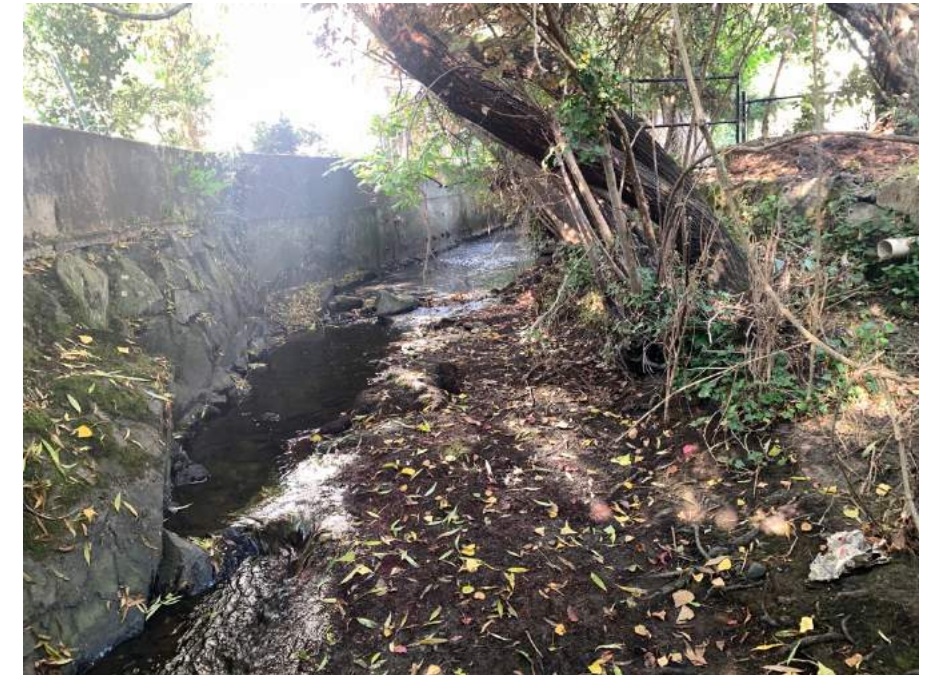
Photo 1A-3. Concrete wall at 1725 Beach Drive, and golden willow mats at 2713 Somass Drive (view upstream).

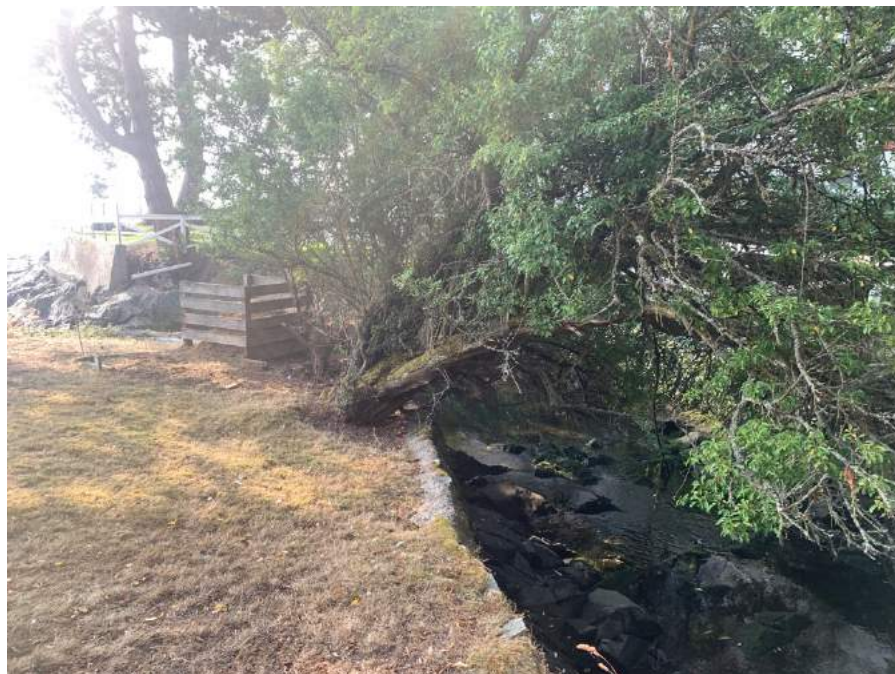
Photo 1A-4. Concrete wall, lawn, ornamental vegetation, and yard waste at 2717 Somass Drive (view downstream).

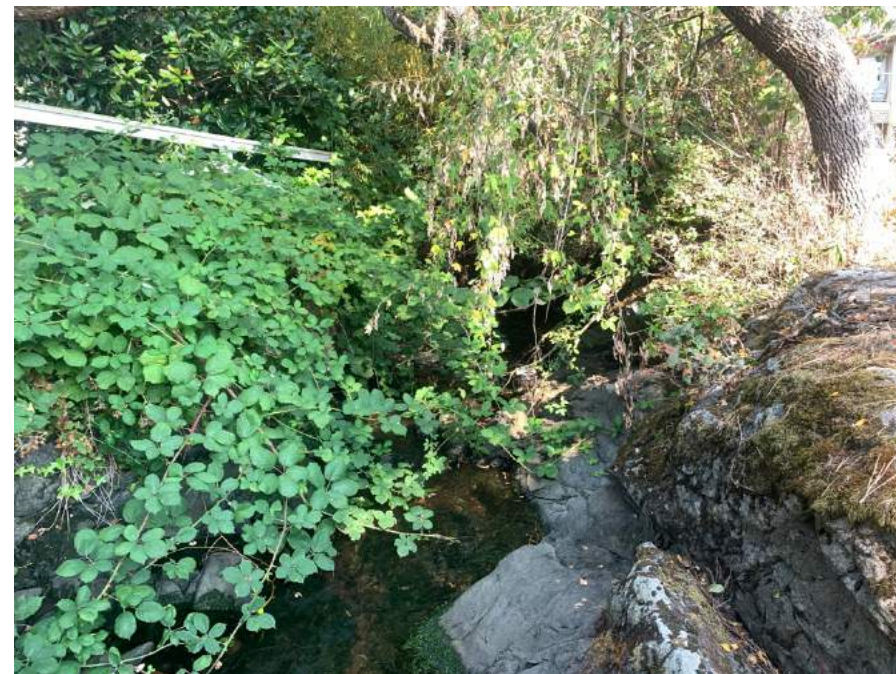
Photo 1A-5. Himalayan blackberry and golden chain tree at 1725 Beach Drive and 2717 Somass Drive (view upstream).

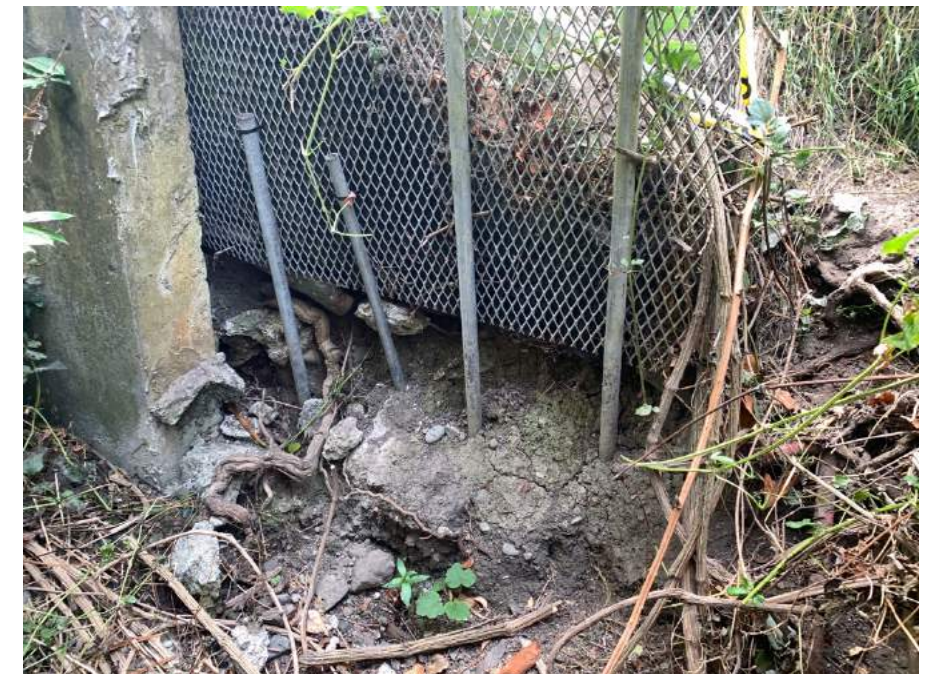
Photo 1A-6. 1725 Beach Drive, erosion downstream of Beach Drive culvert, at upstream end of retaining wall (south bank).

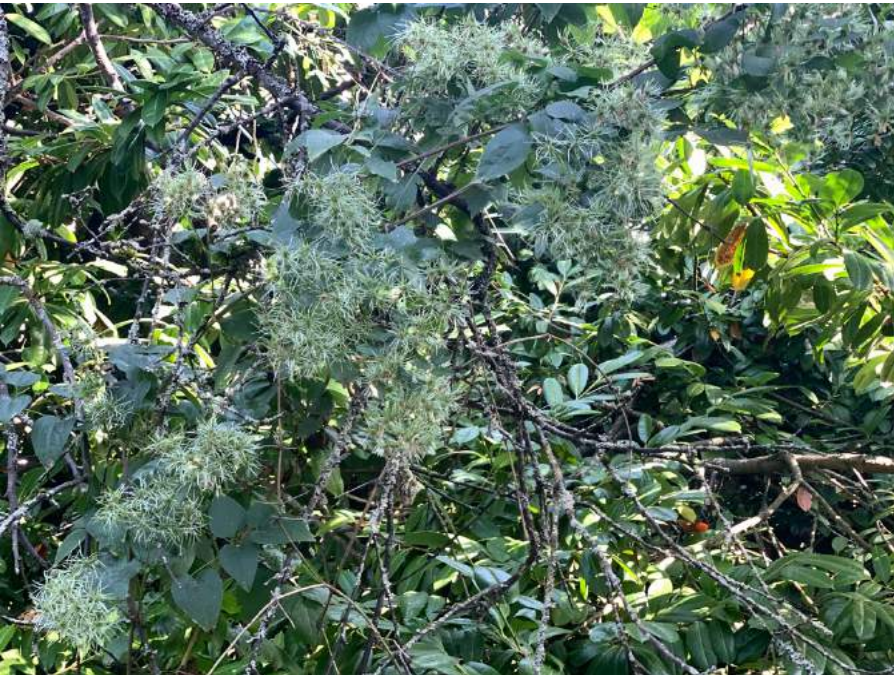
Photo 1A-7. Traveler's joy (clematis) in trees/shrubs downstream of the Beach Drive culvert at 1725 Beach Drive

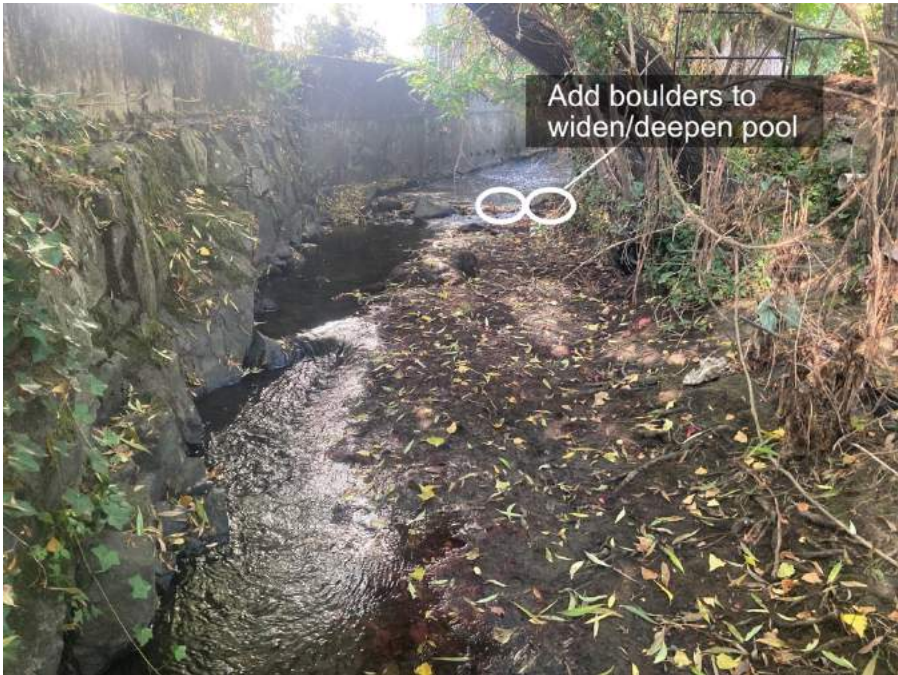
Photo 1A-8. Downstream end of Beach Drive culvert, weir proposed to improve fish passage (view downstream).

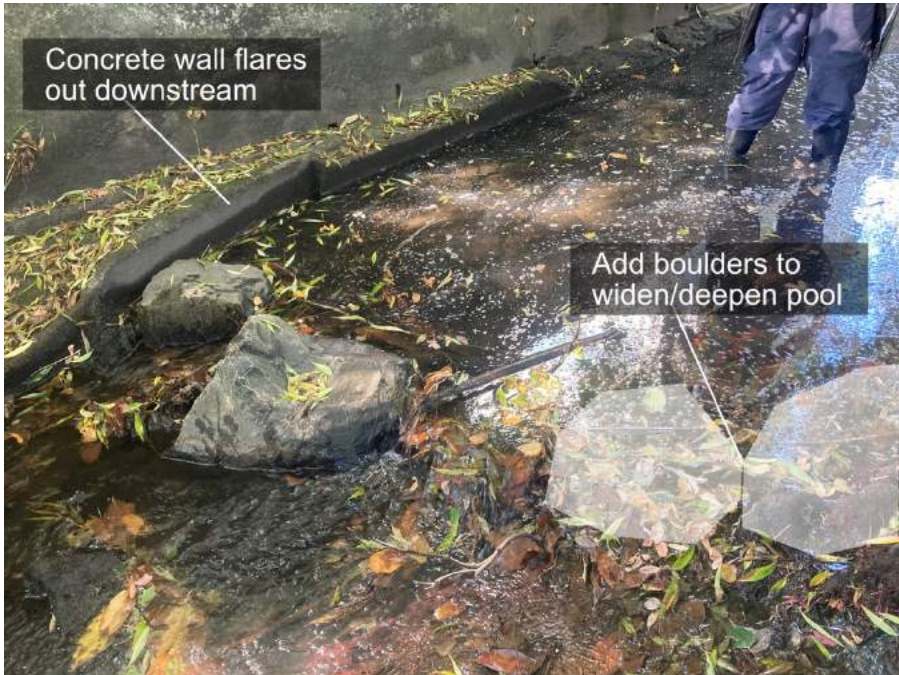
Photo 1A-9. Proposed weir location downstream of Beach Drive.

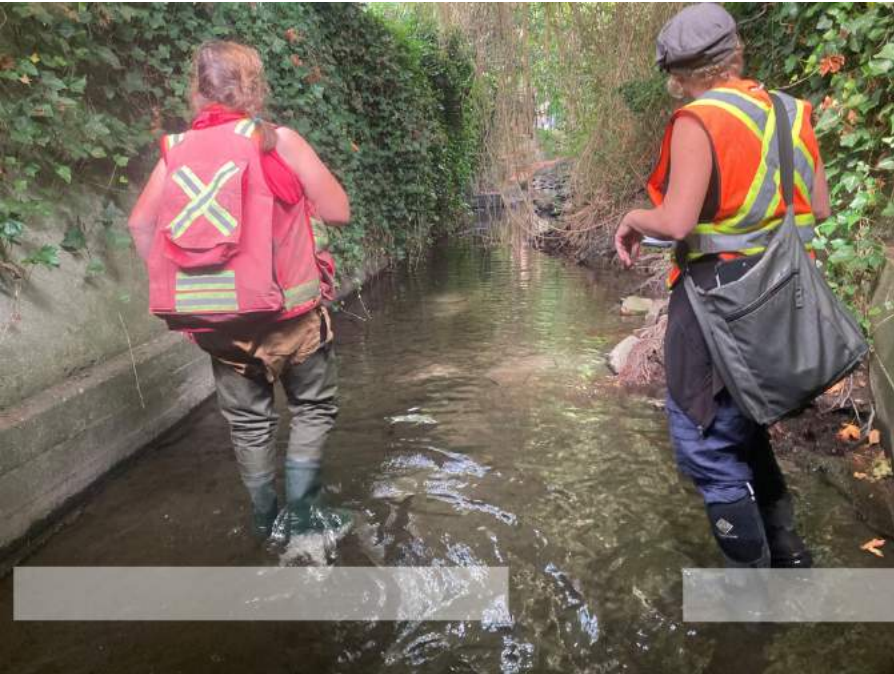
Photo 1A-10. Proposed baffle location downstream of Beach Drive.

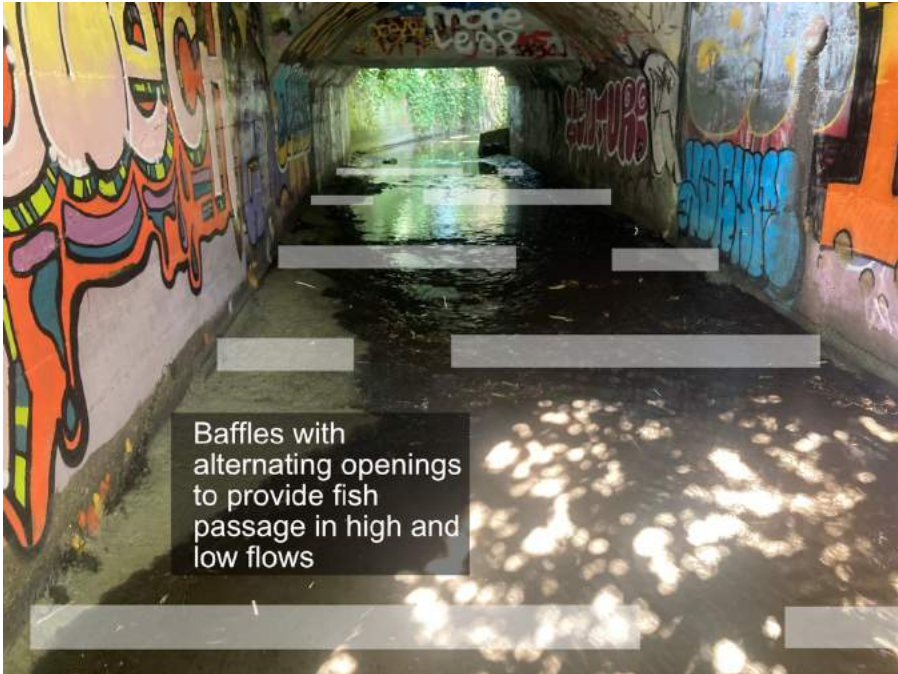
Photo 1A-11. Culvert under Beach Drive, with baffles proposed to assist low flow fish passage (view upstream).

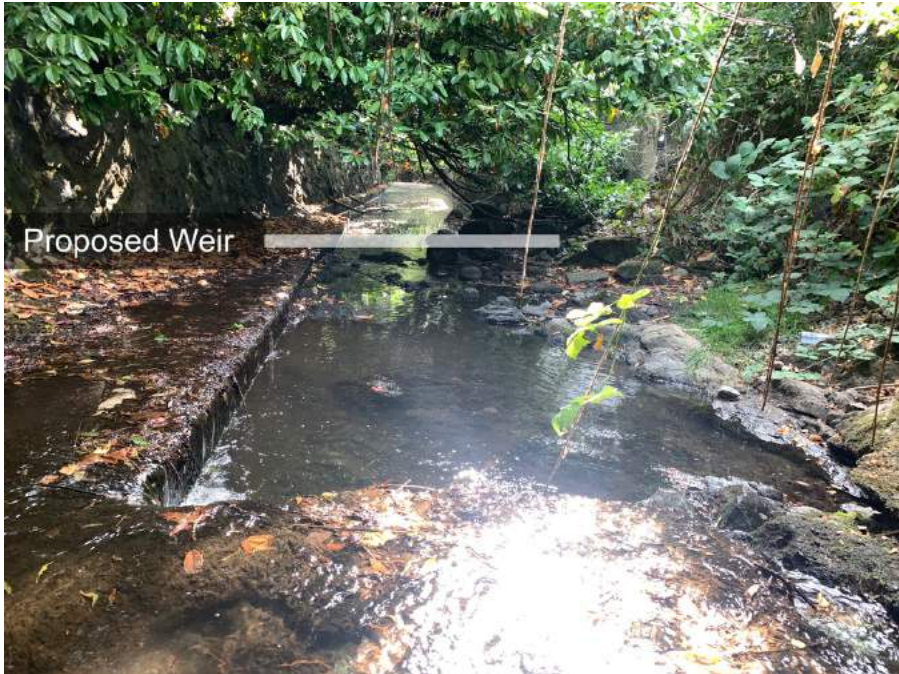
Photo 1A-12. Downstream end of Beach Drive culvert, weir proposed to improve fish passage.

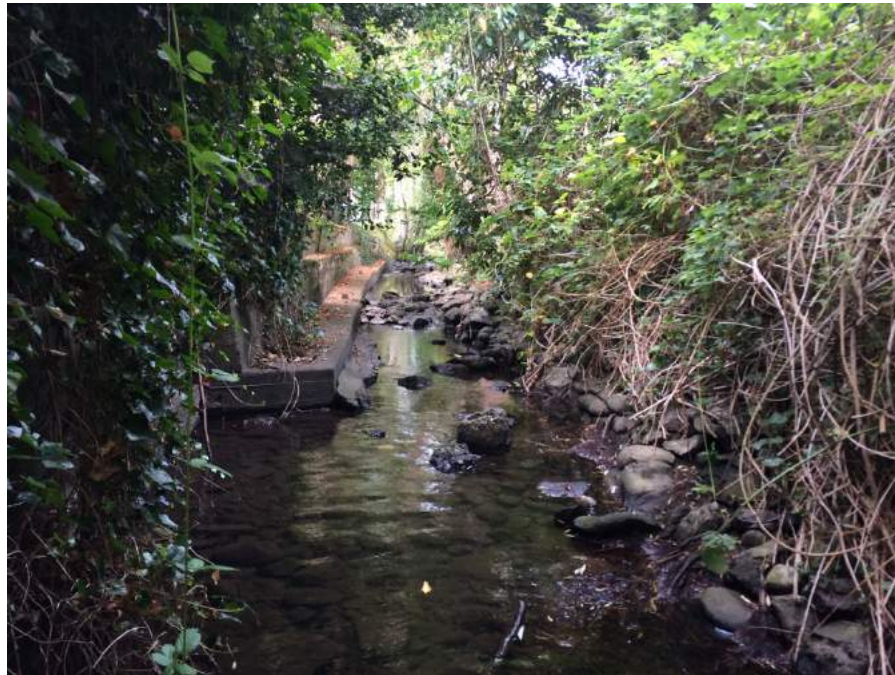
Photo 1A-13. View upstream from Beach Dr culvert: ivy on the concrete wall at 1762 Beach Dr and eroding bank and ivy at 1776 Beach Dr.

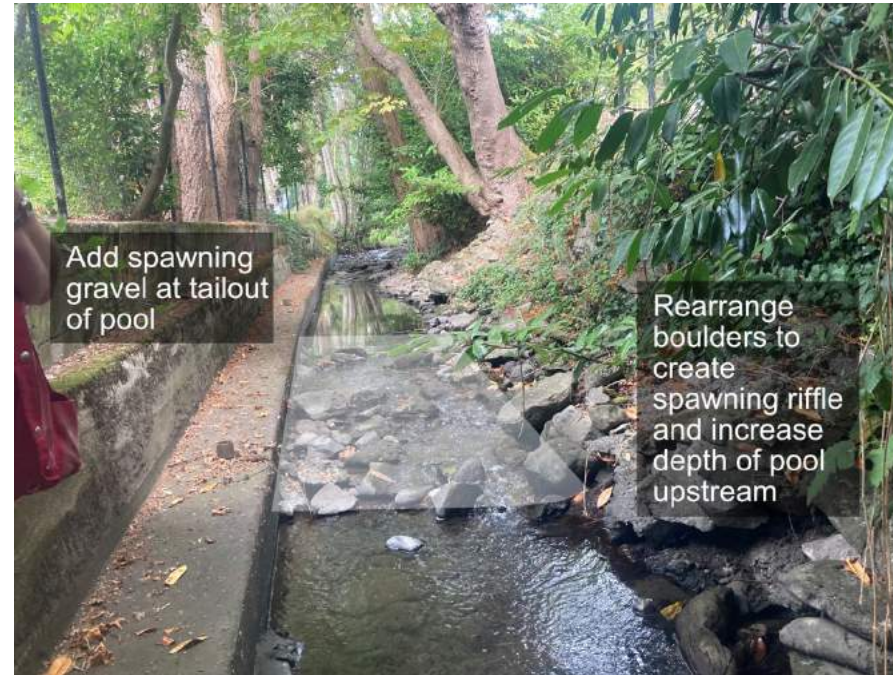
Photo 1A-14. Proposed improvements for fish passage at 1776 Beach Drive, near upstream end of the reach (view upstream).

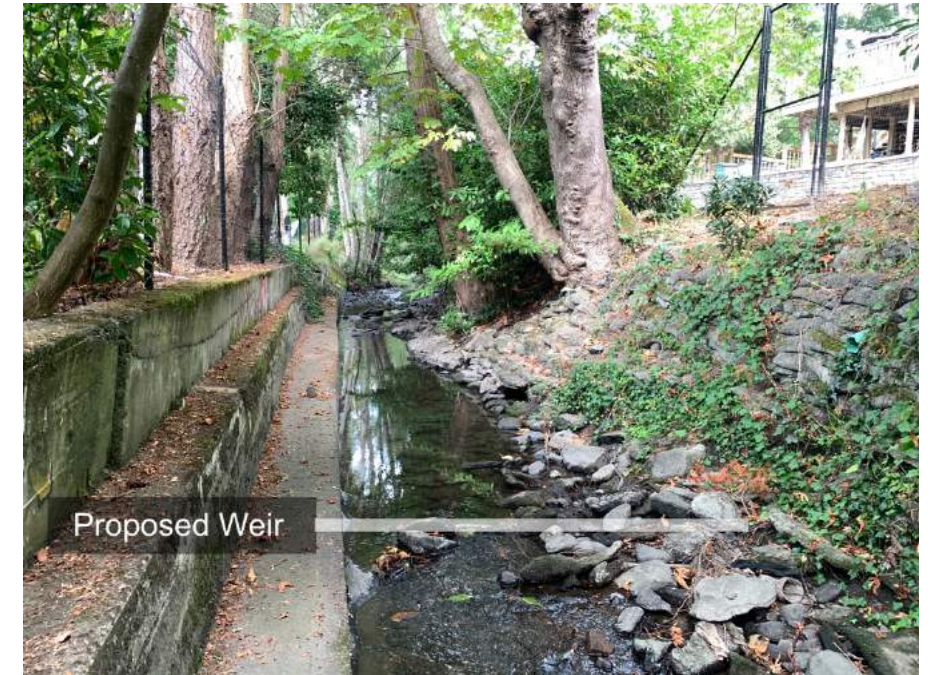
Photo 1A-15. Proposed weir for fish passage at 1776 Beach Drive, near upstream end of the reach (view upstream).

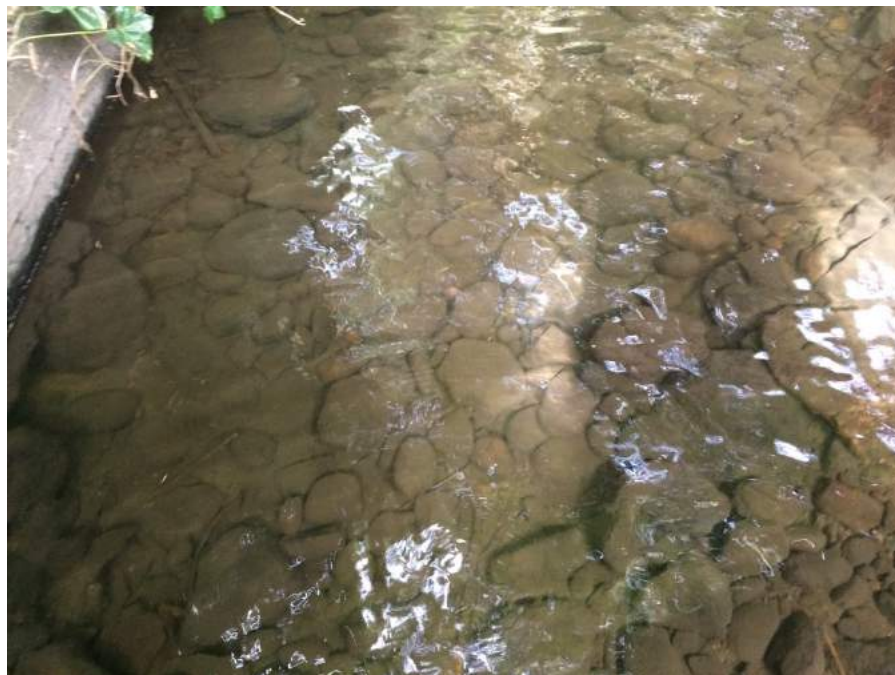
Photo 1A-16. Heavily silted cobble substrate upstream of Beach Drive.

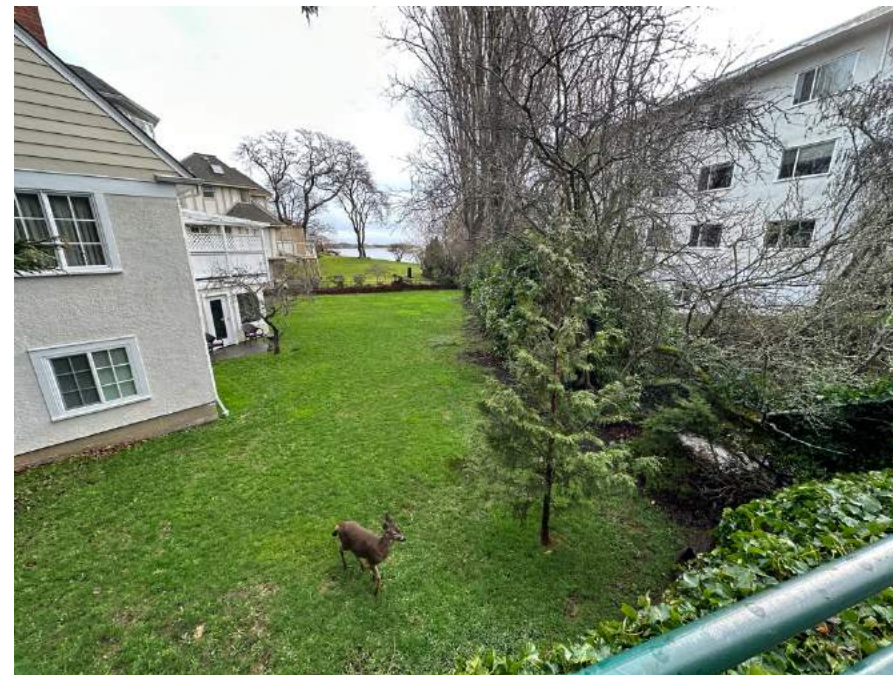
Photo 1A-17. The vegetated riparian area in this reach is very narrow, with lawns extending almost to the edge of the creek (view of north bank downstream from Beach Drive).

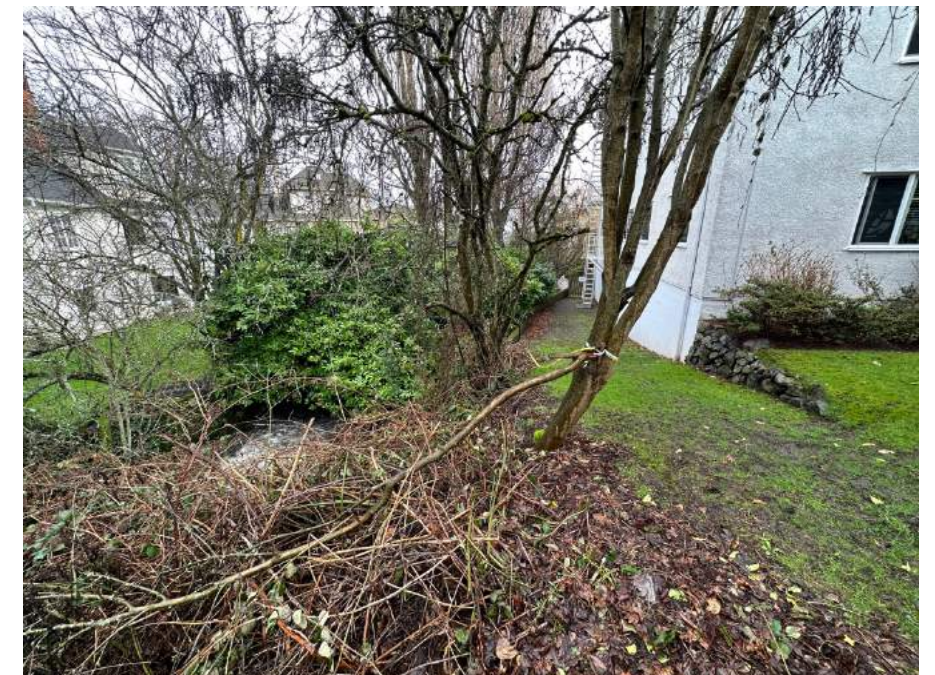
Photo 1A-18. The vegetated riparian area in this reach is very narrow, with development extending almost to the edge of the creek. Warning tape flags off a recent tree blowdown (view of south bank downstream from Beach Drive).

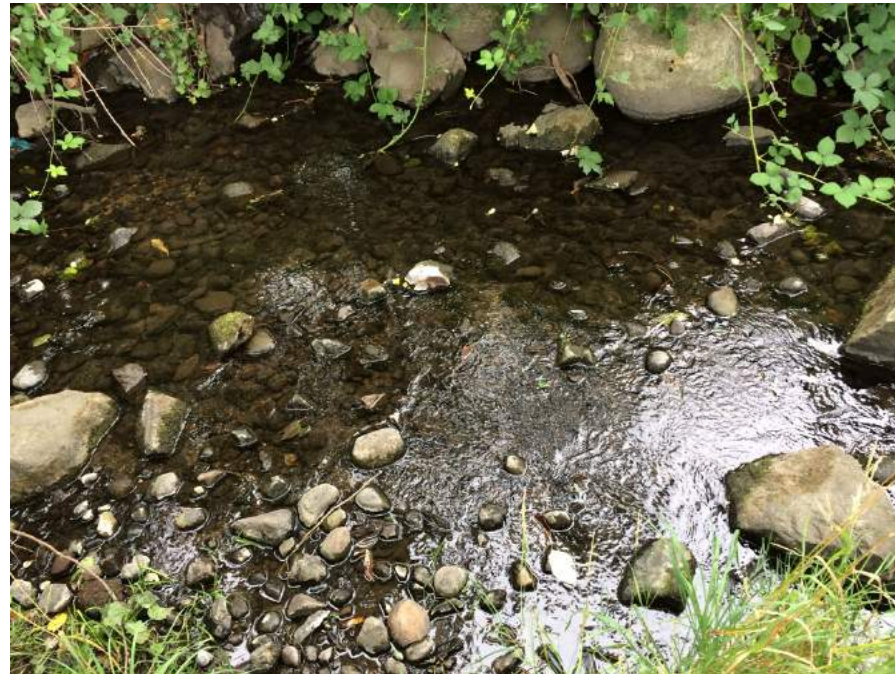
Photo 1B-2. Cobble and occasional boulder creek bottom, with possible areas for stone weirs and gravel spawning beds.

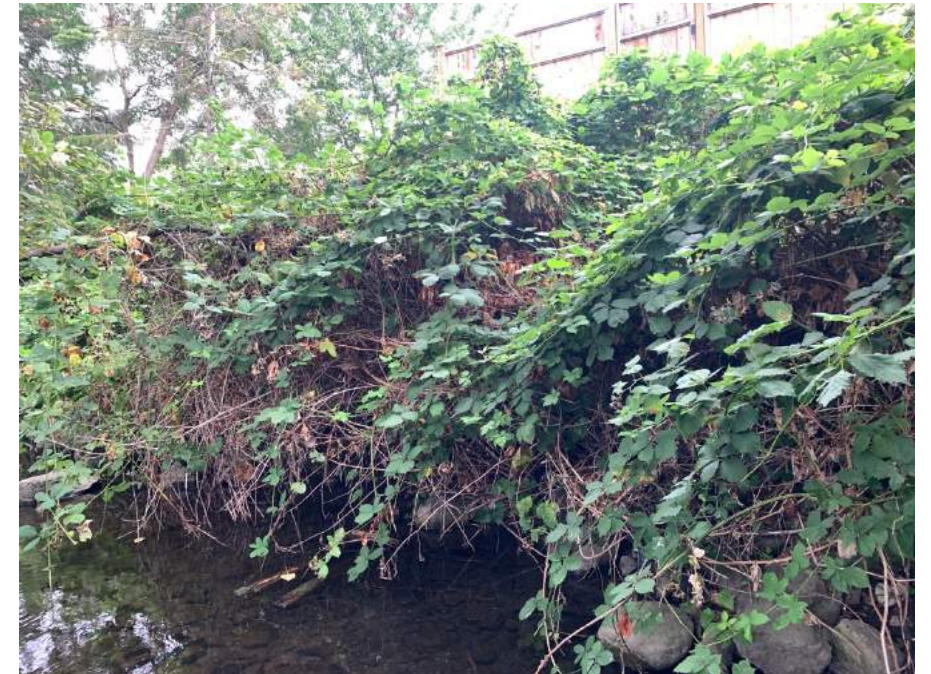
Photo 1B-3. Himalayan blackberry on North Bank (1790 Beach Dr and 2657 Cranmore Rd)(view upstream).

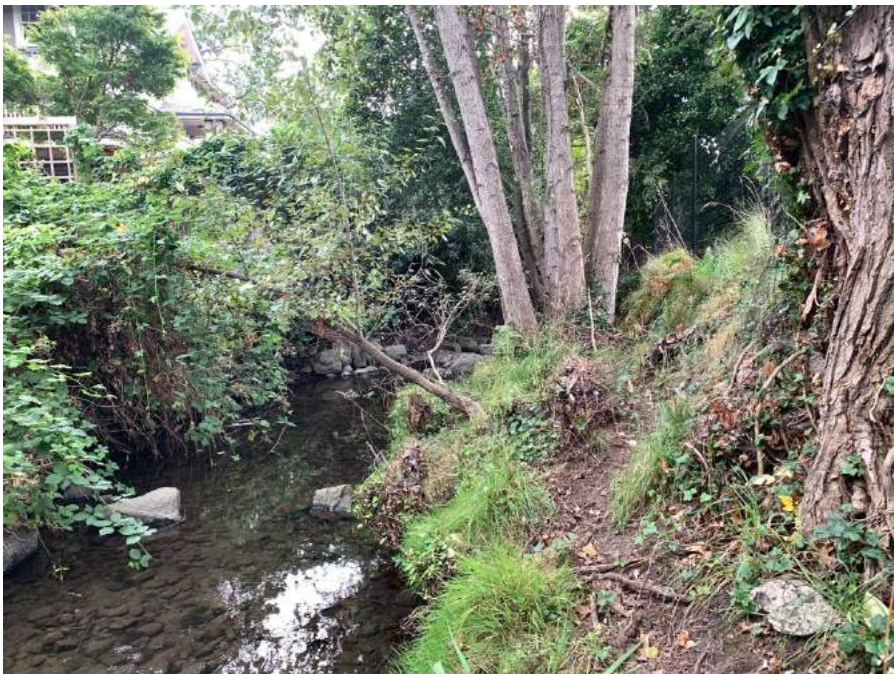
Photo 1B-4. Trees and less steep soil bank on south bank (2660 Shady Lane)(view downstream).

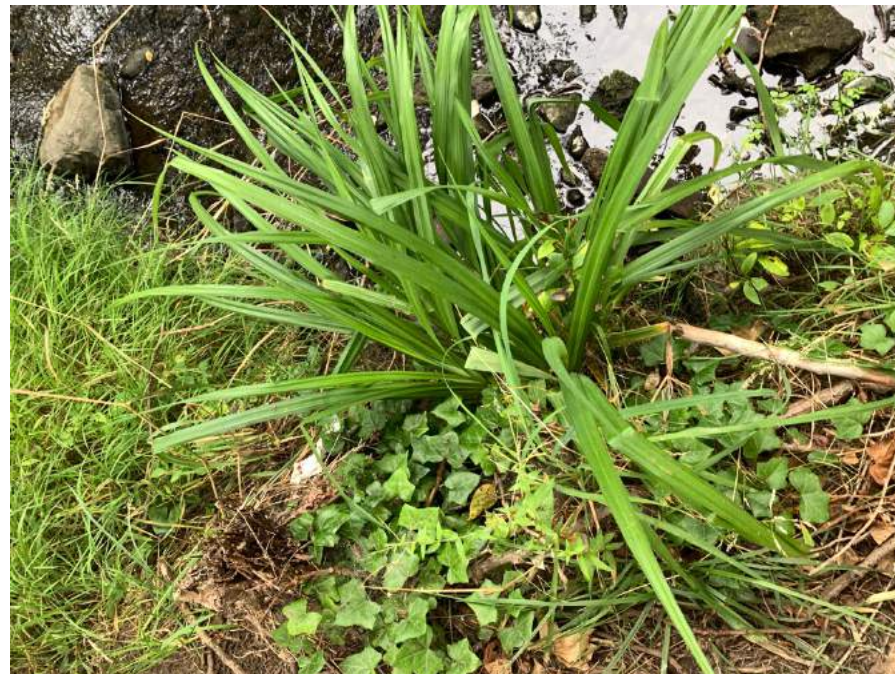
Photo 1B-5. Hanging sedge, new invasive species south bank (2660 Shady Lane).

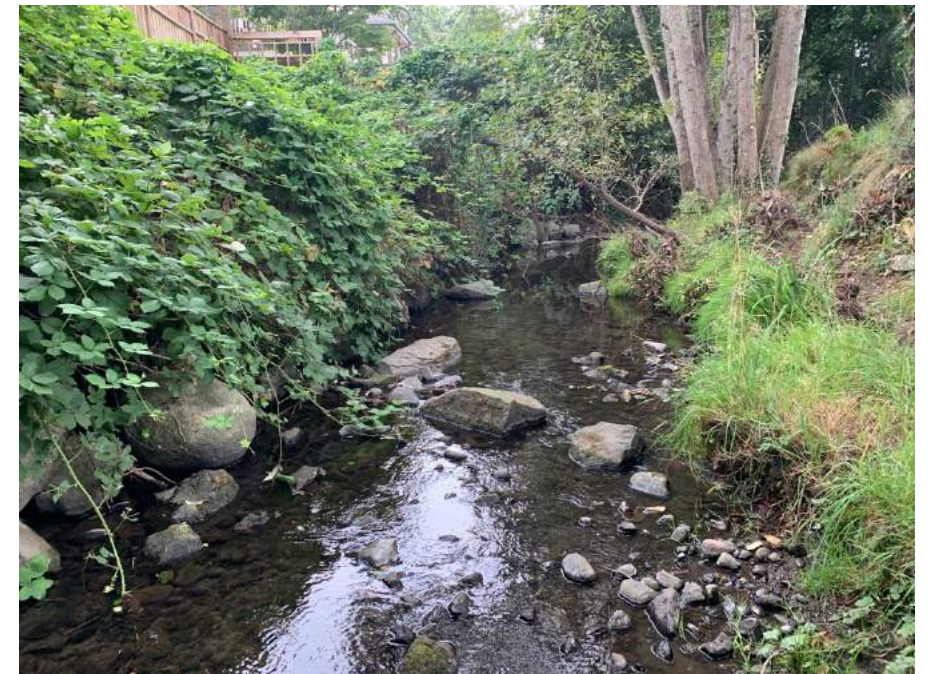
Photo 1B-6. Himalayan blackberry on north bank (2657 Cranmore Rd), and cobble and boulder channel bottom. Fish habitat improvements: enhance existing stone lines into weirs and add spawning gravel on upstream side (view downstream).

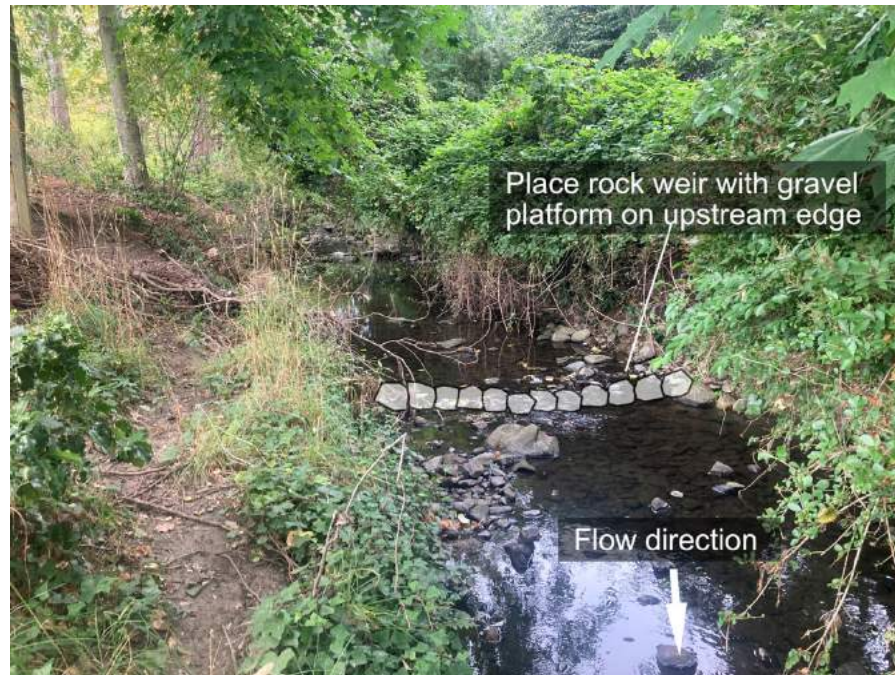
Photo 1B-7. Cobble/boulder channel bottom with fish habitat improvements: enhance existing stone lines into weirs and add spawning gravel on upstream side (view upstream).

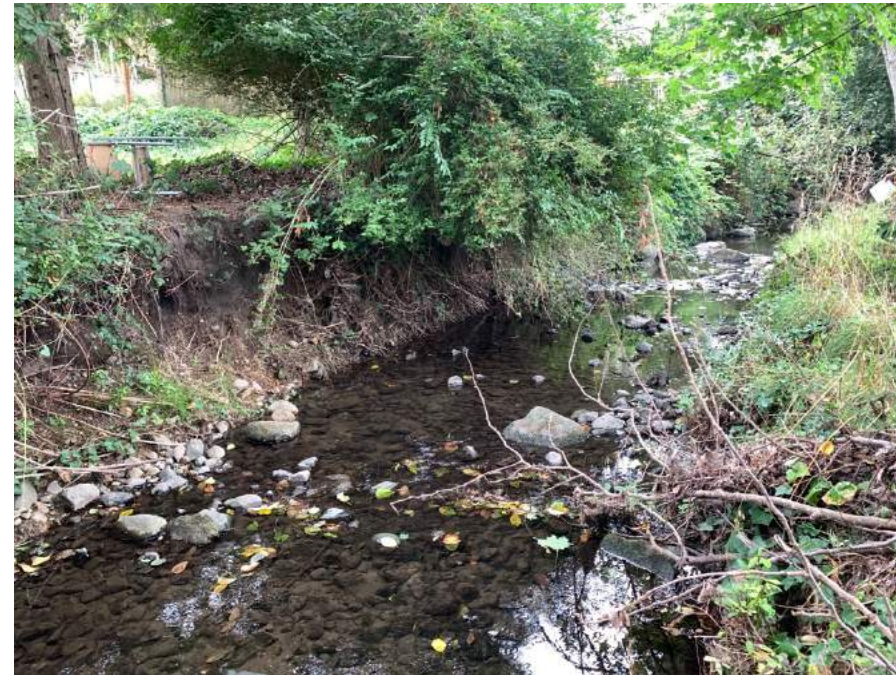
Photo 1B-8. Overhanging and eroding bank at 2645/2647 Cranmore Road (view downstream).

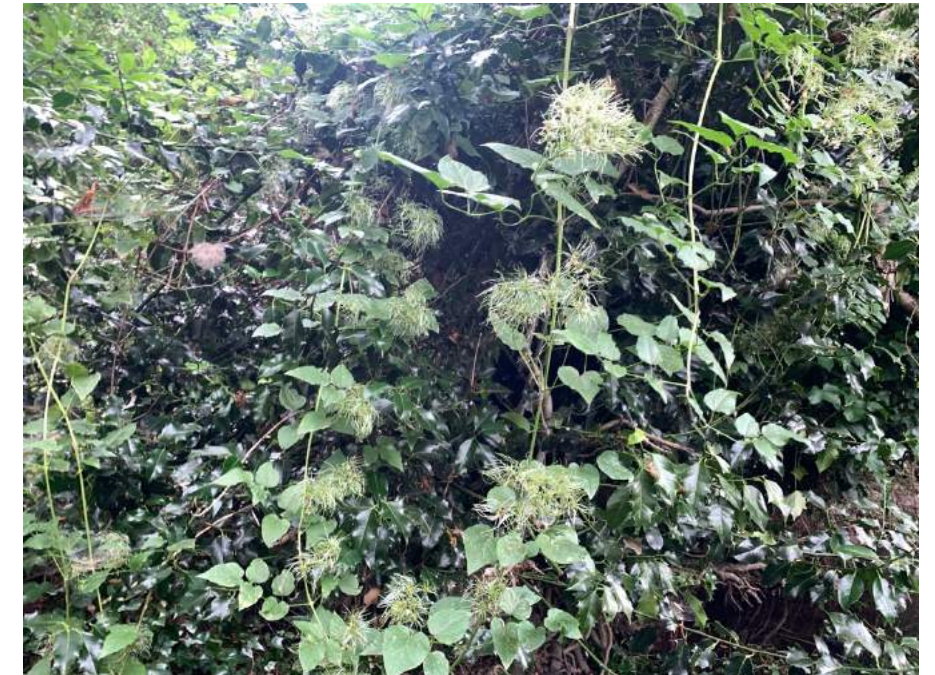
Photo 1B-9. English holly and traveler's joy clematis on north bank.

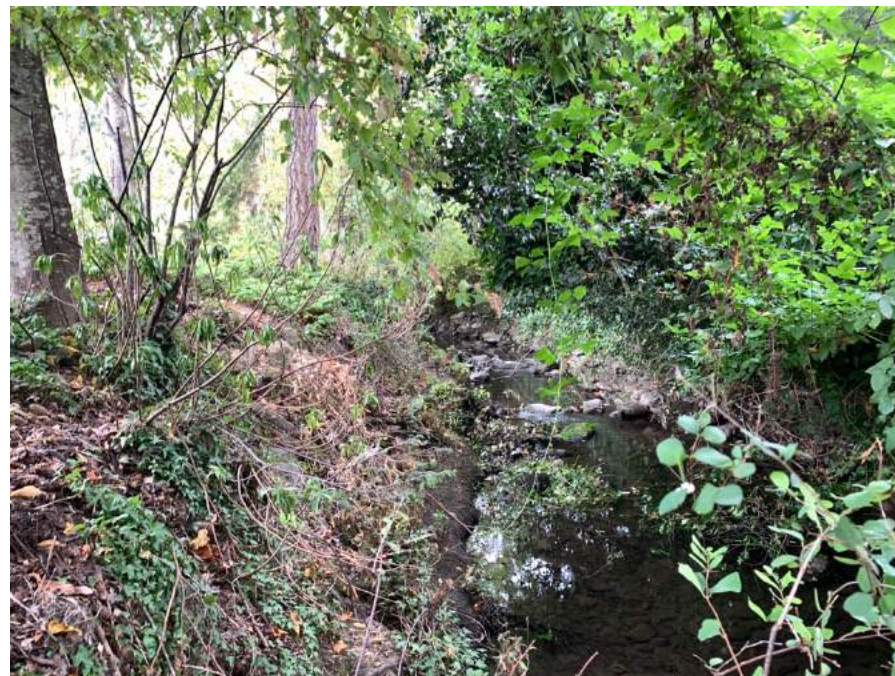
Photo 1B-10. Steep banks, English ivy, traveler's joy, English holly (2645 Cranmore Road)(view upstream).

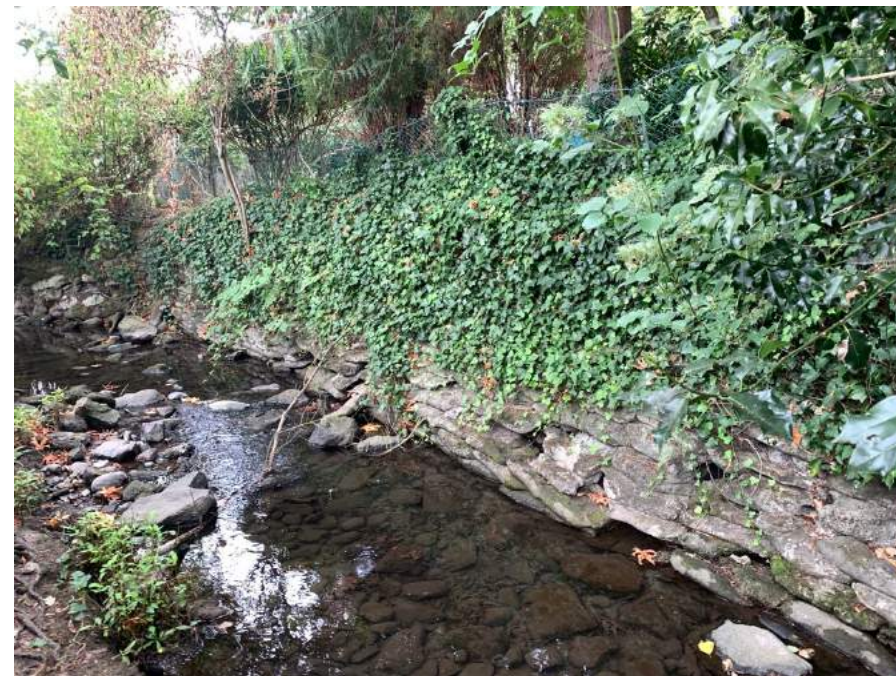
Photo 1B-11. English ivy and concrete sandbags on the north bank at upstream end of Reach 1B (2645/2647 Cranmore Road) (view upstream).

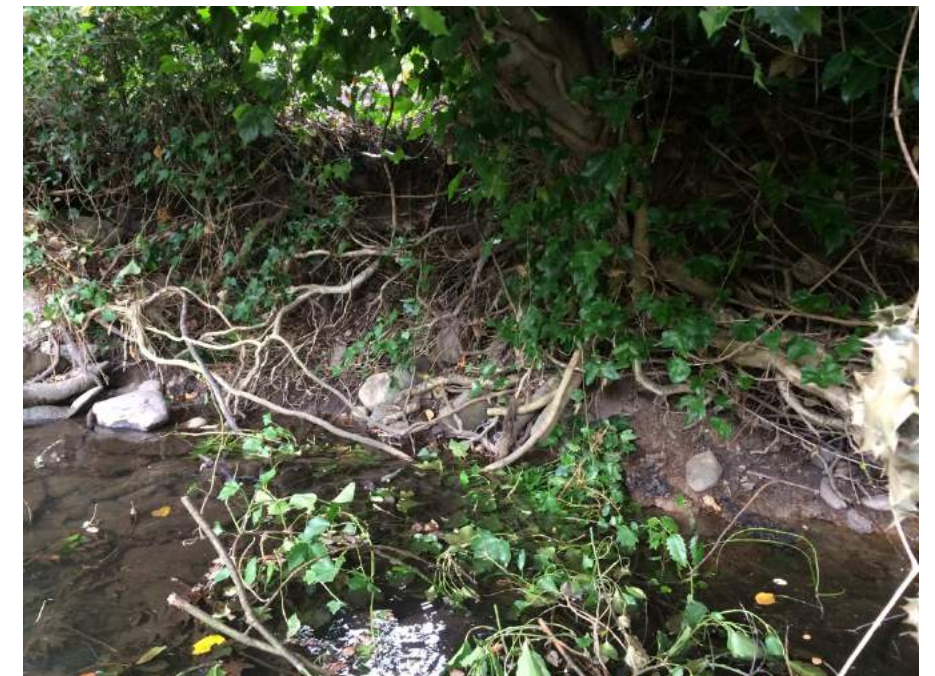
Photo 1B-12. Large diameter English ivy strangling trees (north bank).

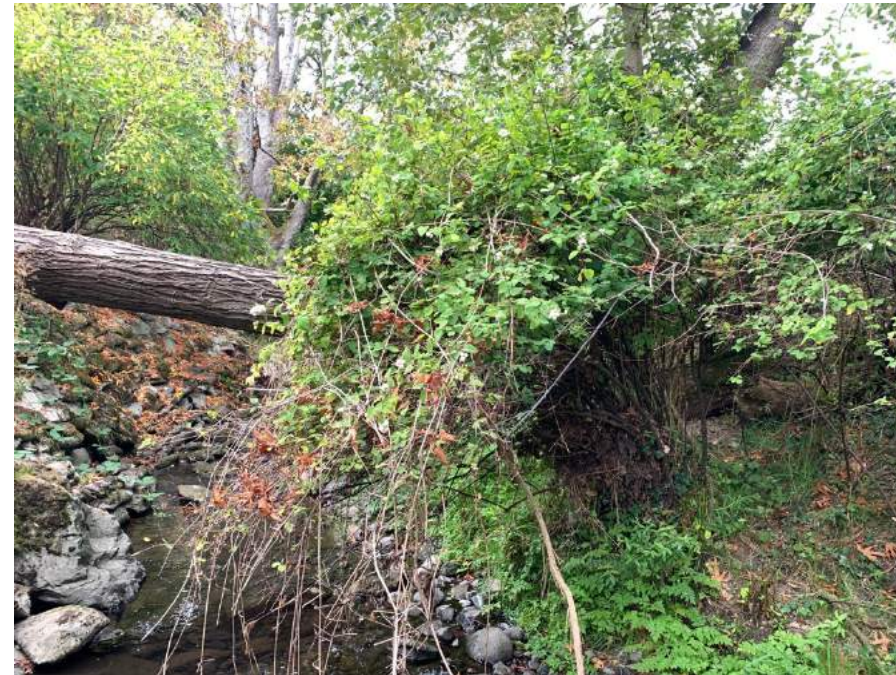
Photo 1C-2. Traveler's joy over native shrubs on the north bank (view upstream).

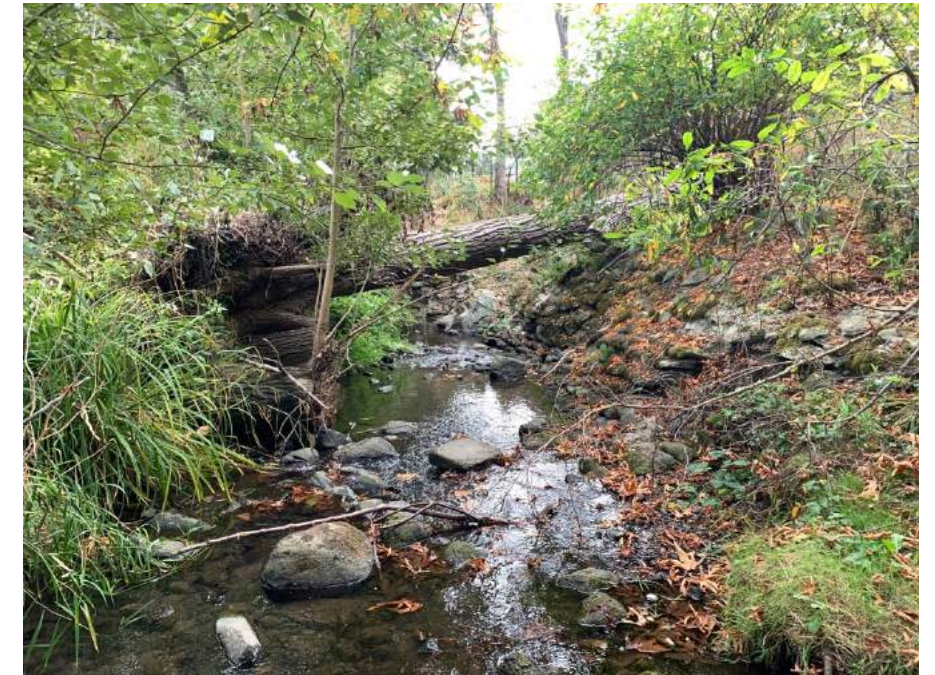
Photo 1C-3. Native vegetation and tree over the channel, some invasive species (traveler's joy, hanging sedge)(view downstream).

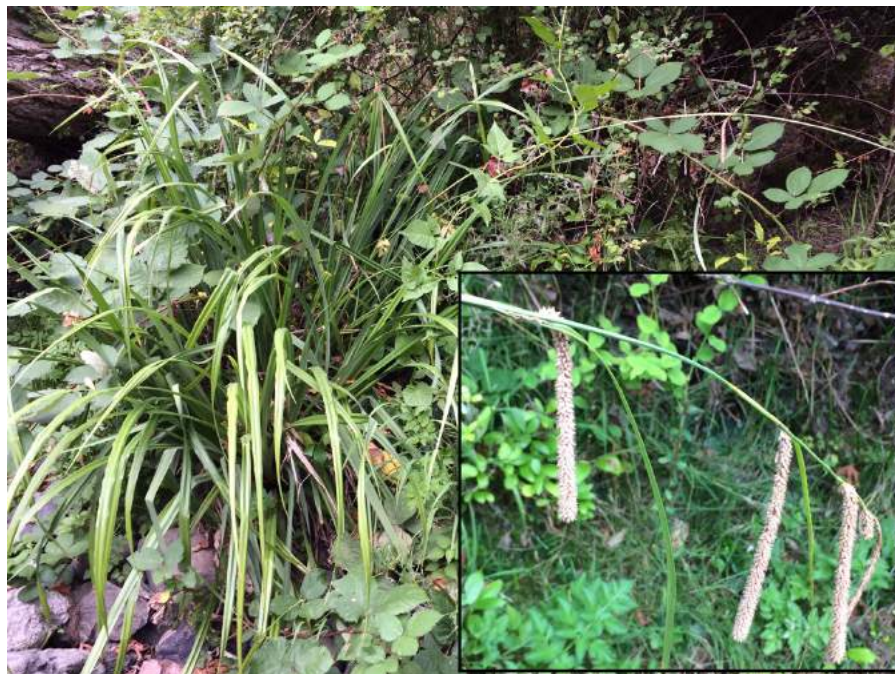
Photo 1C-4. Hanging sedge (new invasive species) on north bank, near downstream end of Reach 1C (near fallen tree over the channel).

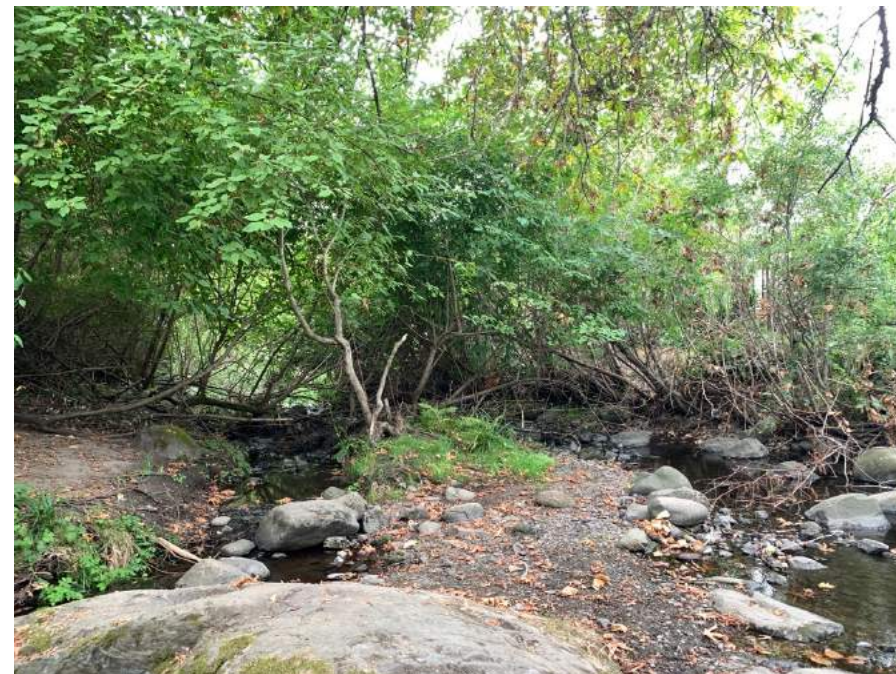
Photo 1C-5. Bedrock in the channel, with gravel/sand bar, with red-osier dogwood and willow on the bank (view upstream). Willows are remnants of bioengineering that was installed (approx. 2009).

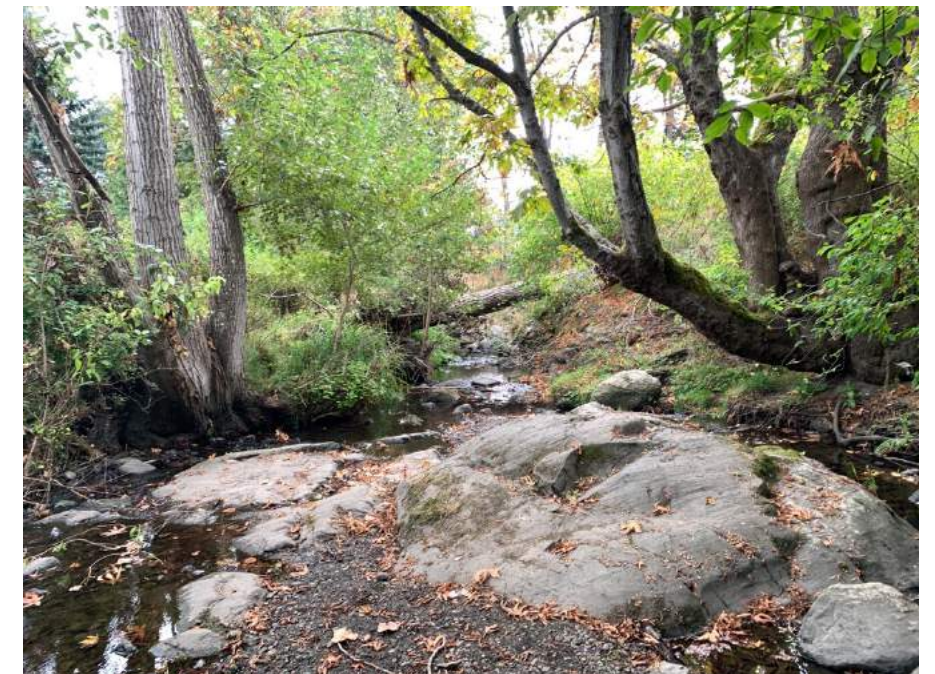
Photo 1C-6. Bedrock in the channel, with gravel/sand bar, with red-osier dogwood and willow on the bank (view downstream).

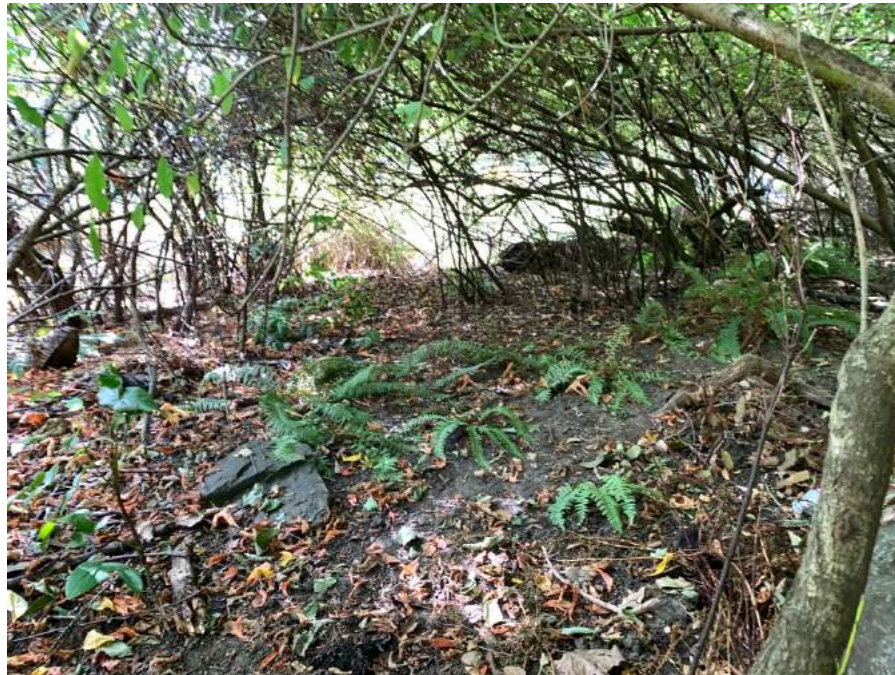
Photo 1C-7. Invasive species removal area (Friends of Bowker Creek) with understory plantings.

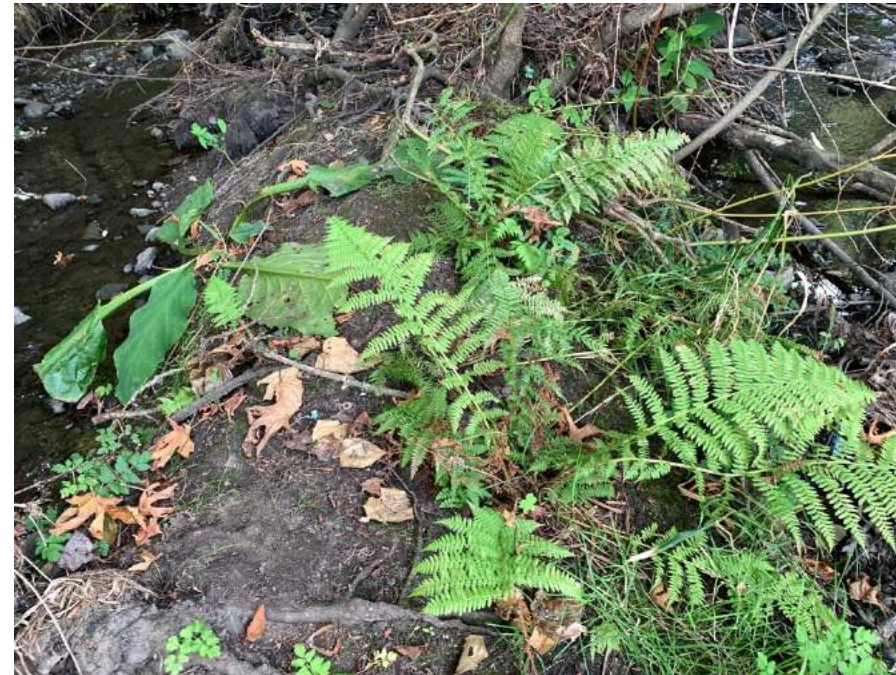
Photo 1C-8. Lady fern and skunk cabbage in the riparian area.
