TABLE OF CONTENTS

BOWKER CREEK ASSESSMENT SUMMARY

REACH 1A
Reach # 1A – Creek mouth into Oak Bay to upstream (west) end of 1776 Beach Drive) (140m) 2733, 2717, and 2713 Somass Drive; 1725, 1762, and 1776 Beach Drive (privately owned)
Channel Description Channel banks are primarily concrete, mortared rock and concrete sandbags (Photos 1-6,8-10,12-15). The channel bottom is a mix of bedrock, heavily silted substrate of sand, gravel, cobble, and boulders, and extensive concrete and asphalt armouring (Photos 3,8,9,12,13,16). Thick algal mats and root mats from golden willow are present. Vertical armoured banks 1-2m tall, channel width 3.0m – 5.5m, wetted width 0.4m-3.5m (summer). The creek is channelized and straightened with a gradient range from 1.5-4% with a narrow strip of riparian vegetation (Photos 17 & 18). There is a 22m long pool downstream of the culvert which is suitable as a holding location for juvenile fish prior to entering the marine environment, and also for adults entering the stream to hold while awaiting higher flows and while maturing. Tidal influence occurs downstream of Beach Drive. Concrete box culvert at Beach Drive (3.0m wide x 2.2m tall x 15m long). Small a

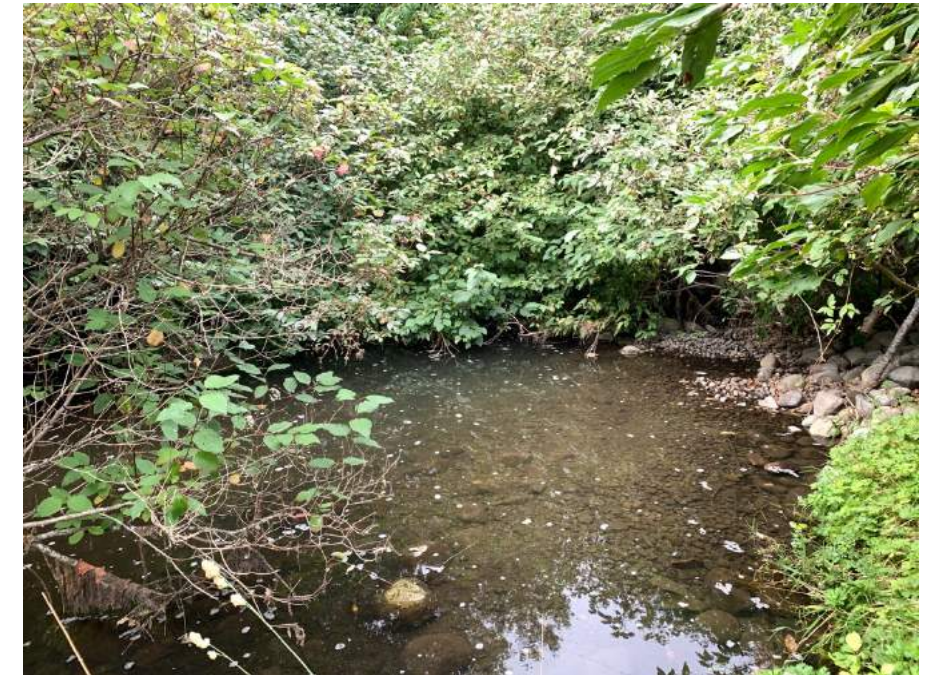
Photo 1C-9. Pool at upstream end of Reach 1C, location of chum incubation area and spawning gravels (view upstream).

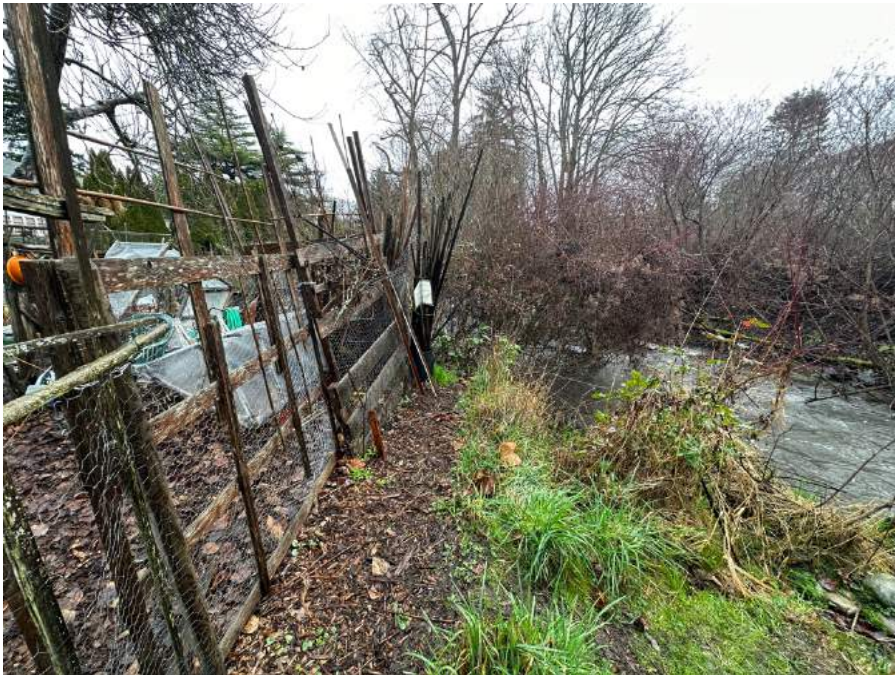
Photo 1C-13. The community gardens at Monteith extend right to the north bank of the creek with <1m to top of bank. A wider riparian buffer here of native vegetation would benefit water quality and reduce potential spread of garden escapees (view downstream).

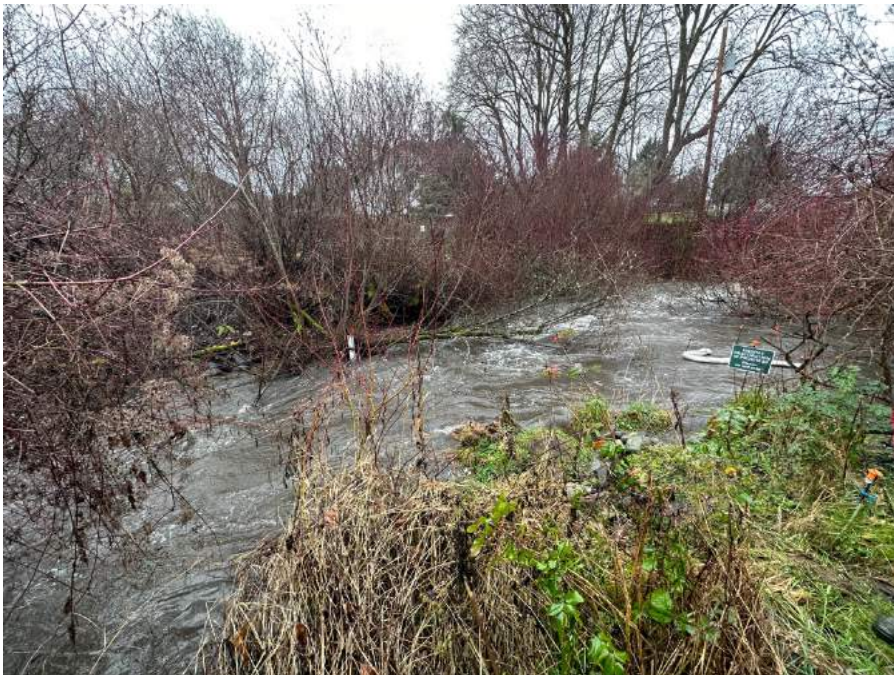
Photo 1C-14. The community gardens at Monteith extend to the edge of the creek. Much of the garden area closest to the creek is used for storage of tools and materials (view downstream).

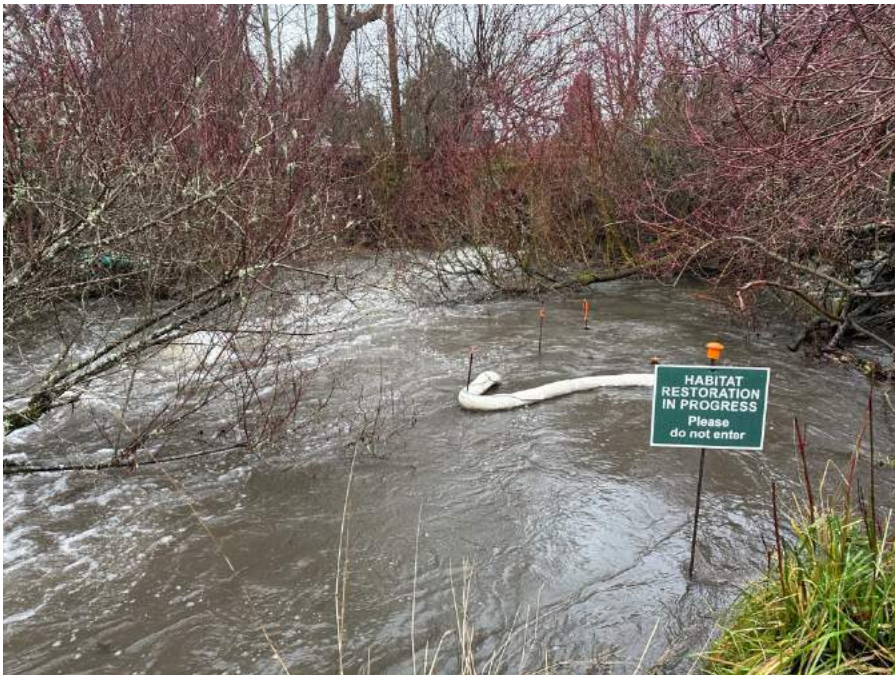
Photo 1C-15. The area of chum egg placement is subject to periodic oil spills (oil booms in upper right). Winter flows have large impacts, especially at the lowest reaches (view upstream from community gardens)

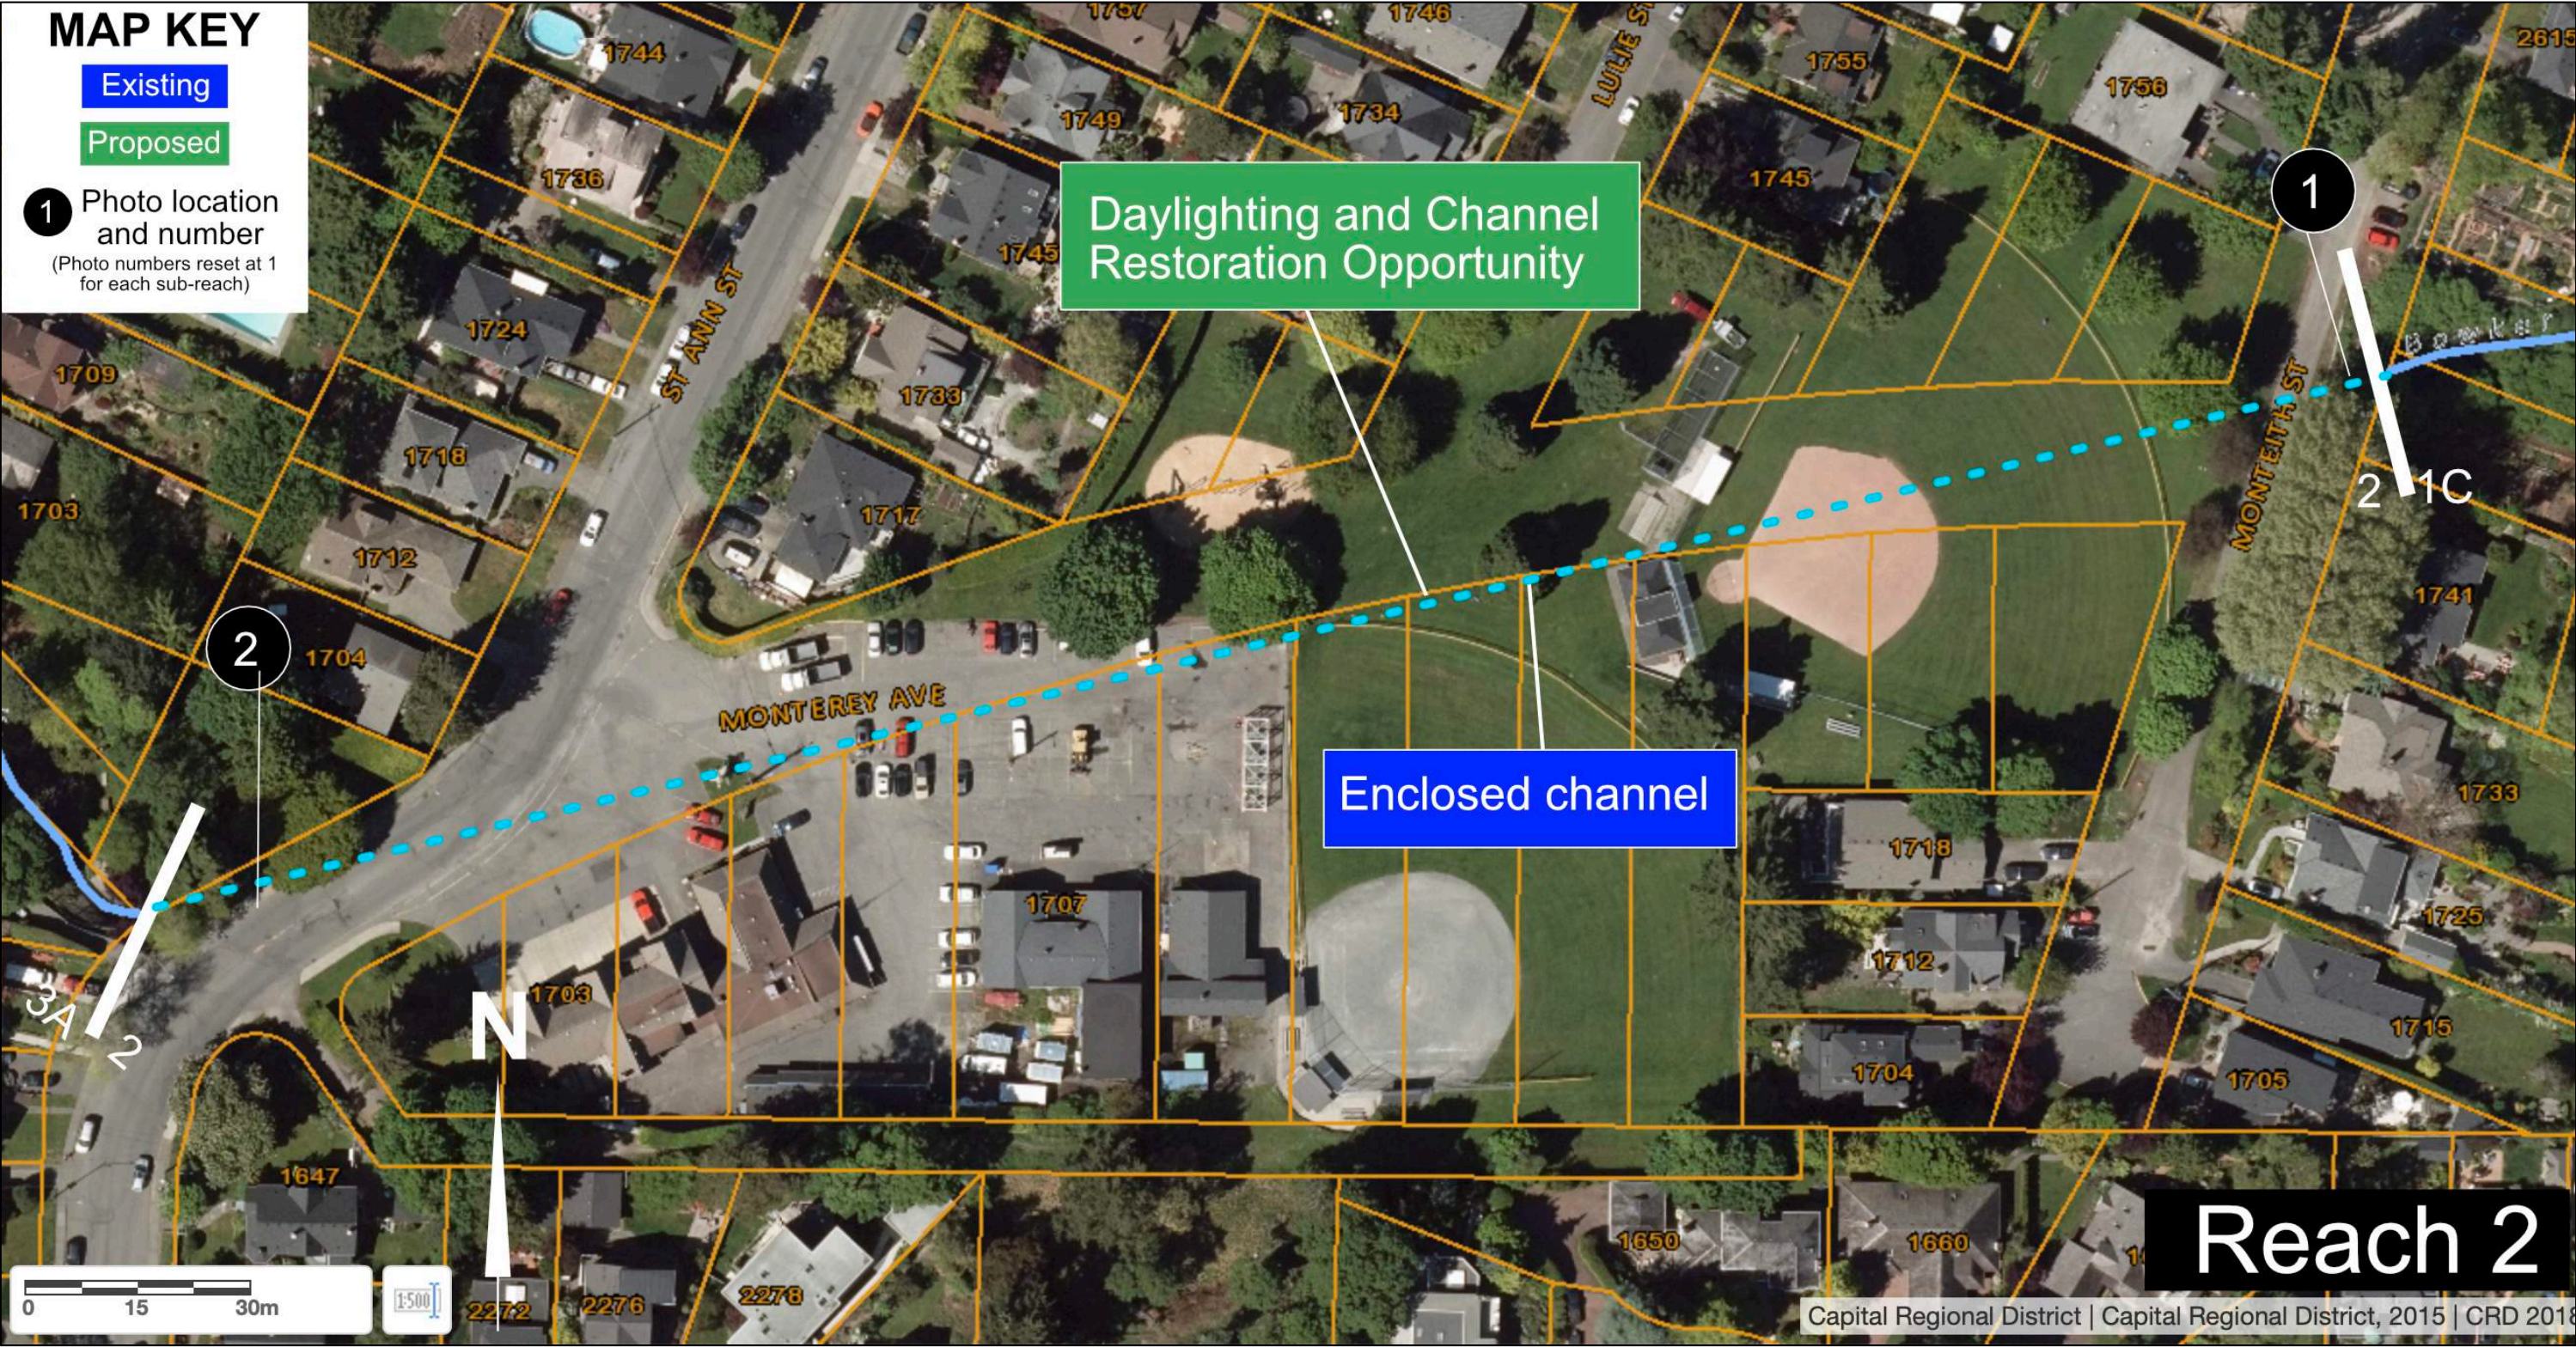
Photo 1C-16. The area of chum egg placement is subject to periodic oil spills (oil booms at right). Winter flows have large impacts, especially at the lowest reaches (view upstream from community gardens)

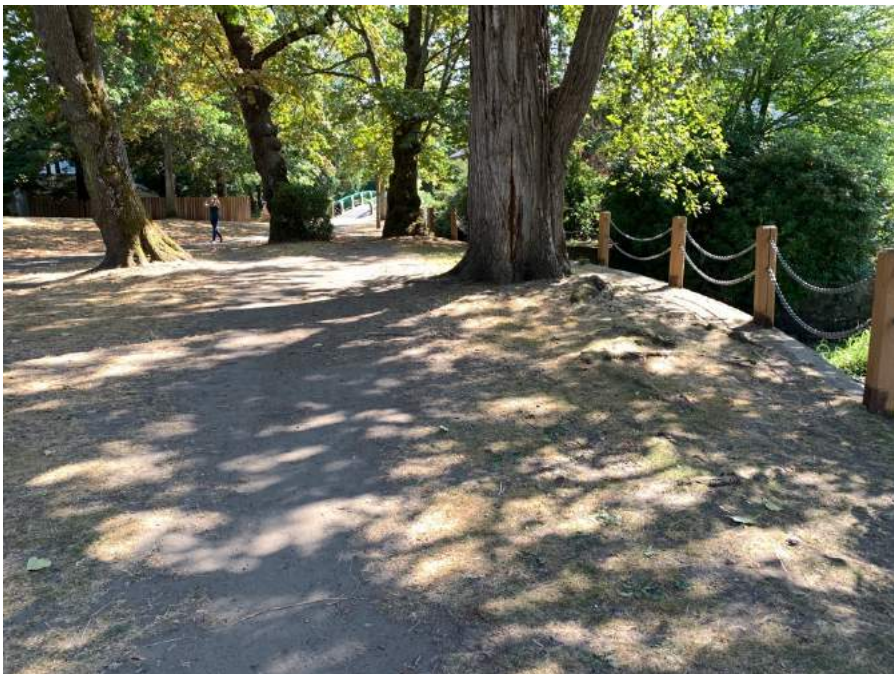
Photo 3A-3. Potential pilot project location for concrete wall removal and restoration of channel and slope upstream from Hampshire Road.

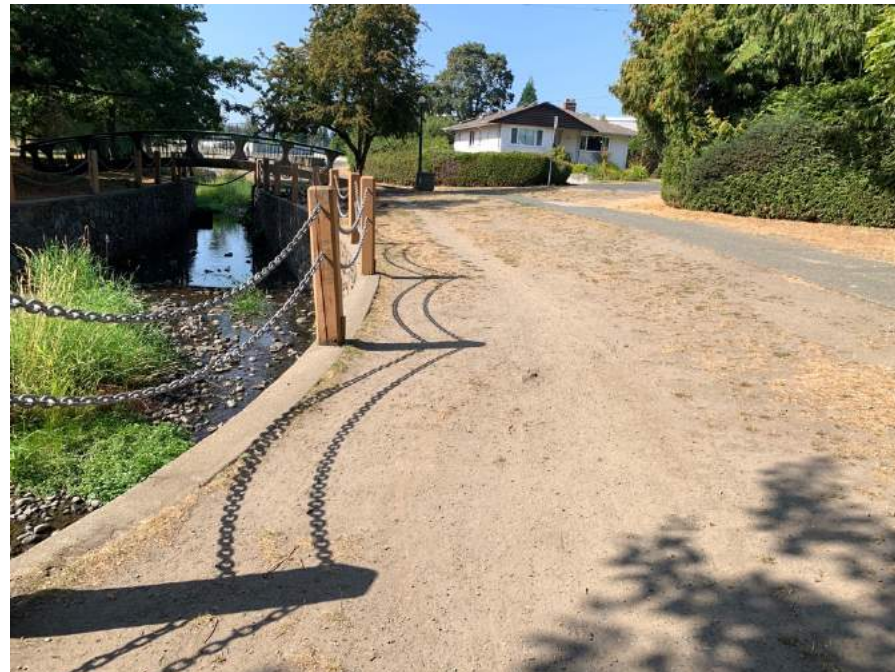
Photo 3A-4. Example of where formal paths are bypassed and creek side vegetation is trampled (view downstream).

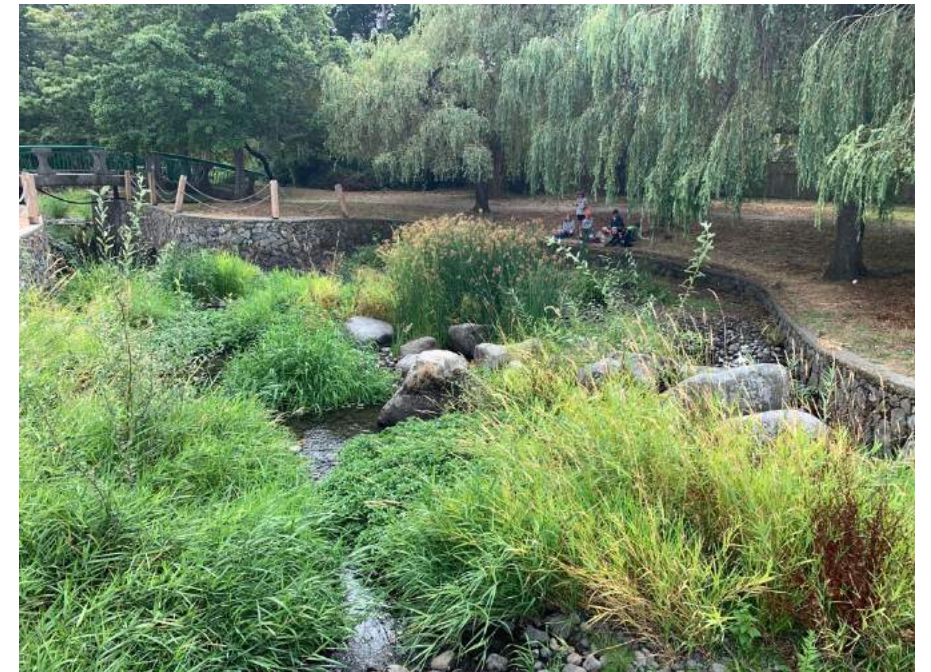
Photo 3A-5. Example of where formal paths are bypassed and creek side vegetation is trampled (view upstream) (see Photo 3A-15 for new plantings here).

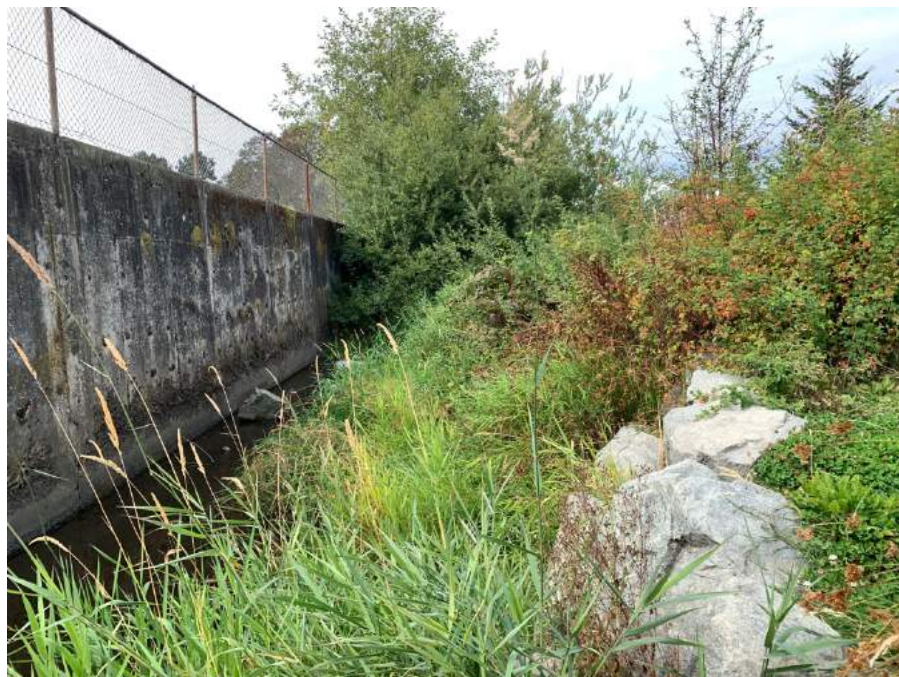
Photo 3B-1. Downstream end of Reach 3B, Himalayan blackberry, traveler's joy, and European bittersweet (view downstream).

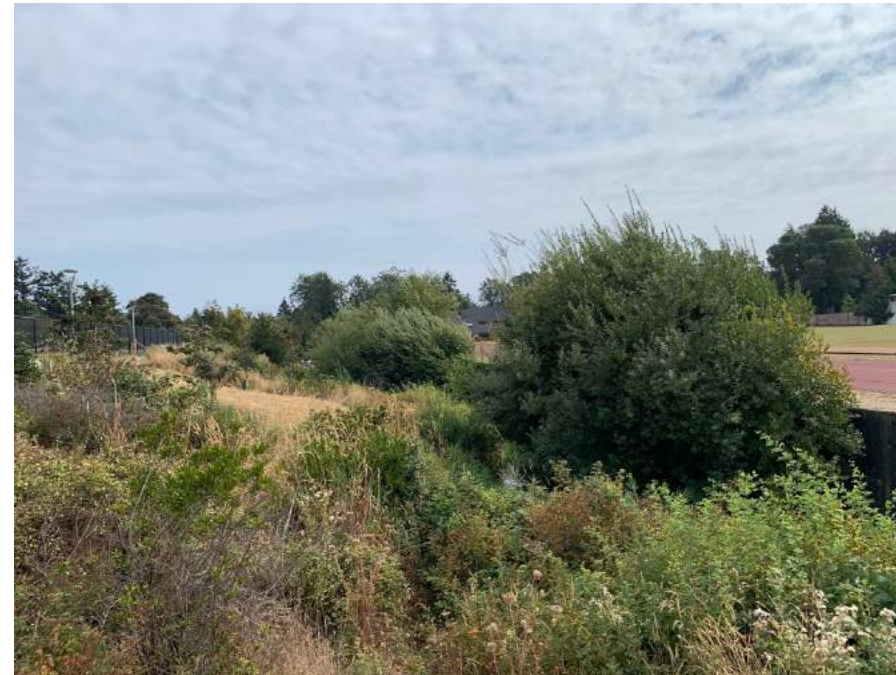
Photo 3B-7. Traveler's joy covering a tree at the upstream end of the reach (view upstream).

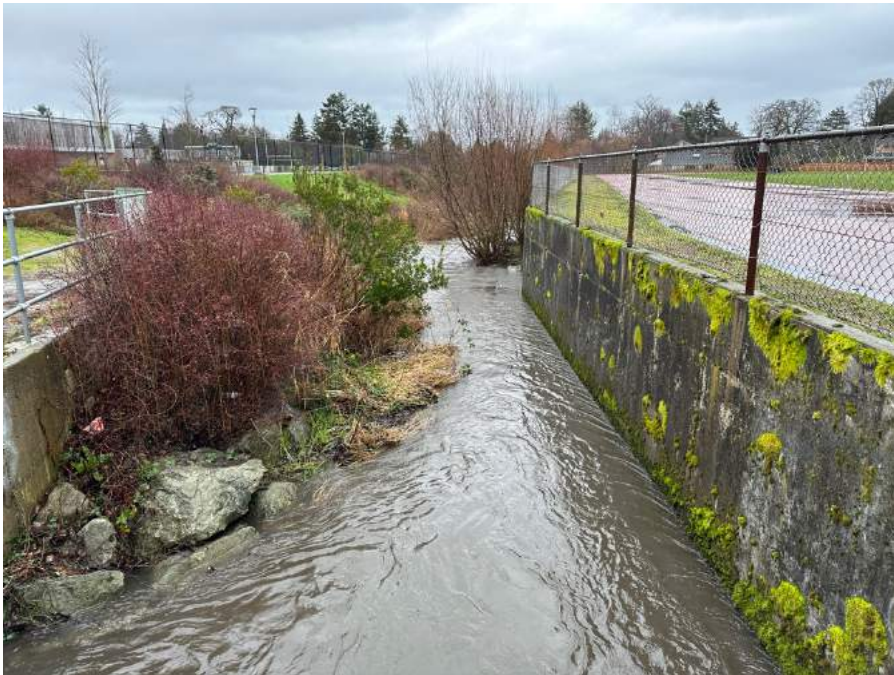
Photo 3B-12. Turbidity in creek, discharged into Reach 3B from Oak Bay Public Works Yard.

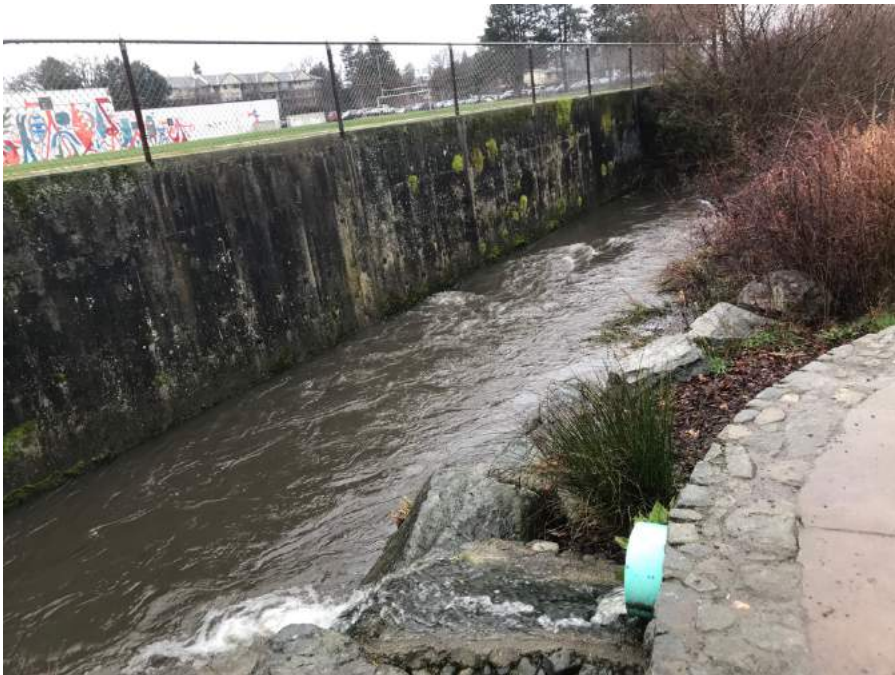
Photo 3B-16. Oil booms deployed for recent oil inputs (view south).

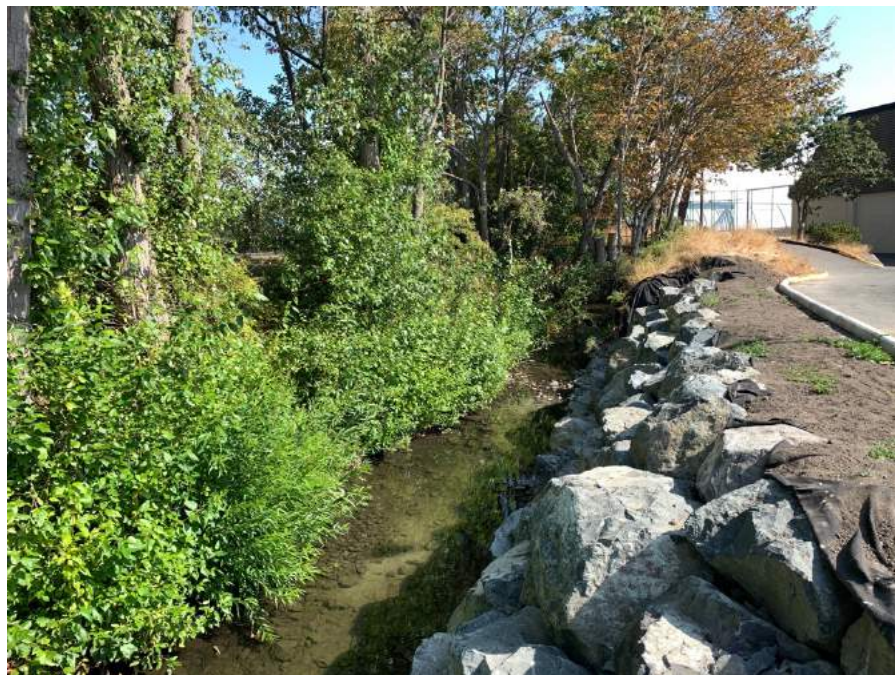
Photo 5A-3. Recent riprap erosion protection along the south bank and the Oak Bay Recreation Centre parking lot is immediately adjacent to the creek (view upstream).

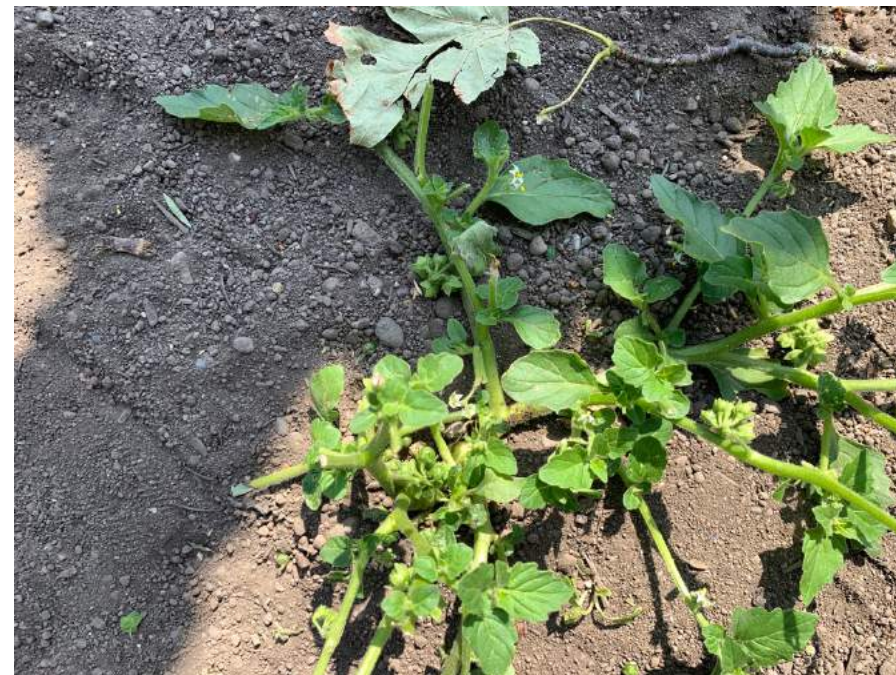
Photo 5A-5. Invasive European black nightshade establishing in topsoil at top of bank of the new erosion protection.

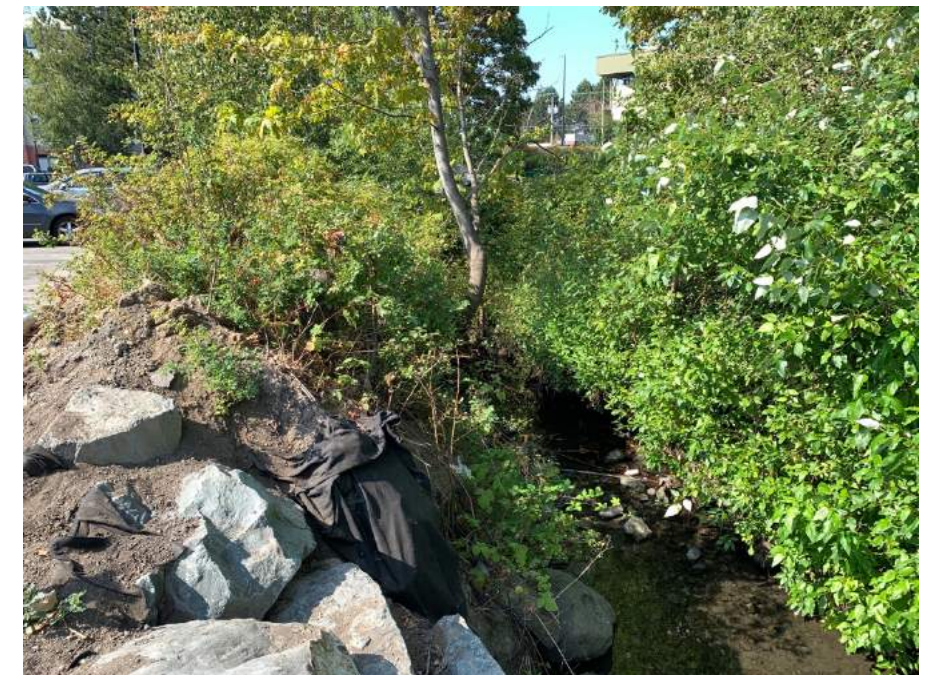
Photo 5A-6. Centre of the reach, steep banks, vegetated on both sides with a mix of native and non-native species (view upstream).

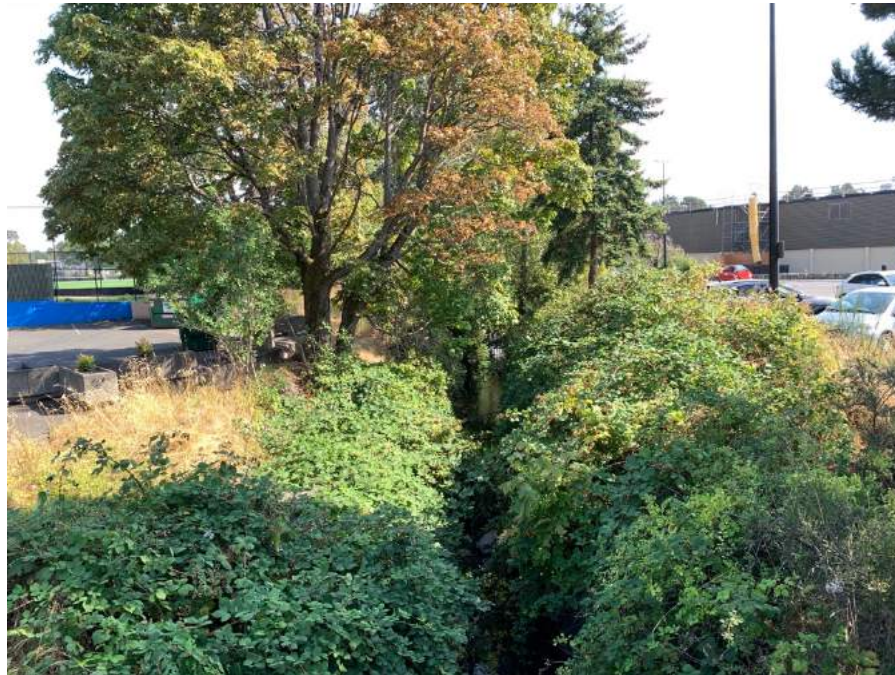
Photo 5A-7. Upstream end of the reach at Bee Street, vegetation dominated by Himalayan blackberry (view downstream).

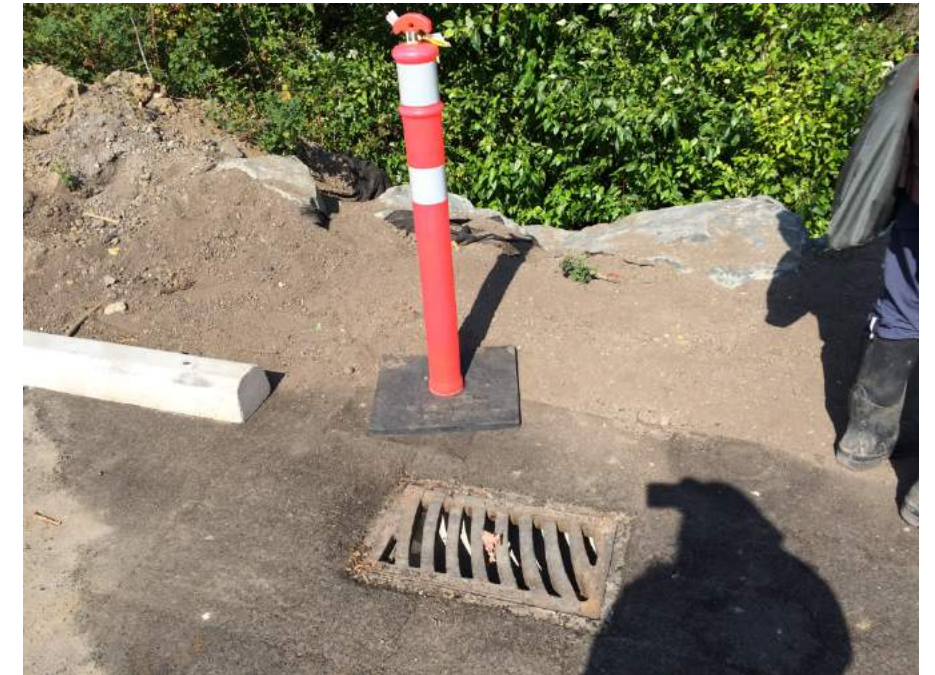
Photo 5A-9. Catchbasins adjacent to the creek in the new riprap erosion protection along the south bank: connection to oil/water separator infrastructure unknown.

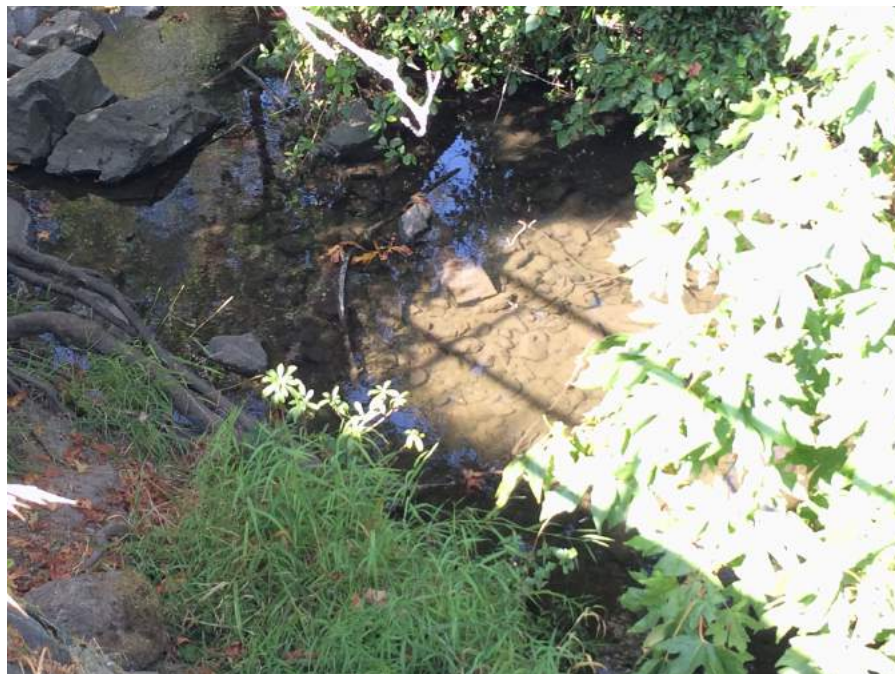
Photo 5A-10. The creek substrate is a mix of rounded cobble and large riprap and is highly silted (view slightly upstream).

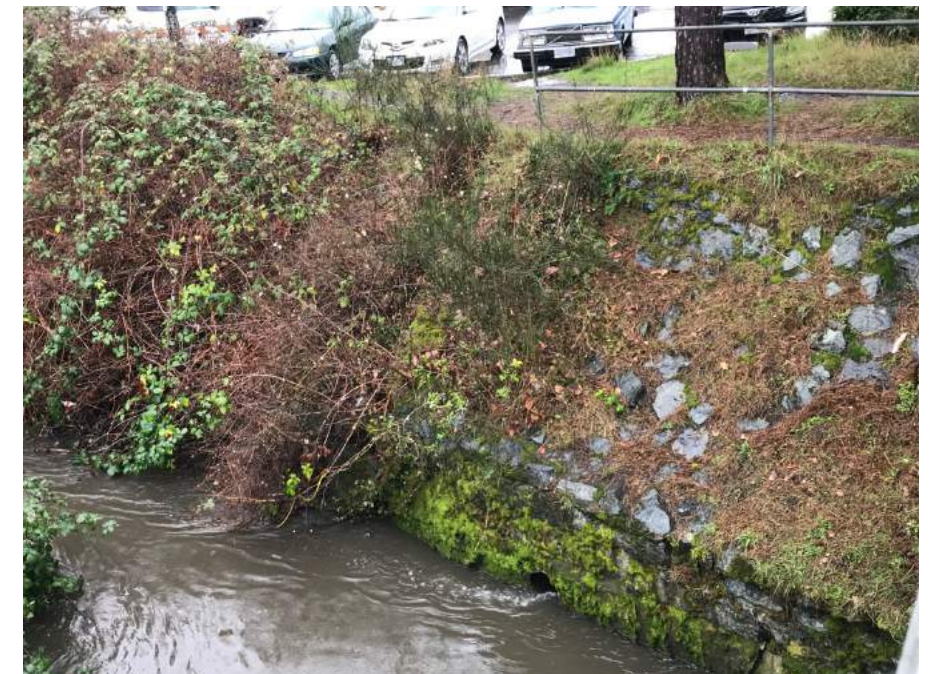
Photo 5A-12. South bank at Bee Street is a mortared rock wall overgrown with blackberry and Scotch broom (view south/downstream in winter flows). A stormdrain outlet from the parking lot is visible at the waterline.

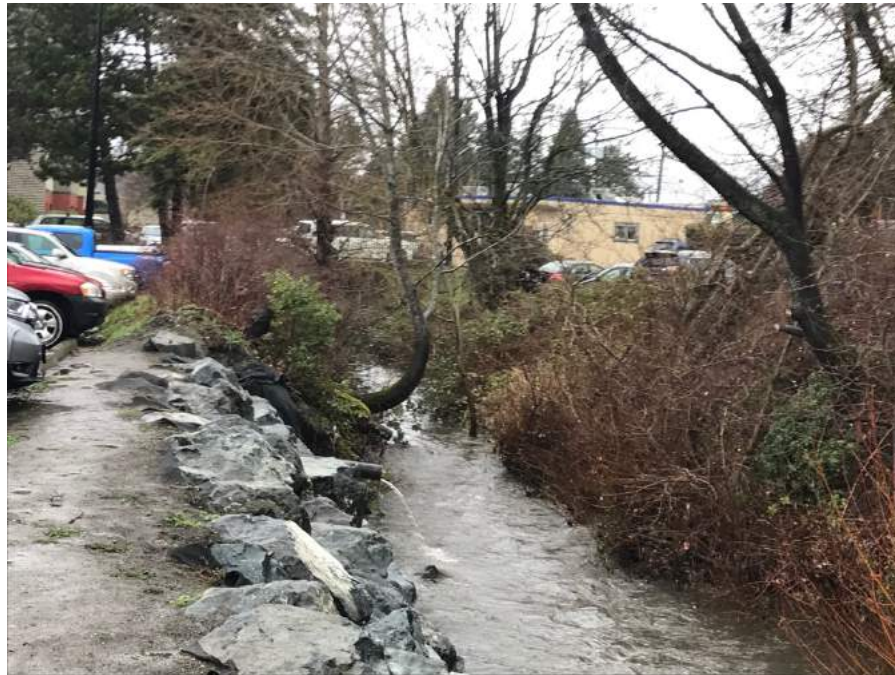
Photo 5A-13. Recent riprap erosion protection along the south bank and the Oak Bay Recreation Centre parking lot is immediately adjacent to the creek. The bowed tree trunk at centre left has had time to straighten its growth upward, indicating the slow ongoing slumping of this bank (view upstream in winter flows).

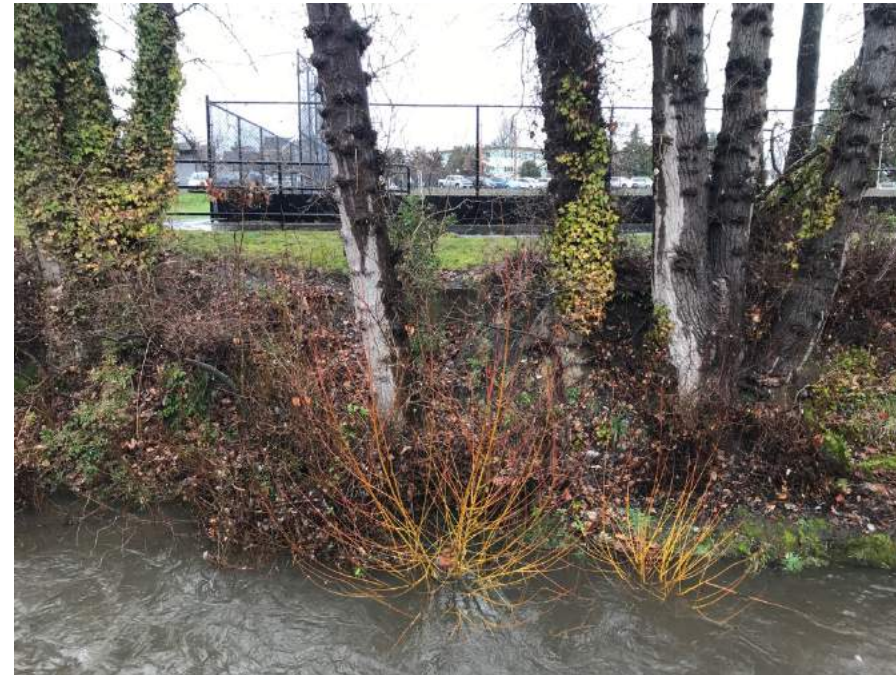
Photo 5A-14. In winter, the concrete retaining wall along the upper slope of the north bank is visible (see below).

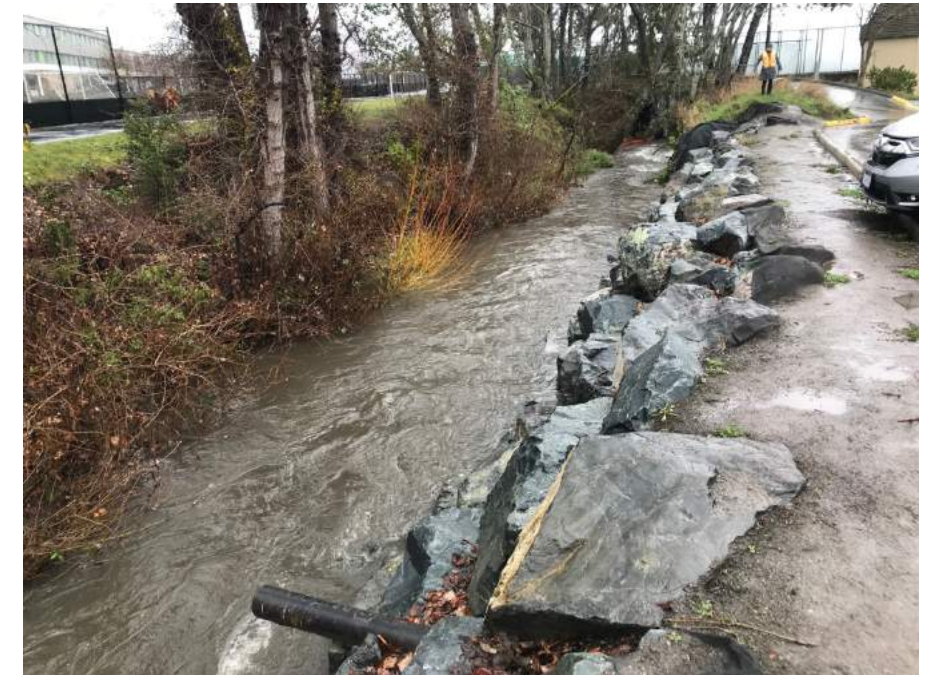
Photo 5A-15. Recent riprap erosion protection along the south bank and the Oak Bay Recreation Centre parking lot is immediately adjacent to the creek (view downstream in winter flows).

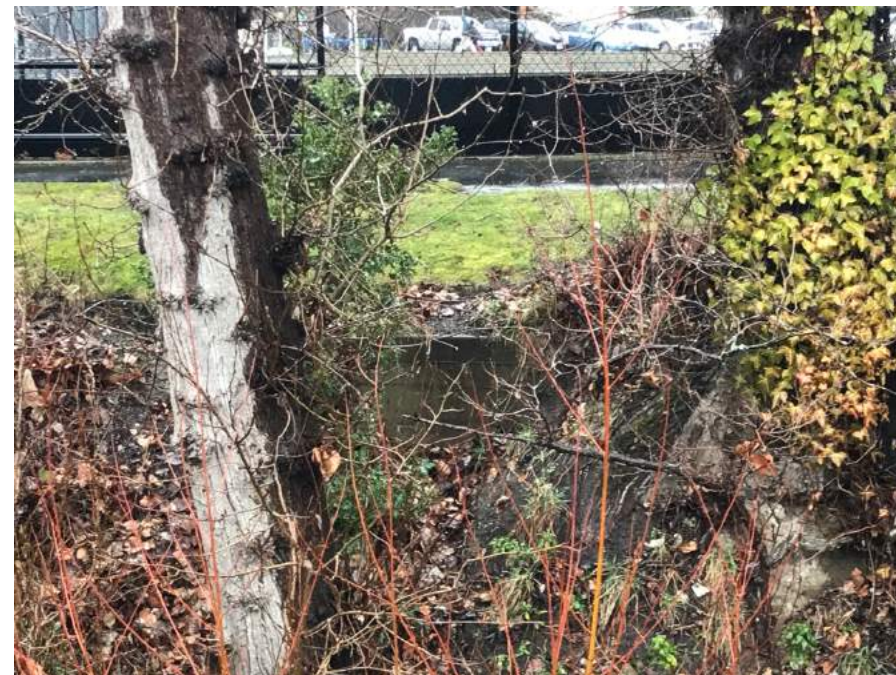
Photo 5A-16. In winter, the concrete retaining wall along the upper slope of the north bank is visible.

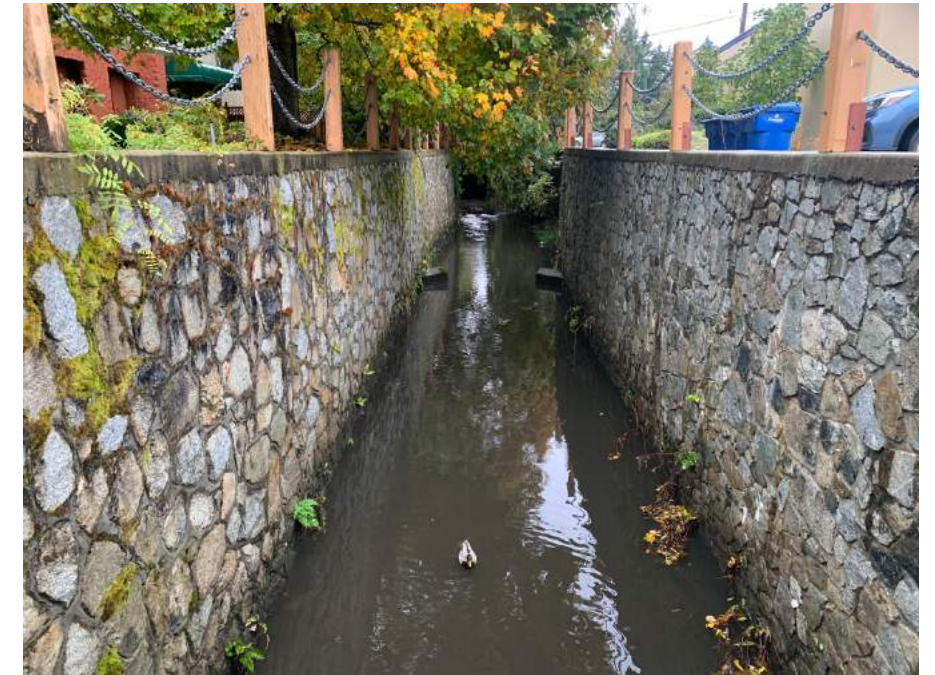
Photo 5B-3. Vertical masonry walls and mixed cobble on hardened channel bottom. Weir structure visible midreach (view upstream from Bee Street).

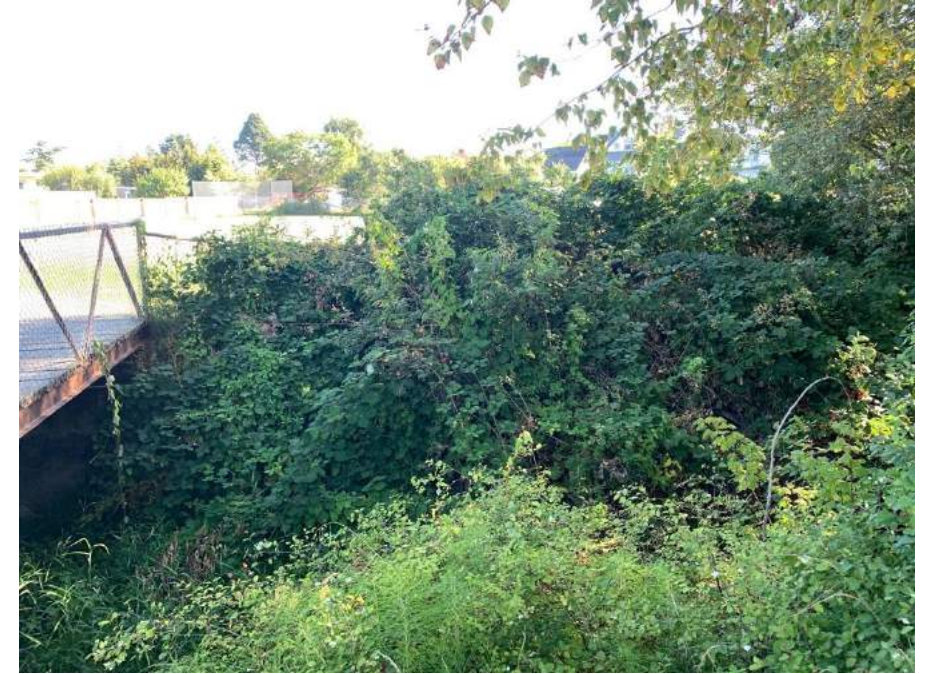
Photo 7A-3. Lower end of reach (45m section downstream of footbridge), restoration demonstration area. Himalayan blackberry patch should be removed.

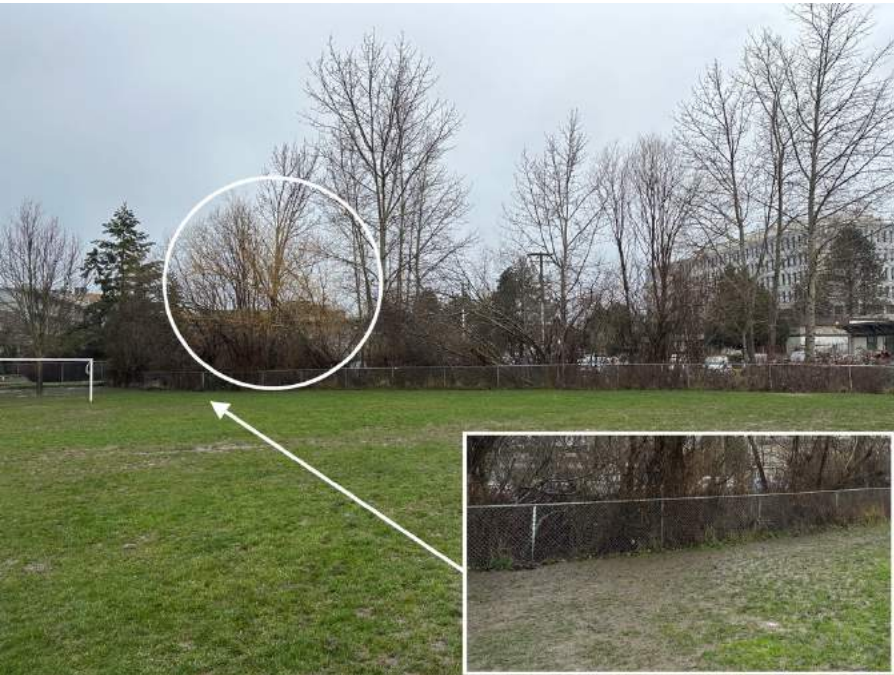
Photo 7A-13. The 45m section of restoration downstream of the footbridge is an example of where the transition to a mature native tree canopy allows for the removal of the only mature golden willow remaining in this section while maintaining wildlife values. The inset demonstrates the opportunity for riparian widening of vegetation.

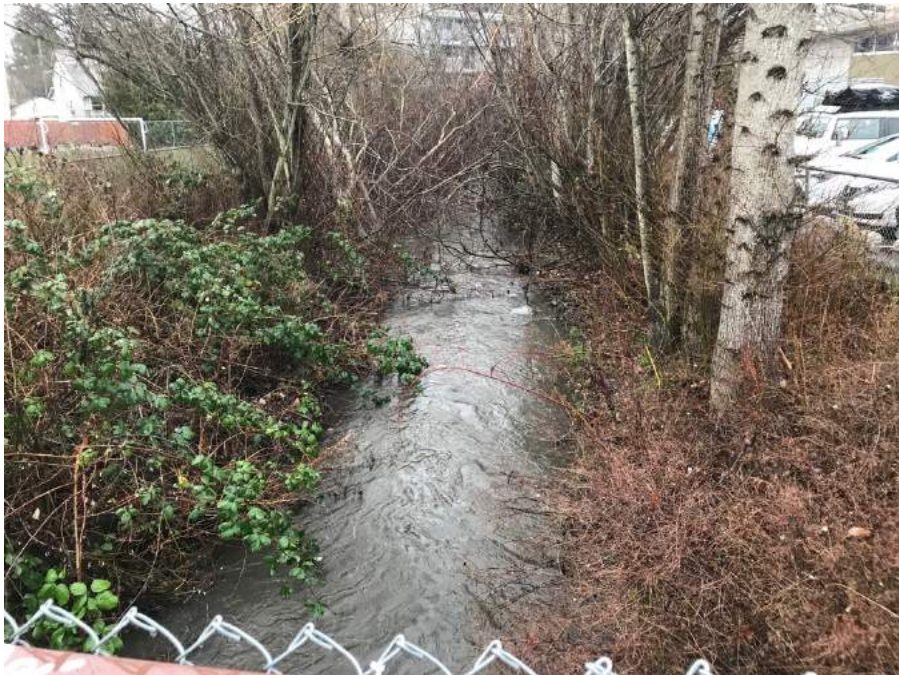
Photo 7A-15. The 45m restoration area looking downstream from the footbridge in winter. Himalayan blackberry beginning to encroach.

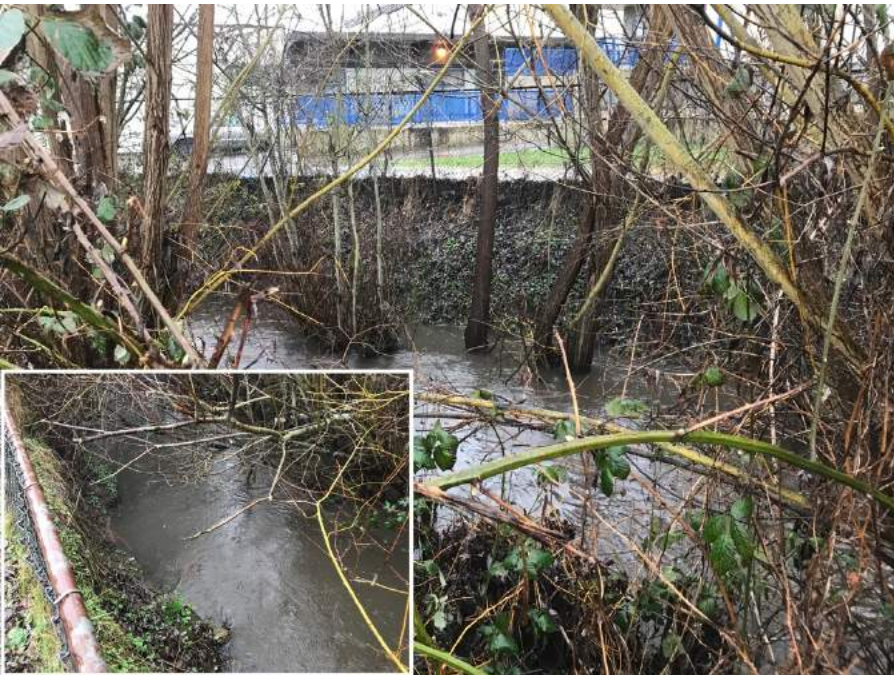
Photo 7A-16. Vertical banks bare of vegetation contribute to the sediment load in the creek and are vulnerable to erosion during high flows (upstream of footbridge view southwest/downstream).

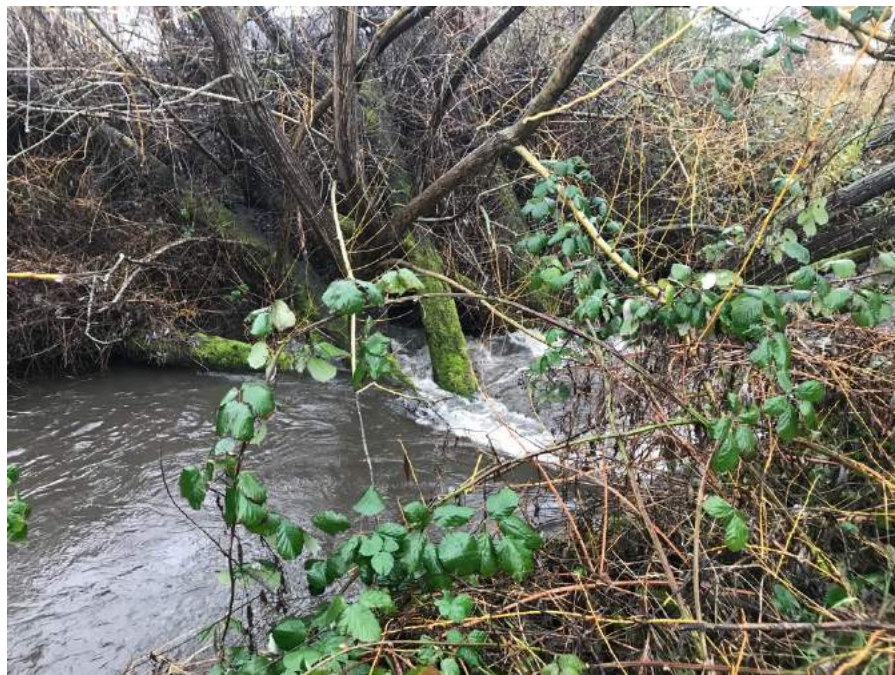
Photo 7A-22. Instream golden willows and debris jams create waterfalls during storm events (view downstream immediately south of Haultain Street).

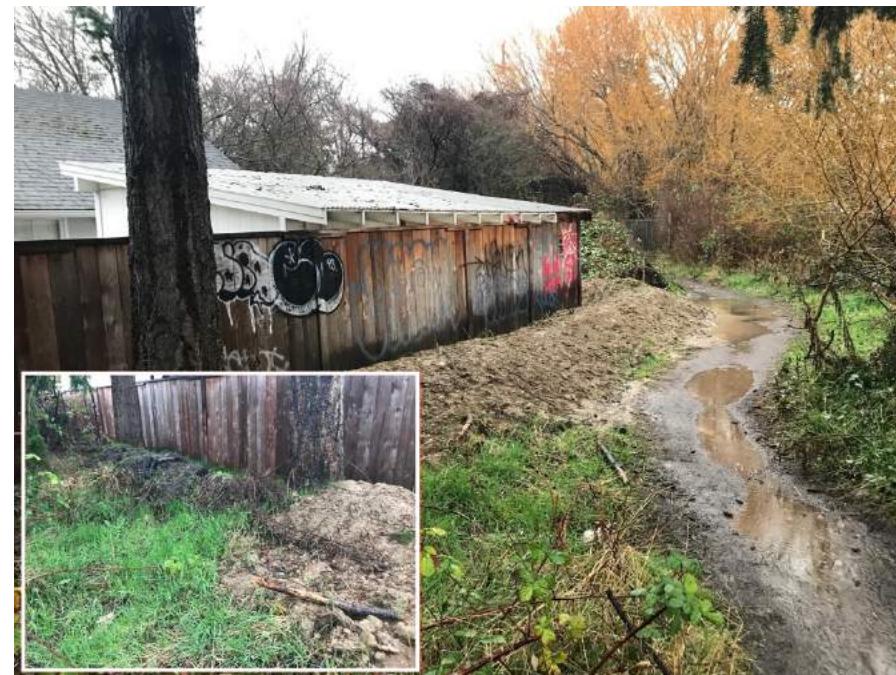
Photo 7A-23. New and old (inset) flood control measures have been installed in the upper reach immediately south of Haultain Street, in some cases leading to sediment-laden runoff (view north on west bank). Planted MSE bags or vegetated berms would be longer-lasting and have less sedimentation potential, especially in high flows.
